State of Wisconsin | DEPARTMENT OF NATURAL RESOURCES

Subject: **Notice of Violation - Chapter 283, Wis. Statutes  
Enforcement Conference - March 9, 2009**

### **3. POTENTIAL VIOLATIONS**

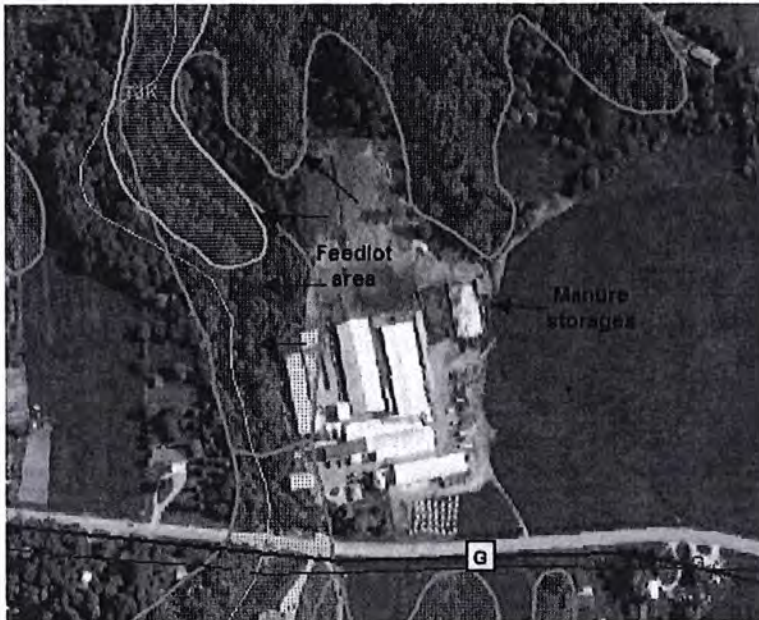
## MAIN FARM LOCATION

Current runoff concerns at the Main Farm location are in regards to the outdoor cattle areas. There are outdoor walkways around the perimeters of the barns that do not provide any containment of manure and storm water runoff. Outdoor "exercise areas" for cows are also utilized to the north of the barns. This area is not vegetated and has steep grades sloping toward the stream (unnamed tributary of Bower Creek) that runs along the western edge of the farm. Please see attachment of photos of Main Farm provided by Brown County Land Conservation.

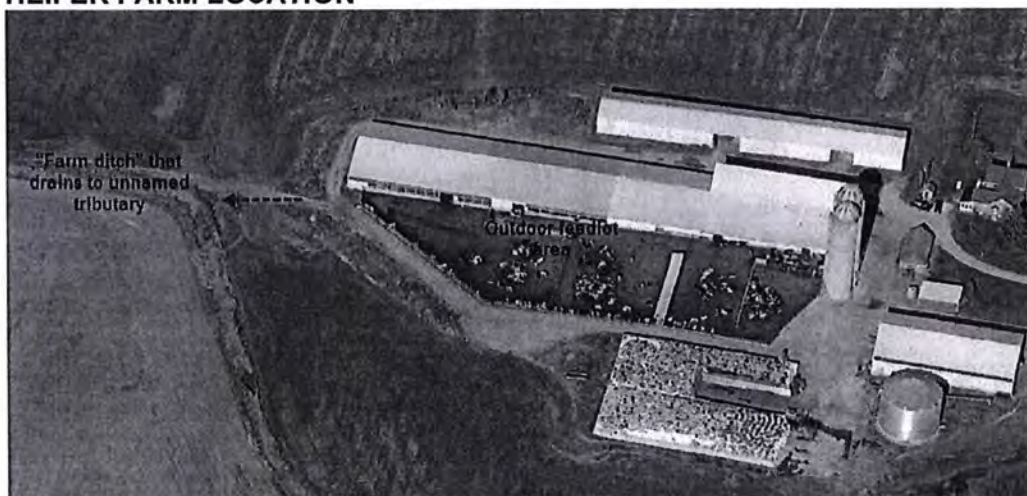
## HEIFER FARM LOCATION

The Heifer Farm has a large feedlot area in which all runoff drains to the west and flows off the feedlot and into a nearby drainage ditch. This ditch connects to the tributary to Bower Creek. The farm owners have recently installed roof gutters to prevent clean storm water from the roof from adding additional runoff water that flushes the manure off of the feedlot. Jason Pansier, co-owner, also indicated they were adding additional straw to help soak up and keep the manure on the feedlot. Permanent measures at the low end of the feedlot need to be installed. Pansier indicated they could do this, however, do not want to submit plans to the county as is required by Brown County ordinance and would be required under a CAFO permit.

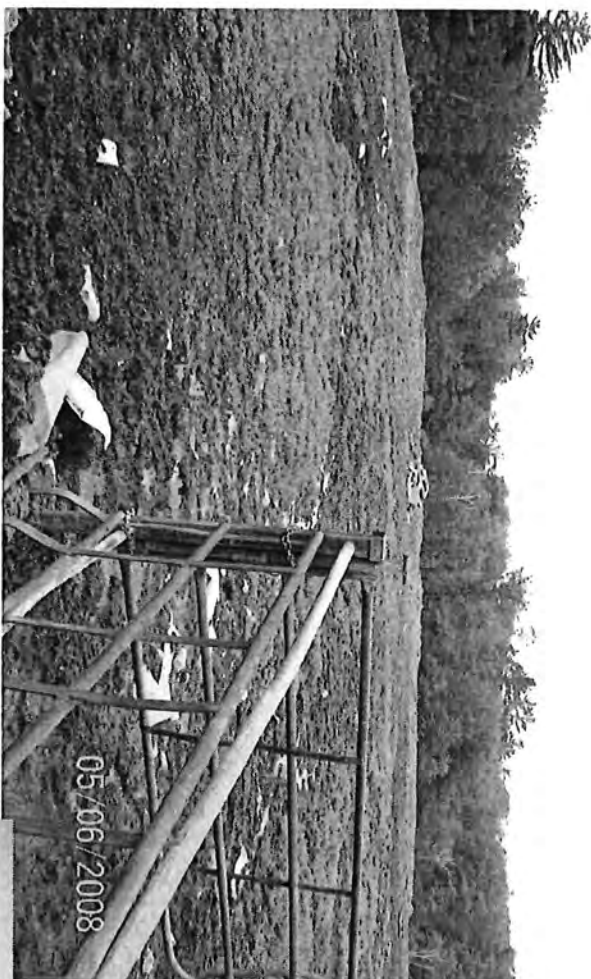
Looking northwest at outdoor lot areas. Areas are just west and north of the free stall barns. Note fill material that has been dumped along the edge of the drop off to the tributary.

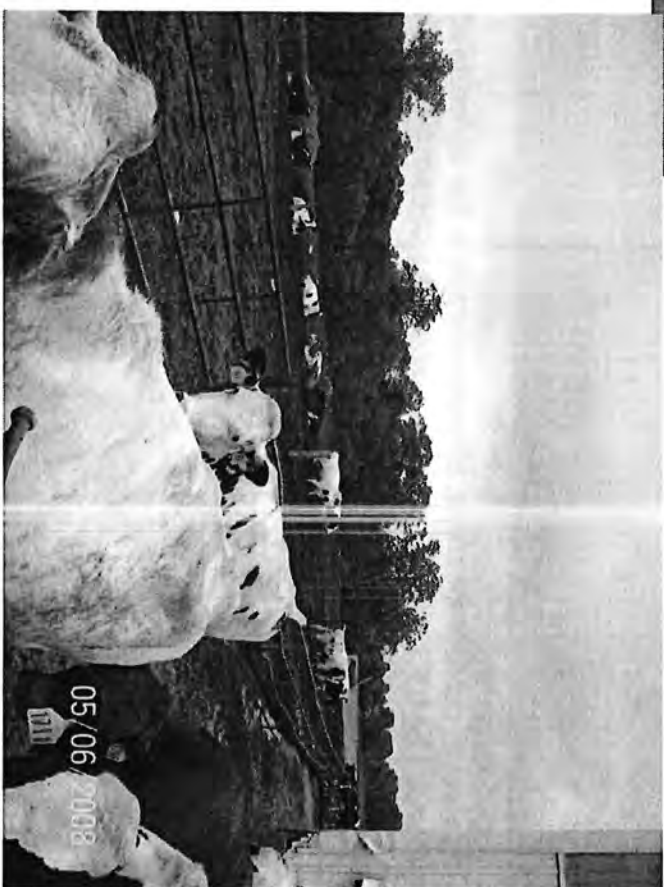
Outdoor feedlot area fenced along the free stall barn. Note that none of the manure and runoff from this area is contained.

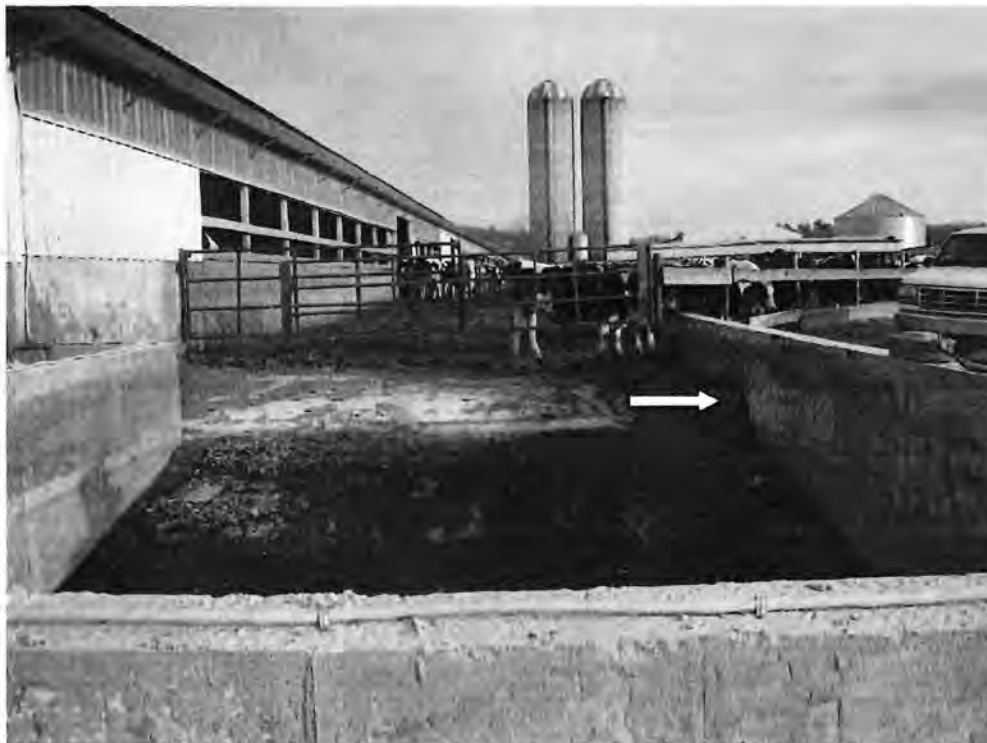
(Leak area shown with arrow, patched with roofing tar)

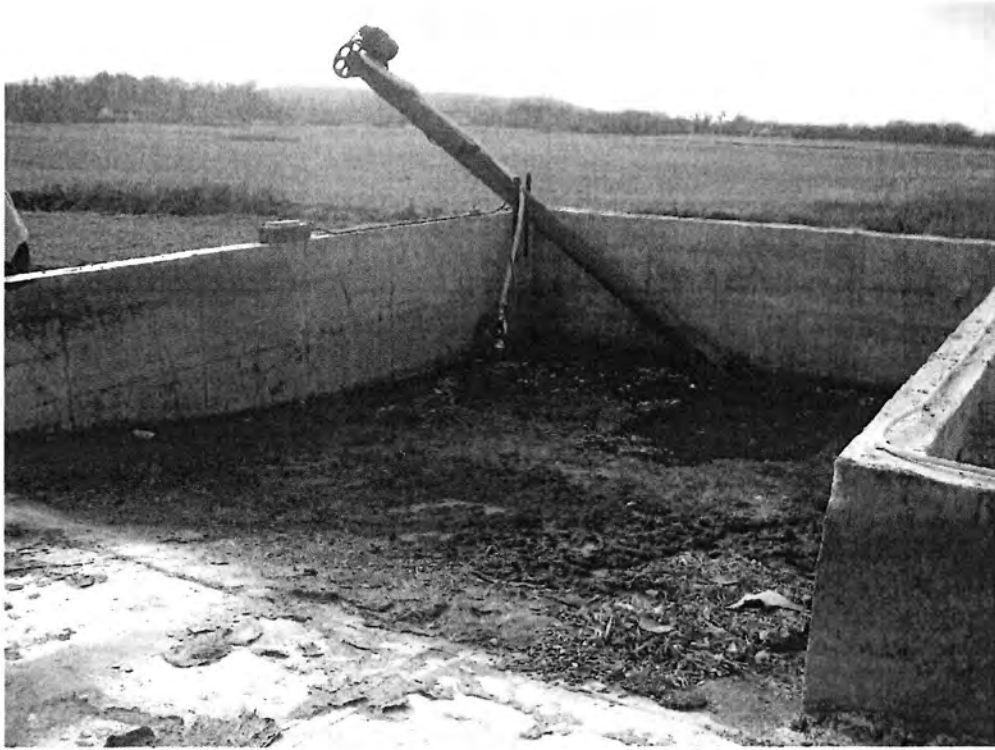
Auger/Sump/Pump

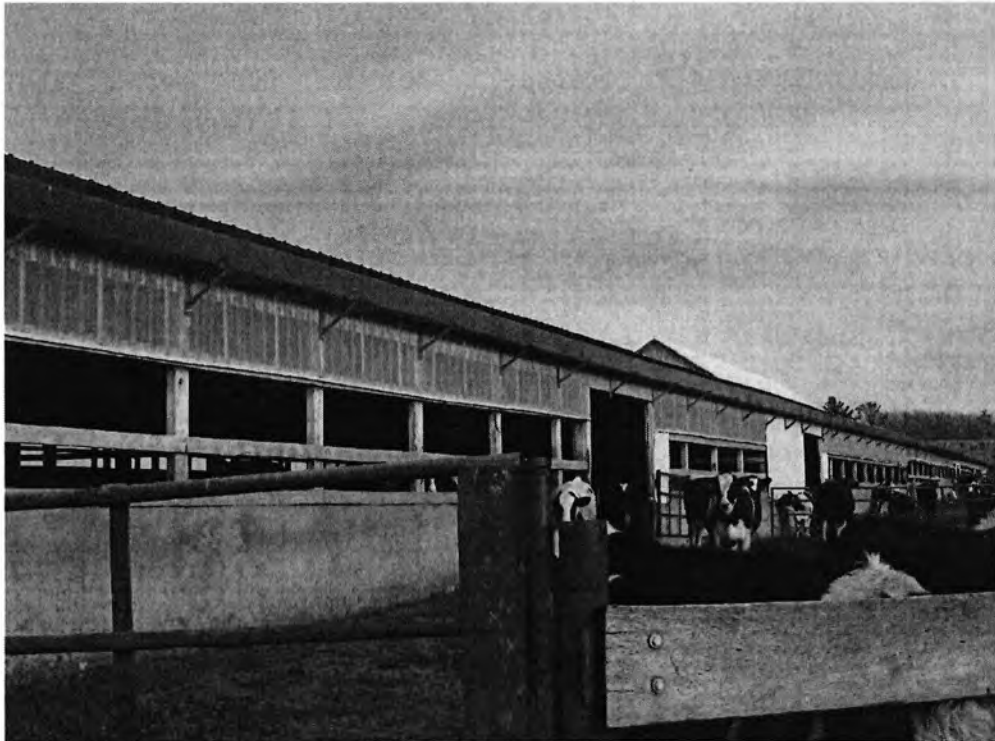
Gutters

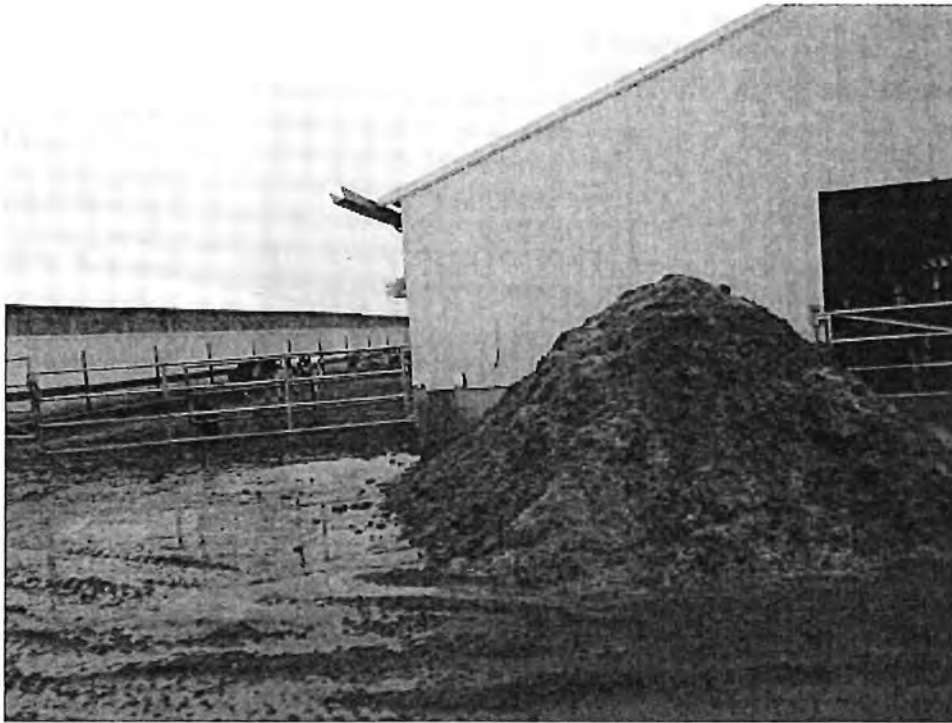
Description: A stockpile of used bedding material was located east of Calf Barn 2. The process wastewater from the open lot and stockpile had no containment and could flow east off site to unnamed tributary on the east side of the site.

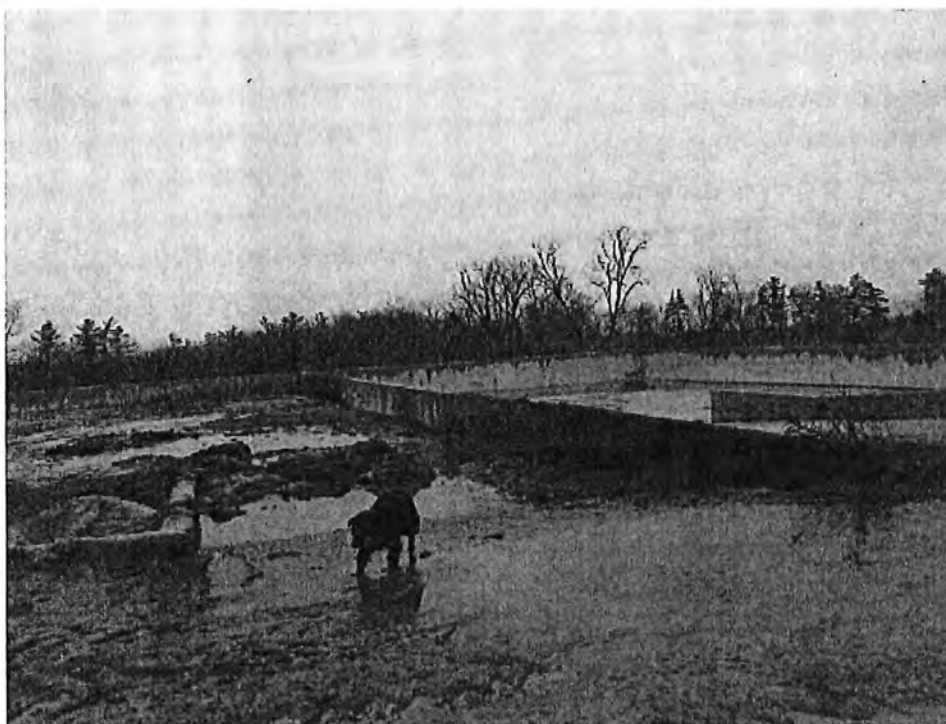
Description: A stockpile of used bedding material was located east of Calf Barn 2. The process wastewater from the open lot and stockpile had no containment and could flow east off site to unnamed tributary.

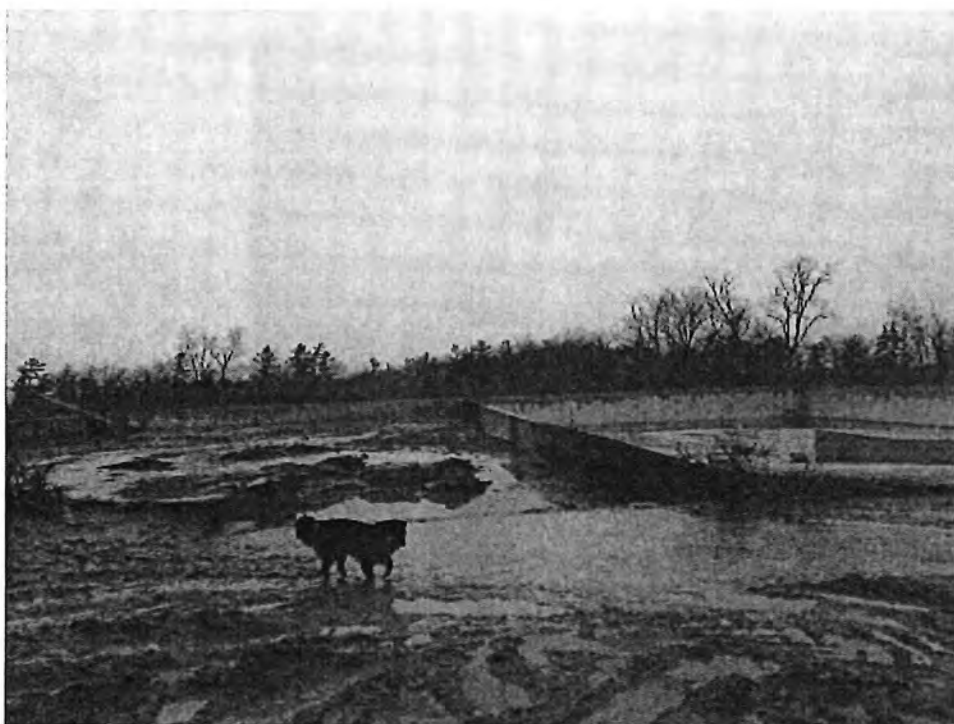
Description: The west concrete pit was approximately half full. The east concrete pit was nearly empty. The water in the east pit was dark and smelled septic.

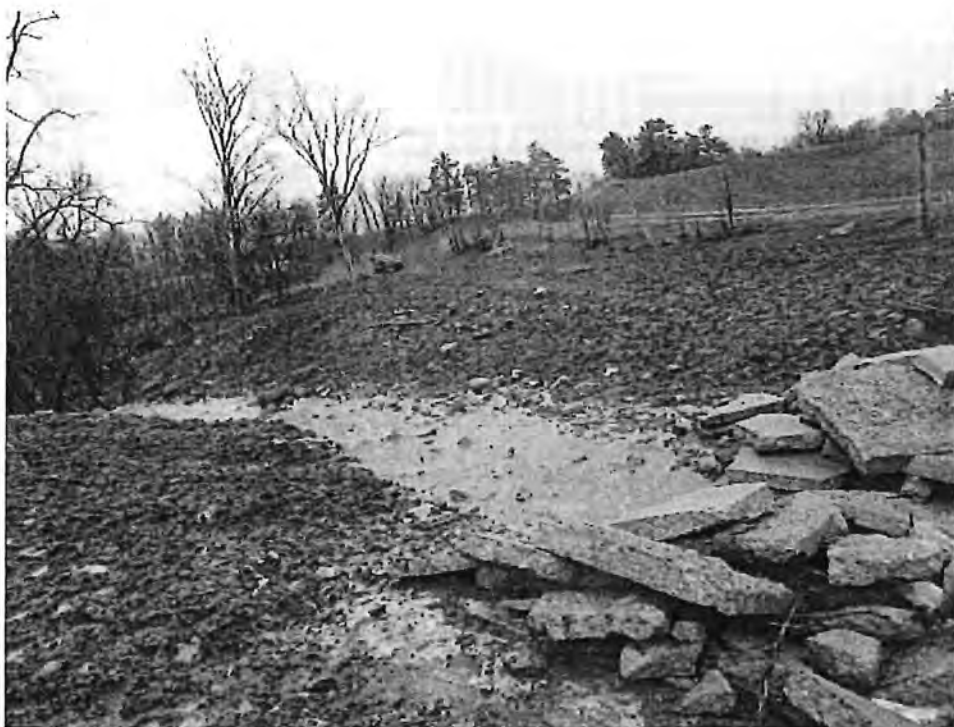
Description: An unnamed tributary flows along the east end of the production area. Cattle had direct access to the unnamed tributary through an open lot. Manure was observed in and around the tributary.

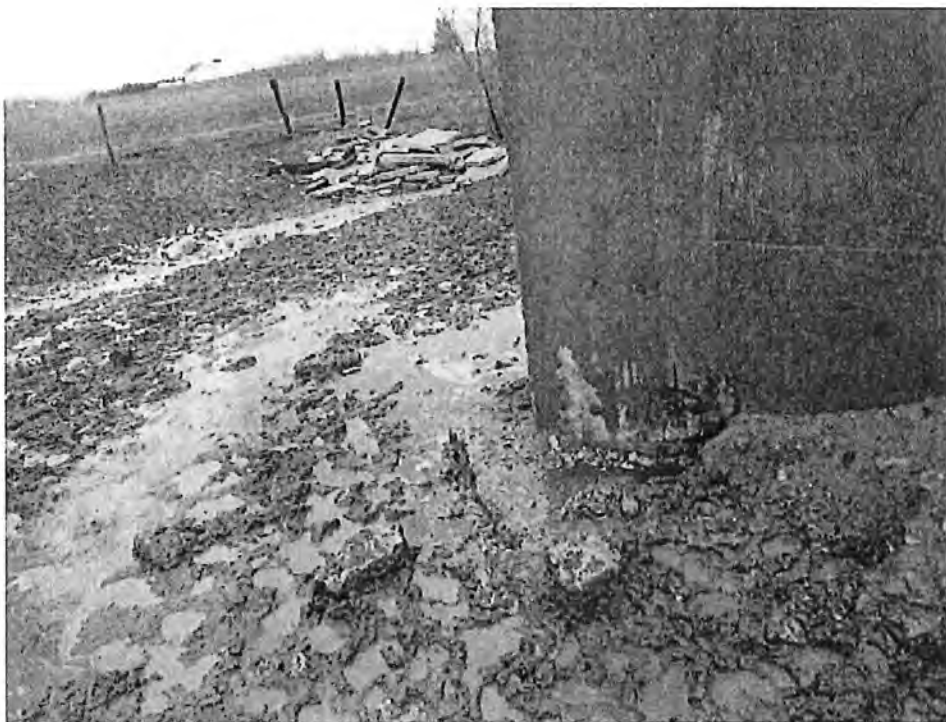
Description: An unnamed tributary flows along the east end of the production area. Cattle had direct access to the unnamed tributary through an open lot. Manure was observed in and around the tributary.

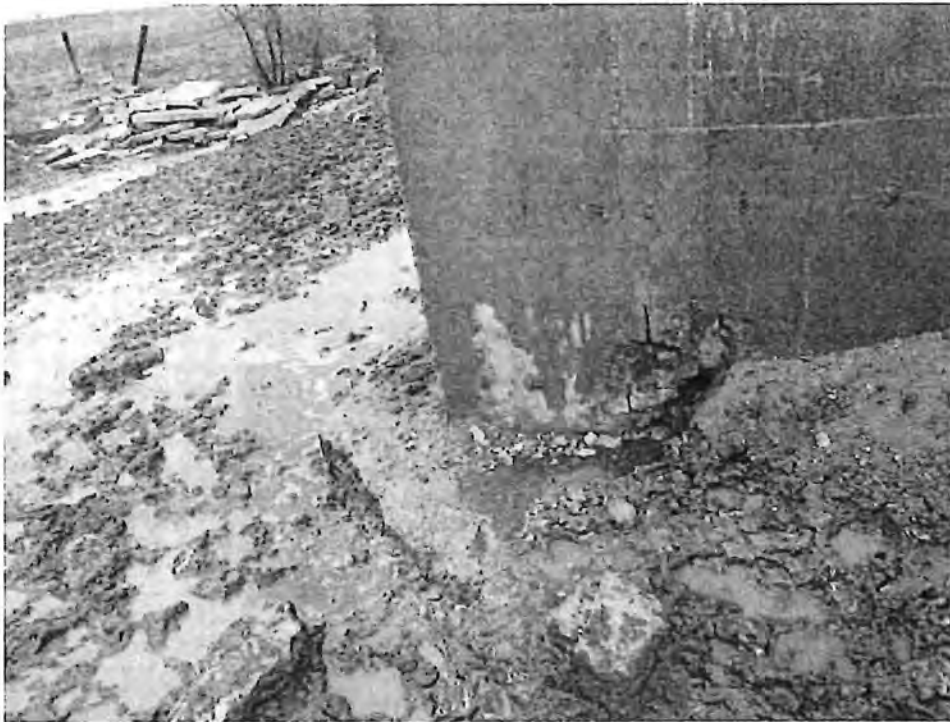
Description: A hole was observed in the corner of the east concrete pit. Mr. Pansier said the pit was currently not used for manure storage. The discharge from the hole in the pit was dark in color and had a septic smell of wastewater. The flow from the hole in the east concrete pit flowed east and entered the unnamed tributary.

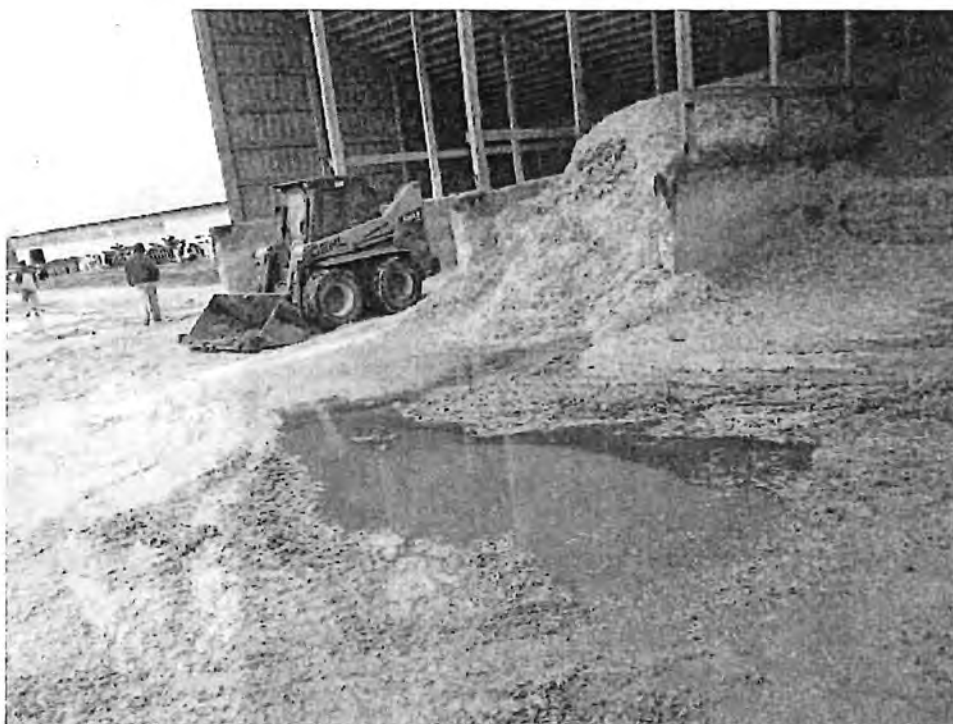
Description: The west concrete manure storage pit was approximately half full.

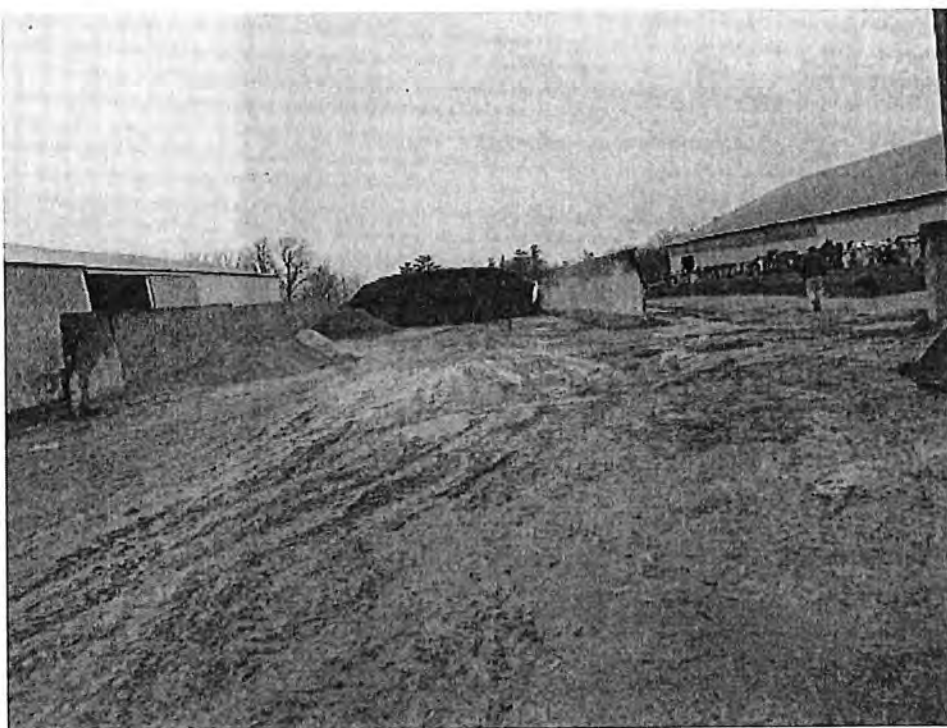
Description: Track out of feed was located on the access way from the commodity storage area.  
The process wastewater flowed north.

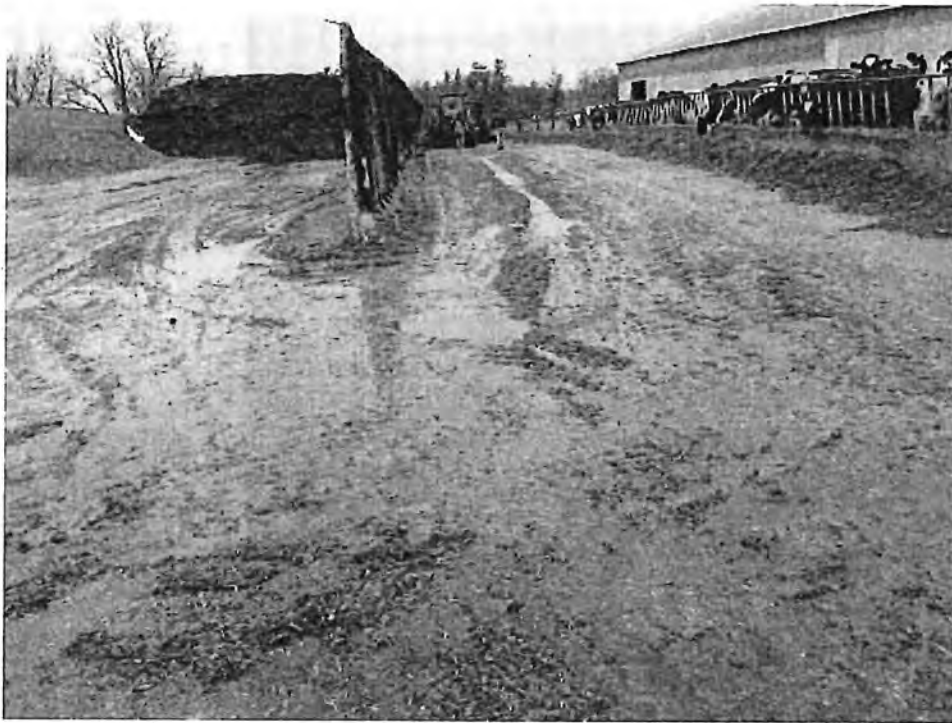
Description: The feed storage bunker did not have containment for process wastewater. Feed was observed on the ground throughout the area. The area drains to the north.

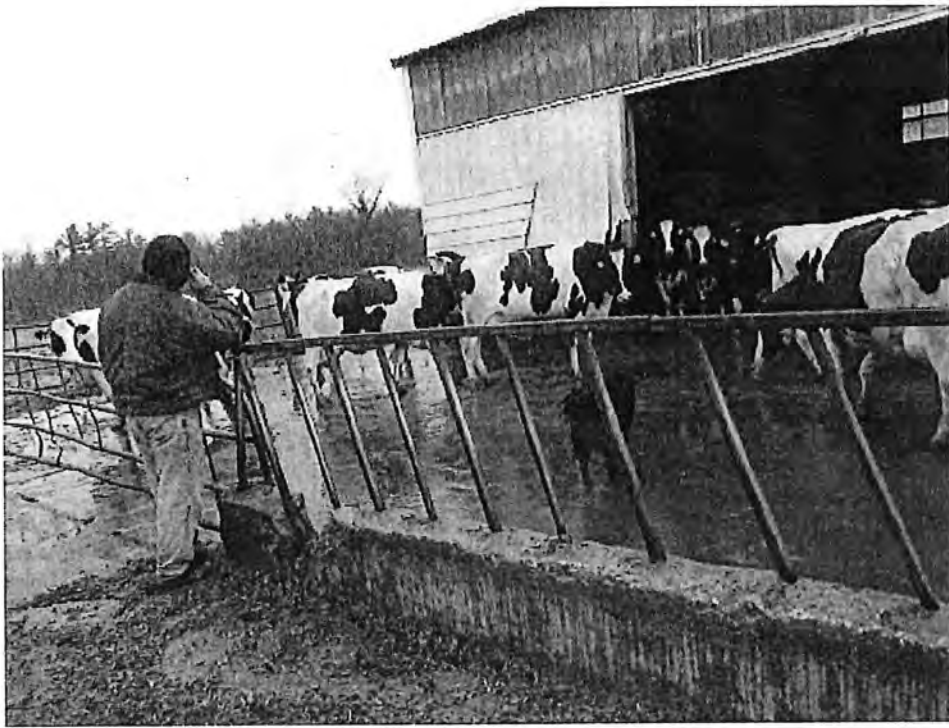
Description: The access way contained feed solids and process wastewater that flowed to the north. The open lot did not have containment for manure and process waste water; the runoff flows north.

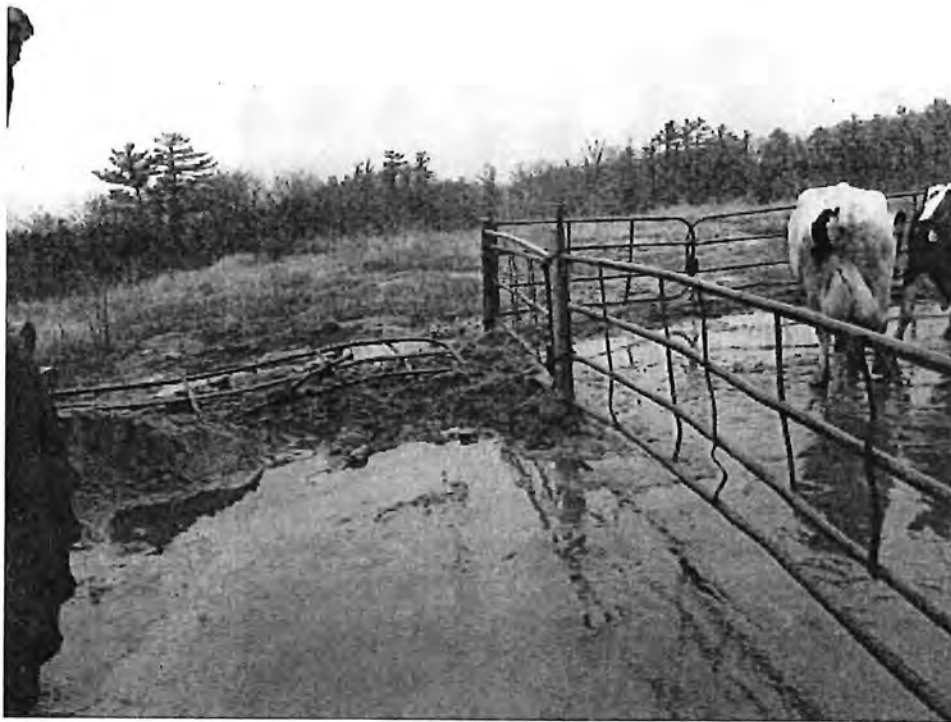
Description: The manure and process wastewater from the open lot drains north.

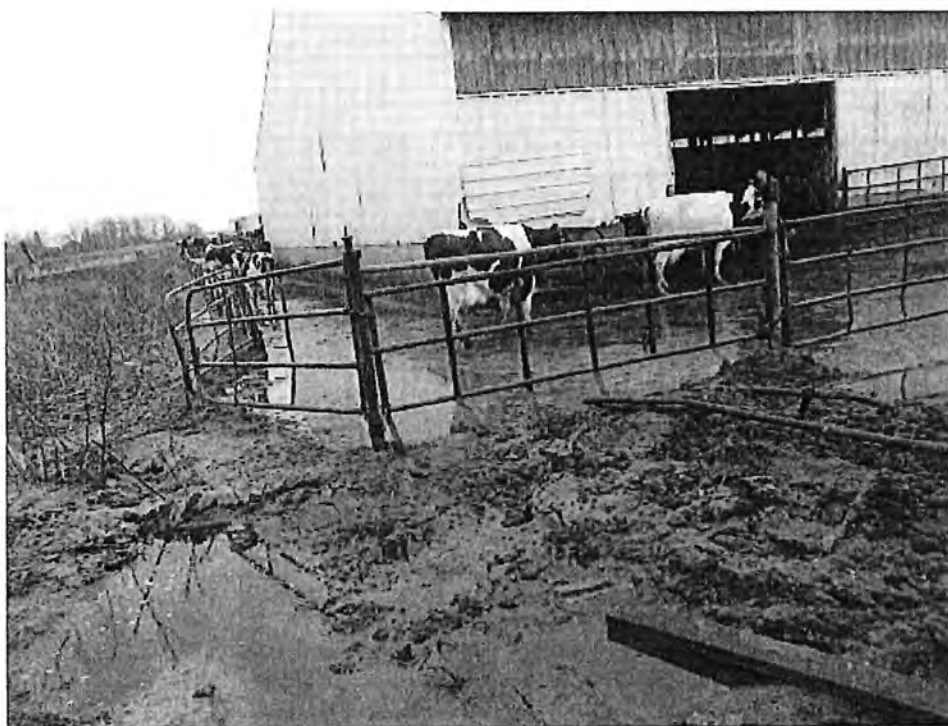
Description: Feed solids, bedding, manure, and process waste water flowed north between the Feed Bunker and Milk Cow Barn and outlet into a field that was once used as an open lot. Feed, manure, and process wastewater were ponded in the field.

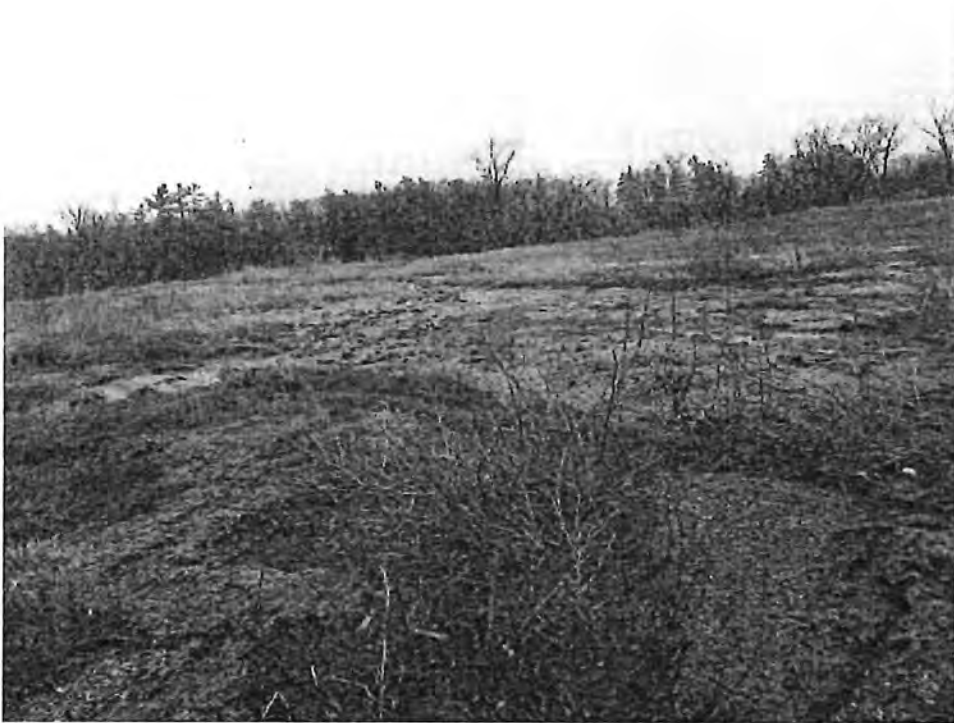
Description: The open lot drained to the north.

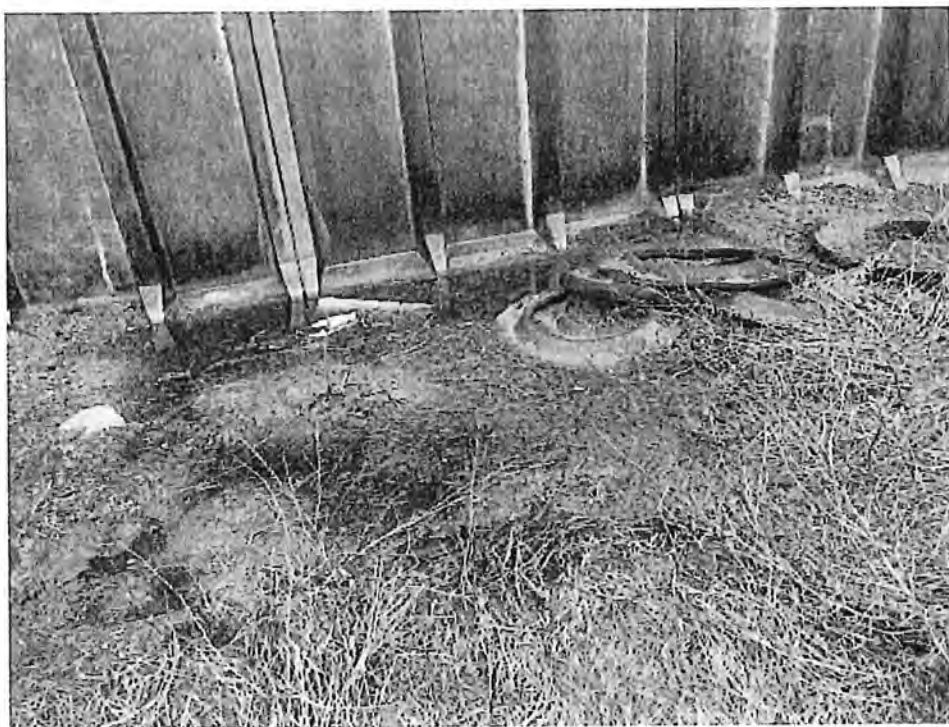
Description: Feed, bedding, and manure solids were observed throughout the field north of the Milk Cow Barn. The field sloped to the north.

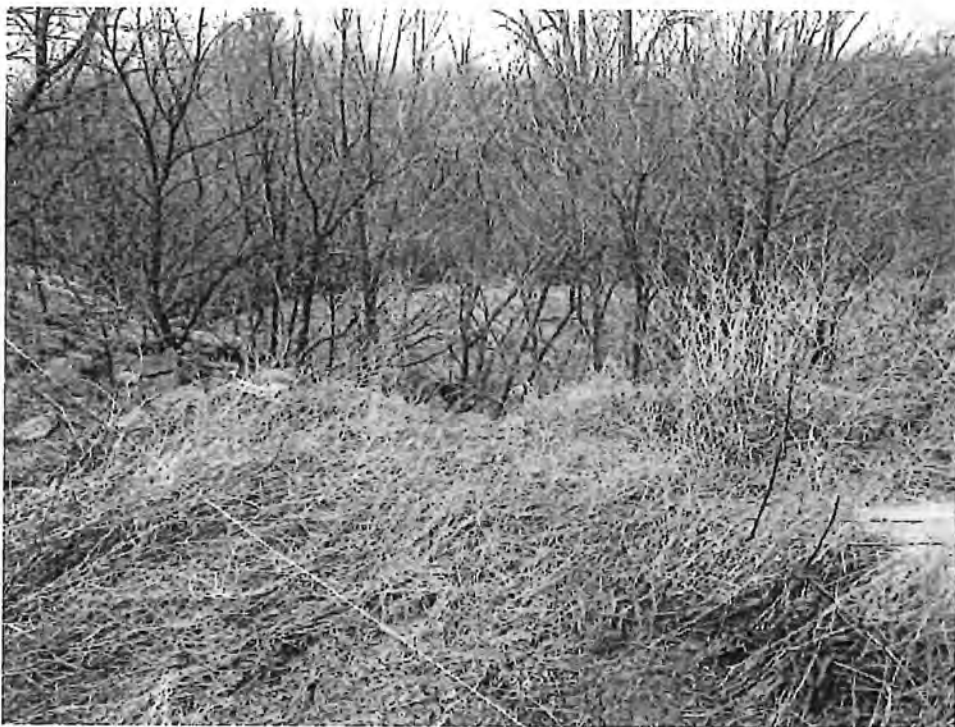
Description: Leachate was observed at the north end of the Feed Bunker.

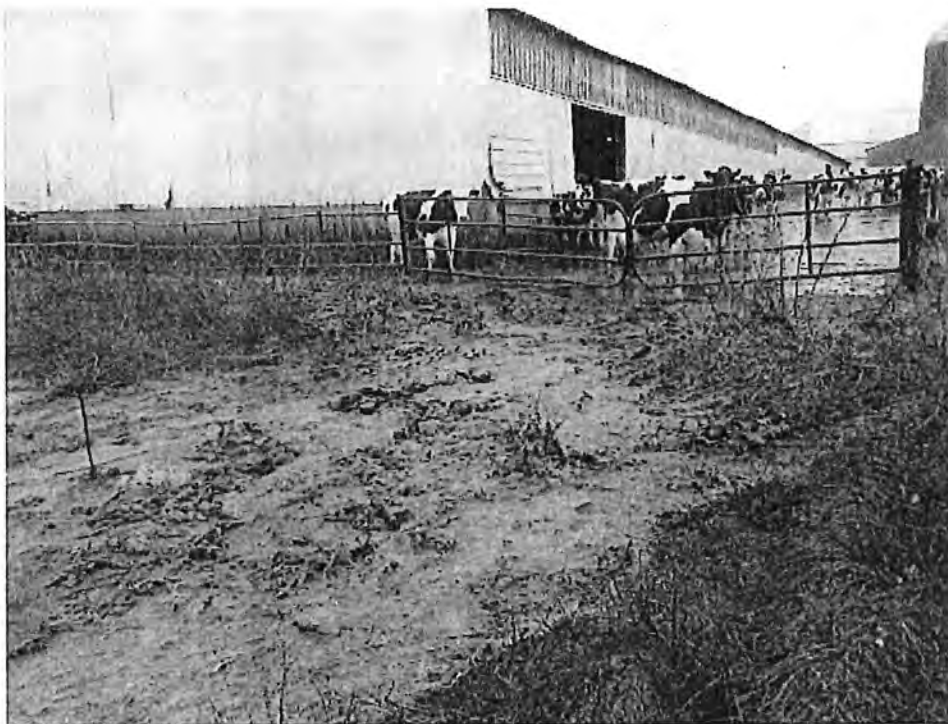
Description: The leachate from the Feed Bunker looked as if could flow west off the ledge at the north end of the Feed Bunker.

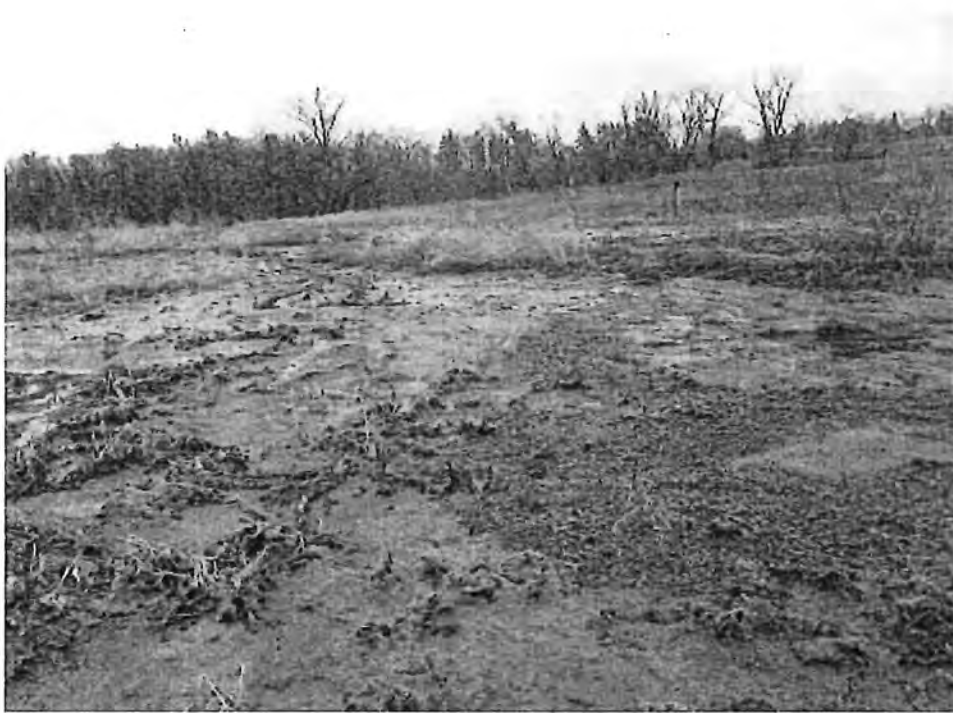
Description: Feed, bedding, manure, and process waste water flowed to the north. Feed and manure solids were observed throughout the field on the north end of the Milk Cow Barn.

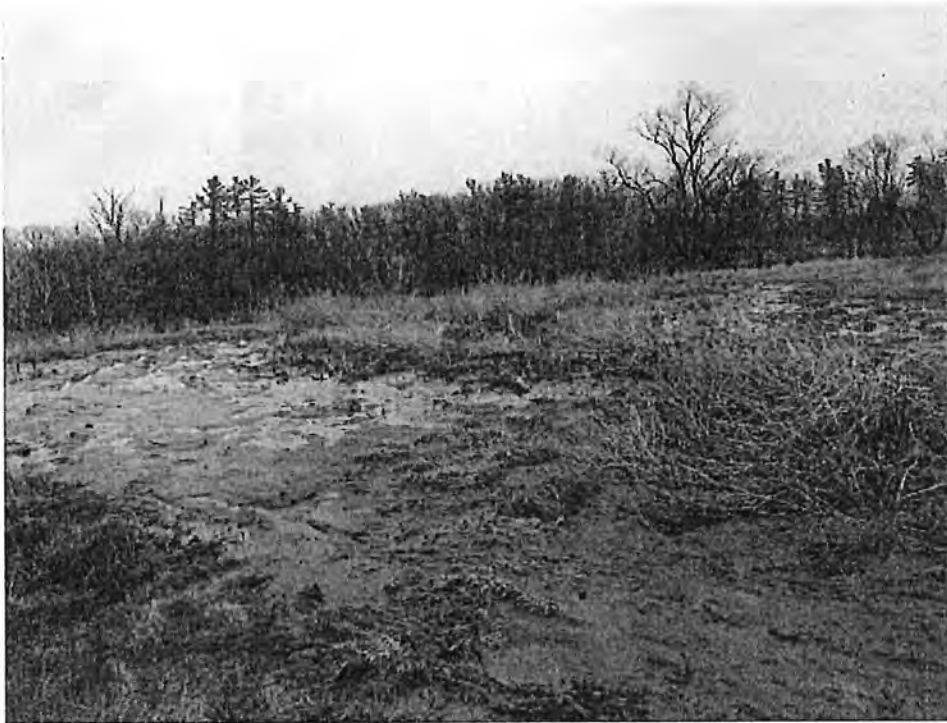
Description: Feed, bedding, and manure solids were observed throughout the field north of the Milk Cow Barn. Manure and process wastewater were ponded throughout the field. The area drained to the north.

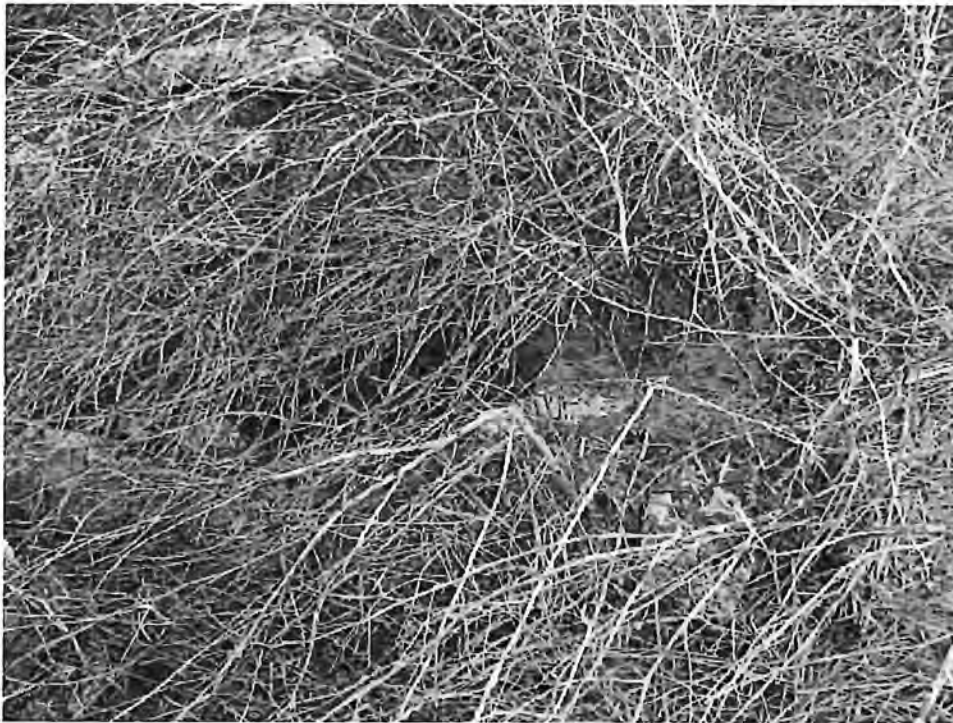
Description: Feed, bedding, and manure solids were observed throughout the field north of the Milk Cow Barn. Manure and process wastewater were ponded throughout the field. The area drained to the north.

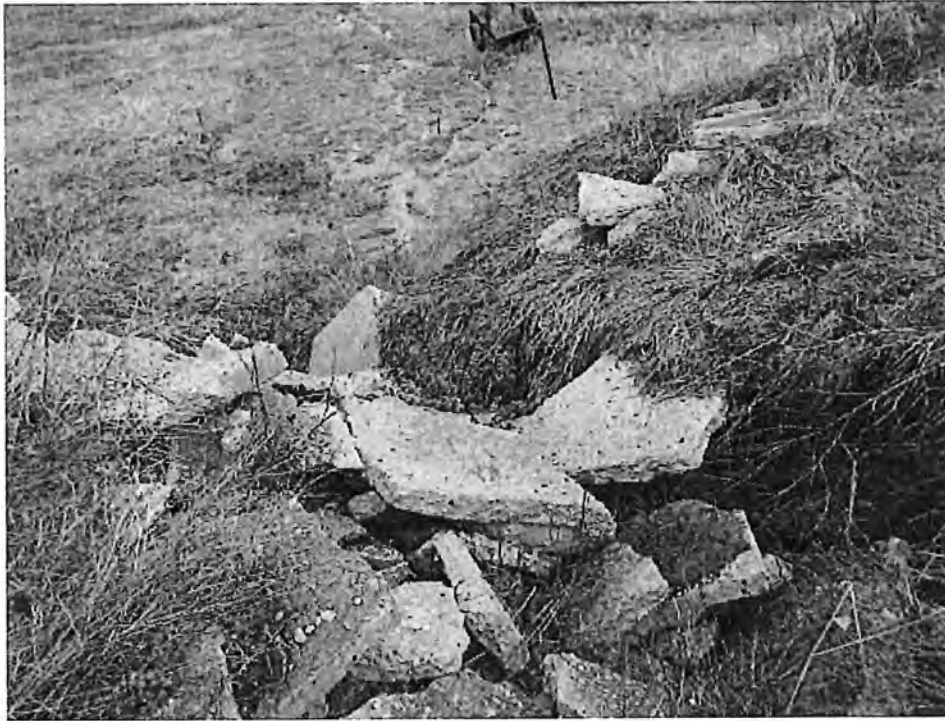
Description: Flow from the field concentrated into multiple pathways.

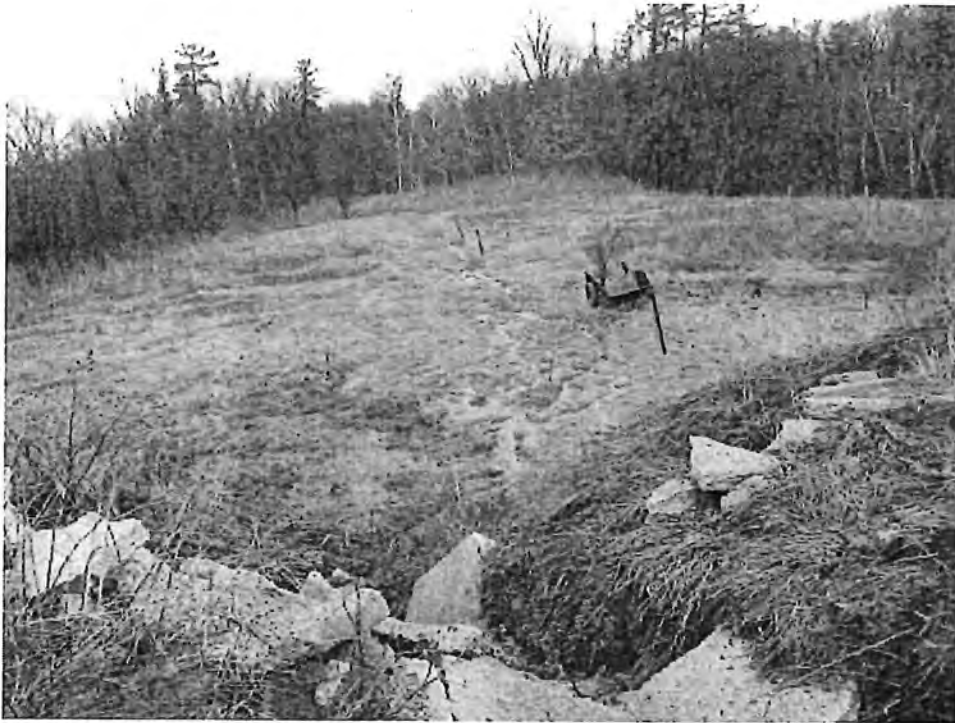
Description: A pathway flows to the north through the field north of the Milk Cow Barn. Rip rap was placed throughout the pathway along the elevation drop.

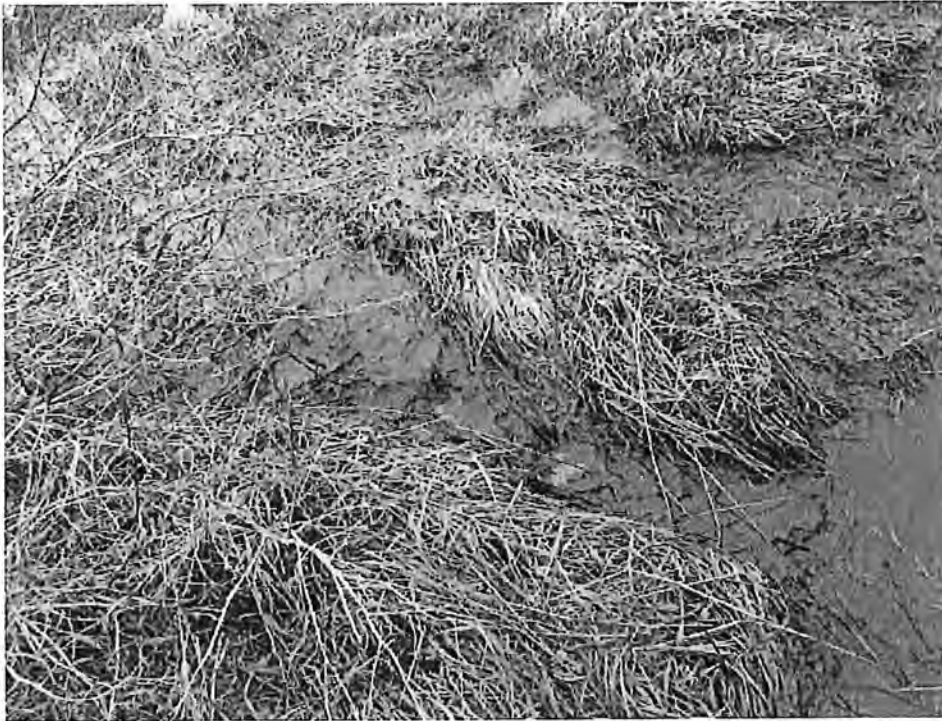
Description: The pathway continues north through the field north of the Milk Cow Barn and then continues west near the two small trees in the background. The pathway flows to the unnamed tributary.

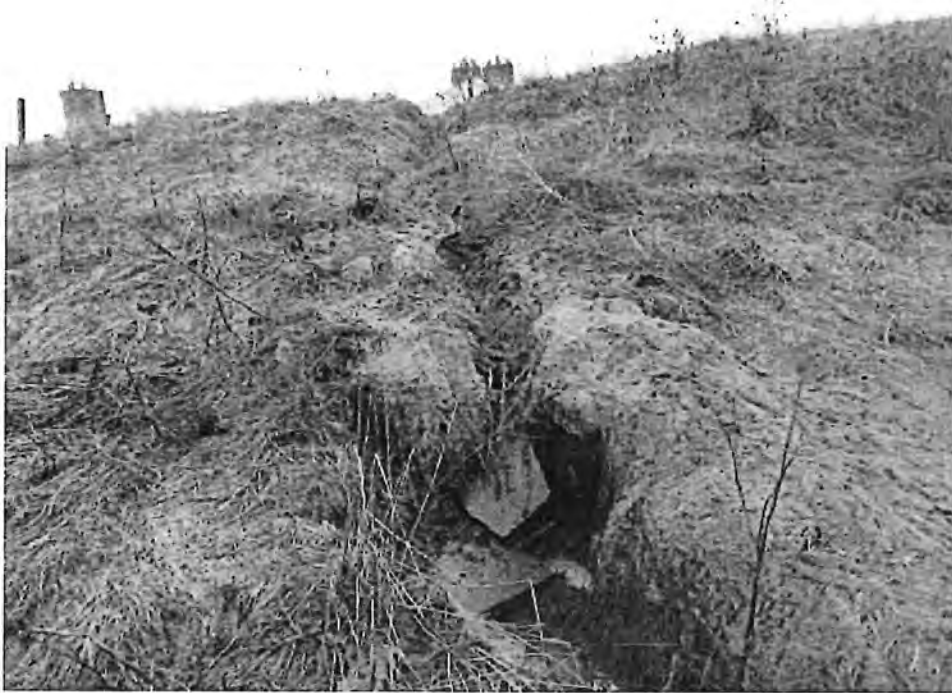
Description: Flow in the pathway in the field north of the Milk Cow Barn.

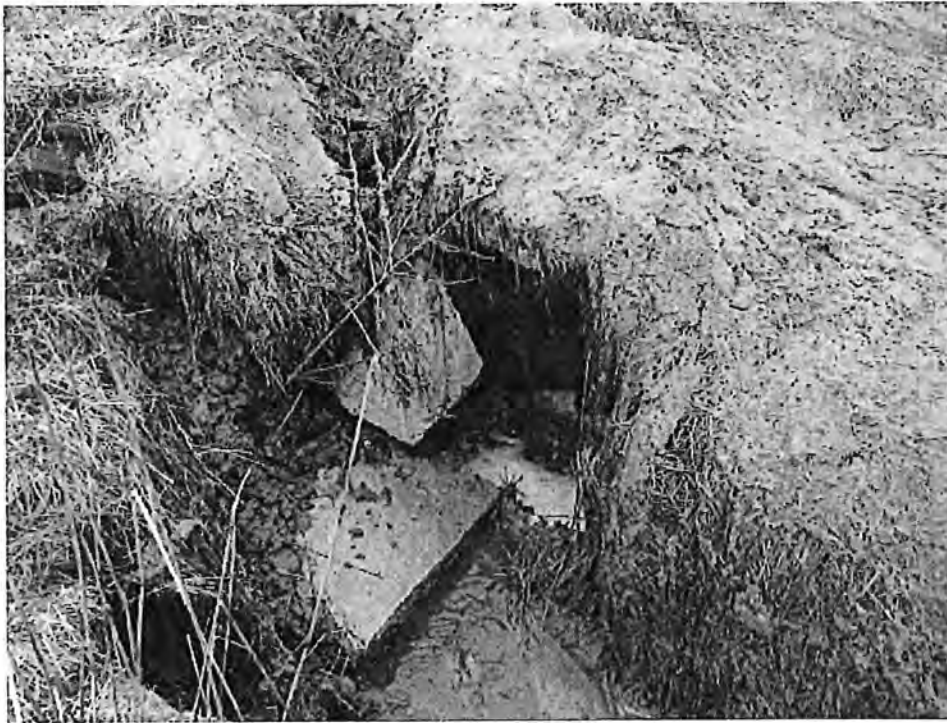
Description: Another flow pathway/gulley was observed on the east end of the field north of the Milk Cow Barn. Manure, feed, and bedding material were observed throughout the pathway. The flow in the pathway looked like the liquid that would be in a manure storage pond or slurry storage.

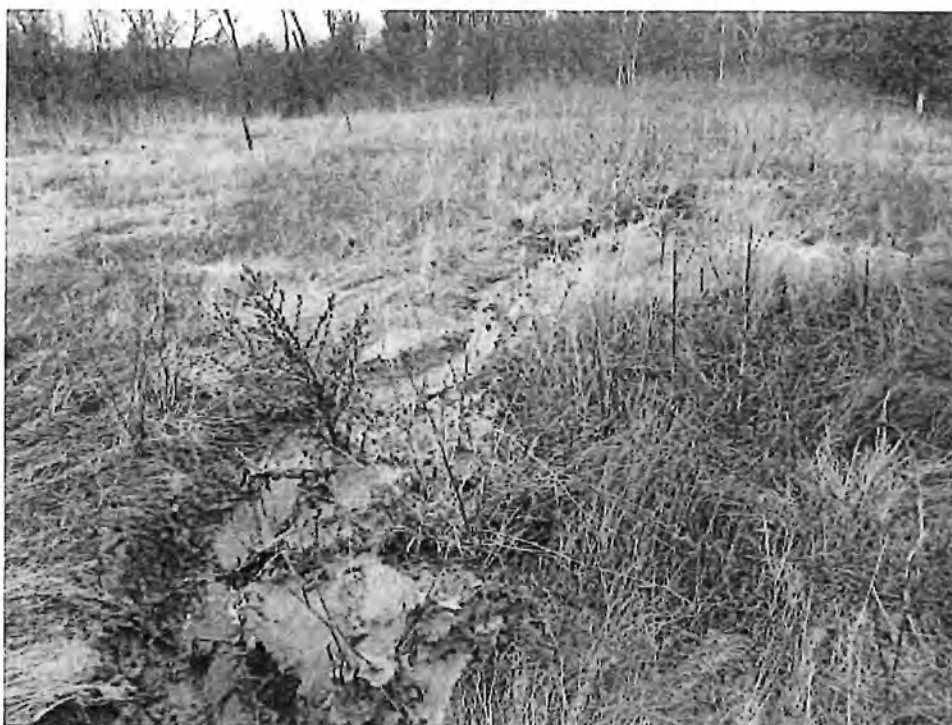
Description: Another flow pathway/gulley was observed on the east end of the field north of the Milk Cow Barn. Manure, feed, and bedding material were observed throughout the pathway. The flow in the pathway looked like the liquid that would be in a manure storage pond or slurry storage.
