State of Wisconsin | DEPARTMENT OF NATURAL RESOURCES

Subject: **Notice of Violation - Chapter 283, Wis. Statutes  
Enforcement Conference - March 9, 2009**

### **3. POTENTIAL VIOLATIONS**

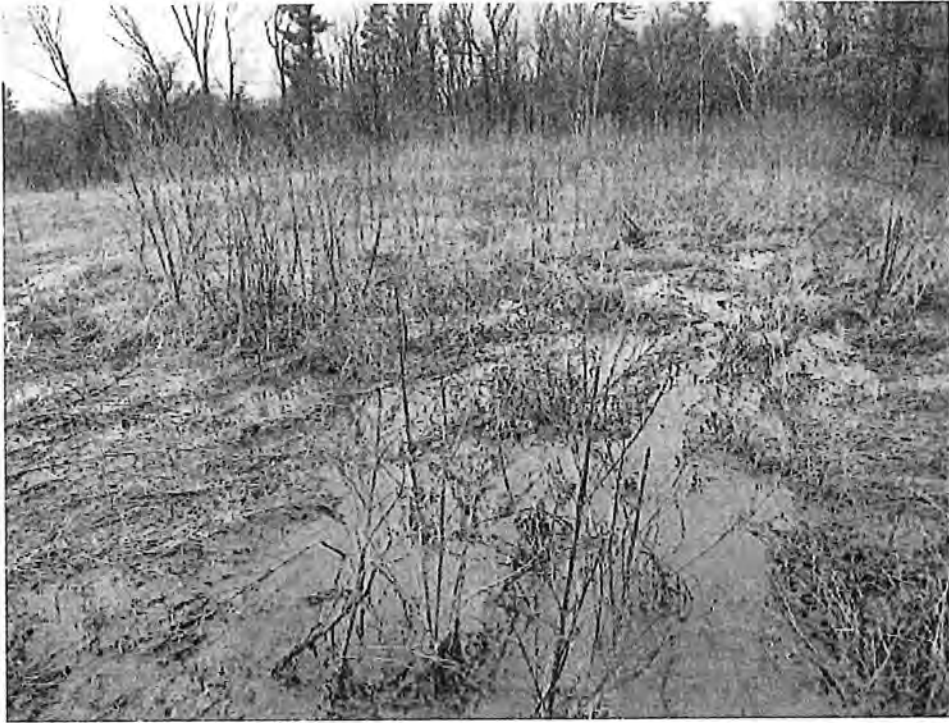
Description: Flow continued north from the pathway/gulley on the east end of the field north of the Milk Cow Barn.

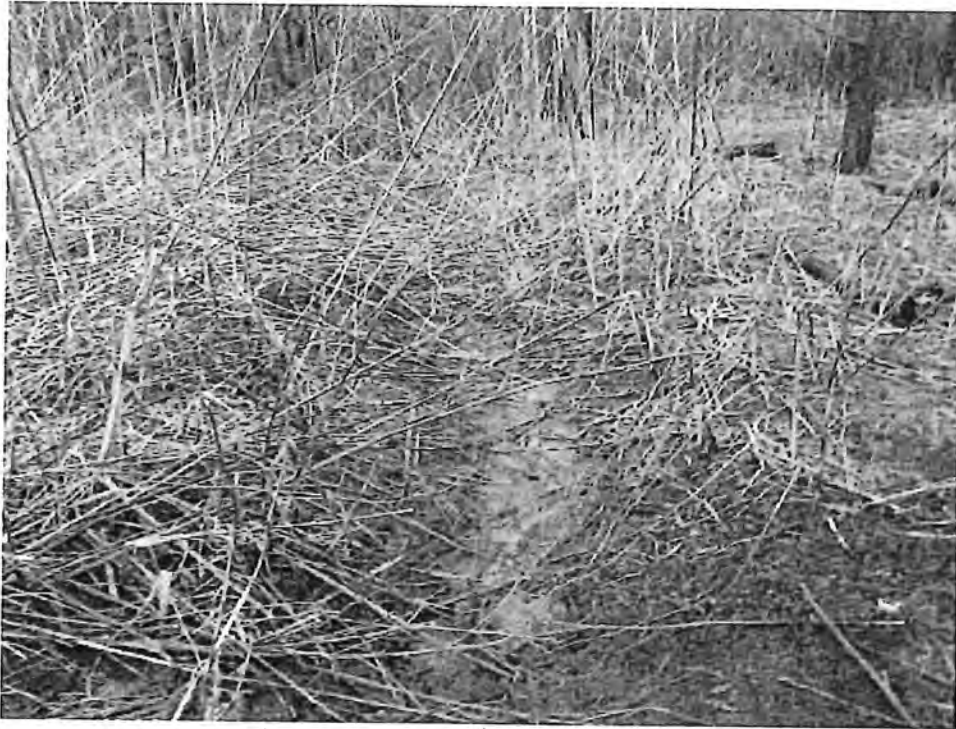
Description: The flow from the east pathway ponded at the end of the field. Portions of this area drained to the west and connected with the other pathway. Other portions of the flow continued north in a pathway that eventually dissipated. On the east side of the ponded area there was an eroded pathway that continued east, however, flow was not observed in this pathway during the inspection.

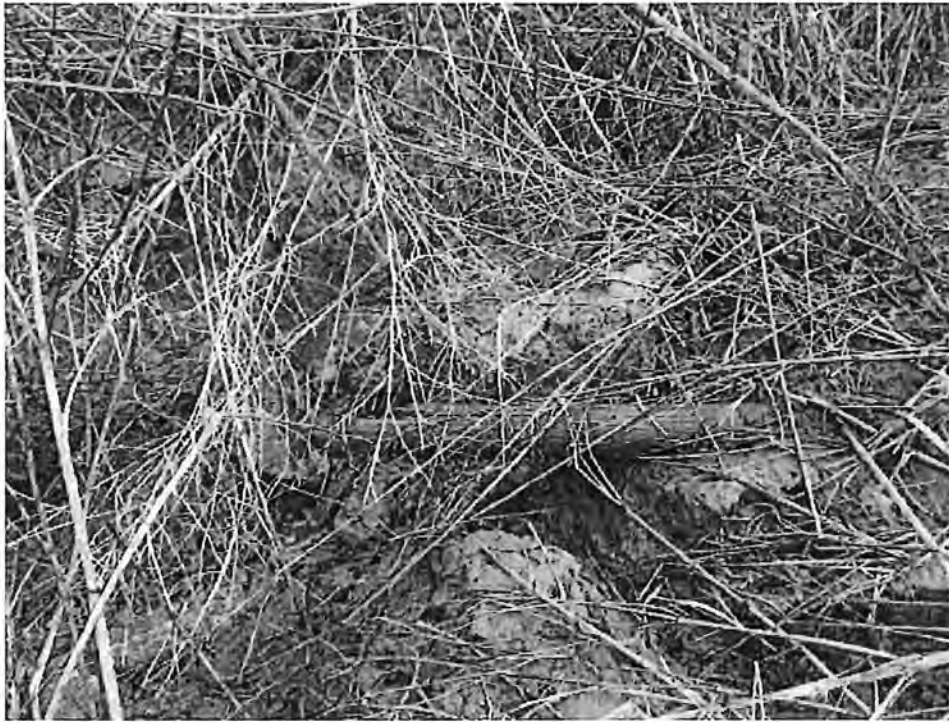
Description: The flow in the pathway continued west and dropped down the ledge into the unnamed stream bordering the west end of the facility.

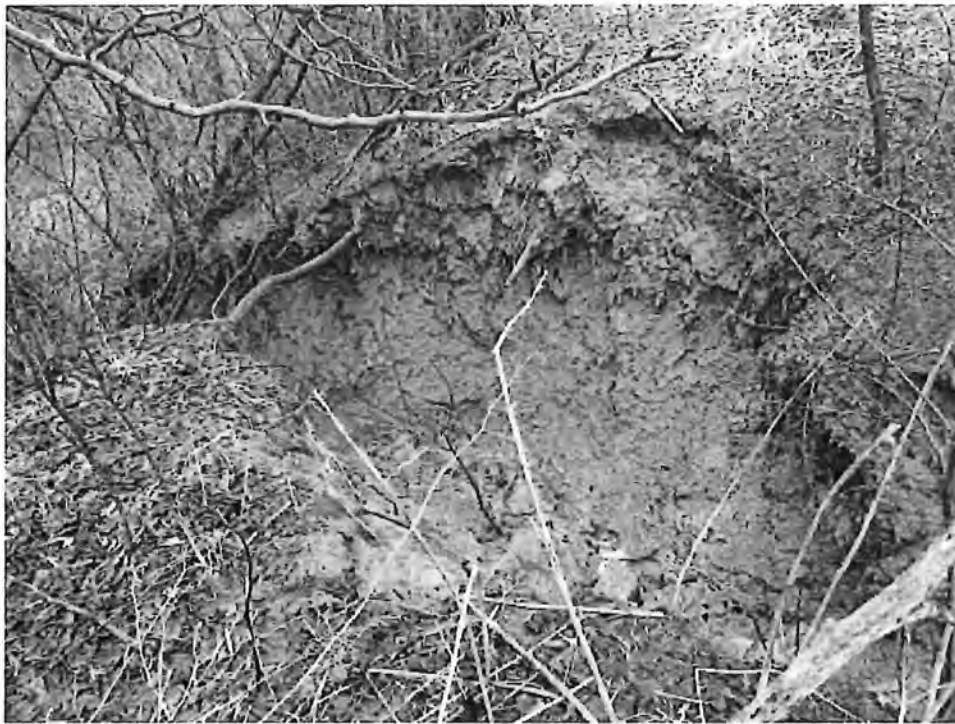
Description: The flow in the pathway continued west and dropped down the ledge into the unnamed stream bordering the west end of the facility.

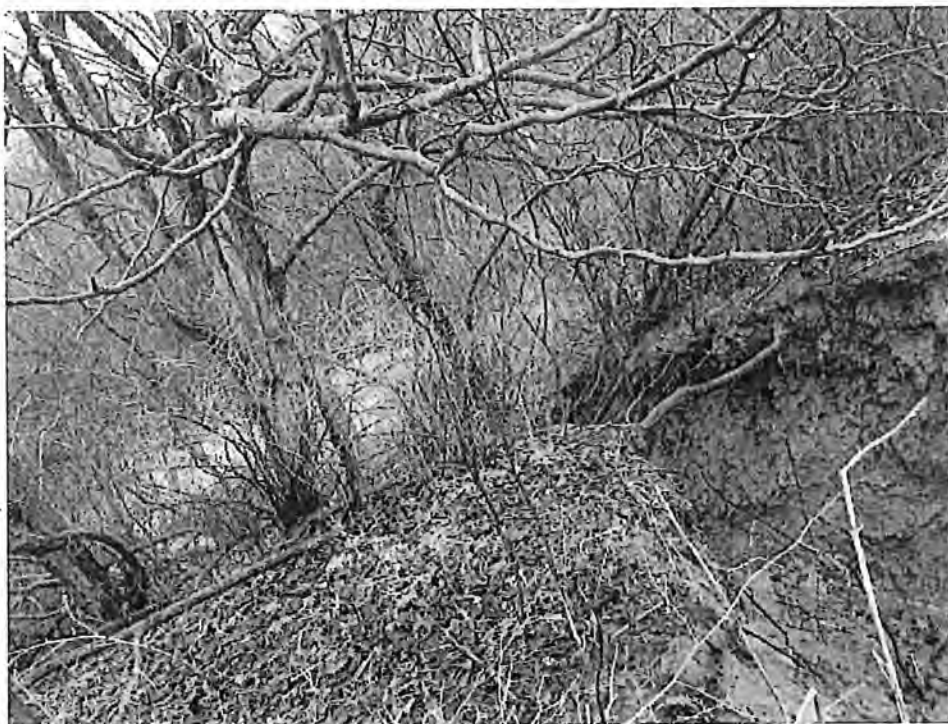
Description: A large eroded area was observed where the flow pathway drops down the ledge and continues to the unnamed stream.

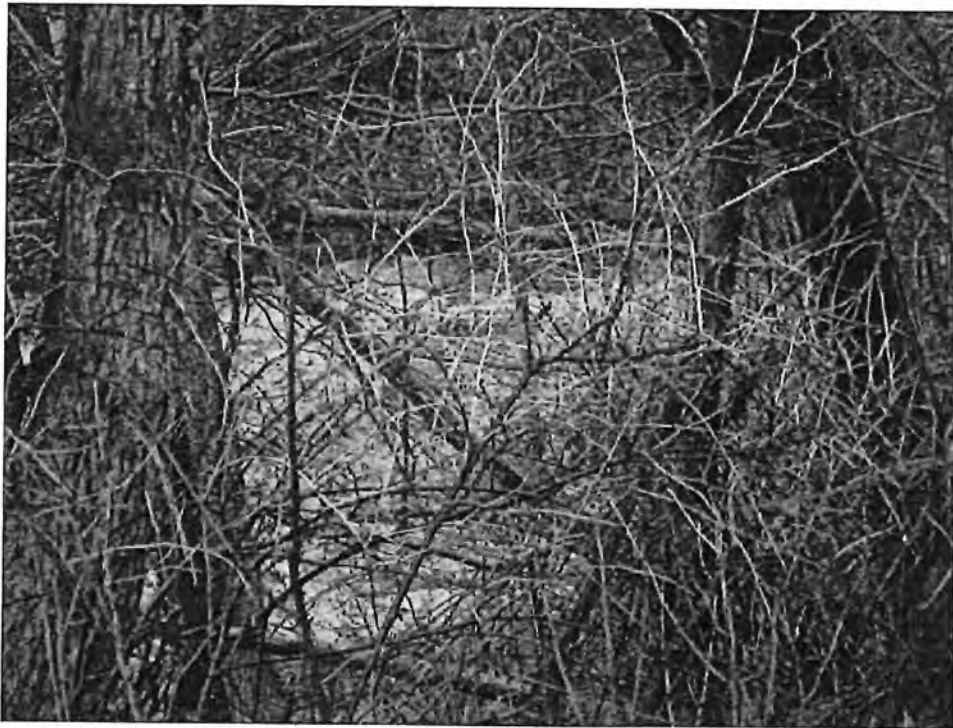
Description: A large eroded area was observed where the flow pathway drops down the ledge and continues to the unnamed stream. The stream can be observed down the ledge.

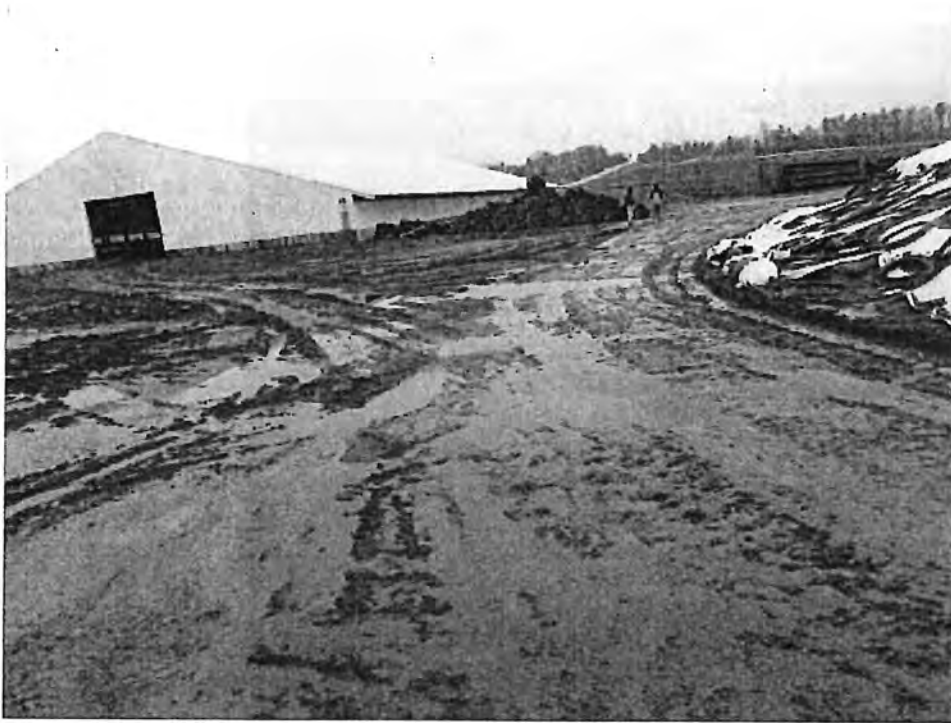
Description: Process wastewater and feed solids were observed around the feed bunkers. The process wastewater was ponded and flowed east into a grassed area.

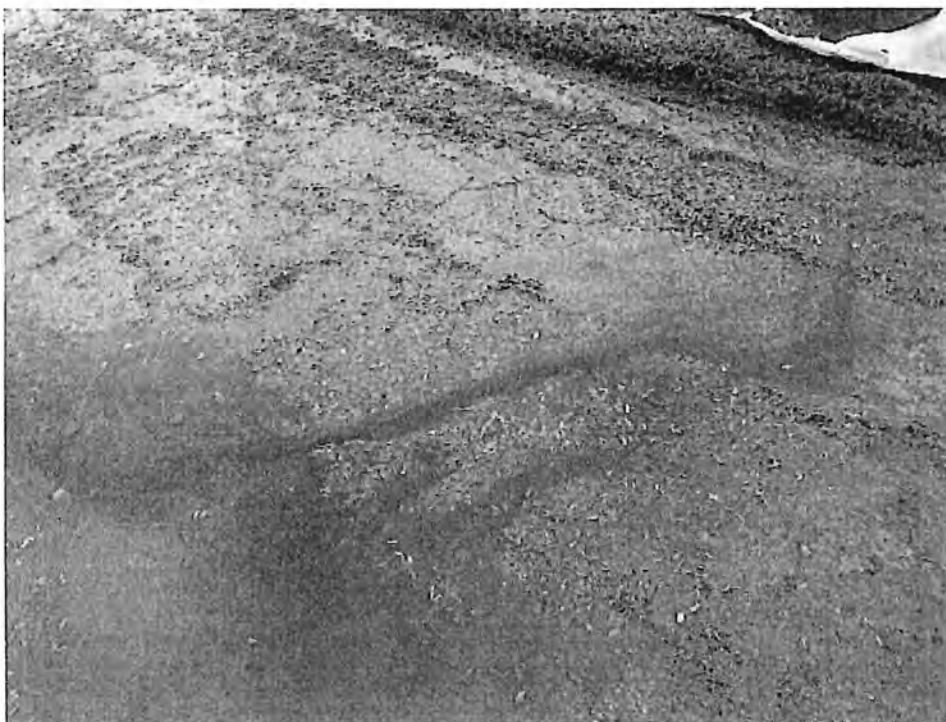
Description: Process wastewater and feed solids were observed around the feed bunkers. The process wastewater was ponded and flowed east into a grassed area.

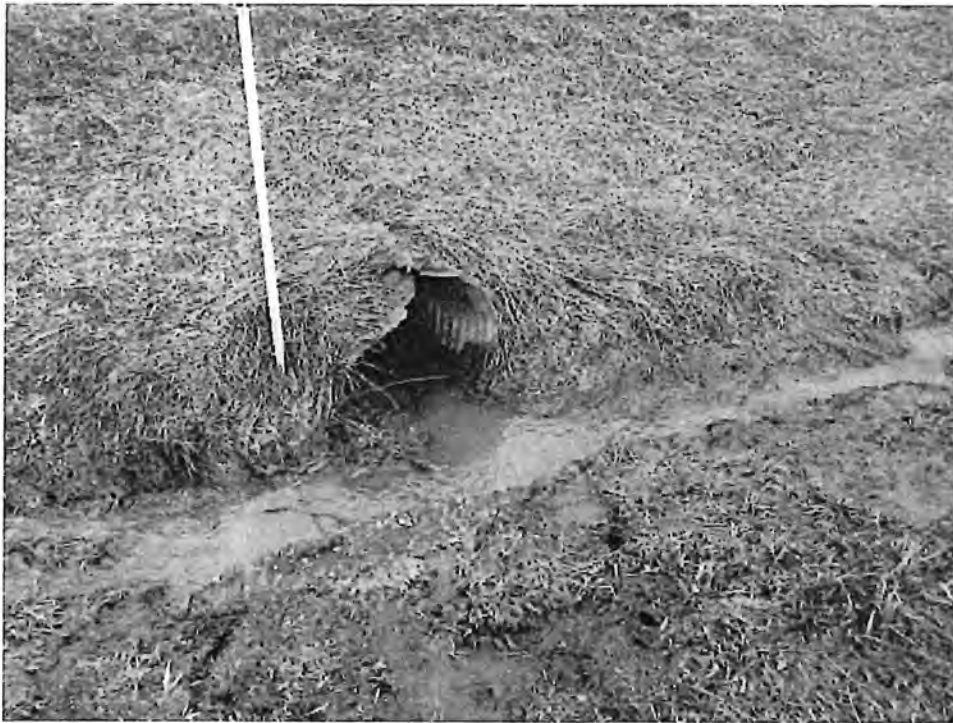
Description: Process wastewater and feed solids flowing out the east end of the feed bunkers.

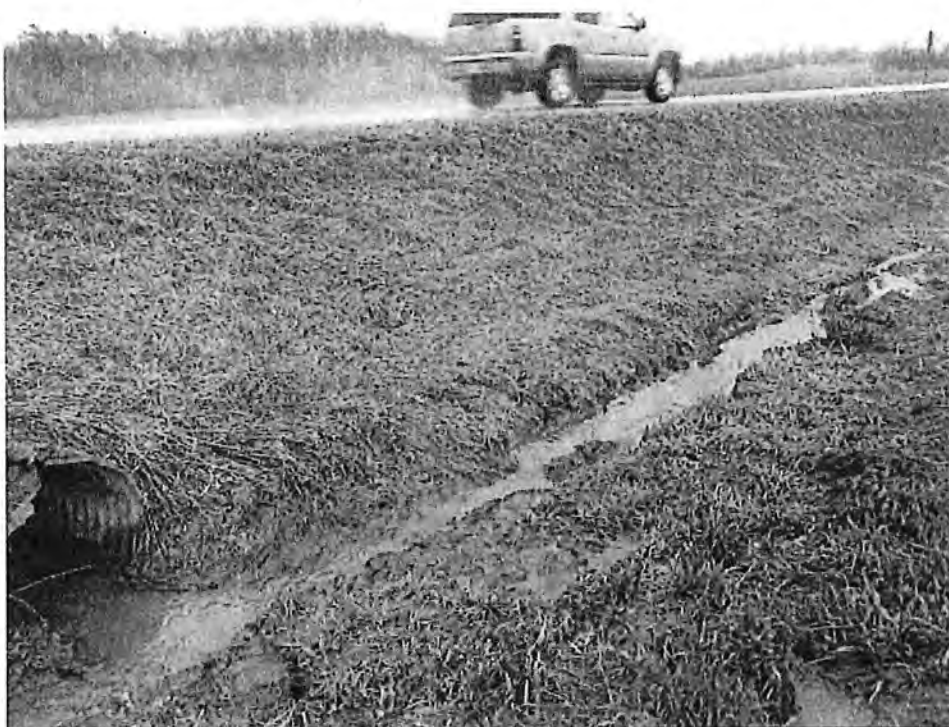
Description: The process wastewater continued through the grassed area and outlet into the ditch. The culvert collected the flow which continued east under County Road V and east along the Silver Lane then north and continued northeast before connecting with an unnamed tributary.

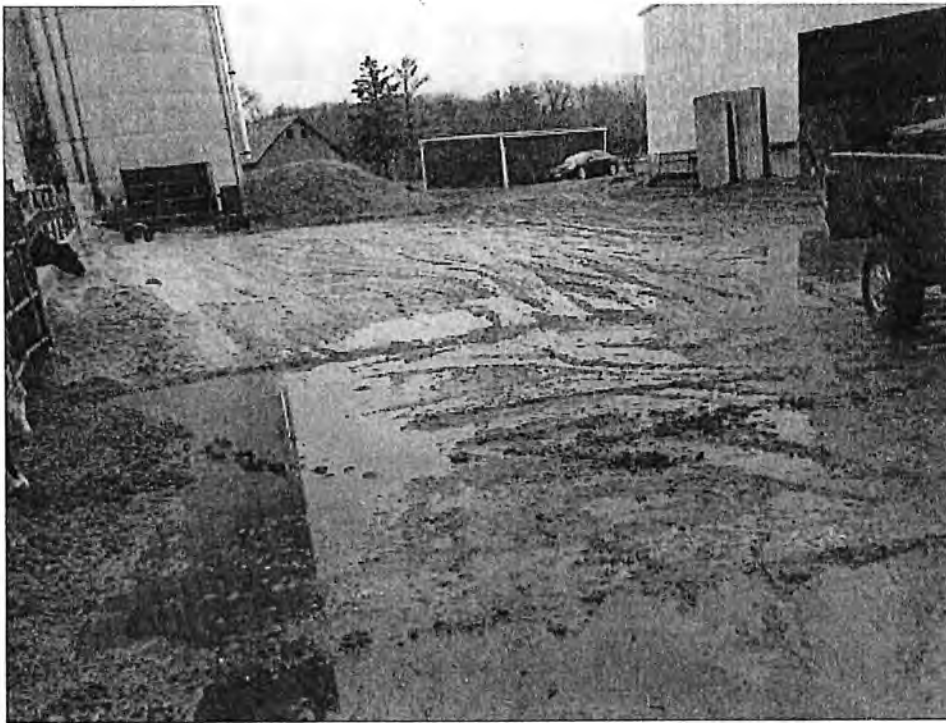
Description: Portions of the open feedlot drained to the east through the grassed area and to the ditch.

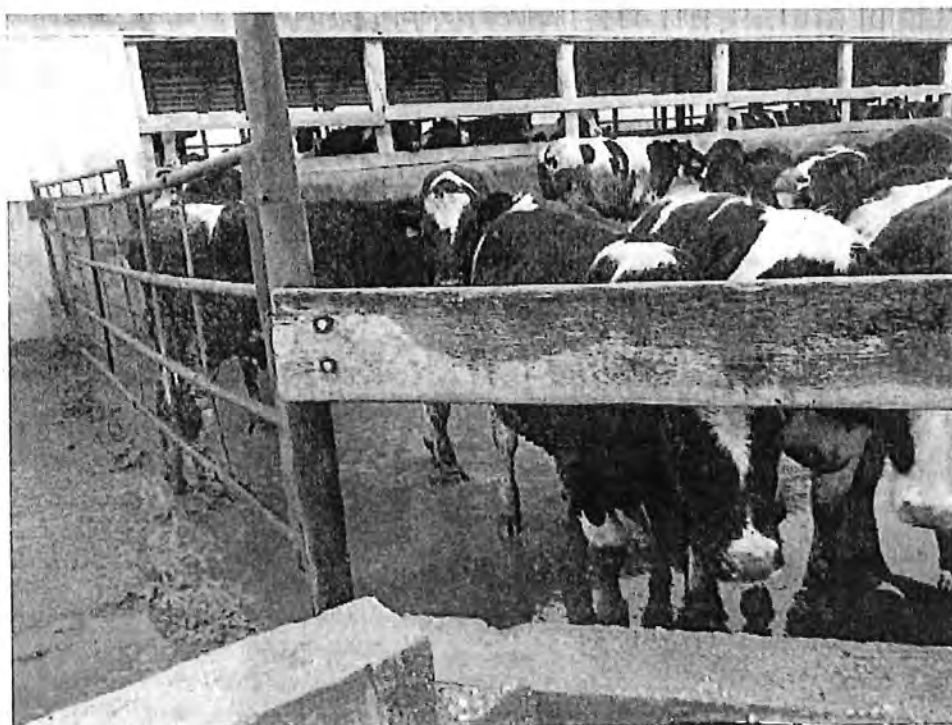
Description: Feed and process wastewater had no containment along the south end of the open feedlot.

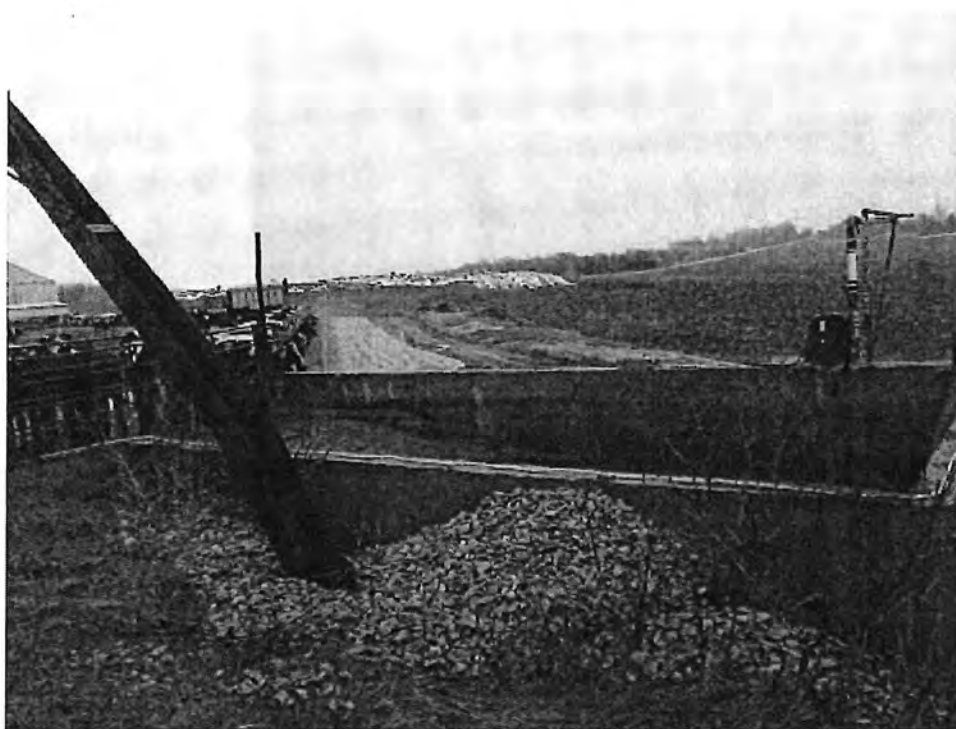
Description: Portions of the open feedlot flowed to the west. The manure and process wastewater is contained in a concrete pit which is pumped out when needed and transferd to the concrete manure pits on the Home site or land applied.

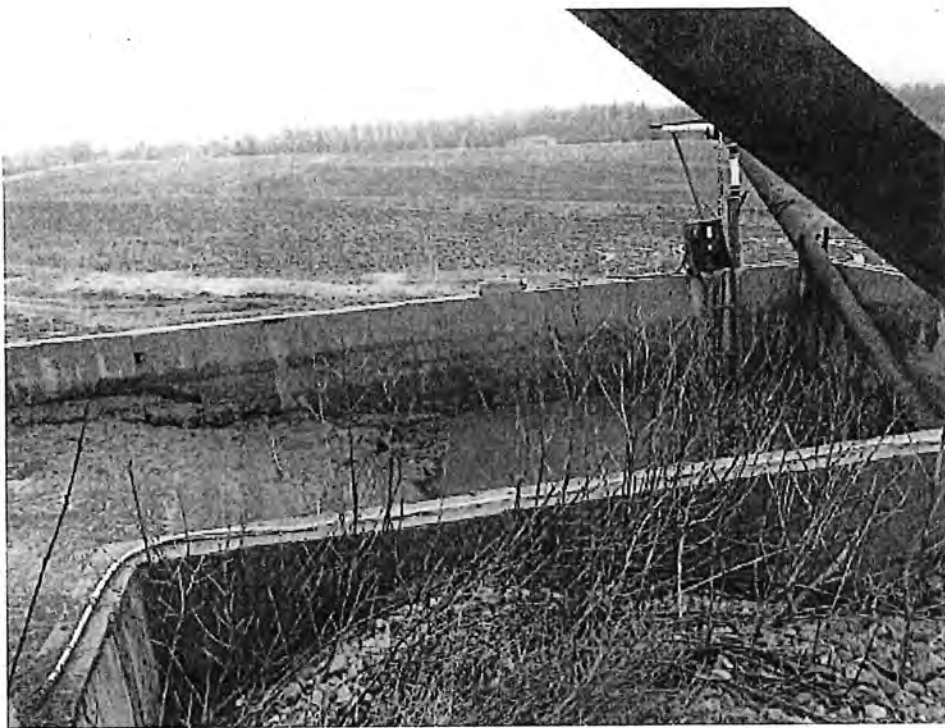
Description: Concrete pit and feed pathway.

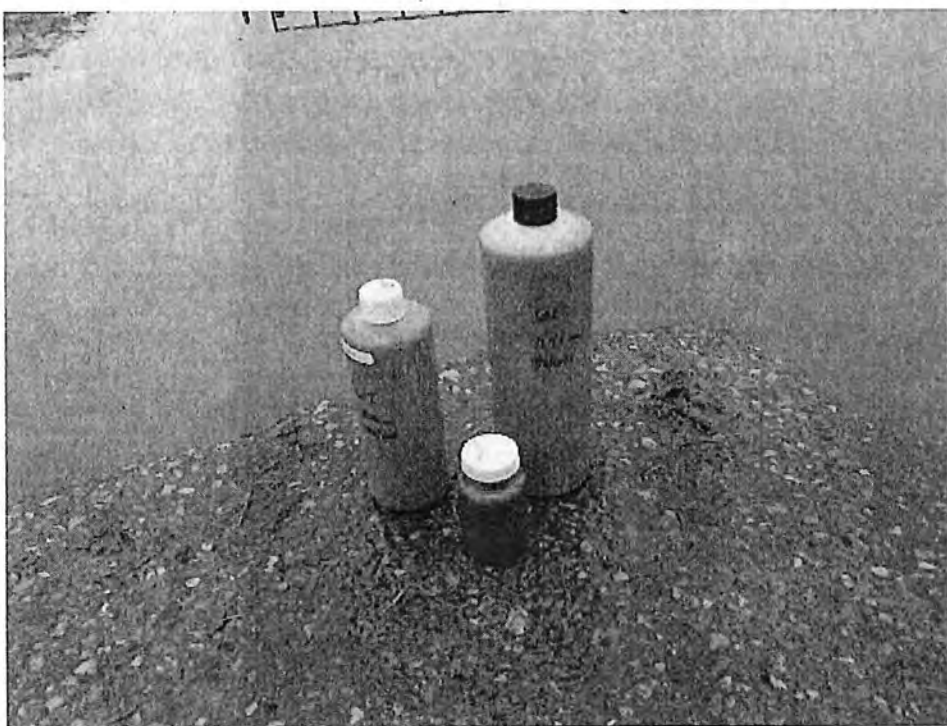
Description: Sample S02, collected in puddle/pathway adjacent to the open feedlot.

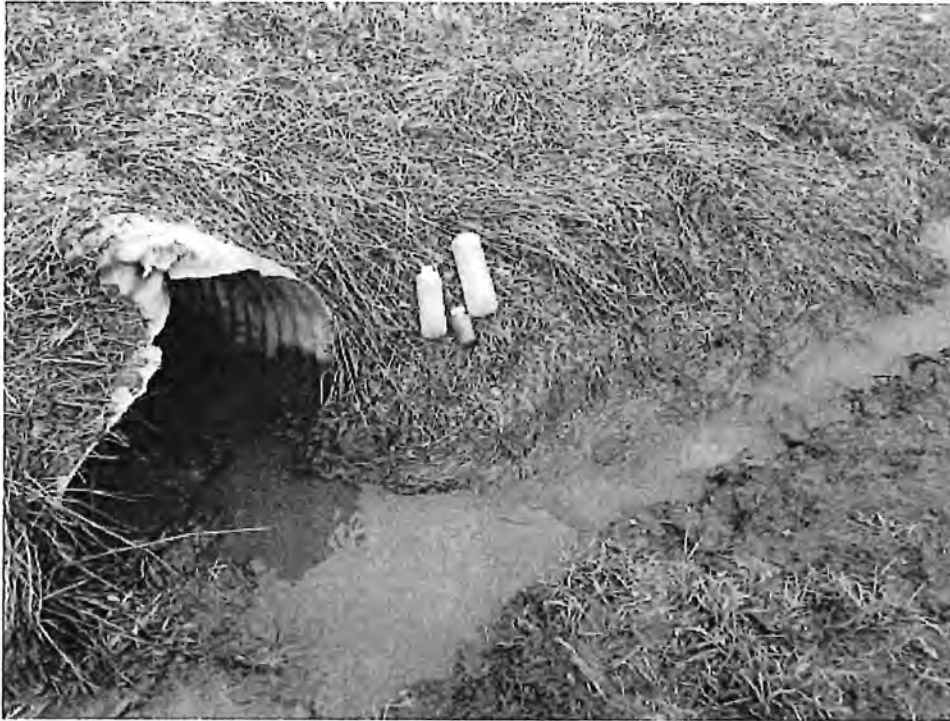
Description: Sample S02, collected in puddle/pathway adjacent to the open feedlot.

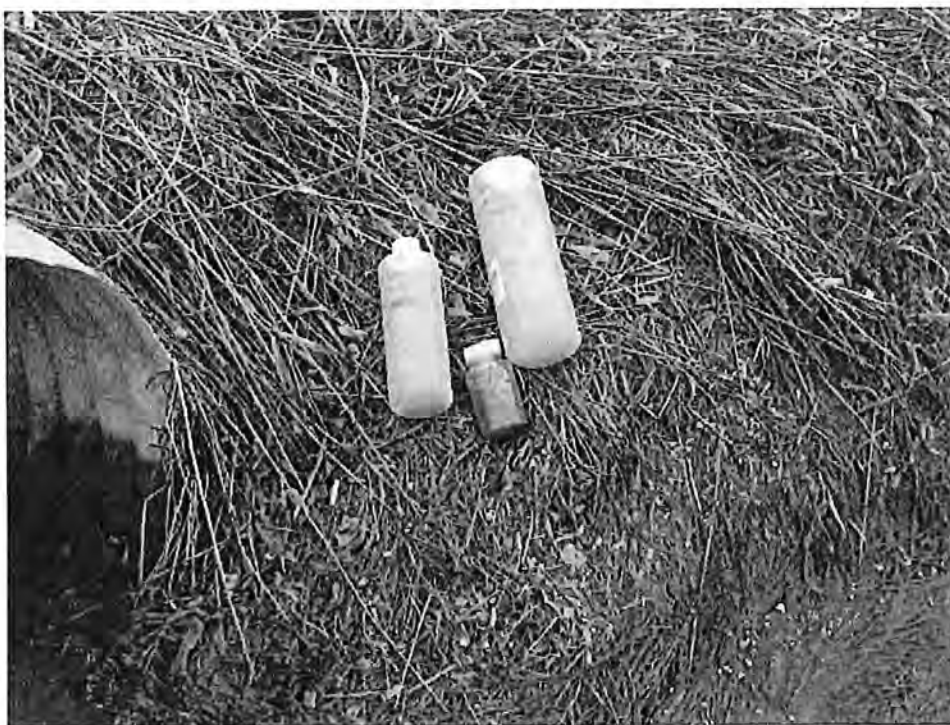
Description: Sample S03, in ditch before flow enters the culvert under County Road V.

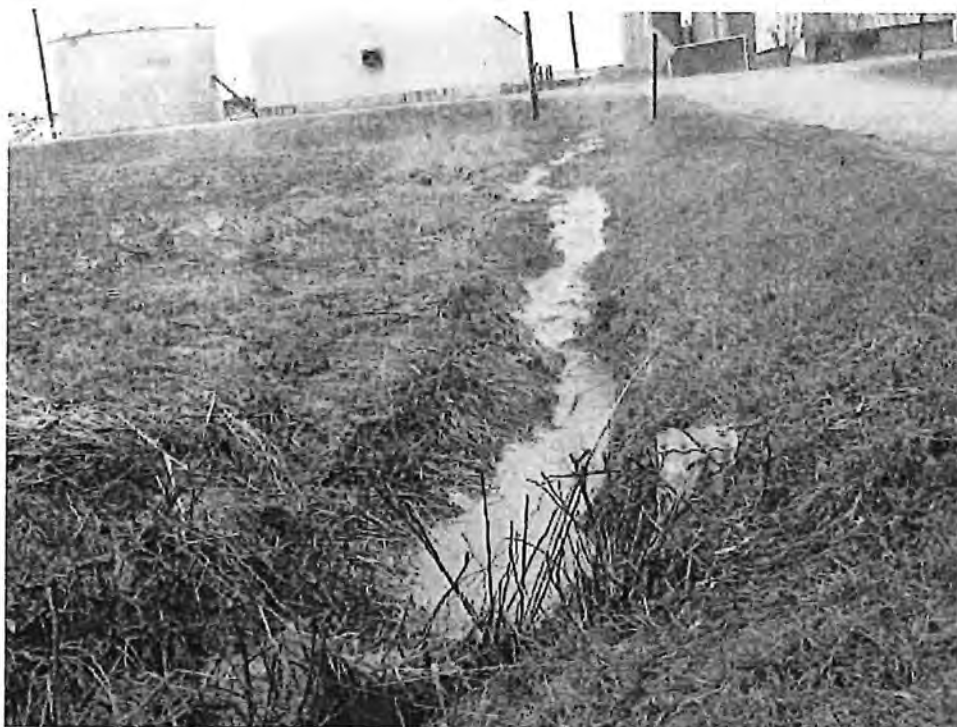
Description: Sample S03, in ditch before flow enters the culvert under County Road V.

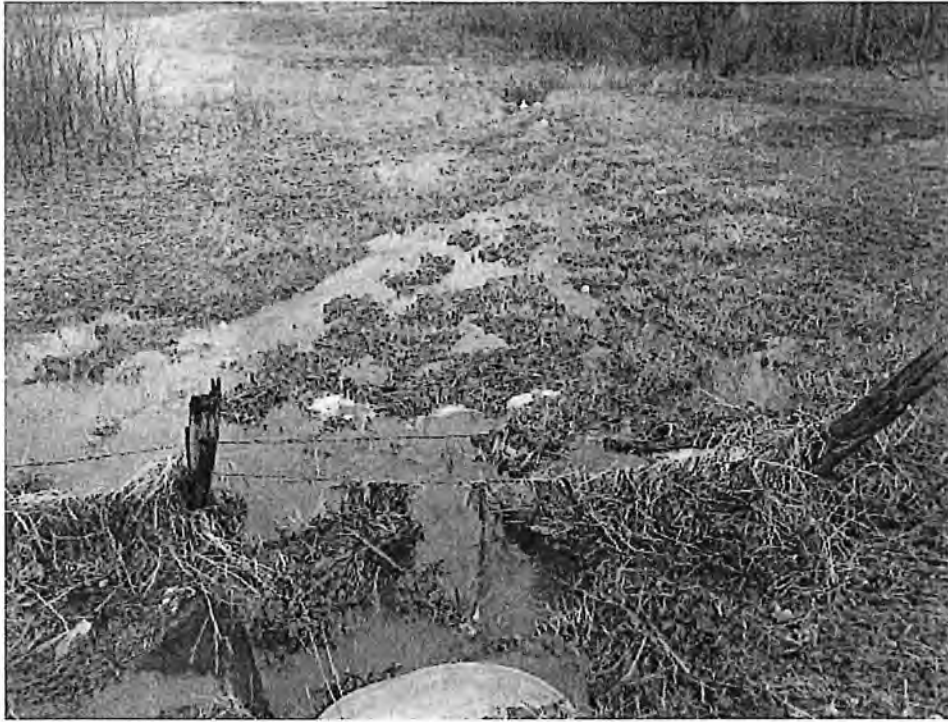
Description: Flow from portions of the open lots and process wastewater from the feed flowed through the culvert and under the County Road V to the east. The flow then turns north through another culvert under Silver Lane.

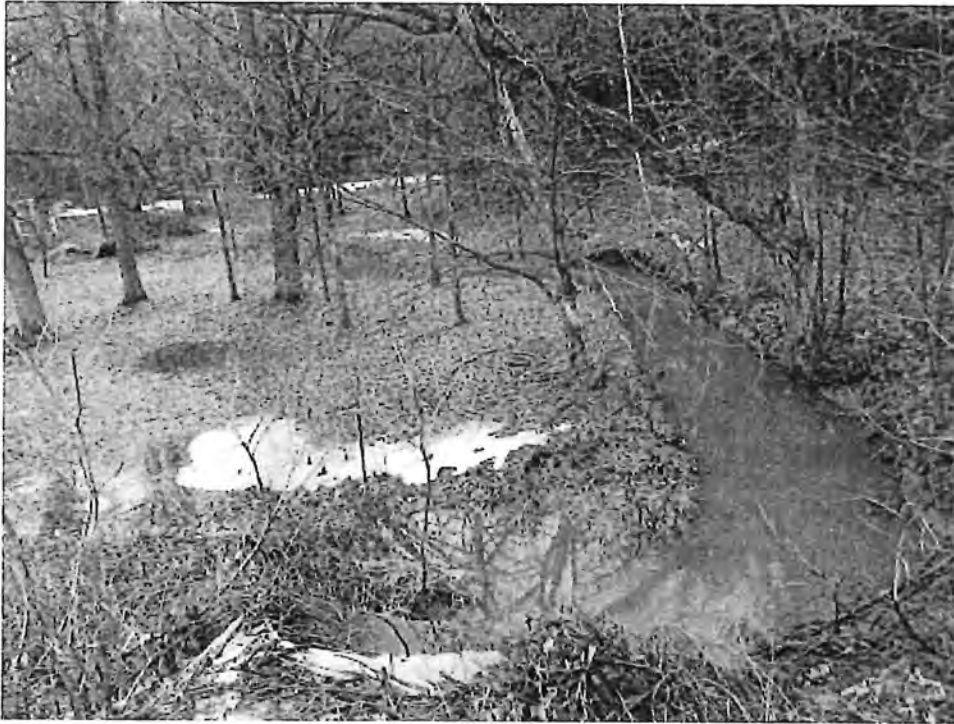
Description: The flow continues north under Silver Lane and through the field to the northeast and connects with an unnamed tributary.

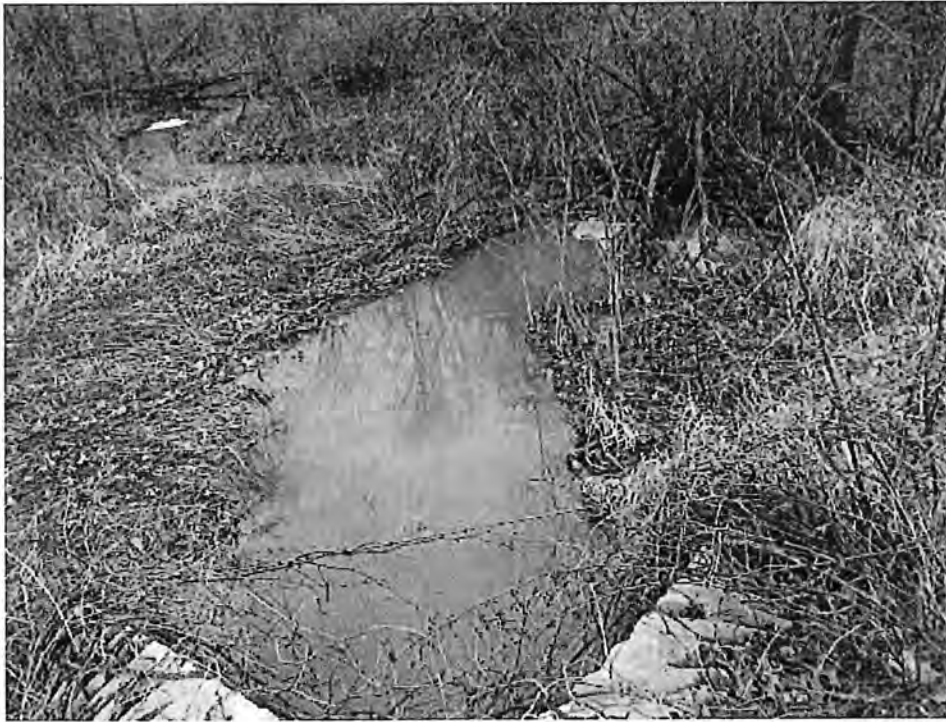
Description: Unnamed tributary flows North to Bower Creek. The culvert was approximately 8-10 ft in diameter at the crossing under Copper Lane.

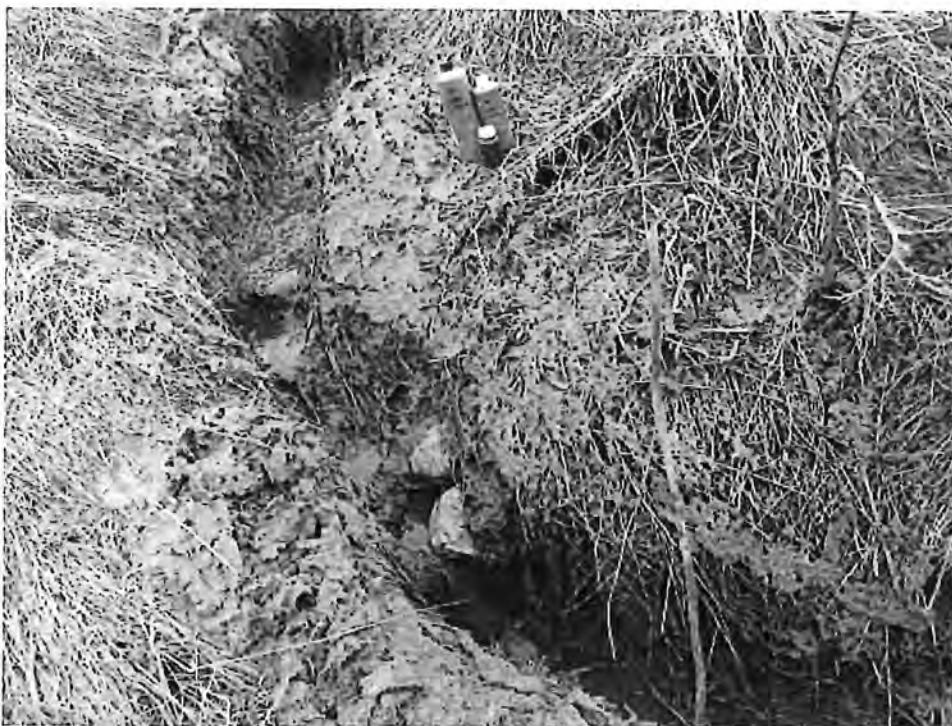
**57: IMGP0310.JPG**

Description: Unnamed tributary flows north to Bower Creek. The culvert was approximately 8-10 ft in diameter at the crossing under Copper Lane.

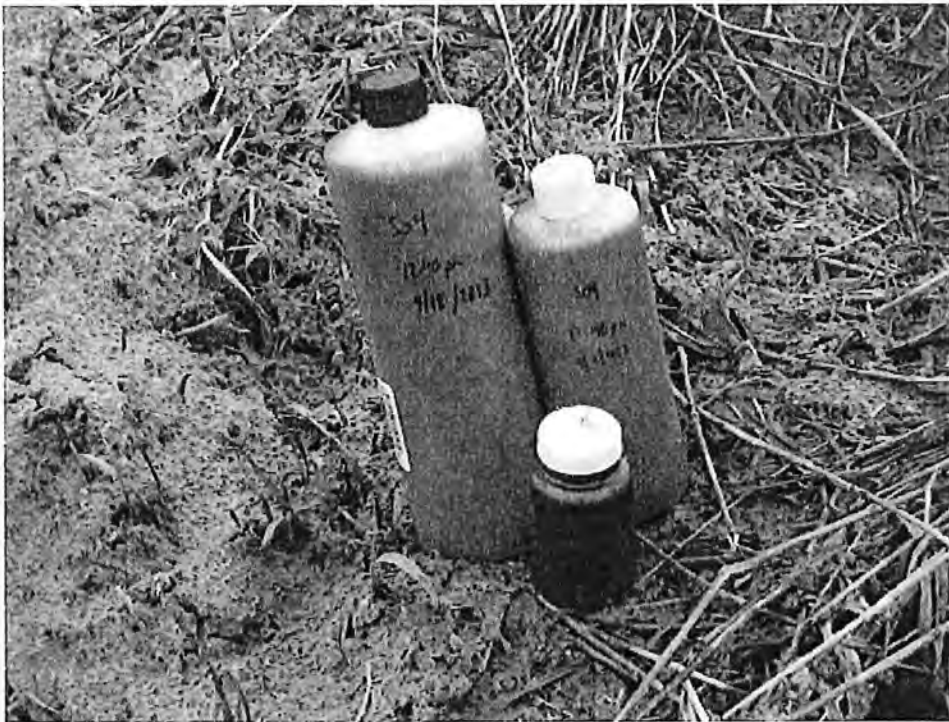
**58: IMG0311.JPG**

Description: Sample S04, in east pathway near the elevation change in the field north of the Milk Cow Barn.

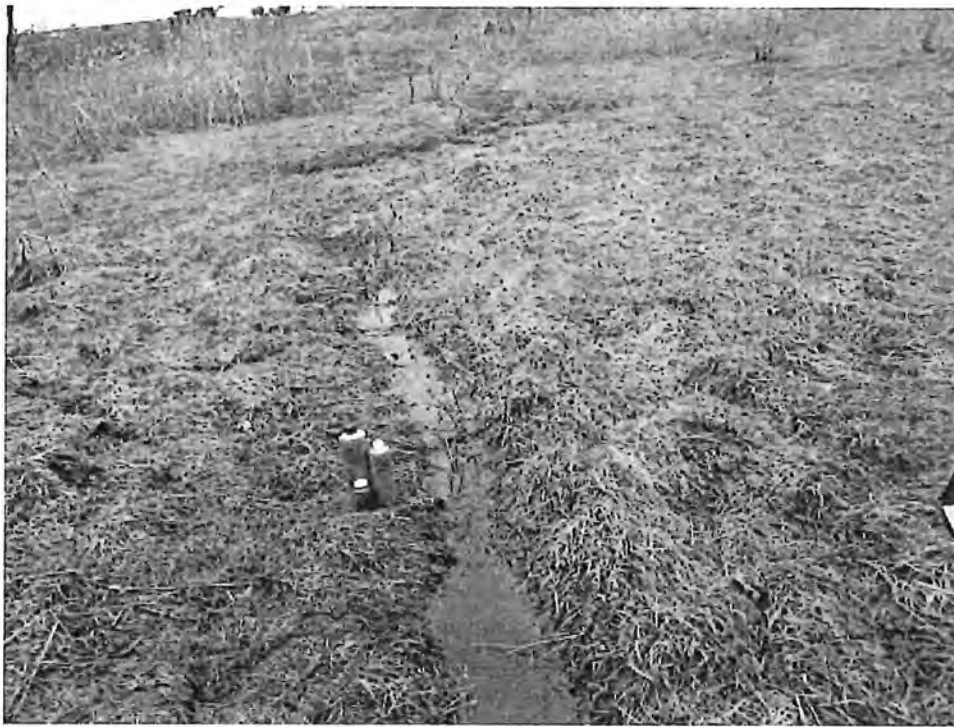
**59: IMGP0312.JPG**

Description: Sample S04, in east pathway near the elevation change in the field north of the Milk Cow Barn.

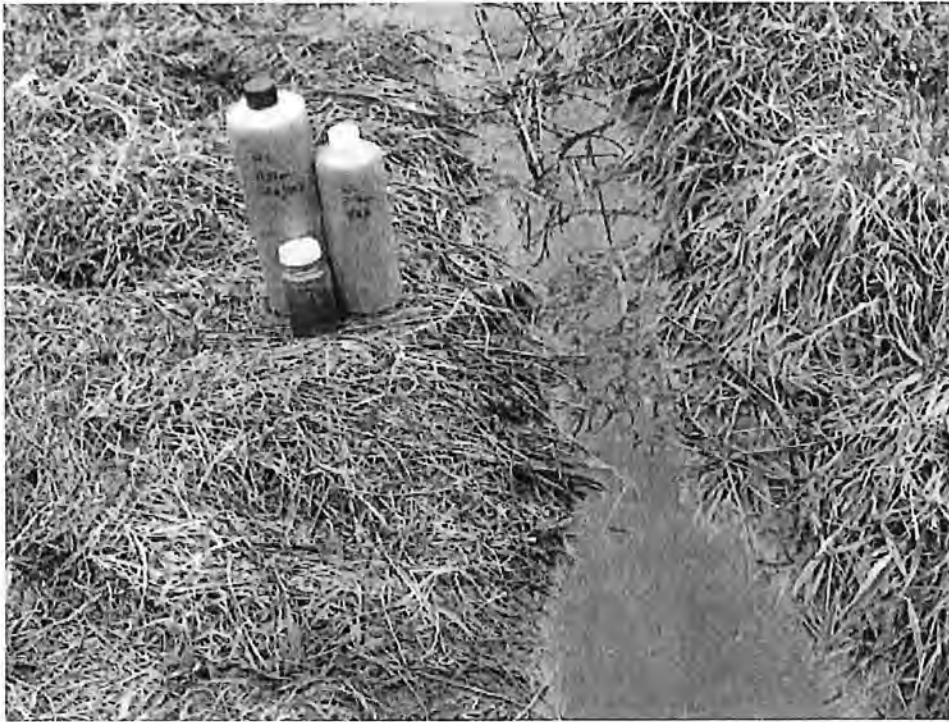
**60: IMGP0313.JPG**

Description: Sample S05, in flow pathway through field north of the Milk Cow Barn.

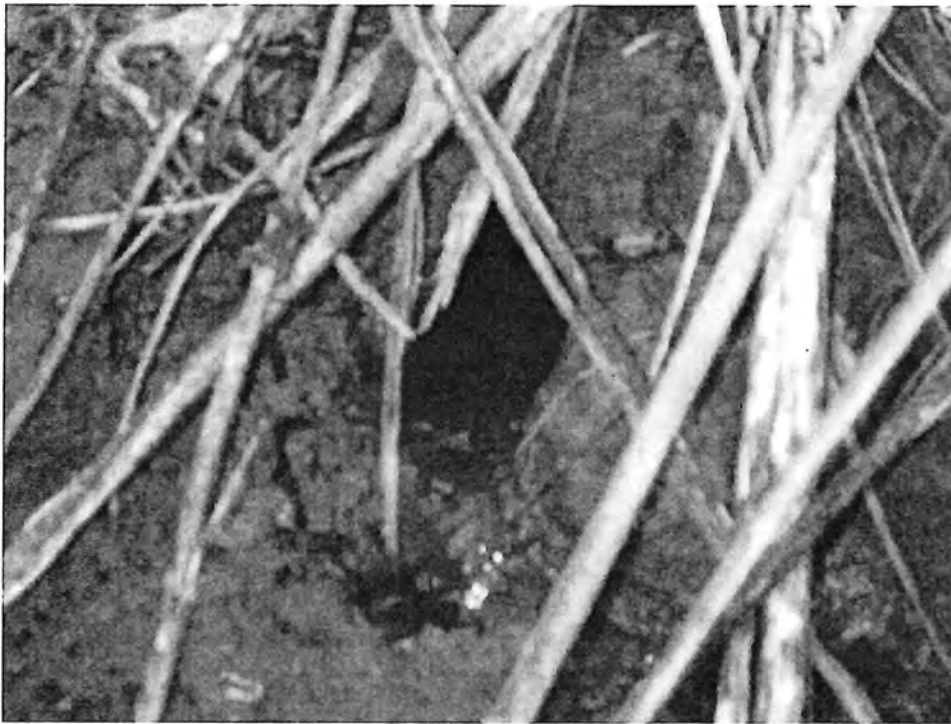
**61: IMGP0314.JPG**

Description: Sample S05, in flow pathway through field north of the Milk Cow Barn.

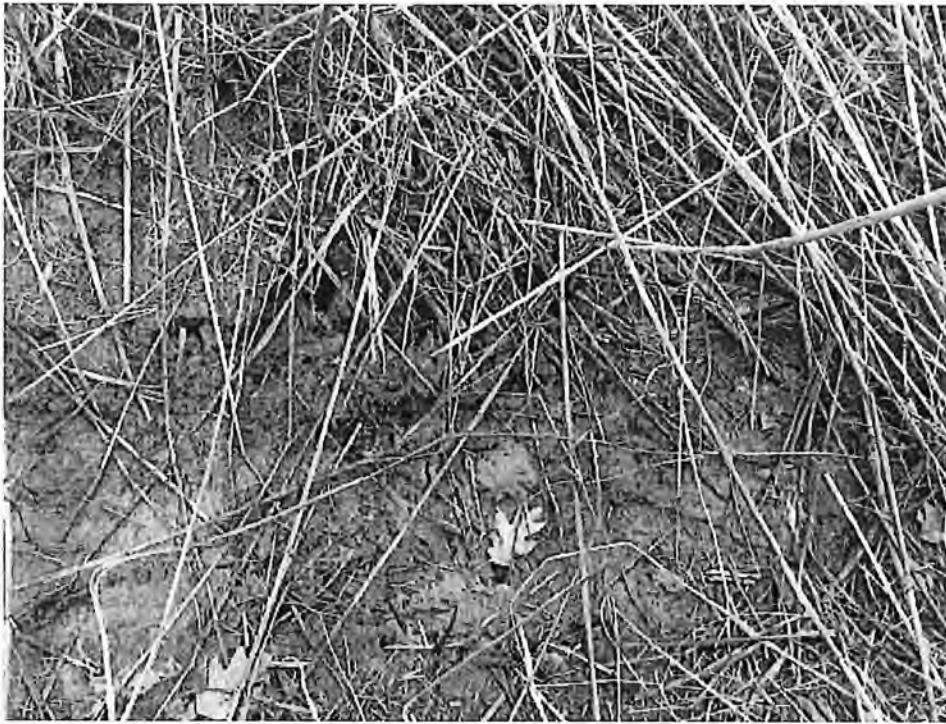
**62: IMGP0315.JPG**

Description: Portion of pathway on the north end of the field north of the Milk Cow Barn leading to unnamed tributary.

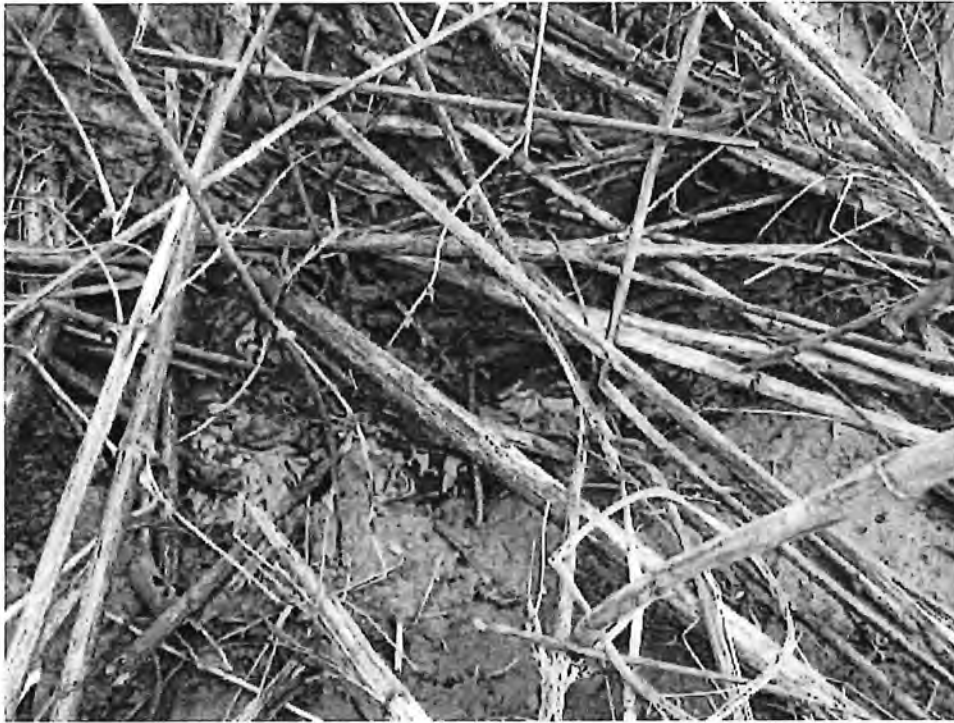
**63: IMGP0316.JPG**

Description: Portion of pathway on the north end of the field north of the Milk Cow Barn leading to unnamed tributary.

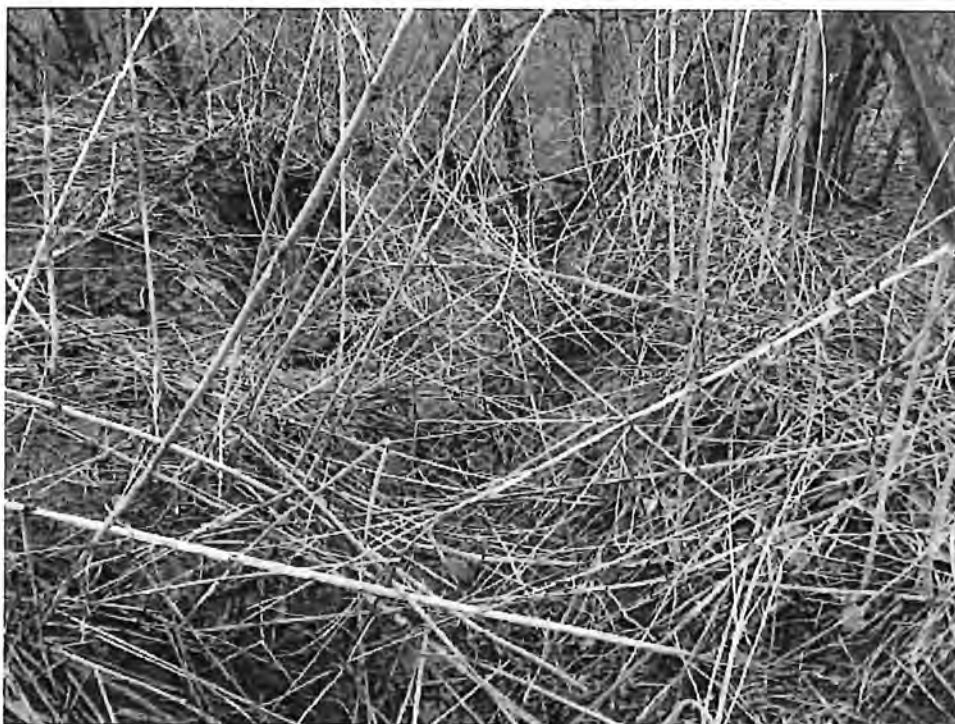
Description: Portion of pathway on the north end of the field north of the Milk Cow Barn leading to unnamed tributary.

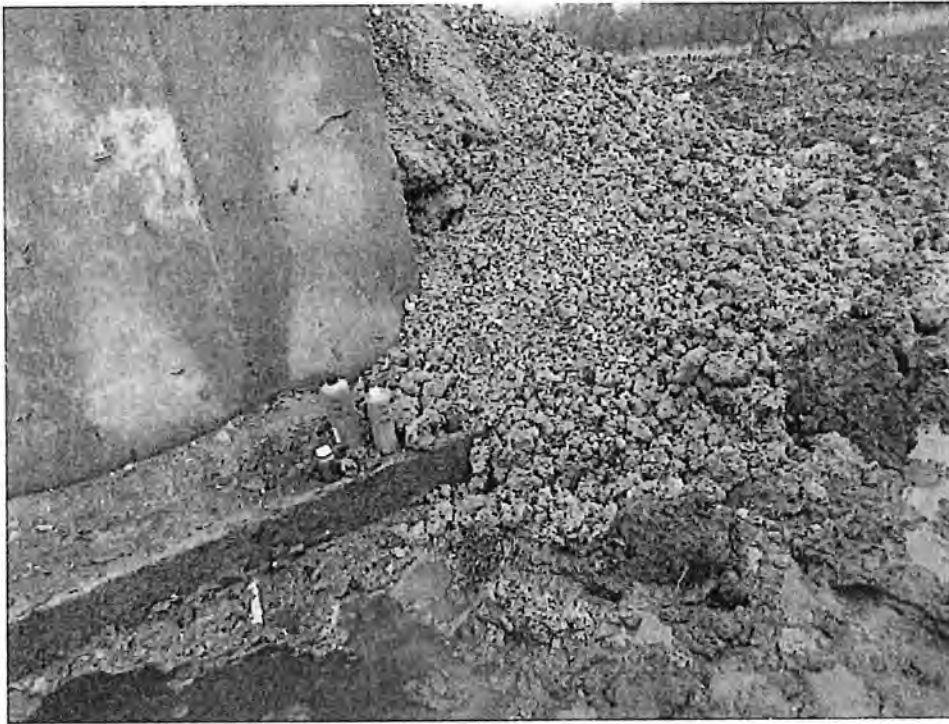
**66: IMGP0319.JPG**

Description: Portion of pathway on the north end of the field north of the Milk Cow Barn leading to unnamed tributary.

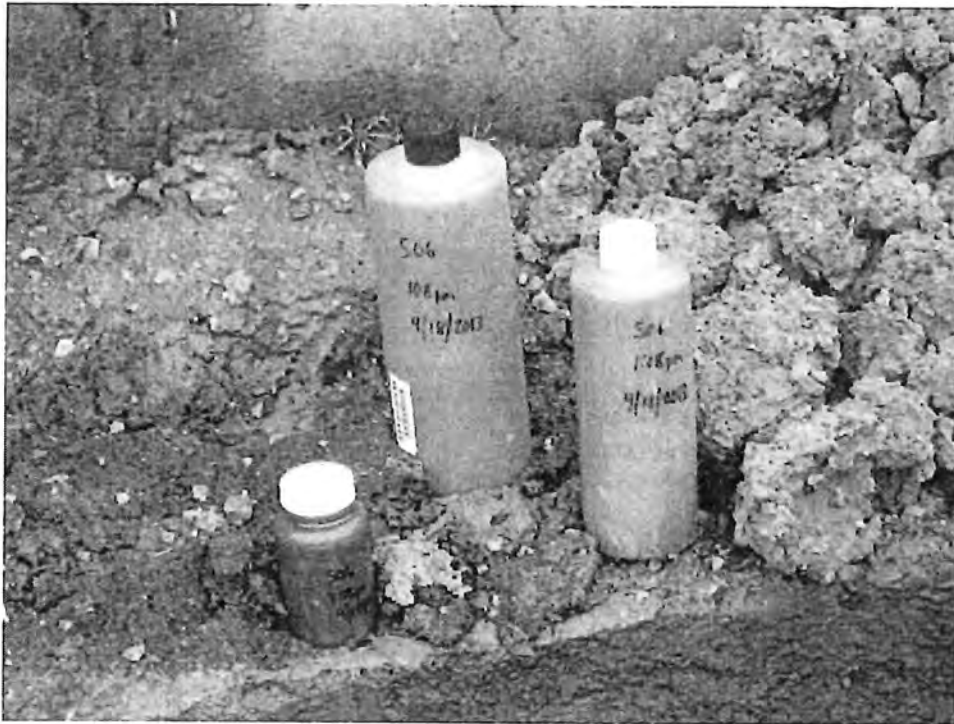
**67: IMG0320.JPG**

Description: Sample S06, wastewater from hole in the concrete manure pit. During the inspection the facility owner placed a pile of fill over the hole in the concrete pit.
