State of Wisconsin | DEPARTMENT OF NATURAL RESOURCES

Subject: **Notice of Violation - Chapter 283, Wis. Statutes  
Enforcement Conference - March 9, 2009**

### **3. POTENTIAL VIOLATIONS**

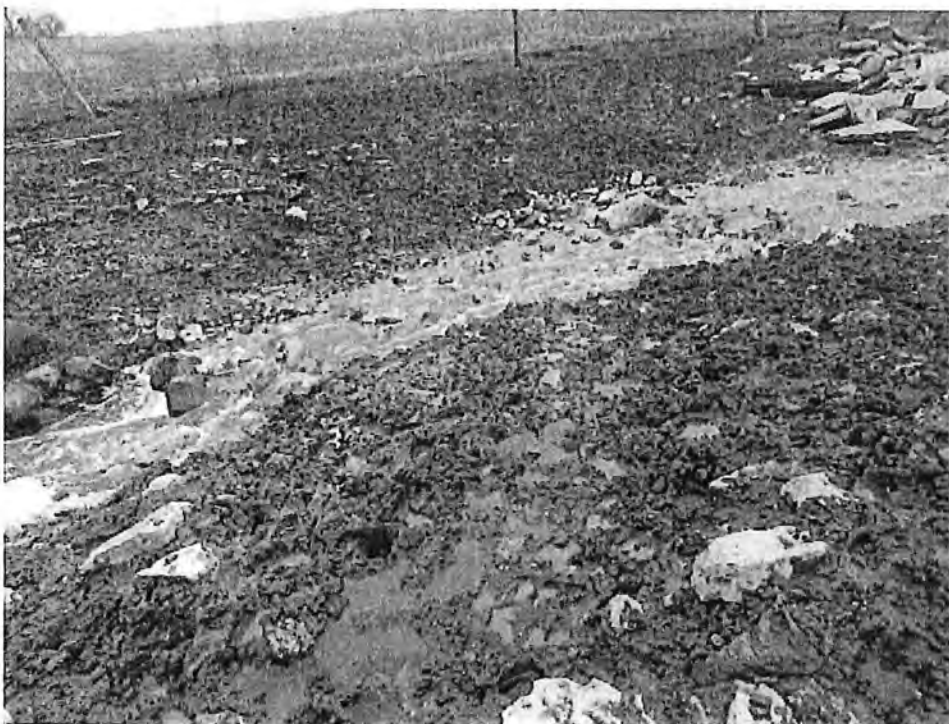
**68: IMGP0321.JPG**

Description: Sample S06, wastewater from hole in the concrete pit.

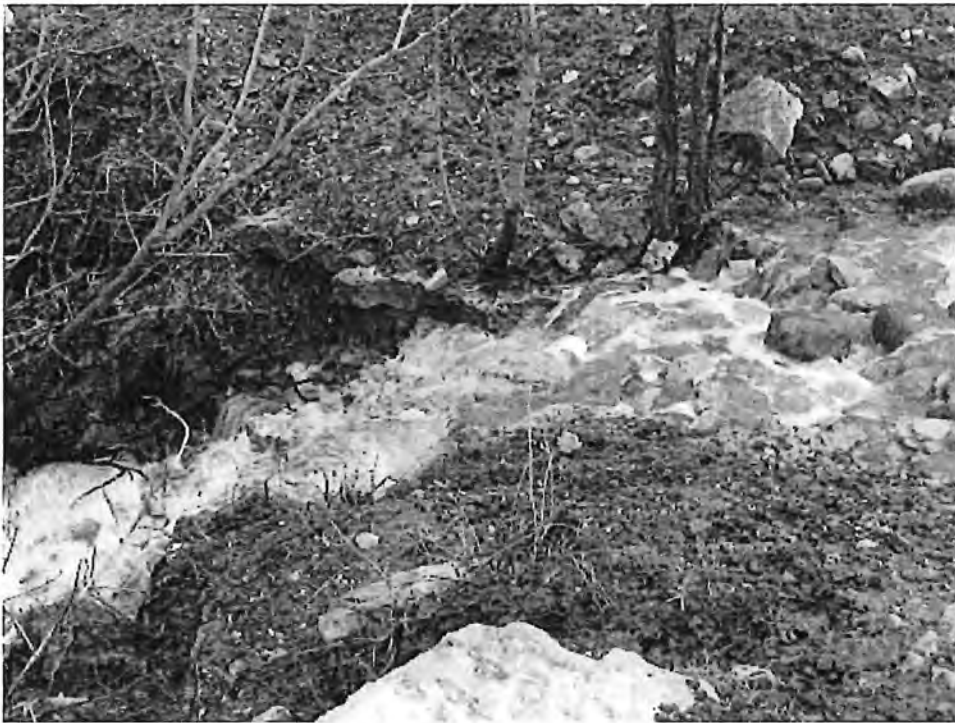
**69: IMGP0322.JPG**

Description: Flow pathway from drainage of the concrete pit to the unnamed tributary.

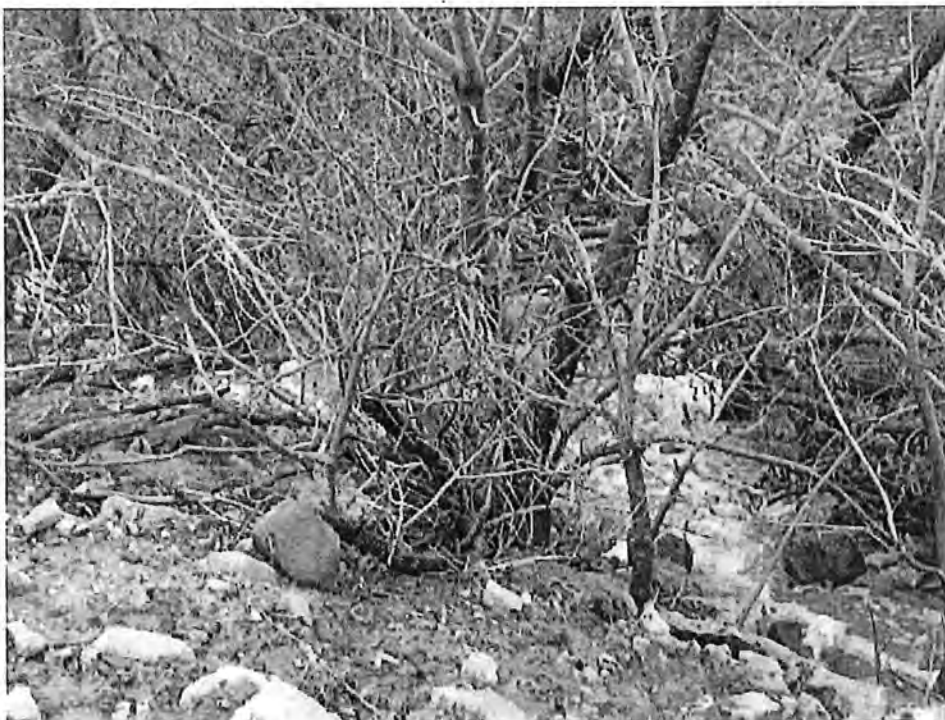
**70: IMGP0323.JPG**

Description: Cattle had direct access to unnamed tributary which flows north through the east side of the production area.

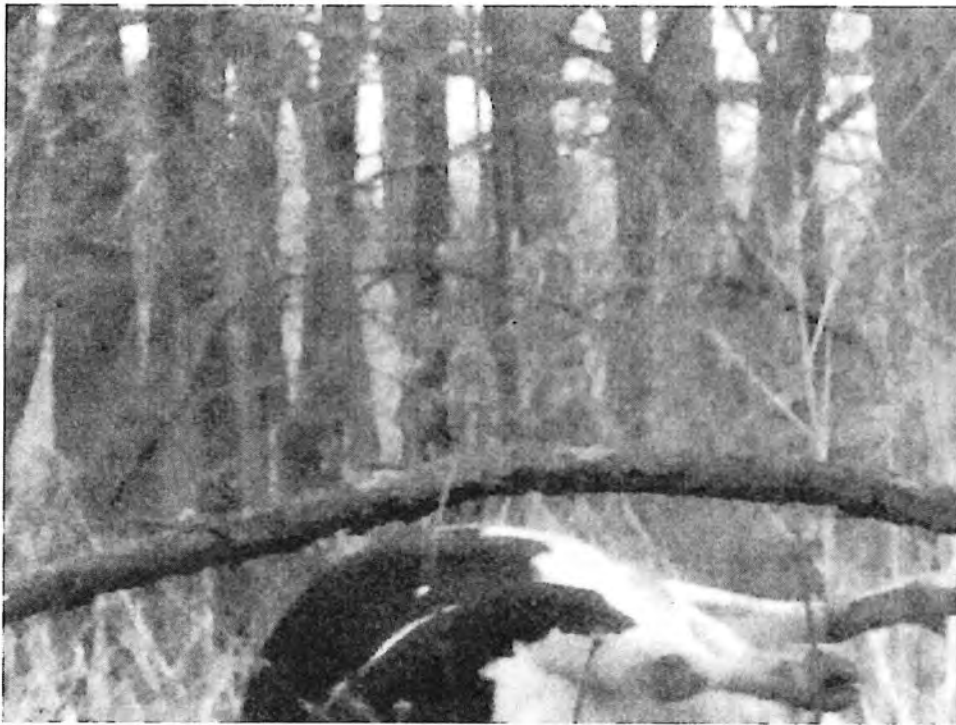
**71: IMGP0324.JPG**

Description: Cattle had direct access to unnamed tributary which flows north through the east side of the production area.

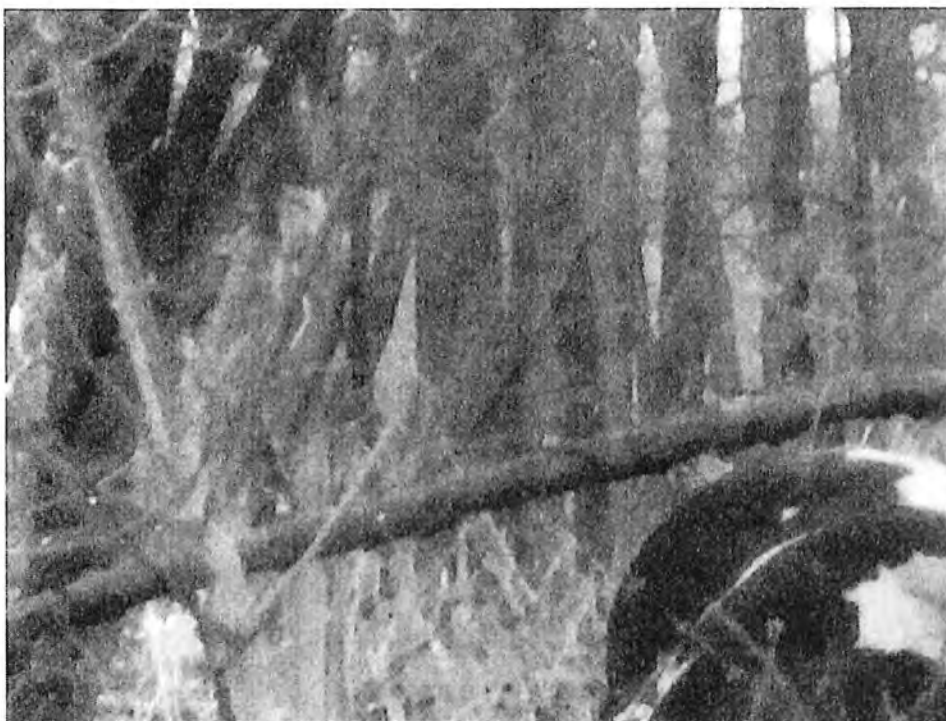
**72: IMGP0325.JPG**

Description: Dead cow in the open lot.

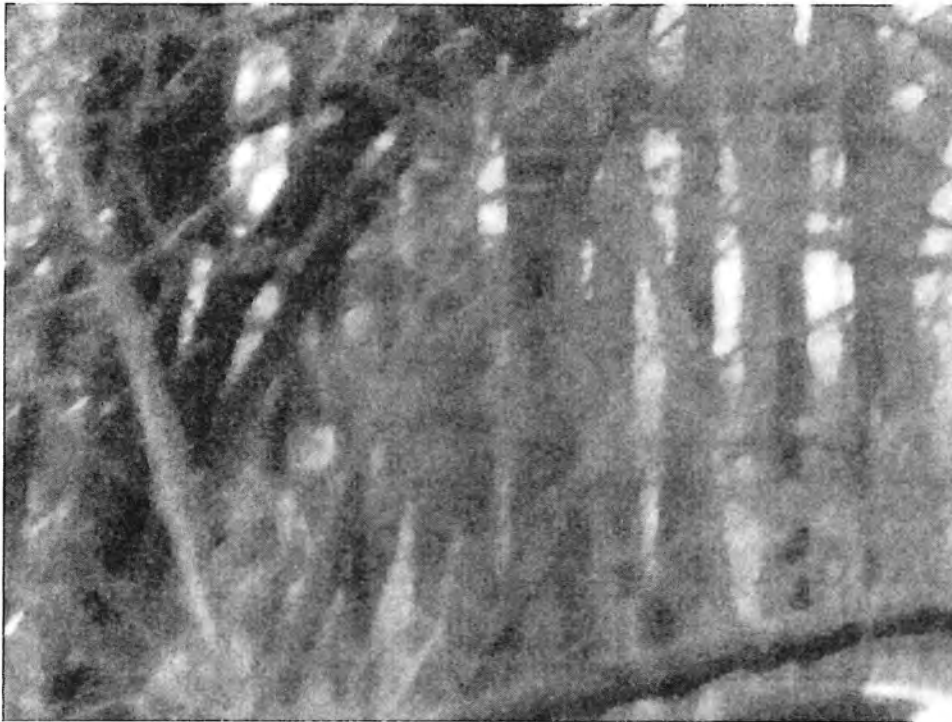
**73: IMGP0326.JPG**

Description: Dead cow in the open lot.

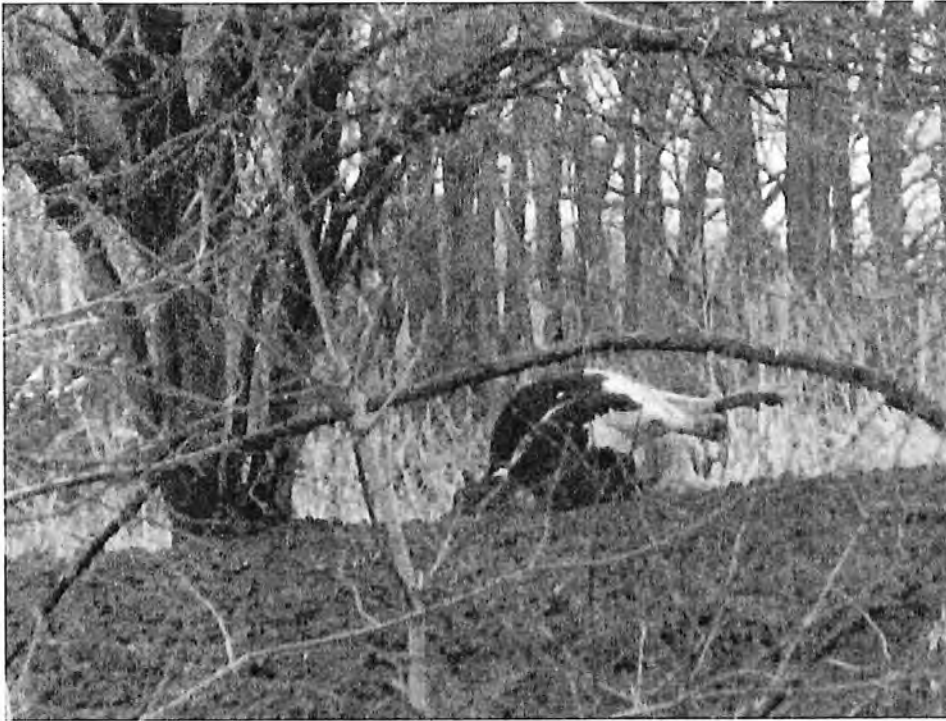
**74: IMGP0327.JPG**

Description: Dead cow in the open lot.

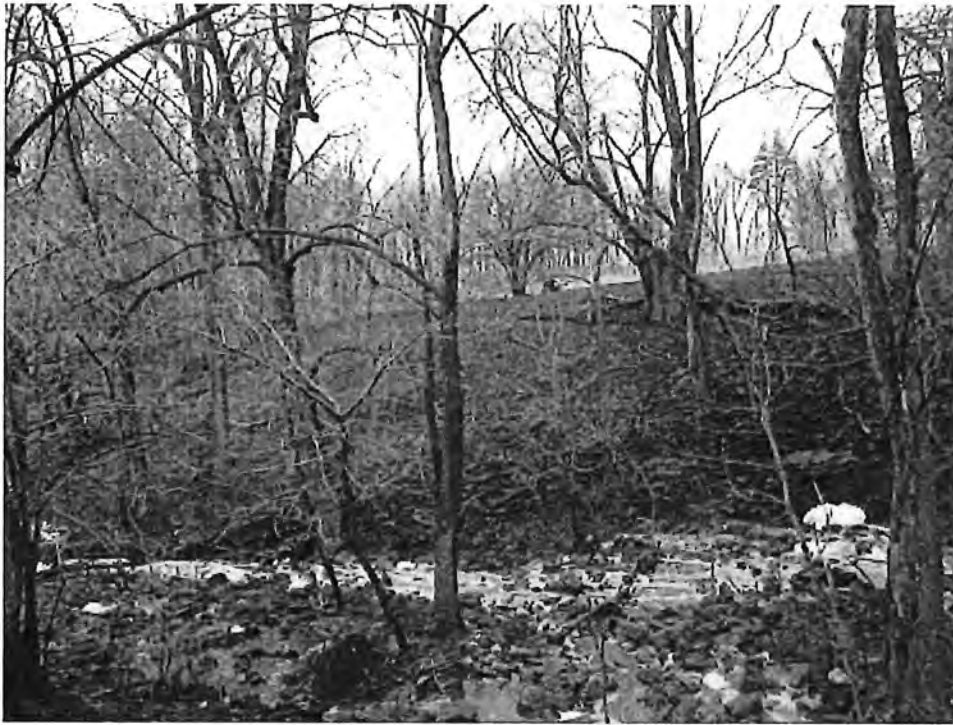
**75: IMGP0328.JPG**

Description: Dead cow in the open lot.

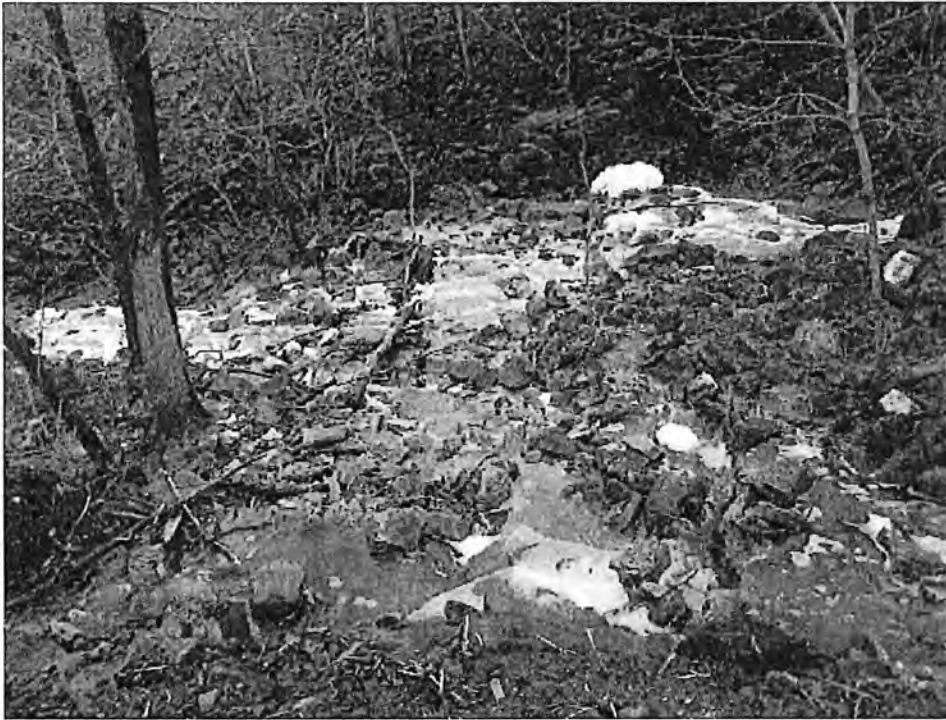
**76: IMGP0329.JPG**

Description: Cattle had direct access to unnamed tributary which flows north through the east side of the production area.

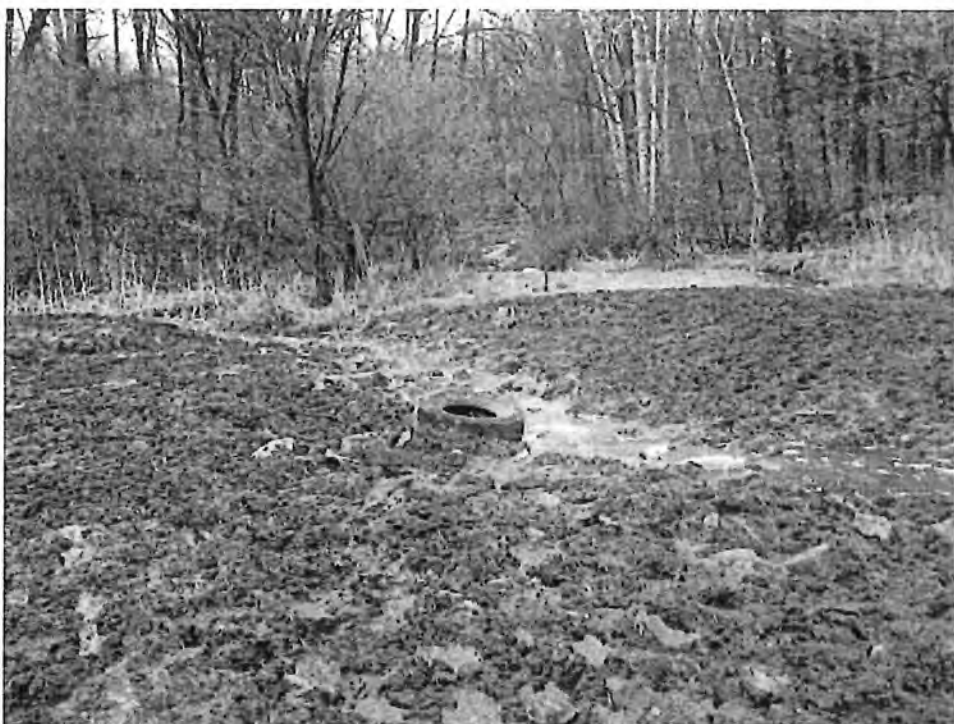
**77: IMG0330.JPG**

Description: Cattle had direct access to unnamed tributary which flows north through the east side of the production area.

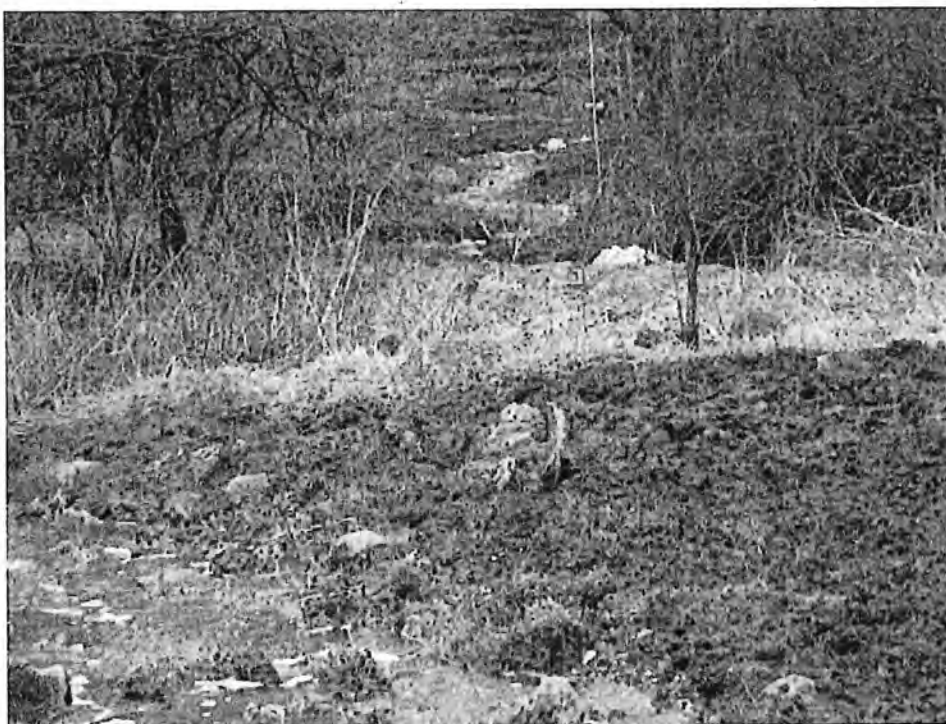
**78: IMGP0331.JPG**

Description: Cattle had direct access to unnamed tributary which flows north through the east side of the production area

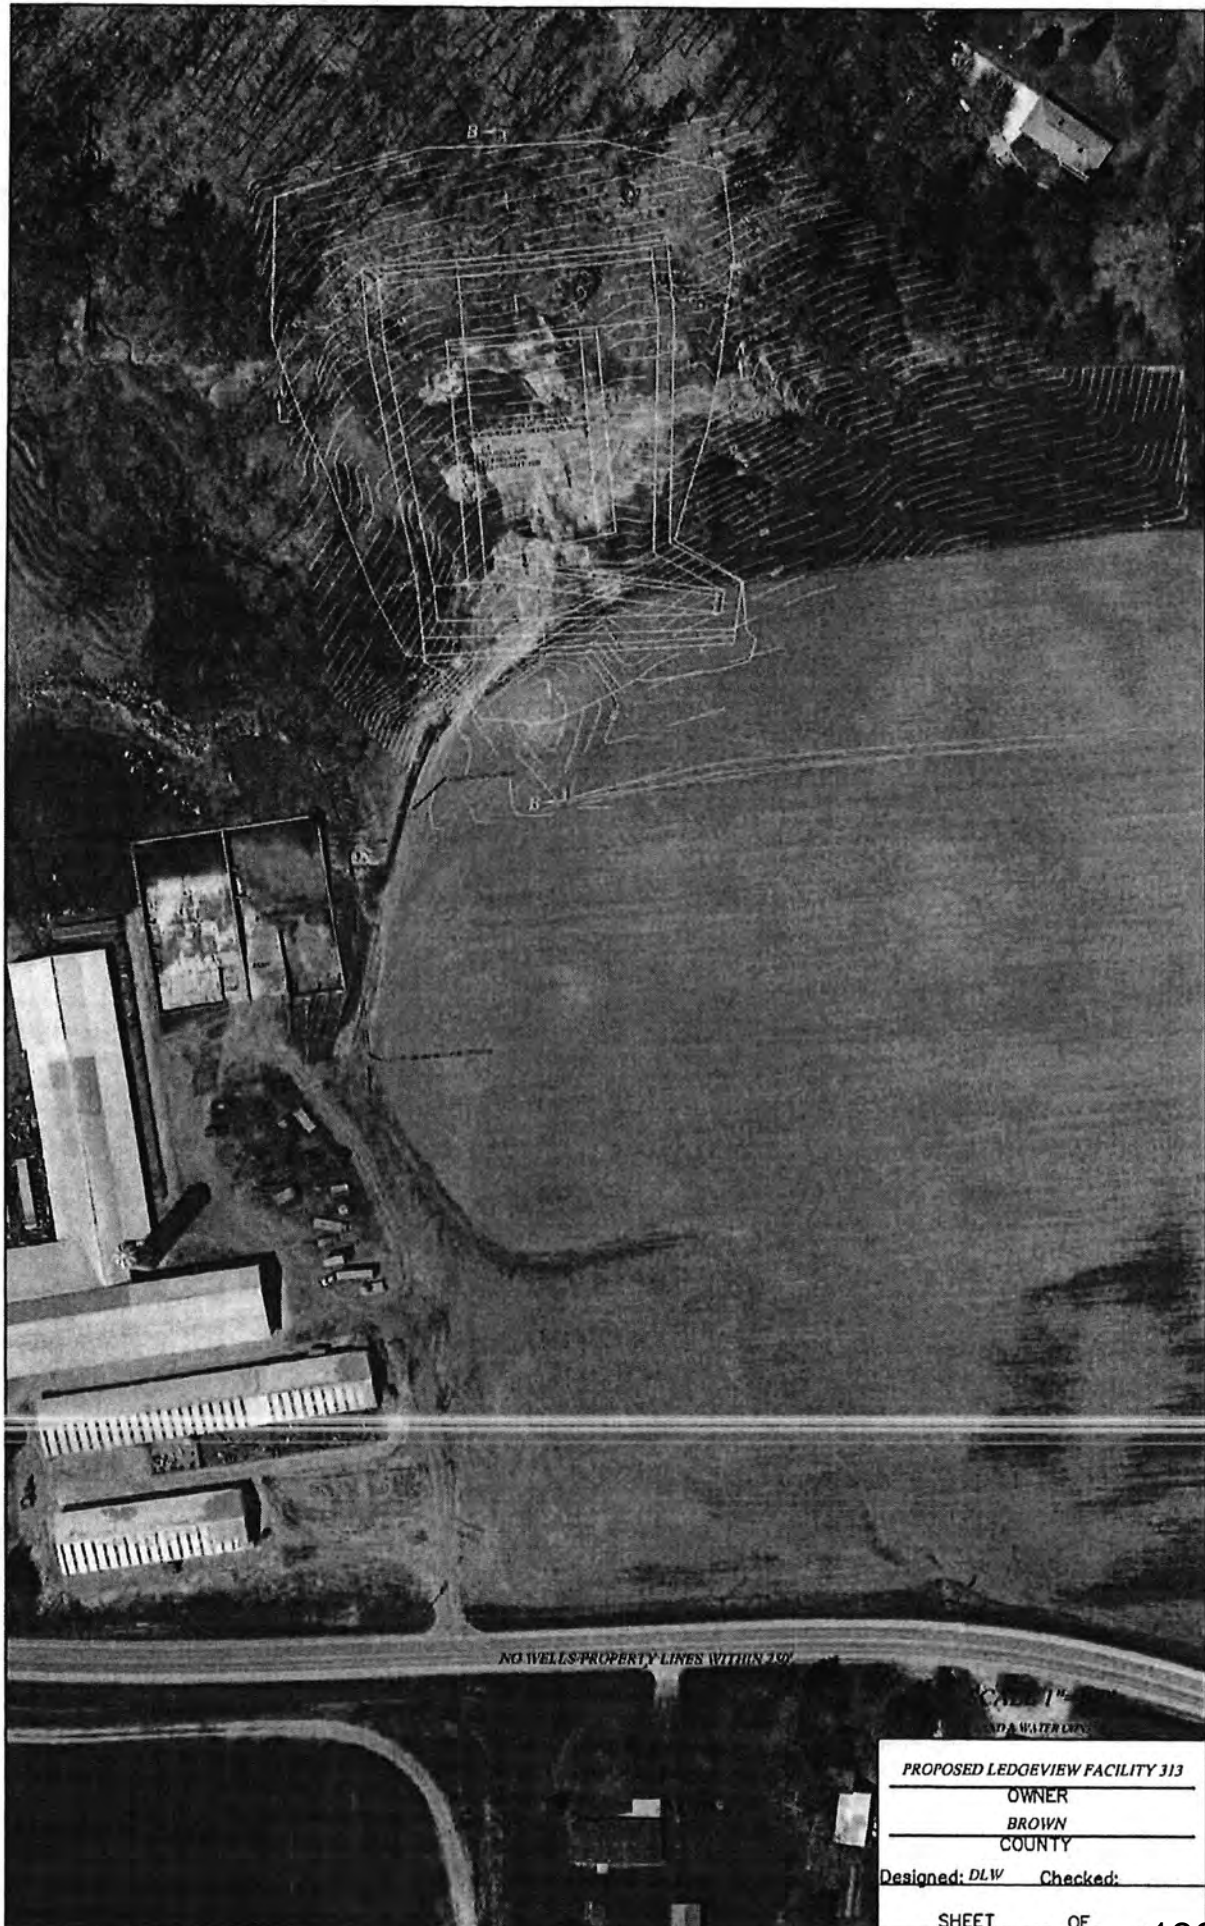
PROPOSED LEDGEVIEW FACILITY 313	
OWNER	
BROWN	
COUNTY	
Designed: DLW	Checked:
SHEET _____ OF _____

**A - Fill in opening w/new wall, contain runoff  
B - Omit cattle from this area**

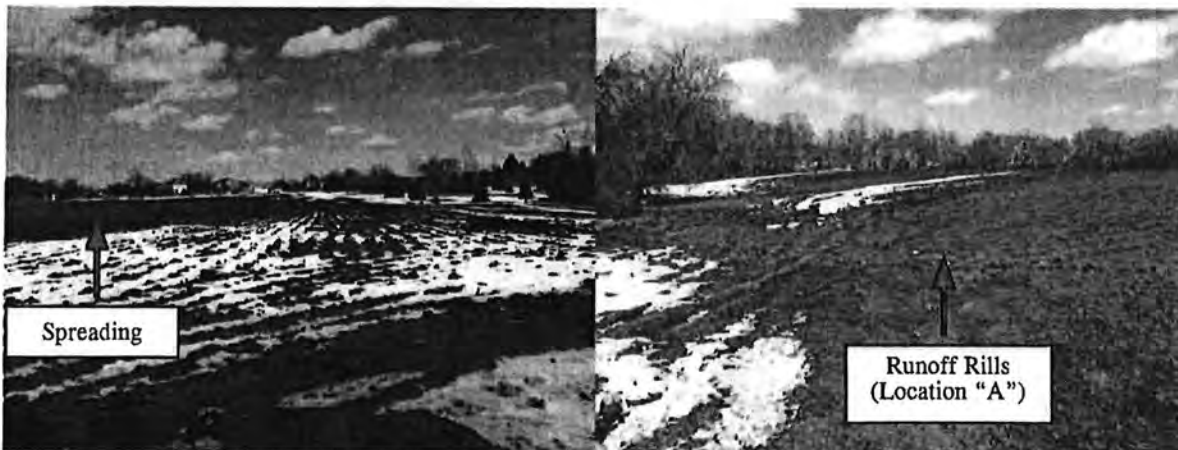
Picture looking northeast along drainage ditch showing  
swale area where runoff had occurred

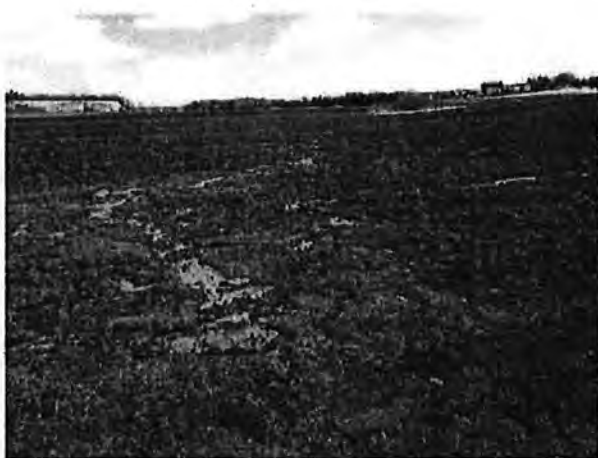
FIELD 11G1 (Location "B")

Picture looking southeast at field area from  
discharge area in ditch

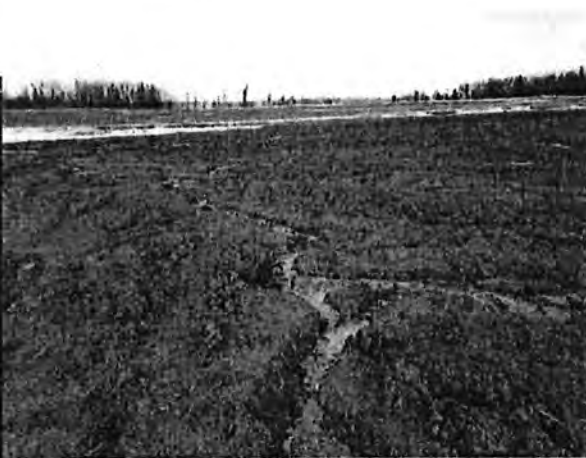
Picture looking north at drainage ditch showing  
swale area where runoff had occurred

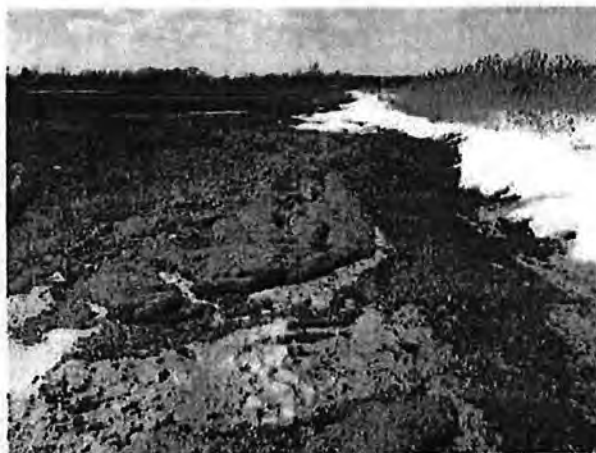
Pictures looking west at previous discharge to ditch

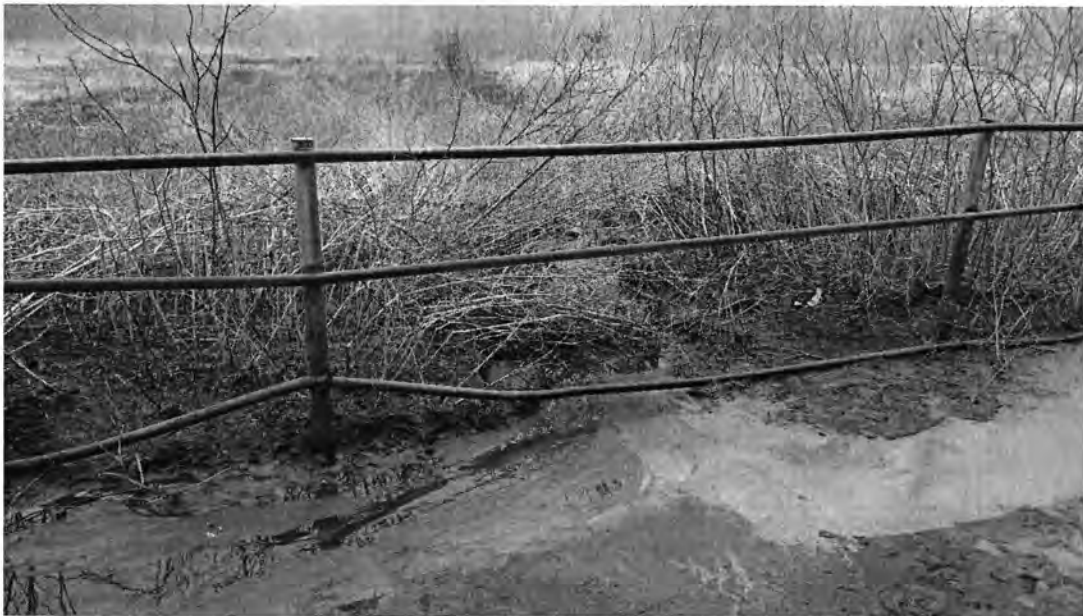
3: RIMG0011

Description: Manure and process wastewater flowed out of the northwest end of the Milk Cow Barn and from the access ways and silage bunker to the west of the Milk Cow Barn. The manure and process waste water flowed north and entered the field to the north of the Milk Cow Barn.

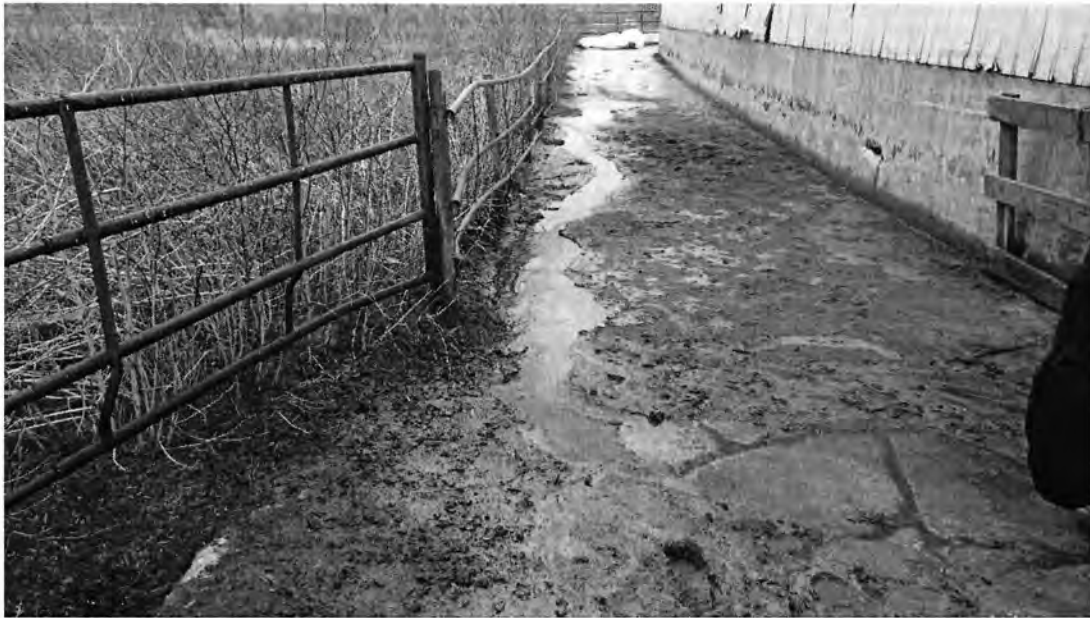
Description: The manure and process waste water flowed north and entered the field to the north of the Milk Cow Barn. The accumulation of manure, bedding, and feed solids was observed through the field north of the Milk Cow Barn.

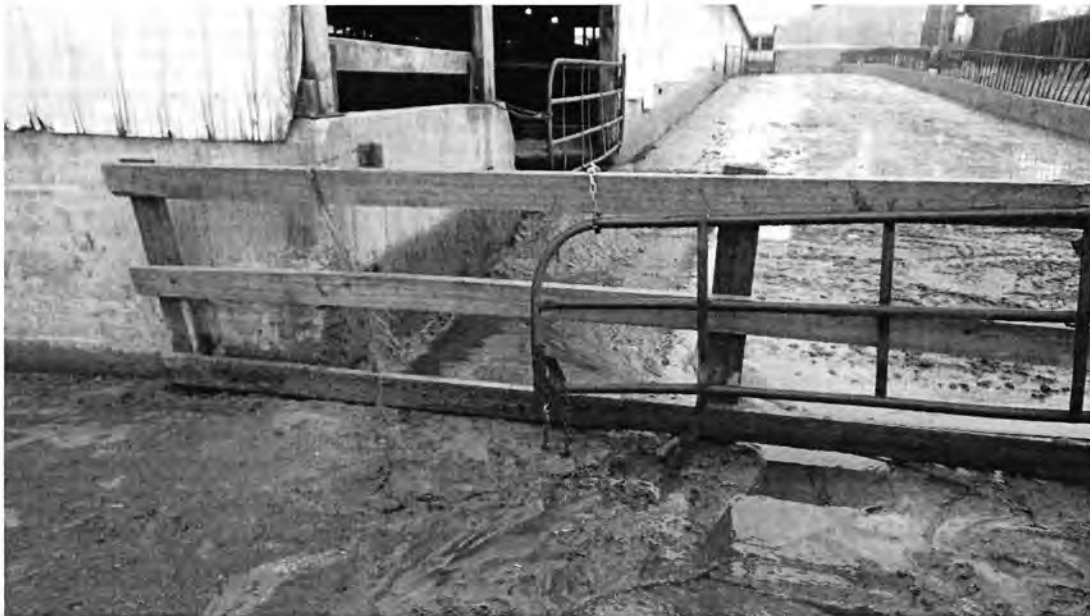
6: RIMG0014

Description: Manure and process wastewater flowed out of the northwest end of the Milk Cow Barn and from the access ways and silage bunker to the west of the Milk Cow Barn. The manure and process waste water flowed north and entered the field to the north of the Milk Cow Barn.

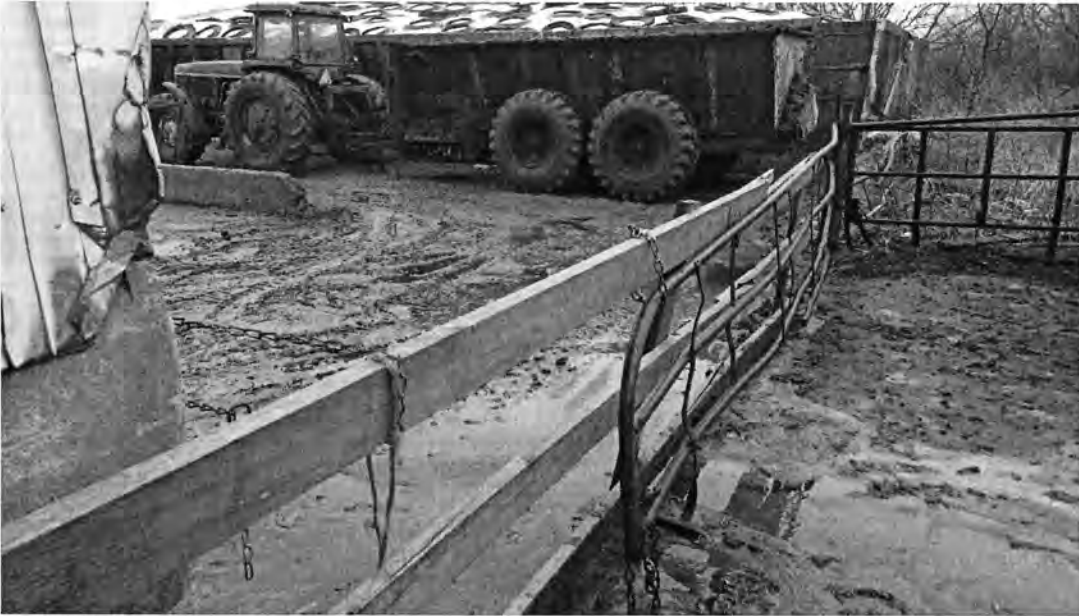
7: RIMG0015

Description: Manure and process wastewater flowed out of the northwest end of the Milk Cow Barn and from the access ways and silage bunker to the west of the Milk Cow Barn. The manure and process waste water flowed north and entered the field to the north of the Milk Cow Barn.

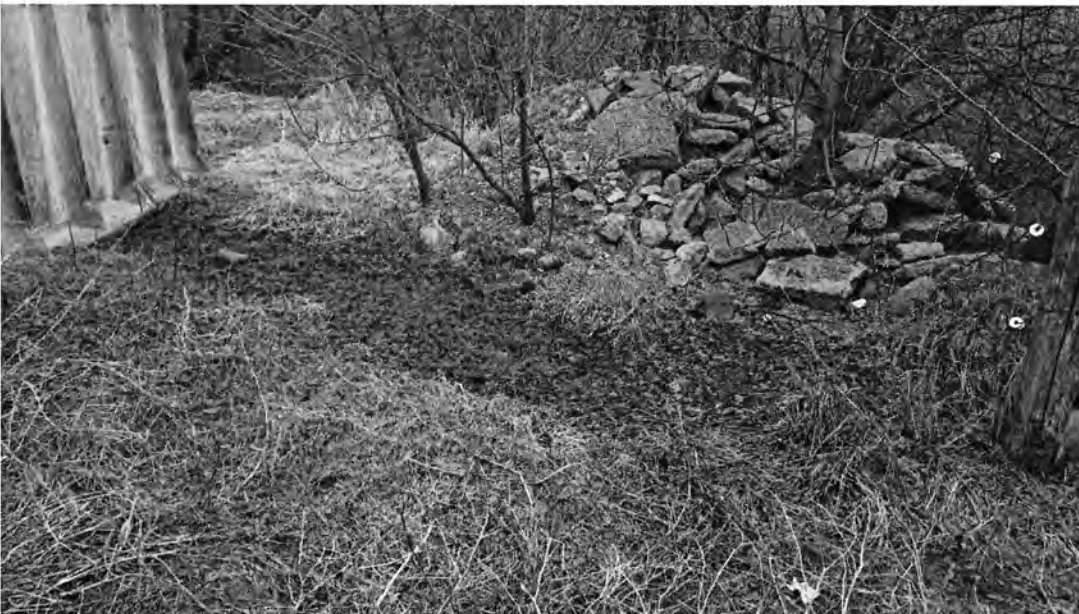
8: RIMG0016

Description: Manure and process wastewater flowed out of the northwest end of the Milk Cow Barn and from the access ways and silage bunker to the west of the Milk Cow Barn. The manure and process waste water flowed north and entered the field to the north of the Milk Cow Barn.

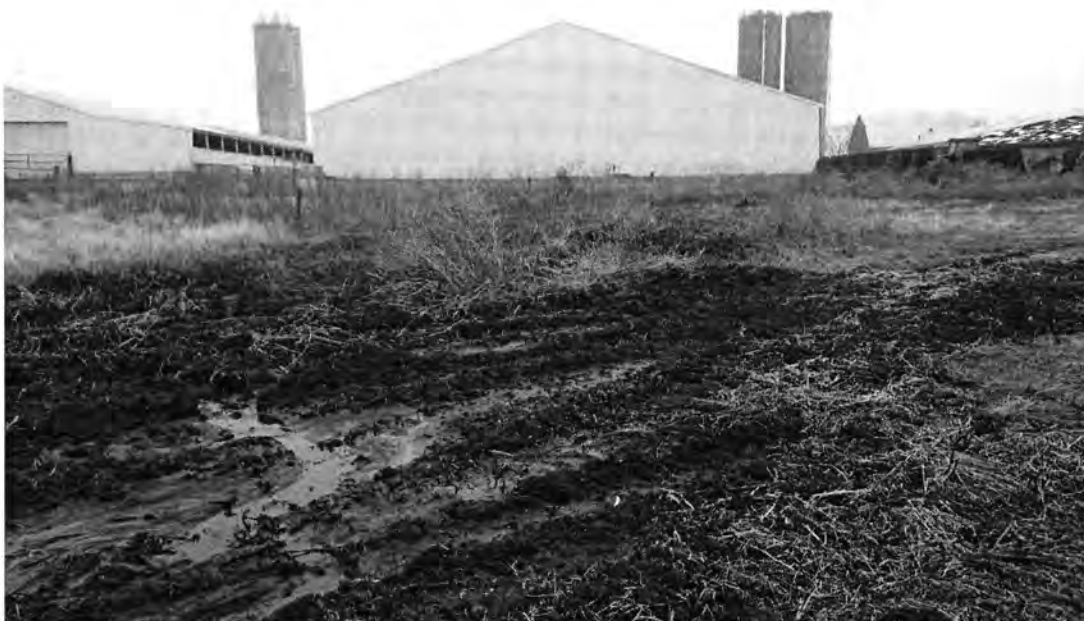
Description: Process wastewater was observed at the north end of the Feed Bunker

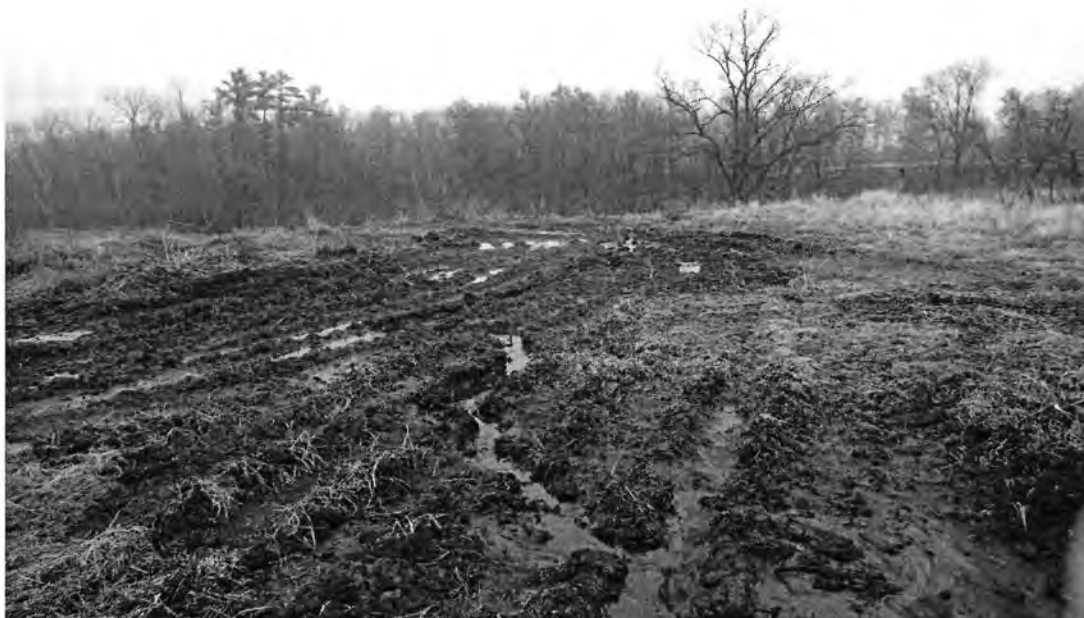
10: RIMG0018

Description: Feed, bedding, and manure solids were observed throughout the field north of the Milk Cow Barn. The field sloped to the north.

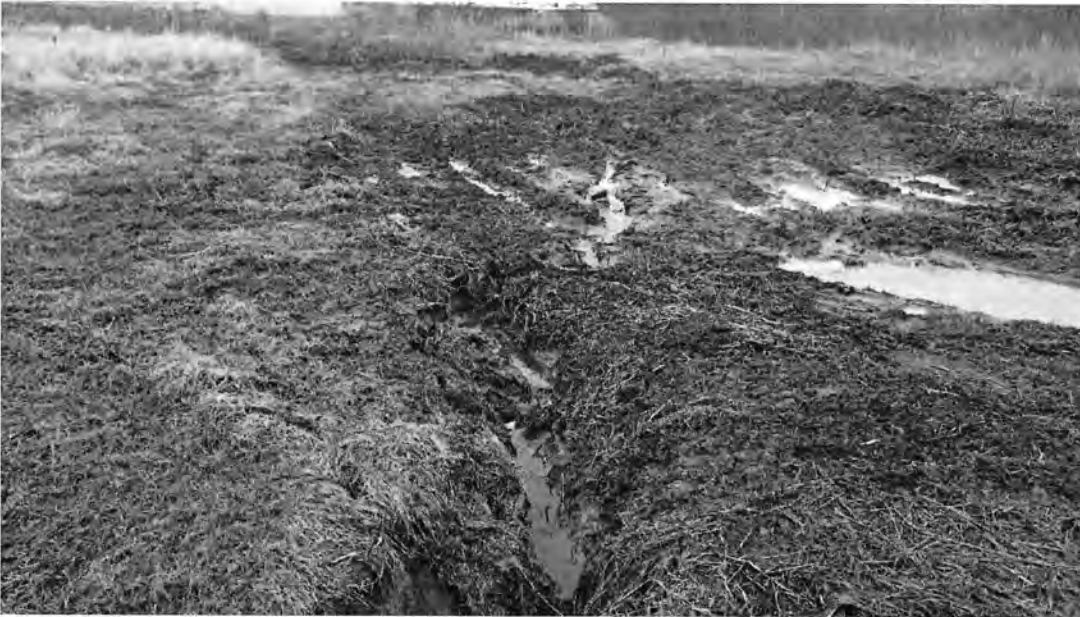
11: RIMG0019

Description: Feed, bedding, and manure solids were observed throughout the field north of the Milk Cow Barn. The field sloped to the north.

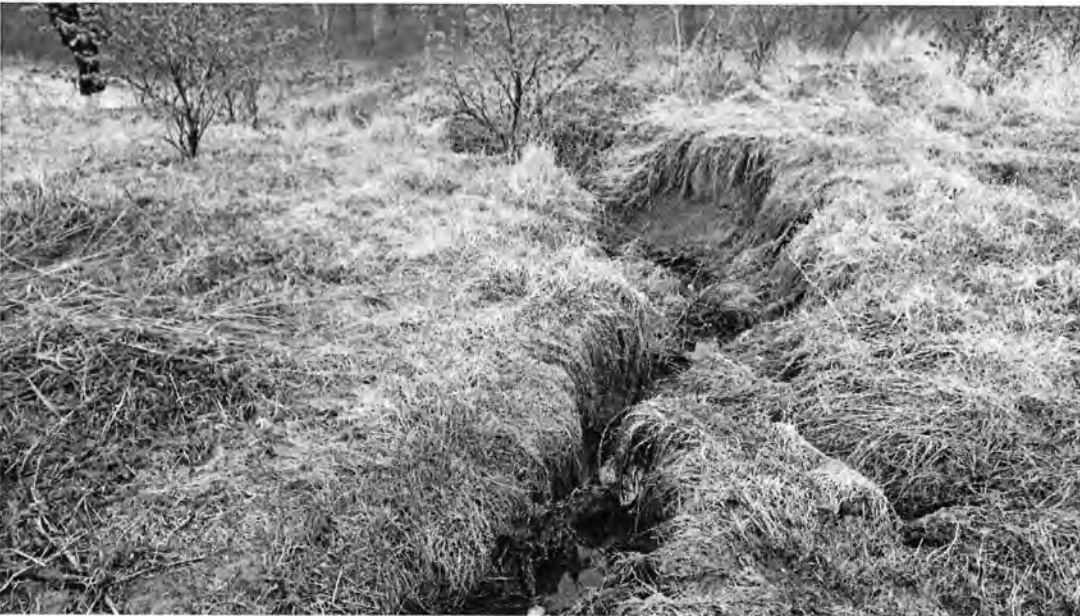
12: RIMG0020

Description: Manure and process wastewater flow from the field concentrated into a pathway.

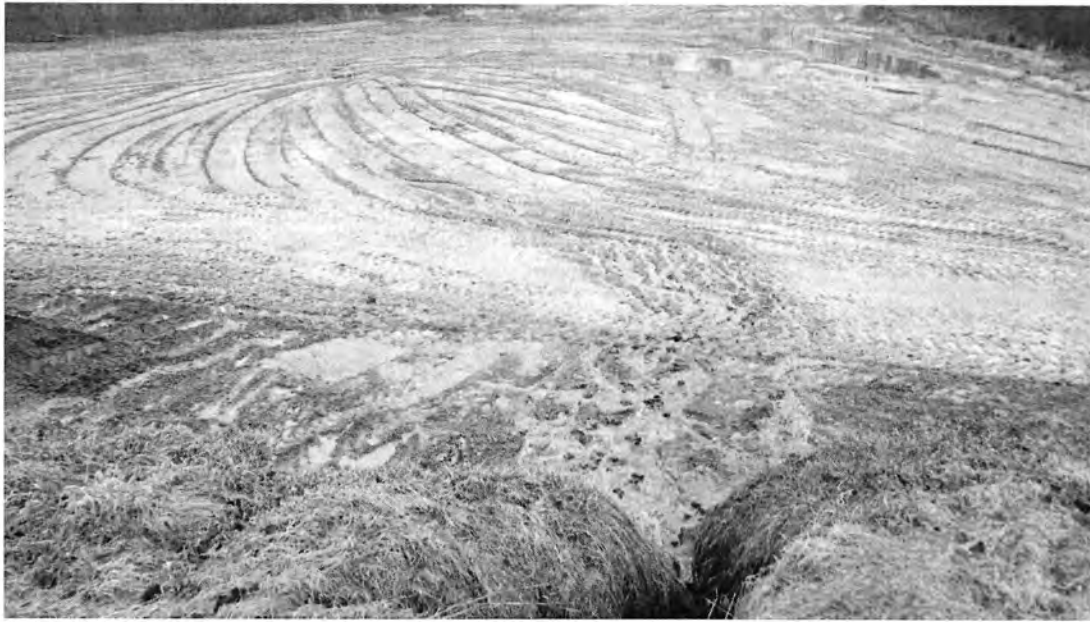
13: RIMG0021

Description: Manure and process wastewater flow from the field concentrated into a pathway.

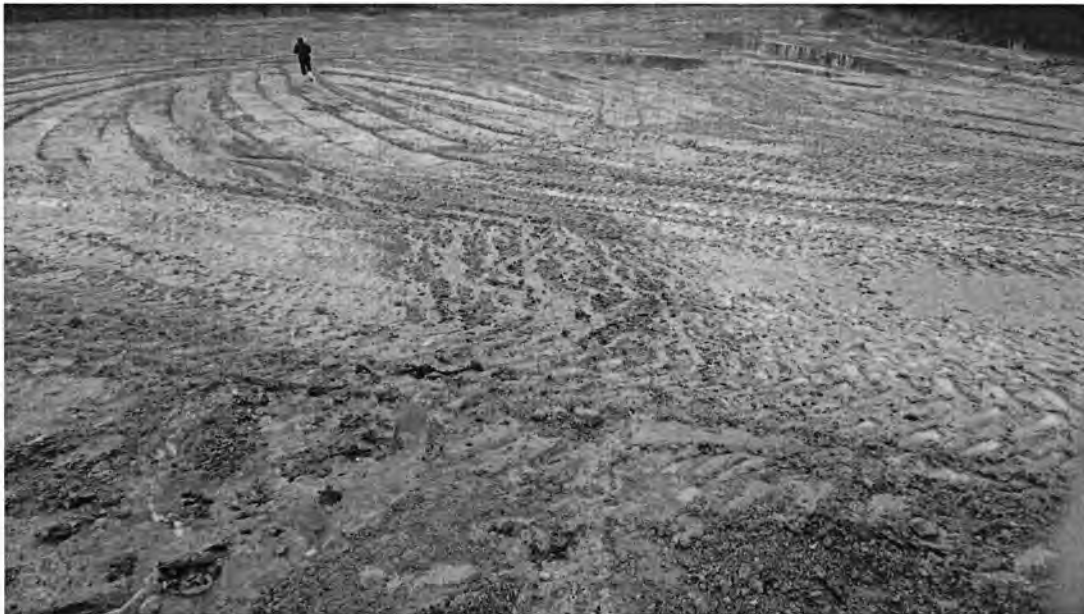
15: RIMG0024

Description: The process wastewater pathway flows to the north through the borrow area north of the Milk Cow Barn. The borrow area was used for the construction of a waste storage facility. Sediment and erosion control measures had not been implemented on the disturbed area.

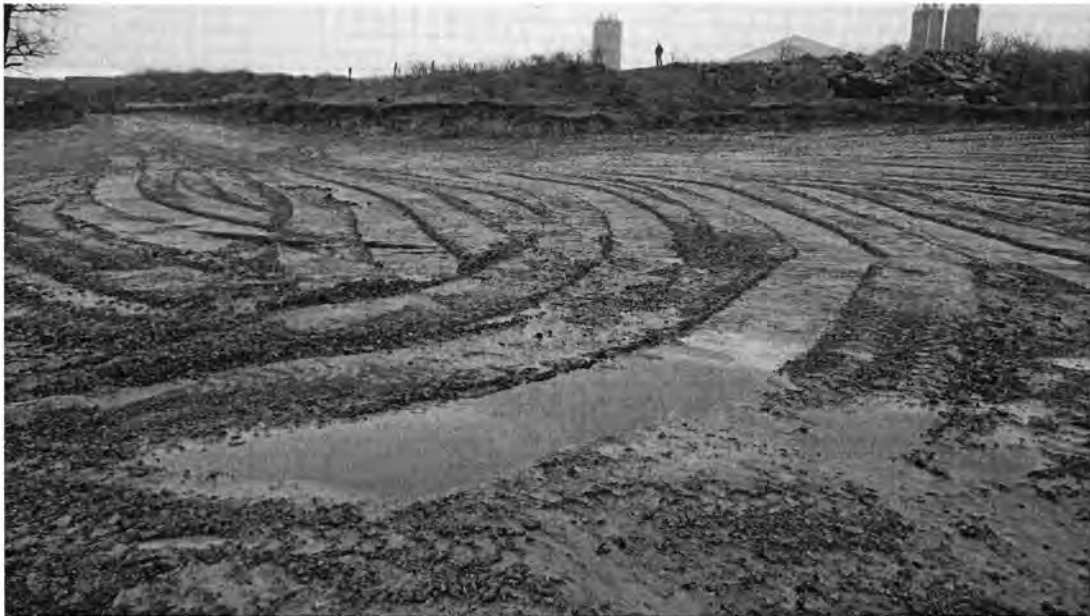
16: RIMG0025

Description: The process wastewater pathway flows to the north through the borrow area north of the Milk Cow Barn. The borrow area was used for the construction of a waste storage facility. Sediment and erosion control measures had not been implemented on the disturbed area. The dark colored water in the borrow area is process wastewater.

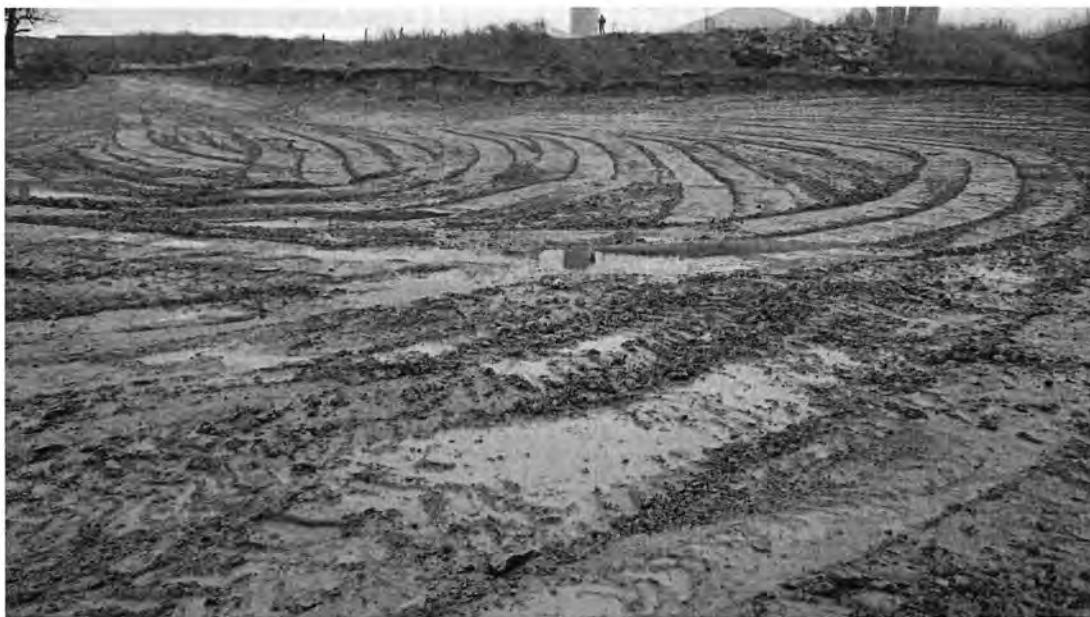
17: RIMG0026

Description: The process wastewater pathway flows to the north through the borrow area north of the Milk Cow Barn. The borrow area was used for the construction of a waste storage facility. Sediment and erosion control measures had not been implemented on the disturbed area. The dark colored water in the borrow area is process wastewater.

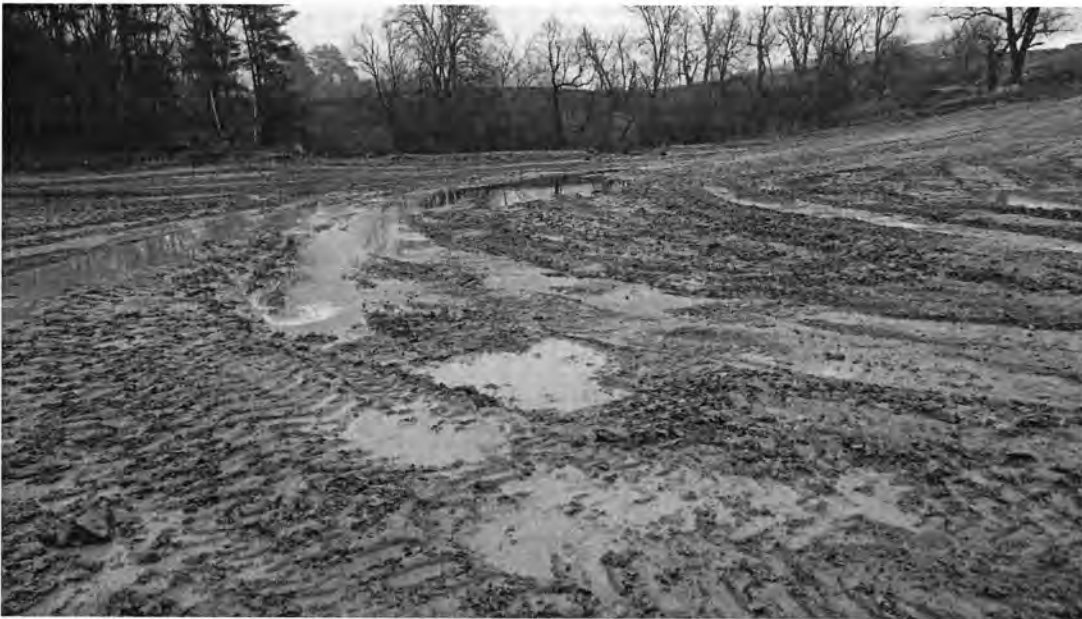
18: RIMG0027

Description: The process wastewater pathway flows to the north through the borrow area north of the Milk Cow Barn. The borrow area was used for the construction of a waste storage facility. Sediment and erosion control measures had not been implemented on the disturbed area. The dark colored water in the borrow area is process wastewater.

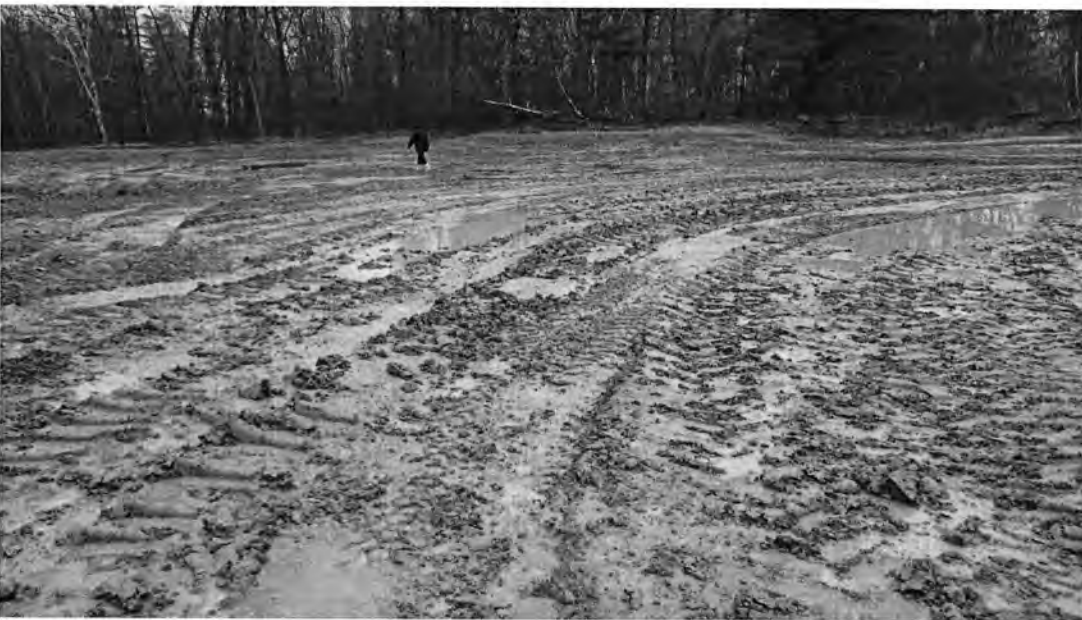
19: RIMG0028

Description: The process wastewater pathway flows to the north through the borrow area north of the Milk Cow Barn. The borrow area was used for the construction of a waste storage facility. Sediment and erosion control measures had not been implemented on the disturbed area. The dark colored water in the borrow area is process wastewater.
