State of Wisconsin | DEPARTMENT OF NATURAL RESOURCES

Subject: **Notice of Violation - Chapter 283, Wis. Statutes  
Enforcement Conference - March 9, 2009**

### **3. POTENTIAL VIOLATIONS**

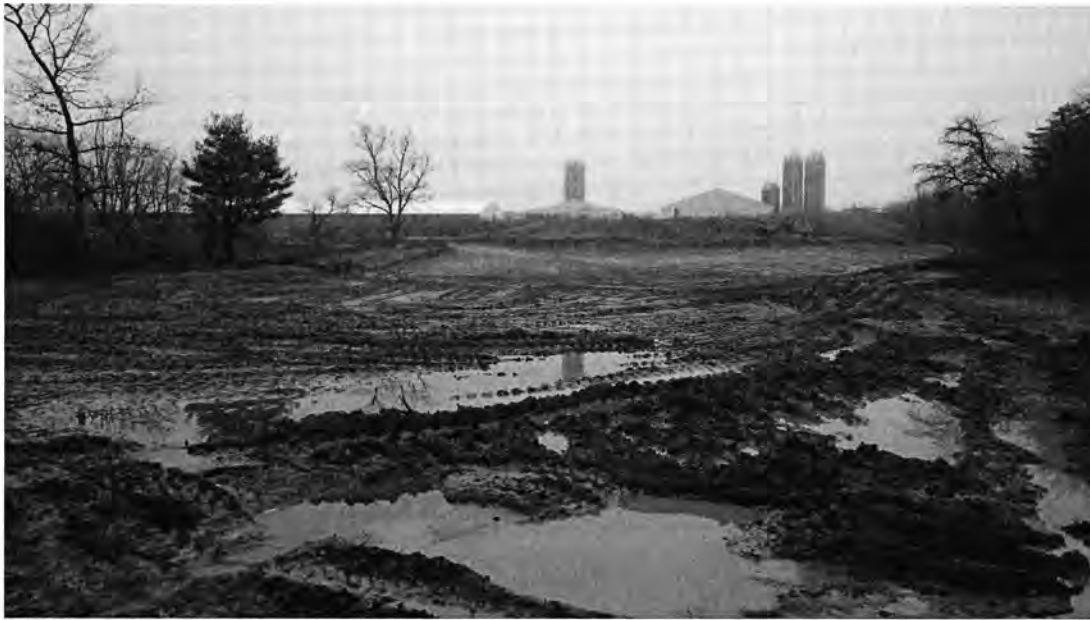
20: RIMG0029

Description: The process wastewater pathway flows to the north through the borrow area north of the Milk Cow Barn. The borrow area was used for the construction of a waste storage facility. Sediment and erosion control measures had not been implemented on the disturbed area. The dark colored water in the borrow area is process wastewater.

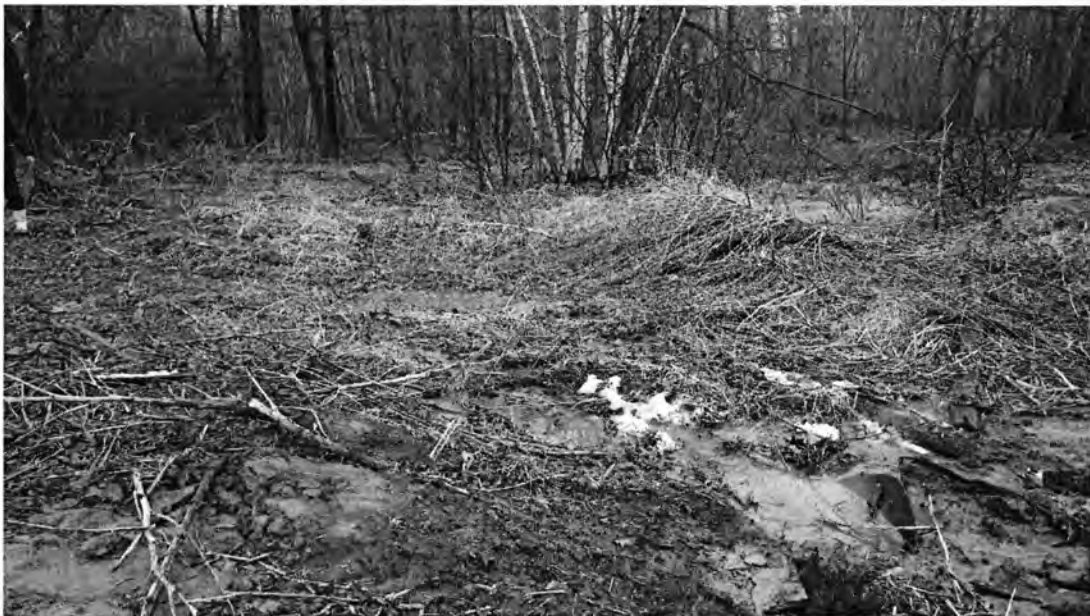
21: RIMG0030

Description: The process wastewater pathway flows to the north through the borrow area north of the Milk Cow Barn. The topography of the disturbed field is sloped such that the flow continues north into a wooded area. There were no sediment and erosion controls to reduce the amount of sediment transferred off site.

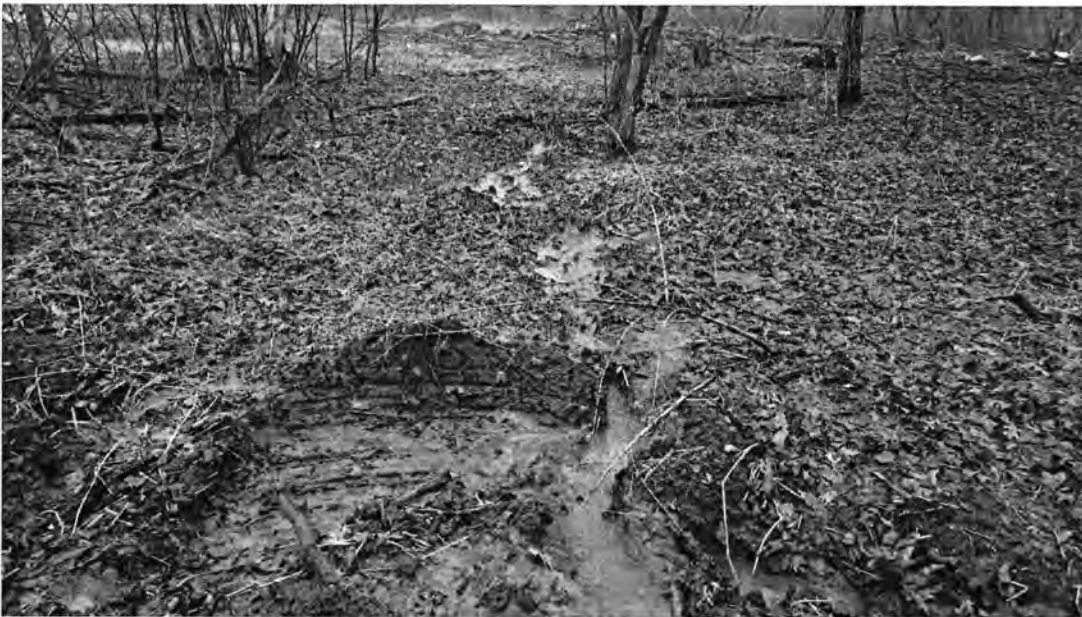
22: RIMG0031

Description: The process wastewater pathway flows to the north through a wooded area. Foam was observed in multiple locations throughout the pathway.

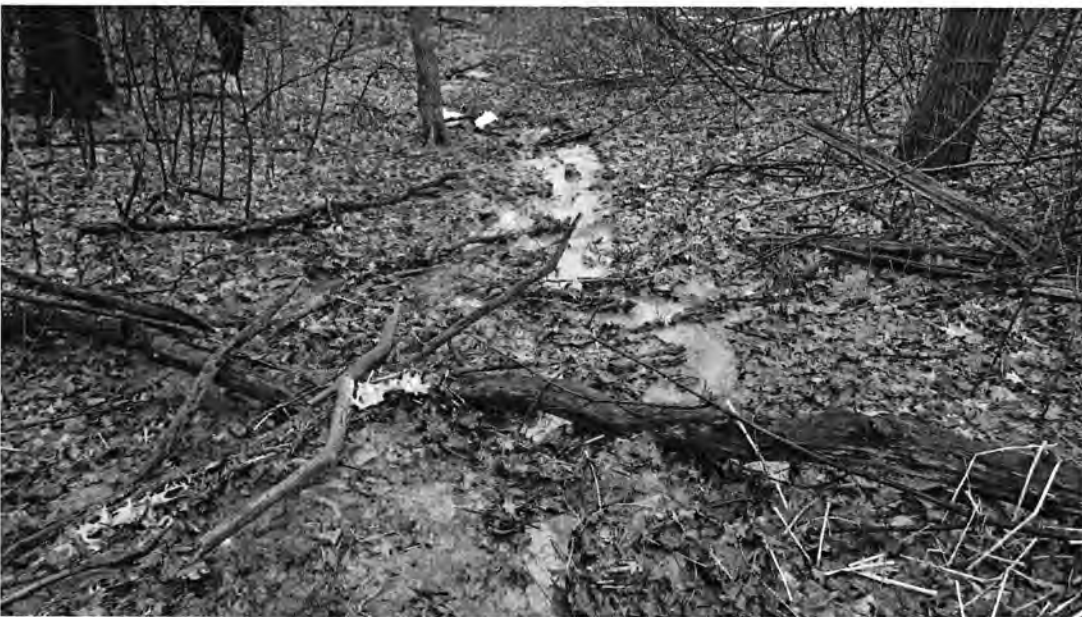
23: RIMG0032

Description: The process wastewater pathway flows to the north through a wooded area. Foam was observed in multiple locations throughout the pathway.

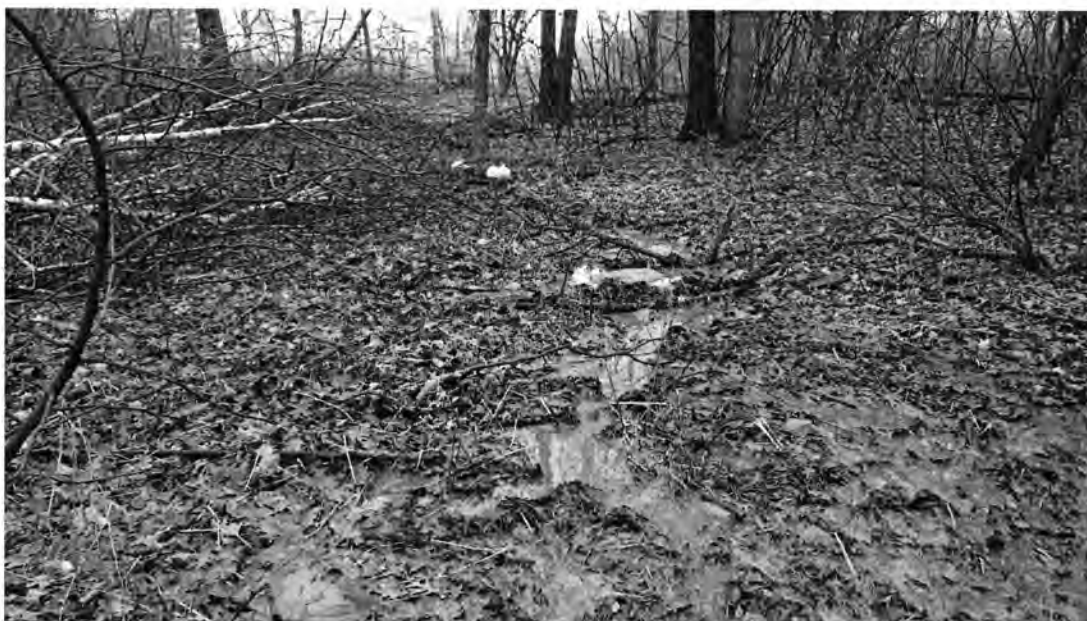
Description: The process wastewater pathway flows to the north through a wooded area. Foam was observed in multiple locations throughout the pathway.

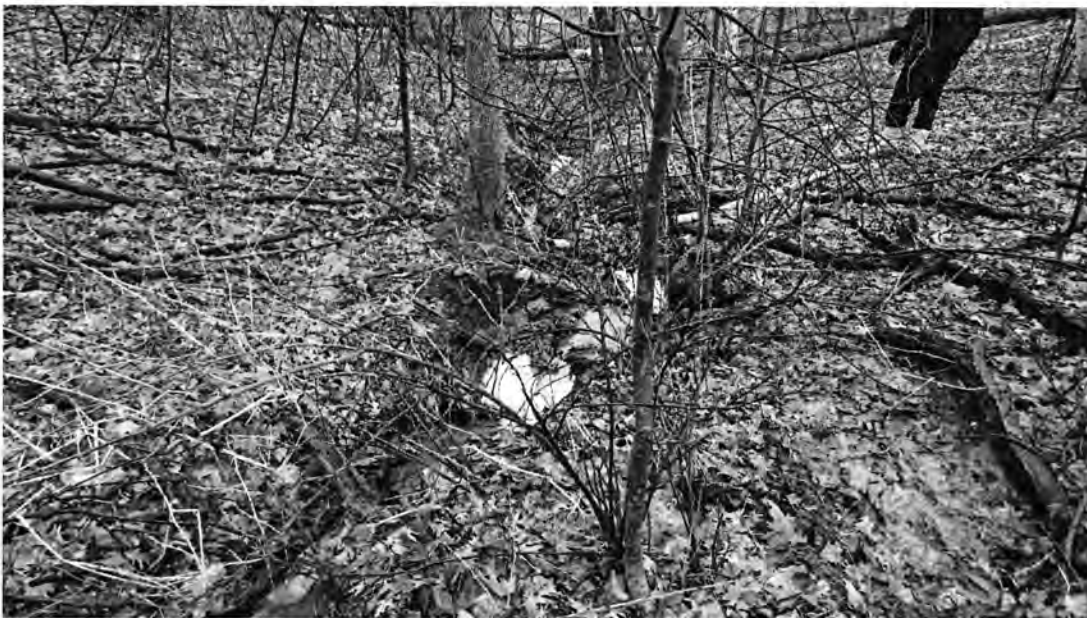
25: RIMG0034

Description: The process wastewater pathway flows to the north through a wooded area. Foam was observed in multiple locations throughout the pathway.

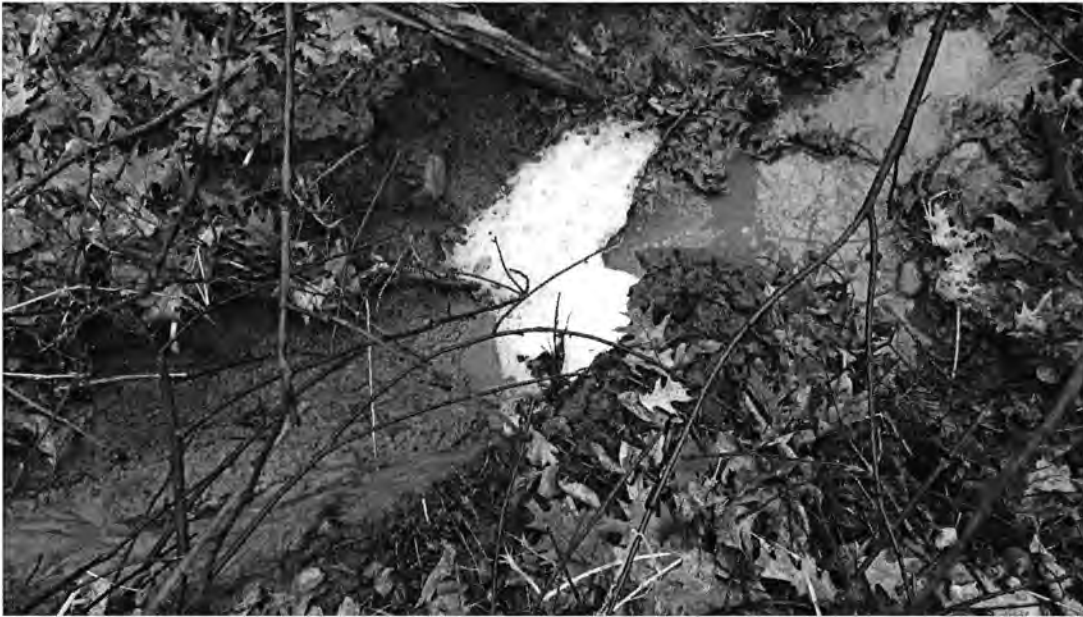
26: RIMG0035

Description: The process wastewater pathway flows to the north through a wooded area. Foam was observed in multiple locations throughout the pathway.

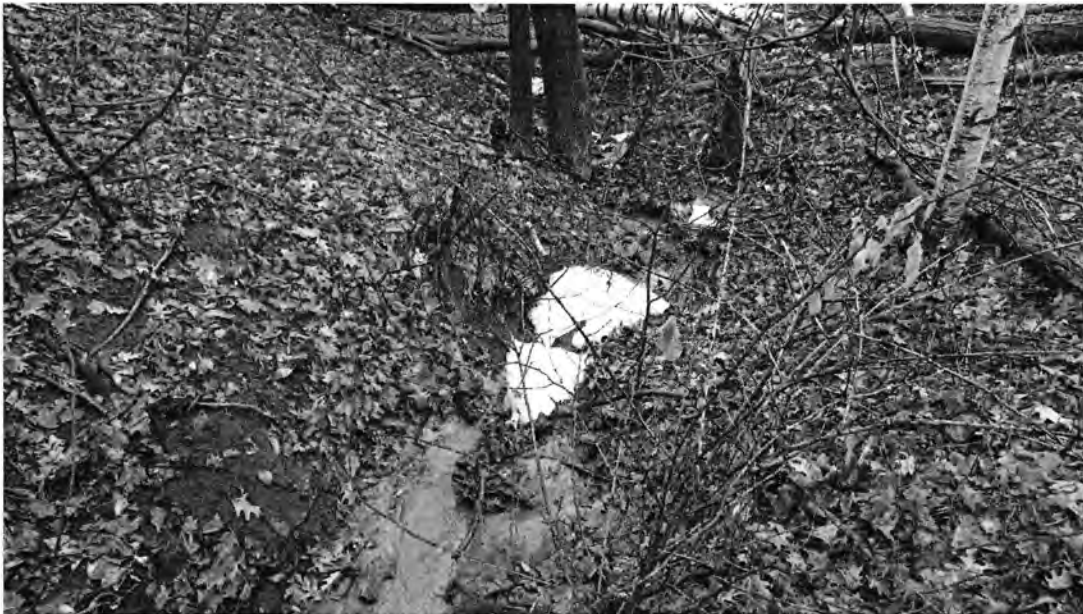
27: RIMG0036

Description: The process wastewater pathway flows to the north through a wooded area. Foam was observed in multiple locations throughout the pathway.

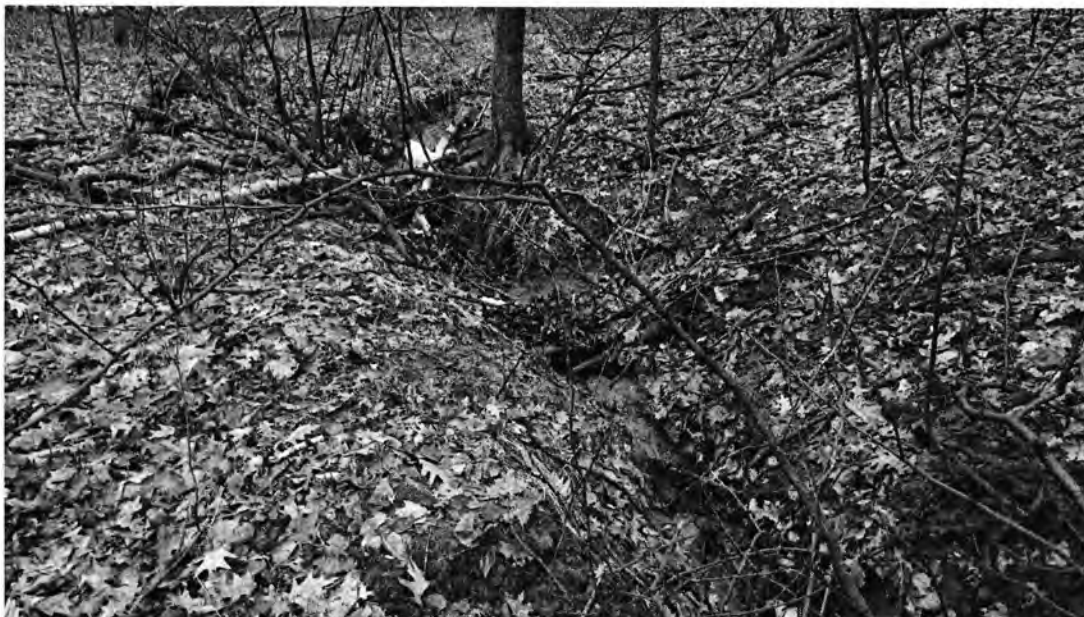
28: RIMG0037

Description: The process wastewater pathway flows to the north through a wooded area. Foam was observed in multiple locations throughout the pathway.

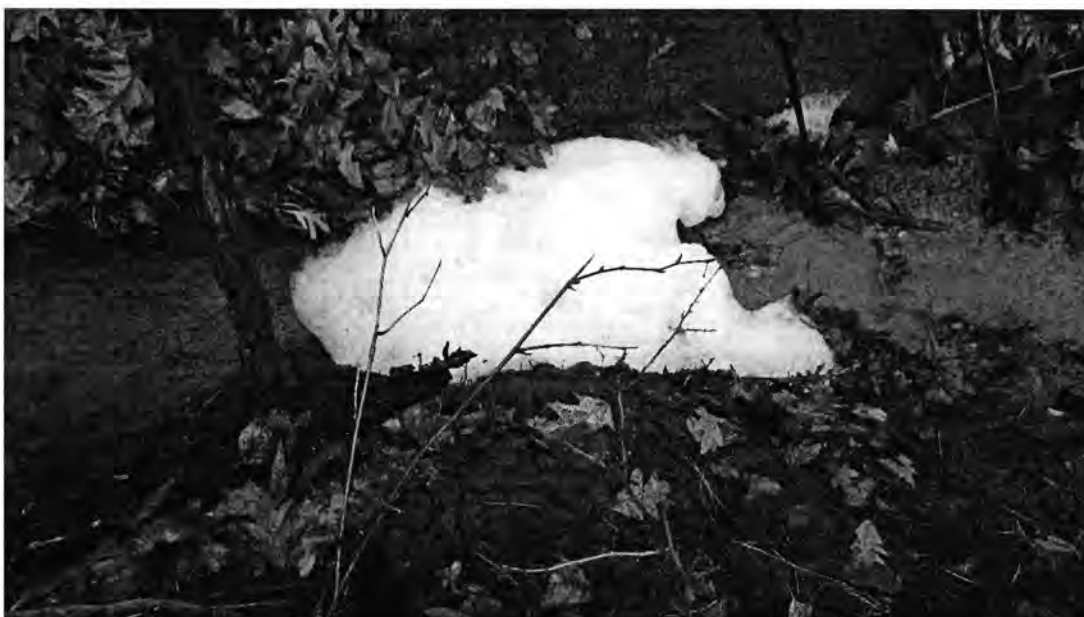
29: RIMG0038

Description: The process wastewater pathway flows to the north through a wooded area. Foam was observed in multiple locations throughout the pathway.

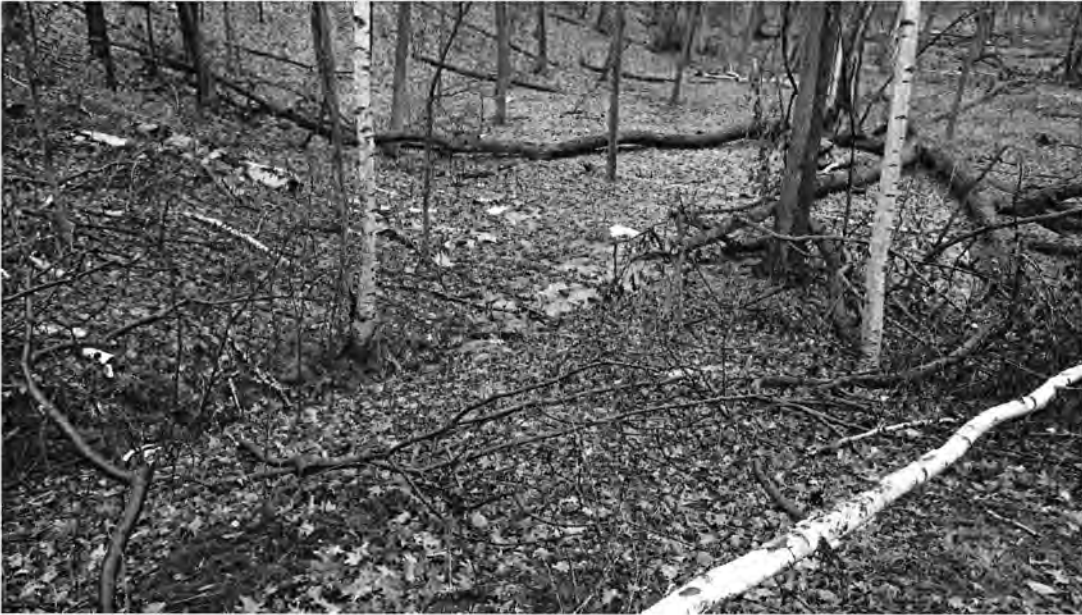
30: RIMG0039

Description: The process wastewater pathway flows to the north through a wooded area. Foam was observed in multiple locations throughout the pathway.

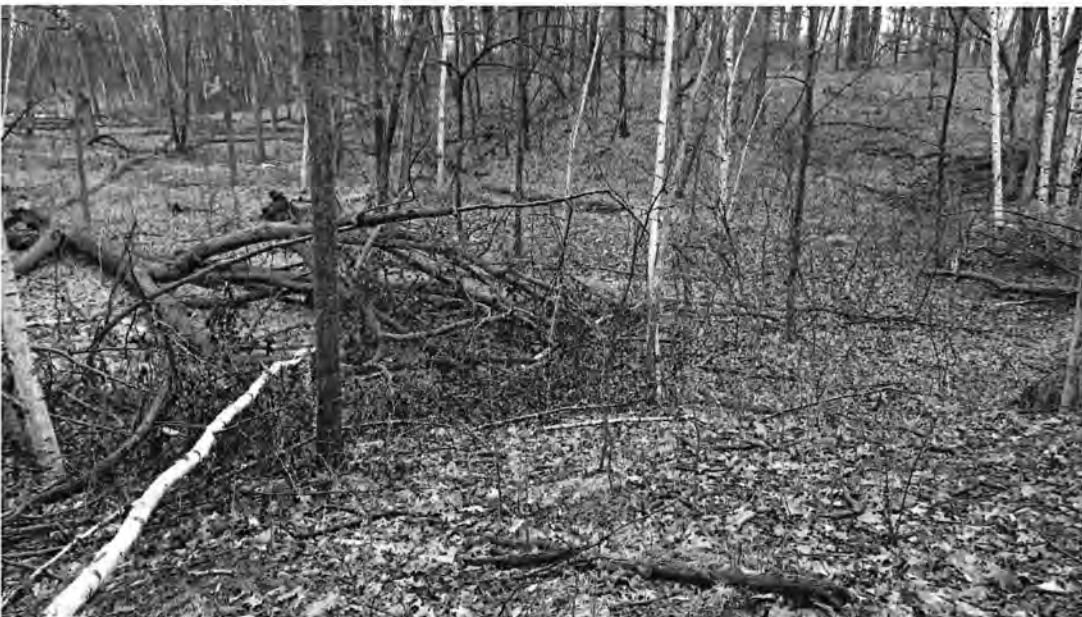
31: RIMG0040

Description: The process wastewater pathway flows to the north through a wooded area. Foam was observed in multiple locations throughout the pathway. After the flow pathway dropped down the ledge, it continued east through an area with relatively little elevation change to the unnamed tributary. Sediment deposition was observed throughout this area covering the forest floor.

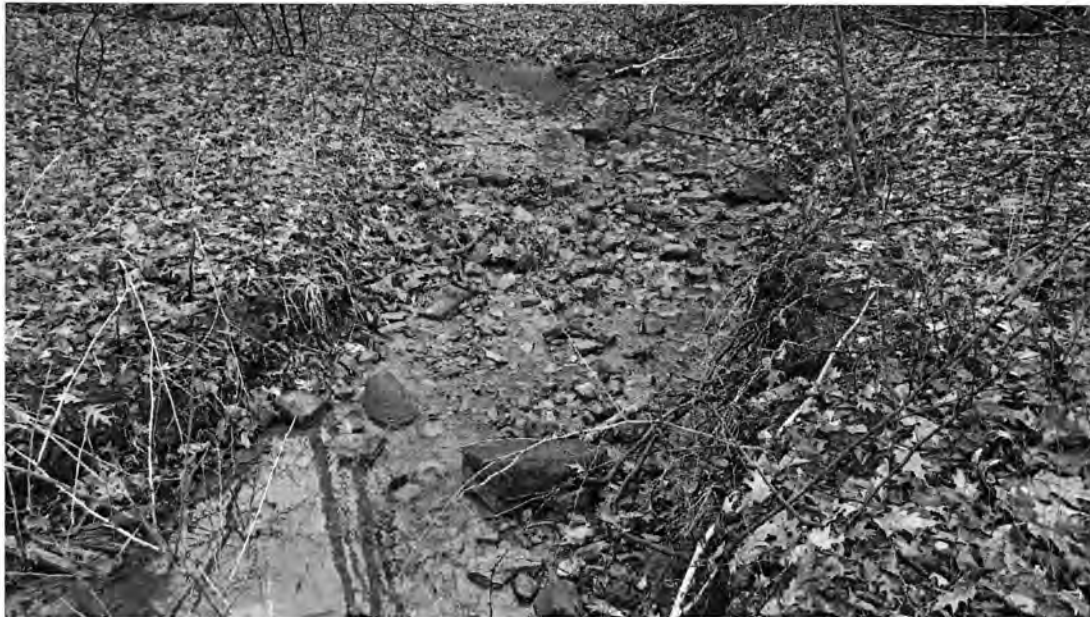
32: RIMG0041

Description: The flow pathway continued east through an area with relatively little elevation change to the unnamed tributary. Sediment deposition was observed throughout this area covering the forest floor.

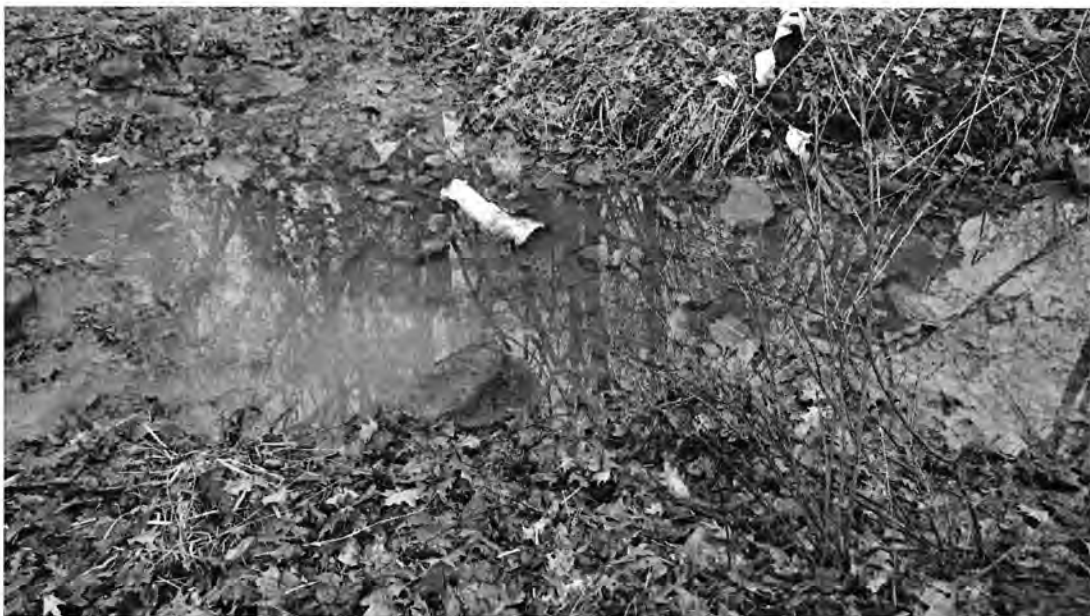
33: RIMG0042

Description: Water from the upstream portion of the unnamed tributary that abuts the east side of the Home site was clear.

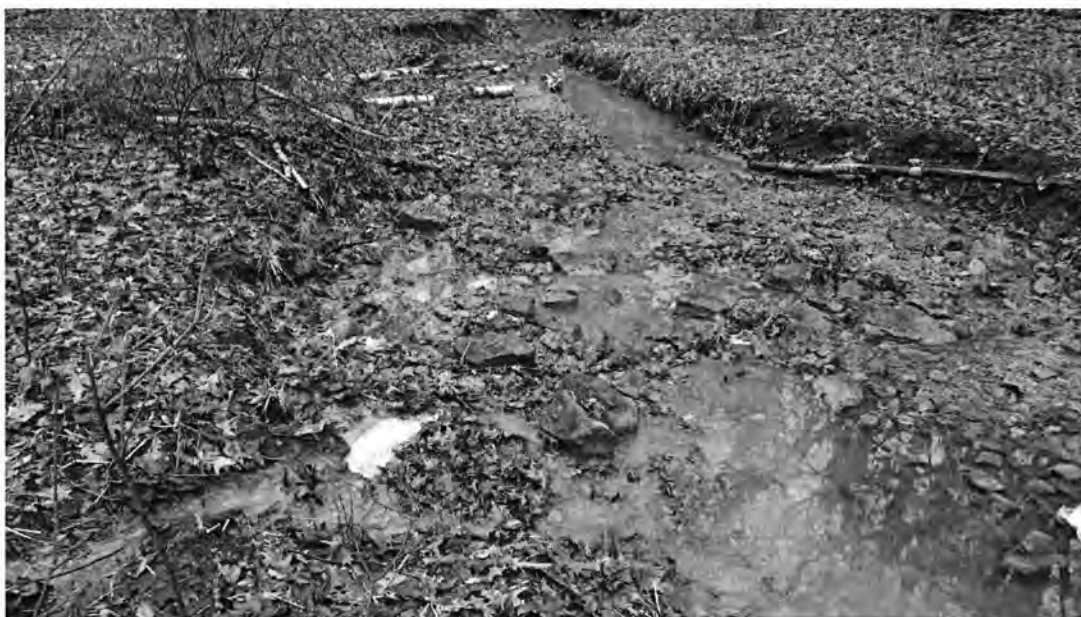
34: RIMG0043

Description: The process wastewater pathway entered the unnamed tributary that abuts the east side of the Home site. The turbid water on the left hand side of the photo from the flow pathway mixed with the clear water from the upstream portion of the unnamed tributary.

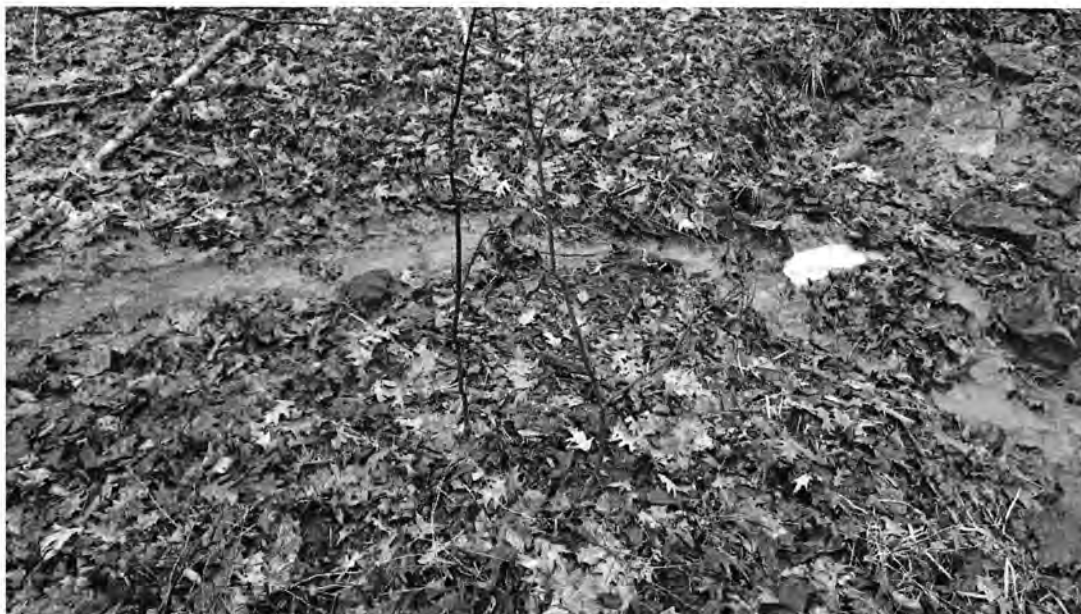
35: RIMG0044

Description: The process wastewater pathway entered the unnamed tributary that abuts the east side of the Home site. The turbid water from the flow pathway was observed throughout the downstream portion of the unnamed tributary.

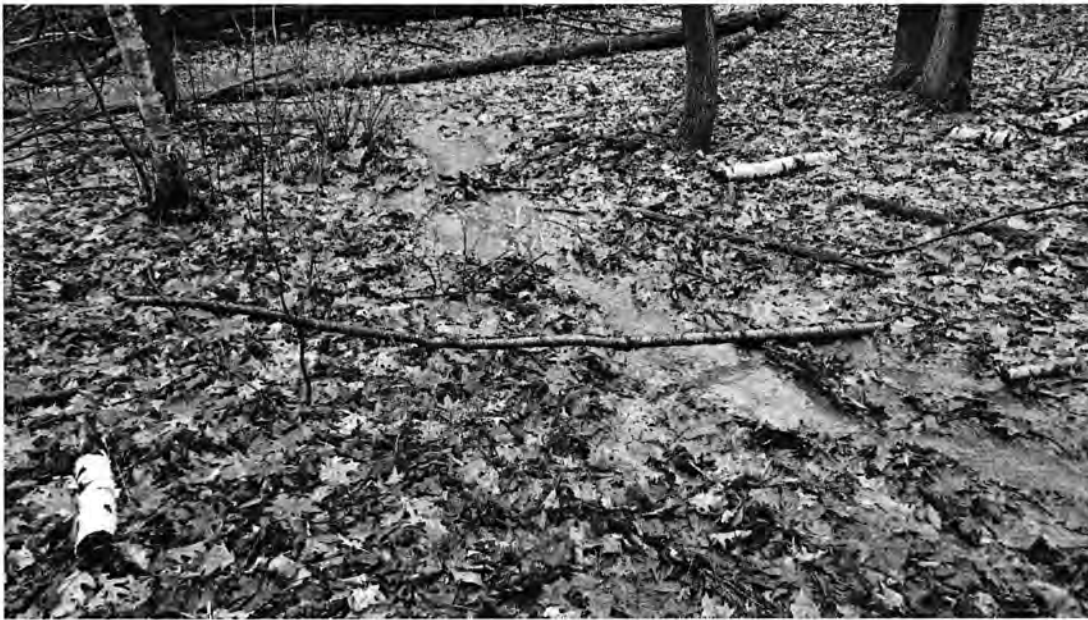
36: RIMG0045

Description: The process wastewater pathway entered the unnamed tributary that abuts the east side of the Home site.

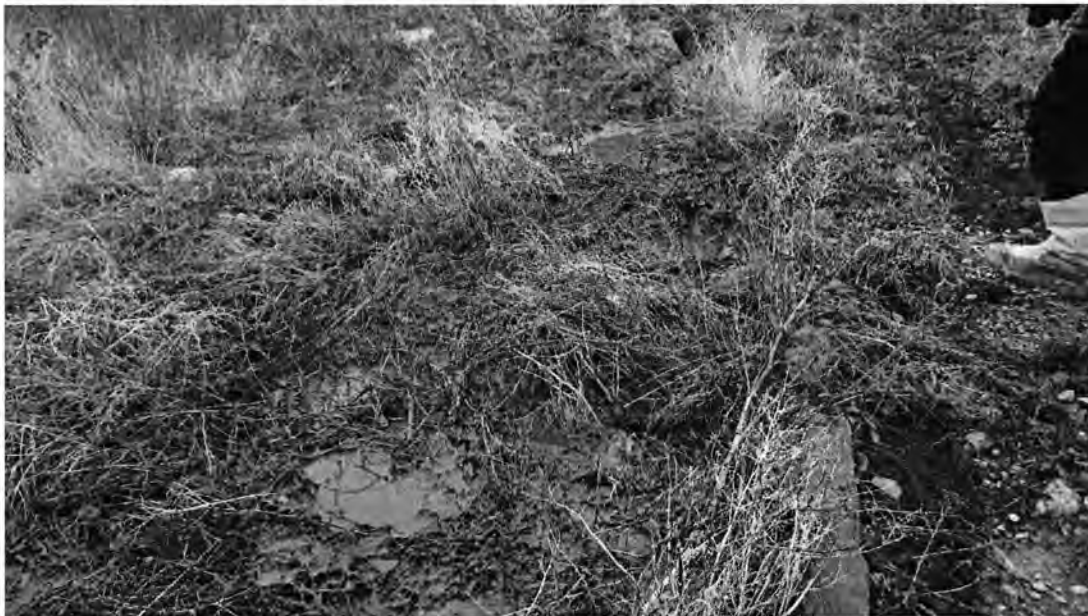
37: RIMG0046

Description: The process wastewater pathway flowing east to the unnamed tributary that abuts the east side of the Home site.

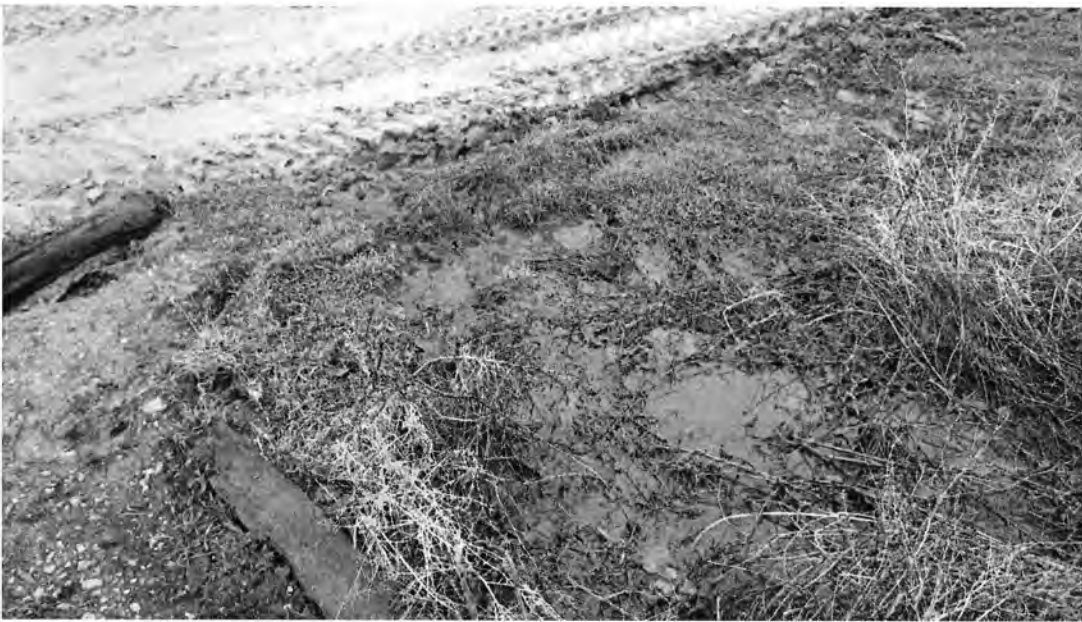
38: RIMG0047

We continued back south where we observed another process wastewater stream flowing down the ledge into the borrow area (Attachment 2: RIMG0047-RIMG0059; RIMG241-RIMG0261). The process wastewater was emanating from the barns and cattle pathways used to transfer dairy cows between the New Barn and the existing barns (Attachment 2: RIMG0078; RIMG0080-RIMG0082; RIMG0091- RIMG0092).

Description: Process wastewater flowed to the north to the borrow area north of the Milk Cow Barn. This process wastewater was emanating from the New Barn, the barn west of the New Barn, and the access ways between these barns.

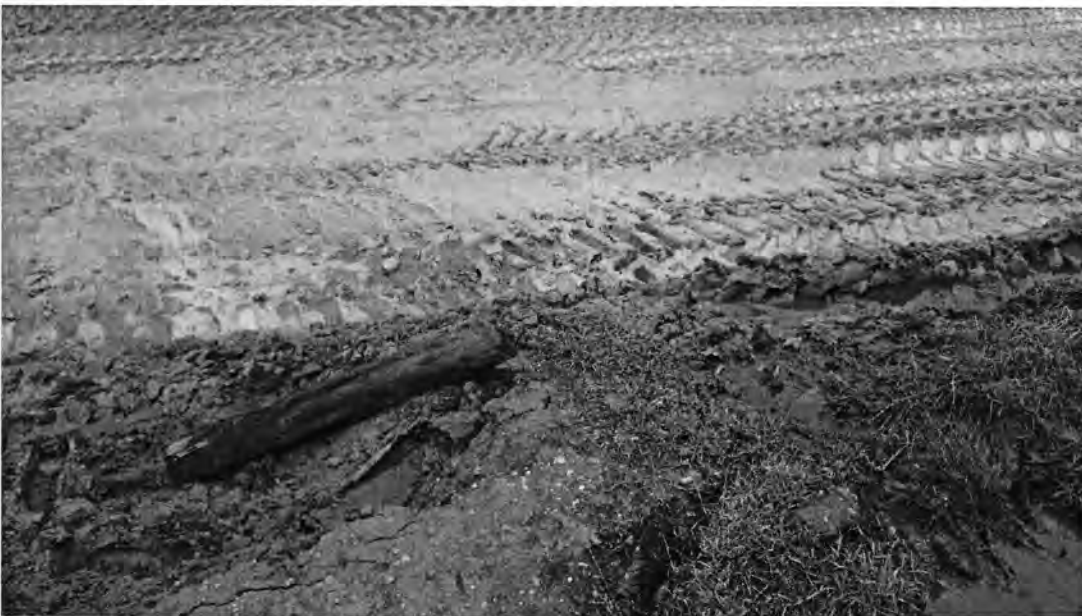
39: RIMG0048

Description: Process wastewater flowed to the north to the borrow area north of the Milk Cow Barn. This process wastewater was emanating from the New Barn, the barn west of the New Barn, and the access ways between these barns.

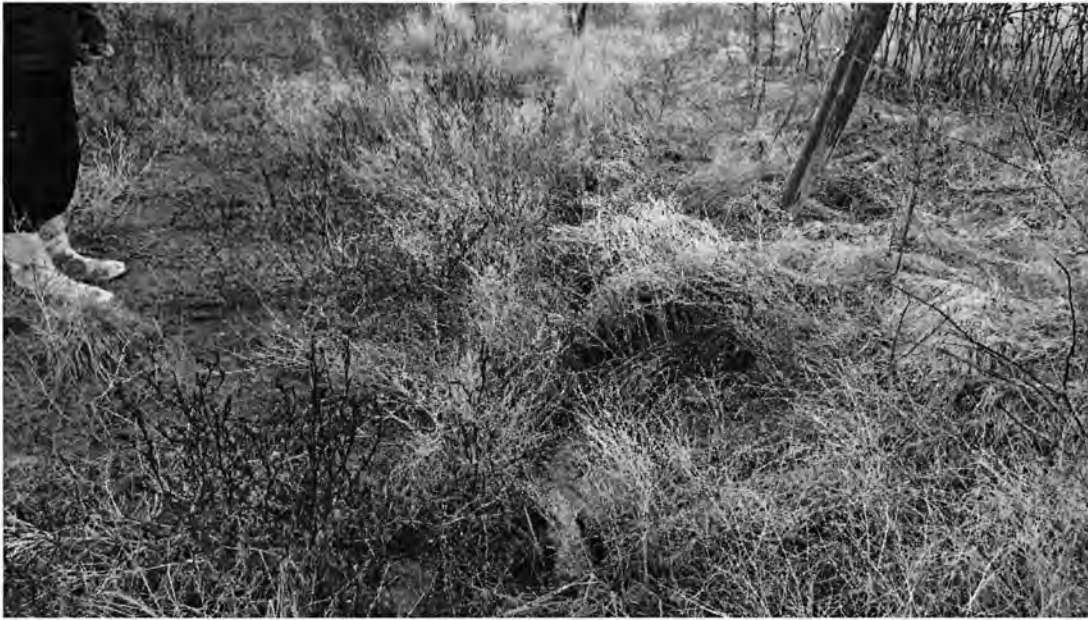
40: RIMG0049

Description: Process wastewater flowed to the north to the borrow area north of the Milk Cow Barn. This process wastewater was emanating from the New Barn, the barn west of the New Barn, and the access ways between these barns.

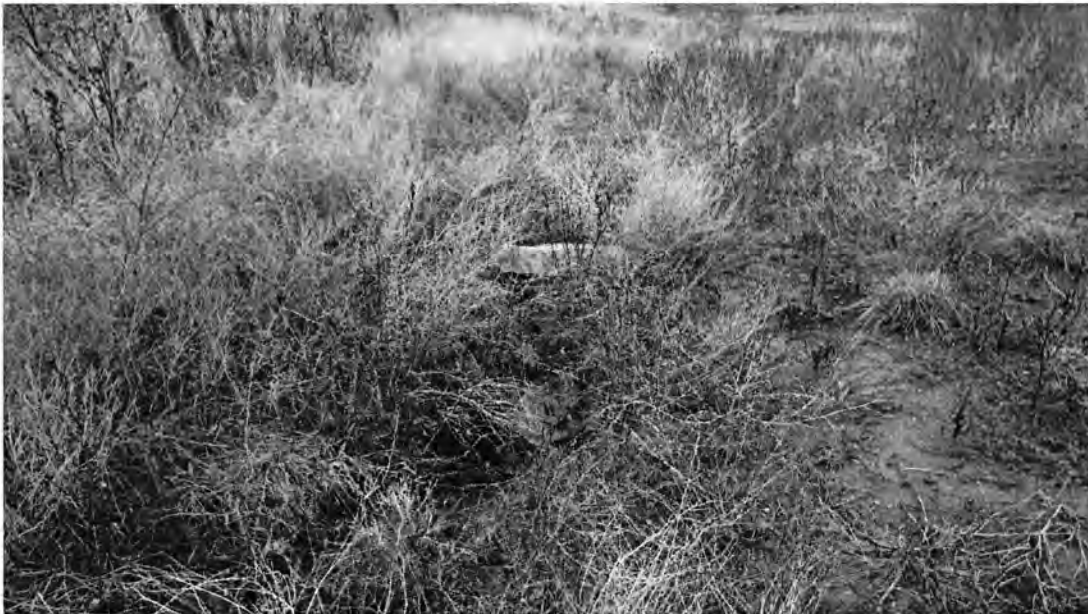
41: RIMG0050

Description: Process wastewater flowed through a pathway to the north to the borrow area north of the Milk Cow Barn. This process wastewater was emanating from the New Barn, the barn west of the New Barn, and the access ways between these barns.

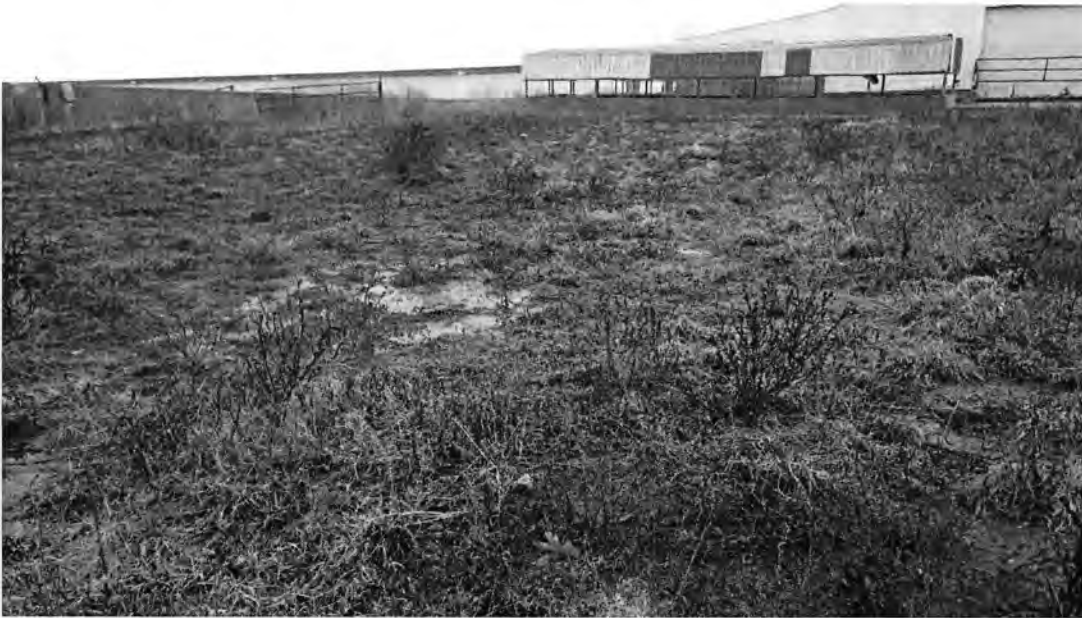
42: RIMG0051

Description: Process wastewater flowed through a pathway to the north to the borrow area north of the Milk Cow Barn. This process wastewater was emanating from the New Barn, the barn west of the New Barn, and the access ways between these barns.

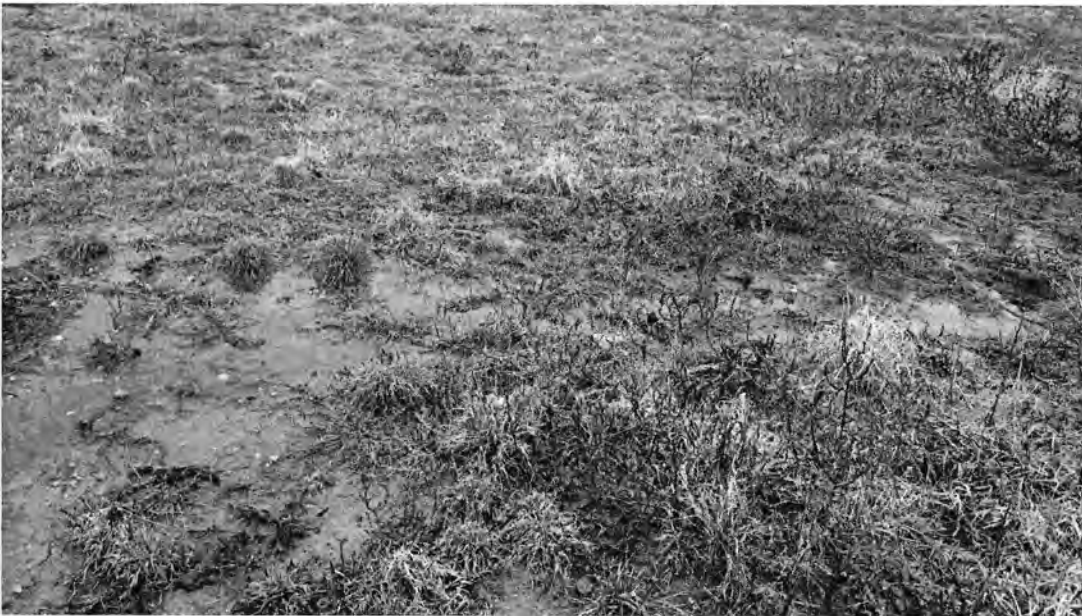
43: RIMG0052

Description: Process wastewater in the field west of the concrete pits.

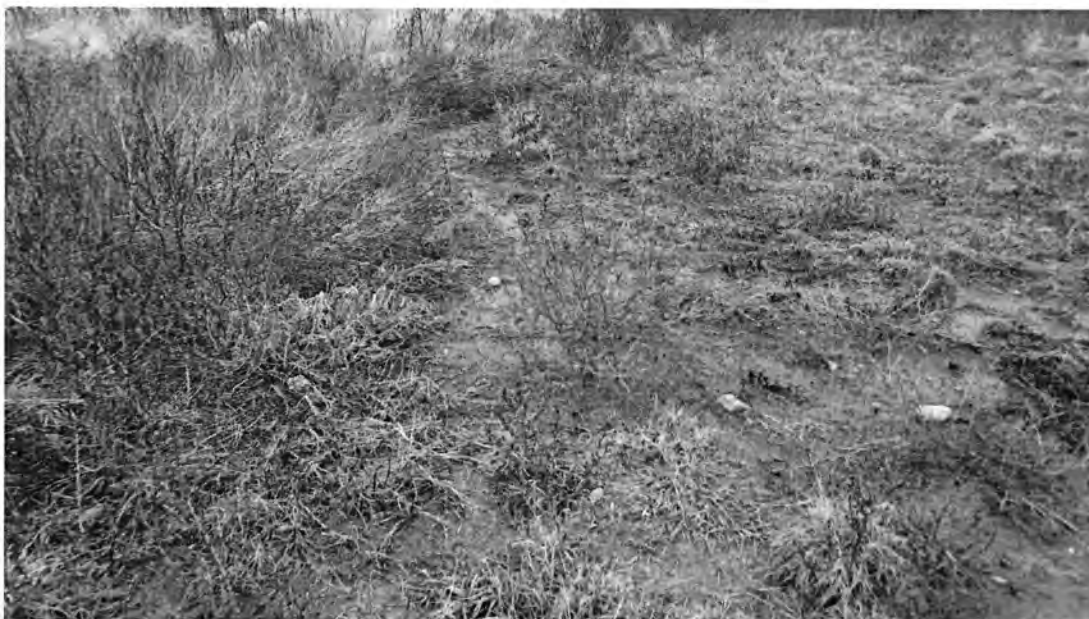
44: RIMG0053

Description: Process wastewater in the field west of the concrete pits.

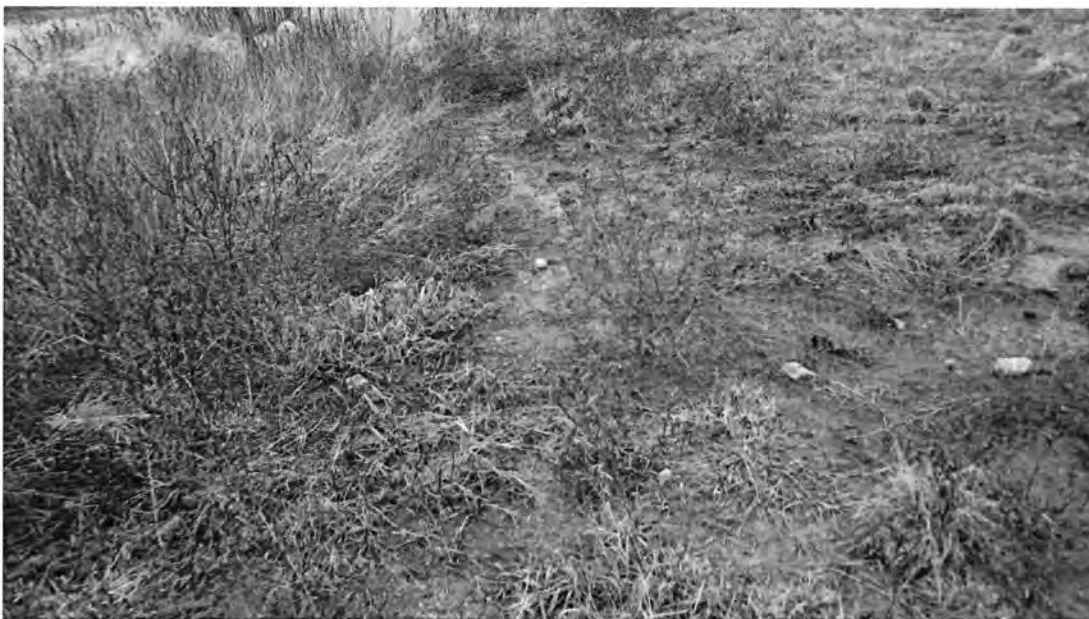
45: RIMG0054

Description: Process wastewater in the field west of the concrete pits.

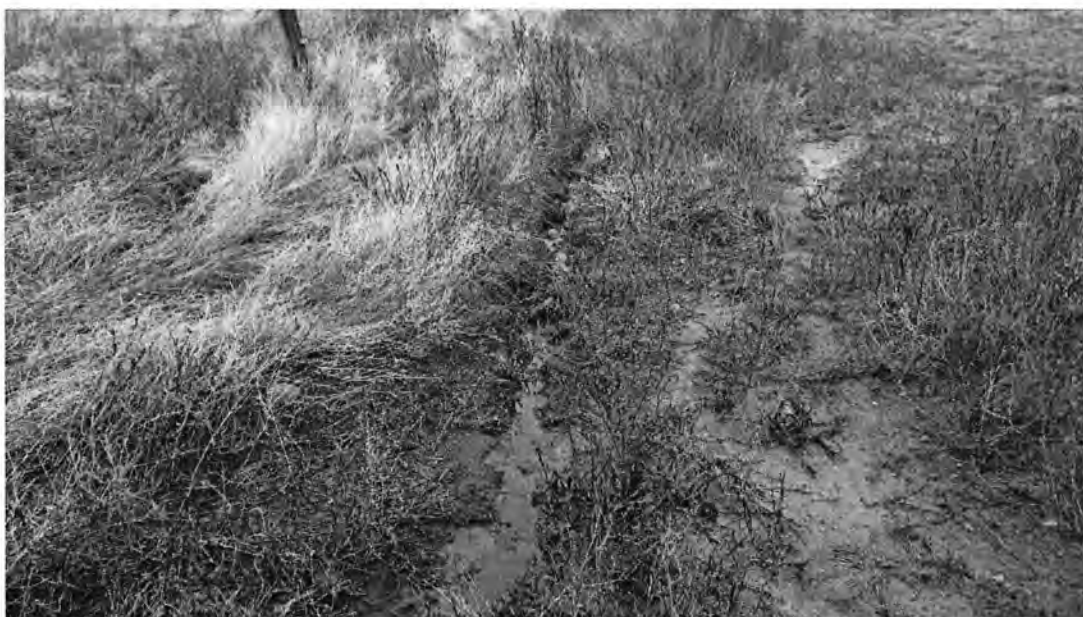
46: RIMG0055

Description: Process wastewater in the field west of the concrete pits.

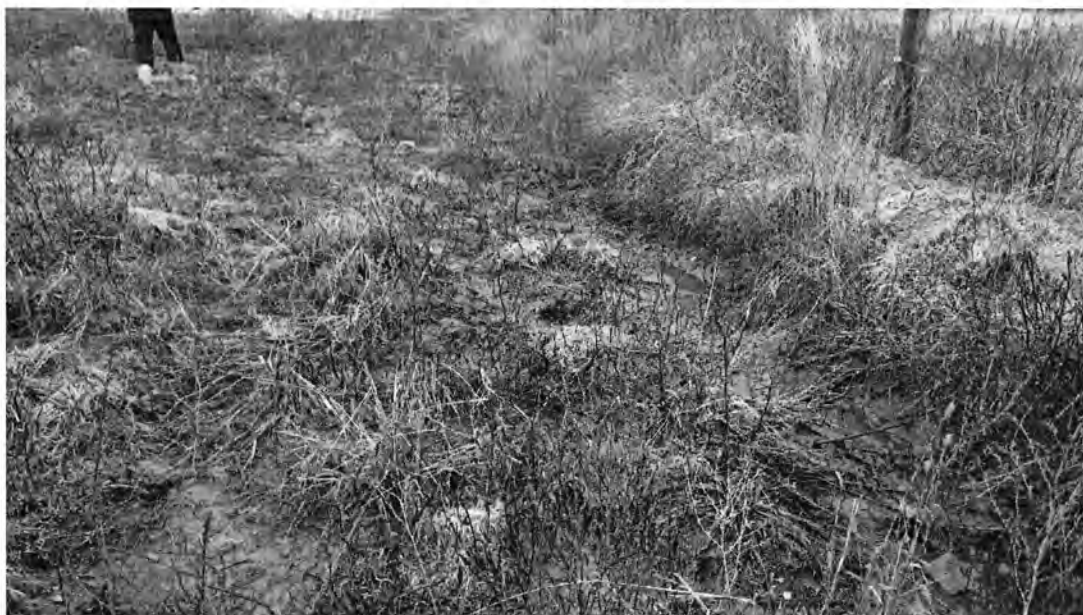
47: RIMG0056

Description: Process wastewater flowed through a pathway to the north to the borrow area north of the Milk Cow Barn. This process wastewater was emanating from the New Barn, the barn west of the New Barn, and the access ways between these barns.

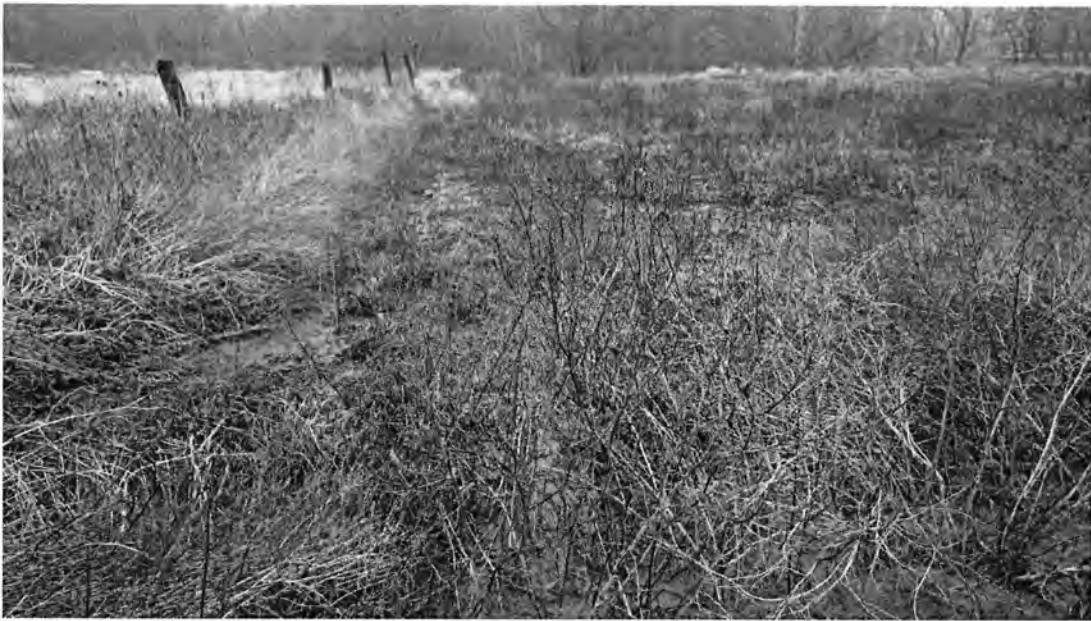
48: RIMG0057

Description: Process wastewater flowed through a pathway to the north to the borrow area north of the Milk Cow Barn. This process wastewater was emanating from the New Barn, the barn west of the New Barn, and the access ways between these barns.

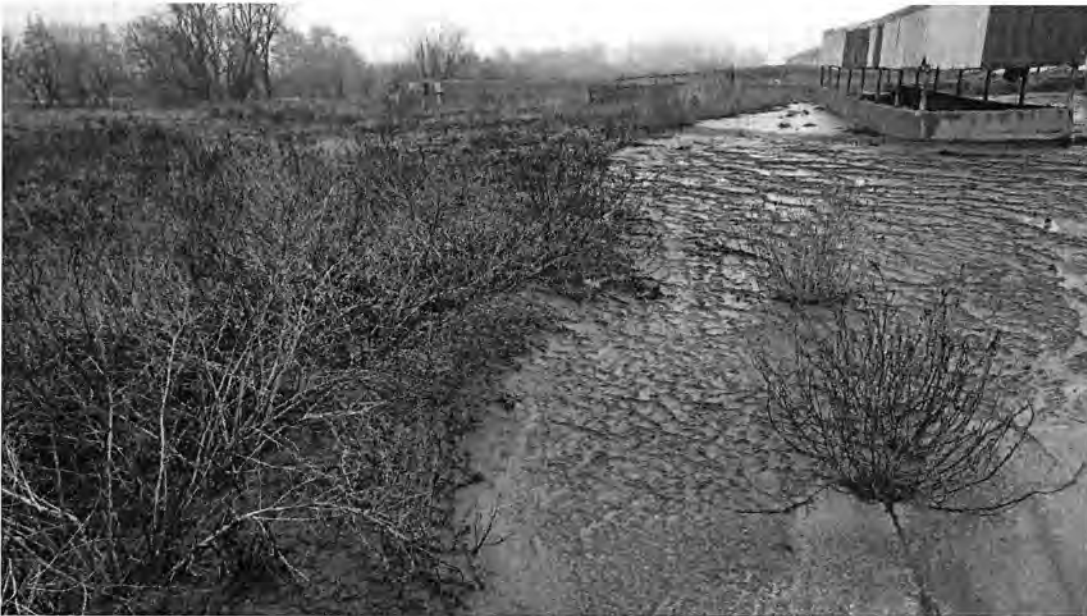
49: RIMG0058

Description: Process wastewater flowed through a pathway to the north to the borrow area north of the Milk Cow Barn. This process wastewater was emanating from the New Barn, the barn west of the New Barn, and the access ways between these barns.

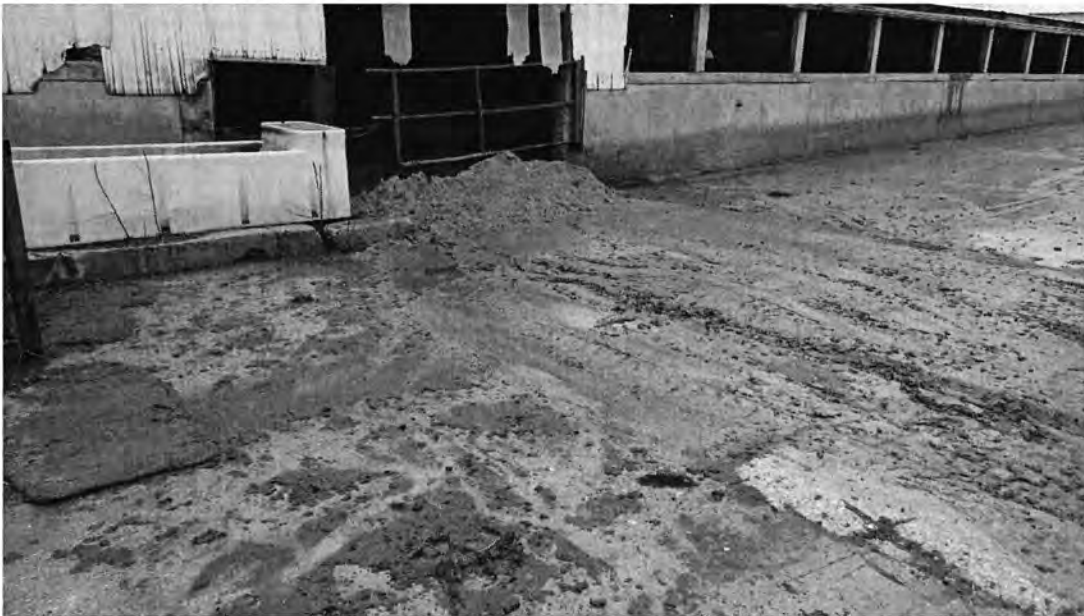
50: RIMG0059

Description: Manure solids and process wastewater flowed off the concrete into the field west of the concrete pits. The manure and process wastewater was emanating from the New Barn, the barn west of the New Barn, and the access ways between these barns.
