State of Wisconsin | DEPARTMENT OF NATURAL RESOURCES

Subject: **Notice of Violation - Chapter 283, Wis. Statutes  
Enforcement Conference - March 9, 2009**

### **3. POTENTIAL VIOLATIONS**

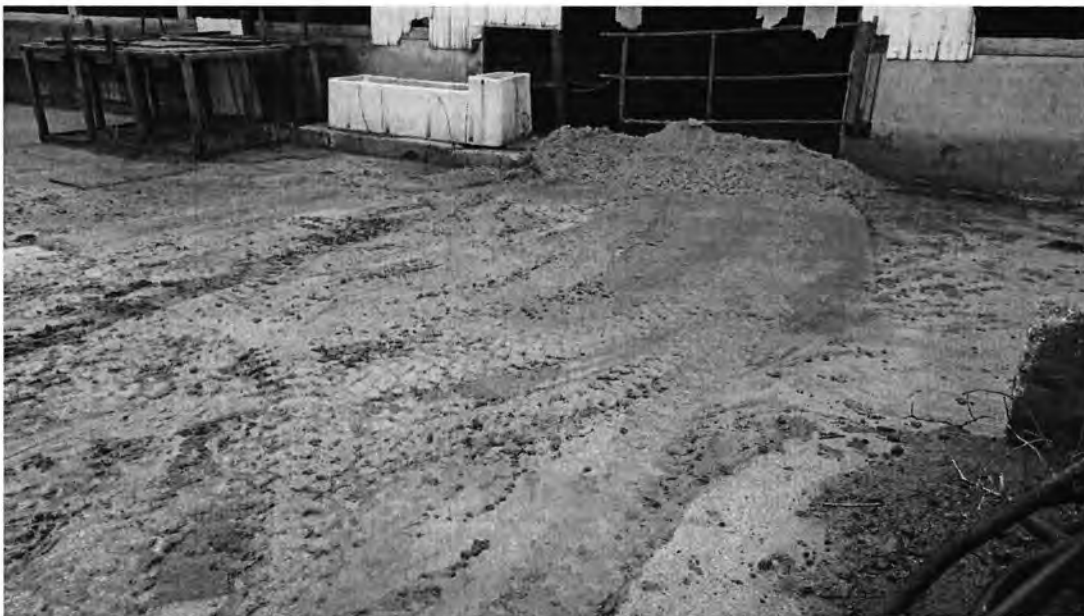
51: RIMG0060

We continued north between the existing barns. I observed manure and process wastewater tracked out of the barn and on the concrete area (Attachment 2: RIMG0060-RIMG0062). Sand had recently been placed at the barn access point in which manure

Description: A recently placed sand berm had been place at a barn doorway. Manure and process wastewater was observed outside of the doorway on the concrete.

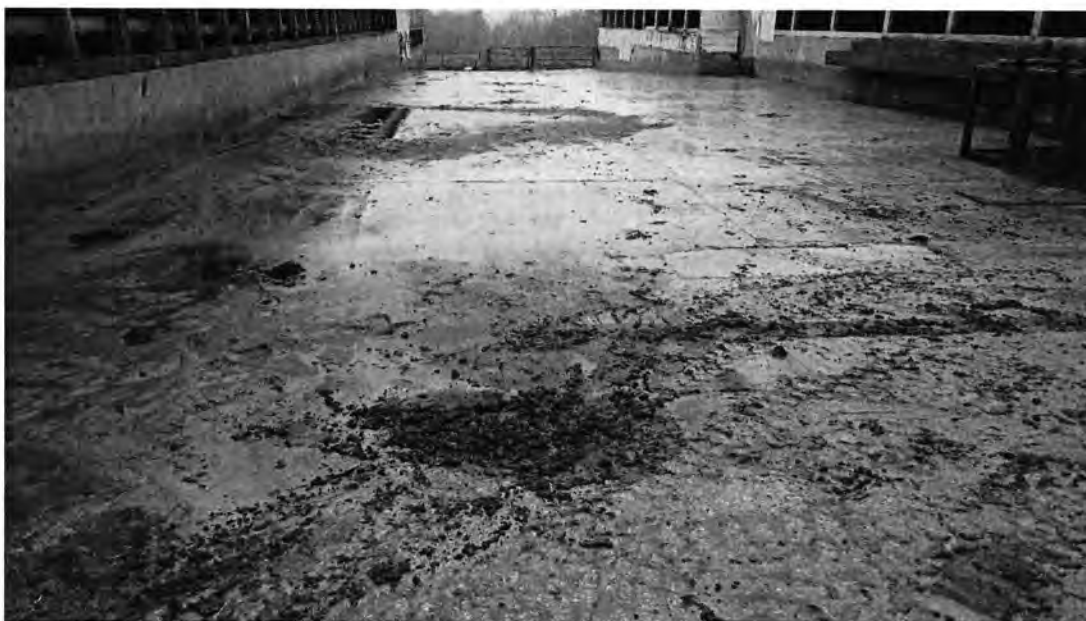
Description: A recently placed sand berm had been place at a barn doorway. Manure and process wastewater was observed outside of the doorway on the concrete.

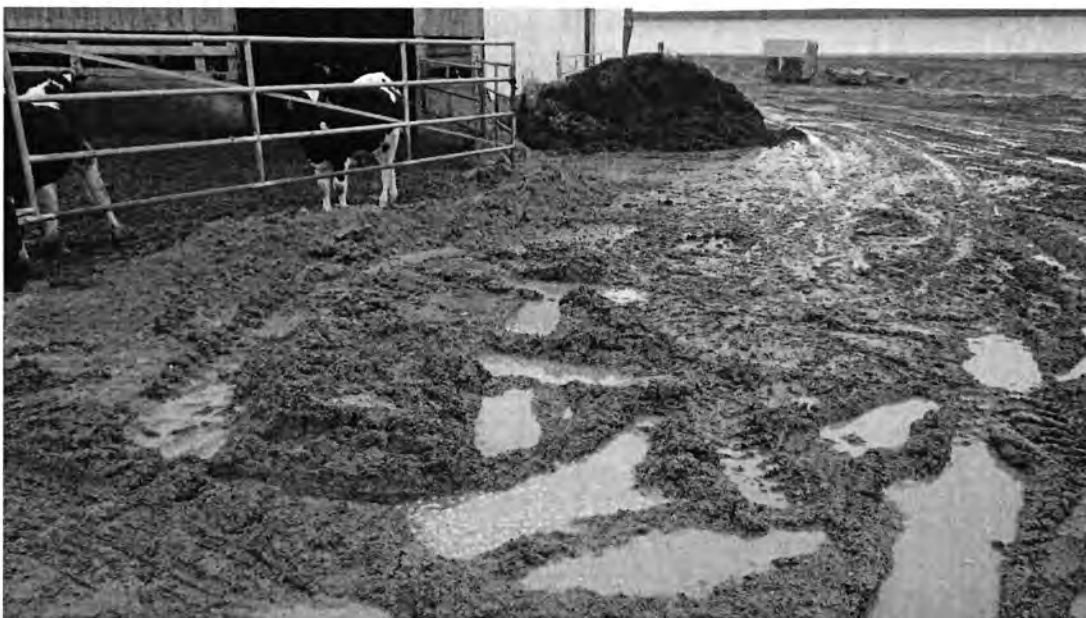
53: RIMG0062

Description: A recently placed sand berm had been placed at a barn doorway. Manure and process wastewater was observed outside of the doorway on the concrete.

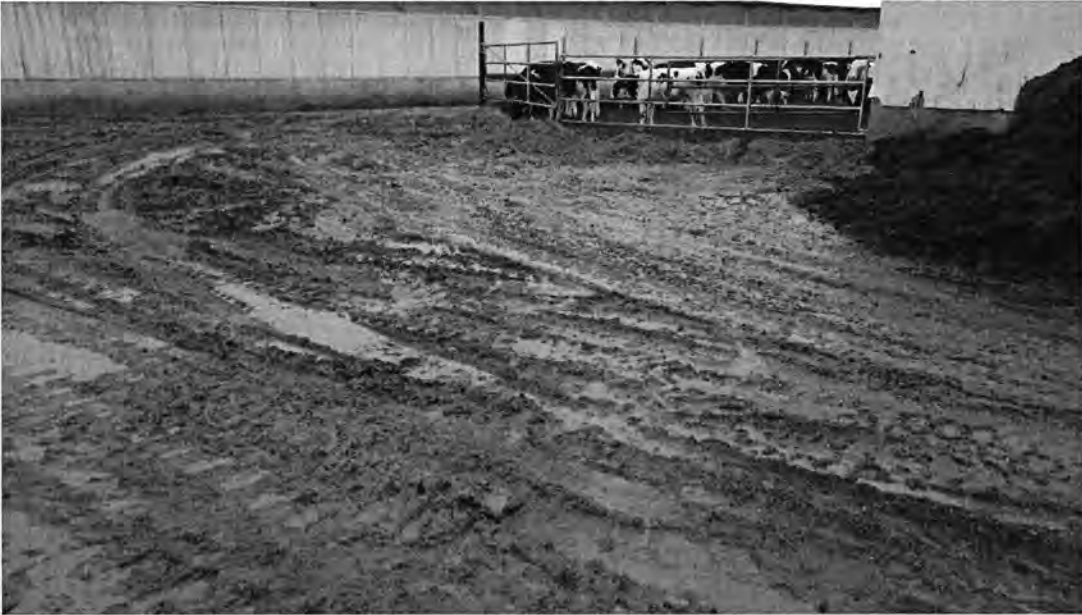
54: RIMG0063

We walked to Lot B. The open lot did not have containment for manure or process wastewater. A sand berm had recently been placed on the east end of the open lot (Attachment 2: RIMG0063-RIMG0064). A pile of bedding was located at the east side of Lot B. The process wastewater from the open lot and pile could flow east and north to a culvert under the New Barn and to the unnamed tributary on the east side of the site (Attachment 2: RIMG0064-RIMG0065). I observed a pile of waste material located east of Lot B (Attachment 2: RIMG0066-RIMG0067). Process wastewater contacting the waste material could flow north to the culvert under the new barn and to the unnamed tributary.

Description: A stockpile of bedding material was located east of Calf Barn 2. A sand berm was placed on the east end of Calf Barn 2. The process wastewater from the open lot and pile could flow east and north to a culvert under the New Barn and to unnamed tributary on the east side of the site.

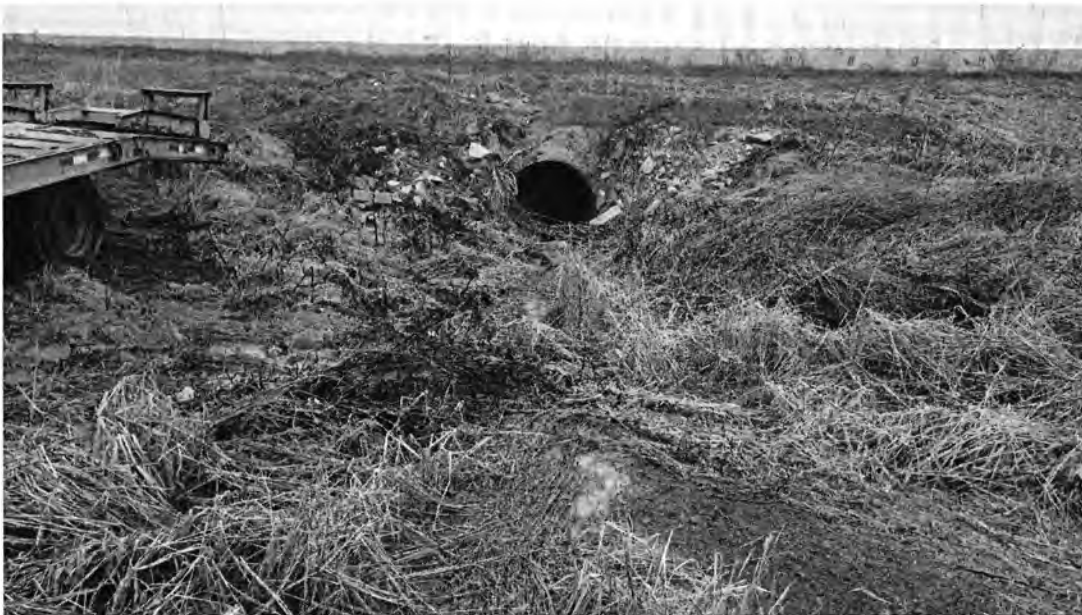
55: RIMG0064

Description: A stockpile of bedding material was located east of Calf Barn 2. A sand berm was placed on the east end of Calf Barn 2. The process wastewater from the open lot and pile could flow east and north to a culvert under the New Barn and to the unnamed tributary on the east side of the site.

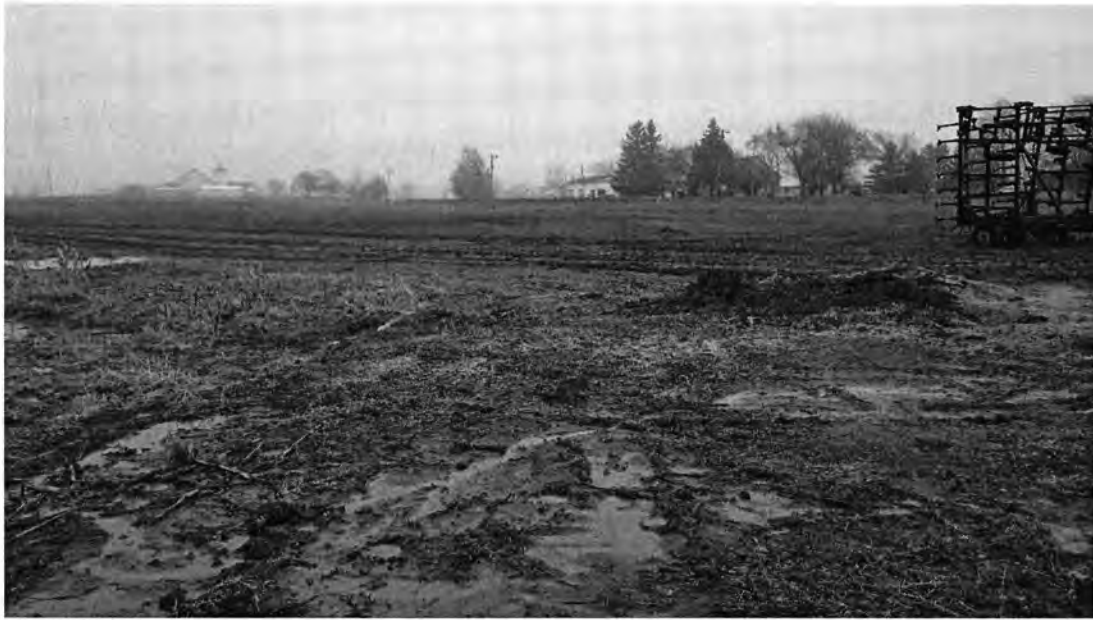
56: RIMG0065

Description: The culvert inlet under the New Barn.

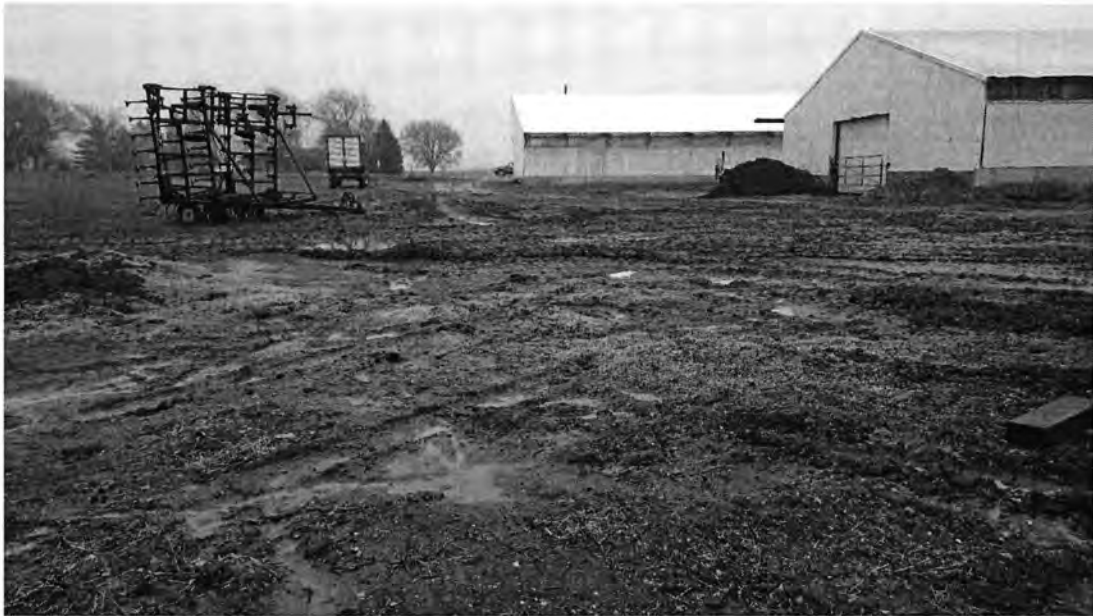
57: RIMG0066

Description: A pile of waste material was placed such that process wastewater generated from it would flow to the culvert under the New Barn which flows to the unnamed tributary on the east side of the site.

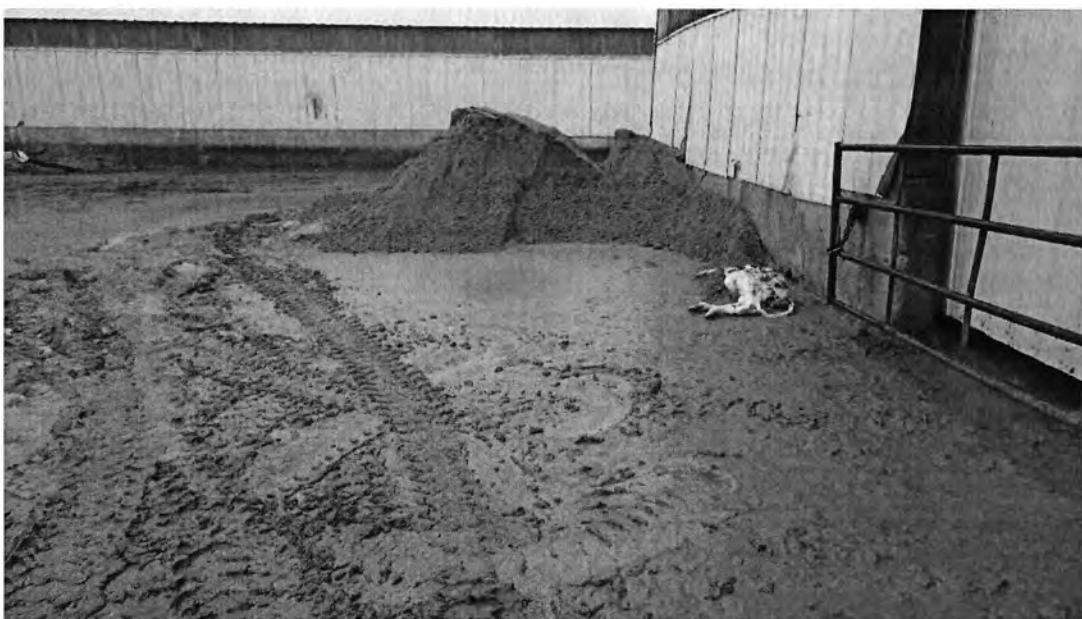
58: RIMG0067

Description: A pile of waste material was placed such that process wastewater generated from it would flow to the culvert under the New Barn which flows to the unnamed tributary on the east side of the site.

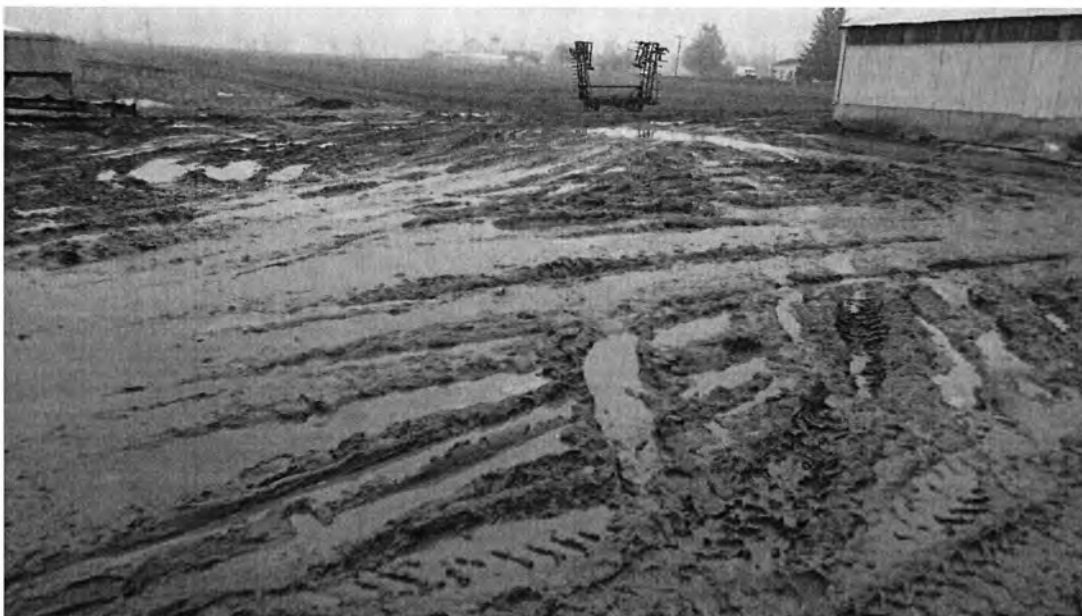
59: RIMG0068

Description: A pile of sand and dead calf.

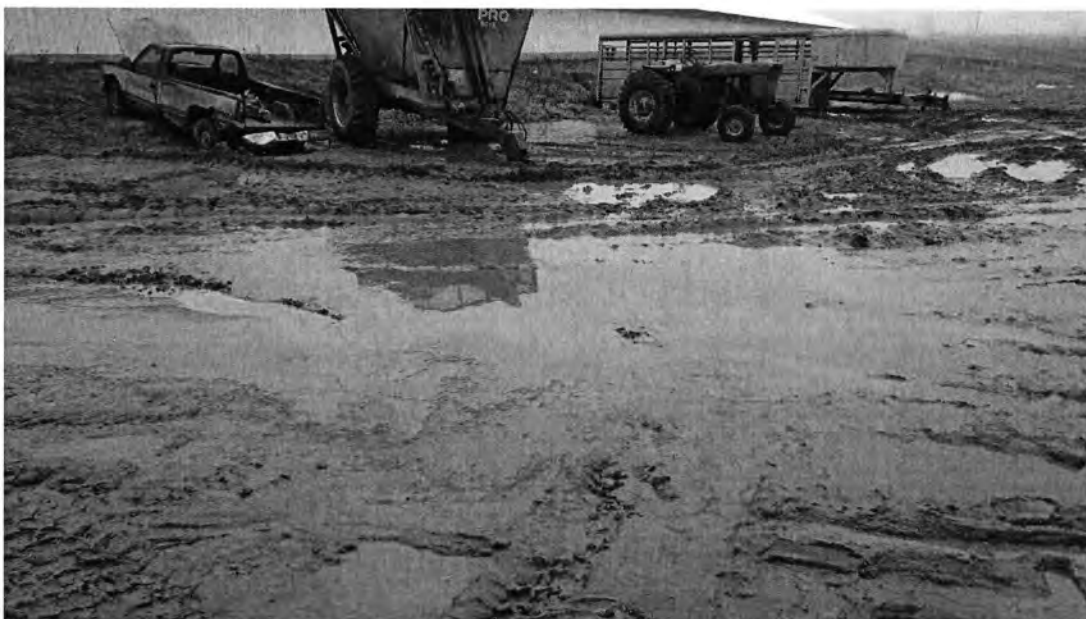
60: RIMG0069

Description: A mucky area drains toward the culvert under the New Barn.

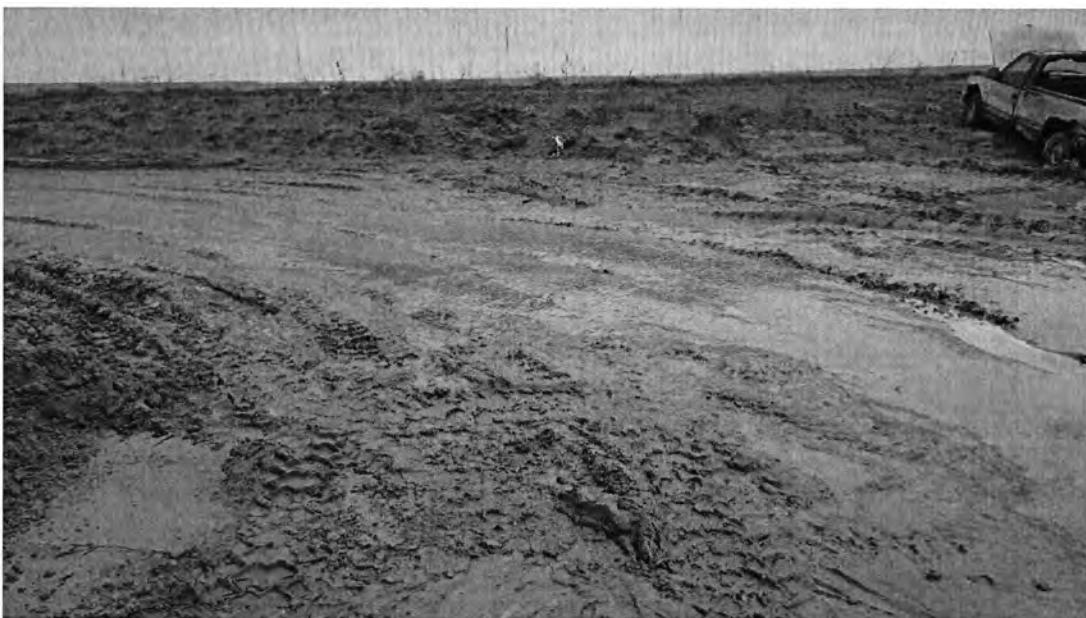
61: RIMG0070

Description: A mucky area drains toward the culvert under the New Barn.

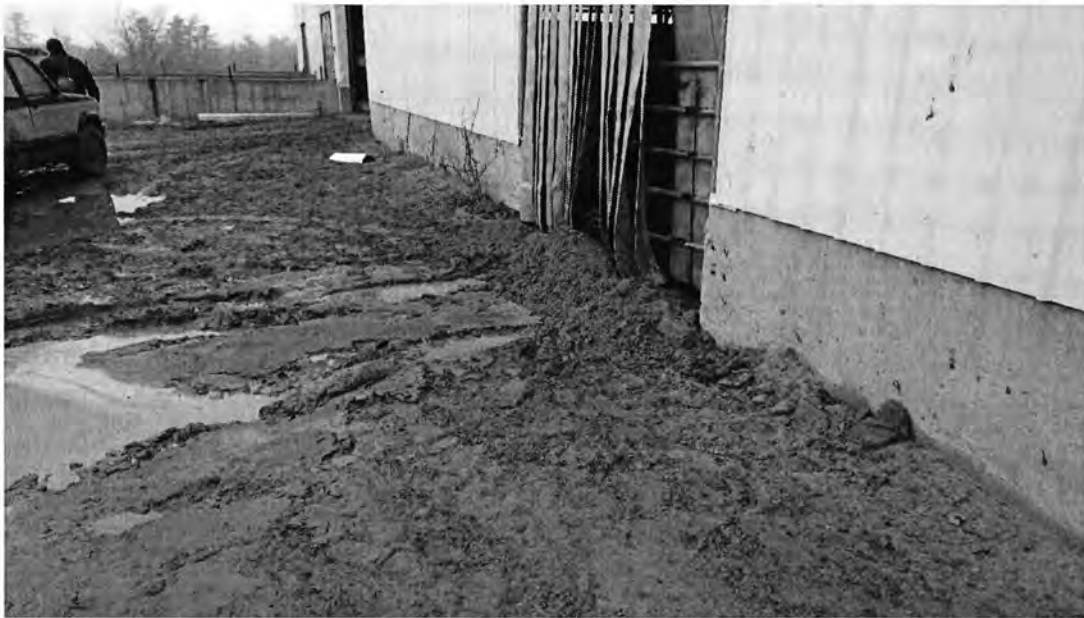
62: RIMG0071

Description: A mucky area drains toward the culvert under the New Barn.

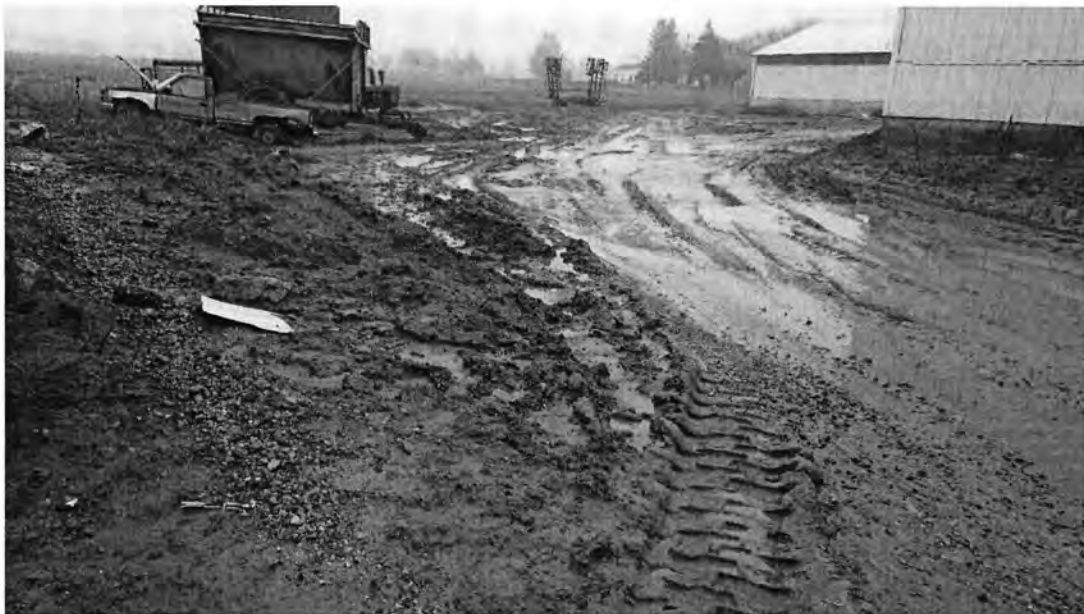
63: RIMG0072

Description: Sand had been placed at an access point along the southwest end of the New Barn. Manure and process wastewater was observed outside of the New Barn and could flow south toward the mucky area.

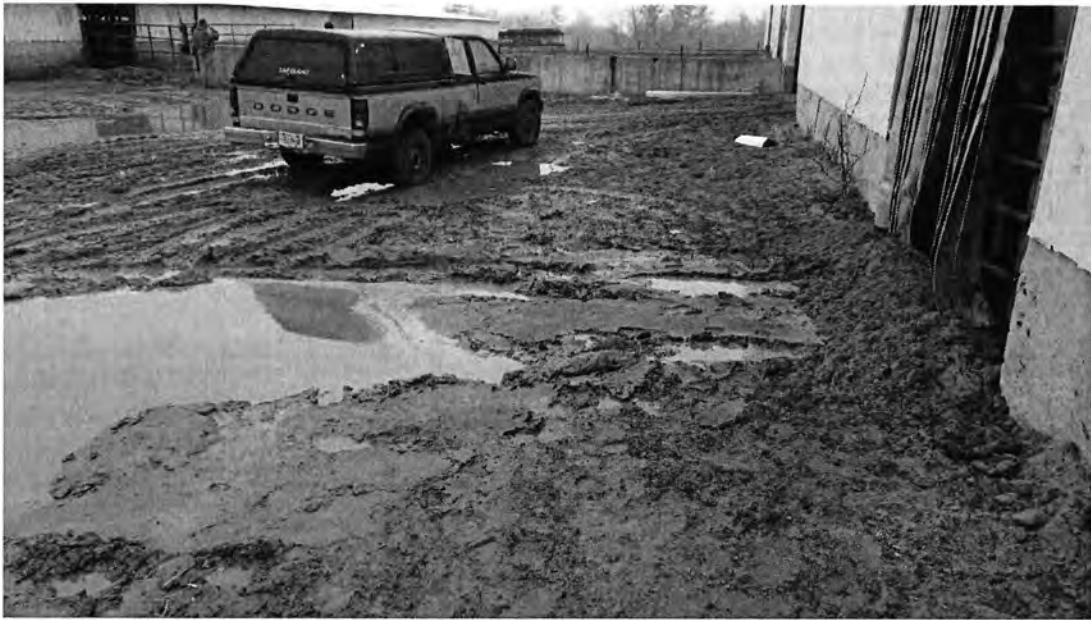
Description: Manure and process wastewater was observed outside of the New Barn and could flow south toward the mucky area.

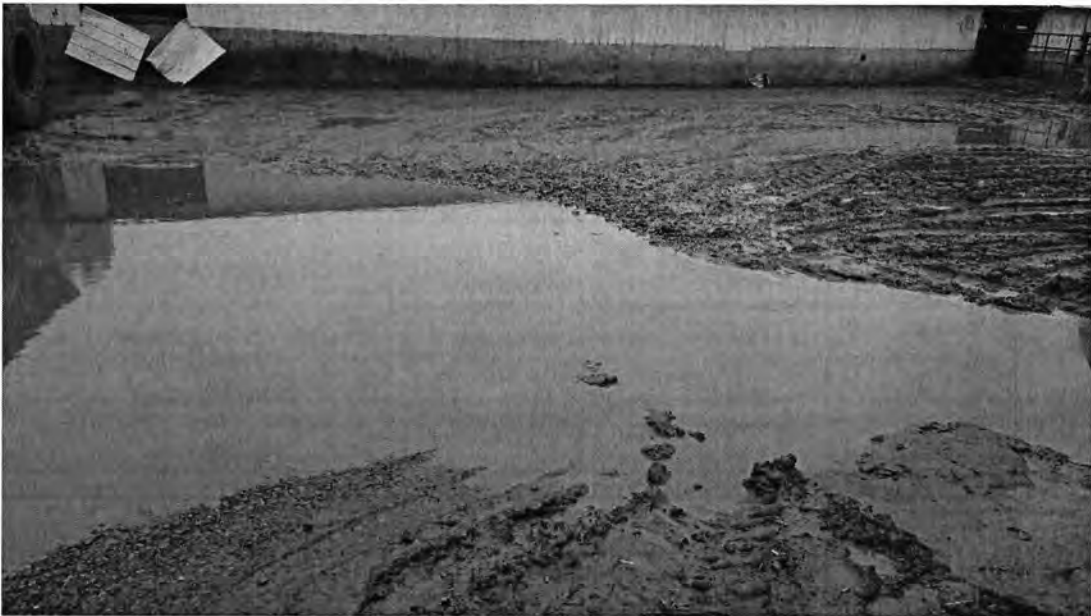
65: RIMG0074

Description: Sand had been placed at an access point along the west end of the New Barn. Manure and process wastewater was observed outside of the New Barn and could flow south toward the mucky area.

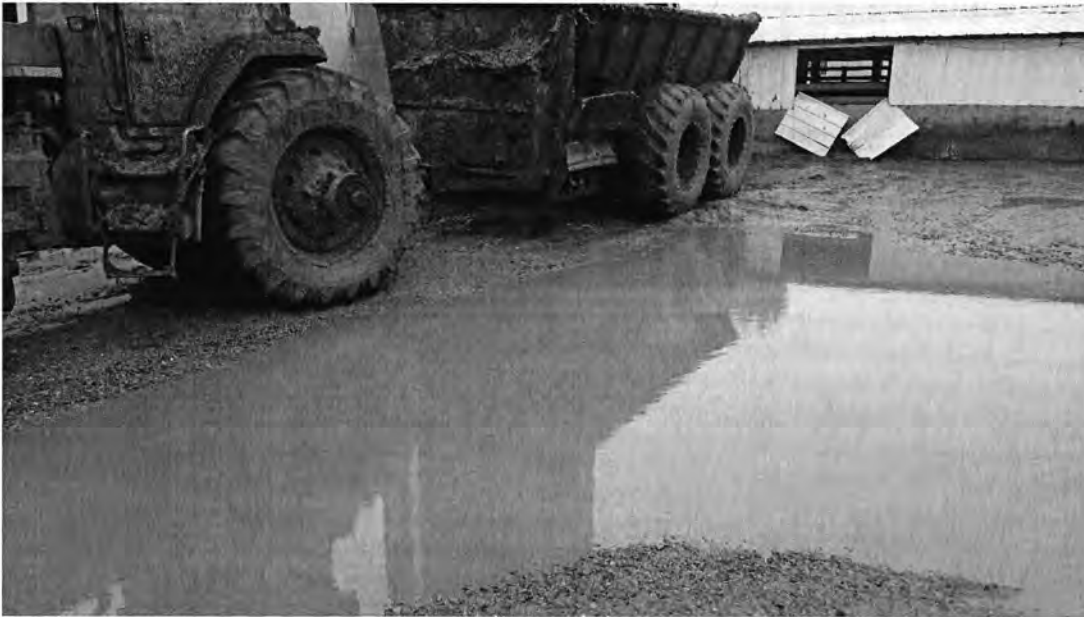
66: RIMG0075

Description: Manure and process wastewater was observed outside of the New Barn and could flow south toward the mucky area.

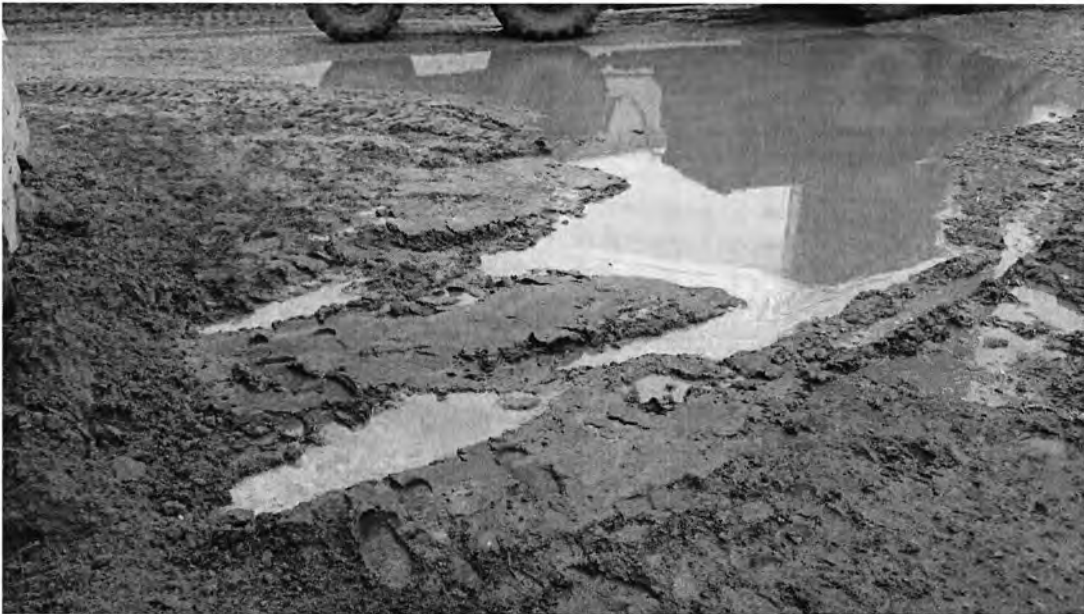
67: RIMG0076

Description: Manure and process wastewater was observed outside of the New Barn and could flow south toward the mucky area.

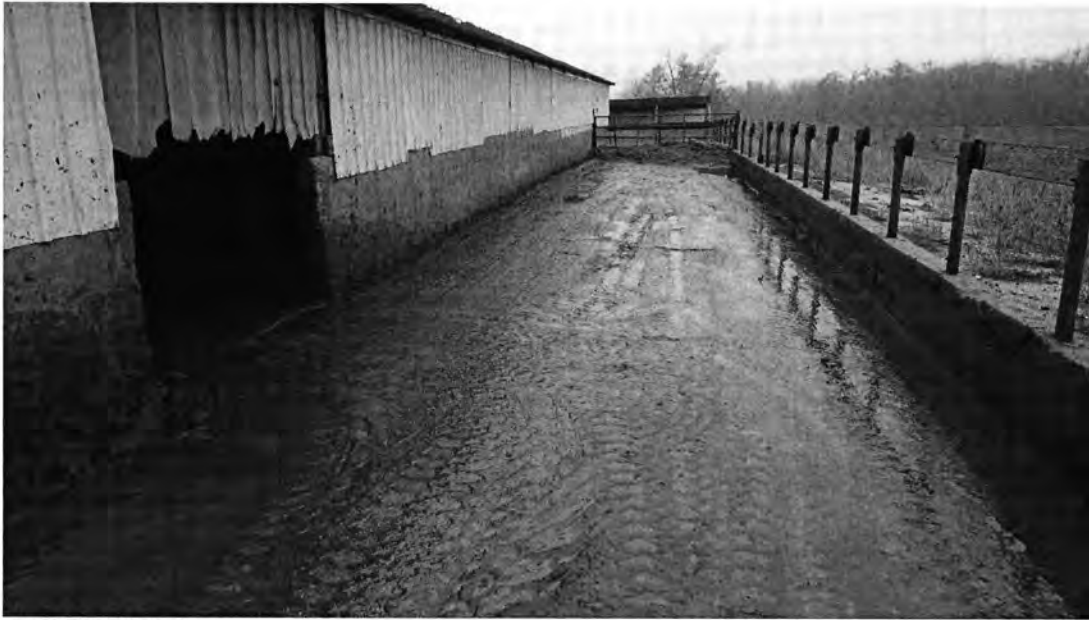
Description: Sand had been placed at an access point along the west end of the New Barn. Manure and process wastewater was observed outside of the New Barn and could flow south toward the mucky area.

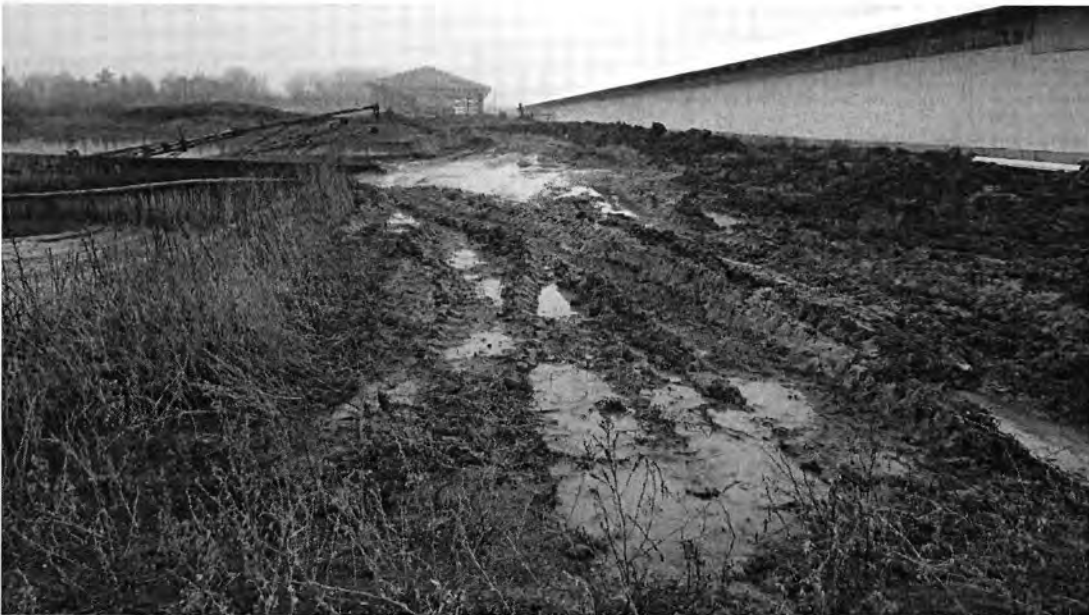
69: RIMG0078

Description: A cow access way between the New Barn and the barn west of the New Barn contained manure solids on its surface and process wastewater flowed north to the field west of the concrete pits.

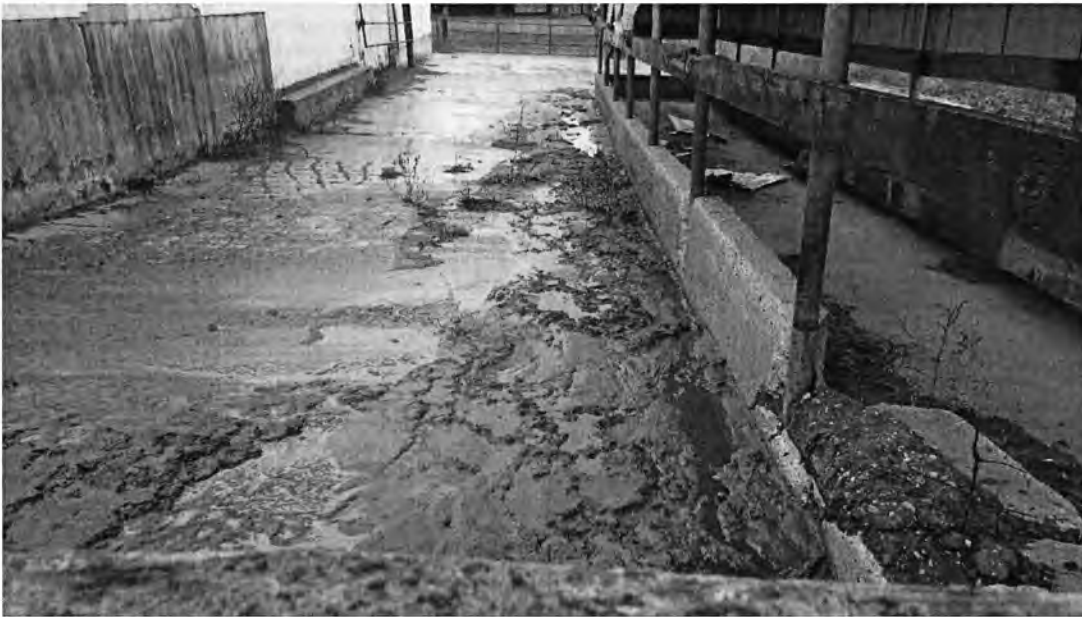
70: RIMG0079

Description: Disturbed area.

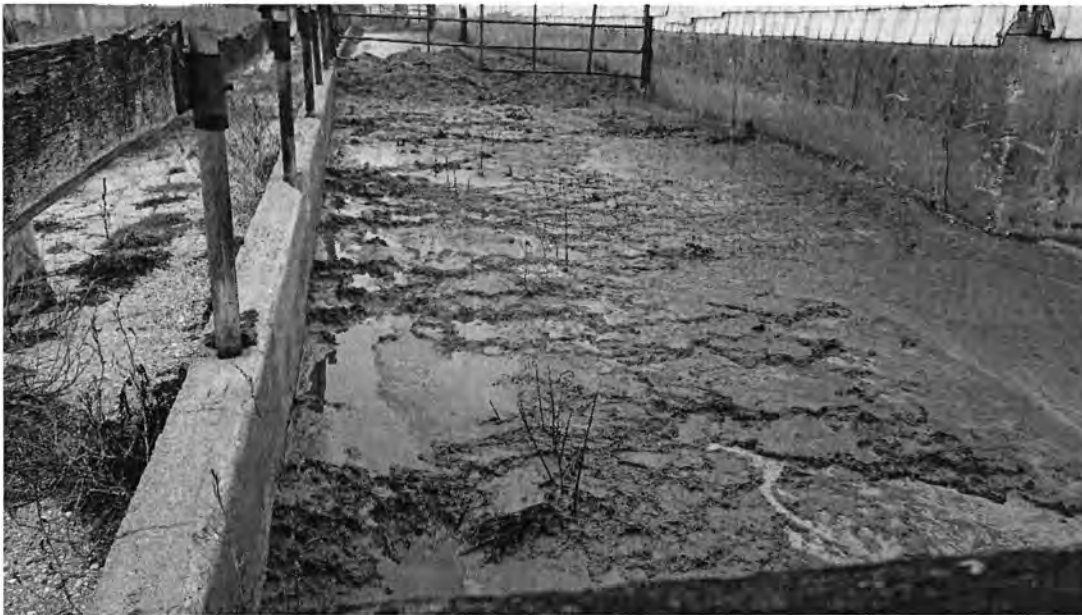
71: RIMG0080

Description: Manure and process wastewater flowed north from the access way between the New Barn and the barn west of the New Barn. It then flowed west after contacting a concrete wall and then flowed to the north into the field west of the concrete pits.

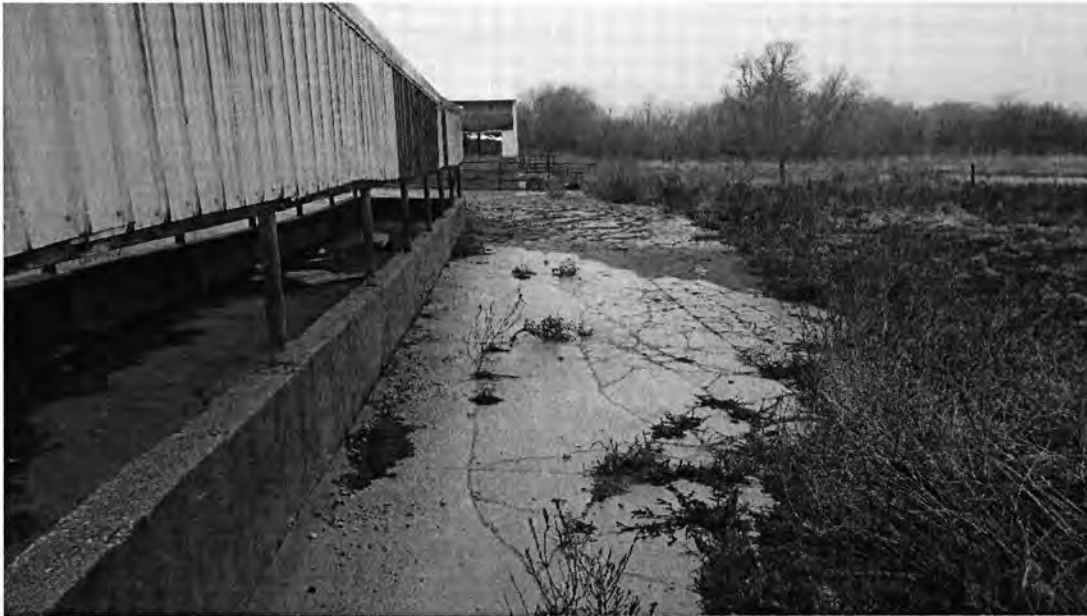
72: RIMG0081

Description: Manure and process wastewater flowed north from the access way between the New Barn and the barn west of the New Barn. It then flowed west after contacting a concrete wall and then flowed to the north into the field west of the concrete pits. A sand berm had recently been placed near the metal gate on the access way.

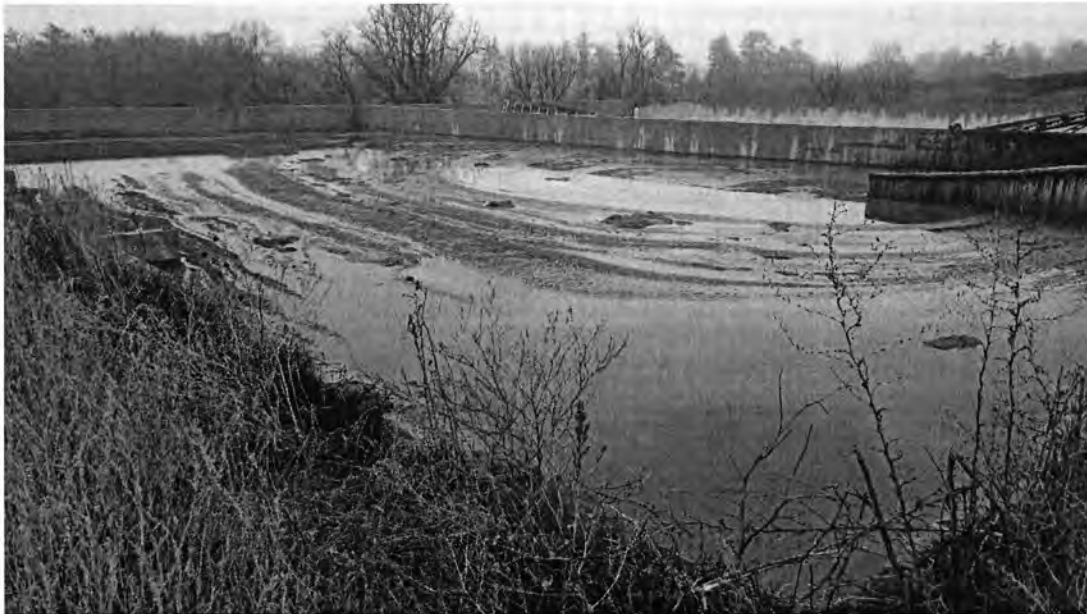
73: RIMG0082

Description: Manure and process wastewater flowed north from the access way between the New Barn and the barn west of the New Barn. It then flowed west after contacting a concrete wall and then flowed to the north into the field west of the concrete pits.

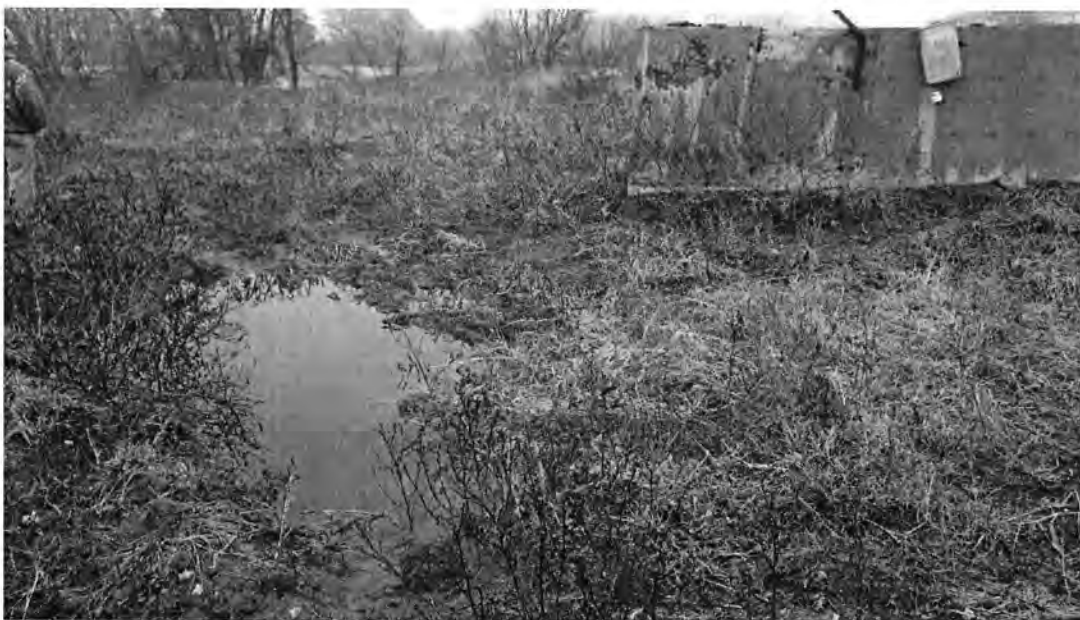
74: RIMG0083

Description: The west concrete pit was about halfway full.

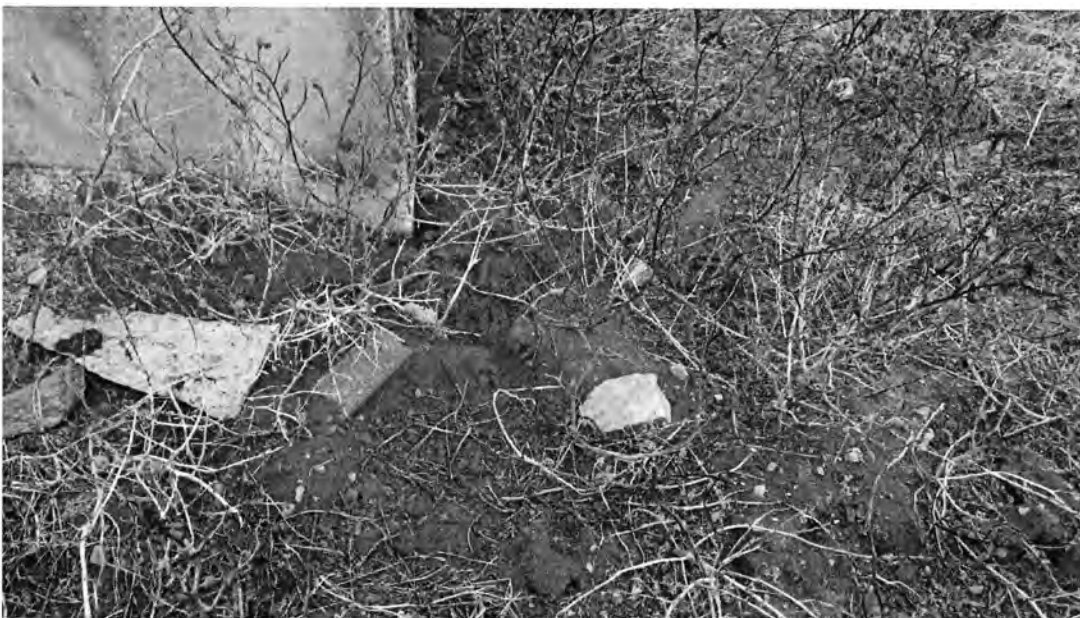
75: RIMG0084

Description: Process wastewater was observed at the northwest corner of the west concrete pit.

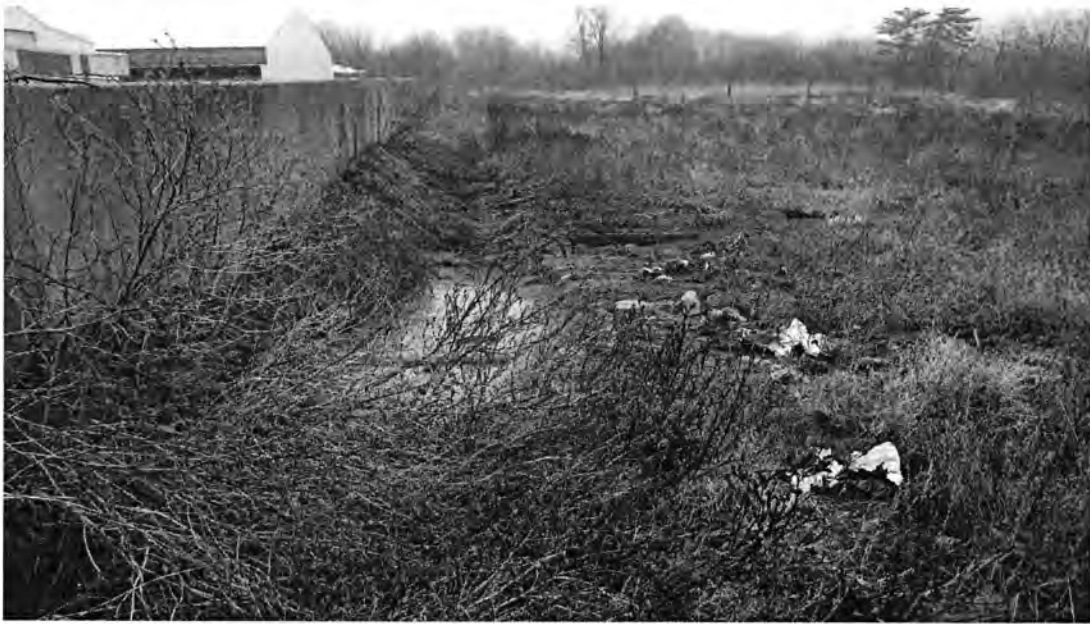
76: RIMG0085

Description: A trickling flow of process wastewater was emanating from the northwest corner of the concrete pit.

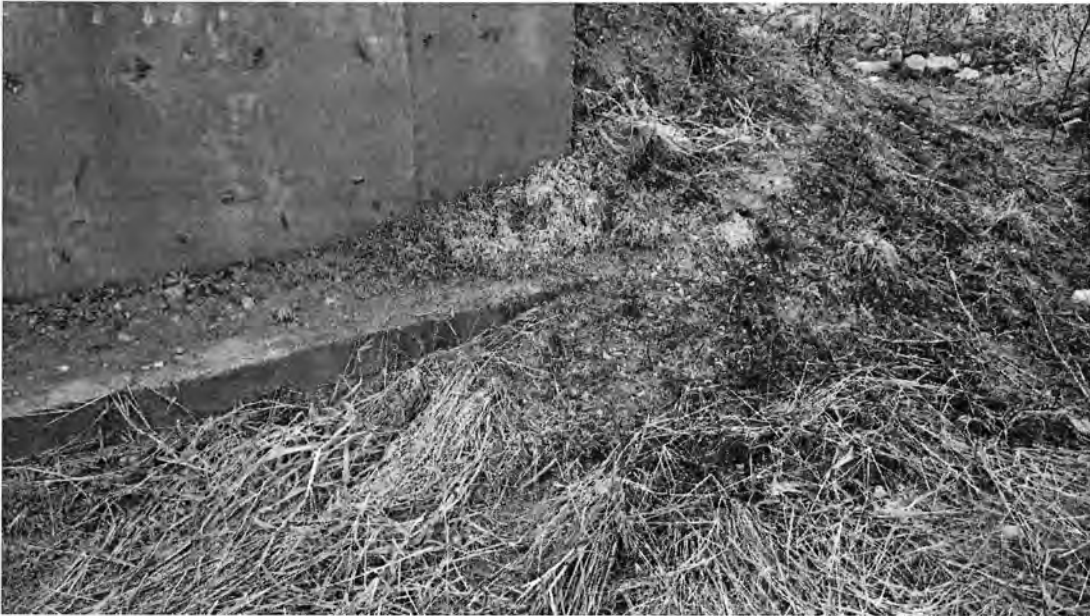
77: RIMG0086

Description: North end of concrete pit.

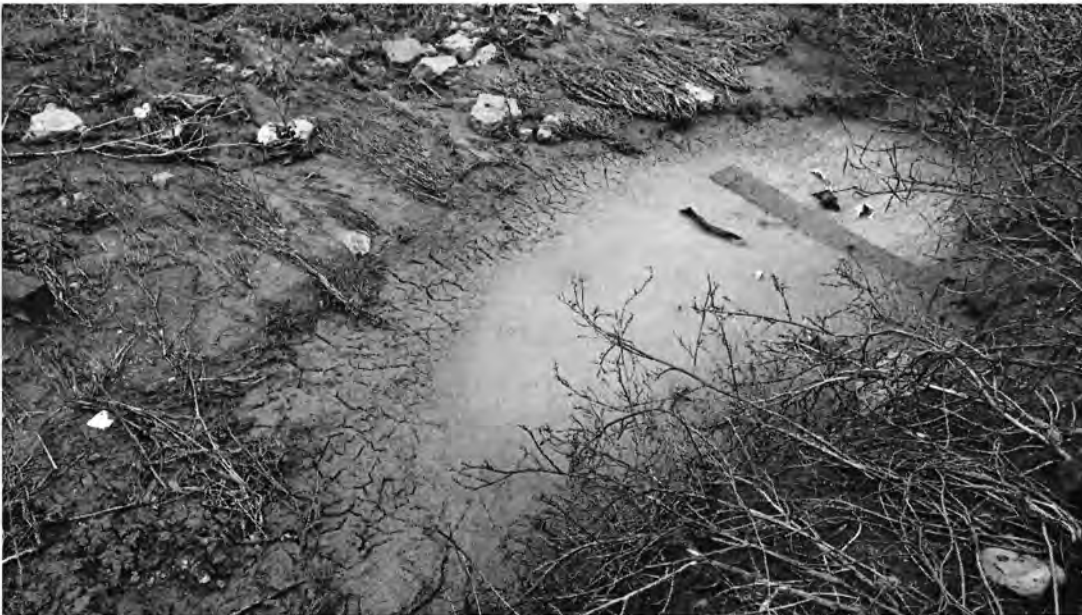
78: RIMG0087

Description: The north east end of the east concrete pit had clay covering a hole that was observed in the east concrete pit in an April 2013 inspection.

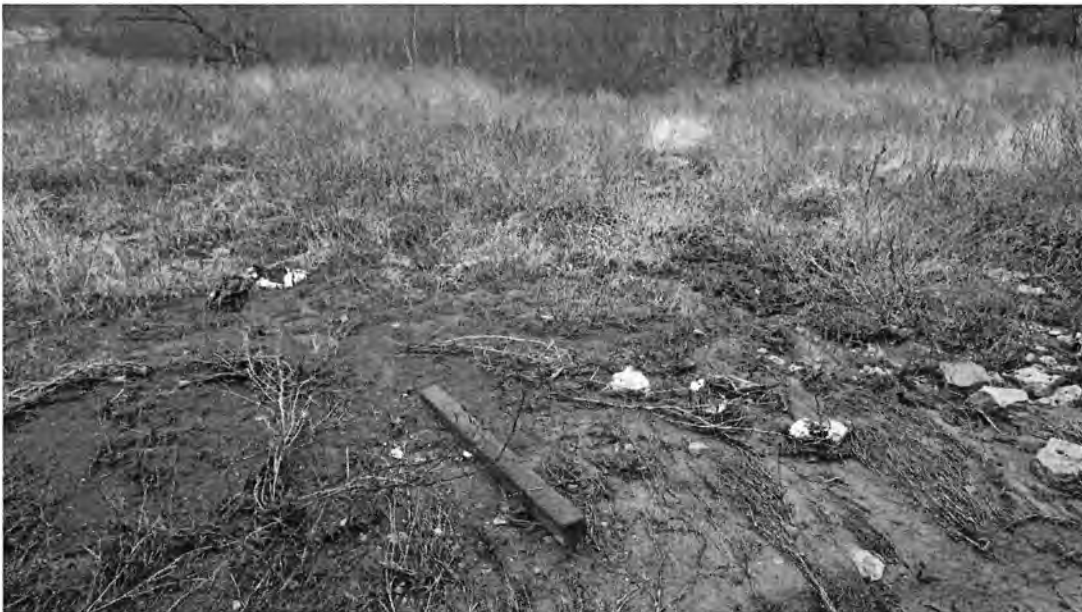
79: RIMG0088

Description: Area on north end of the concrete pit.

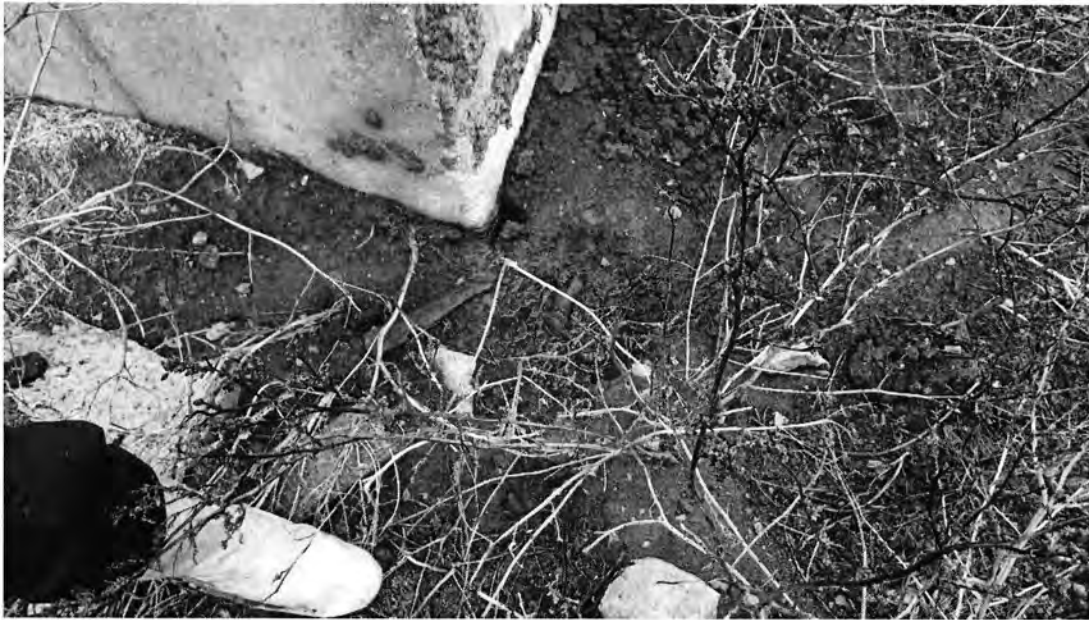
80: RIMG0089

Description: Area on north end of the concrete pit.

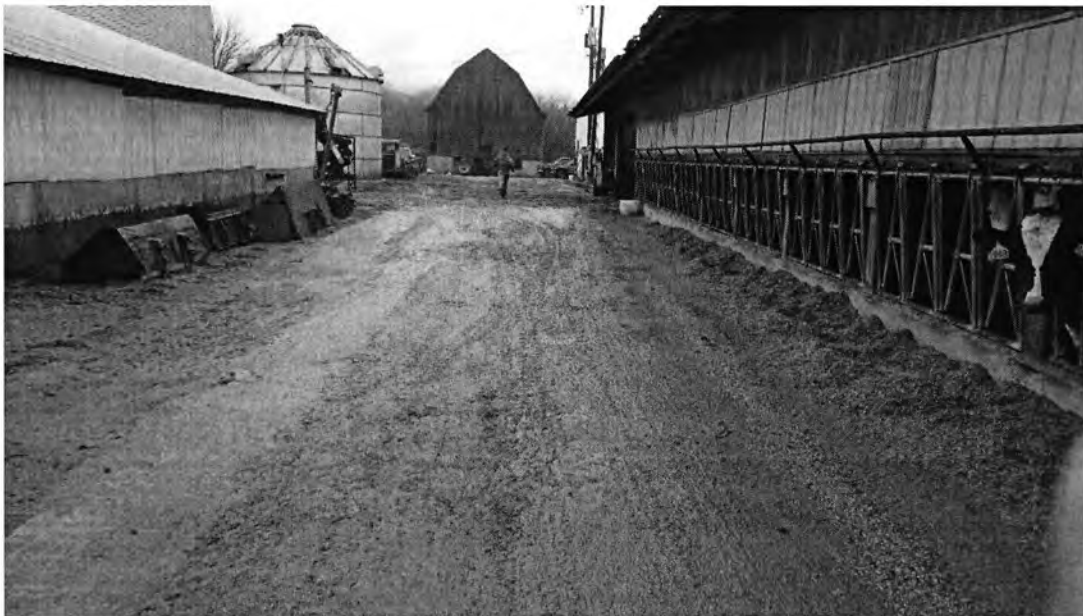
83: RIMG0092

Description: Manure and process wastewater flowed from the New Barn and access way west and then north.

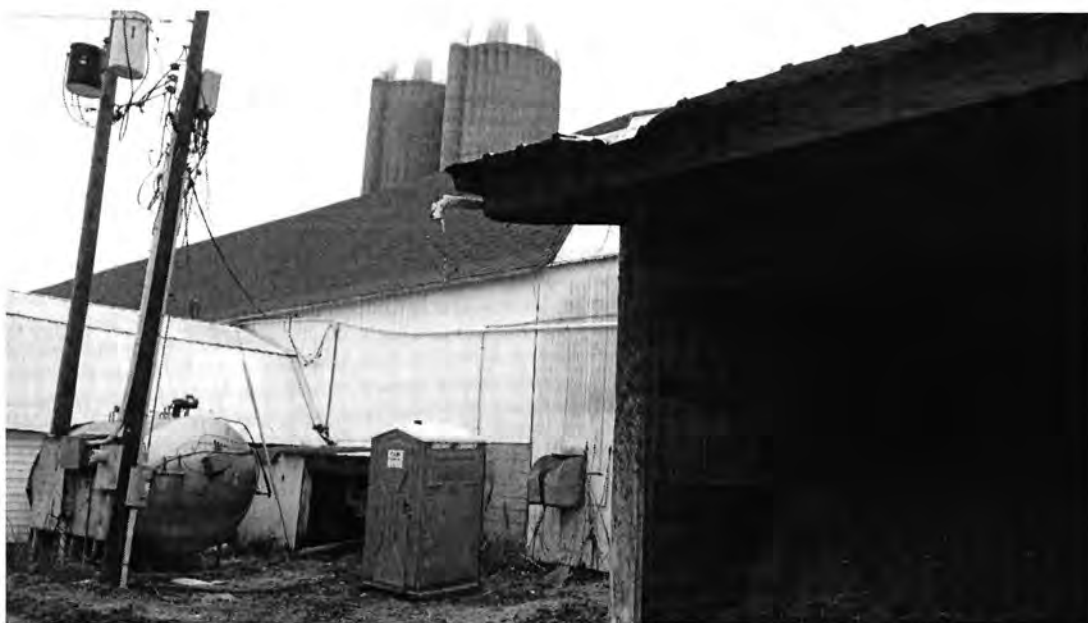
Description: Manure and waste materials were observed on the ground along an access way between the barns.
