State of Wisconsin | DEPARTMENT OF NATURAL RESOURCES

Subject: **Notice of Violation - Chapter 283, Wis. Statutes  
Enforcement Conference - March 9, 2009**

### **3. POTENTIAL VIOLATIONS**

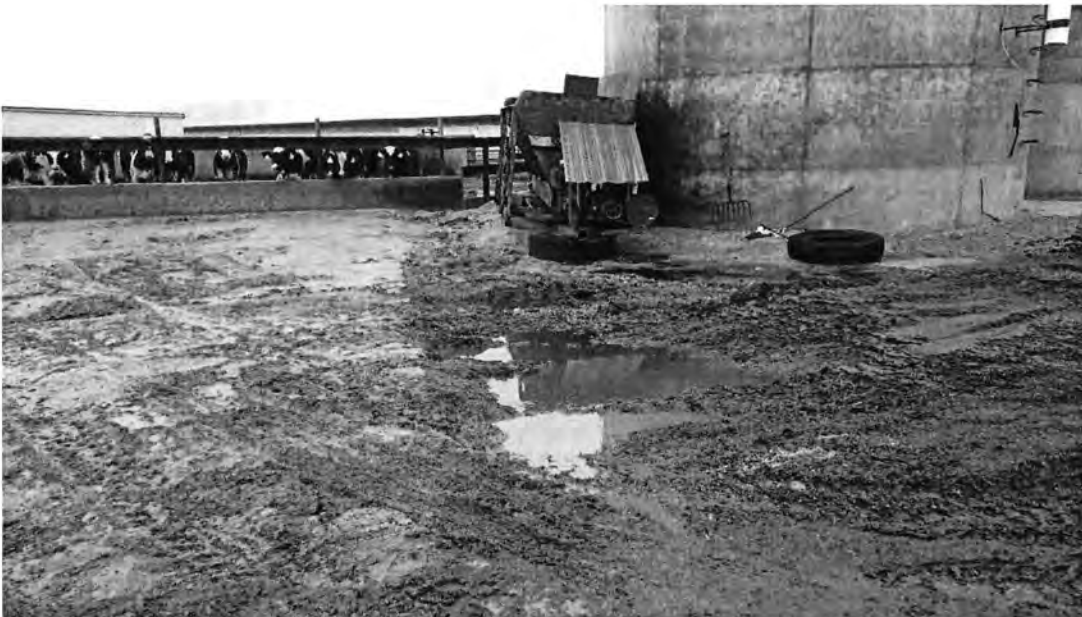
86: RIMG0095

Description: An access way between the barns.

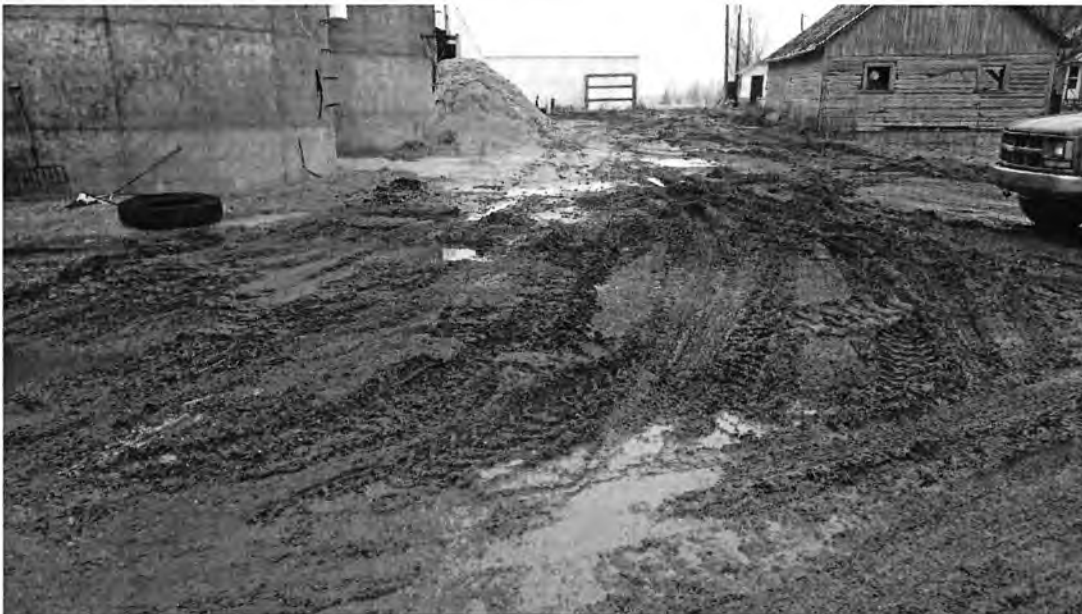
87: RIMG0096

Description: Process wastewater east of Lot D.

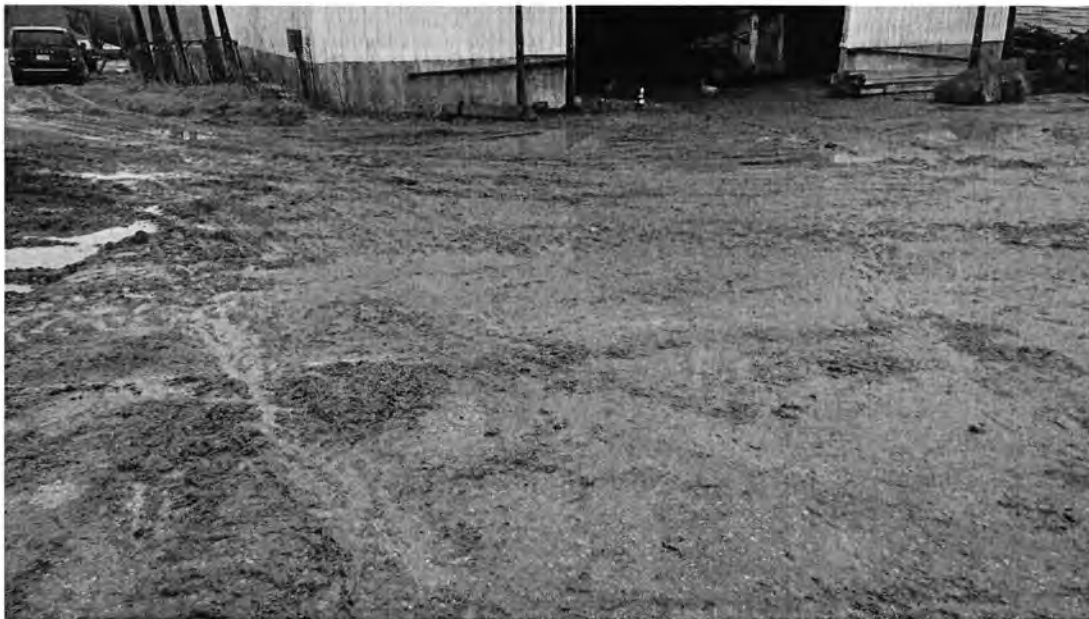
88: RIMG0097

Description: Raw materials east of Lot D.

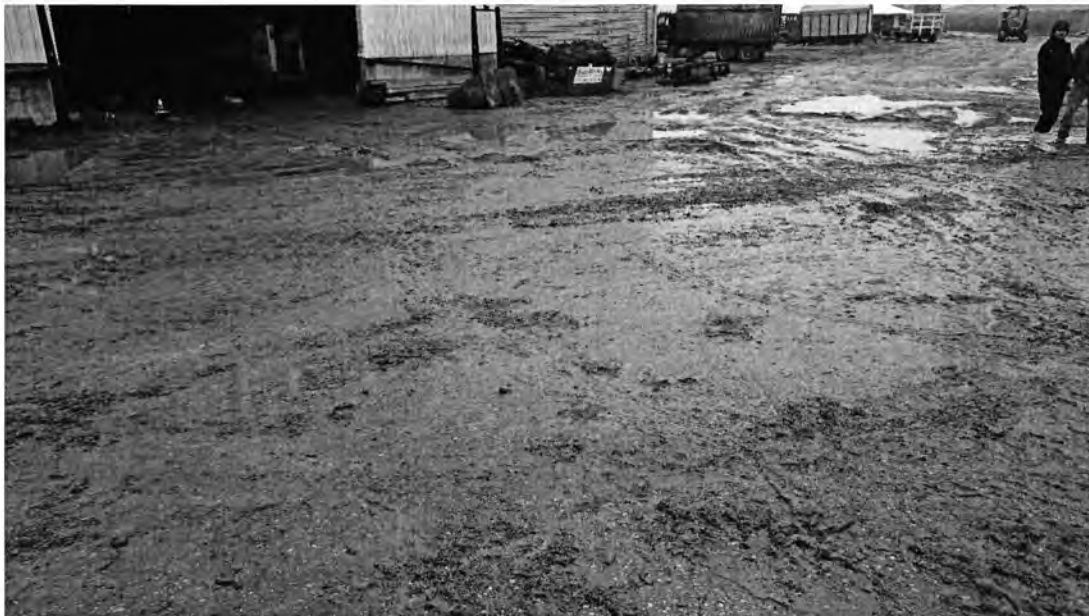
89: RIMG0098

Description: Feed and manure on the concrete east of Lot D.

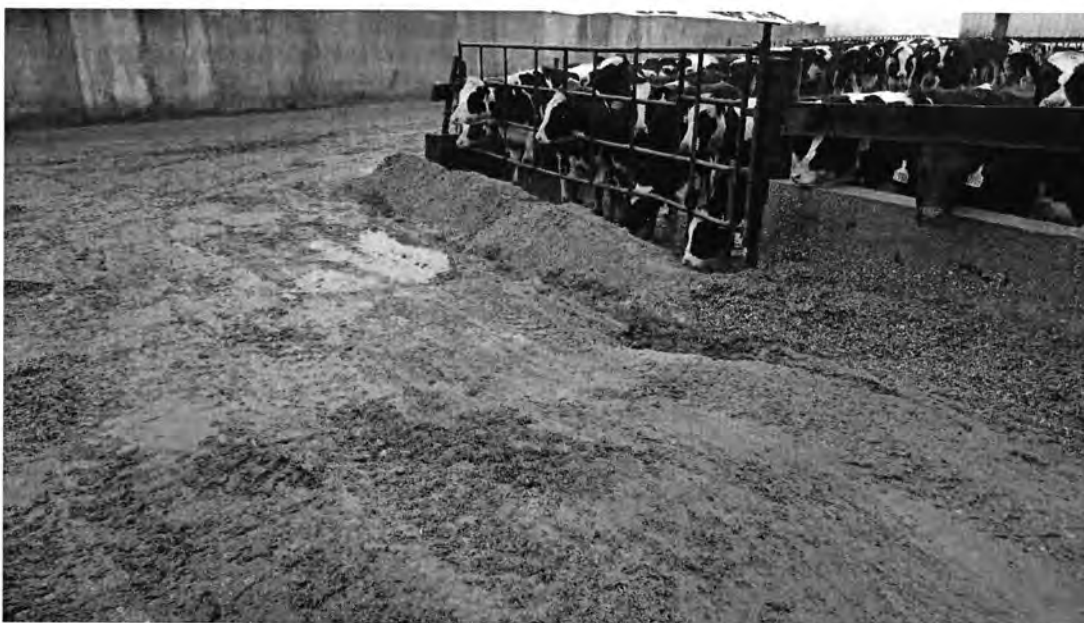
Description: Feed and manure on the concrete east of Lot D.

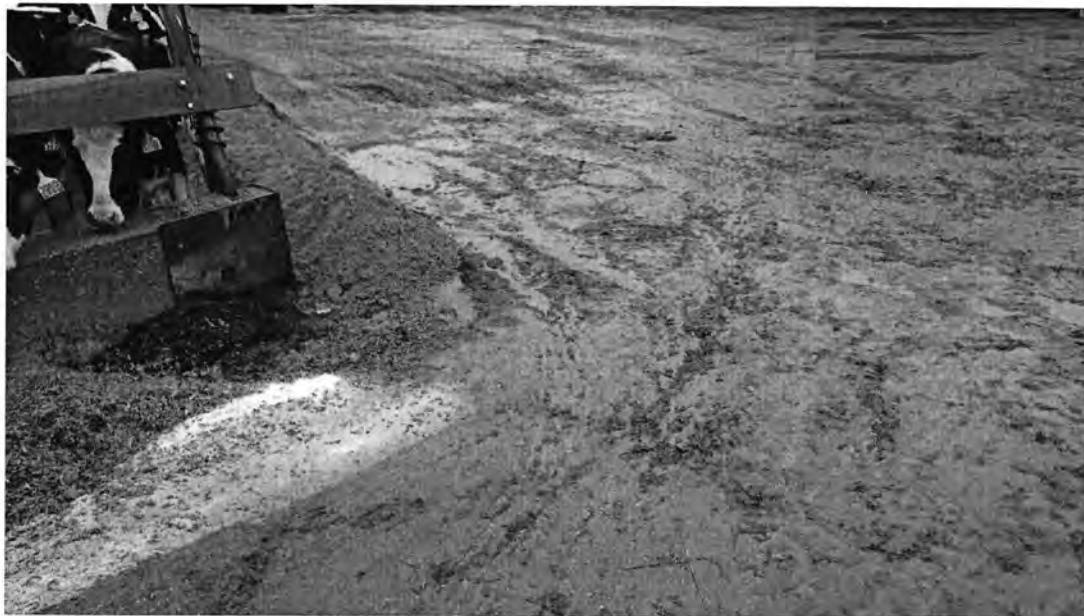
91: RIMG0100

Description: A sand berm had recently been placed at the access gate for Lot D. Manure and process wastewater were observed east of the access gate on the concrete.

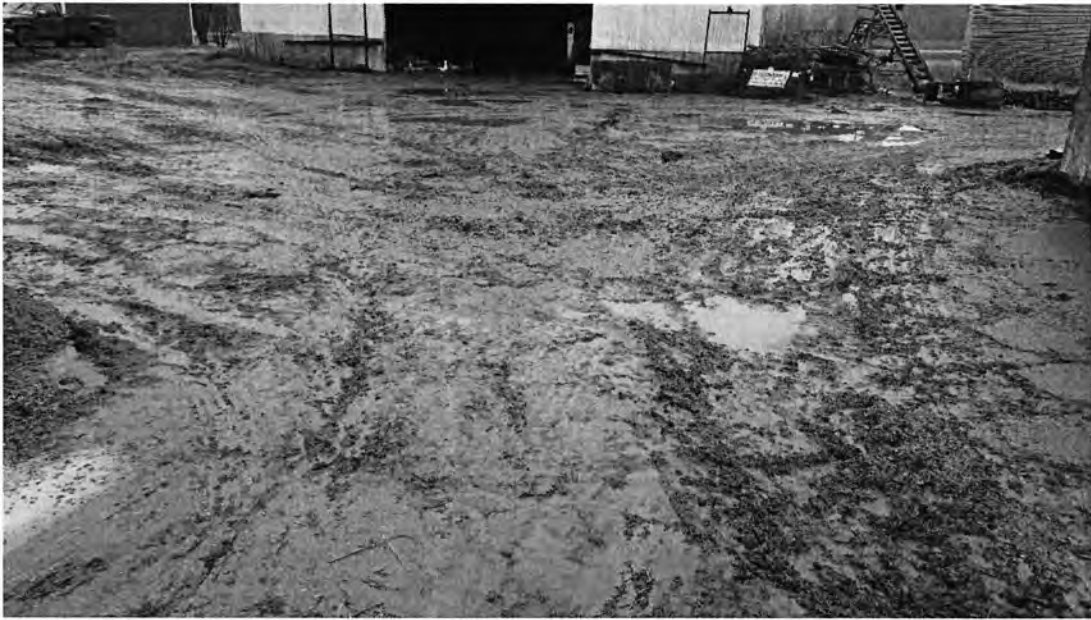
Description: A sand berm had recently been placed at the access gate for Lot D. Manure and process wastewater were observed east of the access gate on the concrete.

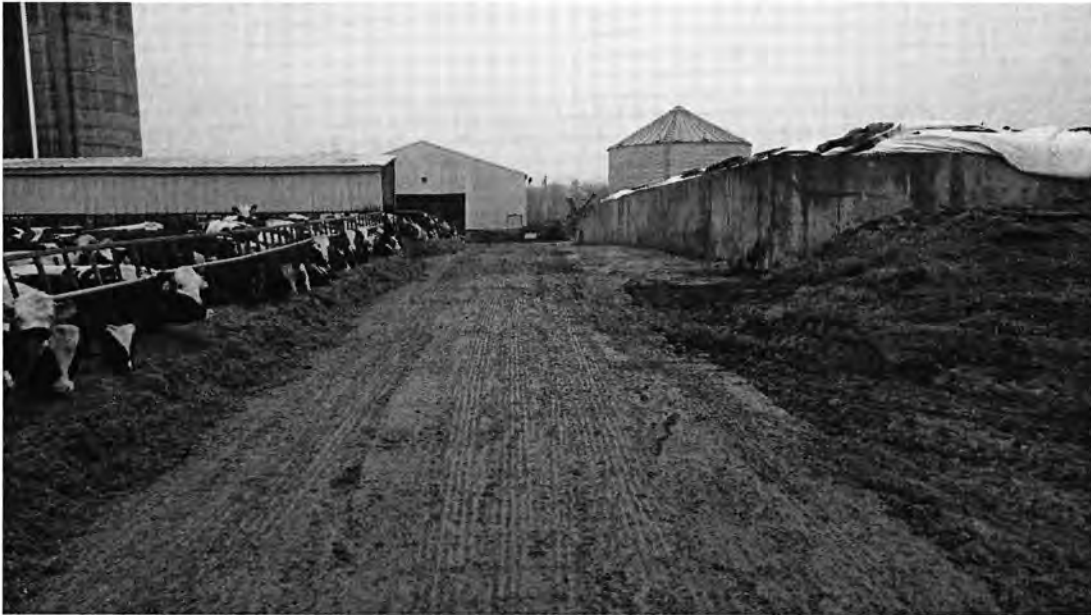
93: RIMG0102

Description: Manure and process wastewater on the concrete east of Lot D.

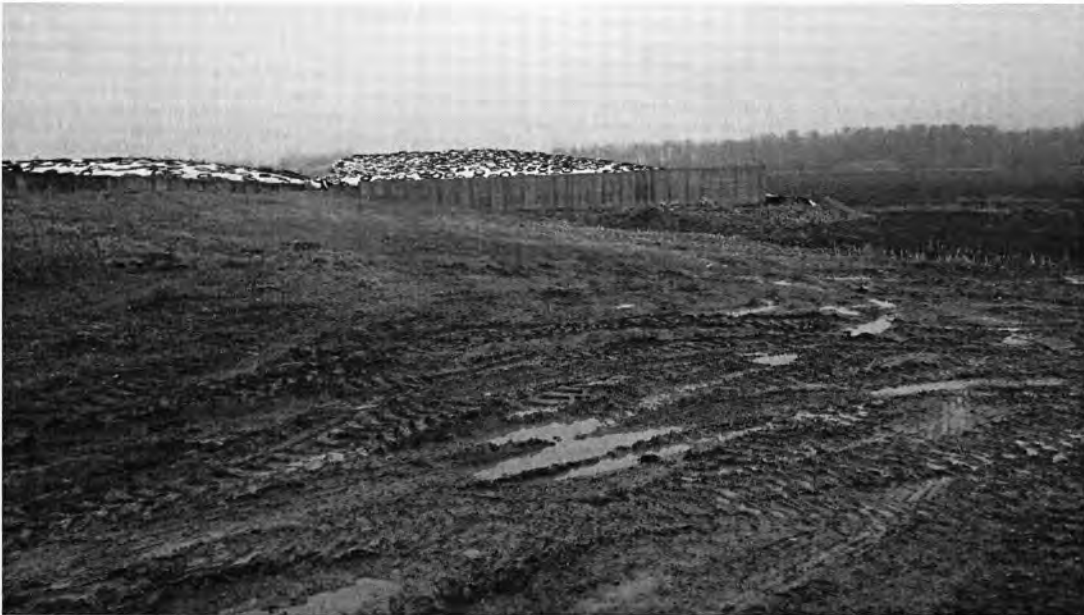
94: RIMG0103

Description: Feed and process wastewater had no containment along the south end of Lot D.

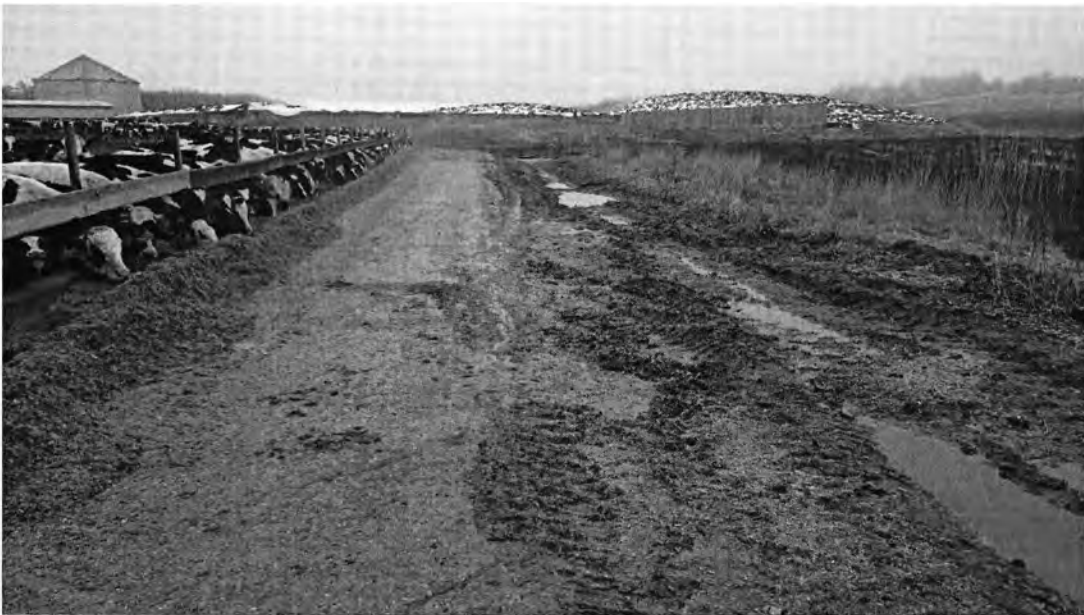
95: RIMG0104

Description: Feed bunkers.

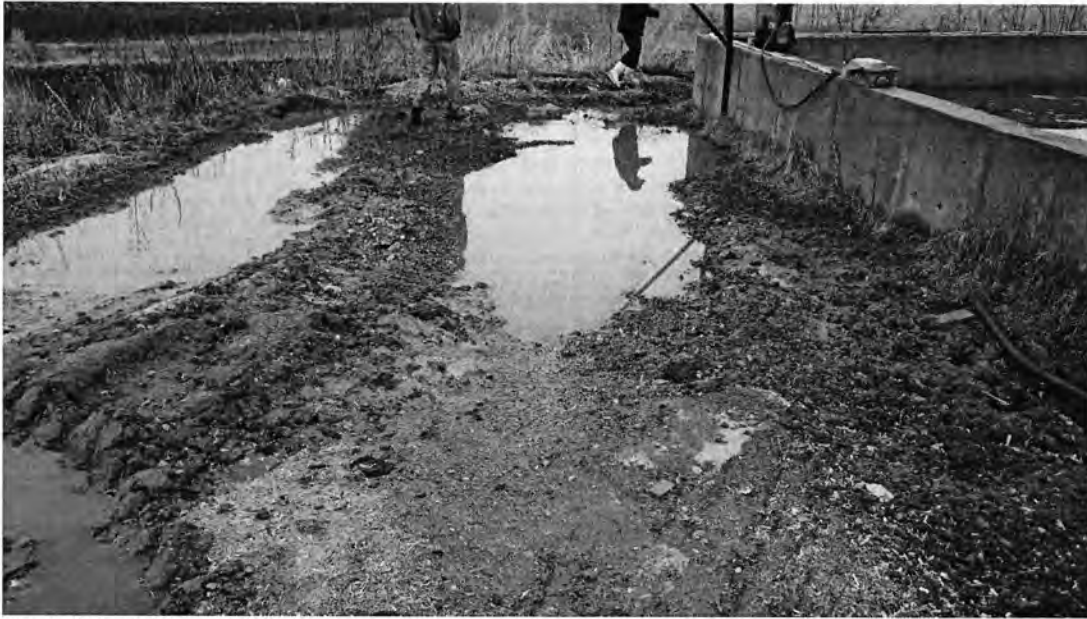
96: RIMG0105

Description: Feed and process wastewater had no containment along the south end of Lot D.

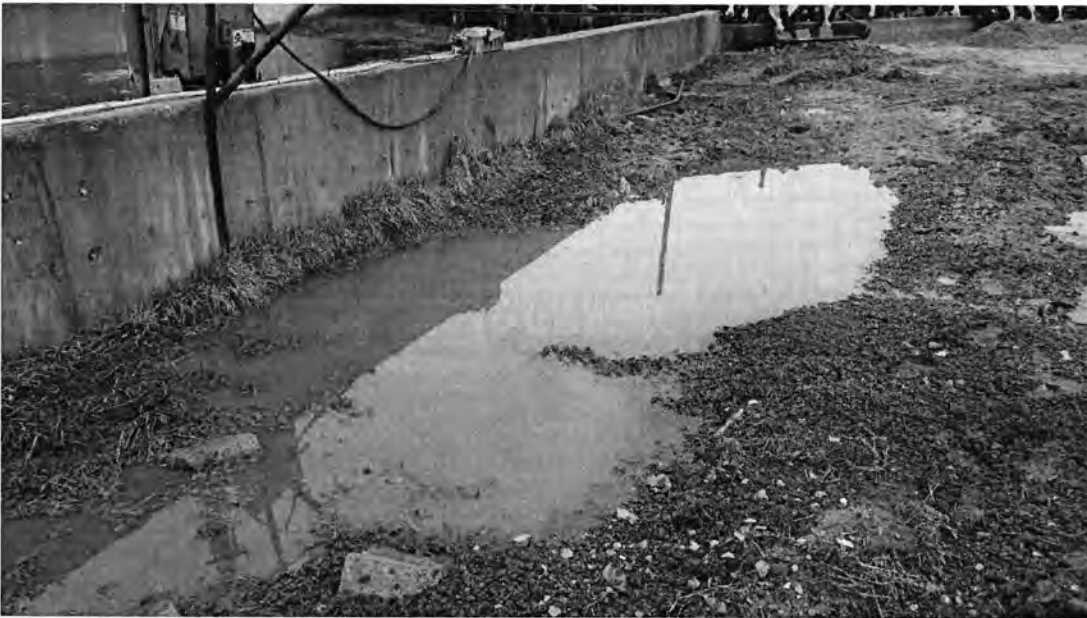
97: RIMG0106

Description: Pit for Lot D.

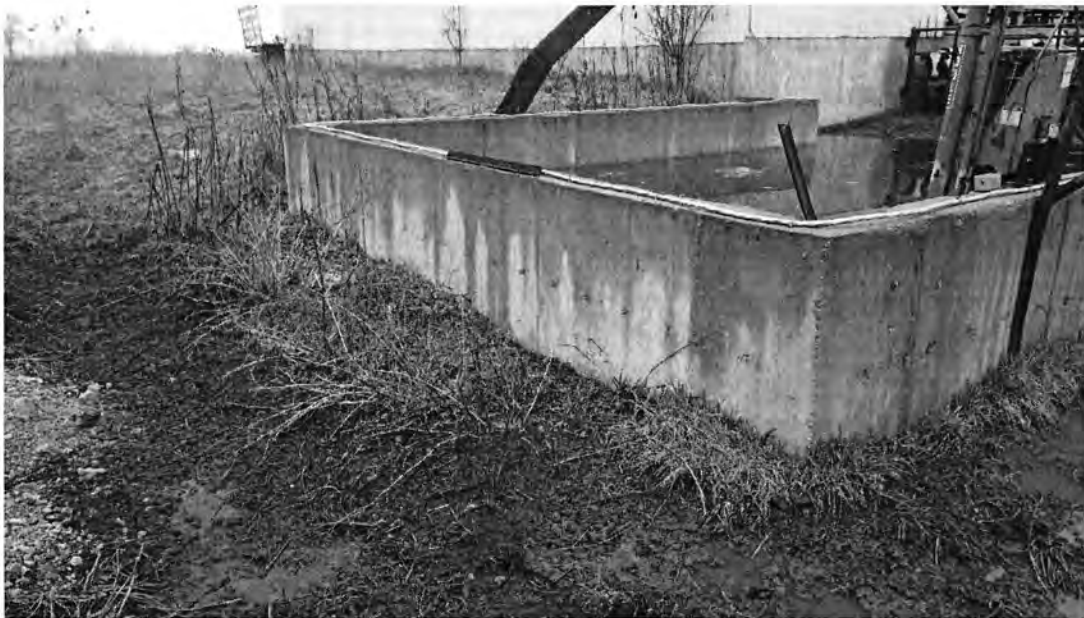
98: RIMG0107

Description: Puddle near pit for Lot D.

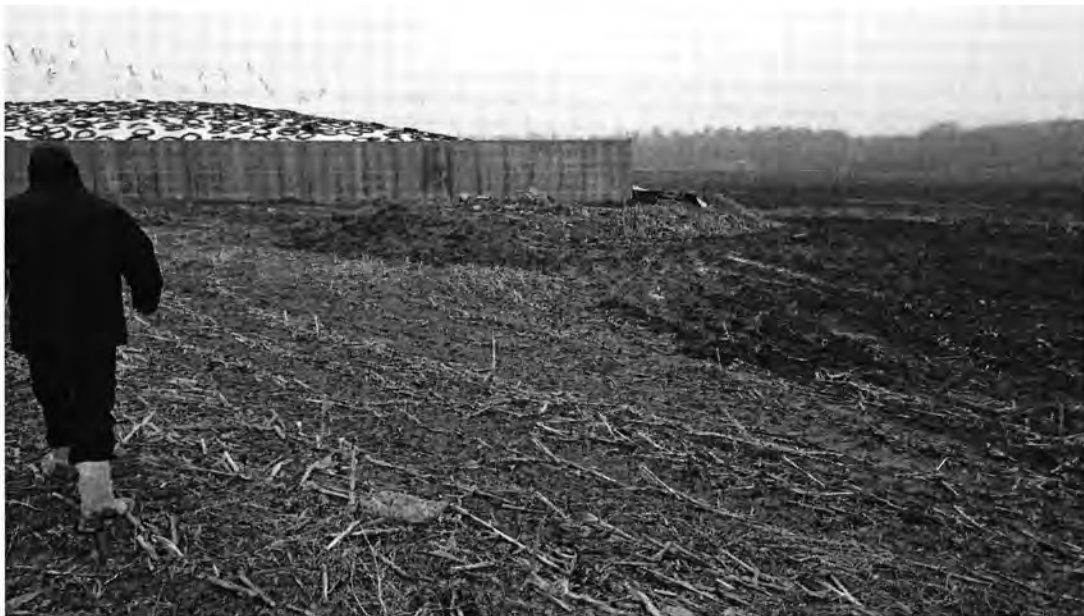
99: RIMG0108

Description: Pit for Lot D.

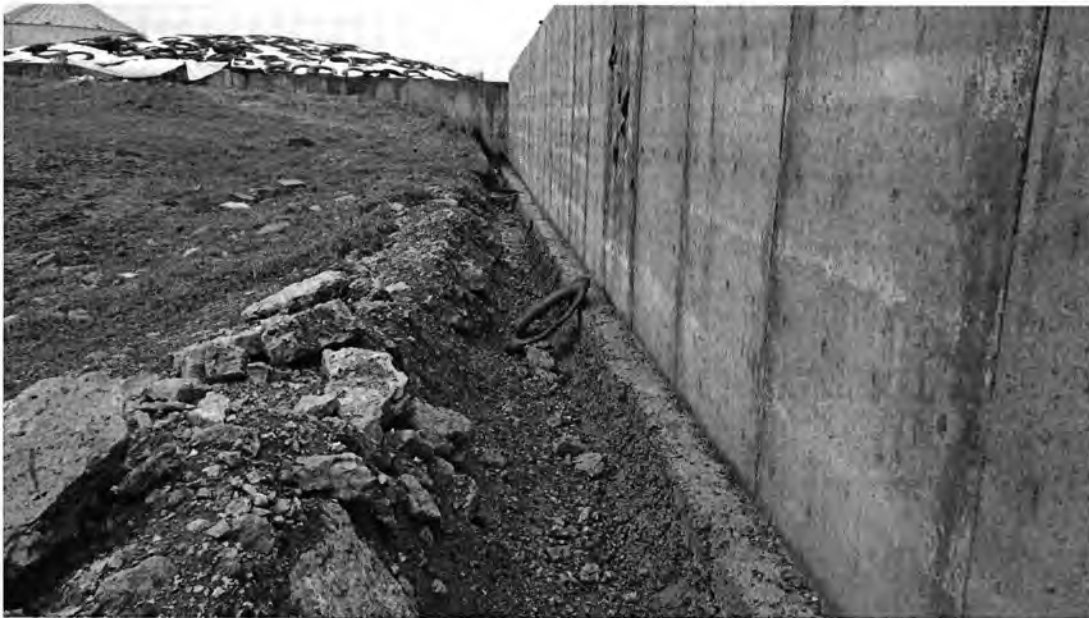
Description: Newly constructed feed bunker.

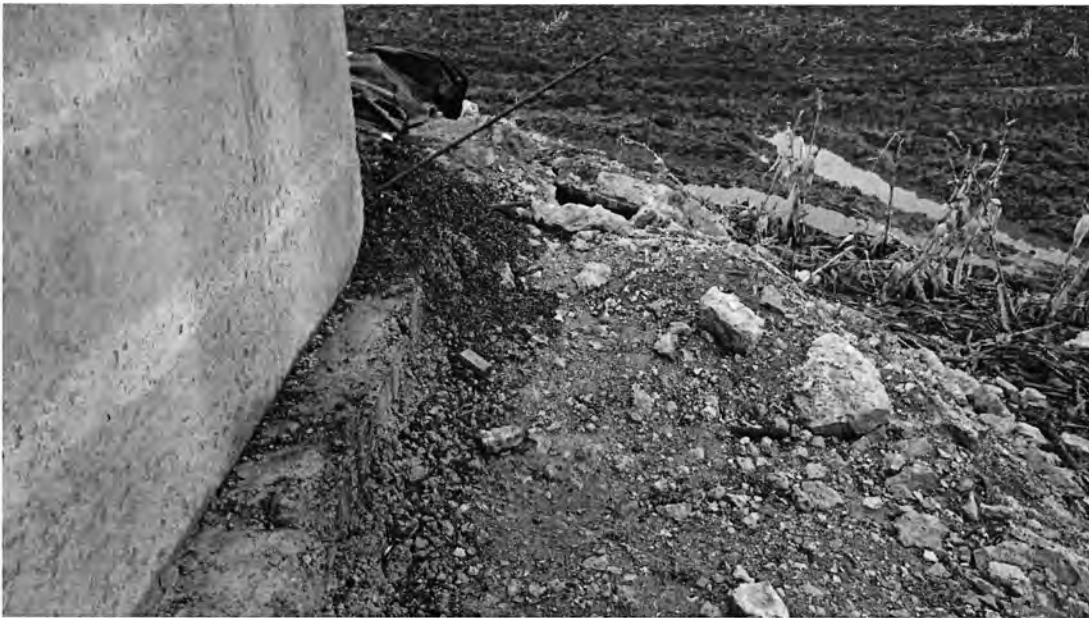
Description: Leachate was observed outside of the bunker wall.

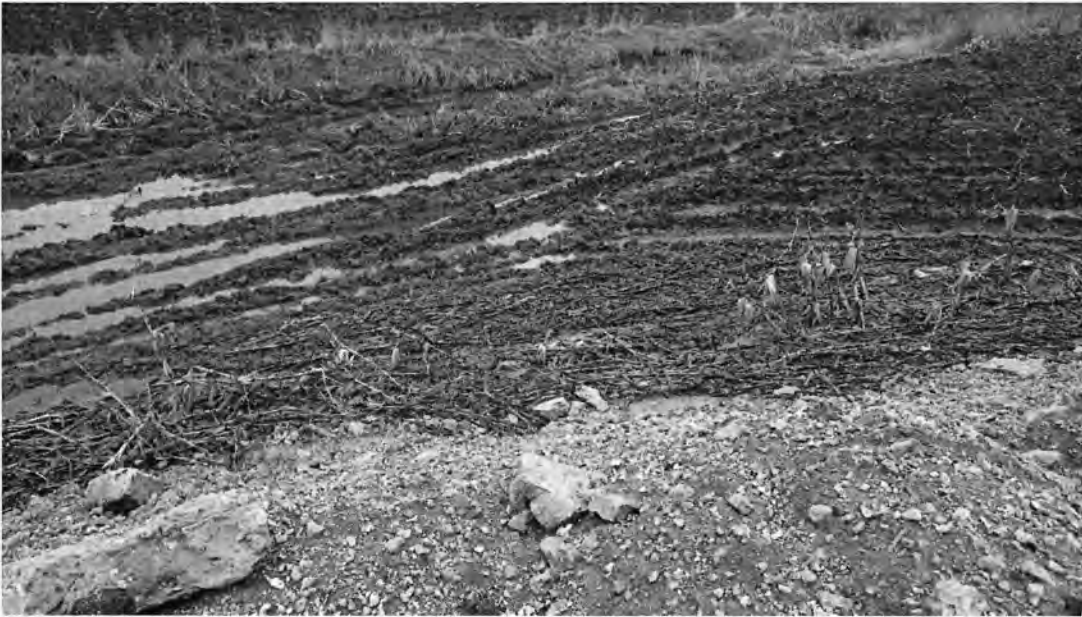
102: RIMG0111

Description: Northwest corner of new bunker.

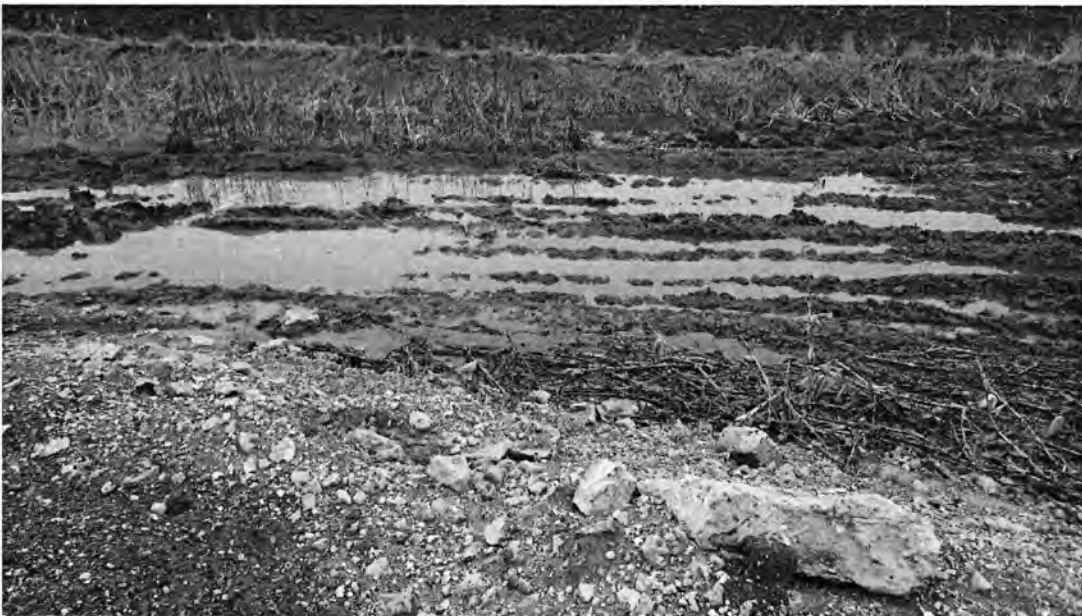
103: RIMG0112

Description: Unnamed tributary is located less than 50 feet from the edge of newly constructed bunker.

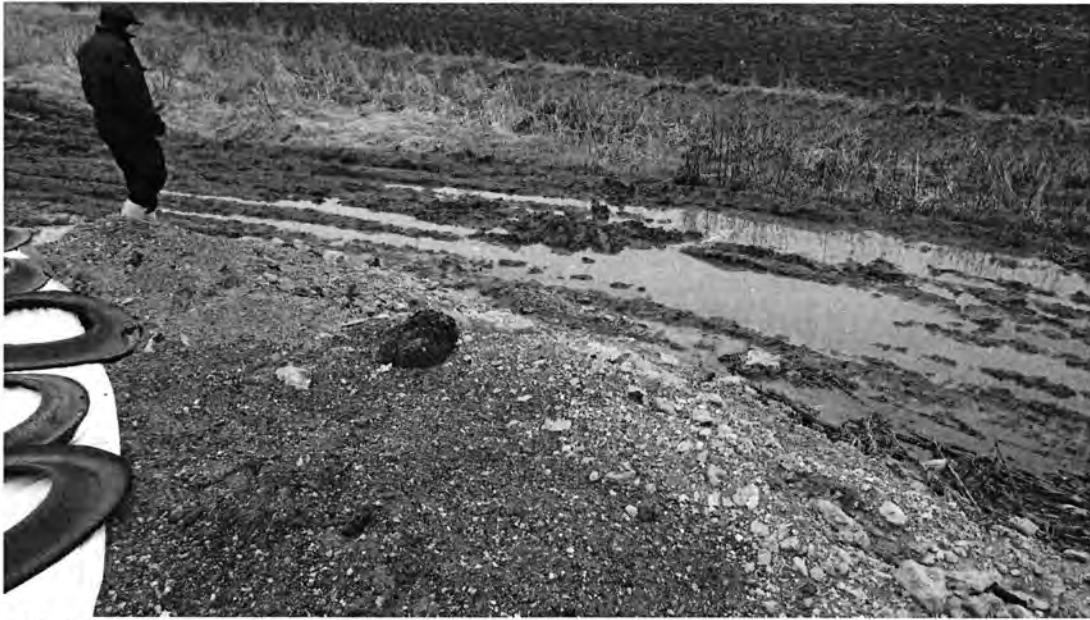
104: RIMG0113

Description: Unnamed tributary is located less than 50 feet from the edge of newly constructed bunker.

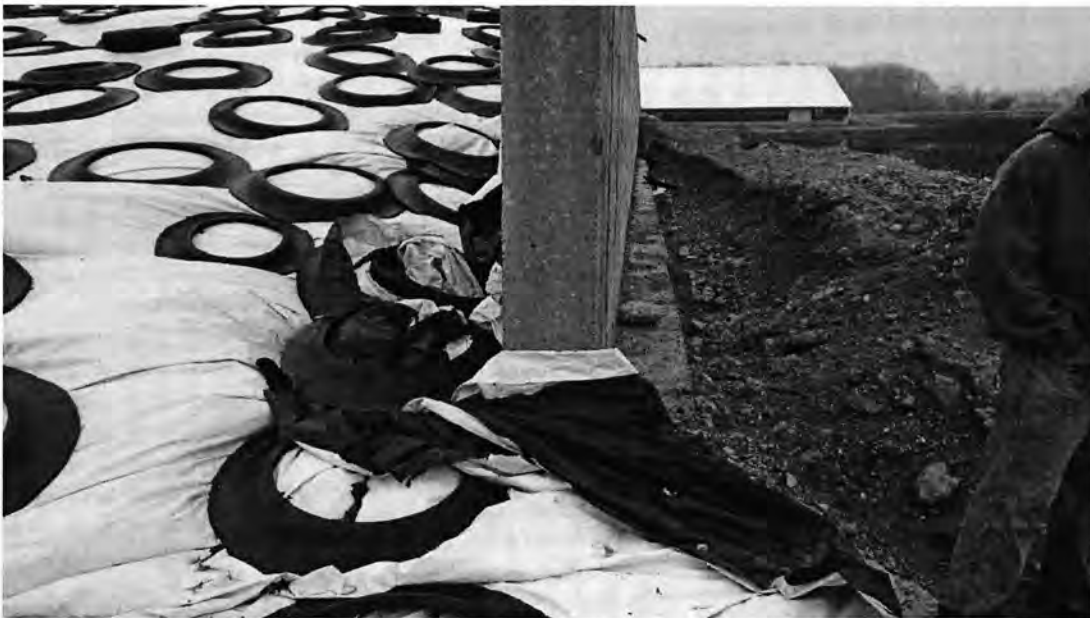
Description: Unnamed tributary is located less than 50 feet from the edge of newly constructed bunker.

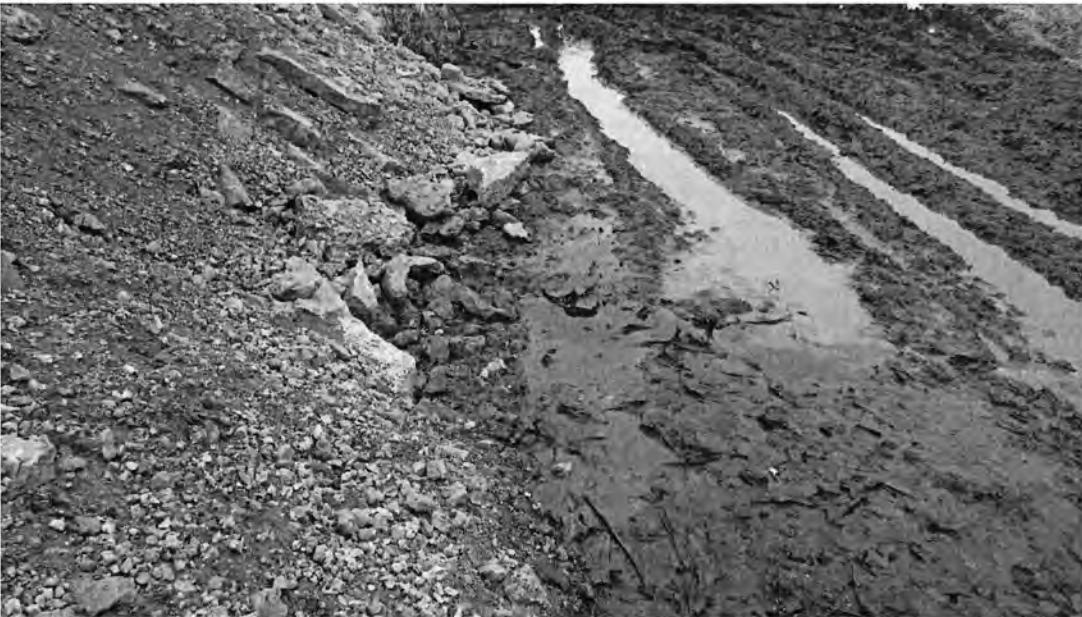
106: RIMG0115

Description: Leachate was observed outside of the bunker wall and was draining through the rock/soil and then overland to the unnamed tributary.

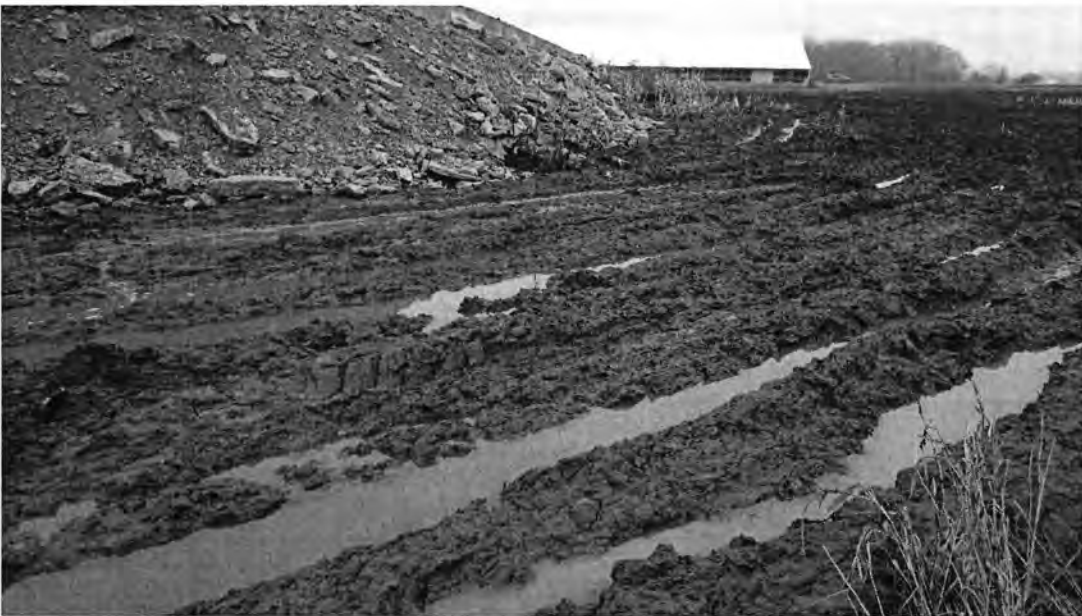
107: RIMG0116

Description: Leachate was seeping out through the rock/soil and then draining overland to the unnamed tributary.

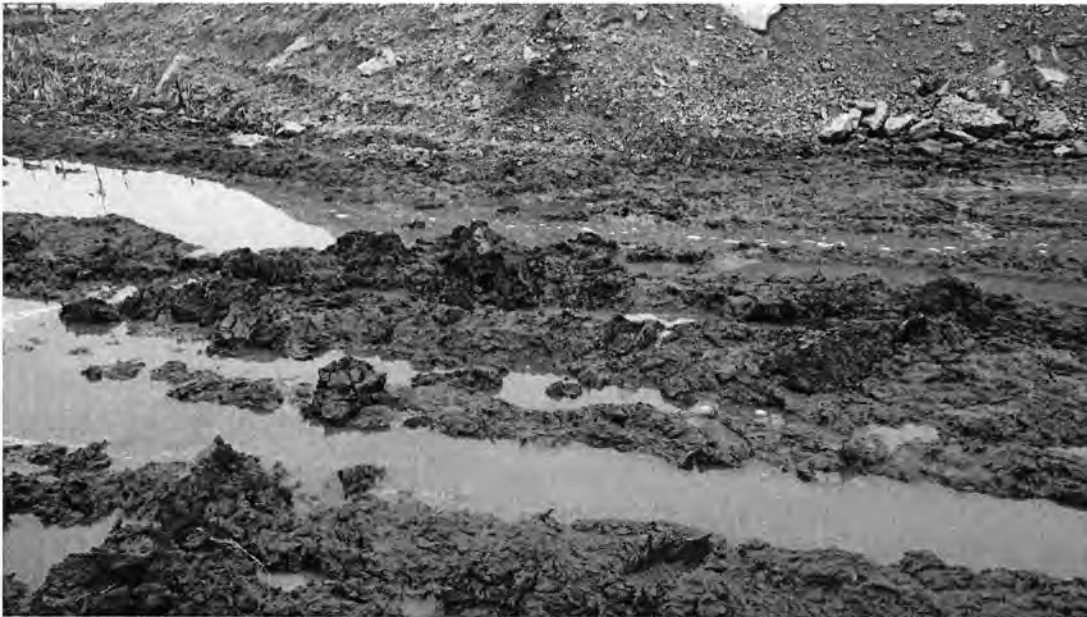
108: RIMG0117

Description: The leachate was draining west through tire ruts and into the unnamed tributary.

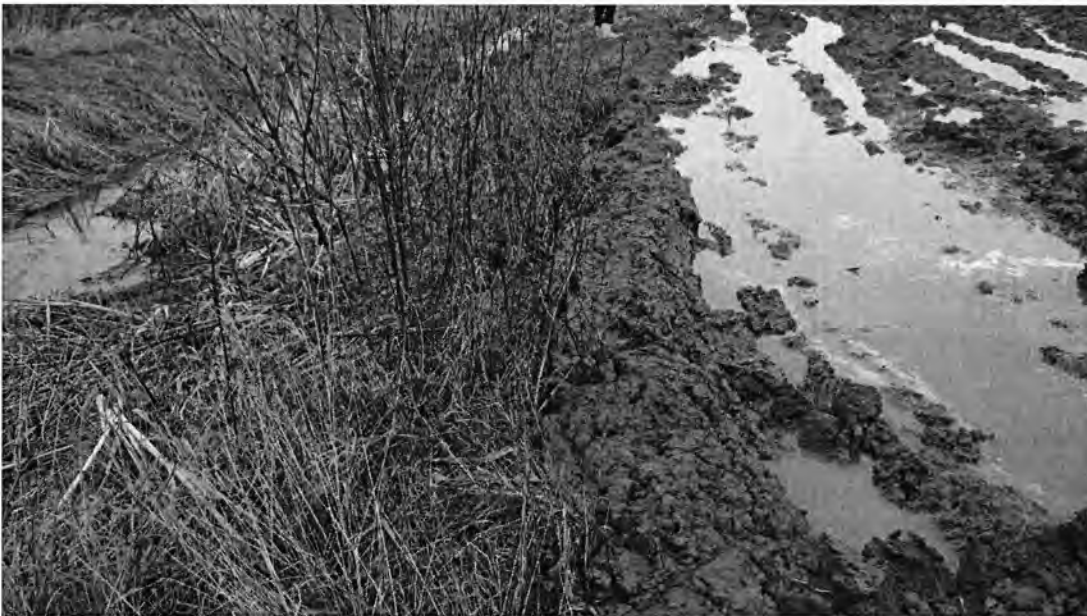
109: RIMG0118

Description: The leachate was draining west through tire ruts and into the unnamed tributary.

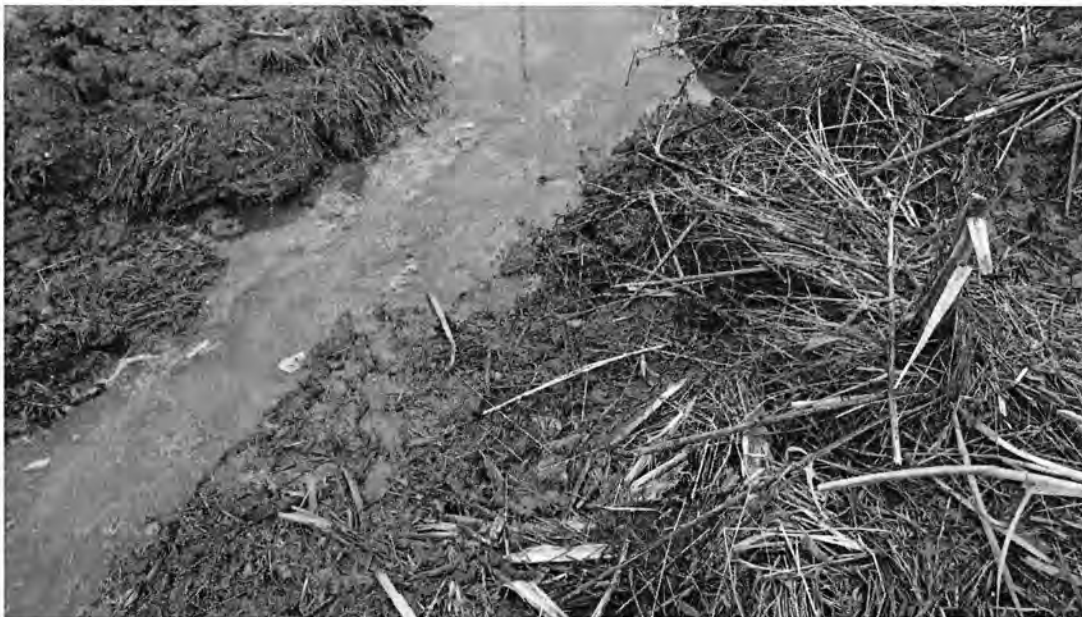
110: RIMG0119

Description: The leachate was draining west through tire ruts and into the unnamed tributary.

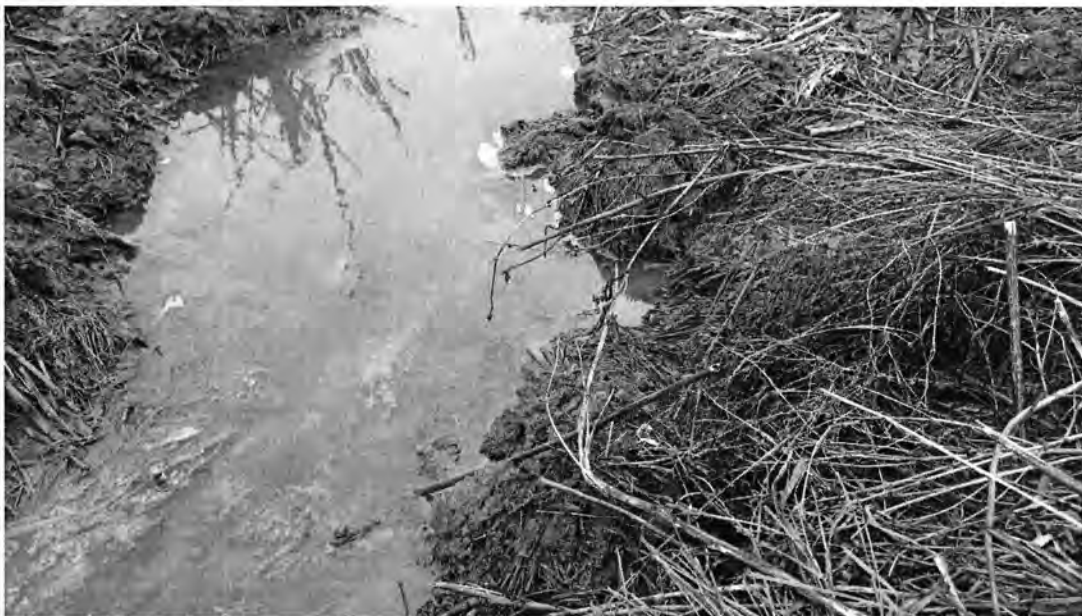
111: RIMG0120

Description: A sheen was observed where the leachate entered the unnamed tributary.

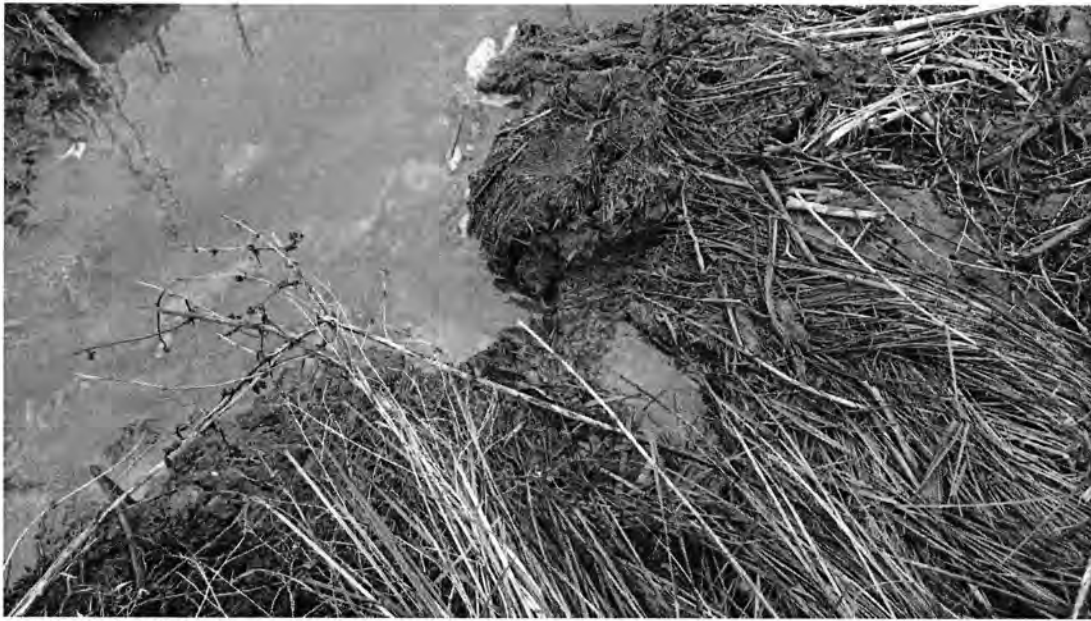
Description: A sheen was observed where the leachate entered the unnamed tributary.

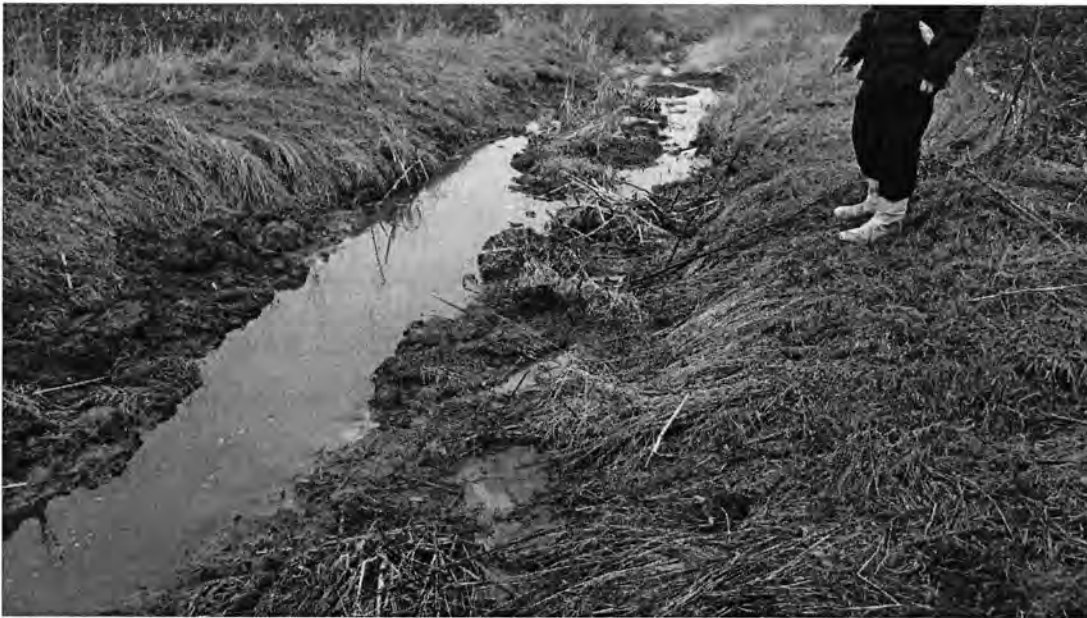
113: RIMG0122

Description: A sheen was observed where the leachate entered the unnamed tributary.

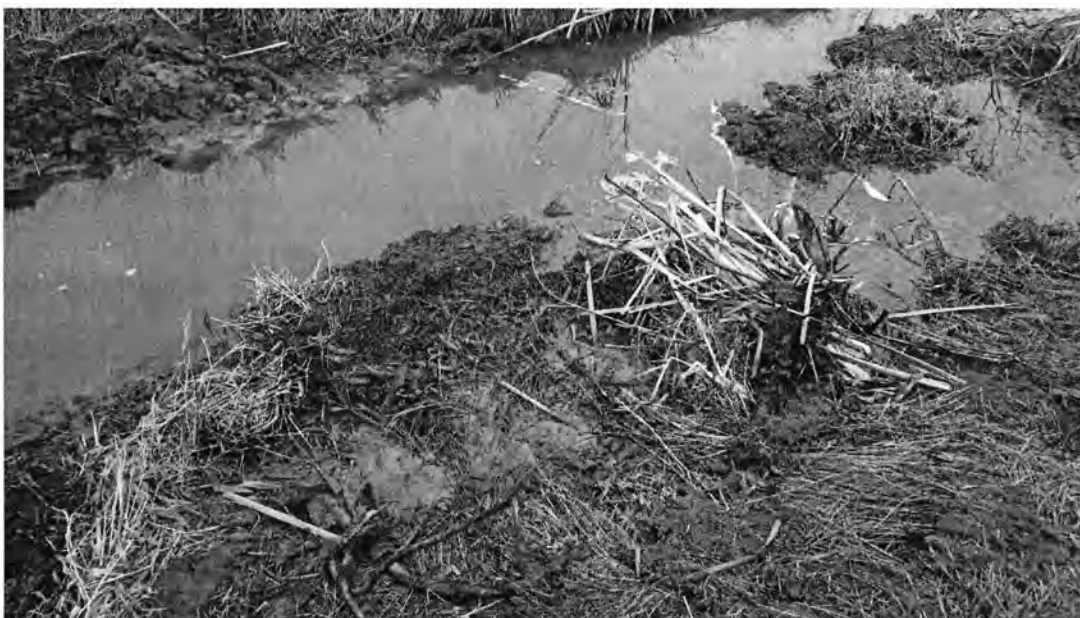
114: RIMG0123

Description: A sheen was observed where the leachate entered the unnamed tributary.

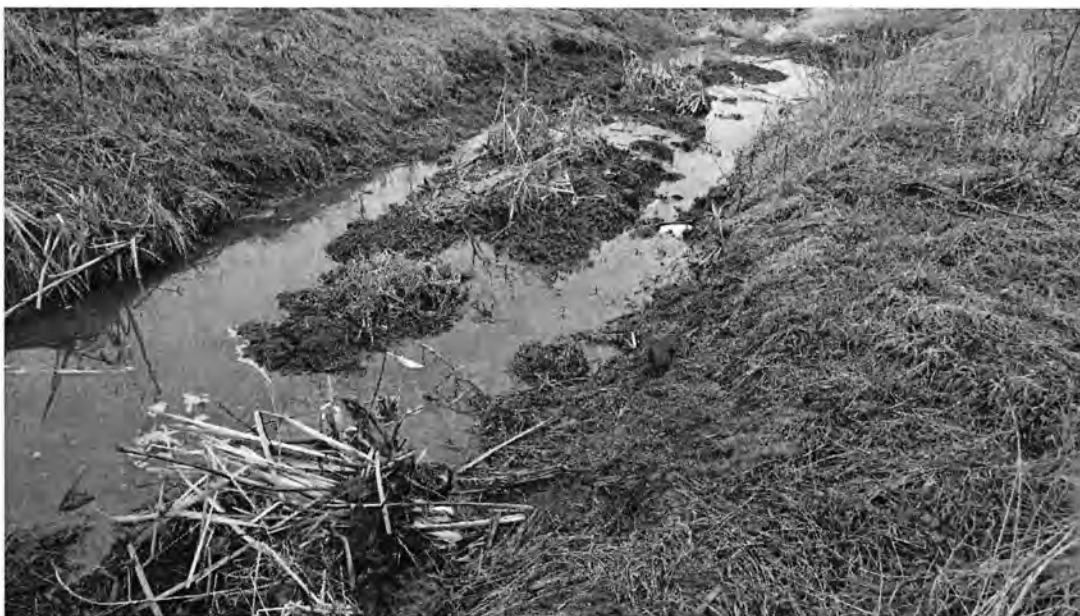
115: RIMG0124

Description: A sheen was observed where the leachate entered the unnamed tributary.

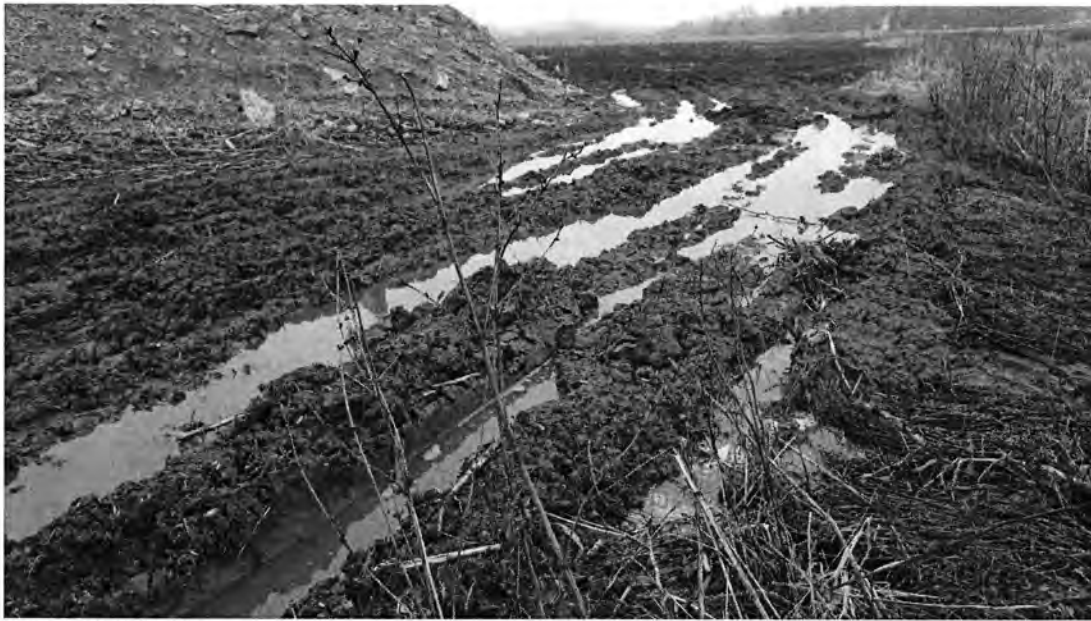
Description: A sheen and foam was observed where the leachate entered the unnamed tributary.

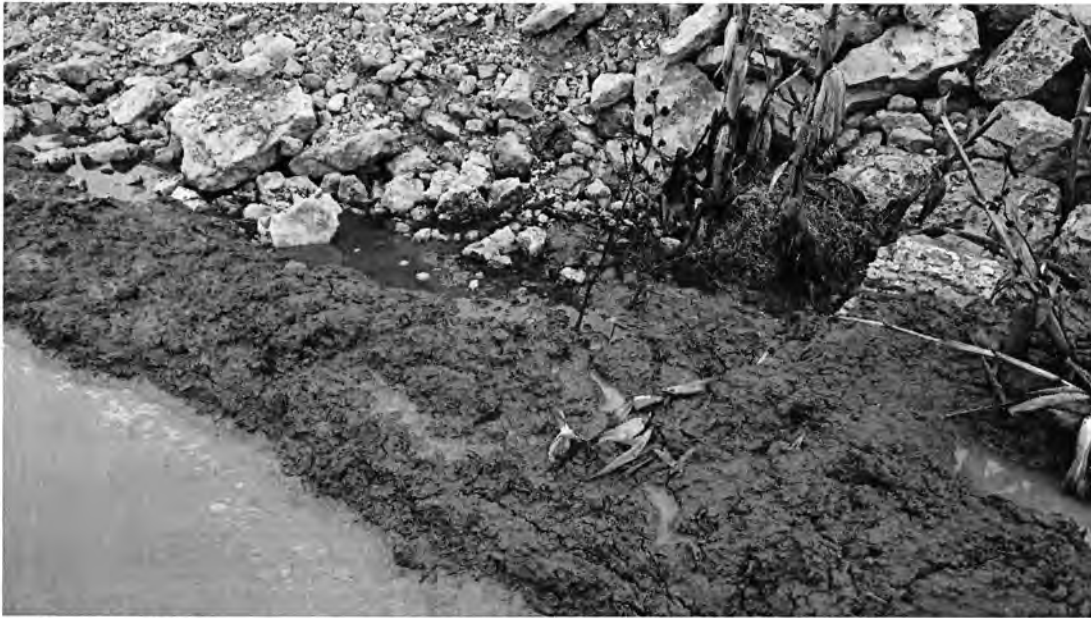
117: RIMG0126

Description: The leachate flowed through the tire ruts to the unnamed tributary.

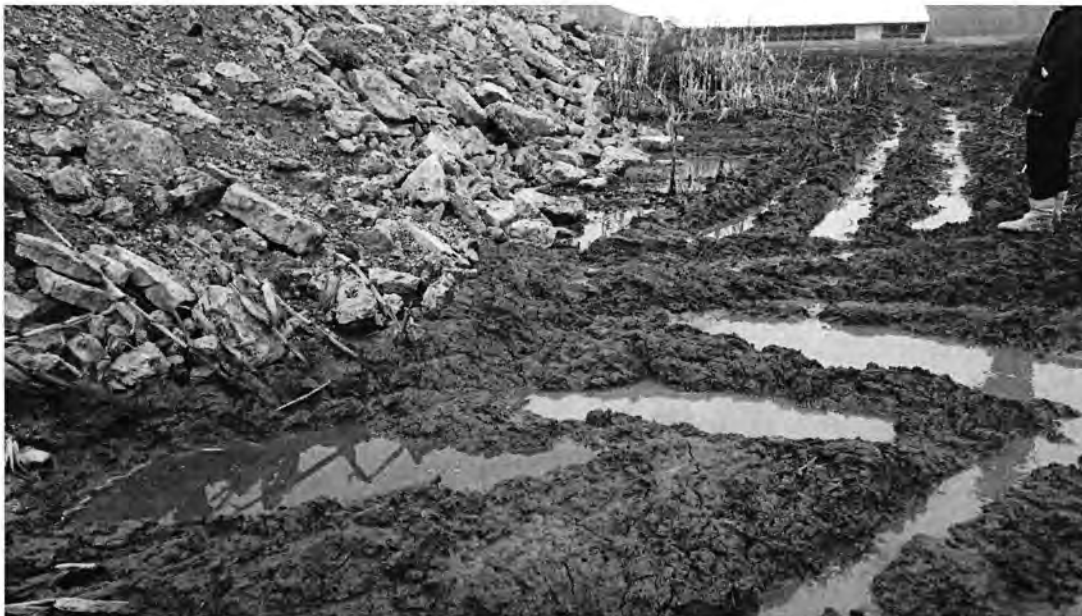
118: RIMG0127

Description: The leachate was seeping out of the rock/soil.
