State of Wisconsin | DEPARTMENT OF NATURAL RESOURCES

Subject: **Notice of Violation - Chapter 283, Wis. Statutes  
Enforcement Conference - March 9, 2009**

### **3. POTENTIAL VIOLATIONS**

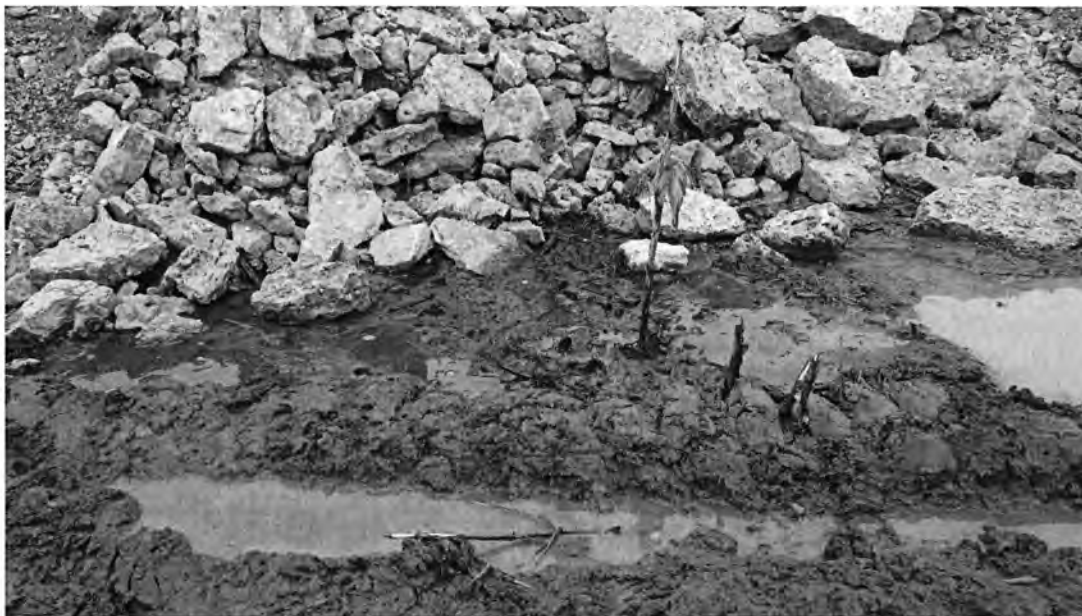
119: RIMG0128

Description: The leachate was seeping out of the rock/soil.

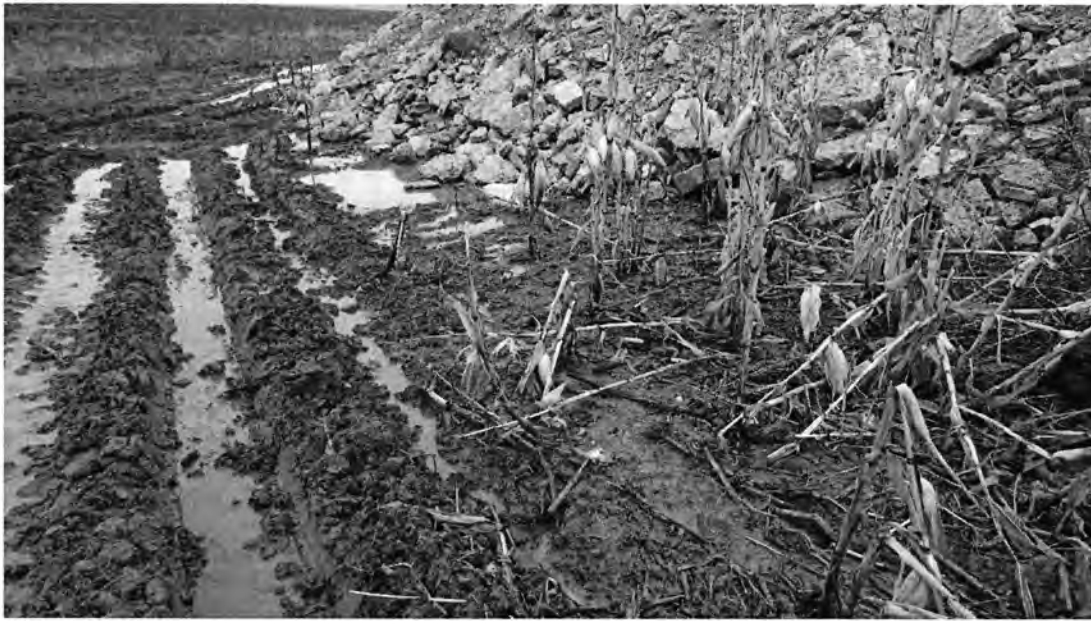
120: RIMG0129

Description: The leachate was seeping out of the rock/soil.

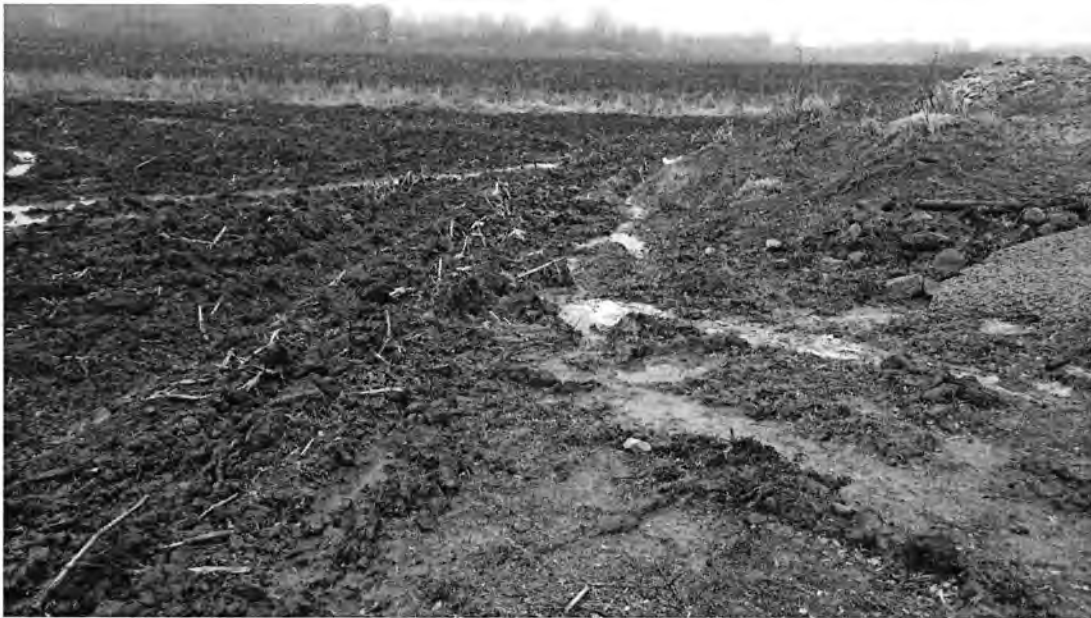
121: RIMG0130

Description: The leachate was seeping out of the rock/soil.

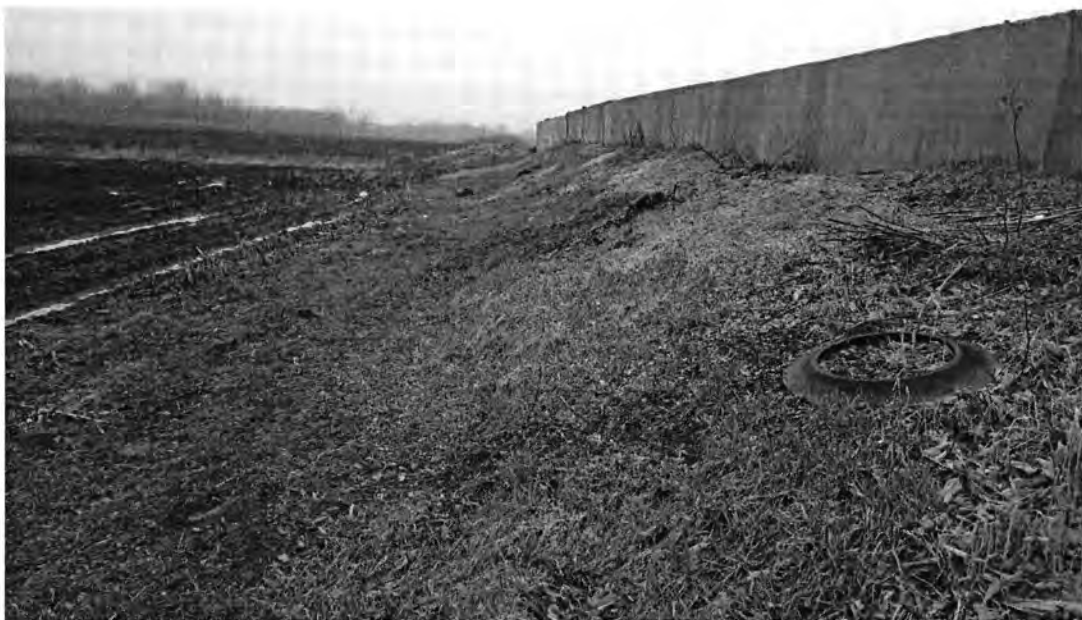
122: RIMG0131

Description: The topography on the south side of the feed bunkers are situated such that it drains to the unnamed tributary.

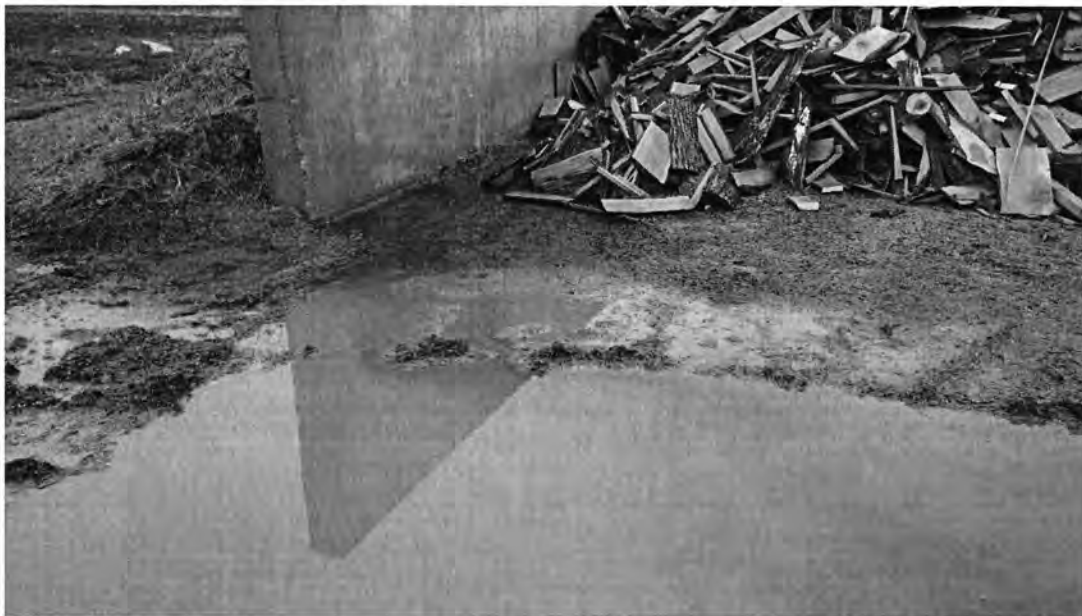
123: RIMG0132

Description: The topography on the south side of the feed bunkers are situated such that it drains to the unnamed tributary.

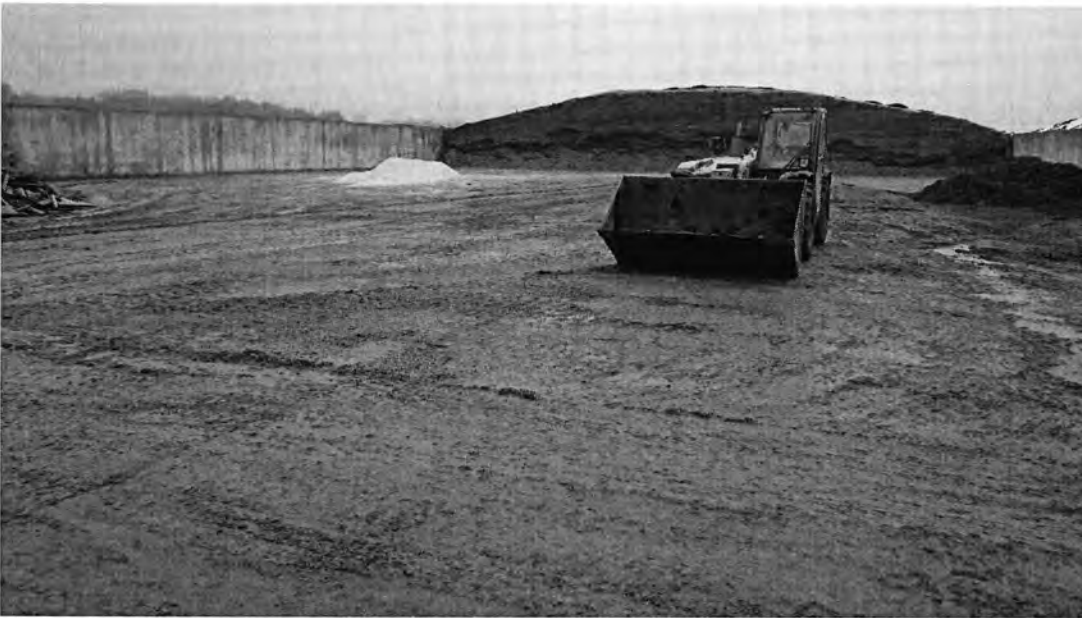
125: RIMG0134

Description: Process wastewater from the southeast end of the feed bunker flows south into the field.

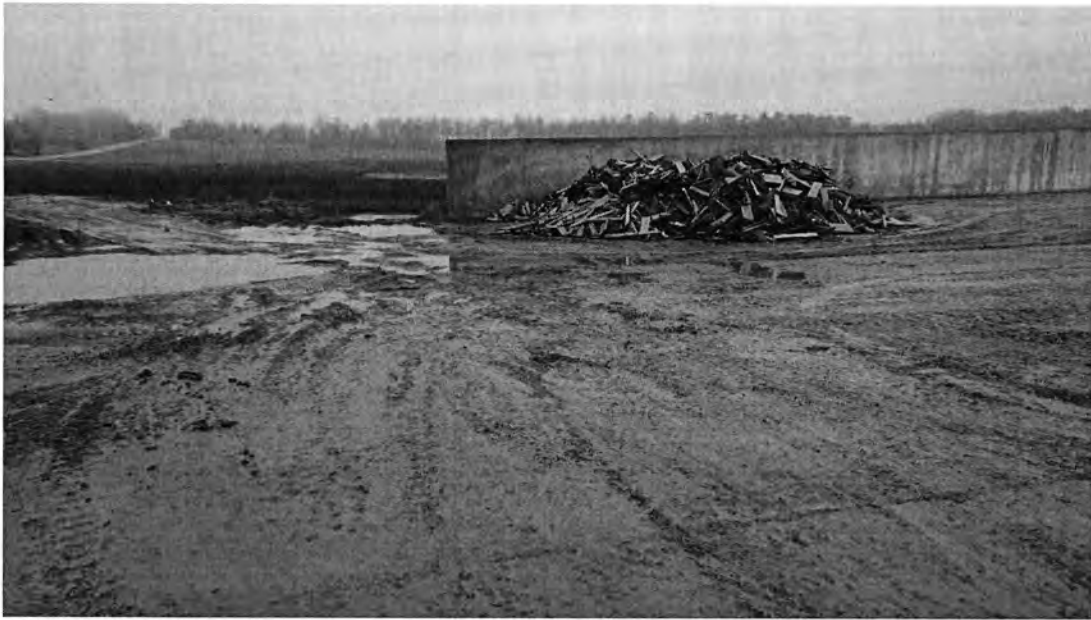
126: RIMG0135

Description: Raw material and feeds solids were scattered throughout the concrete surface of the feed bunker.

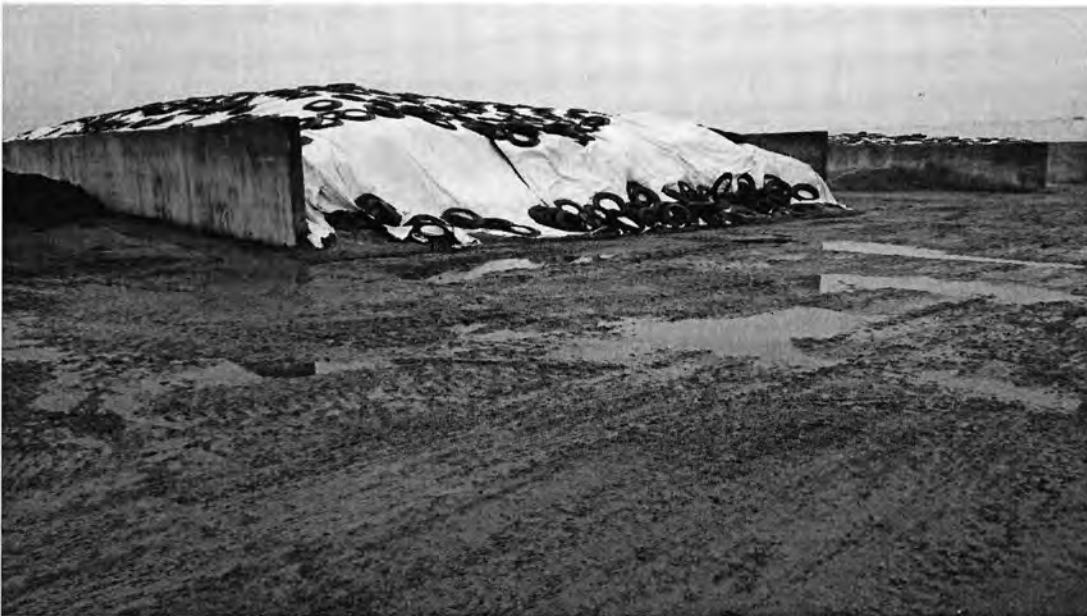
127: RIMG0136

Description: Process wastewater from the southeast end of the feed bunker flows south into the field.

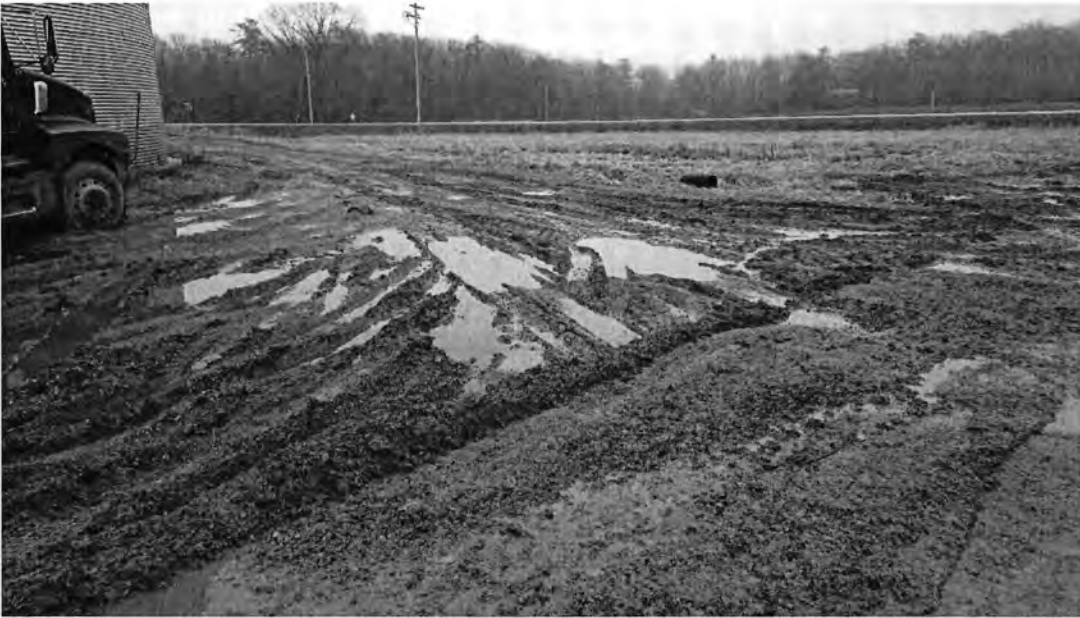
128: RIMG0137

Description: Process wastewater and feed solids were observed around the feed bunkers. The process wastewater was ponded and flowed east into a grassed area. Drainage from most portions of the feed bunkers flowed east into a grassed area and to a ditch.

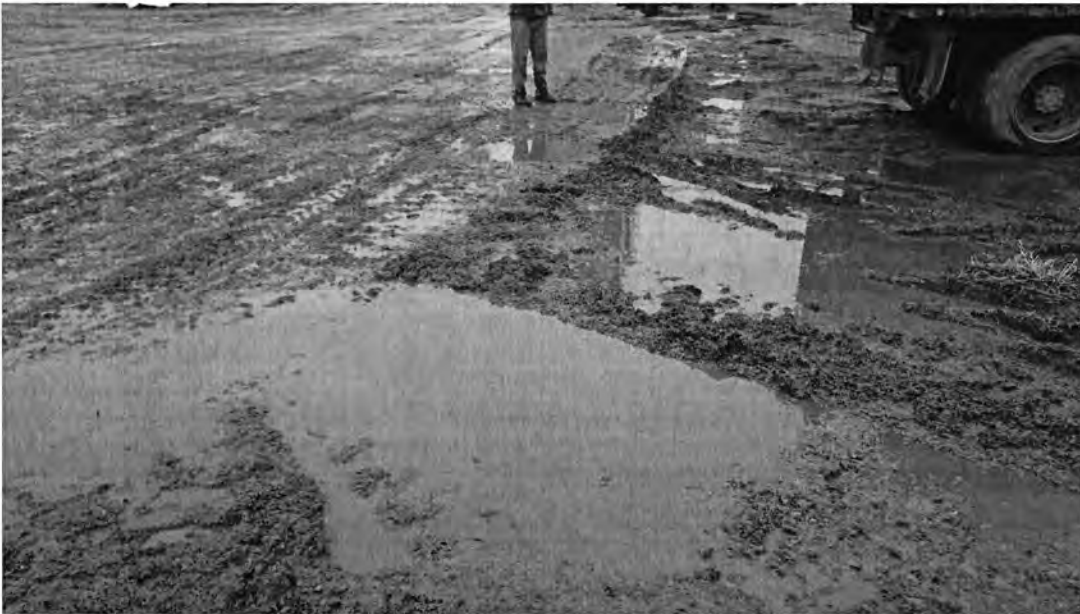
129: RIMG0138

Description: Process wastewater and feed solids were observed throughout the grassed area and the drainage paths leading to the grassed area.

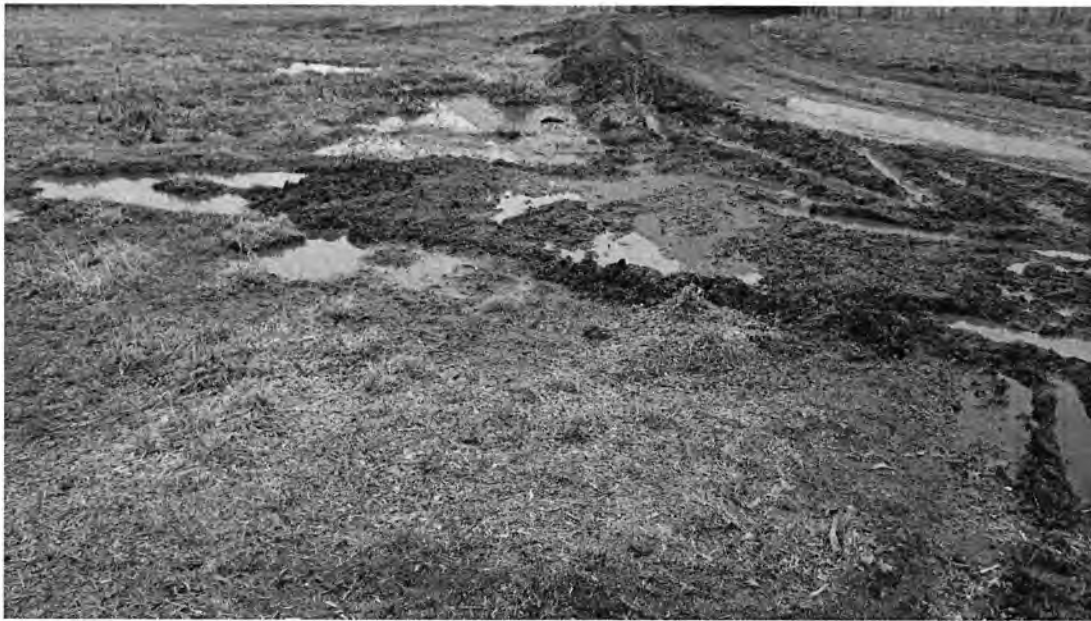
Description: Process wastewater and feed solids were observed throughout the grassed area and the drainage paths leading to the grassed area.

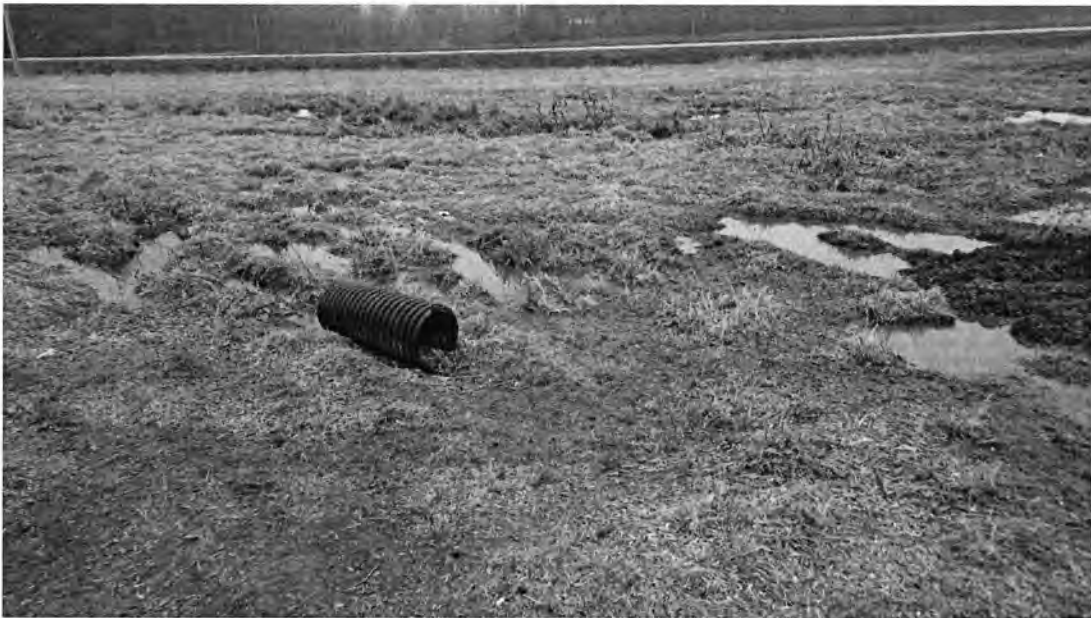
Description: Process wastewater and feed solids were observed throughout the grassed area and the drainage paths leading to the grassed area.

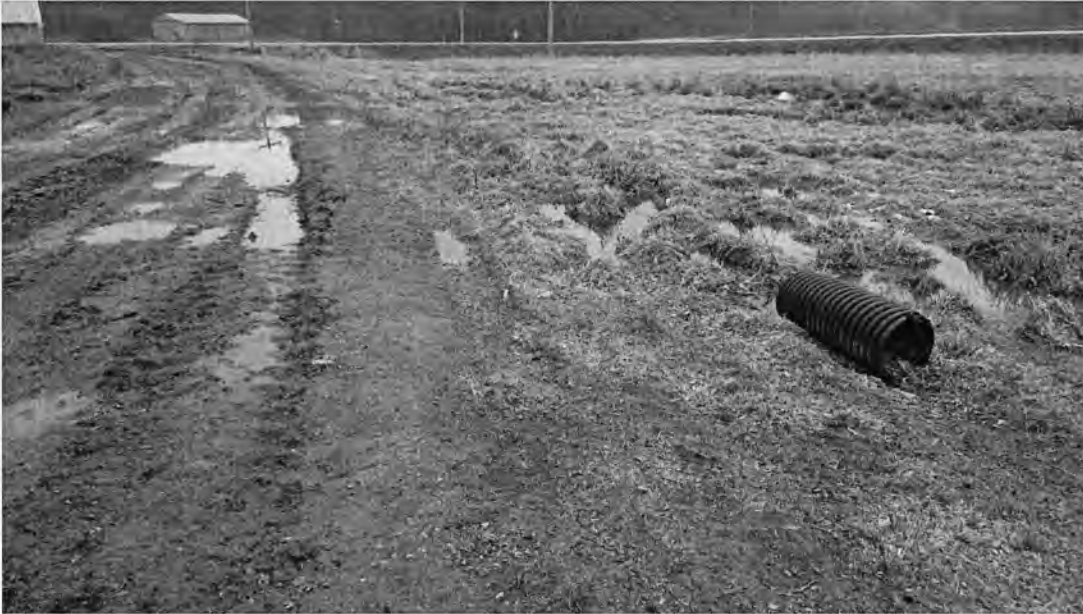
132: RIMG0141

Description: Process wastewater and feed solids were observed throughout the grassed area.

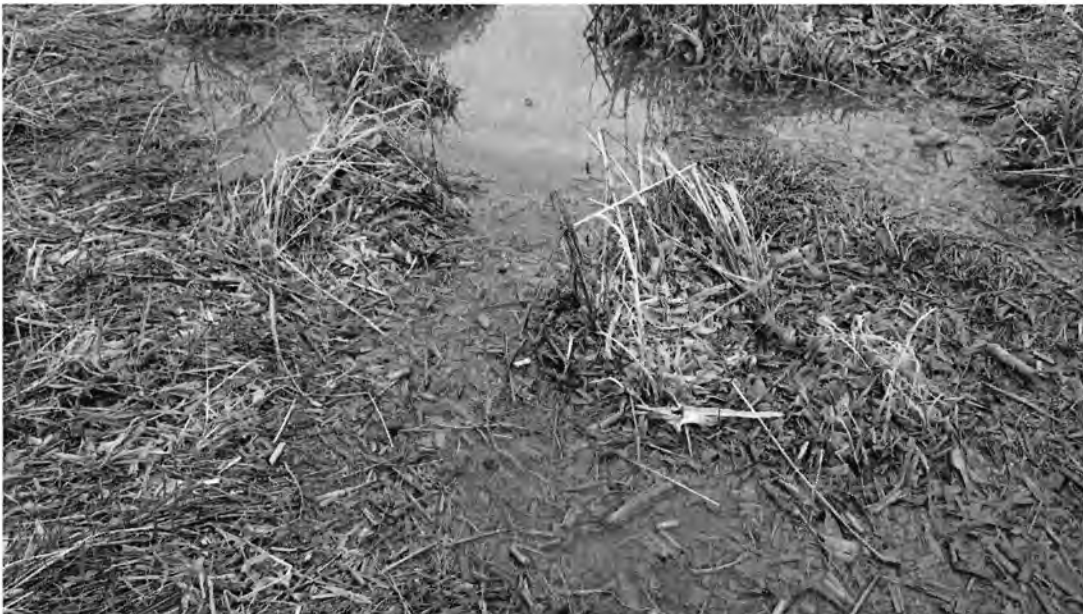
133: RIMG0142

Description: Process wastewater and feed solids were observed throughout the grassed area and the drainage paths leading to the grassed area.

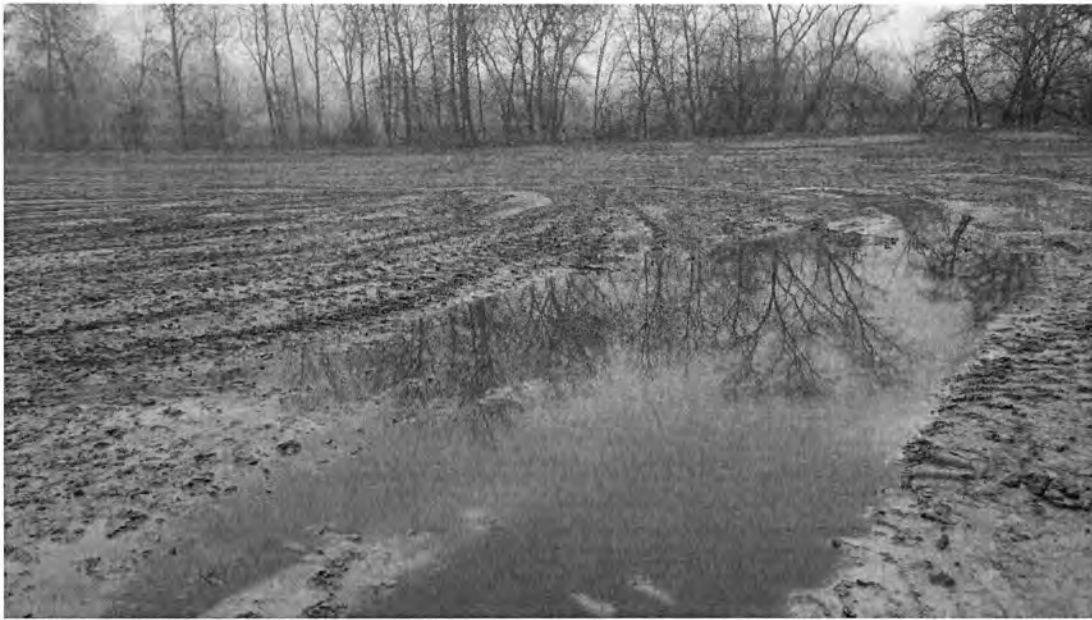
Description: Process wastewater and feed solids observed in the grassed area.

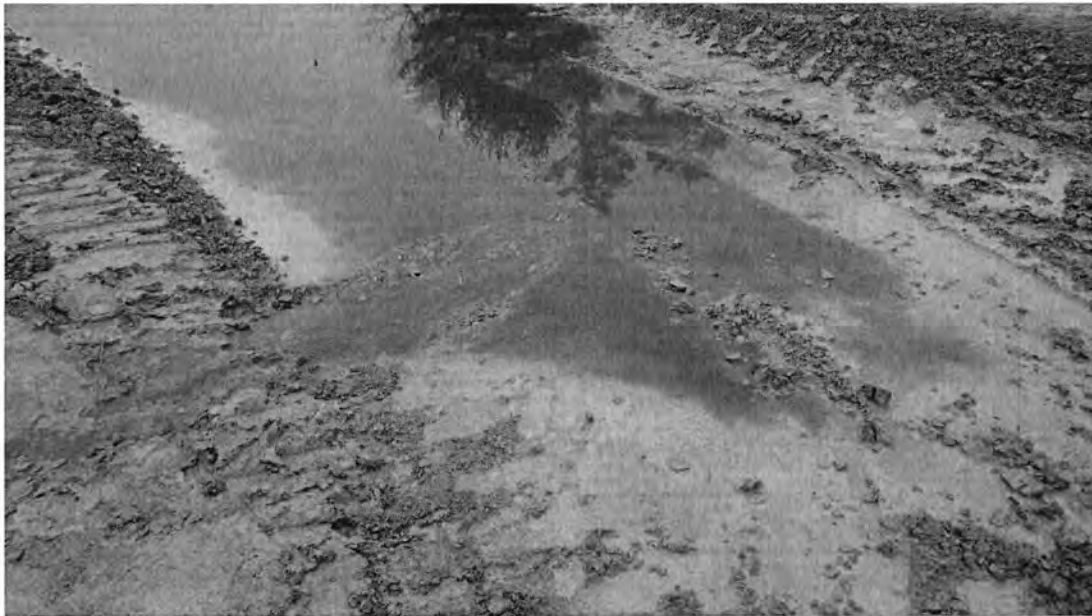
223: RIMG0232

Description: The drainage pathway flowed to the unnamed tributary.

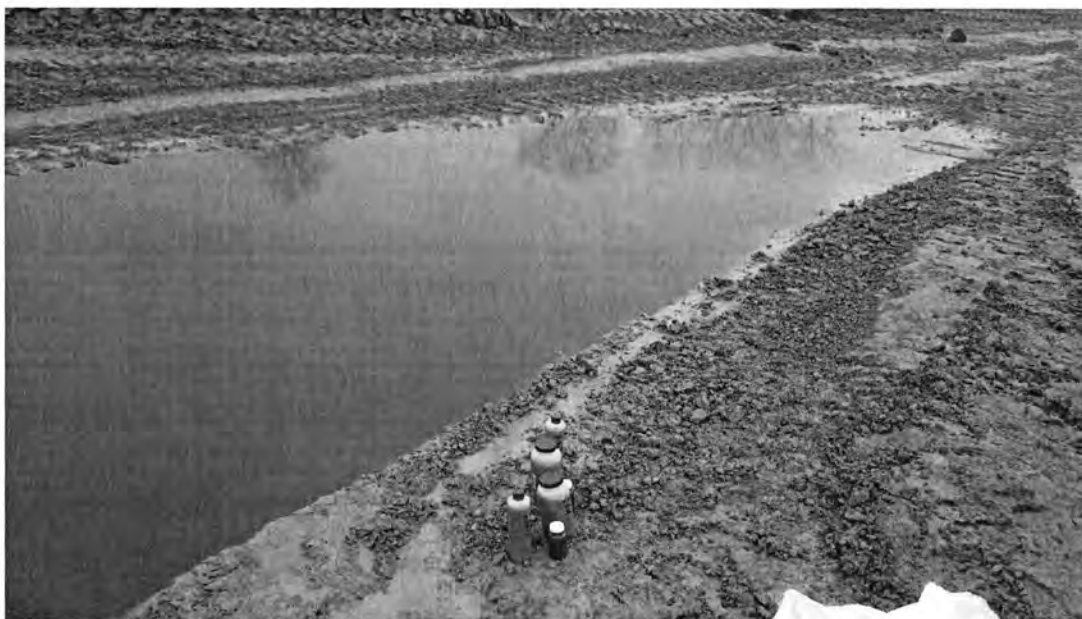
224: RIMG0233

Description: The drainage pathway flowed to the unnamed tributary.

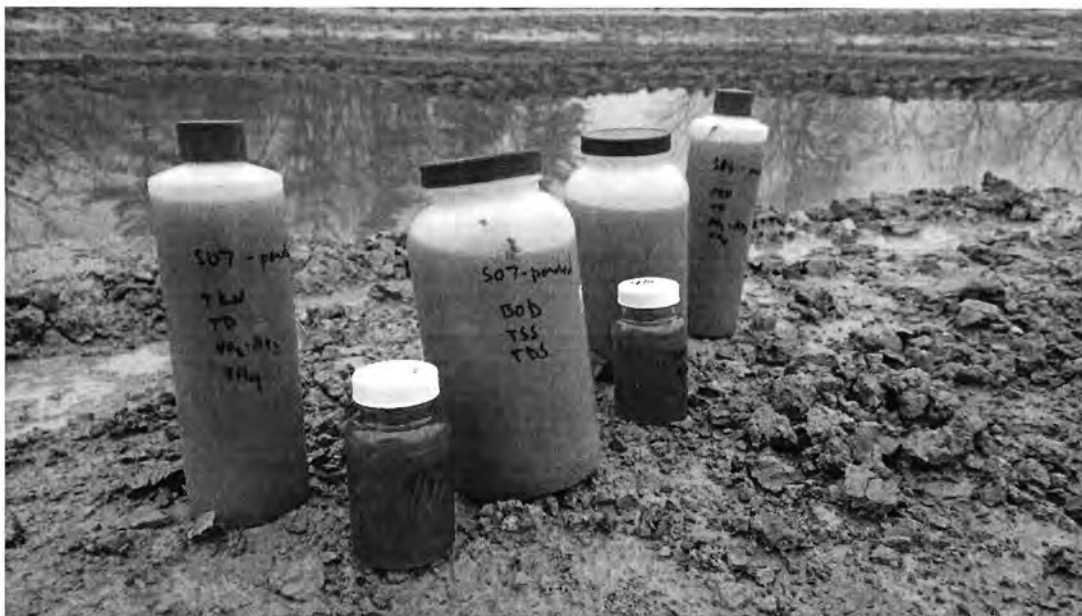
225: RIMG0234

Description: Sample S06 and S07 were taken at 1:00 p.m. from process wastewater in the drainage pathway in the borrow area that drains to the unnamed tributary on the east side of the Home site.

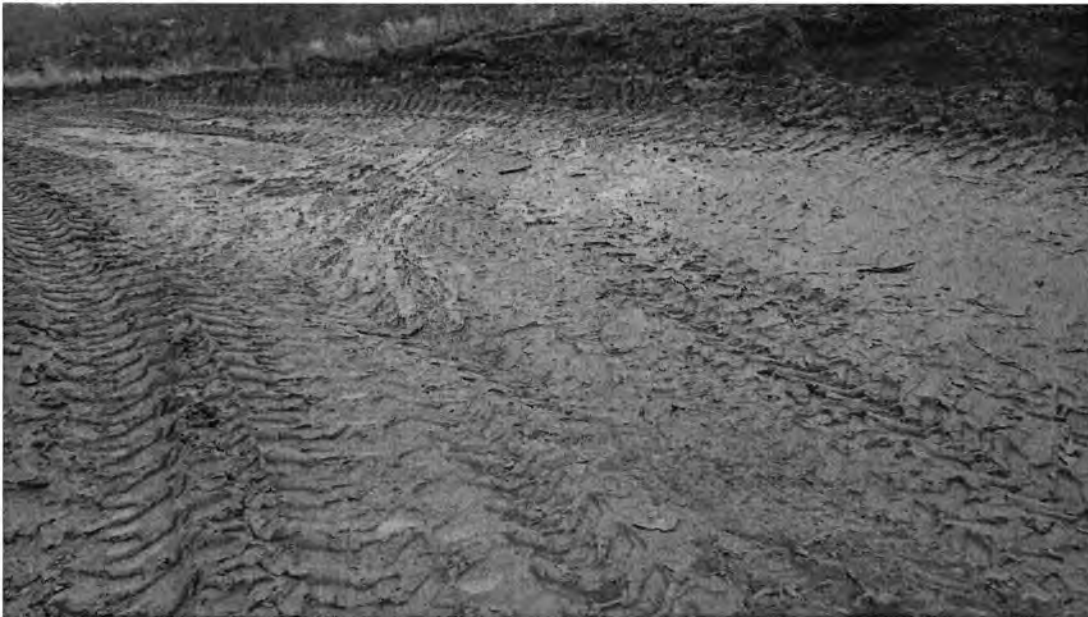
226: RIMG0235

Description: Sample S06 and S07 were taken at 1:00 p.m. from process wastewater in the drainage pathway in the borrow area that drains to the unnamed tributary on the east side of the Home site.

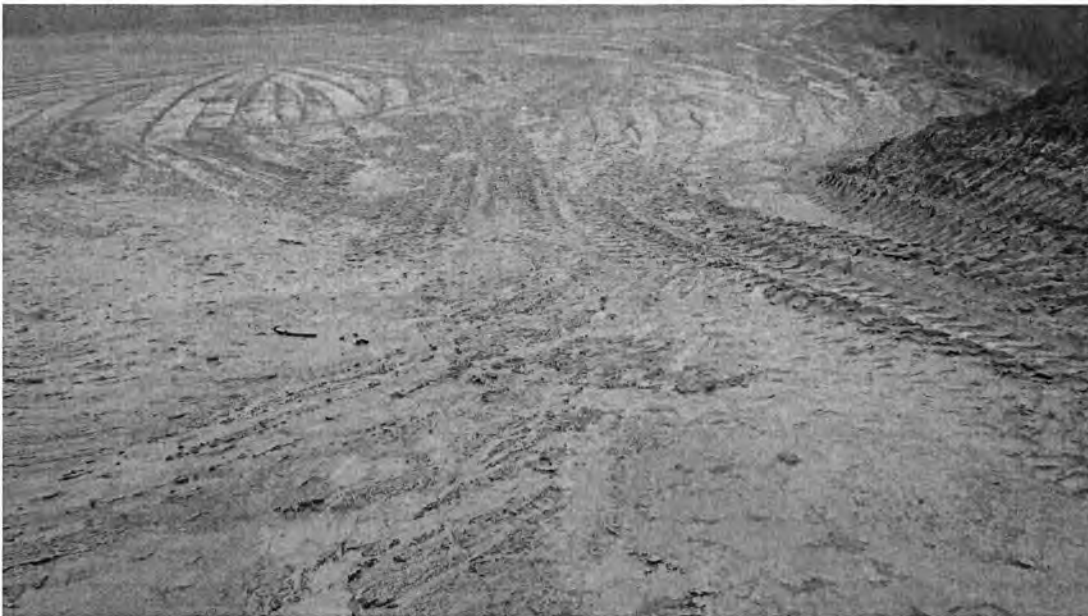
227: RIMG0236

Description: Manure and process wastewater flowed into the borrow area from the New Barn and cattle walkways between the New Barn and the barn west of the New Barn.

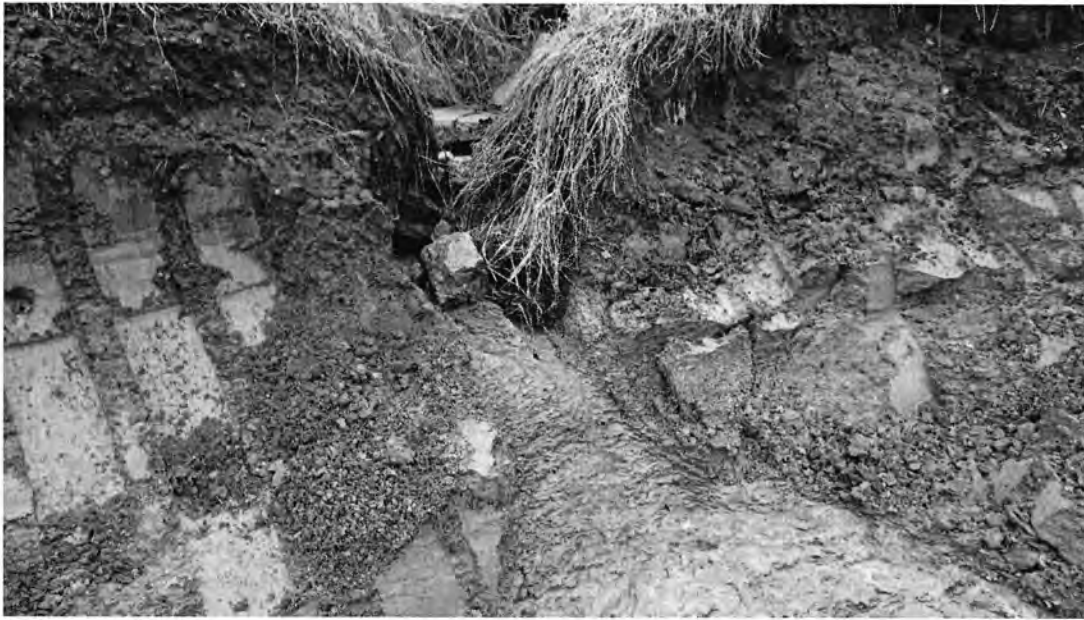
228: RIMG0237

Description: Manure and process wastewater flowed north through the borrow area from the New Barn and cattle walkways between the New Barn and the barn west of the New Barn.

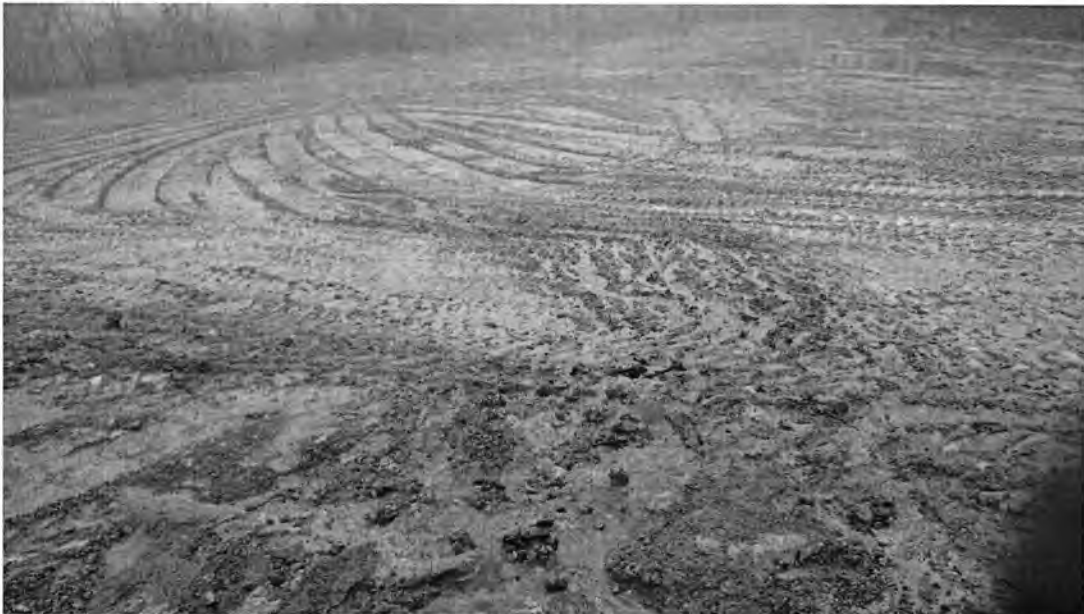
229: RIMG0238

Description: Manure and process wastewater flowed into the borrow area from the Milk Cow Barn and the access way between the Milk Cow Barn and the feed bunkers.

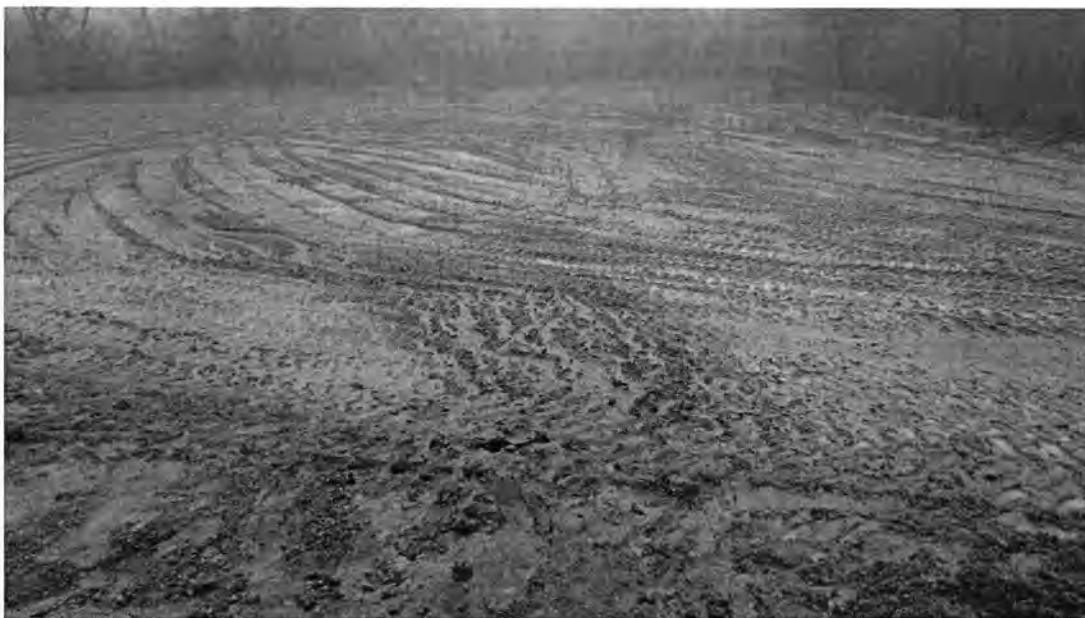
230: RIMG0239

Description: Manure and process wastewater flowed north through the borrow area from the Milk Cow Barn and the access way between the Milk Cow Barn and the feed bunkers.

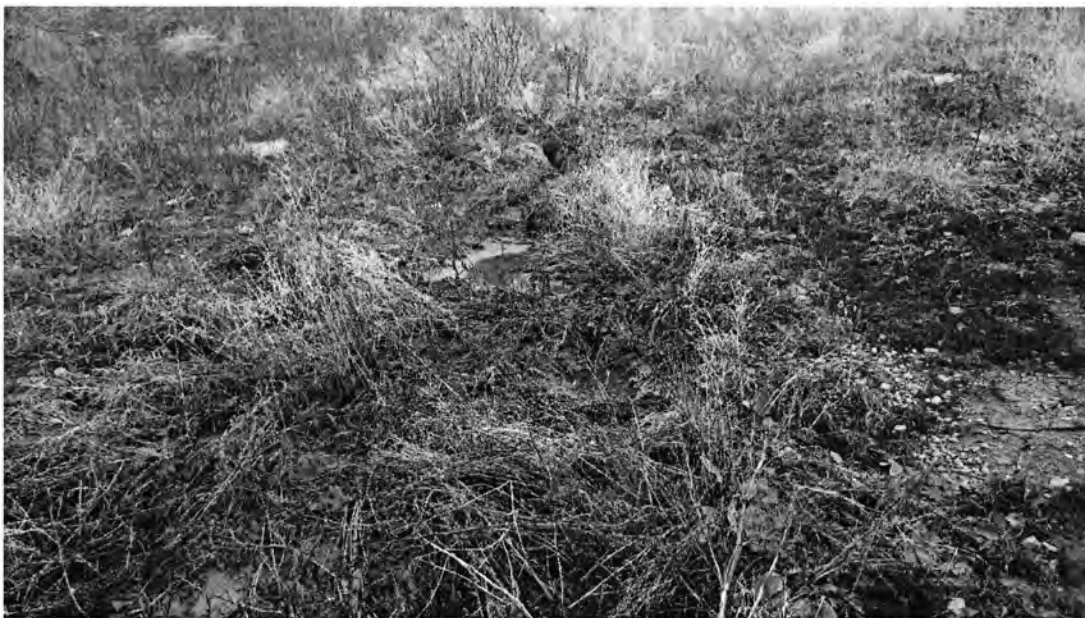
231: RIMG0240

Description: Manure and process wastewater flowed north through the borrow area from the Milk Cow Barn and the access way between the Milk Cow Barn and the feed bunkers.

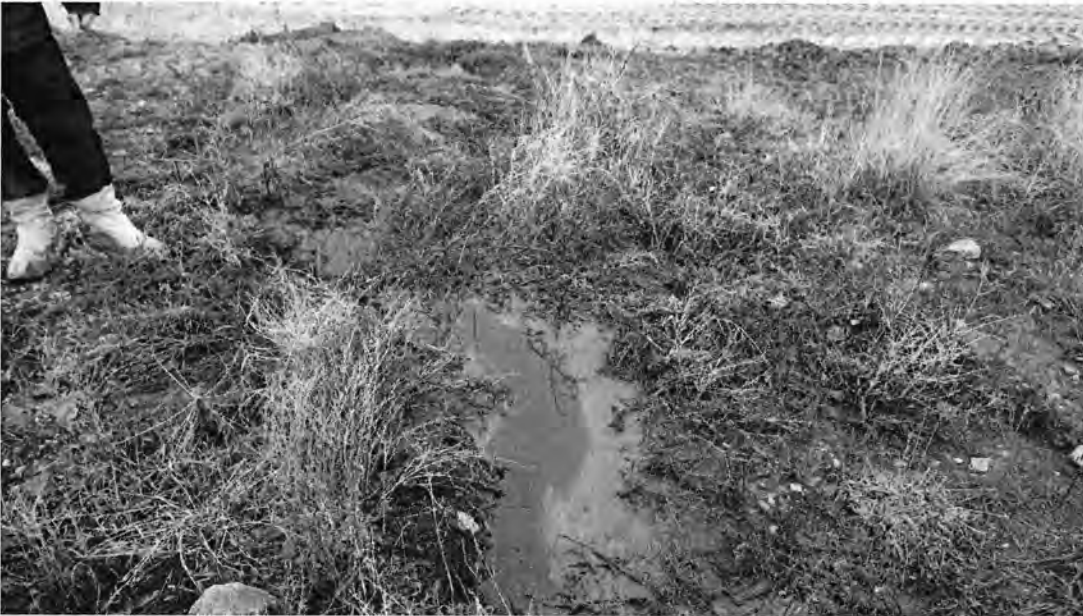
232: RIMG0241

Description: Manure and process wastewater flowed north toward the borrow area from the New Barn and cattle walkways between the New Barn and the barn west of the New Barn.

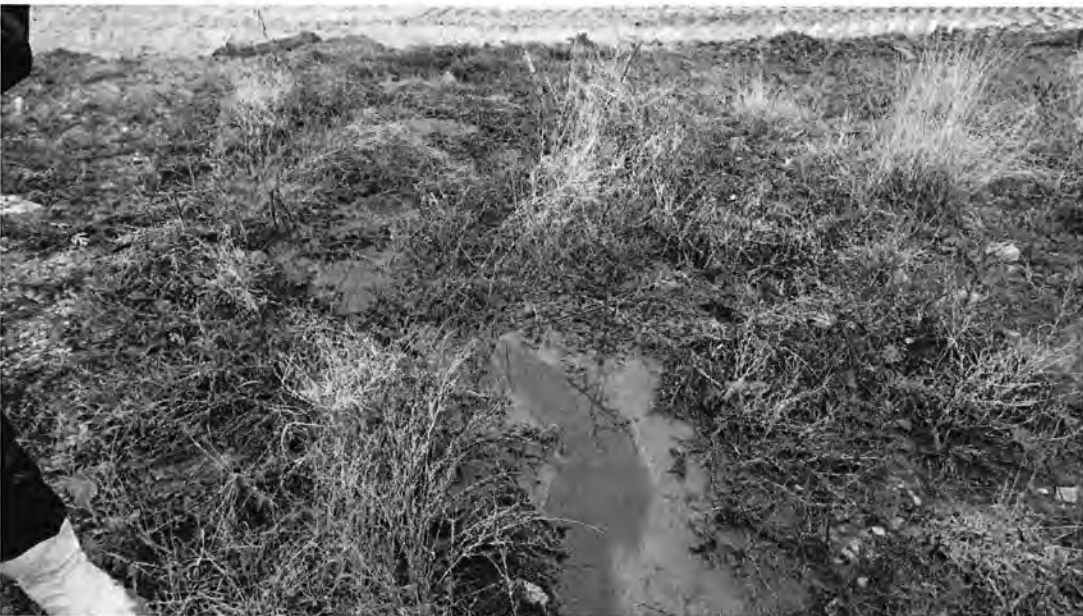
233: RIMG0242

Description: Manure and process wastewater flowed north toward the borrow area from the New Barn and cattle walkways between the New Barn and the barn west of the New Barn.

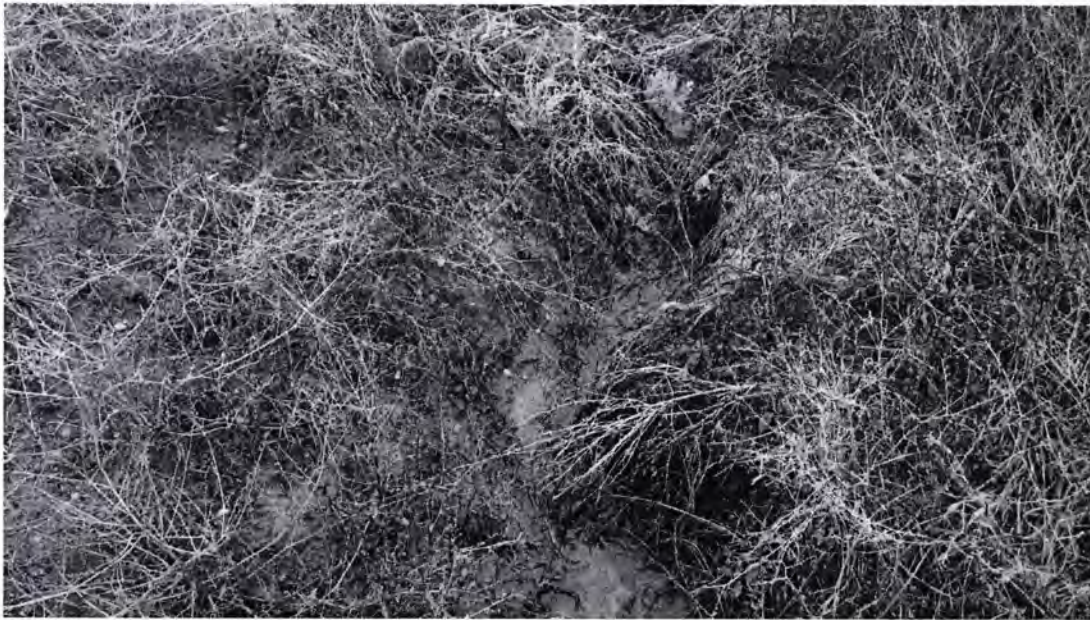
234: RIMG0243

Description: Manure and process wastewater flowed north toward the borrow area from the New Barn and cattle walkways between the New Barn and the barn west of the New Barn.

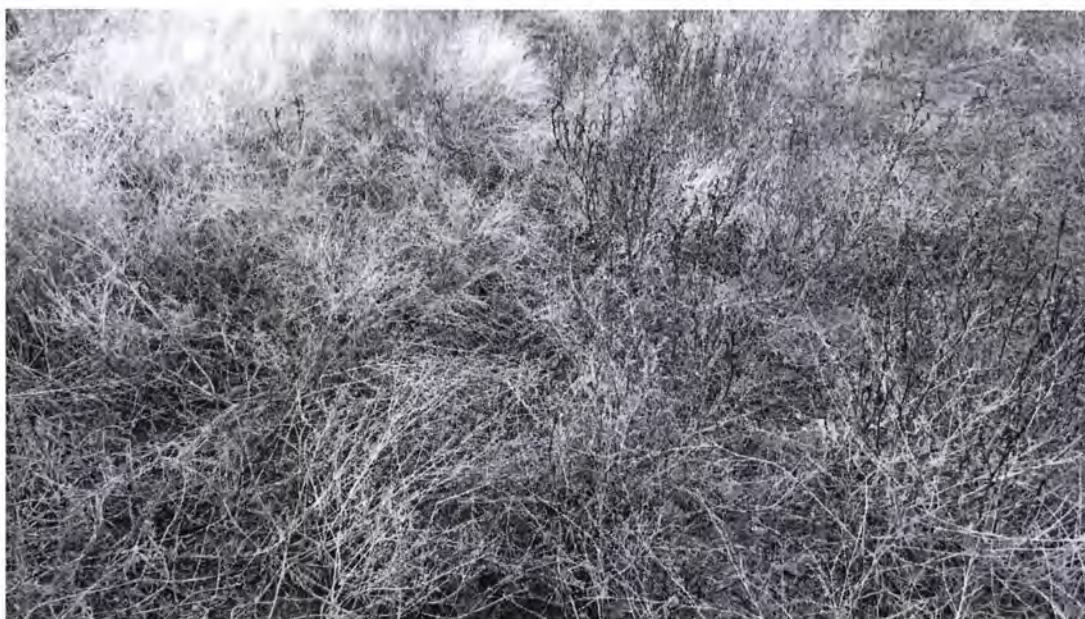
236: RIMG0245

Description: Manure and process wastewater flowed north toward the borrow area from the New Barn and cattle walkways between the New Barn and the barn west of the New Barn.

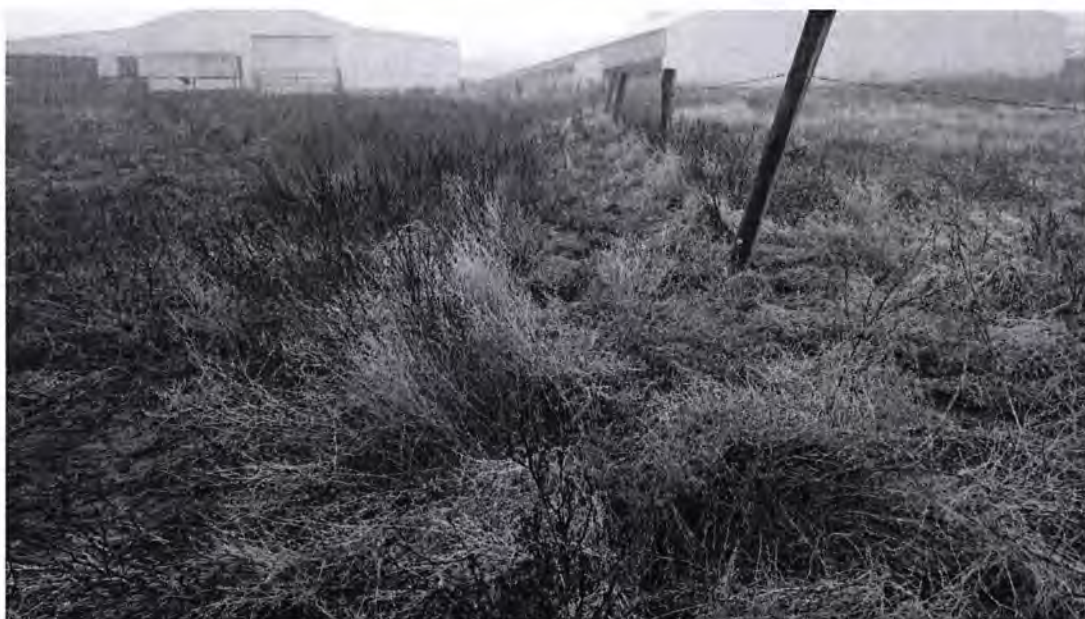
237: RIMG0246

Description: Manure and process wastewater flowed north toward the borrow area from the New Barn and cattle walkways between the New Barn and the barn west of the New Barn.

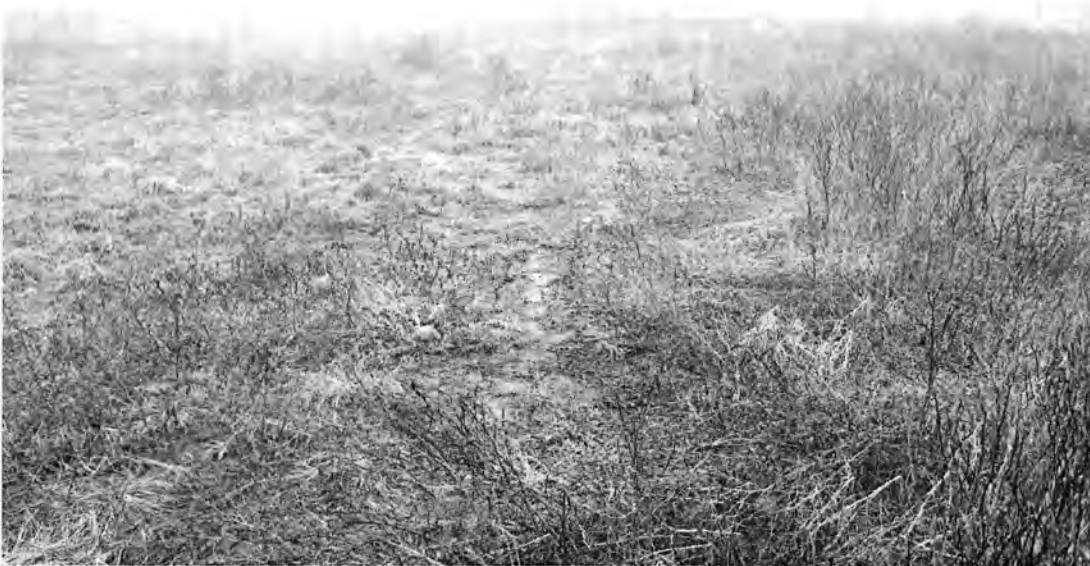
239: RIMG0248

Description: Manure and process wastewater flowed north toward the borrow area from the New Barn and cattle walkways between the New Barn and the barn west of the New Barn.

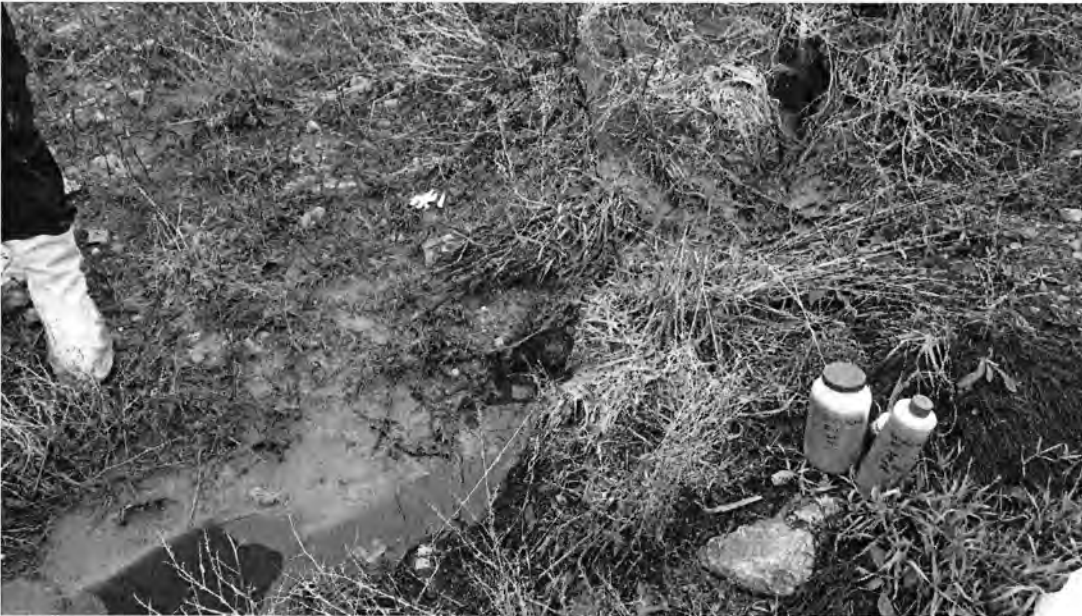
240: RIMG0249

Description: Manure and process wastewater flowed north toward the borrow area from the New Barn and cattle walkways between the New Barn and the barn west of the New Barn.

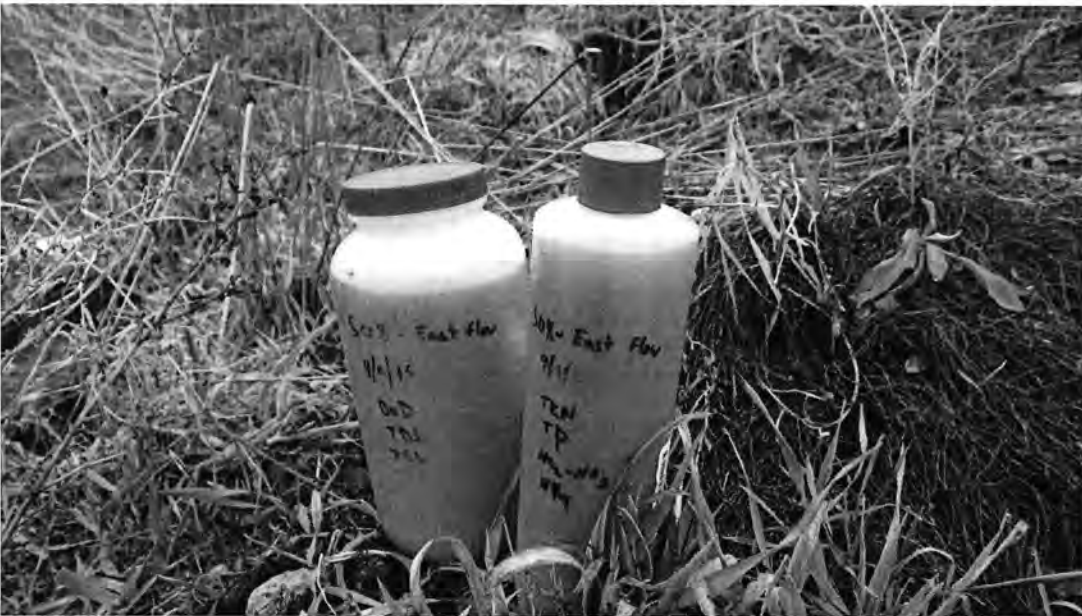
241: RIMG0250

Description: Sample S08 was taken at 1:12 p.m. of manure and process wastewater in a pathway emanating from the New Barn and cattle walkways between the New Barn and the barn west of the New Barn.
