State of Wisconsin | DEPARTMENT OF NATURAL RESOURCES

Subject: **Notice of Violation - Chapter 283, Wis. Statutes  
Enforcement Conference - March 9, 2009**

### **3. POTENTIAL VIOLATIONS**

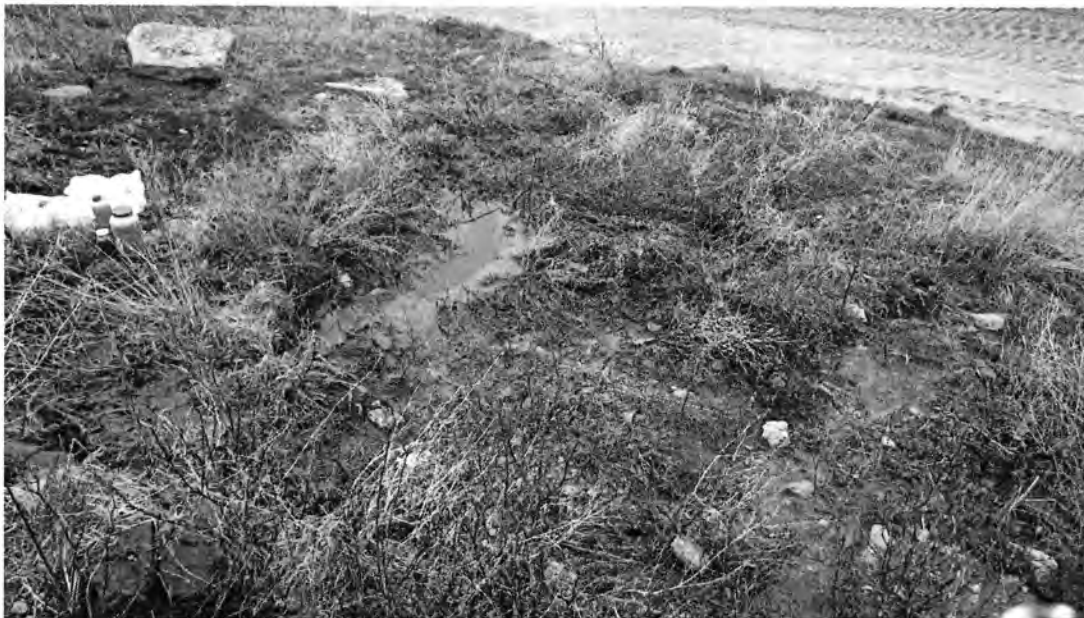
242: RIMG0251

Description: Sample S08 was taken at 1:12 p.m. of manure and process wastewater in a pathway emanating from the New Barn and cattle walkways between the New Barn and the barn west of the New Barn.

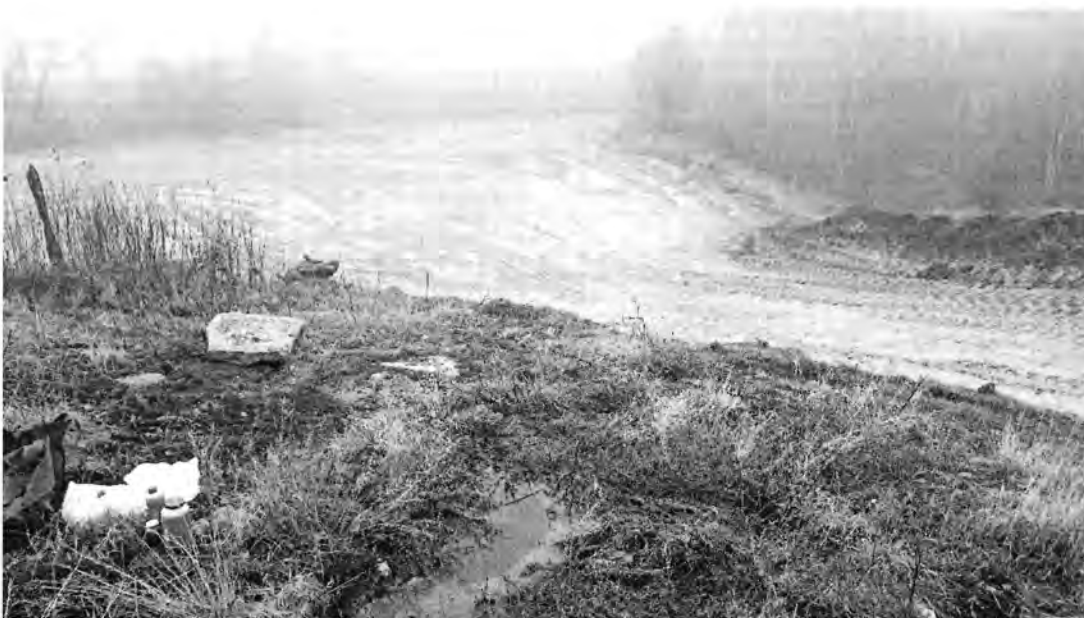
243: RIMG0252

Description: Sample S08 was taken at 1:12 p.m. of manure and process wastewater in a pathway emanating from the New Barn and cattle walkways between the New Barn and the barn west of the New Barn.

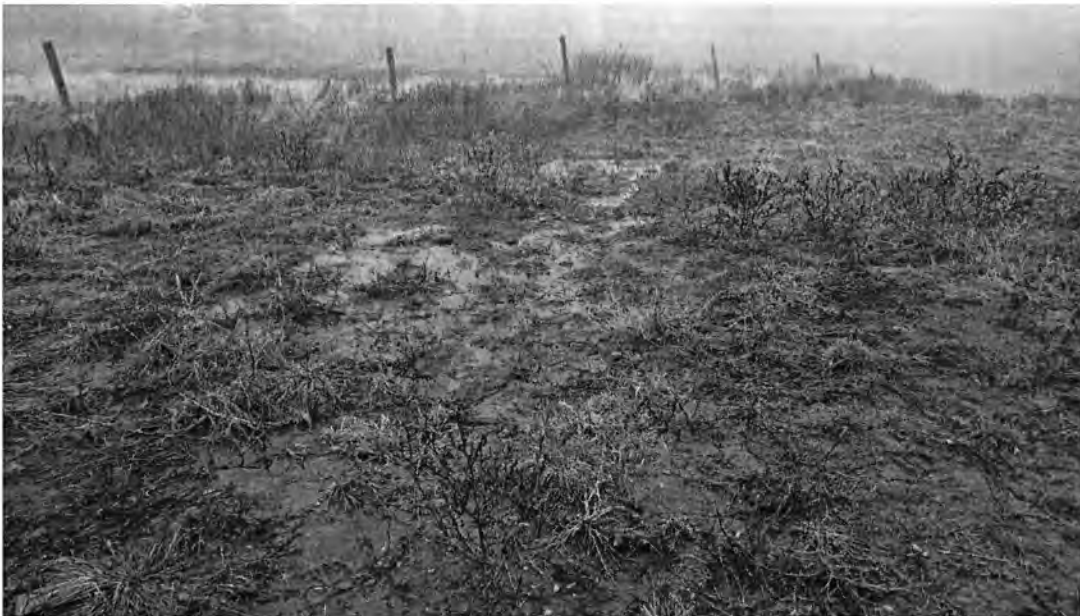
244: RIMG0253

Description: Sample S08 was taken at 1:12 p.m. of manure and process wastewater in a pathway emanating from the New Barn and cattle walkways between the New Barn and the barn west of the New Barn.

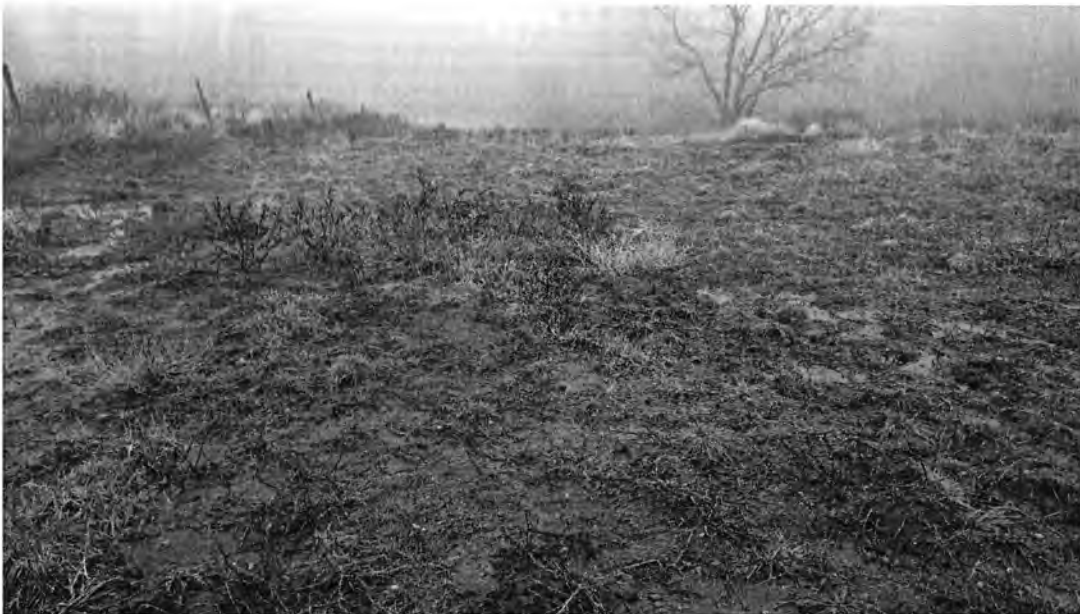
245: RIMG0254

Description: Manure and process wastewater flowed north toward the borrow area from the New Barn and cattle walkways between the New Barn and the barn west of the New Barn.

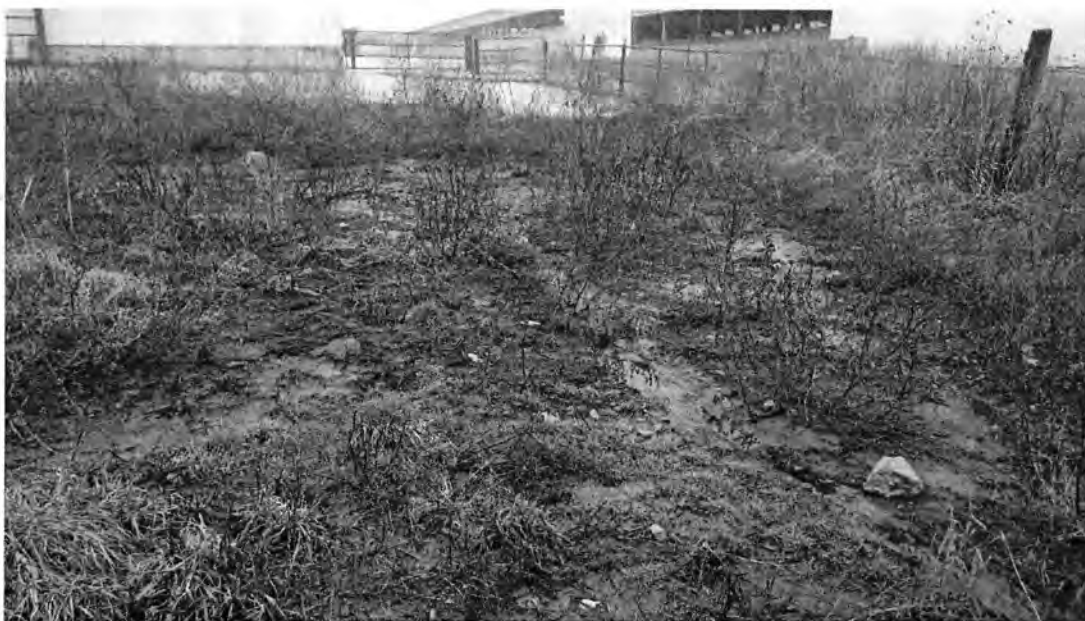
246: RIMG0255

Description: Manure and process wastewater flowed north toward the borrow area from the New Barn and cattle walkways between the New Barn and the barn west of the New Barn.

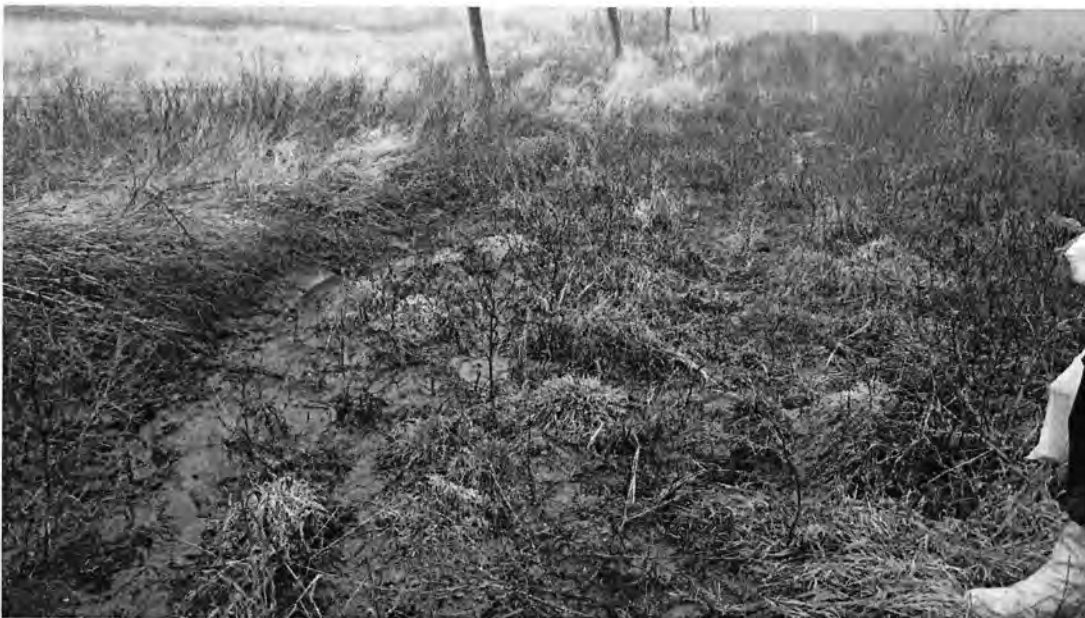
247: RIMG0256

Description: Manure and process wastewater flowed north toward the borrow area from the New Barn and cattle walkways between the New Barn and the barn west of the New Barn.

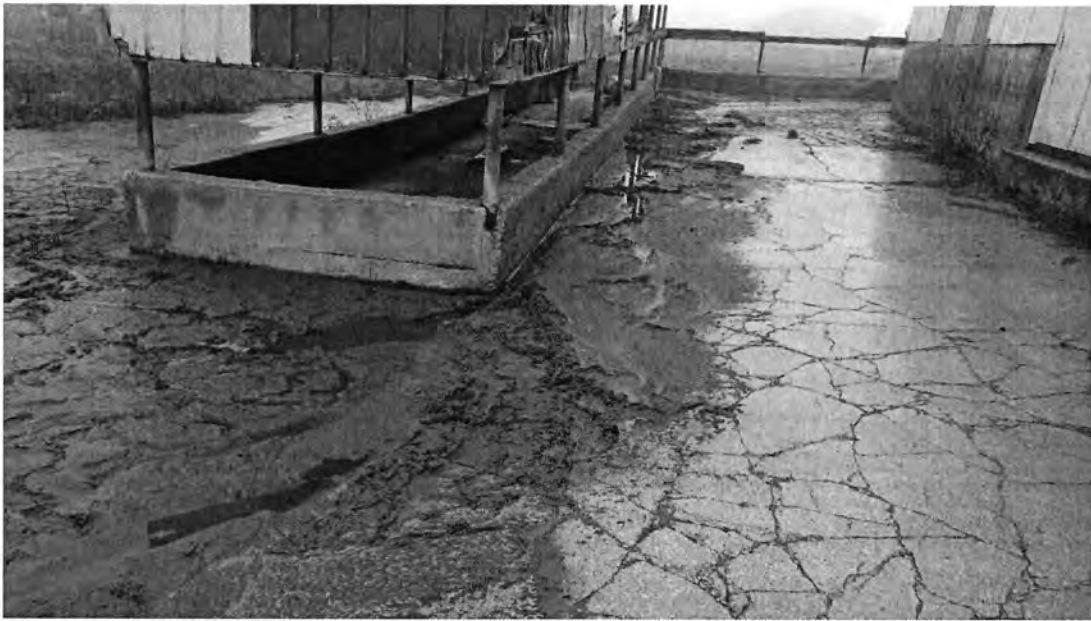
248: RIMG0257

Description: Manure and process wastewater flowed north toward the borrow area from the New Barn and cattle walkways between the New Barn and the barn west of the New Barn.

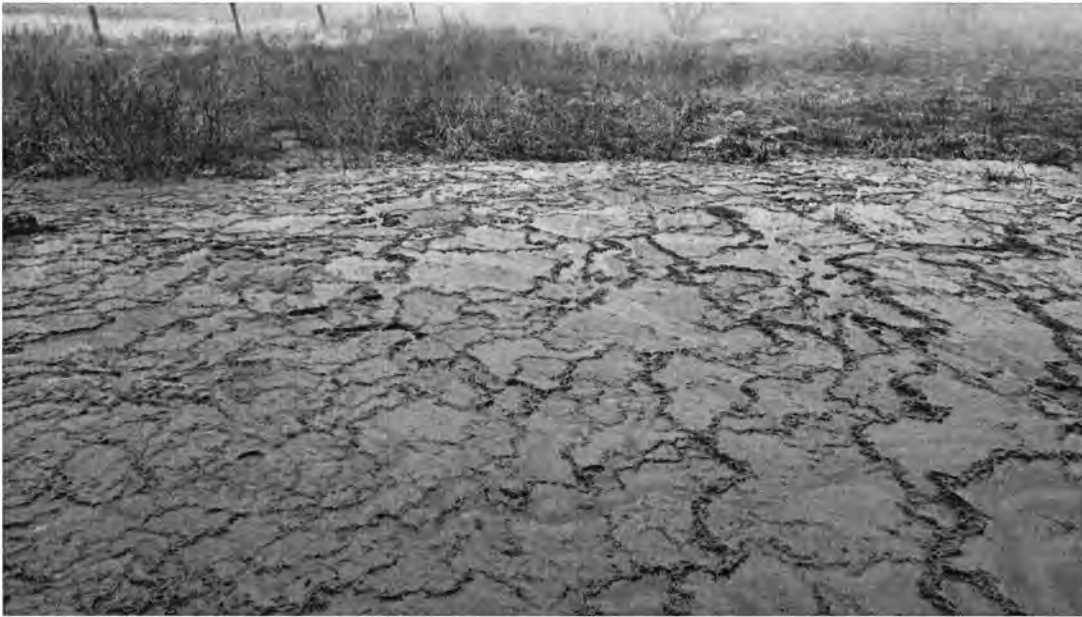
250: RIMG0259

Description: Manure and process wastewater flowed north toward the borrow area from the New Barn and cattle walkways between the New Barn and the barn west of the New Barn.

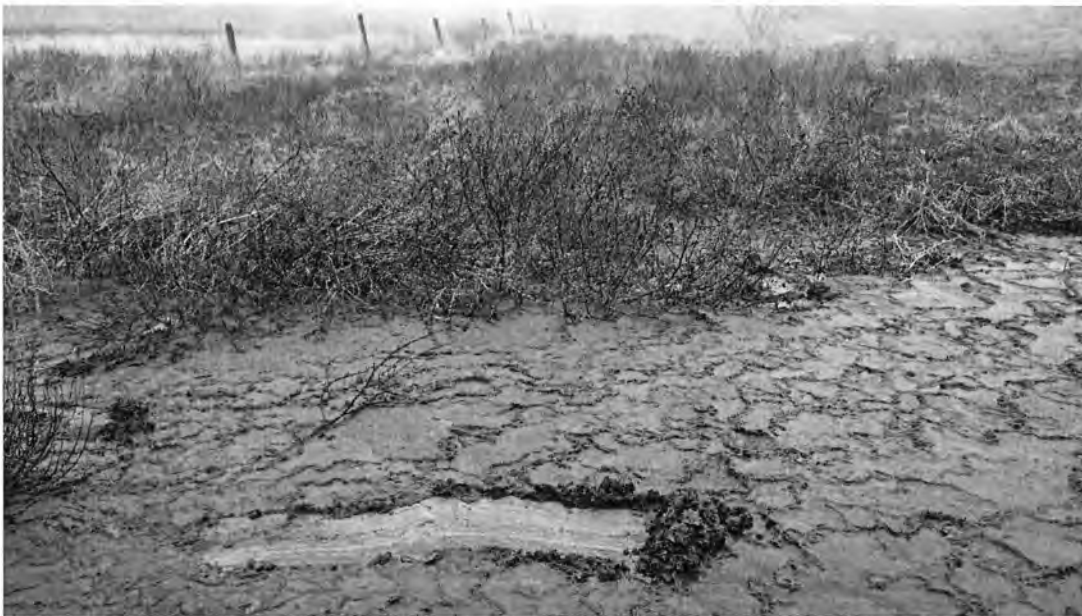
251: RIMG0260

Description: Manure and process wastewater flowed north toward the borrow area from the New Barn and cattle walkways between the New Barn and the barn west of the New Barn.

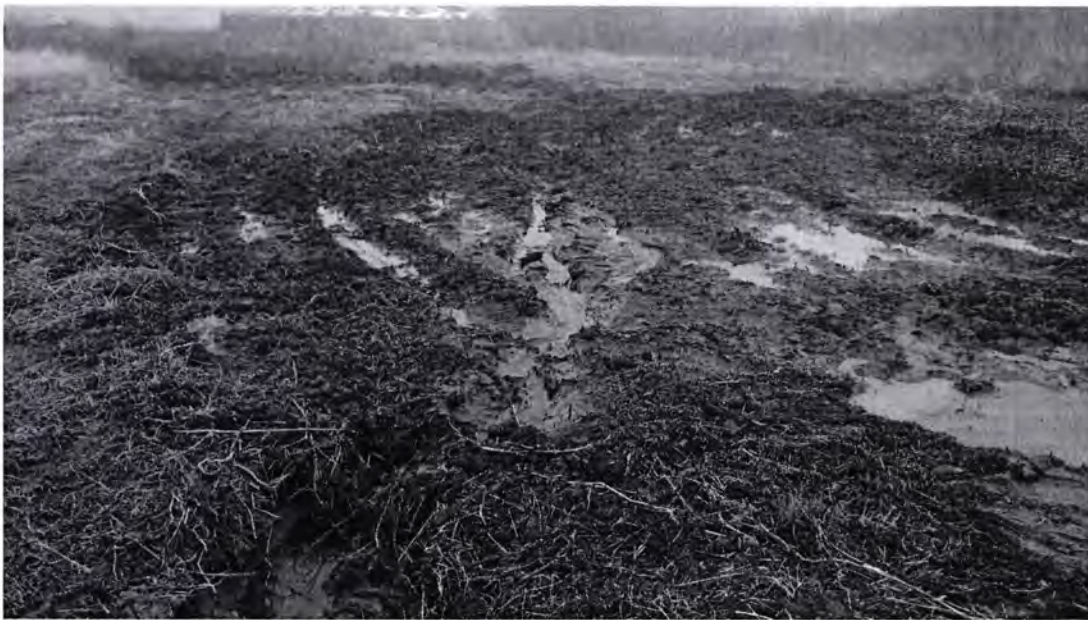
252: RIMG0261

Description: Manure and process wastewater flowed north toward the borrow area from the New Barn and cattle walkways between the New Barn and the barn west of the New Barn.

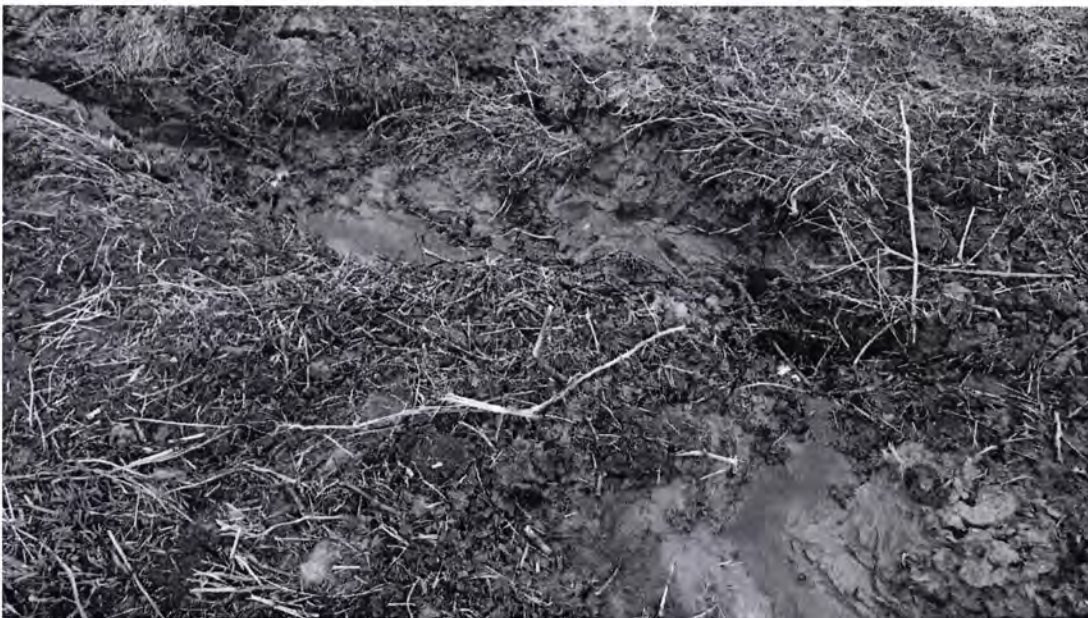
253: RIMG0262

Description: Manure and process wastewater flowed north through the borrow area from the Milk Cow Barn and the access way between the Milk Cow Barn and the feed bunkers.

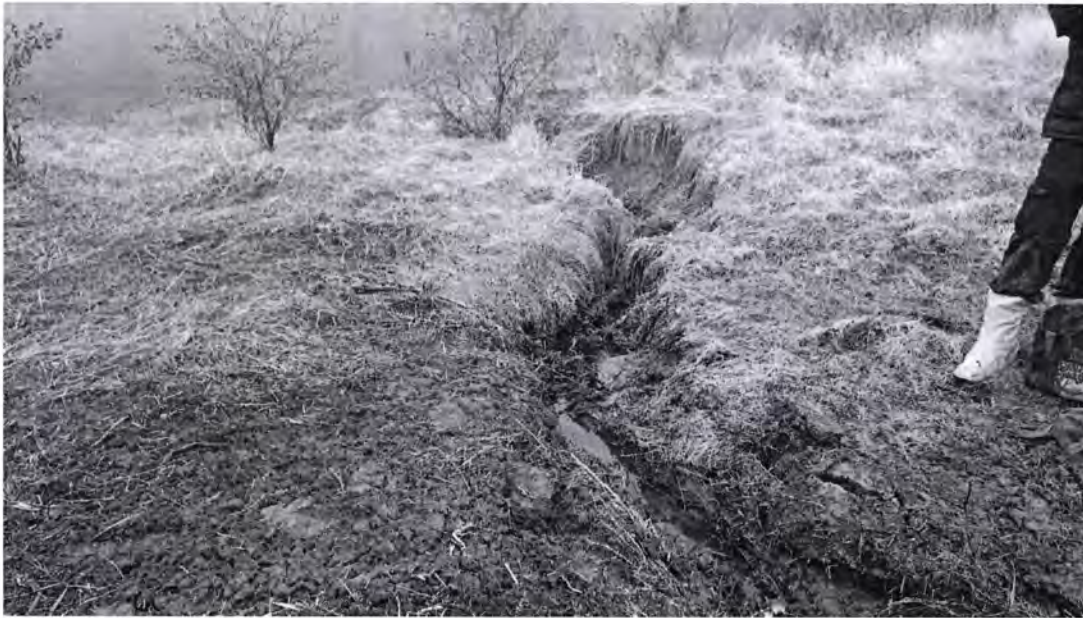
254: RIMG0263

Description: Manure and process wastewater flowed north through the borrow area from the Milk Cow Barn and the access way between the Milk Cow Barn and the feed bunkers.

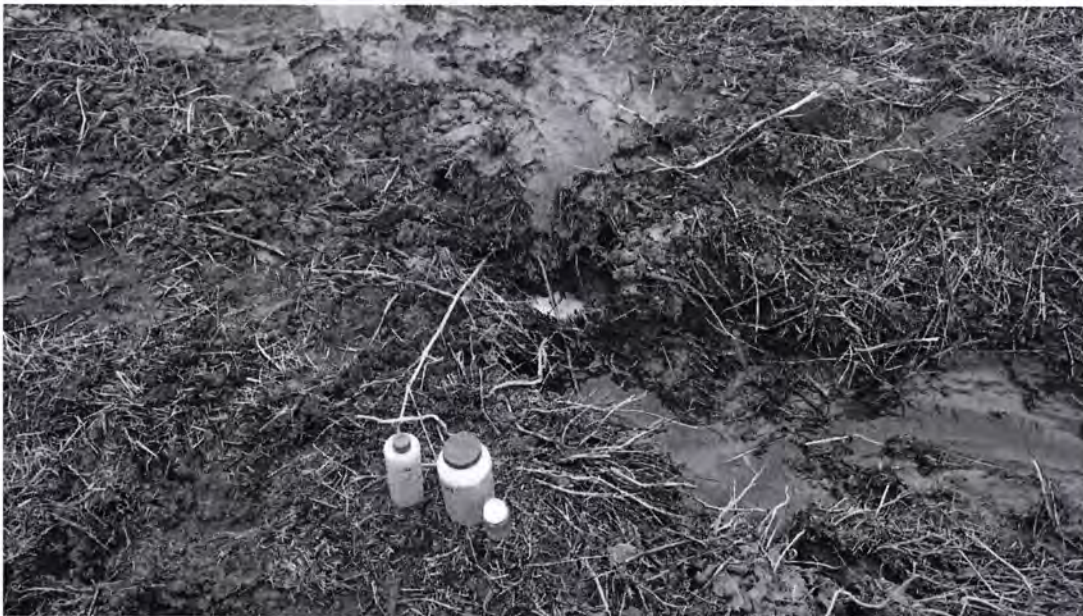
255: RIMG0264

Description: Manure and process wastewater flowed north through the borrow area from the Milk Cow Barn and the access way between the Milk Cow Barn and the feed bunkers.

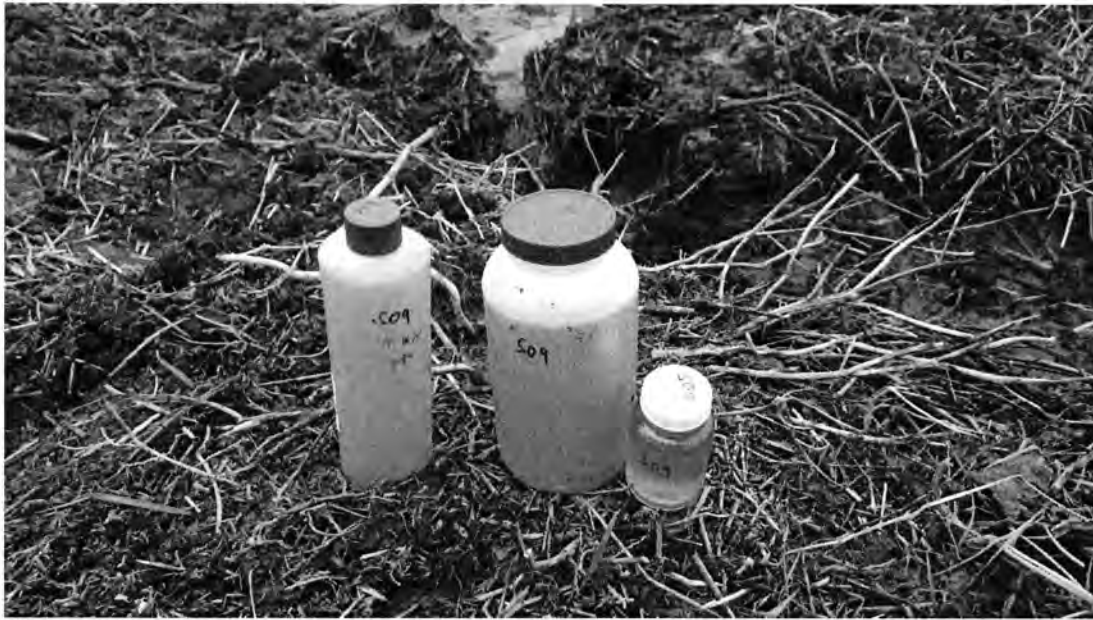
256: RIMG0265

Description: Sample S09 was taken at 1:20 p.m. of manure and process wastewater in a pathway emanating from the Milk Cow Barn and the access way between the Milk Cow Barn and the feed bunkers.

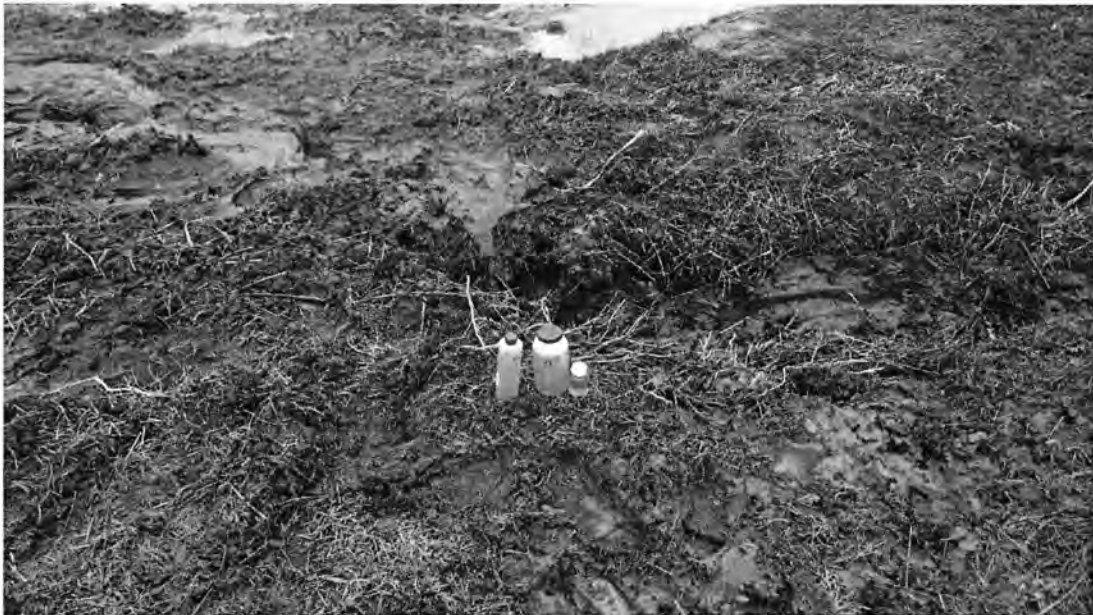
257: RIMG0266

Description: Sample S09 was taken at 1:20 p.m. of manure and process wastewater in a pathway emanating from the Milk Cow Barn and the access way between the Milk Cow Barn and the feed bunkers.

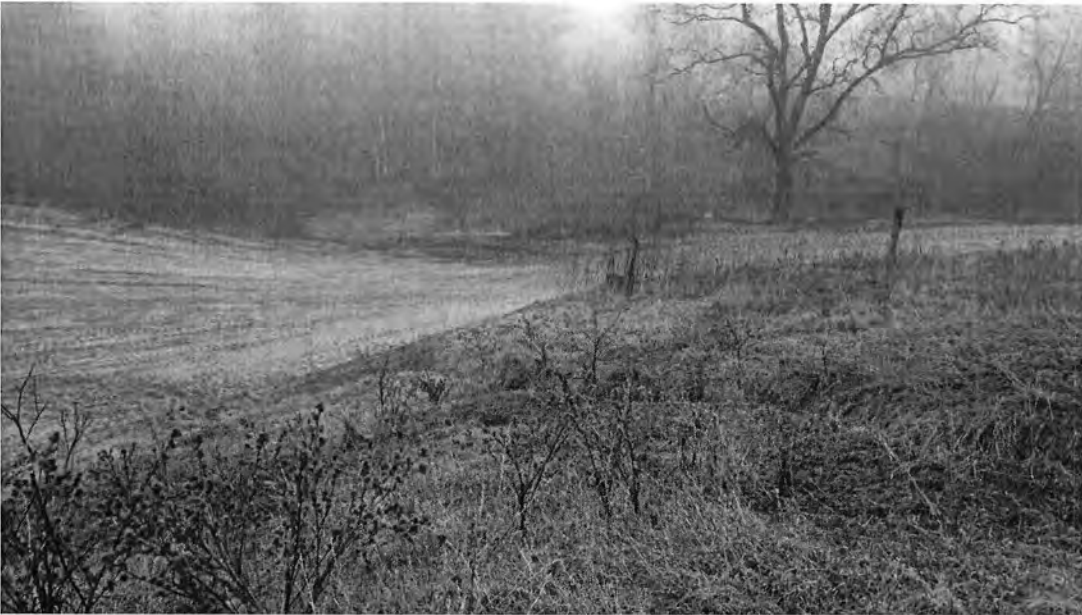
259: RIMG0268

Description: The borrow area did not have sediment and erosion controls installed.

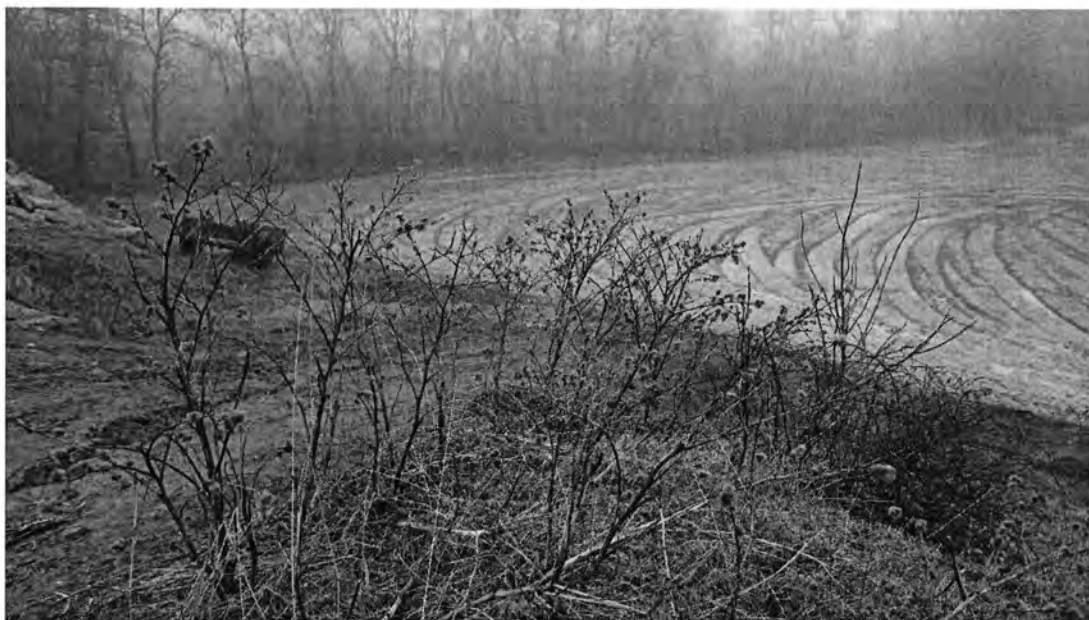
260: RIMG0269

Description: The borrow area did not have sediment and erosion controls installed.

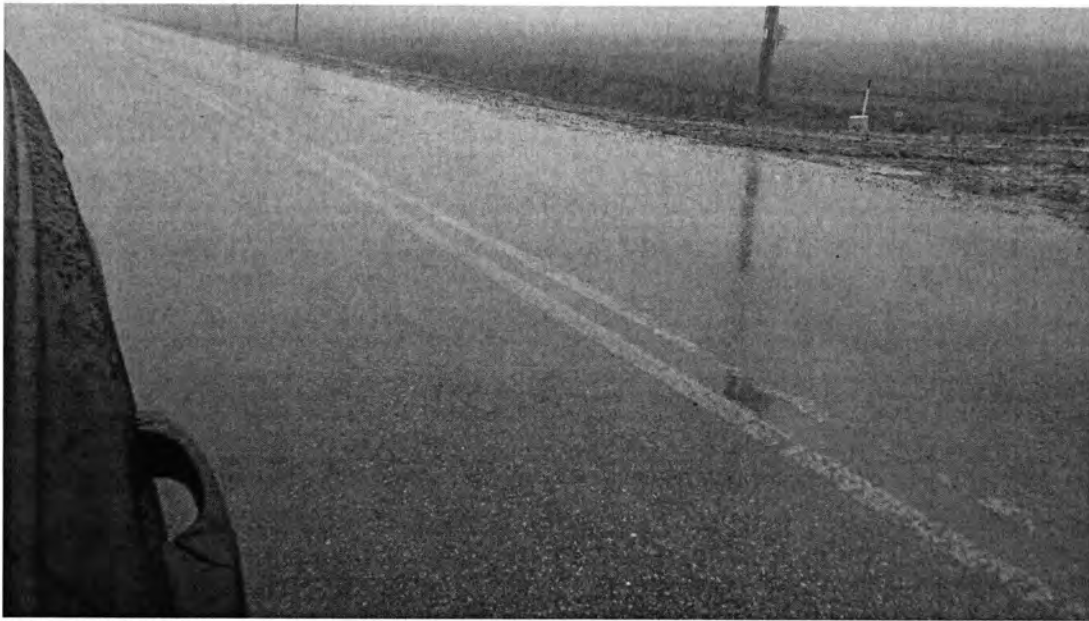
264: RIMG0273  
Description: Sediment had been tracked out onto the south bound lane of County Road V.

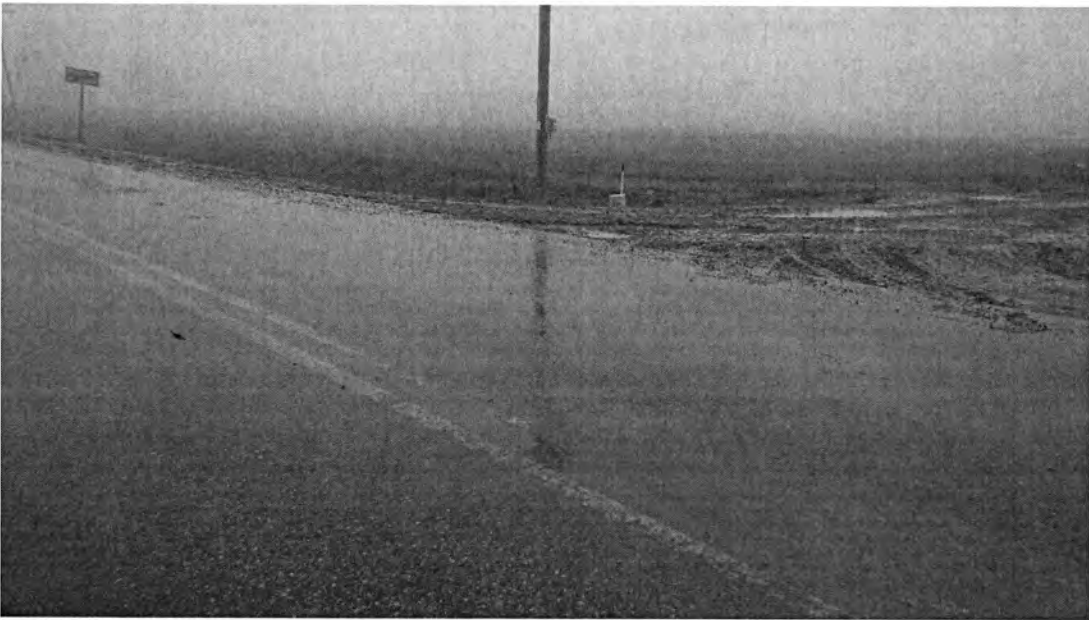
265: RIMG0274

Description: Sediment had been tracked out onto the south bound lane of County Road V.

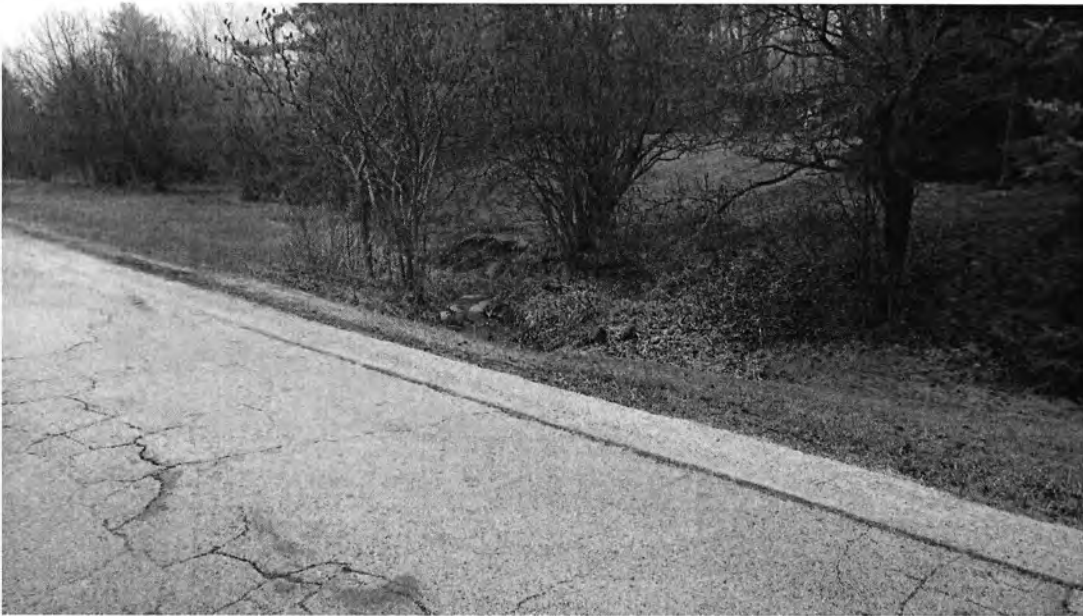
267: RIMG0276

Description: Sediment had been tracked out onto the south bound lane of County Road V.

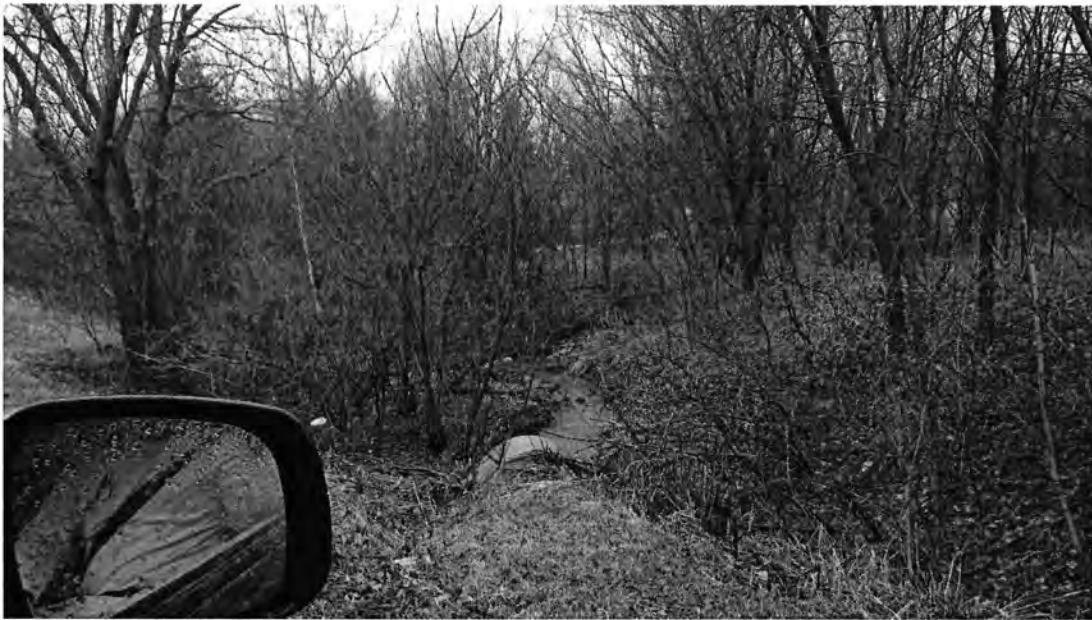
268: RIMG0277

Description: The unnamed tributary had a bed and bank and flow was conveyed via a large culvert under Dollar Road.

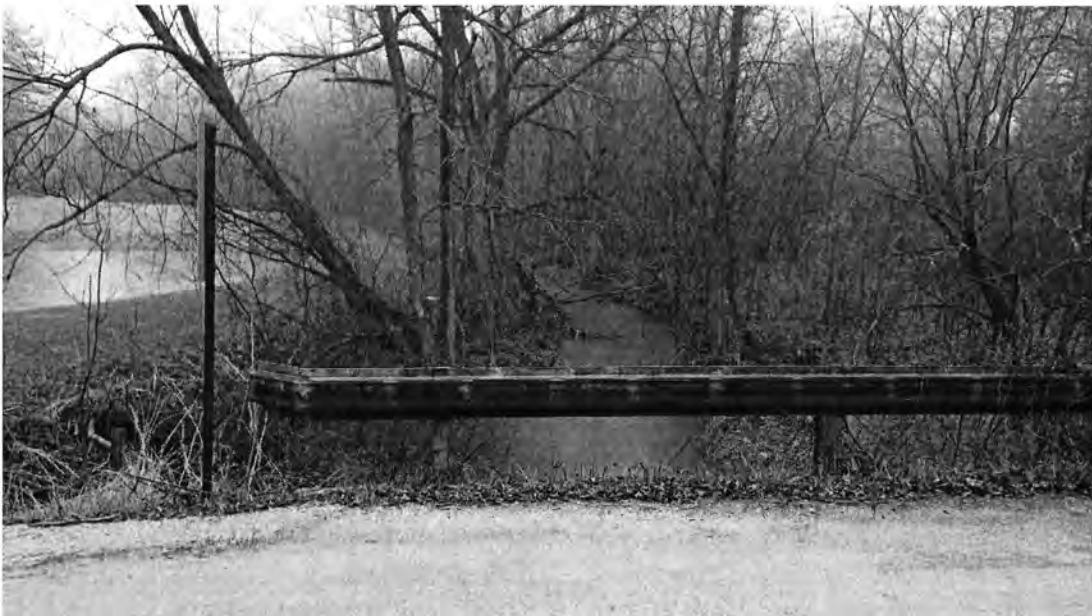
269: RIMG0278

Description: The unnamed tributary had a bed and bank and flow was conveyed via a large culvert under Dollar Road.

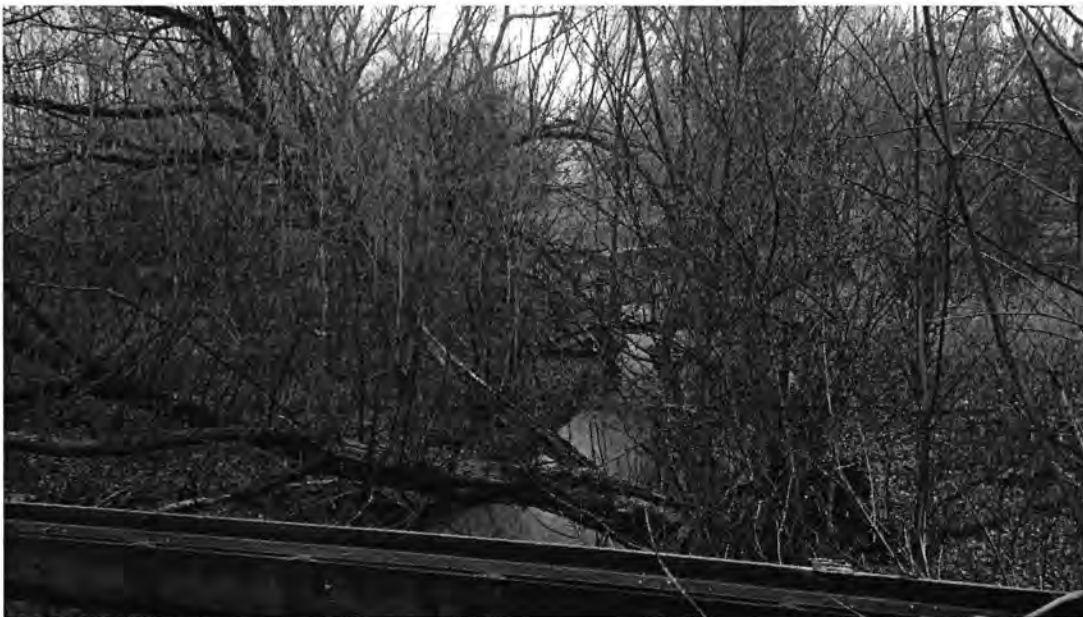
270: RIMG0279

Description: The unnamed tributary had a bed and bank and flow was conveyed under Dollar Road.

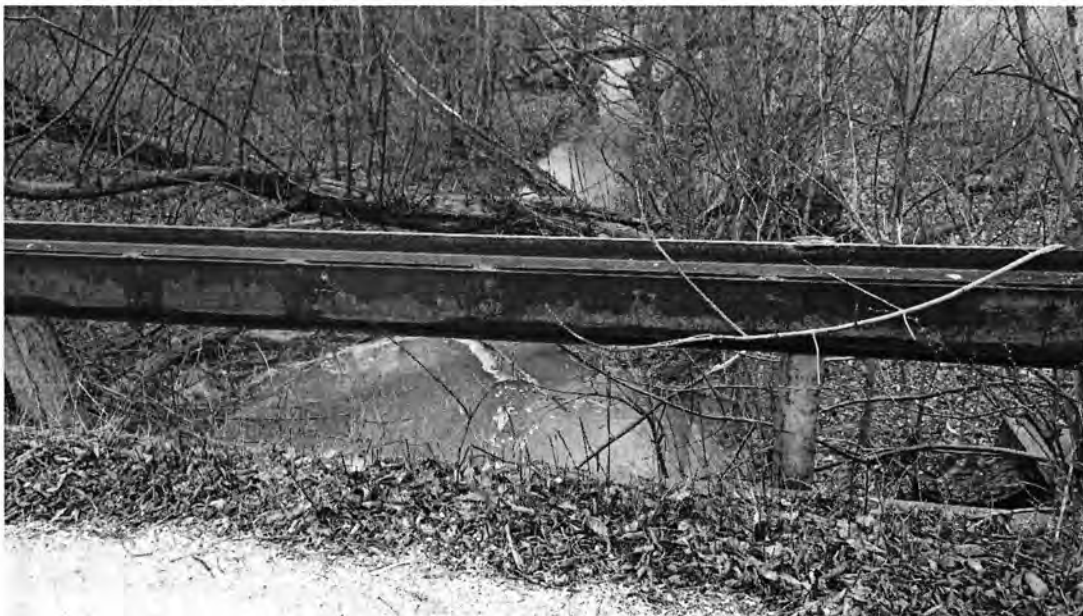
271: RIMG0280

Description: The unnamed tributary had a bed and bank and flow was conveyed under Dollar Road.

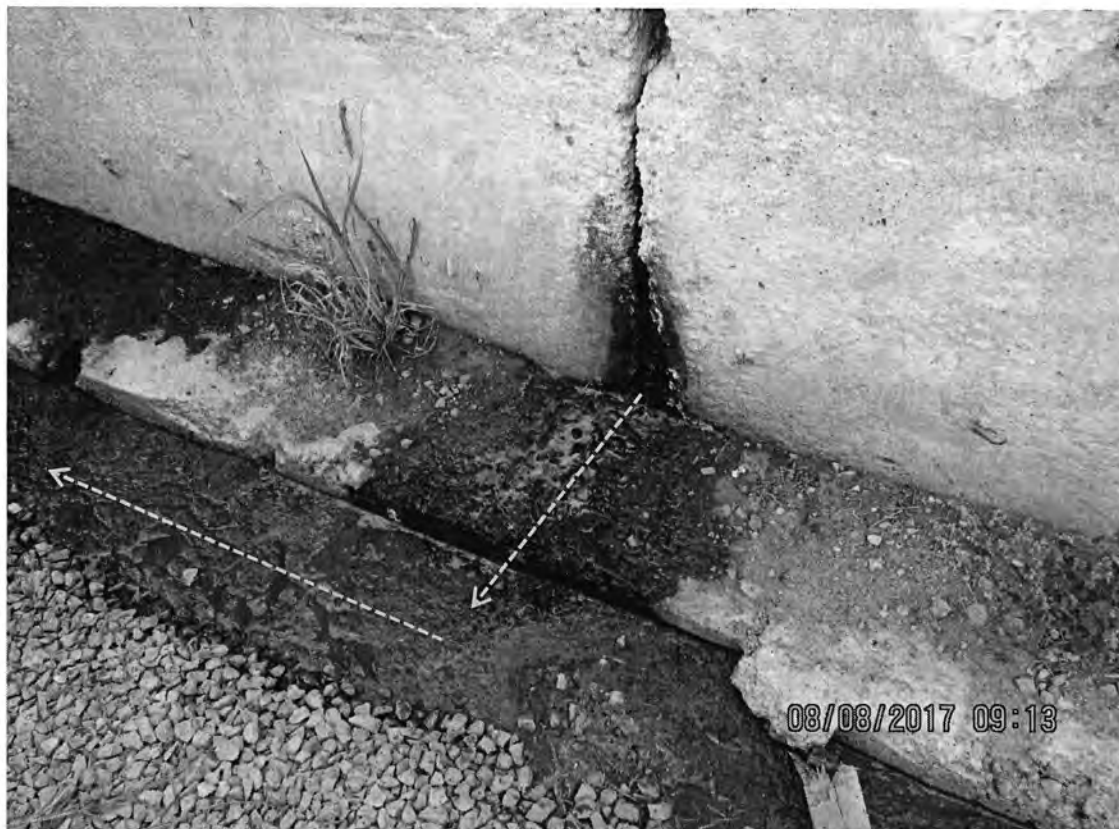
**Photo 1:** View of a discharge point of leachate / process wastewater on the outer west wall of the feed storage bunker at the heifer site. Dashed orange arrows indicate the direction of discharge flow. Photo direction is down.

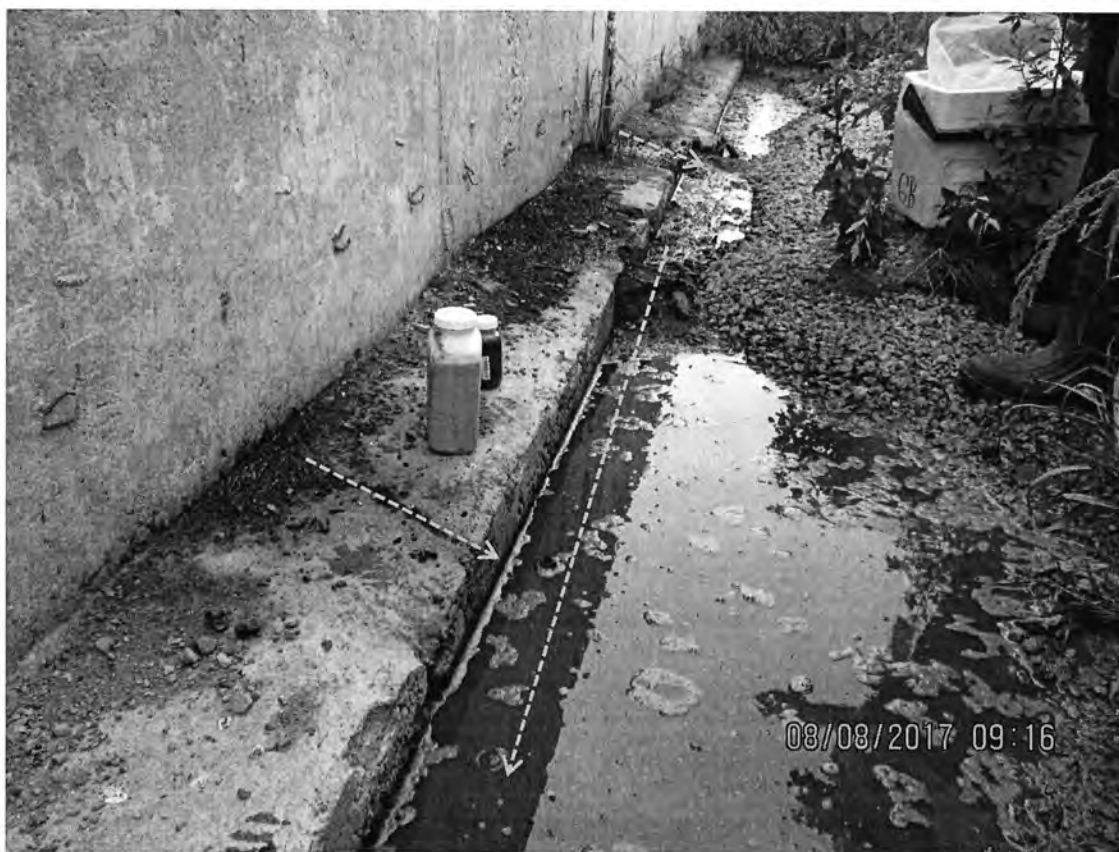
**Photo 2:** View of discharge points of leachate / process wastewater on the outer west wall of the feed storage bunker at the heifer site. Samples (LD1) were collected from the ponded wastewater adjacent to the location of the bottles. Dashed orange arrows indicate the direction of discharge flow. Photo direction is south and down.

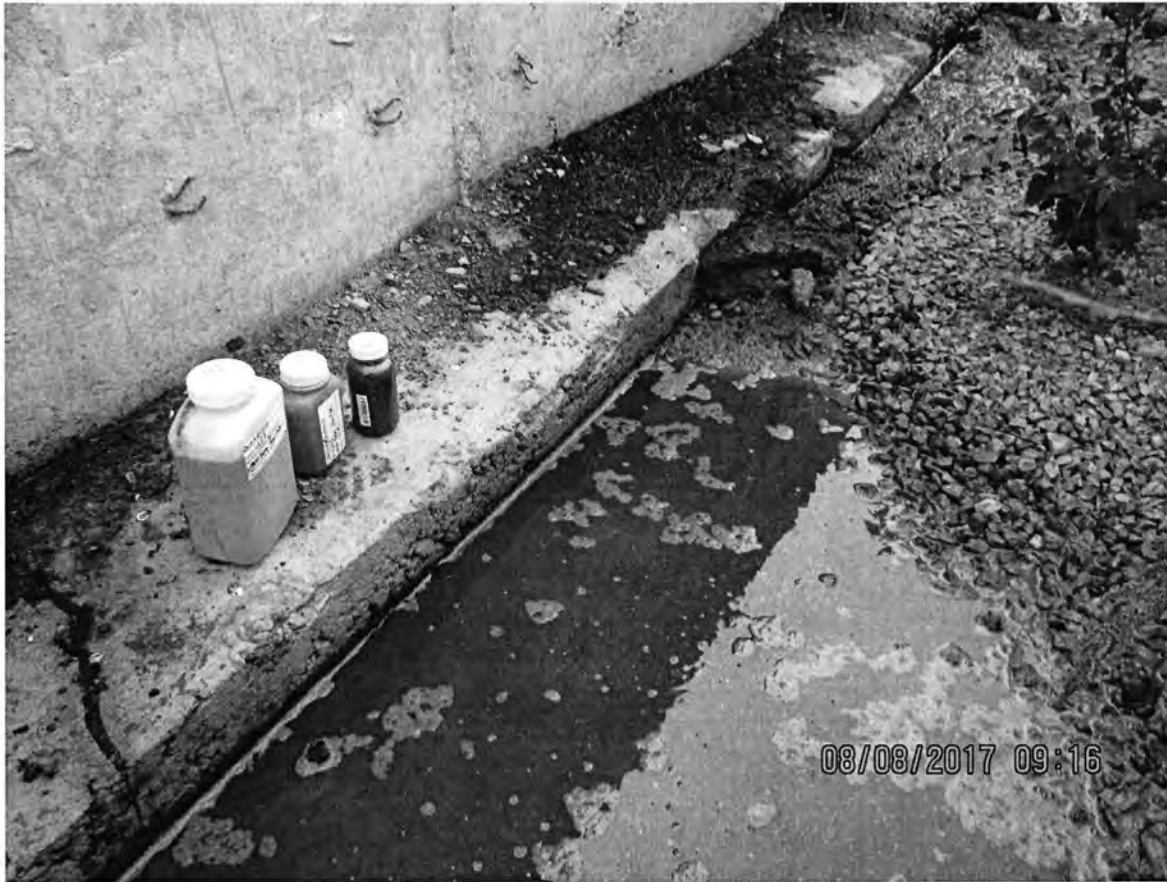
**Photo 2:** Close up view of the location of sample collection along the outer west wall of the feed storage bunker at the heifer site. Samples (LD1) were collected from the ponded wastewater adjacent to the location of the bottles. Photo direction is down.

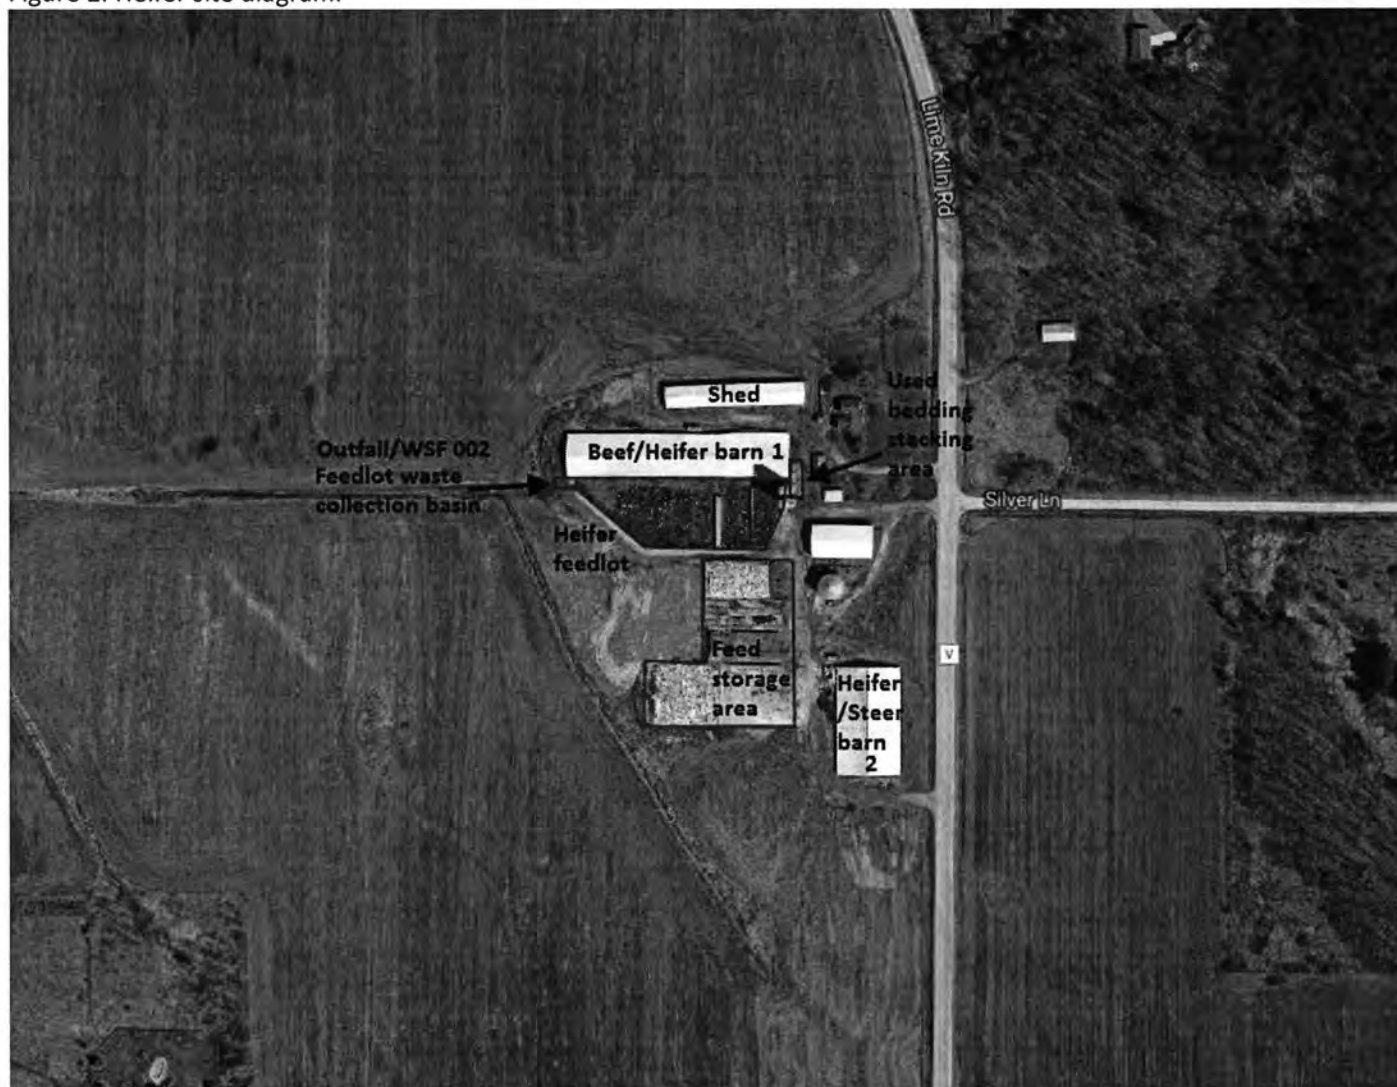
Figure 2. Heifer site diagram.

Figure 2 is a site diagram of the heifer site, which is located approximately 0.7 miles north and slightly east of the main farm on Lime Kiln Rd/Cty Rd V. Heifers are raised at this site as well as beef animals. No milking occurs at this site. Two heifer/steer barns, concrete feedlot, and the feed storage area are located at the heifer site. The feedlot drains to an aboveground concrete collection basin on the west end of the feedlot. Storm water is diverted from the feedlot by roof gutters on the barn that discharge to the fields west of the barn. A residence onsite was vacant at the time of the inspection with no plans for further use. There is a well associated with the residence. Ledgeview has discussed the possibility of abandoning the well at the residence but that has not been done as of the date of this report.
