State of Wisconsin | DEPARTMENT OF NATURAL RESOURCES

Subject: **Notice of Violation - Chapter 283, Wis. Statutes  
Enforcement Conference - March 9, 2009**

### **3. POTENTIAL VIOLATIONS**

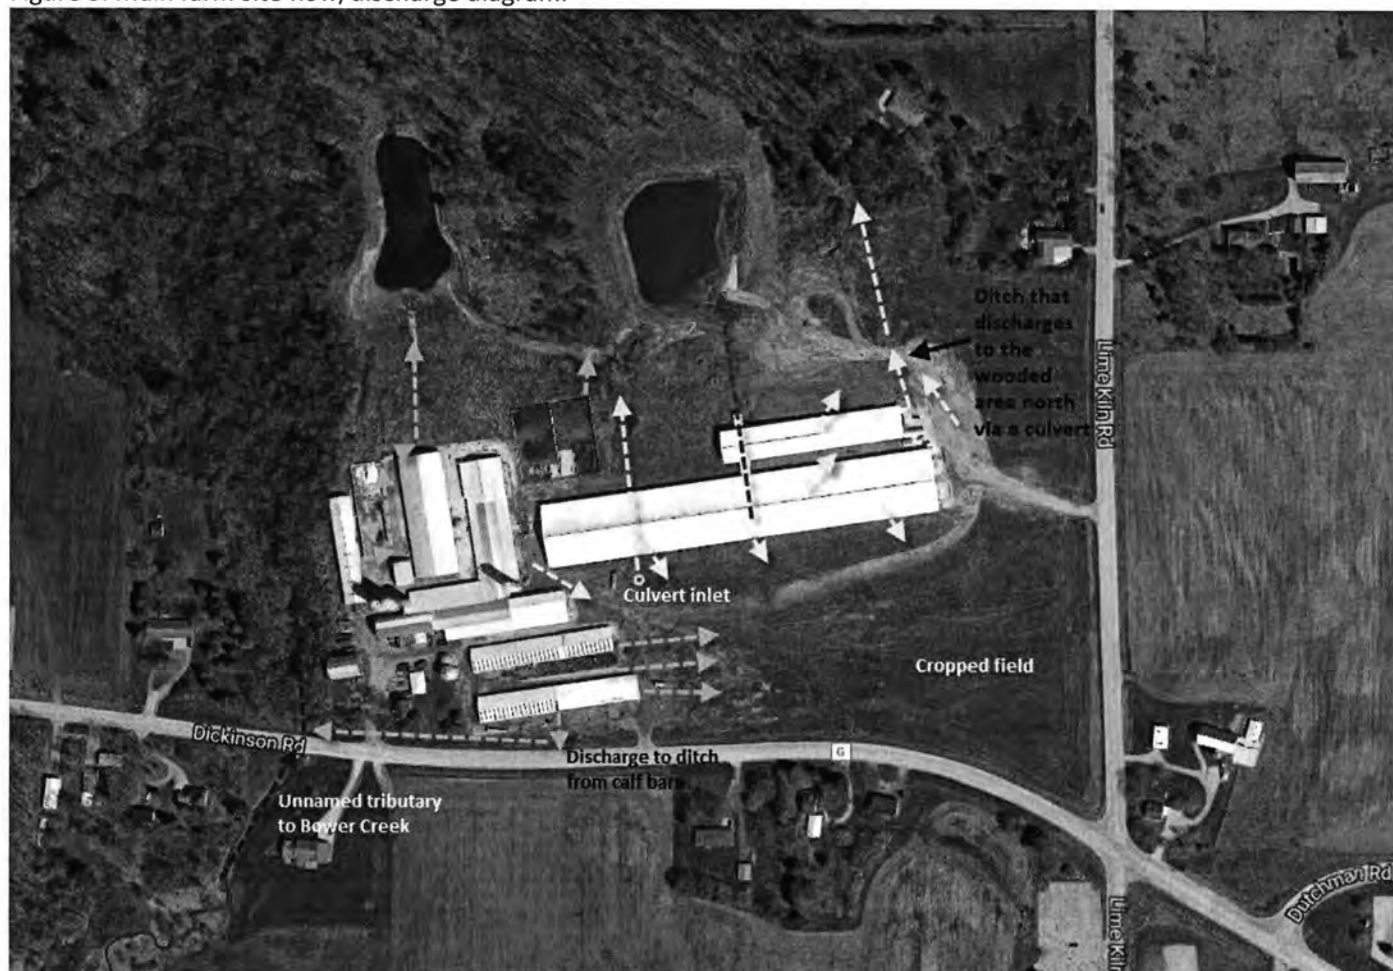
Figure 3. Main farm site flow/discharge diagram.

Figure 3 shows the discharge flow paths from the main farm site. The orange dashed arrows represent the flow path of animal waste and process wastewater. The dashed yellow arrows represent the flow path of uncontaminated storm water onsite. The majority of storm water from the building roofs discharges to vegetated areas adjacent to the buildings and infiltrates to groundwater. These areas are maintained to remain vegetated to facilitate infiltration. The red dashed arrow represents the manure transfer system that discharges manure from the freestall barn and process wastewater from the milking parlor directly to WSF 001. The blue dashed arrows indicate the location of and flow direction of mapped water resources near the farm site.

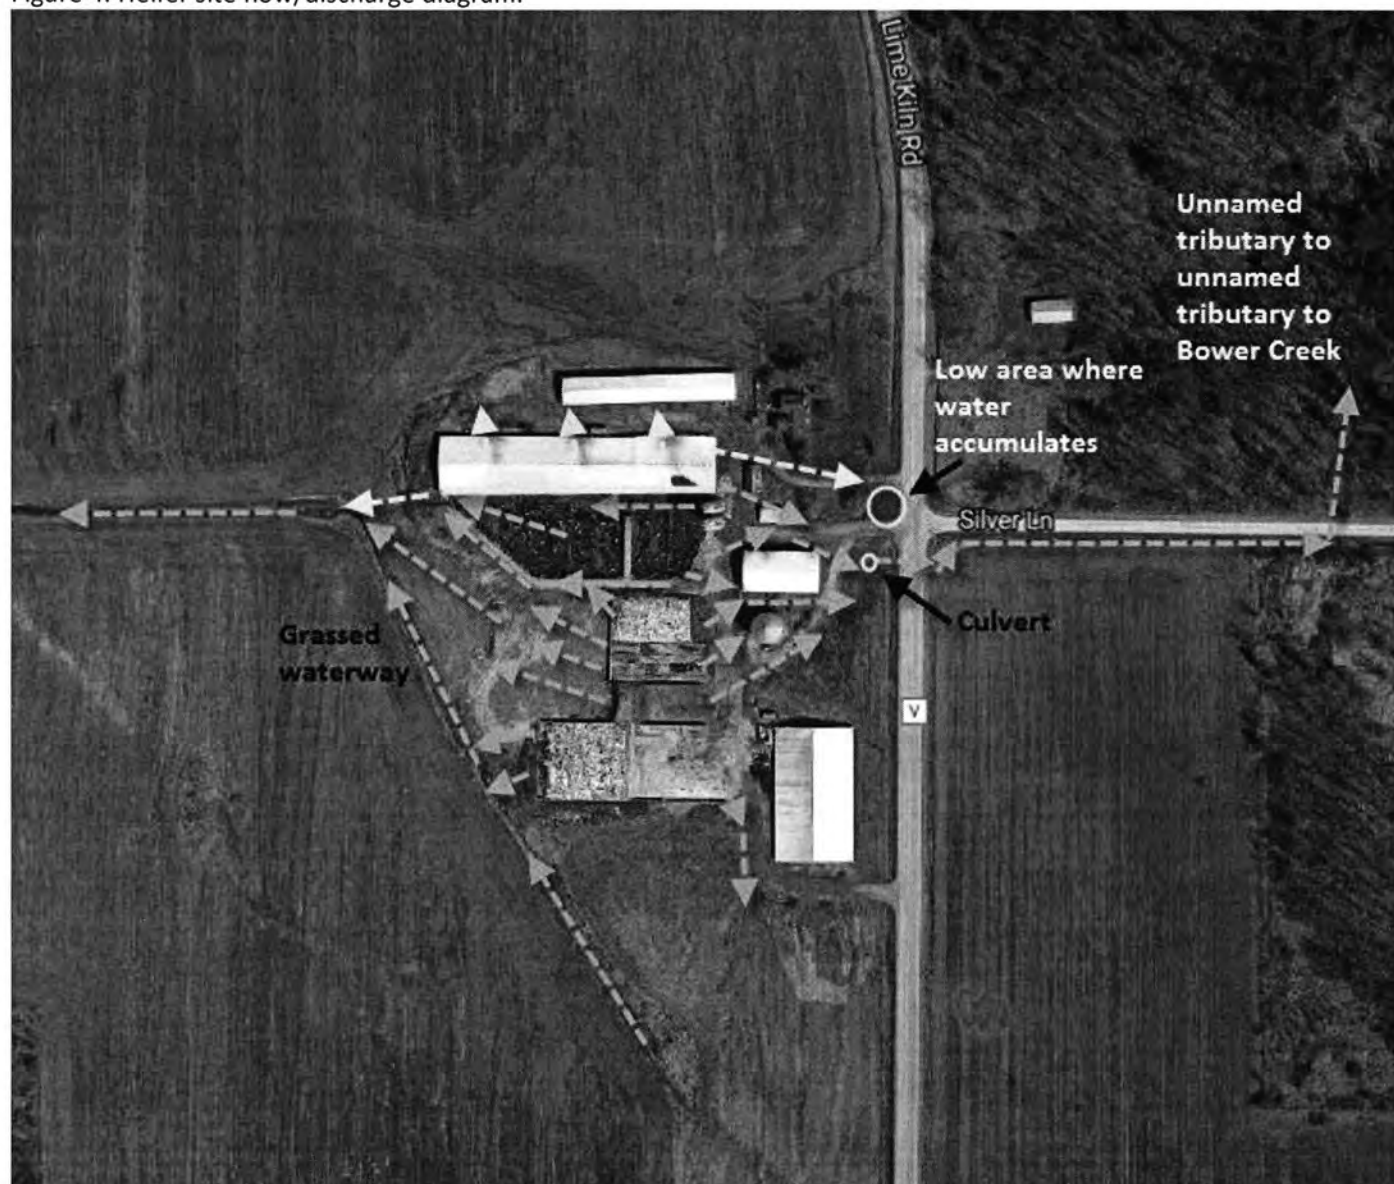
Figure 4. Heifer site flow/discharge diagram.

Figure 4 shows the discharge flow paths from the heifer site. The orange dashed arrows represent the flow path of animal waste and process wastewater. The yellow solid line represents the roof gutters on the south side of the barn that collect uncontaminated storm water, and the yellow dashed arrows represent the flow path of uncontaminated storm water. Storm water from the gutters discharges to the agricultural field west of the barn and feedlot where a grassed waterway is located. Storm water from the north side of the barn roof discharges to a vegetated area adjacent to the barn and infiltrates to groundwater. Storm water from the northeast part of the roof discharges through the site east toward a low area adjacent to a driveway and Lime Kiln Rd. It does not appear that there is a discharge outlet from this ponded area to surface waters. The green dashed arrows indicate the presence of a grassed waterway and the direction of flow in the waterway.

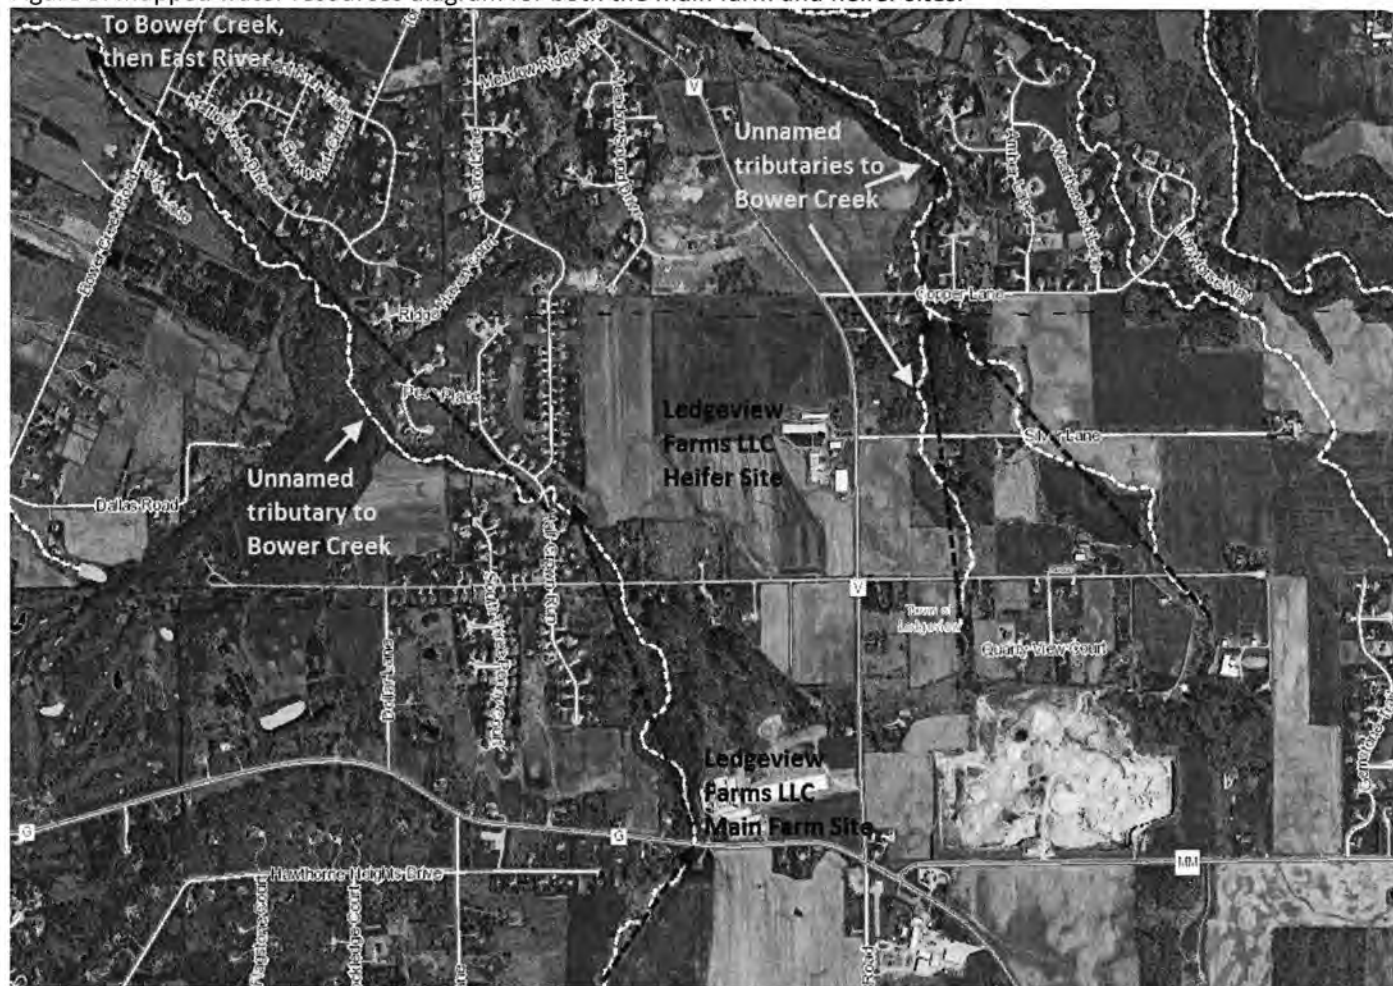
Figure 5. Mapped water resources diagram for both the main farm and heifer sites.

Figure 5 shows the water resources flow diagram from the Department's Surface Water Data Viewer (SWDV) for both the main farm and heifer sites in relation to the mapped waterways around Ledgeview. The white dashed lines indicate intermittent waterways mapped in SWDV. The blue dashed arrows were added to the SWDV map and represent the flow direction of the mapped waterways in the watershed. There are unnamed tributaries in close proximity (within 0.2 miles) to both sites in addition to numerous ditches and grassed waterways that connect the surrounding land area to those tributaries. The unnamed tributaries identified in Figure 5 are tributaries to Bower Creek (WBIC 118400), which is a tributary to the East River (WBIC 118000), which is a tributary to the Fox River (WBIC 117900), which discharges into Green Bay/Lake Michigan (WBIC 20).

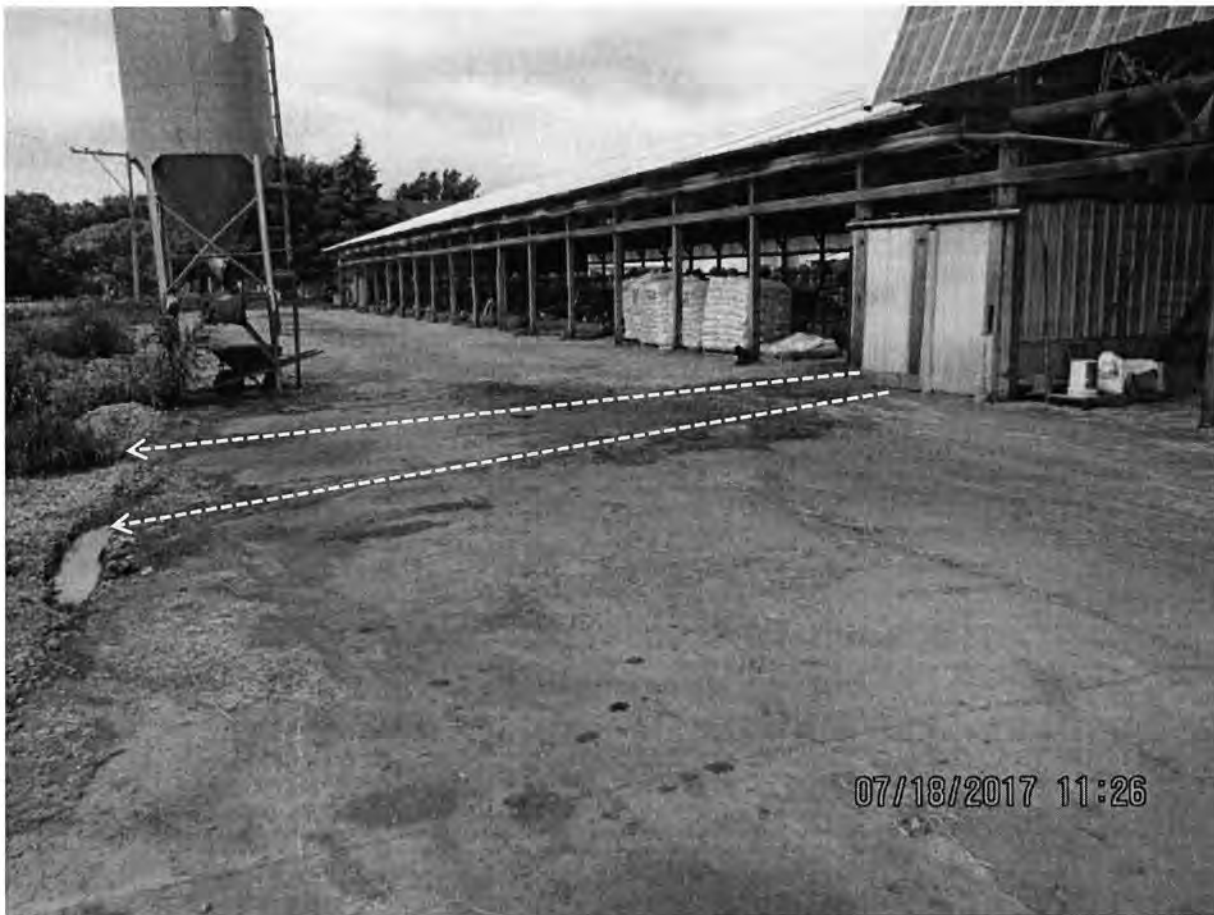
**Photo 1:**  
View of the west end of the calf barn. Dashed yellow arrows indicate process wastewater discharge flow path. Photo direction is NW.

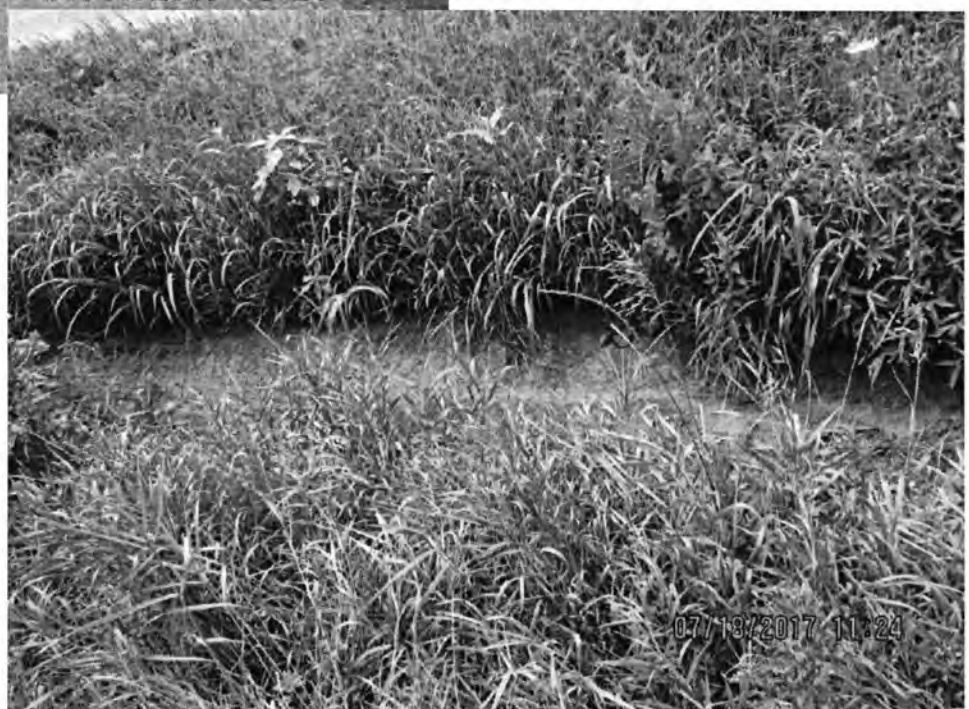
**Photo 3:** View of ponded process wastewater from the calf barn in the ditch north of Dickinson Rd. Photo direction is down.

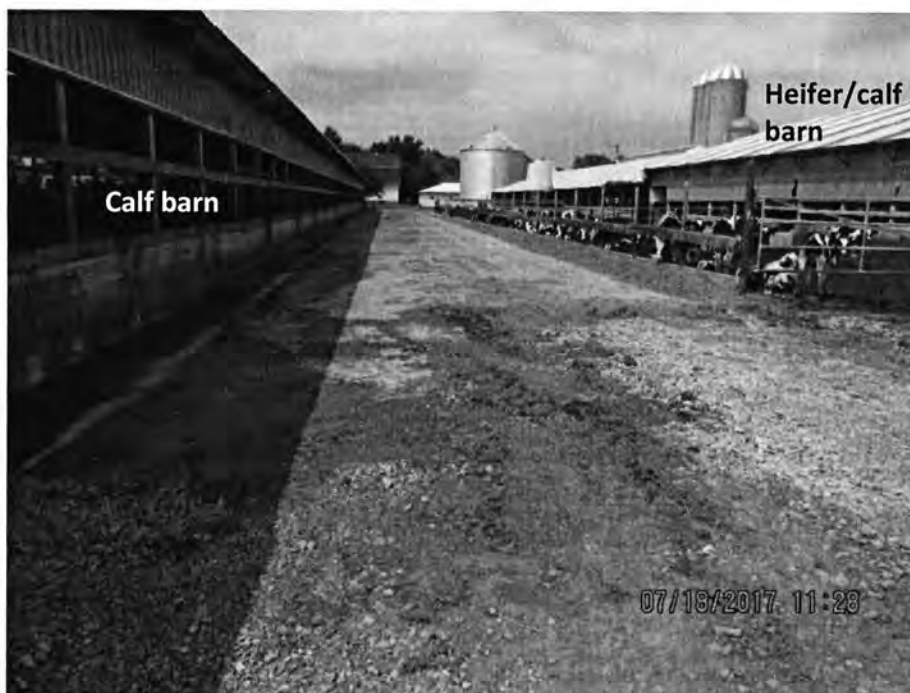
There are no runoff controls or containment for the bedding stacking areas for either calf barn to prevent waste discharges. The bedding is stacked directly on concrete that is sloped toward a vegetated area east of the barns. Discharges of waste from the calf/heifer barn and from the stacked bedding areas flow east and into the vegetated area. The vegetated area is maintained with vegetation and/or an agricultural crop.

**Photo 7:** View of the heifer/calf barn and feedlot. Photo direction is west.

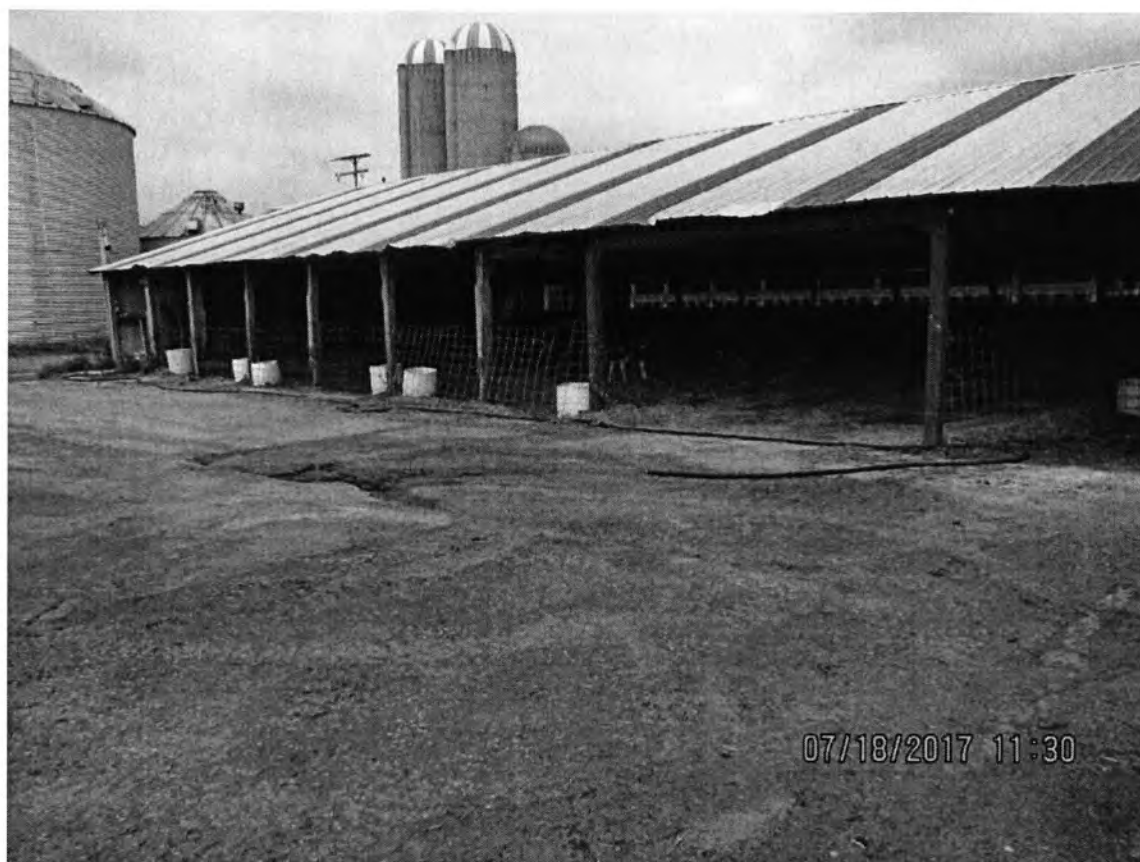
**Photo 9:** View of the west end of the heifer/calf barn and feedlot. Photo direction is NW.

The only feedlot at the main farm site is attached to the heifer/calf barn. The feedlot area is partially contained by a concrete curb that is open on the west and east ends of the feedlot. Uncontained waste was observed on both the east and west ends of the feedlot as well as the east end of the barn.

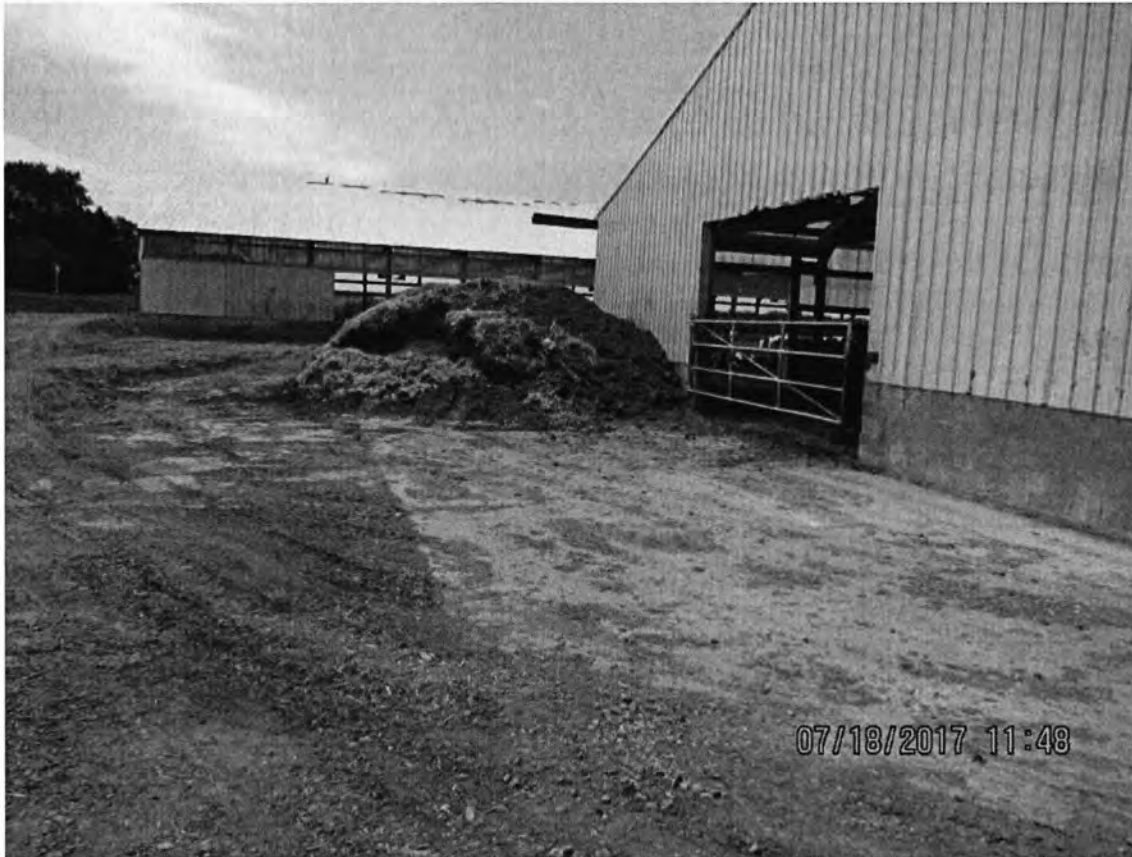
**Photo 10:** View of the east end of the heifer/calf barn. The used bedding solids are visible stacked adjacent to the barn. Photo direction is south.

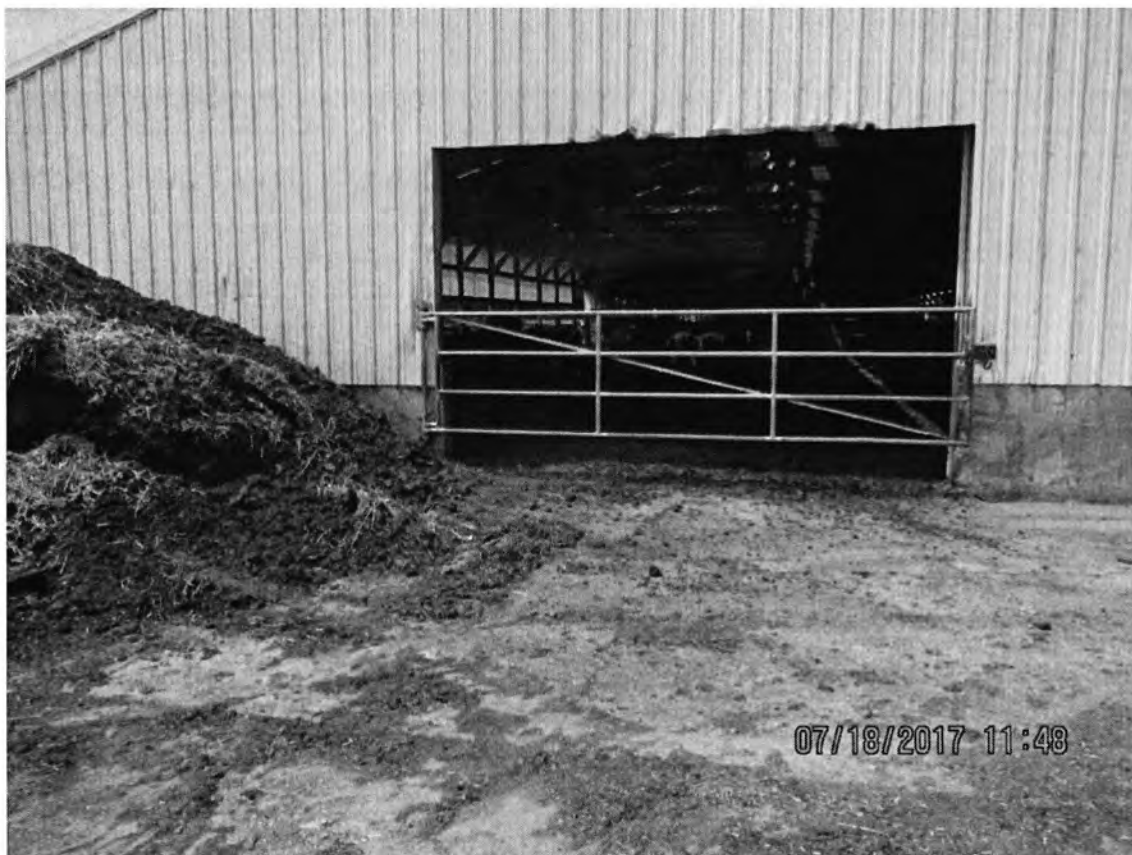
**Photo 11:** Close up view of the east end of the heifer/calf barn. Photo direction is west.

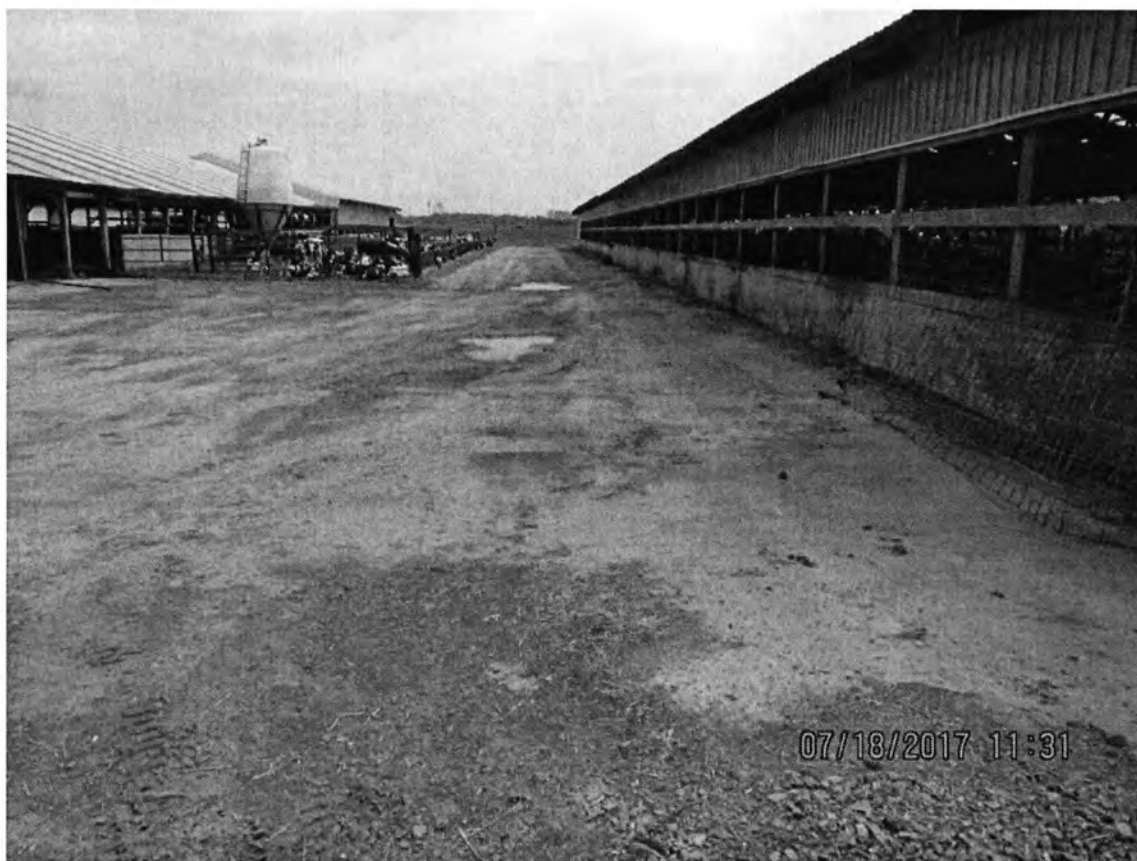
**Photo 12:** View of the concrete lane between the calf and heifer/calf barns. Photo direction is east.

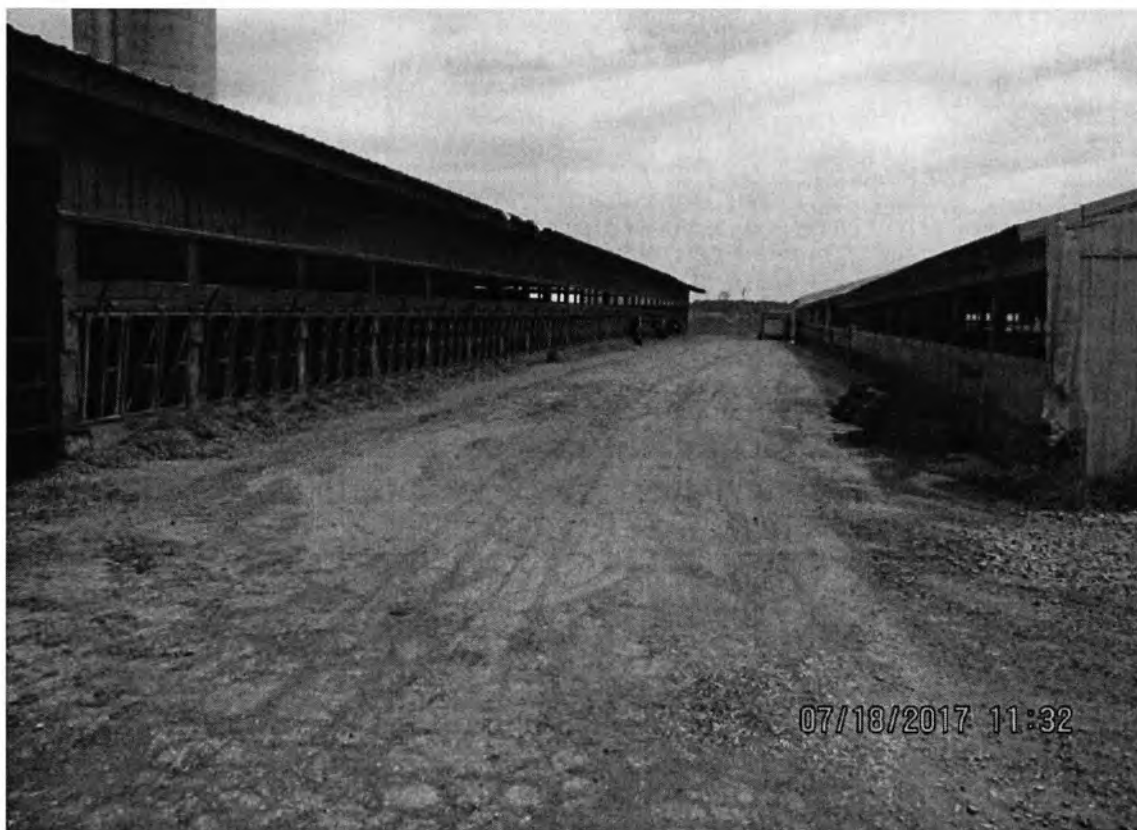
**Photo 13:** View of the concrete lane between the heifer/calf and maternity barns. Photo direction is east.

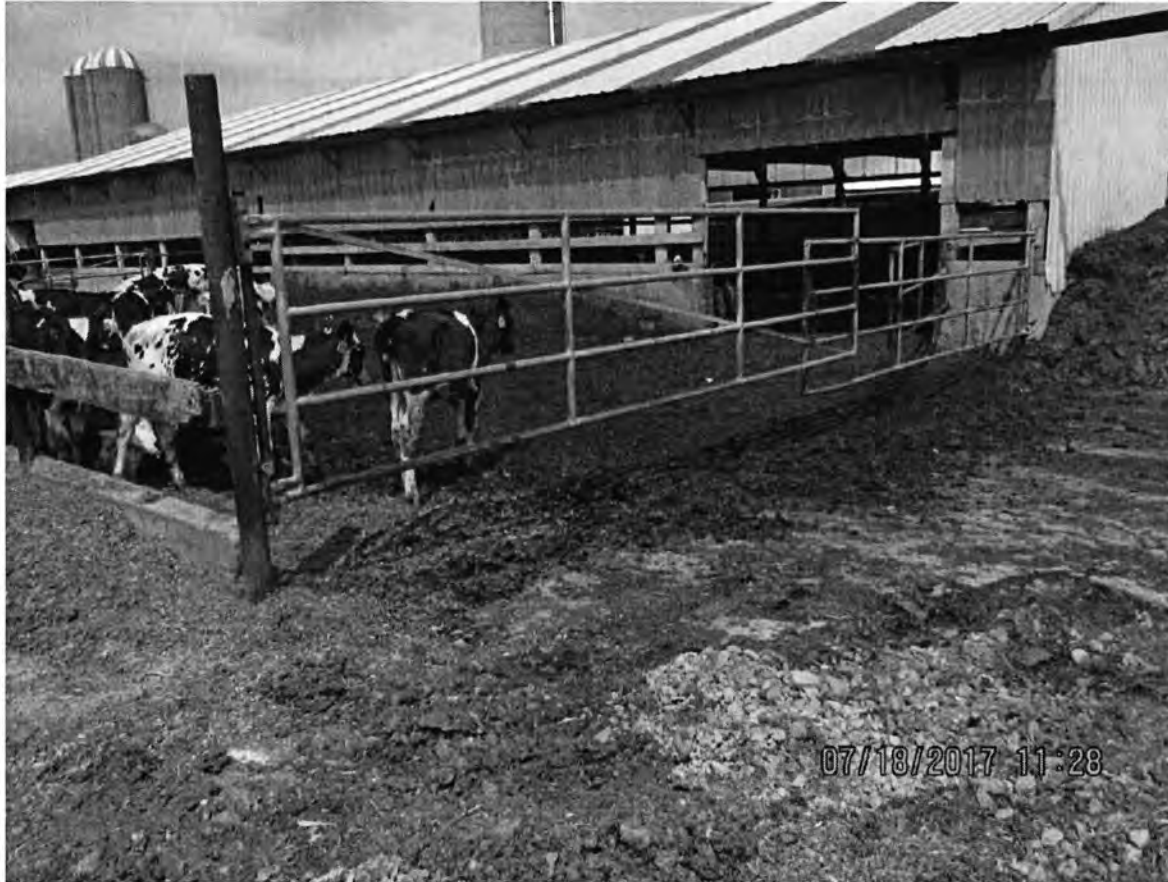
**Photo 14:** View of the east end of the heifer/calf barn feedlot. Photo direction is NW.

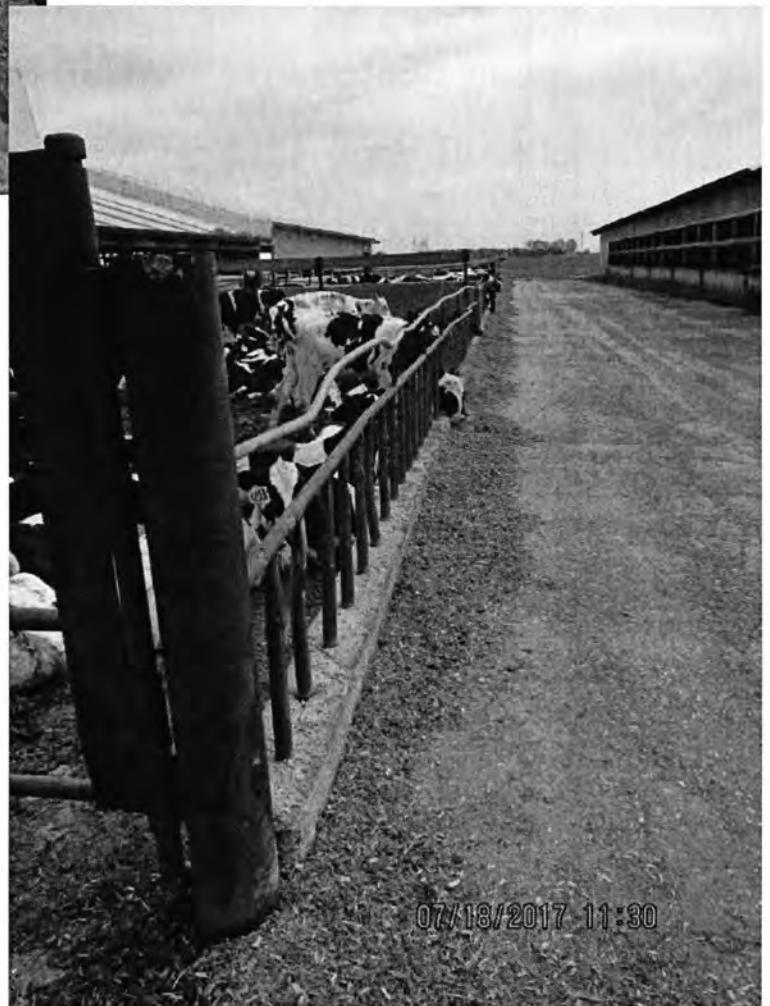
**Photo 16:** View of the heifer/calf barn feedlot. Photo direction is east.

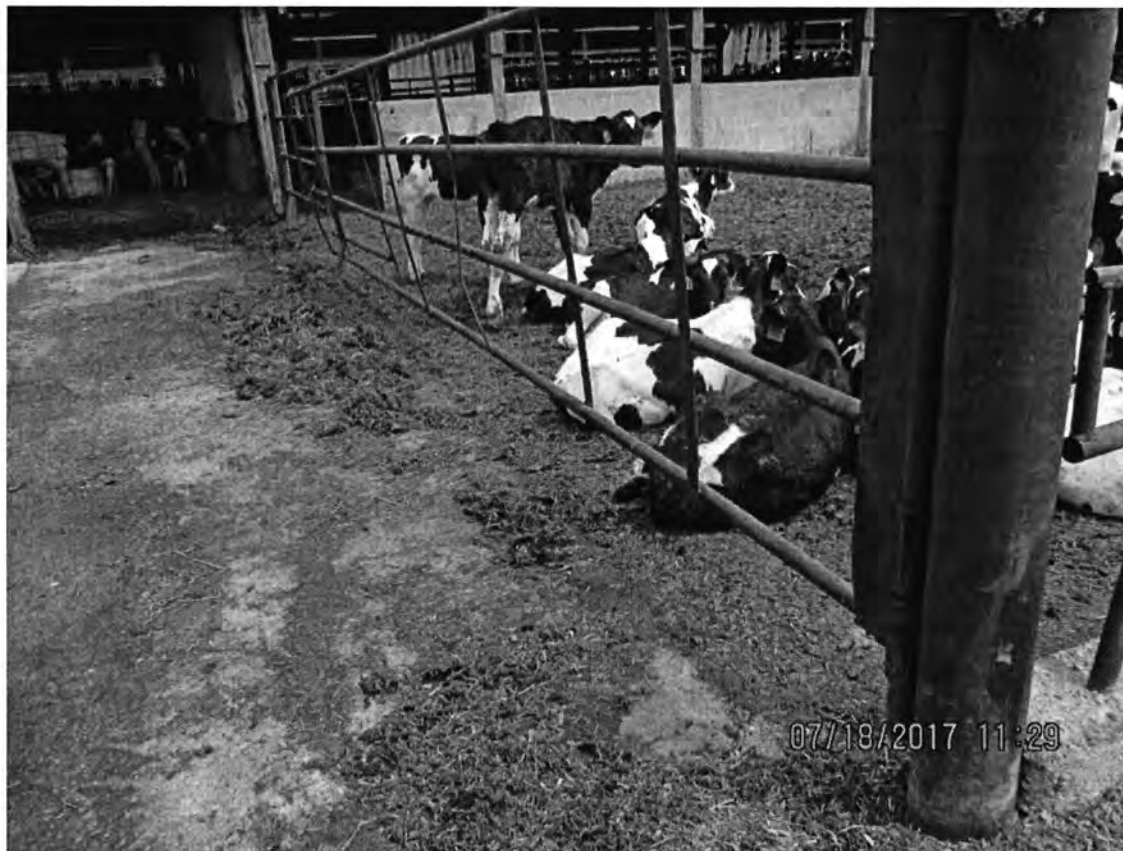
**Photo 17:** View of the west end of the heifer/calf barn feedlot. Photo direction is NE.

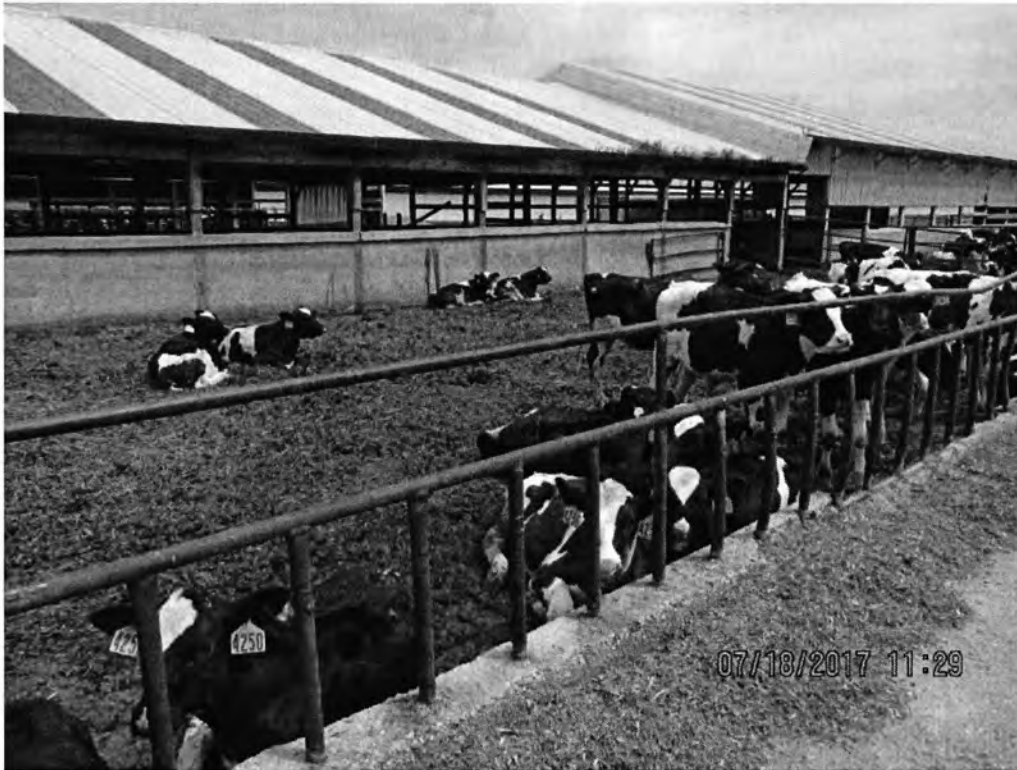
**Photo 19:** View of the heifer/calf barn feedlot. Photo direction is NE.

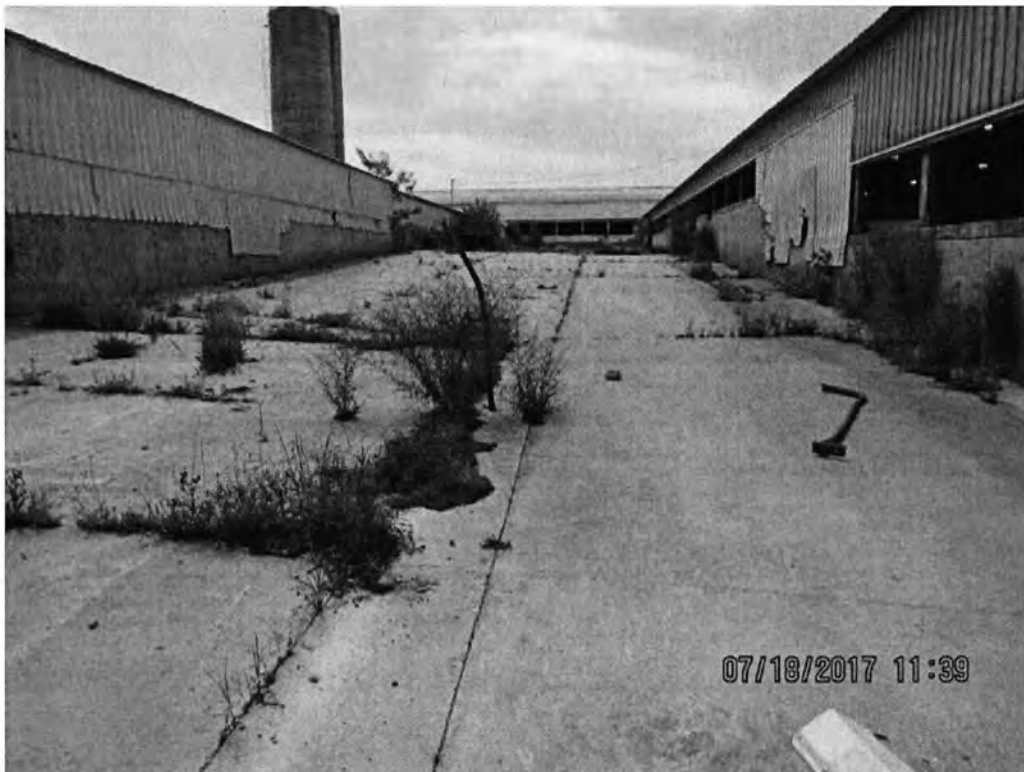
Three feedlot areas between the cow barns at the main farm site are no longer utilized as feedlots, and have been abandoned as of the date of the inspection.

**Photo 20:** View of an abandoned feedlot between the cow barns at the main site. Photo direction is south.

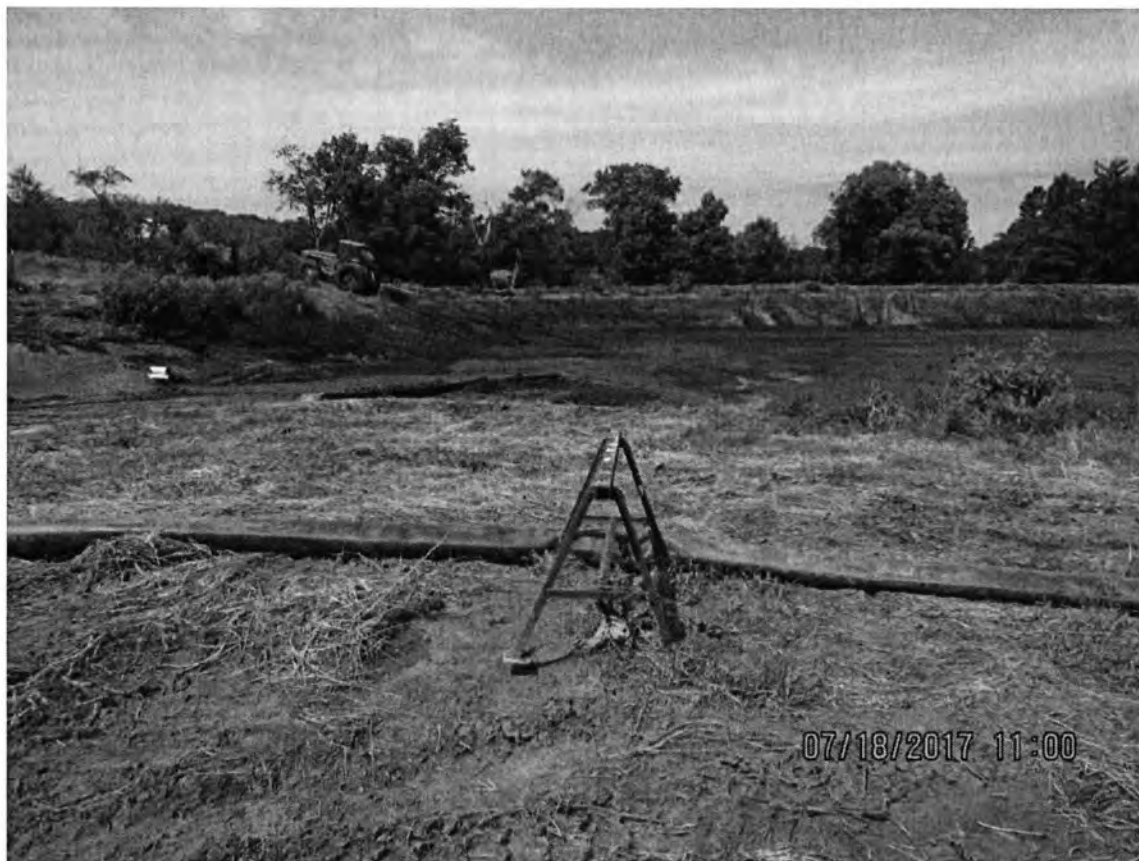
- Earthen/clay-lined waste storage facility built in 2015.
- Concrete ramp and MOL marker present.
  - i. MOL marker needs clarification.
  - ii. MOS not present.
- Fence needs repair/reinstallation.
- No discharge, leakage, or rodent holes observed.
- Facility requires an engineering evaluation to determine compliance with statutory and administrative code requirements.

**Photo 22:** View of the southern section of outfall/WSF 001. Photo direction is west.

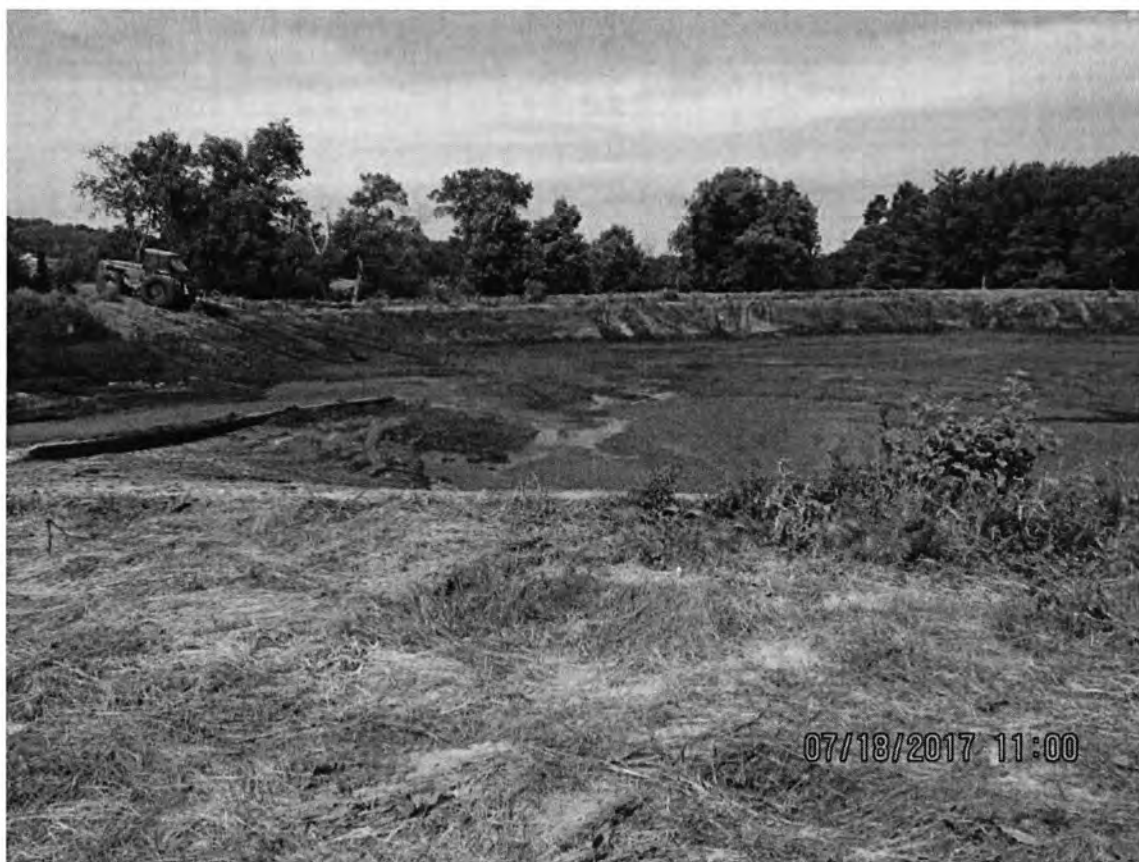
**Photo 23:** View of the southern and middle sections of outfall/WSF 001. Photo direction is west.

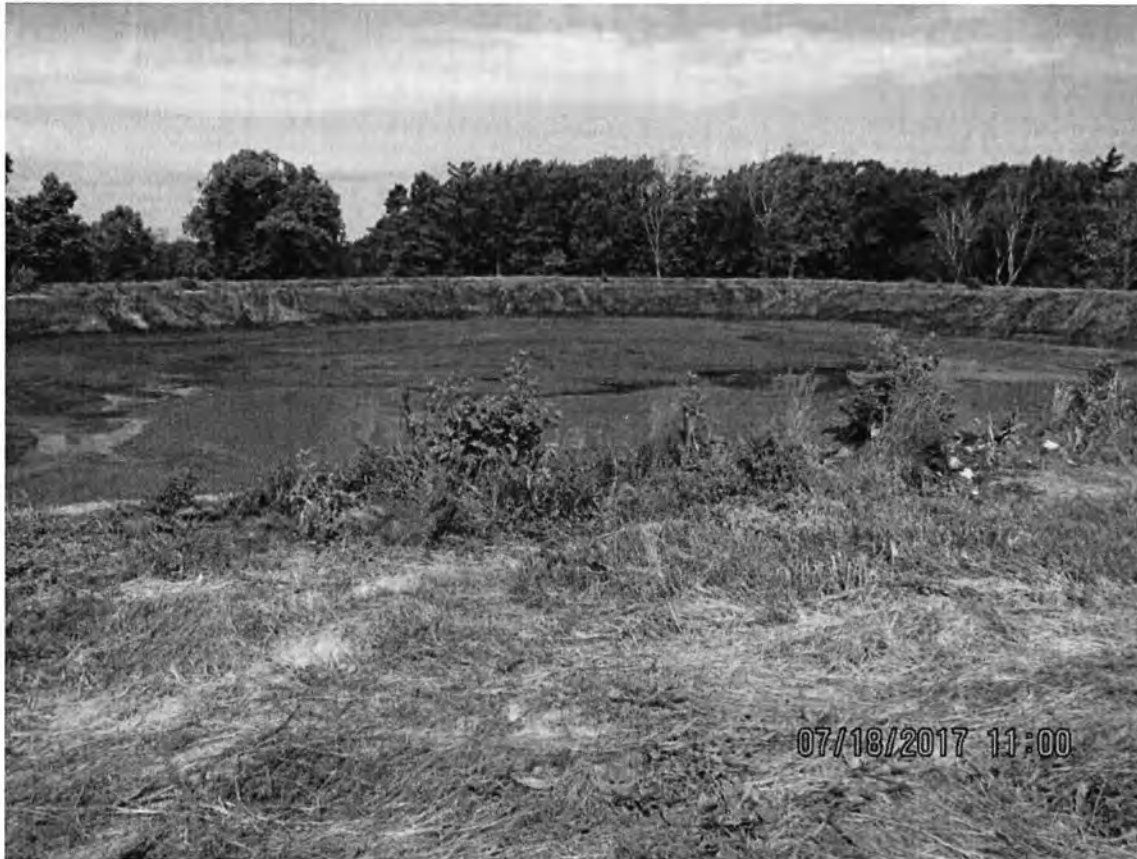
**Photo 24:** View of outfall/WSF 001. Photo direction is NW.

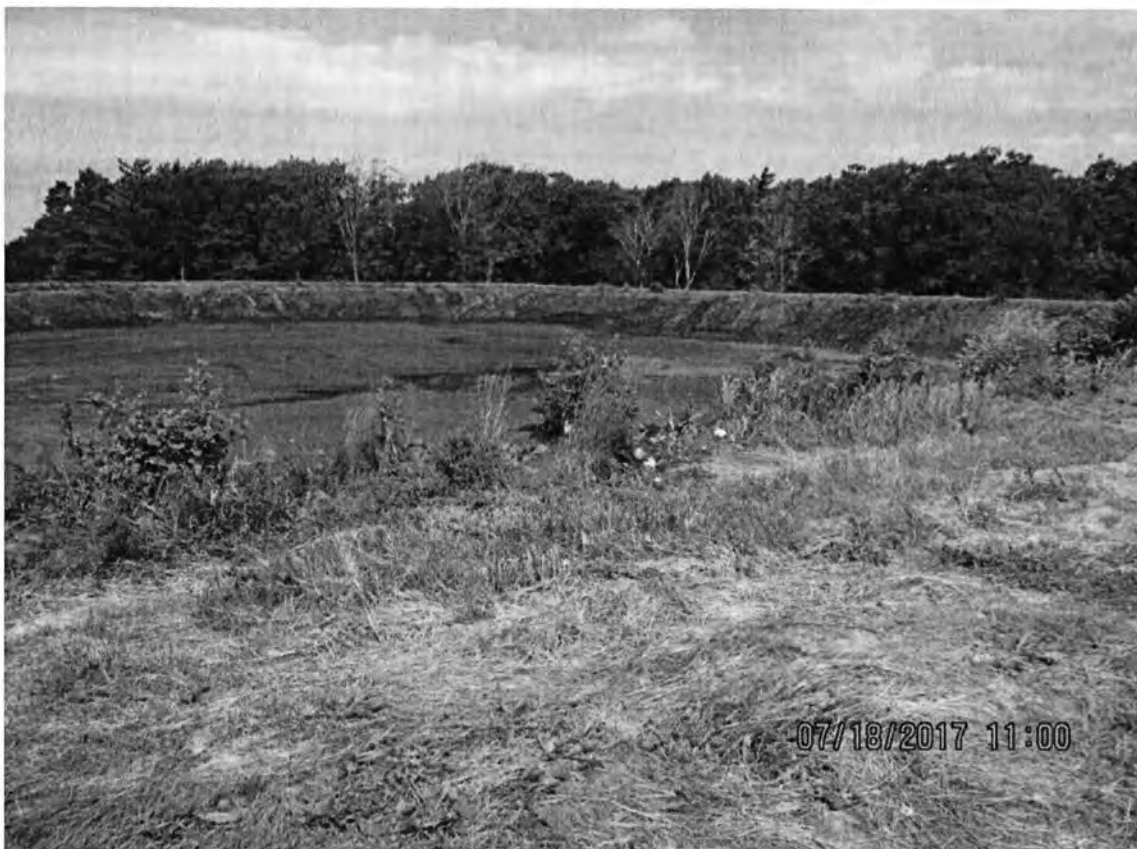
**Photo 25:** View of the middle and northern sections of outfall/WSF 001. Photo direction is NW.

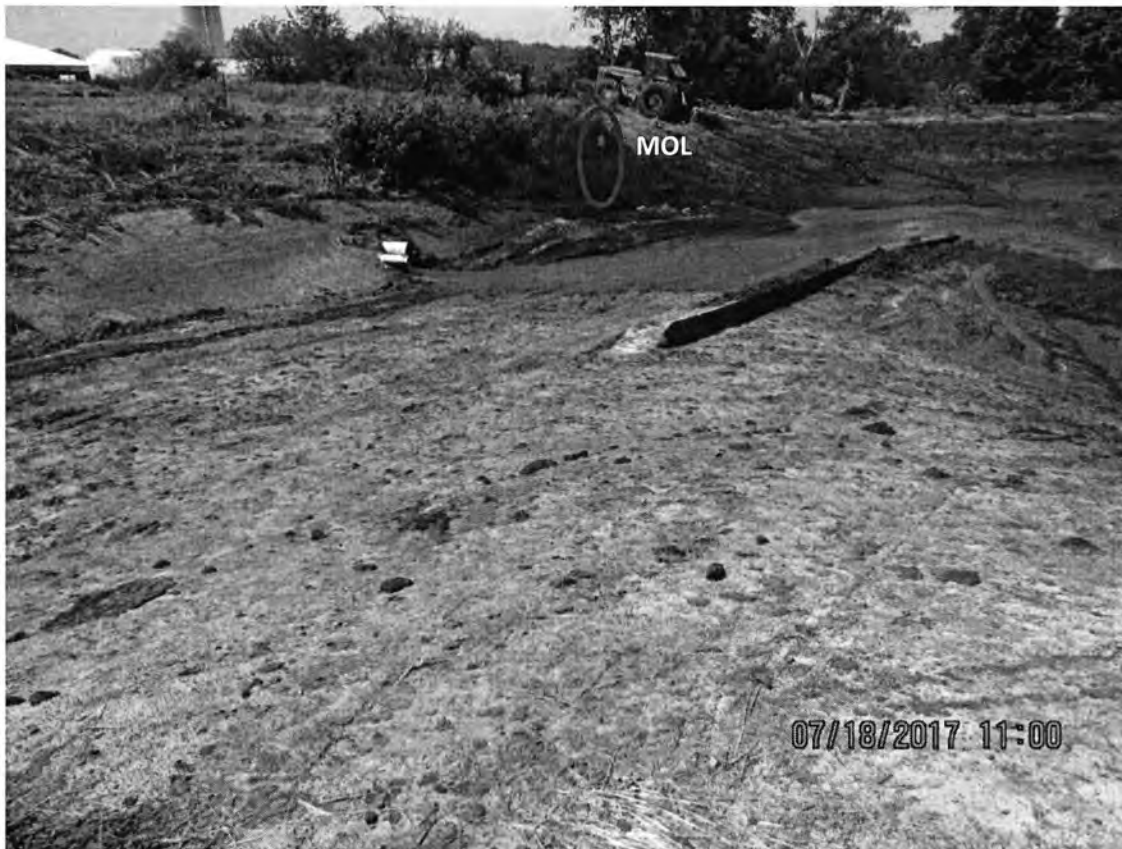
**Photo 26:** View of the southern section of outfall/WSF 001 showing the concrete ramp. Photo direction is west.
