State of Wisconsin | DEPARTMENT OF NATURAL RESOURCES

Subject: **Notice of Violation - Chapter 283, Wis. Statutes  
Enforcement Conference - March 9, 2009**

### **3. POTENTIAL VIOLATIONS**

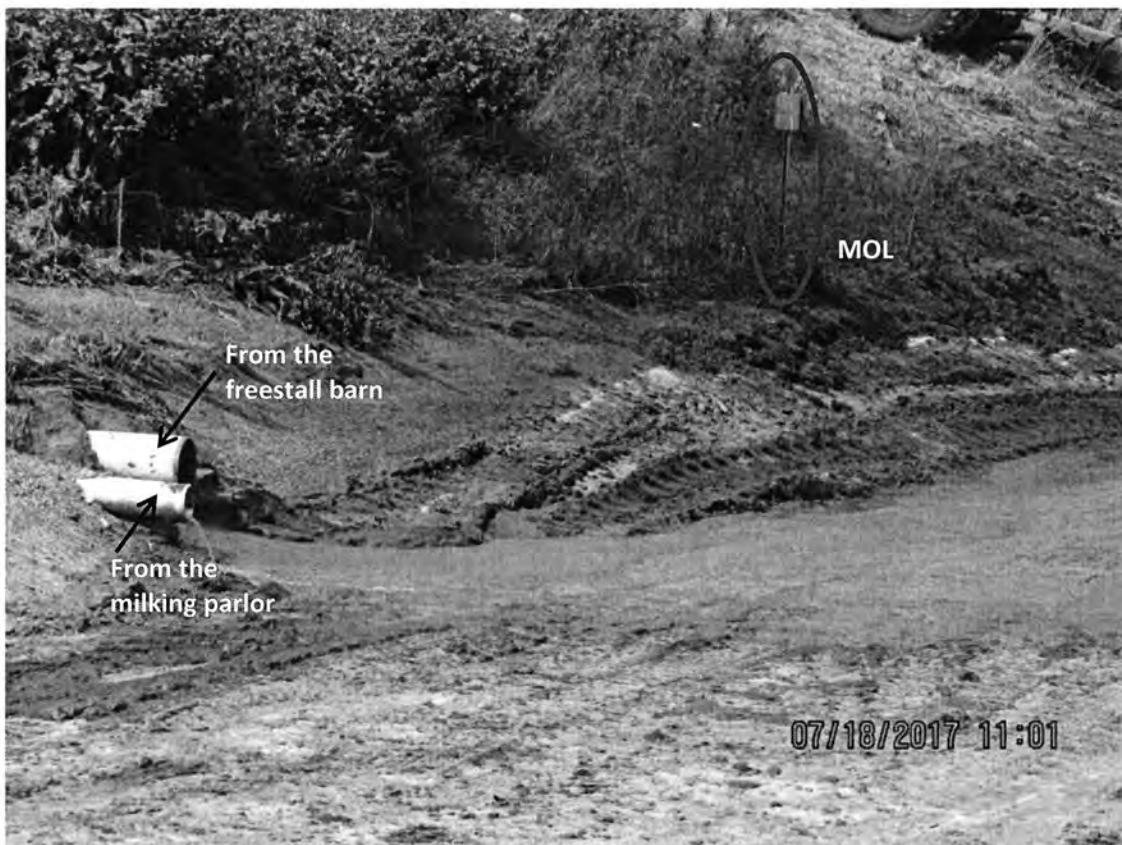
- Earthen/clay-lined waste storage facility built in 2015.
- Concrete ramp and MOL marker present.
  - i. MOL marker needs clarification.
  - ii. MOS not present.
- Fence needs repair/reinstallation.
- No discharge, leakage, or rodent holes observed.
- Facility requires an engineering evaluation to determine compliance with statutory and administrative code requirements.

**Photo 27:** Close up view of the MOL and manure transfer system discharge pipes in the southern section of outfall/WSF 001. Photo direction is west and down.

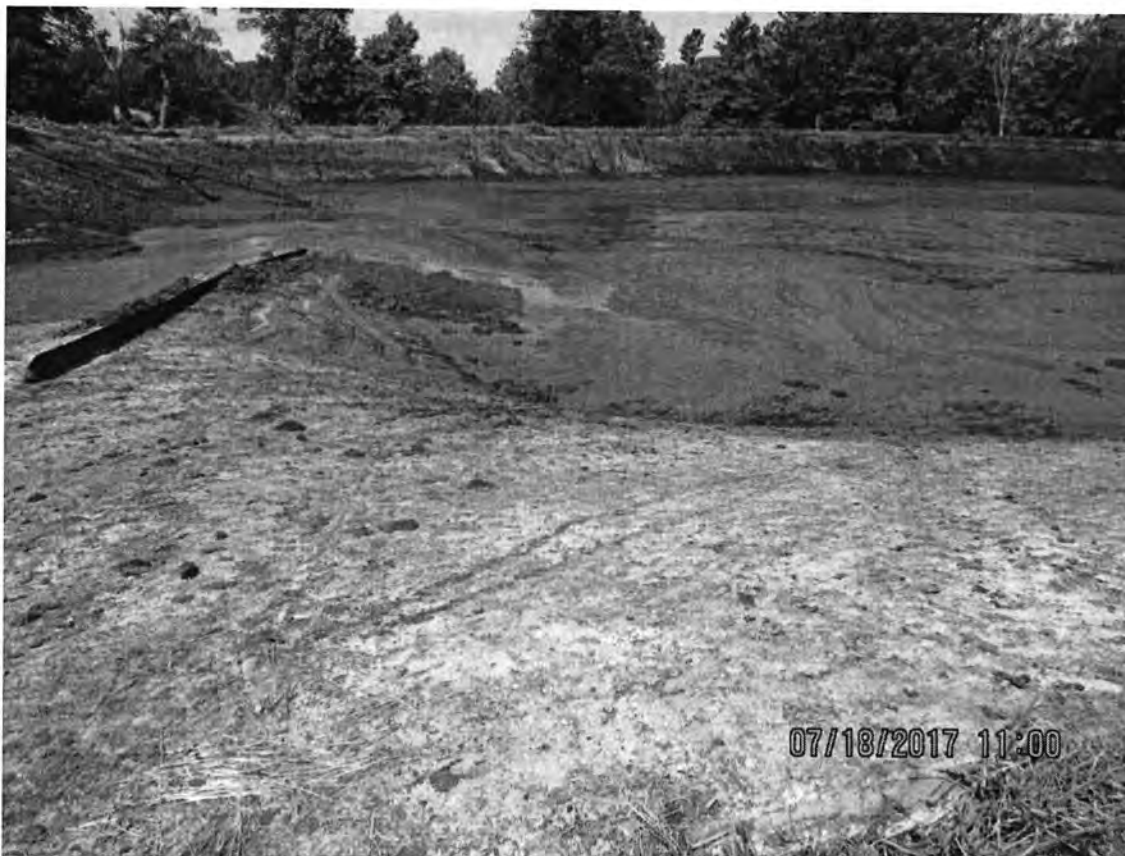
**Photo 29:** View of outfall/WSF 001 showing the concrete ramp. Photo direction is west.

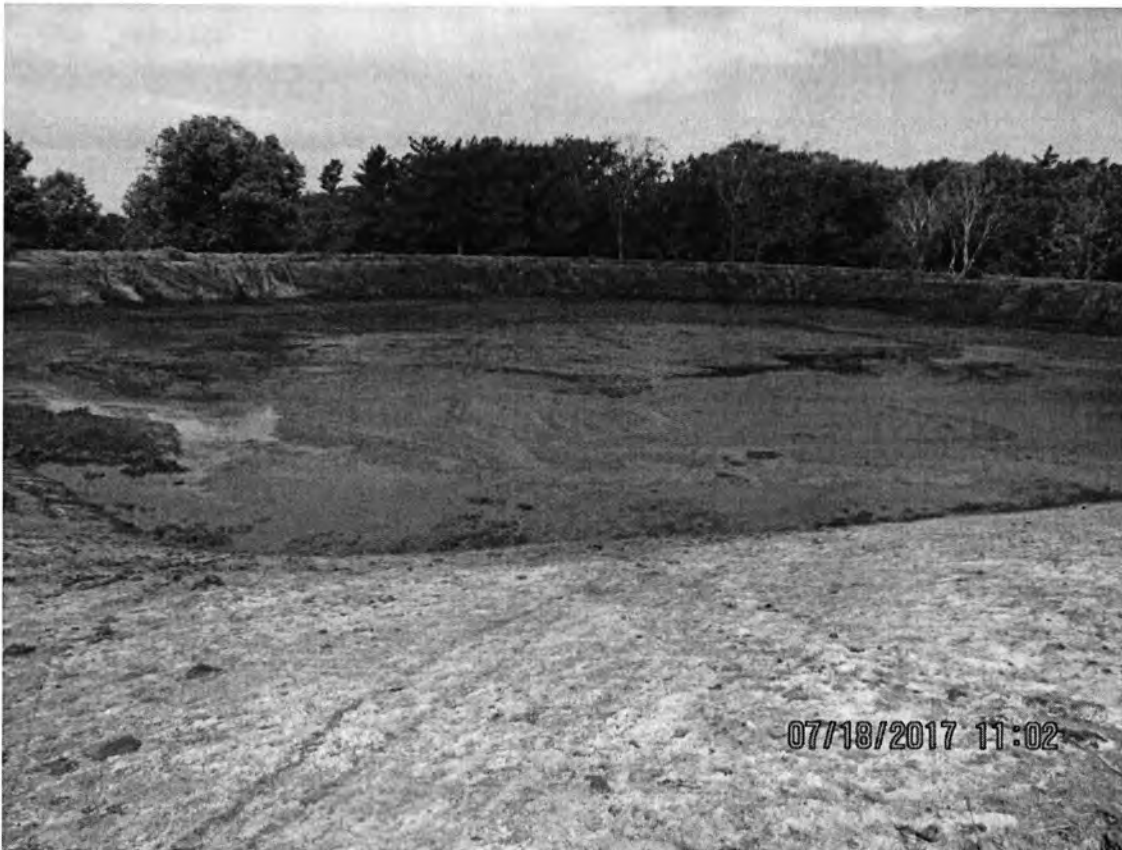
**Photo 30:**  
Alternate view of  
outfall/WSF 001  
showing the  
concrete ramp.  
Photo direction is  
NW.

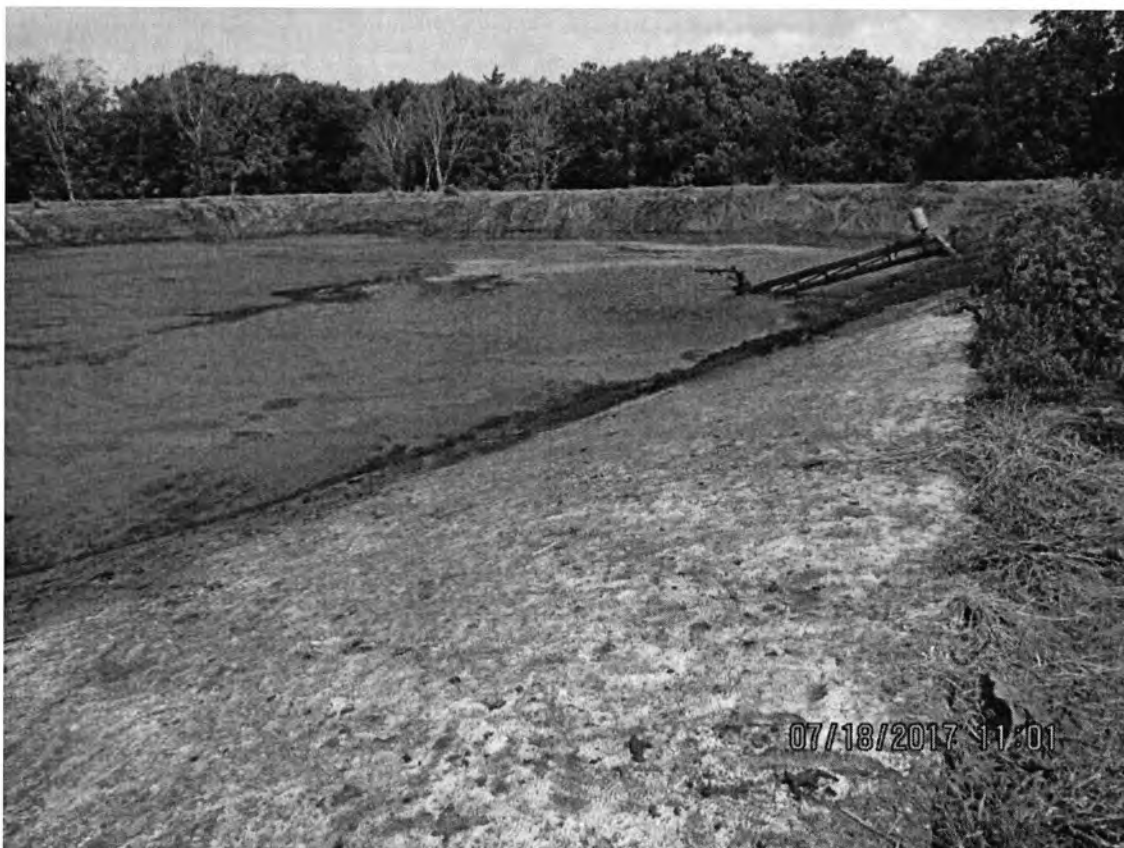
**Photo 31:** View of  
the northern  
section of  
outfall/WSF 001  
showing the  
concrete ramp.  
Photo direction is  
NW.

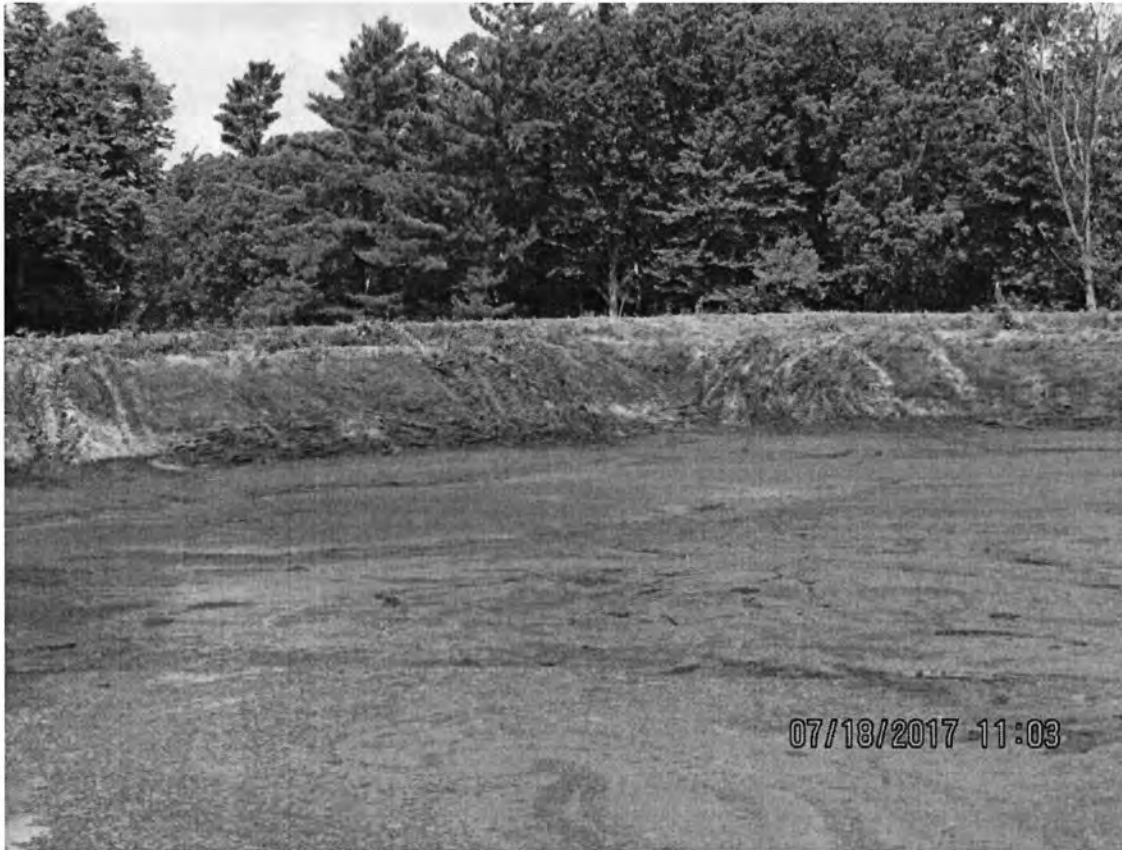
**Photo 32:** Close up view of the interior western wall of outfall/WSF 001. Photo direction is west.

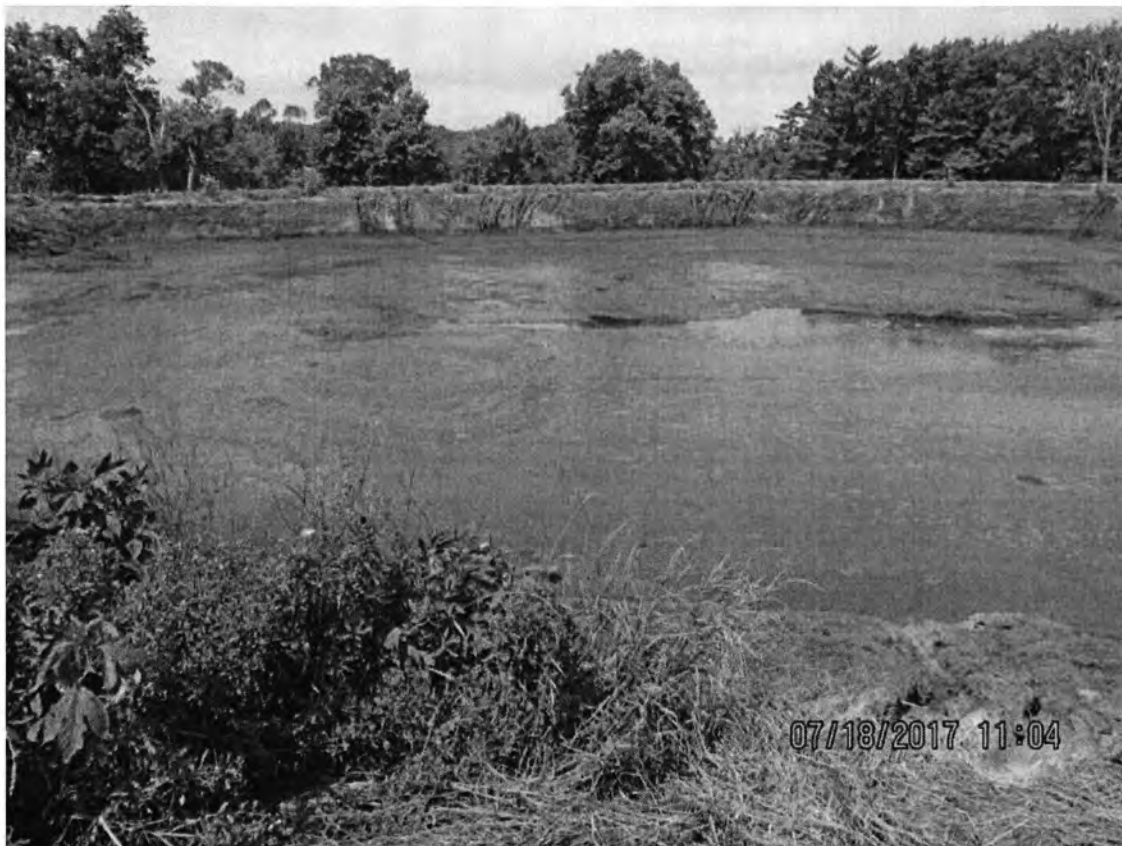
**Photo 33:** View of outfall/WSF 001. Photo direction is west.

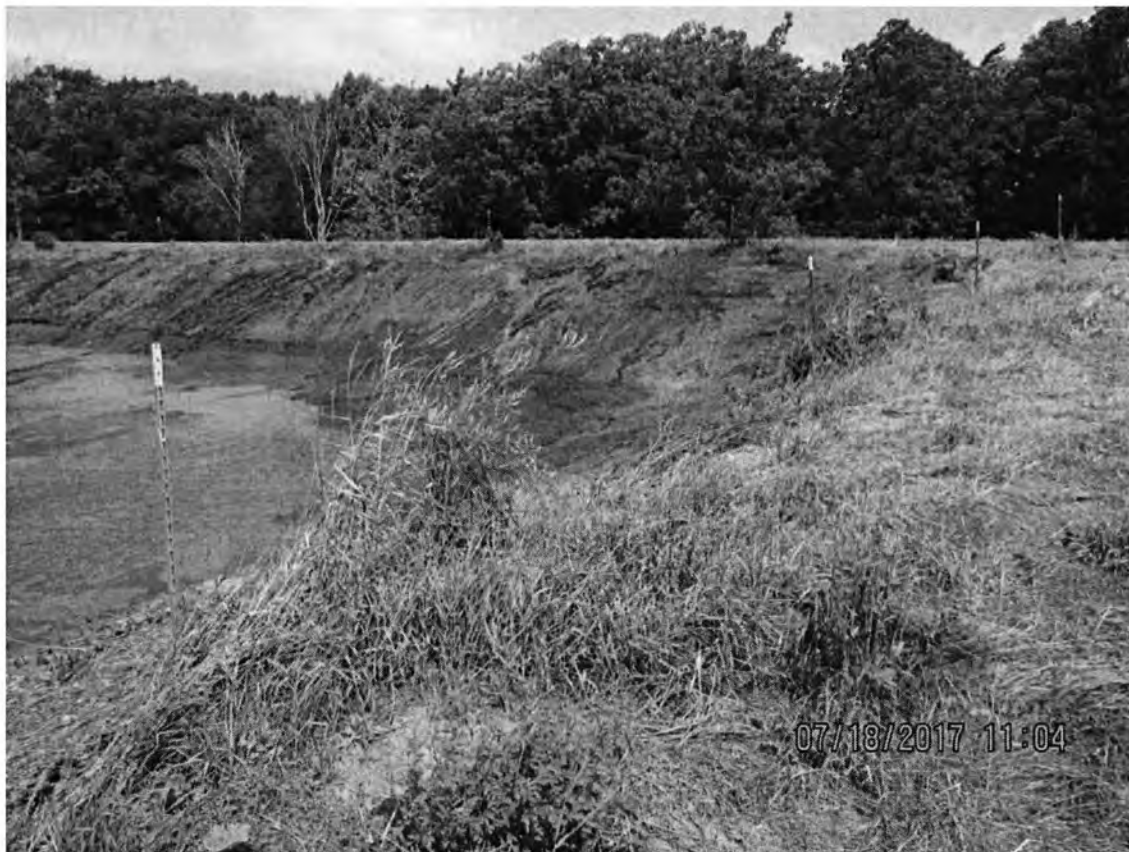
**Photo 34:** View of the NE corner of outfall/WSF 001. Photo direction is NW.

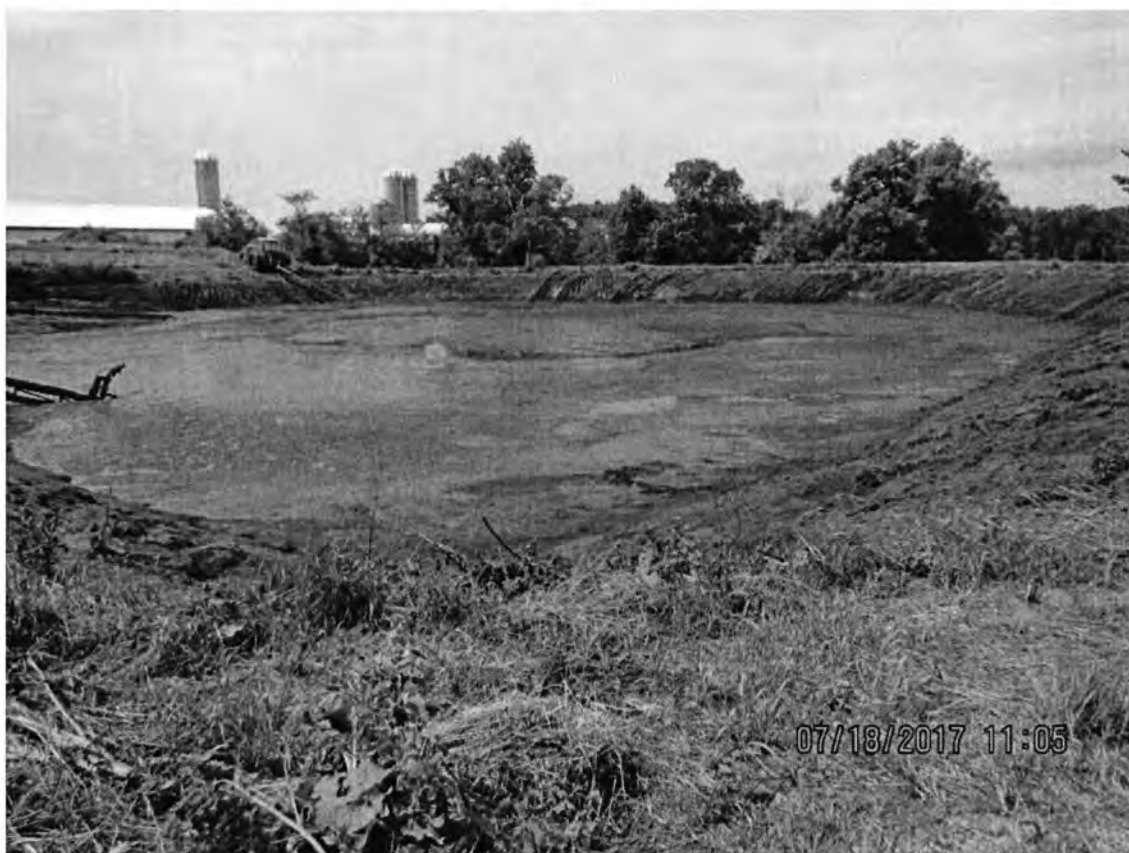
**Photo 35:** Alternate view of outfall/WSF 001. Photo direction is SW.

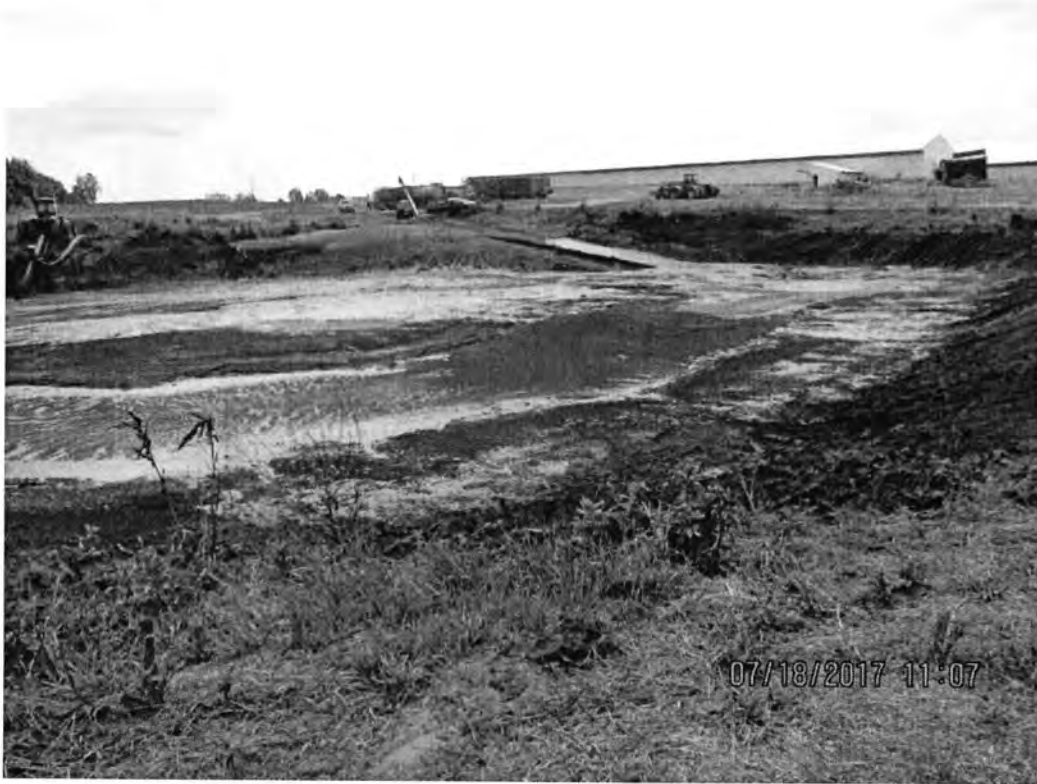
**Photo 36:**  
Alternate view of  
outfall/WSF 001  
showing the  
concrete ramp.  
Photo direction is  
SE.

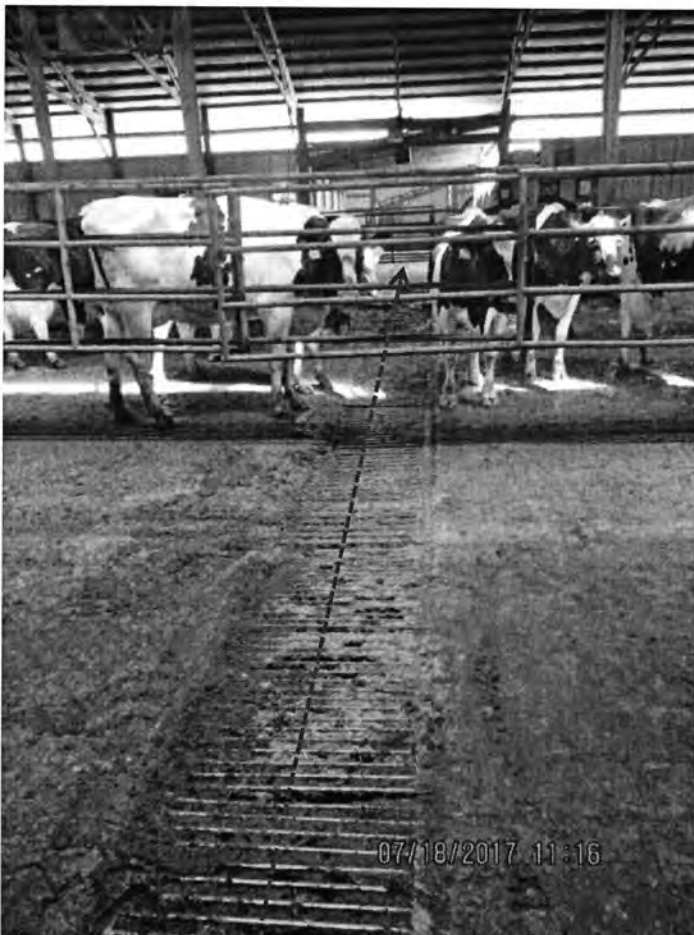
**Photo 37:** View of  
the waste  
collection/manure  
transfer system  
inside the freestall  
barn that  
discharges directly  
into outfall/WSF  
001. Red dashed  
arrow indicates  
the flow direction  
of waste. Photo  
direction is north.

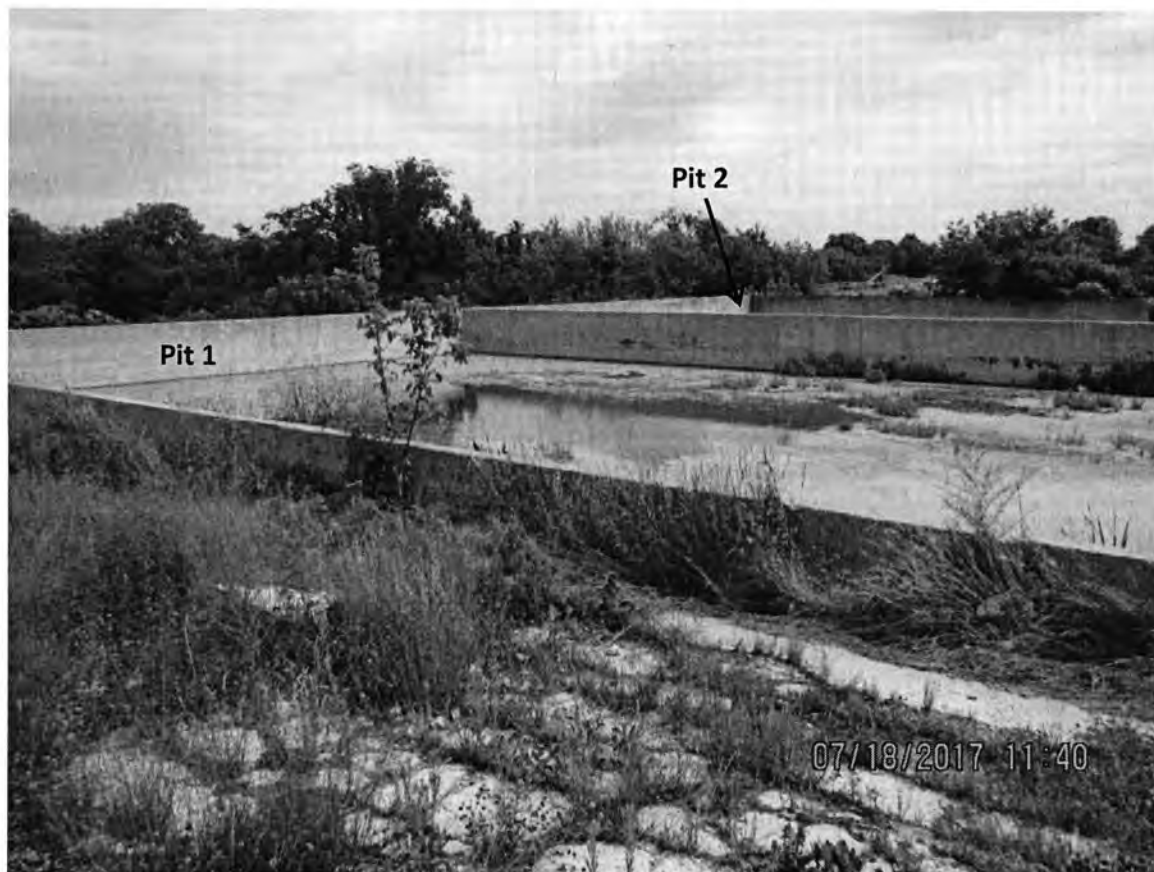
**Photo 38:** View of pits 1 & 2 at the main farm site. Storm water is visible in the pits. Photo direction is NE.

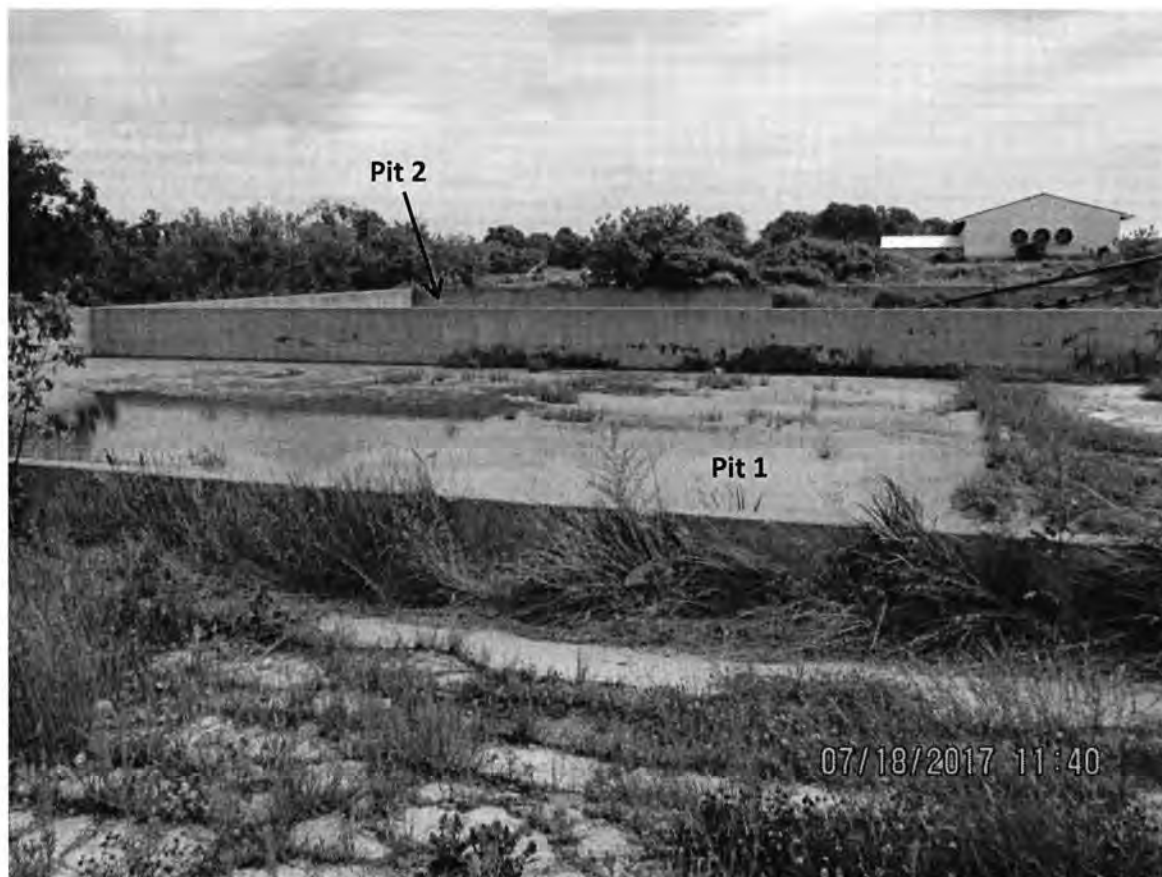
- Aboveground concrete waste storage facilities.
- Pit 1 = 489,223 gallons; built in 1995.
- Pit 2 = 503,783 gallons; built in 1999.
  - i. Crack/hole needs repair in NE corner.
- MOL/MOS markers not present.
- Both storage facilities were not in use for animal waste/process wastewater storage at the time of inspection.
  - i. Storm water was observed in both storage facilities during the inspection.
- Permanent plan for the storage facilities is potential abandonment.
  - i. Abandonment plan is required if storage facilities will be abandoned.
- Facilities require engineering evaluations to determine compliance with statutory and administrative code requirements in order to resume use as waste storage facilities.

**Photo 39:**  
Alternate view of  
pits 1 & 2 at the  
main farm site.  
Storm water is  
visible in the pits.  
Photo direction is  
east.

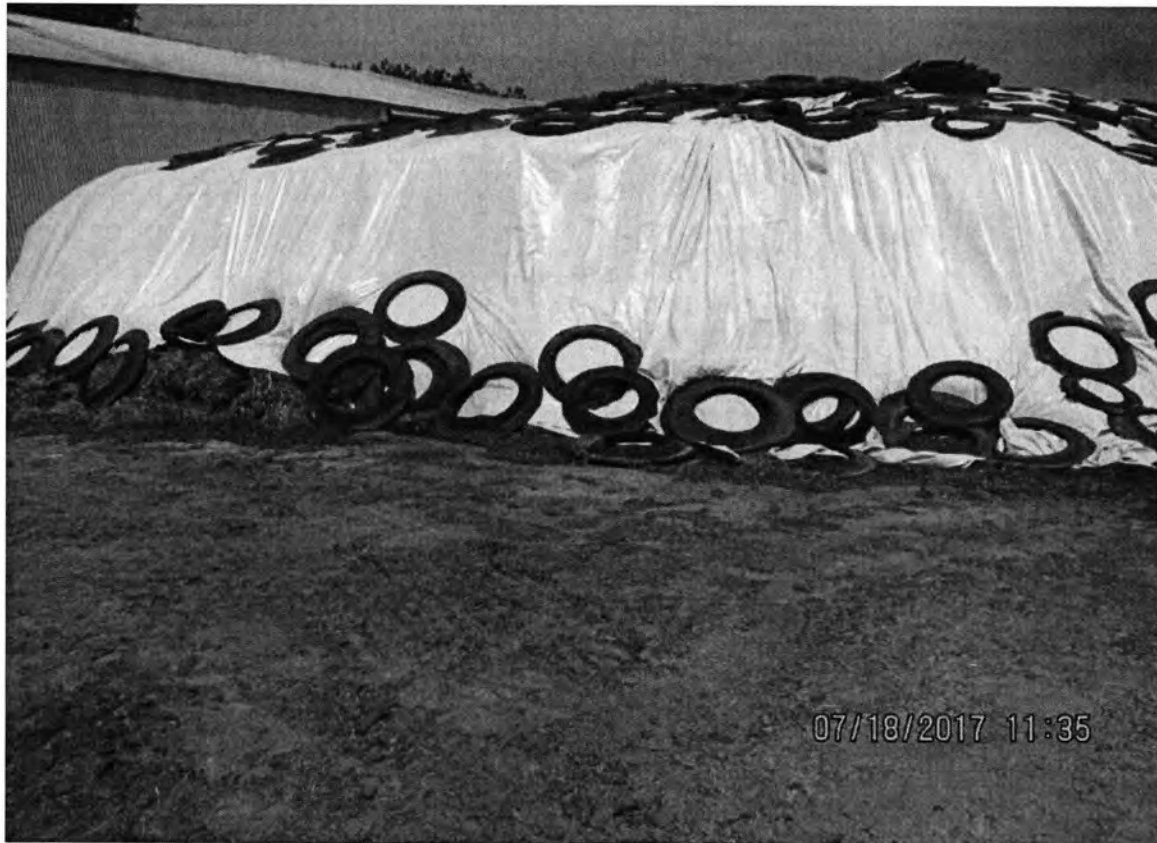
**Photo 40:** View of the feed storage area at the main farm site. Photo direction is NW.

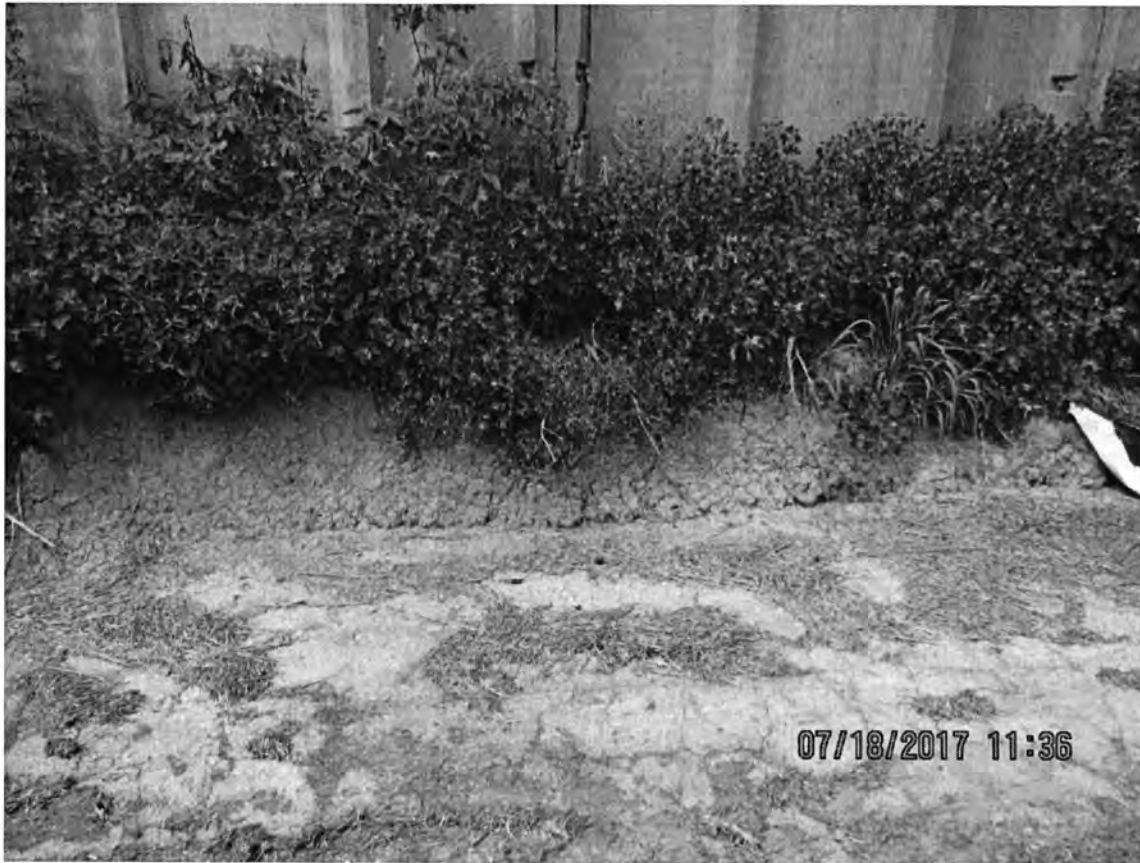
**Photo 42:** Close up view of the east wall of the feed storage area at the main farm site showing clay placed along the bottom of the wall to prevent leachate discharges. Photo direction is west and down.

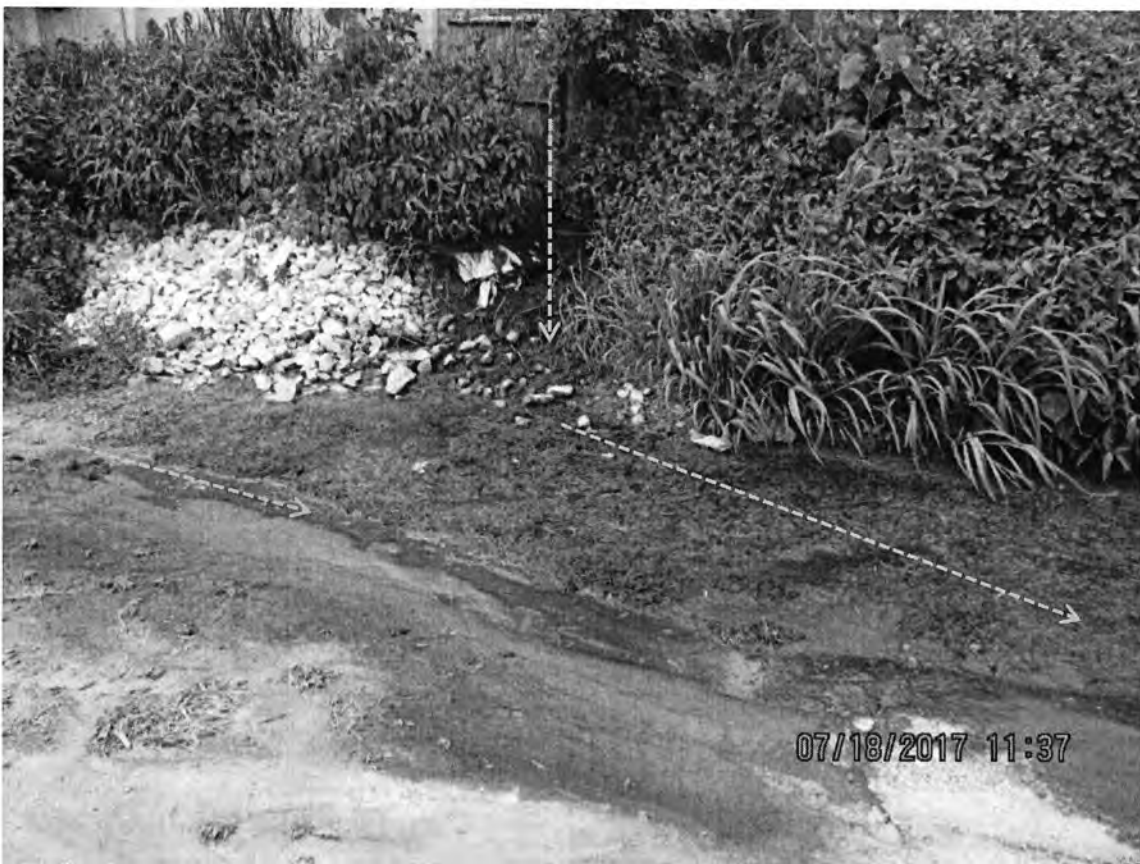
**Photo 43:** View of the leachate discharge from the NE corner of the feed storage area. Orange dashed arrows indicate the flow path and direction of leachate. Photo direction is SW and down.

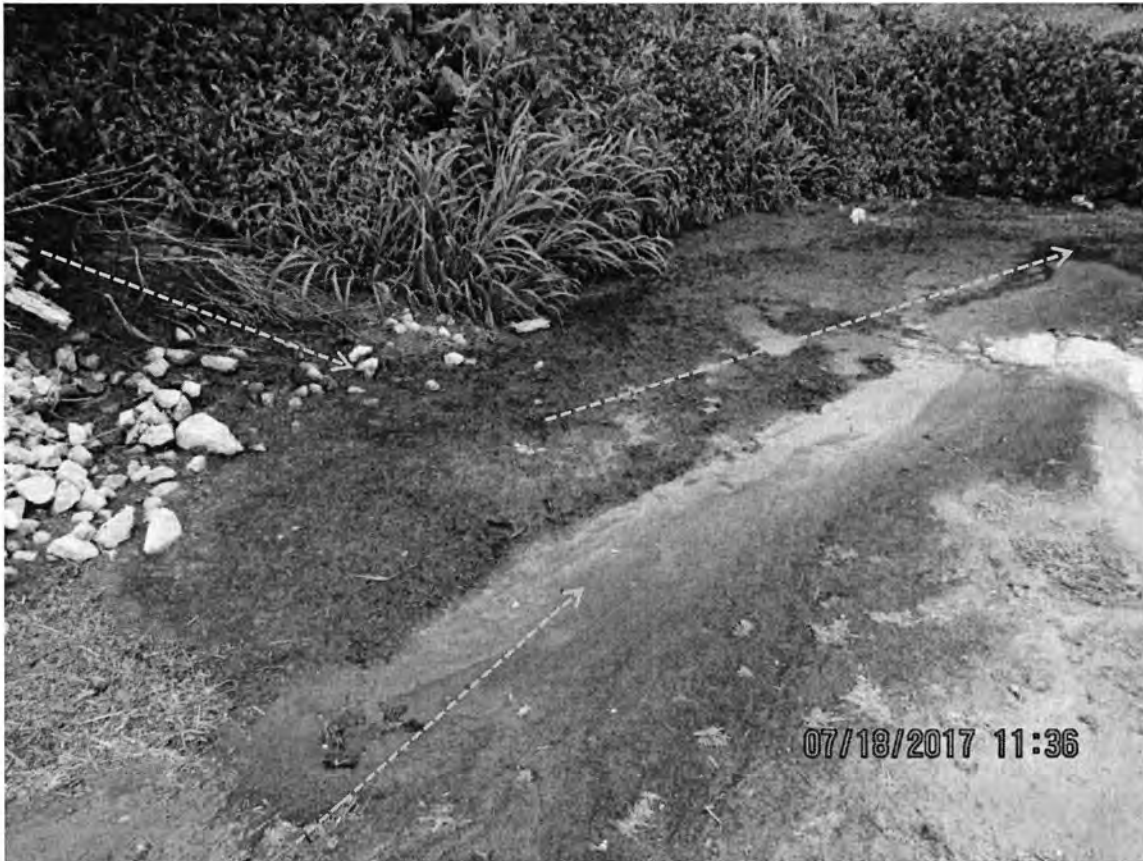
**Photo 44:** View of the leachate discharge from the NE corner of the feed storage area. Orange dashed arrows indicate the flow path and direction of leachate. Photo direction is north and down.

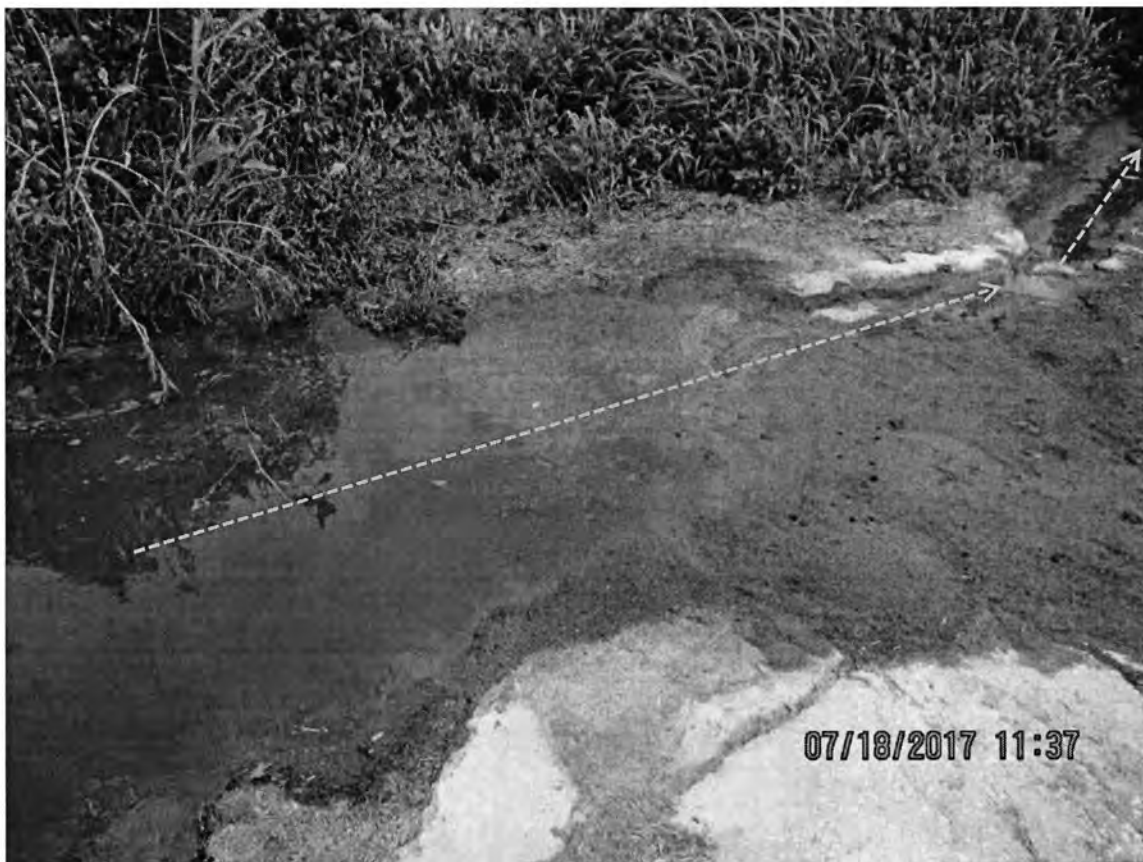
**Photo 45:** View of the leachate discharge path as it flows NE from the NE corner of the feed storage area. Orange dashed arrows indicate the flow path and direction of leachate. Photo direction is down.

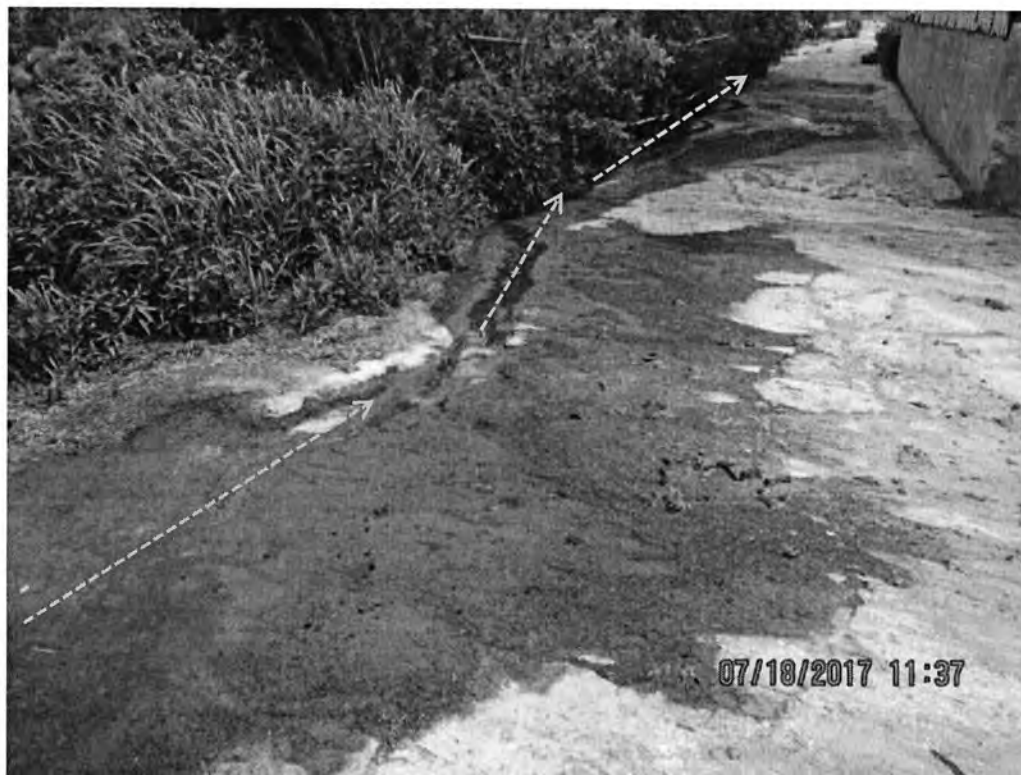
**Photo 46:** View of the leachate discharge path as it flows NE from the NE corner of the feed storage area. Orange dashed arrows indicate the flow path and direction of leachate. Photo direction is east and down.

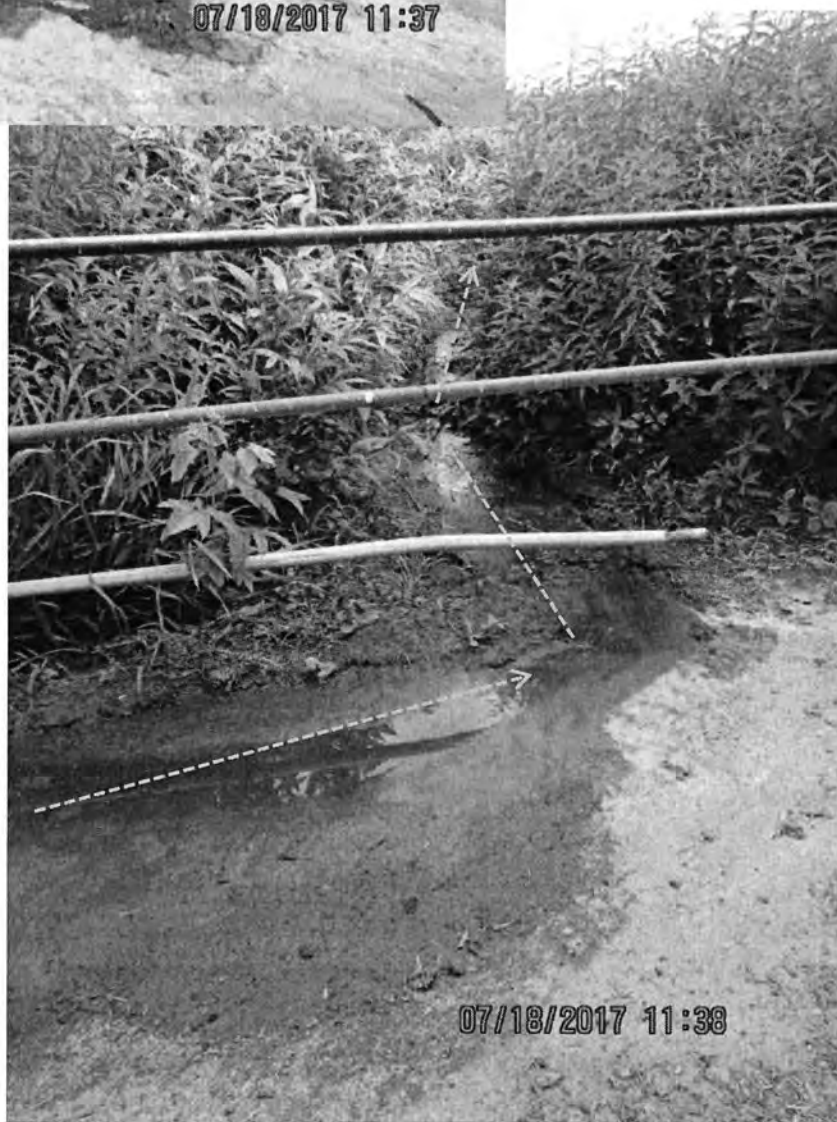
The feed storage area at the main farm site is located west of the cow barns and is a smaller storage area than the feed storage at the heifer site. It is comprised of a single bunker constructed by three concrete block walls. Leachate was observed ponded and discharging from the south end of the feed pile as well as from the NE corner of the concrete wall. Clay was placed along the bottom of the concrete wall blocks at the direction of EPA to prevent leachate discharges, but the clay appeared very dry and weathered. The clay was not/no longer containing leachate from the feed storage area, and a discharge path was observed along the eastern wall and from the NE corner of the feed storage area. The discharge path flowed in a northeasterly direction for approximately 80 feet before heading north into a vegetated area that eventually discharges to an unnamed tributary (WBIC 5019477) to Bower Creek. Topographical soils data show that the elevation changes in the vegetated area, and C slopes (6-12%) are present. The C slope area adjoins a soil map unit with A slopes (0-2%) and high groundwater, through which an unnamed tributary (WBIC 5019477) to Bower Creek flows.

**Photo 47:** View of the leachate discharge path as it flows NE from the NE corner of the feed storage area. Orange dashed arrows indicate the flow path and direction of leachate. Flow is north into the vegetation. Photo direction is north.

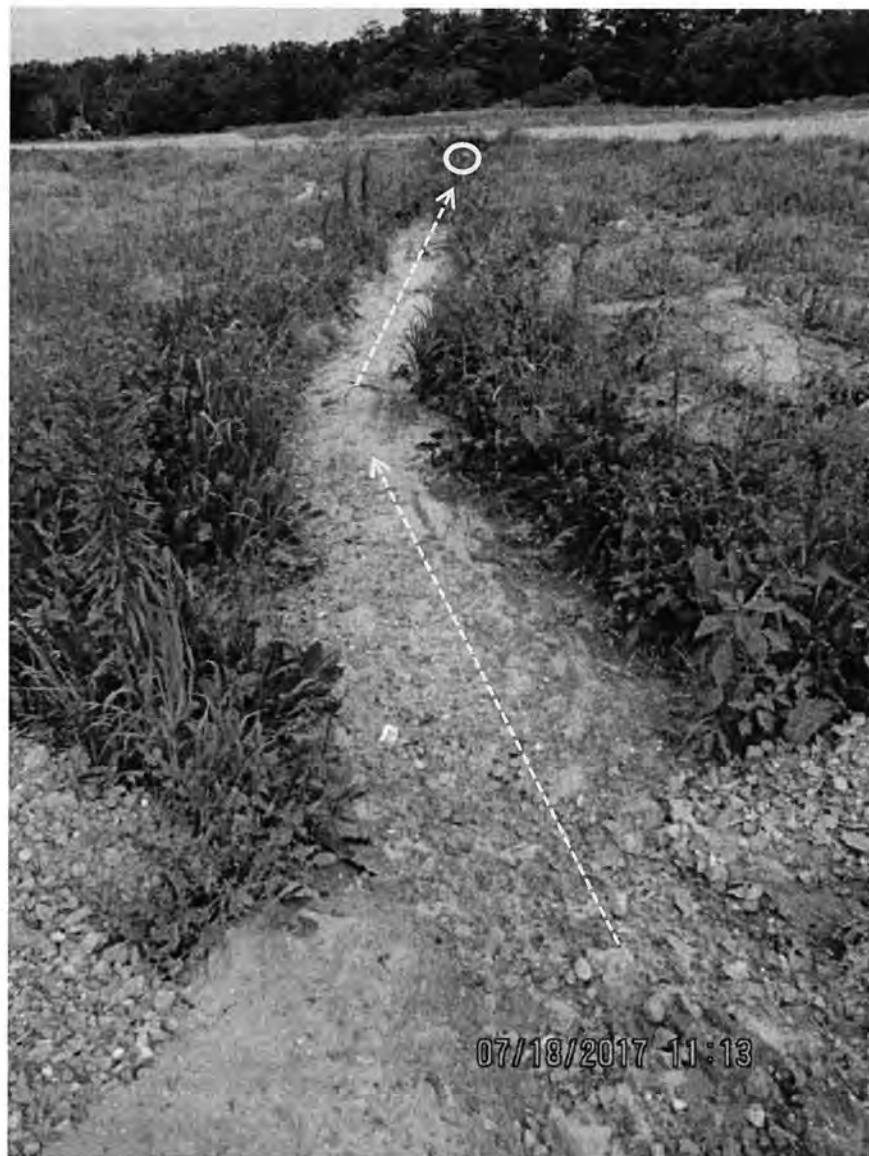
**Photo 48:** View of the storm water flow path on the east side of the main farm in front of the freestall barn and milking parlor. Yellow dashed arrows indicate direction of flow path. Yellow circle is a culvert. Photo direction is north.

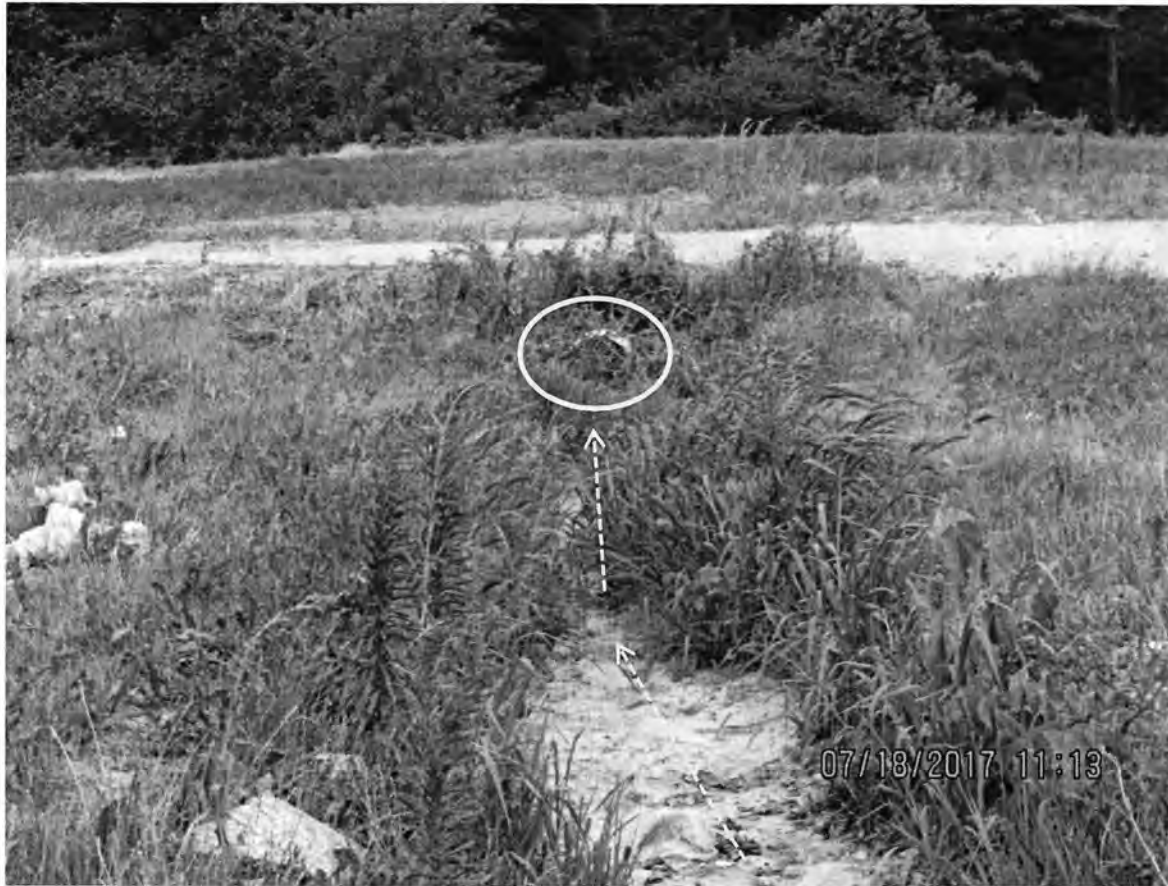
Storm water management at the main farm site consists of vegetated infiltration areas and culverts/graded areas to direct uncontaminated storm water to the vegetated areas for infiltration. Storm water from roofs that falls directly on the vegetated areas remains uncontaminated, but there are several areas onsite that require better management to prevent storm water from becoming contaminated, which will require containment and management. These areas include stacking areas for bedding, uncontained feedlot areas, and open barn doors where waste is present.

**Photo 49:** Close up view of the culvert through which storm water flows on the east side of the main farm in front of the freestall barn and milking parlor. Yellow dashed arrows indicate direction of flow path. Yellow circle is the culvert. Photo direction is north.

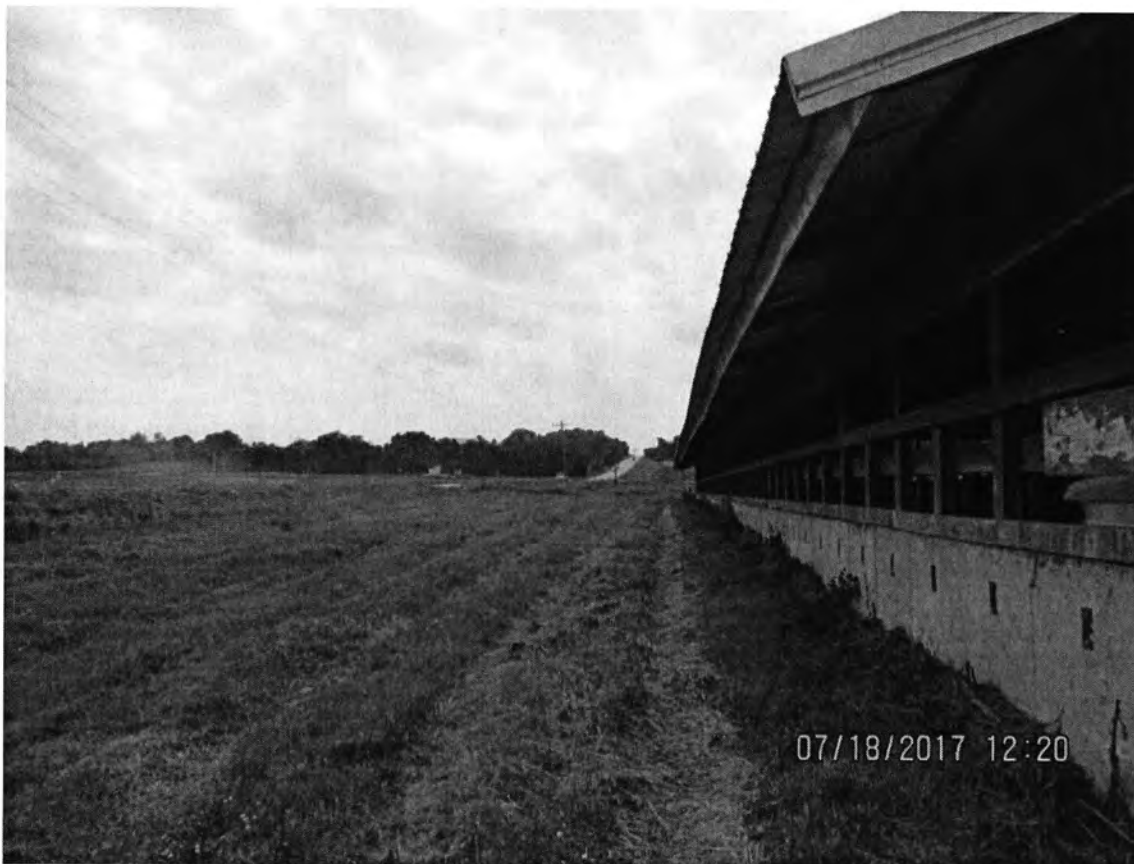
**Photo 53:** View of the exterior of the east wall of the large steer barn at the heifer site. Photo direction is south.
