State of Wisconsin | DEPARTMENT OF NATURAL RESOURCES

Subject: **Notice of Violation - Chapter 283, Wis. Statutes  
Enforcement Conference - March 9, 2009**

### **3. POTENTIAL VIOLATIONS**

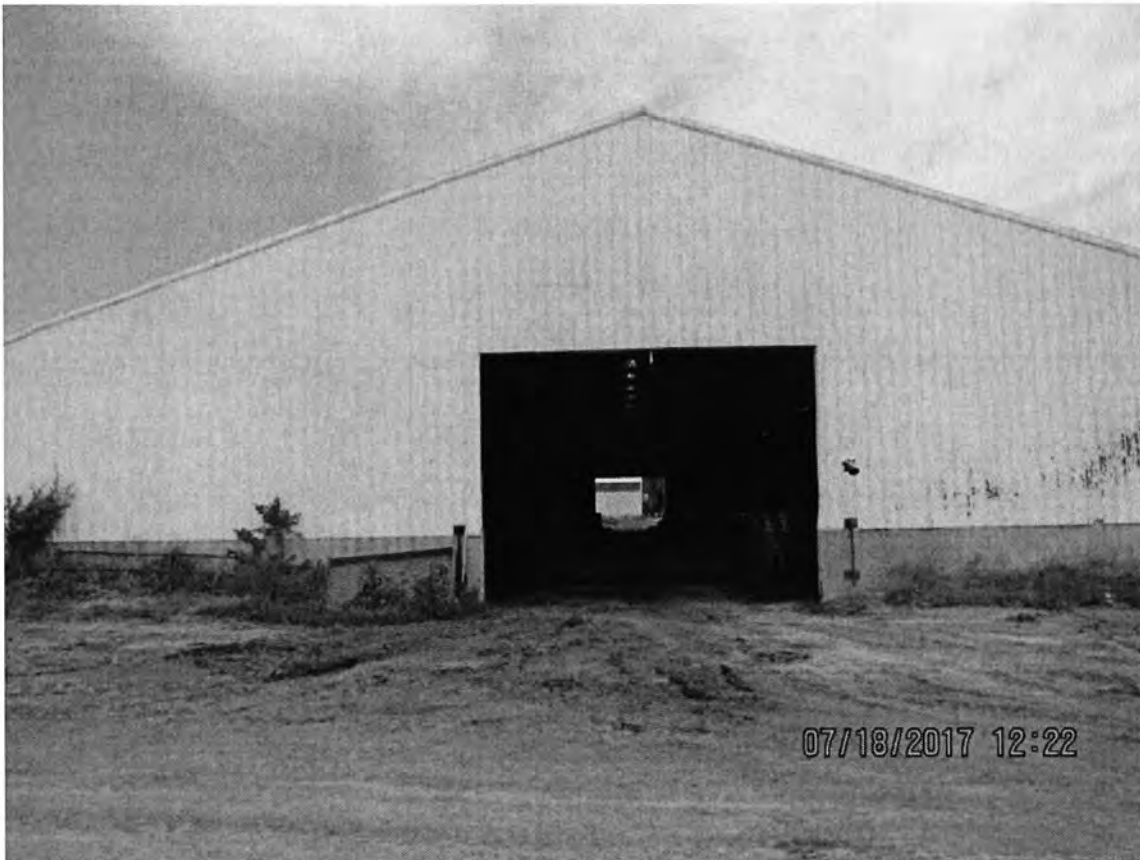
**Photo 54:** View of the south side of the large steer barn at the heifer site. Photo direction is north.

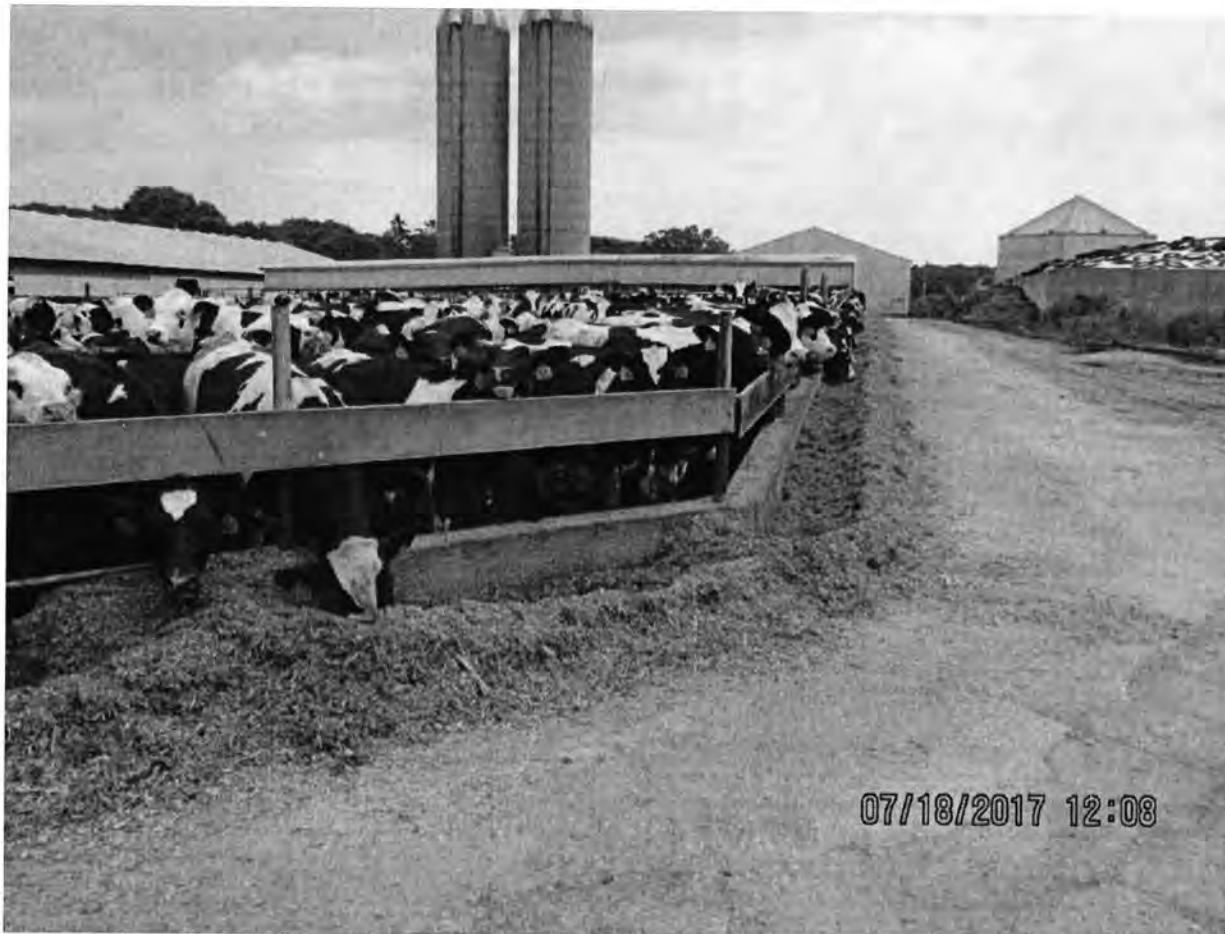
The concrete feedlot at the heifer site is attached to a freestall barn that contains heifers of various ages. The feedlot spans the length of the barn and is divided into two sections by a short concrete wall area that is roofed; the sections remain connected, as the wall does not provide complete separation. The feed lot is approximately 38,000 square feet. The feedlot is contained by a short concrete wall that provides nearly complete containment and separation from the yard area. An entrance on the east side of the feedlot is open and not contained by the concrete wall, only a metal gate. Waste was visible outside the feedlot area from the east gate, and evidence of past discharges from this area in an easterly direction was observed on the ground surface. The west side of the feedlot discharges directly into a concrete collection/reception tank that is located on the west end of the feedlot for waste collection from the feedlot. A metal gate separates the feedlot area from the tank. Waste collected in this tank is removed and directly land applied to fields as needed based on waste volume in the tank.

**Photo 56:**  
View of the  
feedlot at the  
heifer site.  
Photo  
direction is  
east.

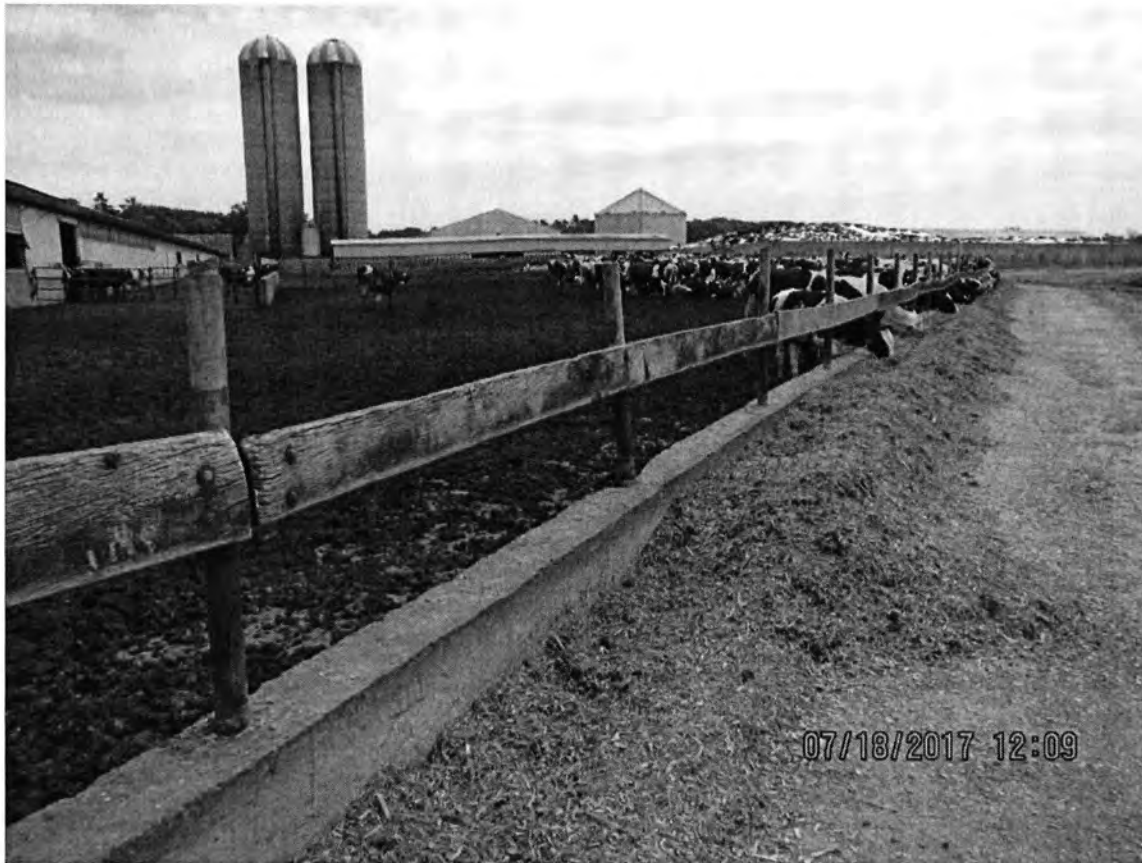
**Photo 57:** View of the feedlot at the heifer site. Photo direction is SE.

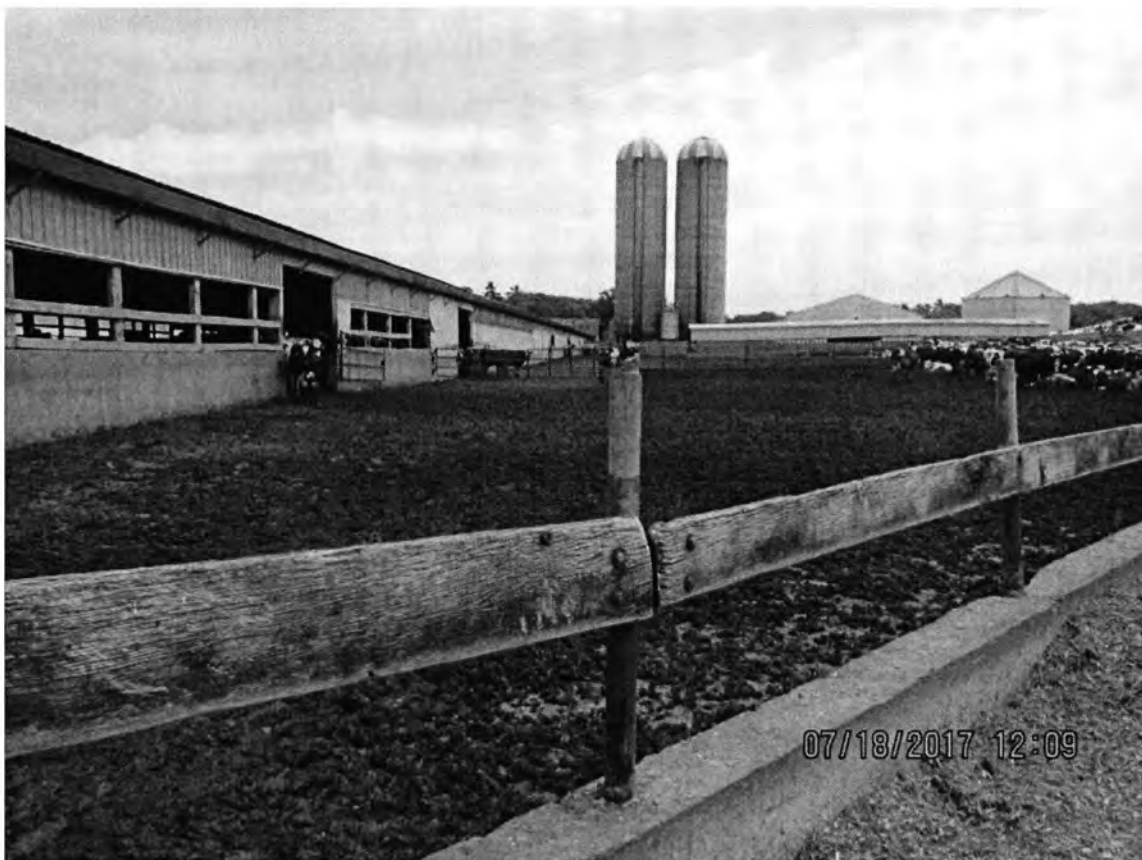
**Photo 58:** View of the feedlot at the heifer site. Photo direction is east.

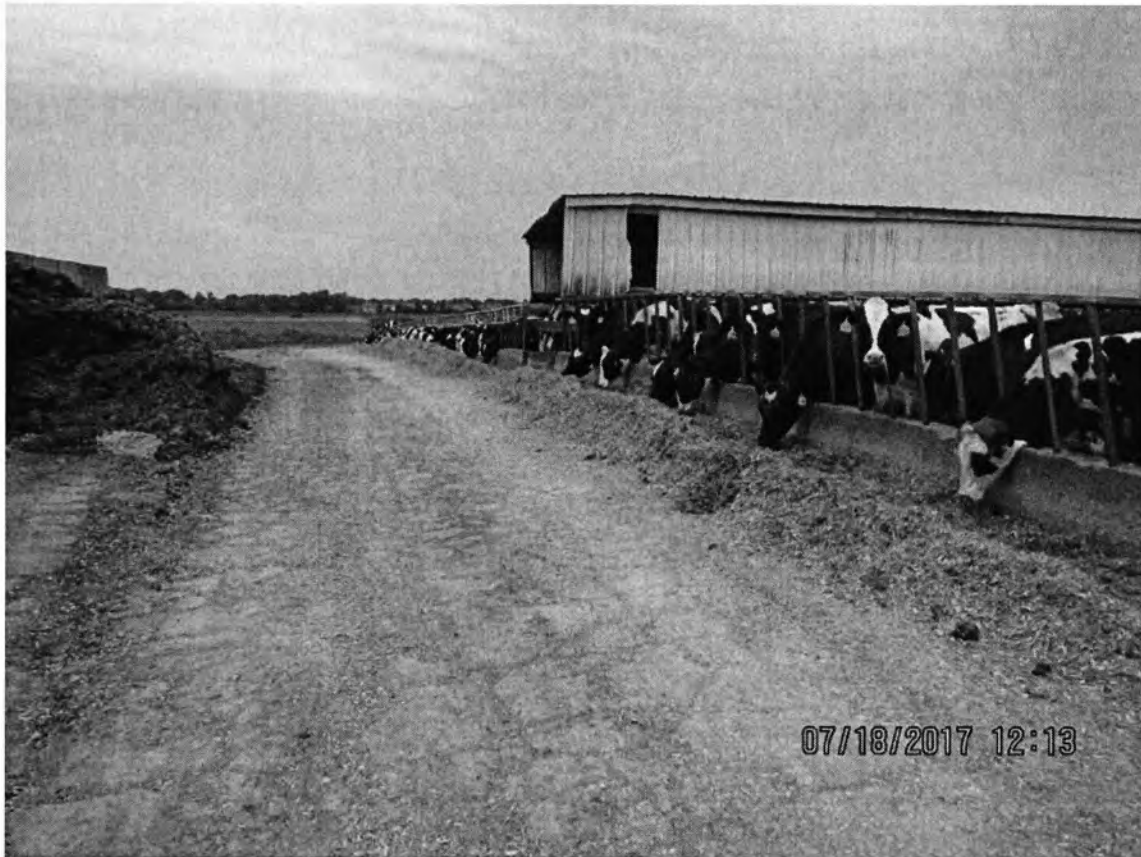
**Photo 61:** View of the feedlot at the heifer site. Photo direction is west.

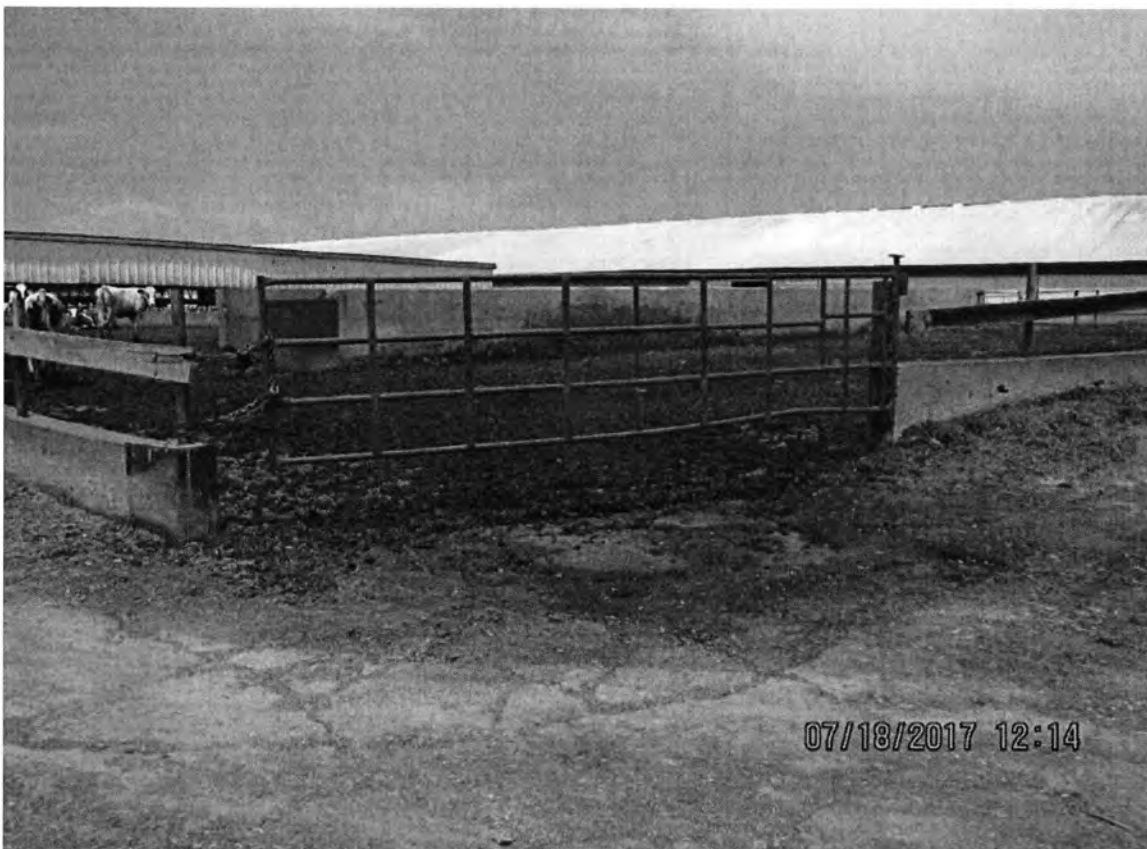
**Photo 62:** View of the east end of the feedlot at the heifer site. Photo direction is NW.

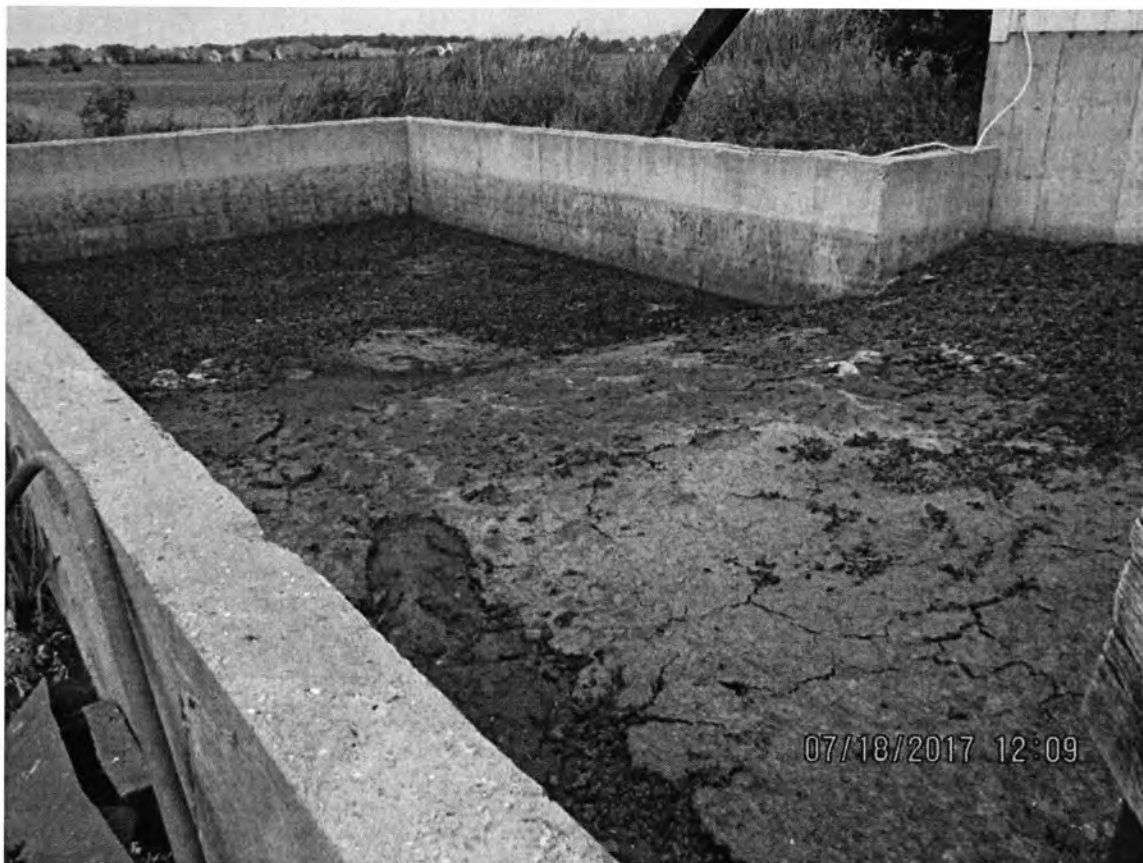
- Concrete waste storage facility on the west end of the feedlot.
  - i. Open top and partially below ground.
  - ii. Capacity and construction information not known.
- MOL/MOS markers not present.
- No discharge, leakage, or holes/cracks observed.
- Facility requires an engineering evaluation to determine compliance with statutory and administrative code requirements.

**Photo 65:** View of outfall/WSF 002 at the heifer site. Photo direction is NW.

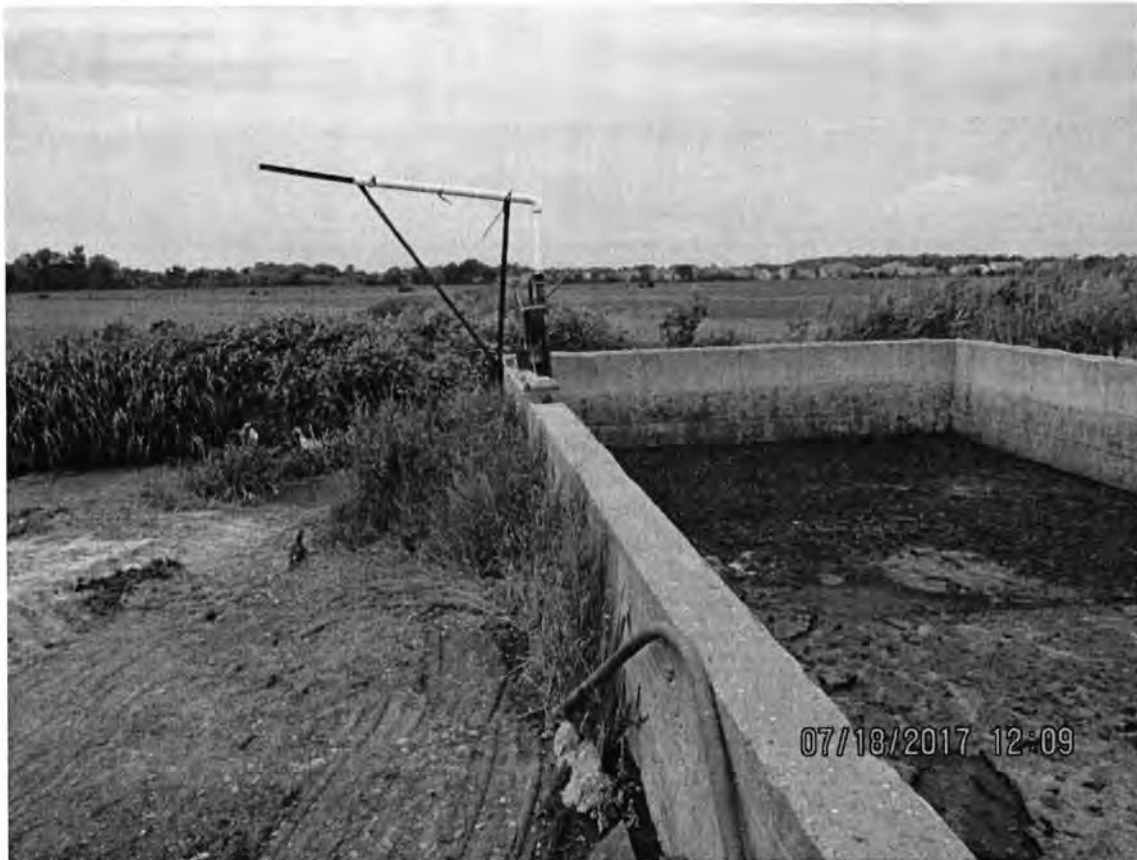
**Photo 66:** View of outfall/WSF 002 at the heifer site. Photo direction is west.

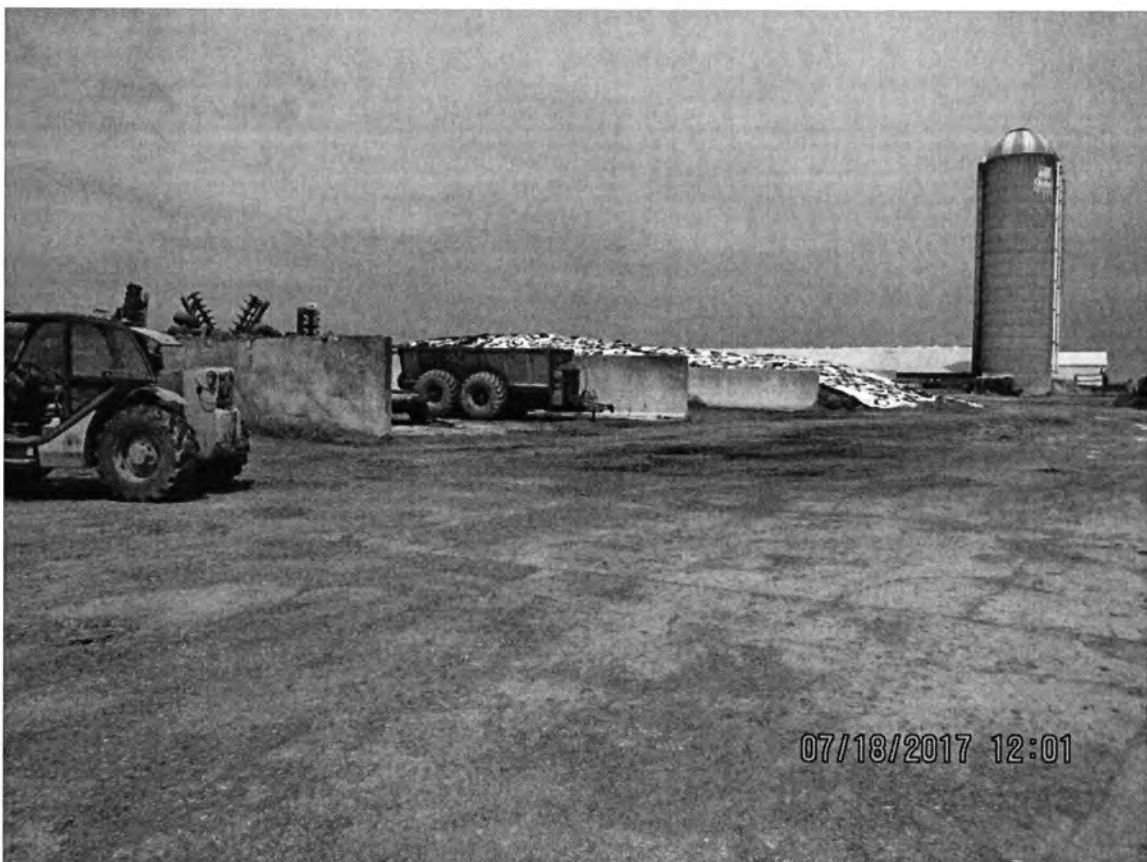
The feed storage area at the heifer site is the main feed storage area for the operation. It is located south of the large heifer barn/barn 1 and consists of several bunkers on a concrete pad. The feed storage area has undergone expansions since it was originally constructed, and there are plans for further expansion in the future. No runoff controls are currently in place for leachate and process wastewater from the feed storage area, and discharges were observed from multiple cracks in the concrete walls and drainage pathways off the concrete pad. Leachate and process wastewater discharge to the grassed waterway in the field west of the site. The drainageway in the agricultural field flows NW through the field and through a series of culverts to an unnamed tributary of Bower Creek. Waste feed piles near the feed storage area were observed contributing leachate/process wastewater to the waste discharges to the field west of the site. Ponded leachate and process wastewater were observed near the feed storage area in multiple locations.

**Photo 68:** View of the feed storage area at the heifer site. Photo direction is NW.

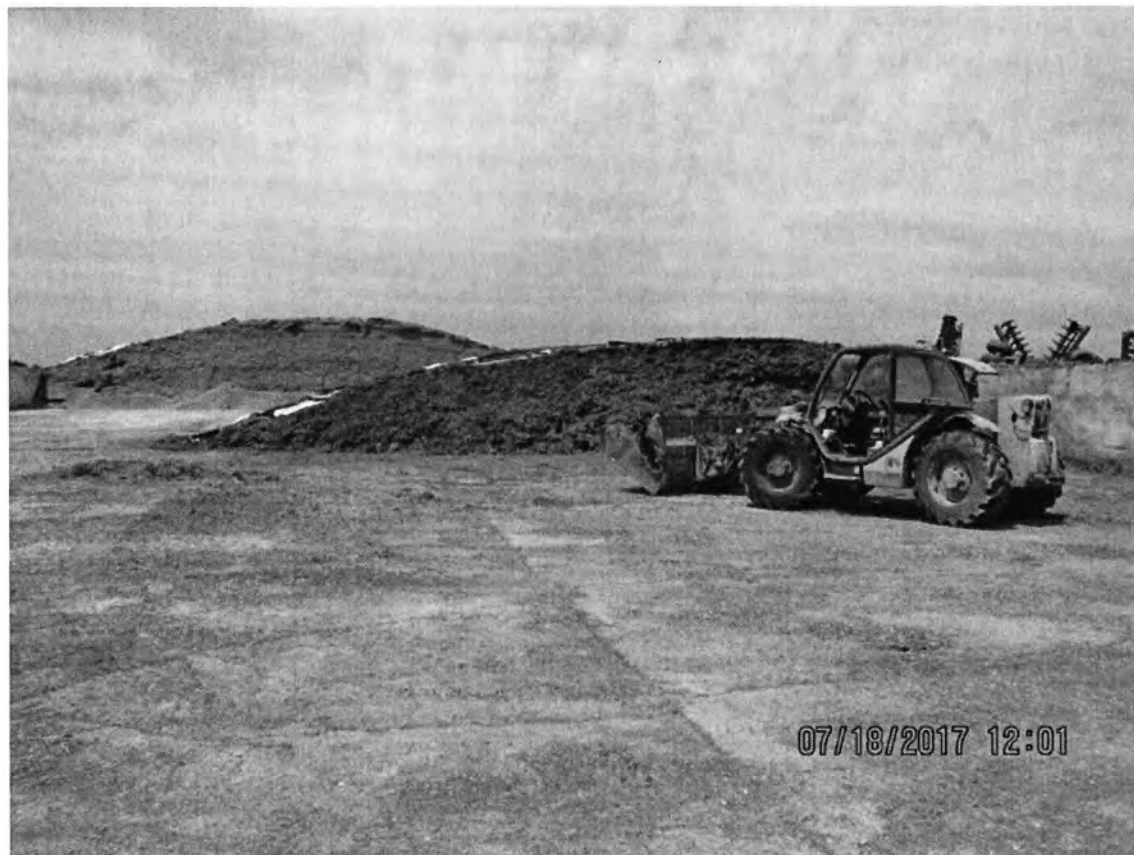
**Photo 69:**  
Alternate view of  
the feed storage  
area at the heifer  
site. Photo  
direction is west.

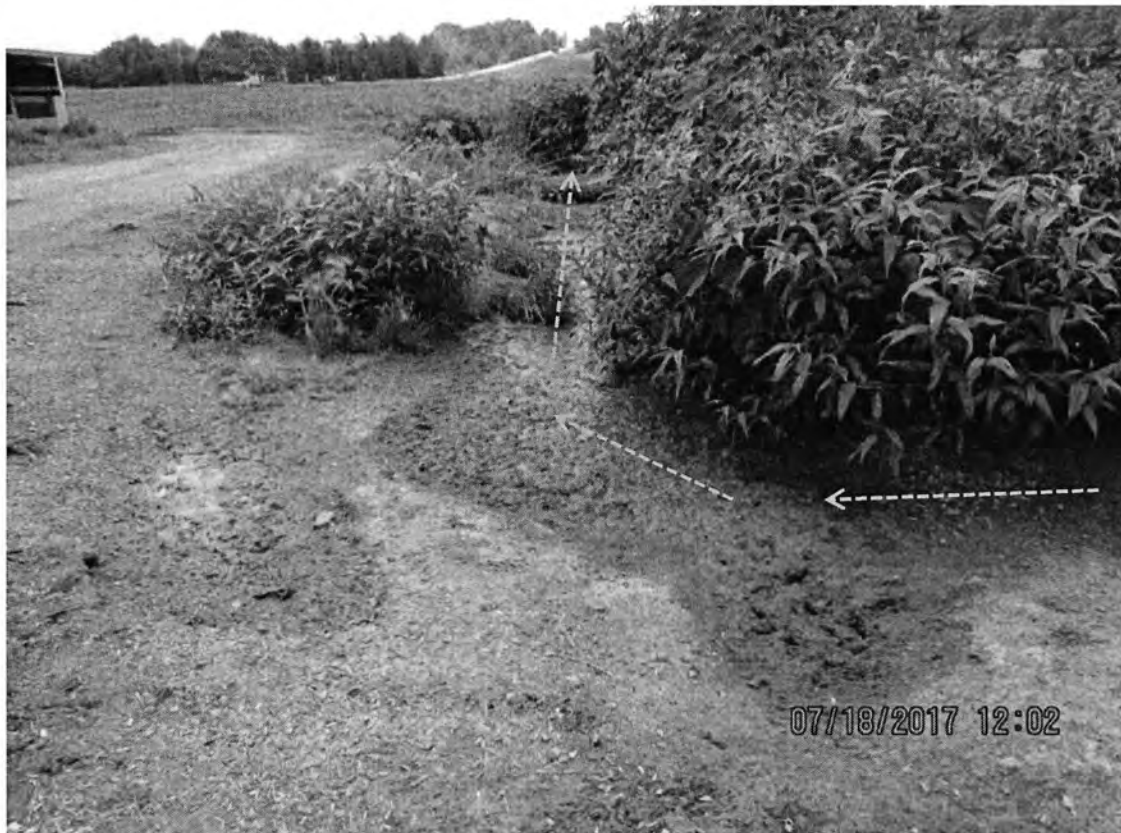
**Photo 71:** Close up view of leachate discharging from the south wall of the feed storage area at the heifer site. Orange dashed arrows indicate flow direction of leachate. Photo direction is south.

- b. Waste feed piles were observed at the Heifer Site that contributed to the process wastewater runoff.
- c. There are currently no runoff controls for leachate and process wastewater from the feed storage area.

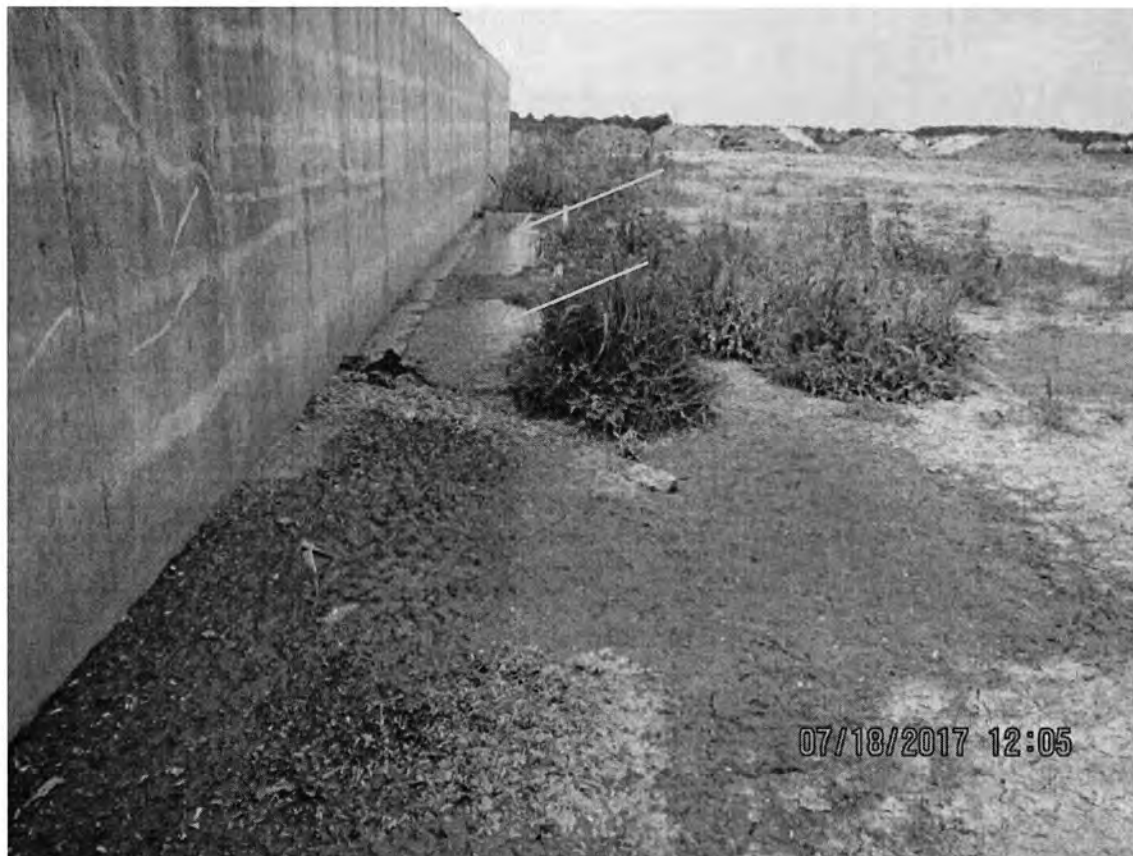
**Photo 73:** Close up view of a concrete wall from the middle of the feed storage area at the heifer site. Ponded leachate was observed adjacent to the wall (orange arrows). Photo direction is west.

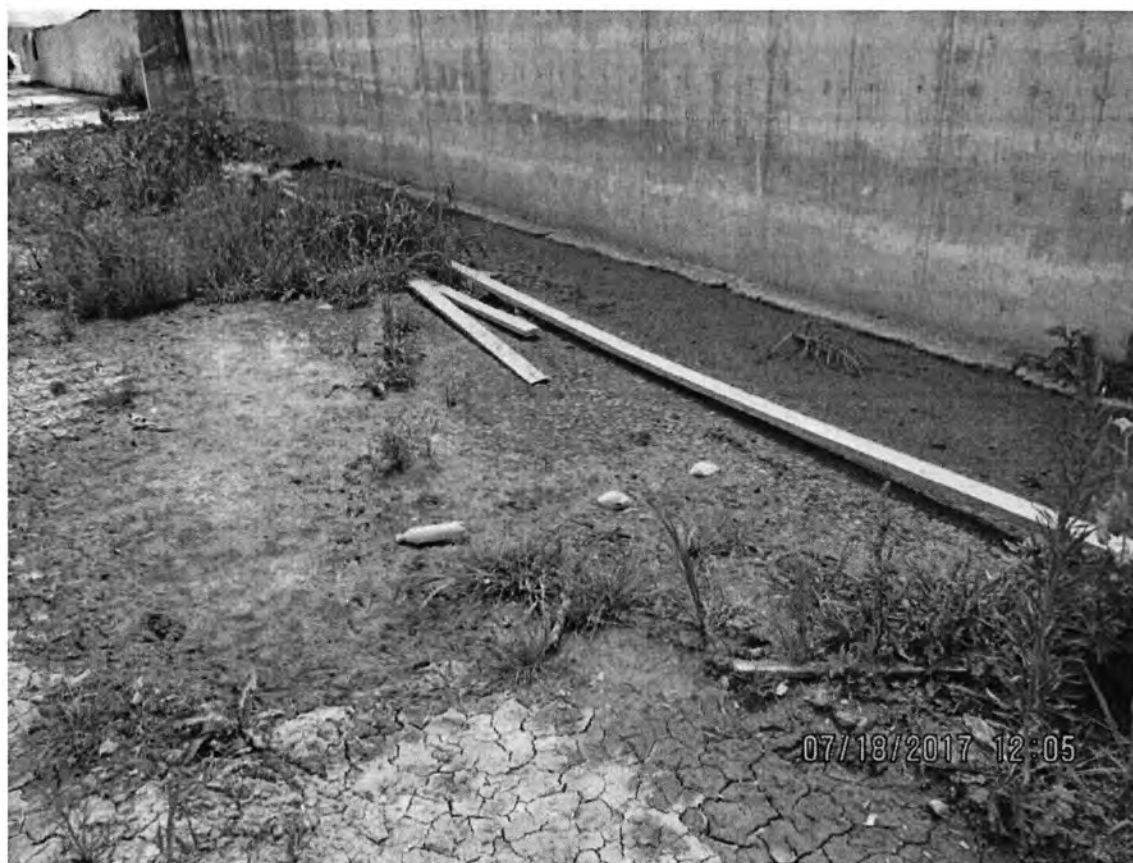
**Photo 74:** Close up view of a concrete wall from the middle of the feed storage area at the heifer site. Ponded leachate was observed adjacent to the wall. Photo direction is west.

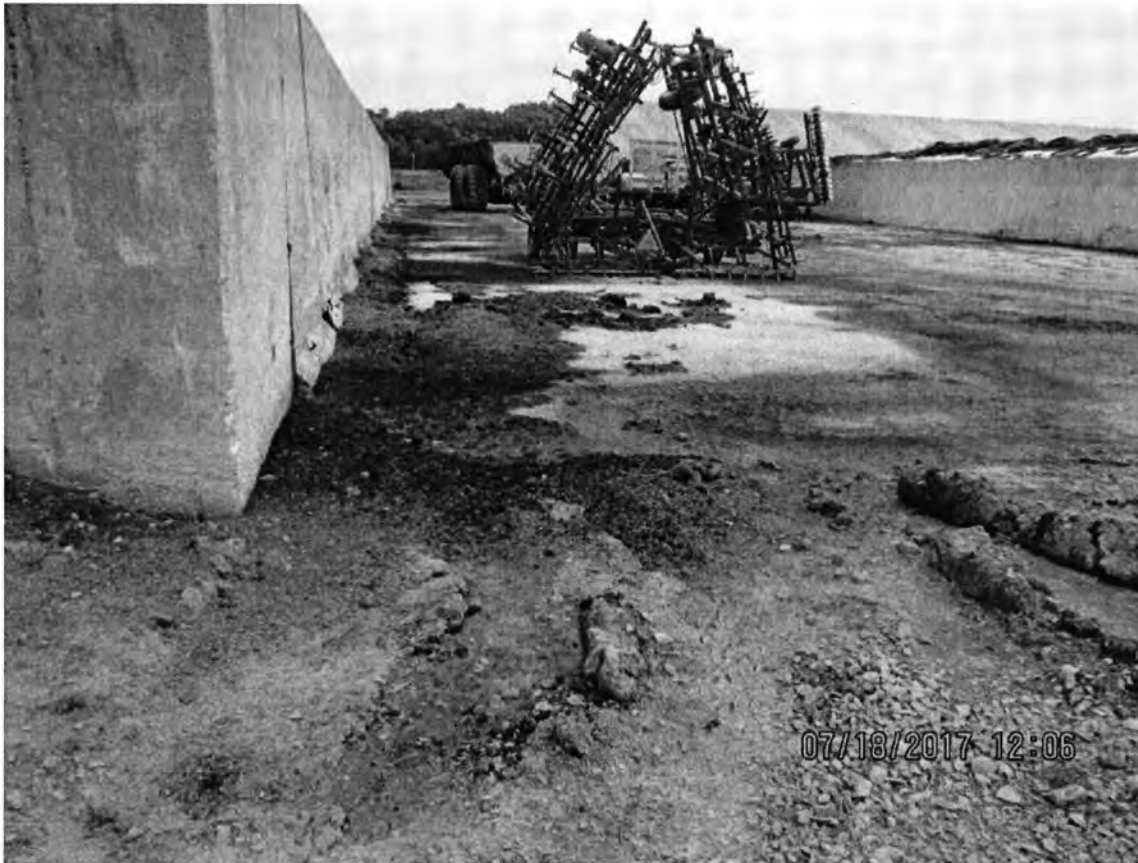
**Photo 75:** View of a concrete wall from the middle of the feed storage area at the heifer site. Leachate was observed discharging from the wall (black liquid/substance). Photo direction is east.

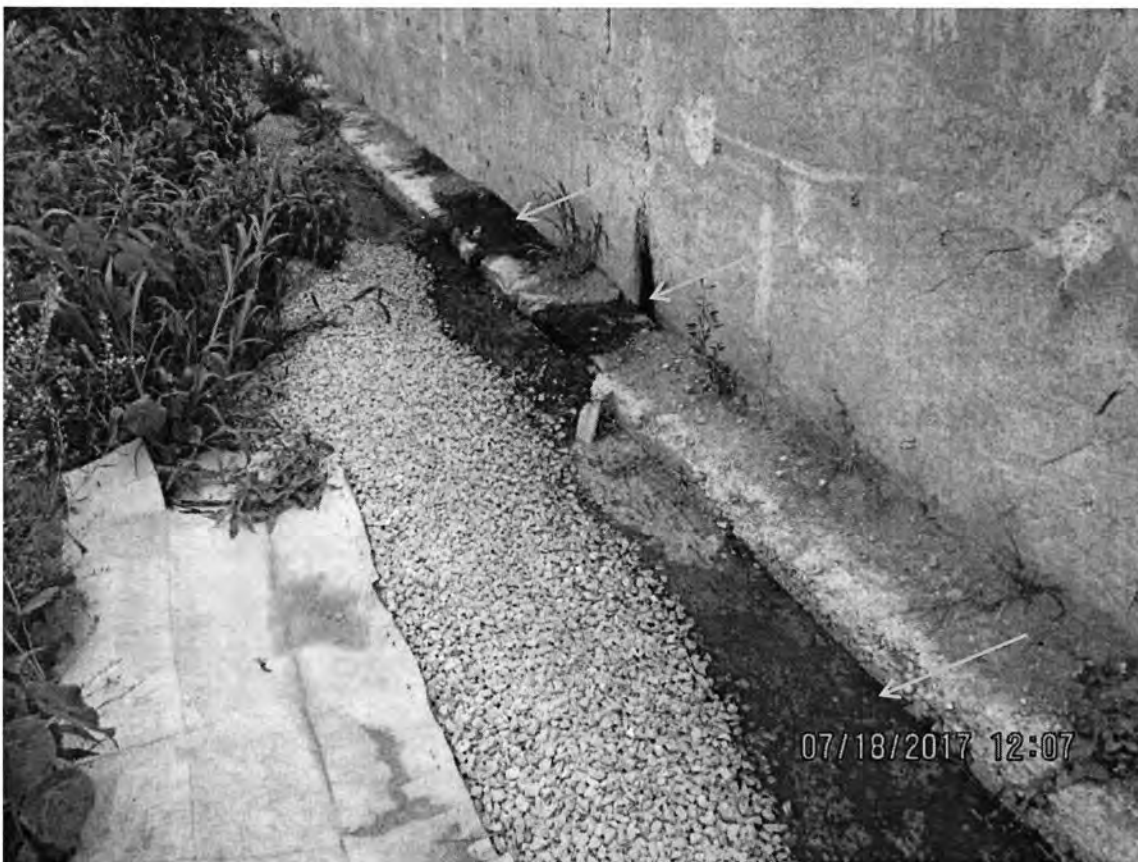
**Photo 76:** Close up view of the concrete wall on the NW side of the feed storage area at the heifer site. Leachate was observed discharging from the wall and was ponded adjacent to the wall (orange arrows). Photo direction is NE and down.

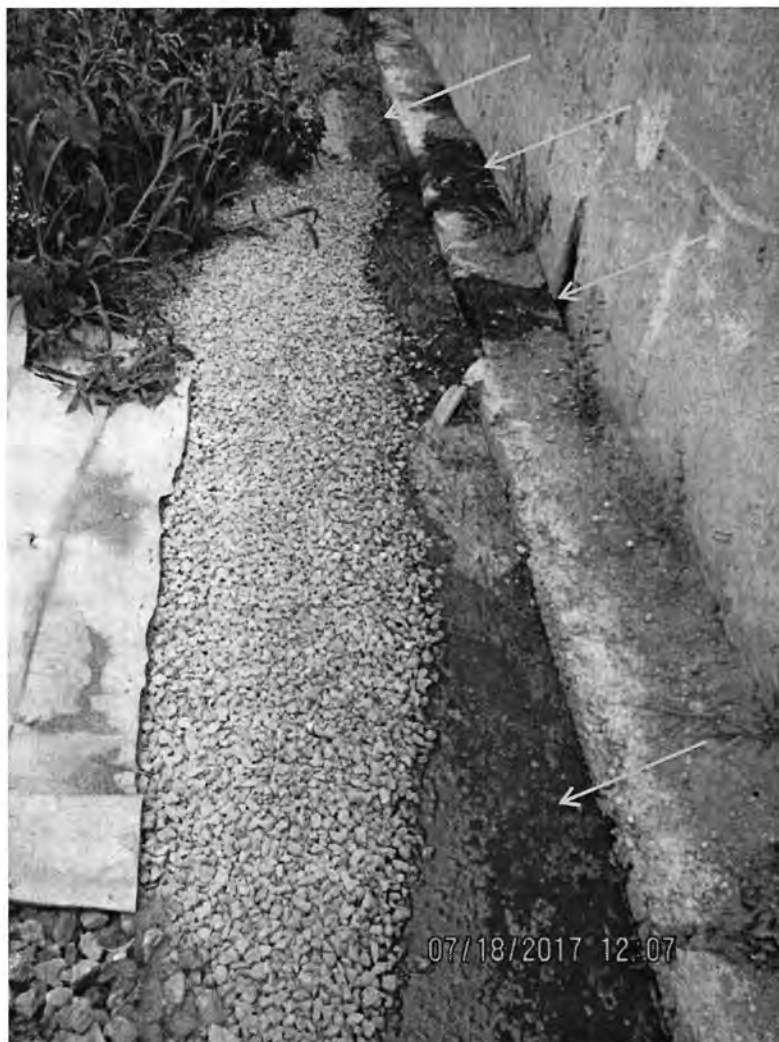
**Photo 77:**  
Alternate view of the concrete wall on the NW side of the feed storage area at the heifer site. Leachate was observed discharging from the wall and was ponded adjacent to the wall (orange arrows). Photo direction is NE and down.

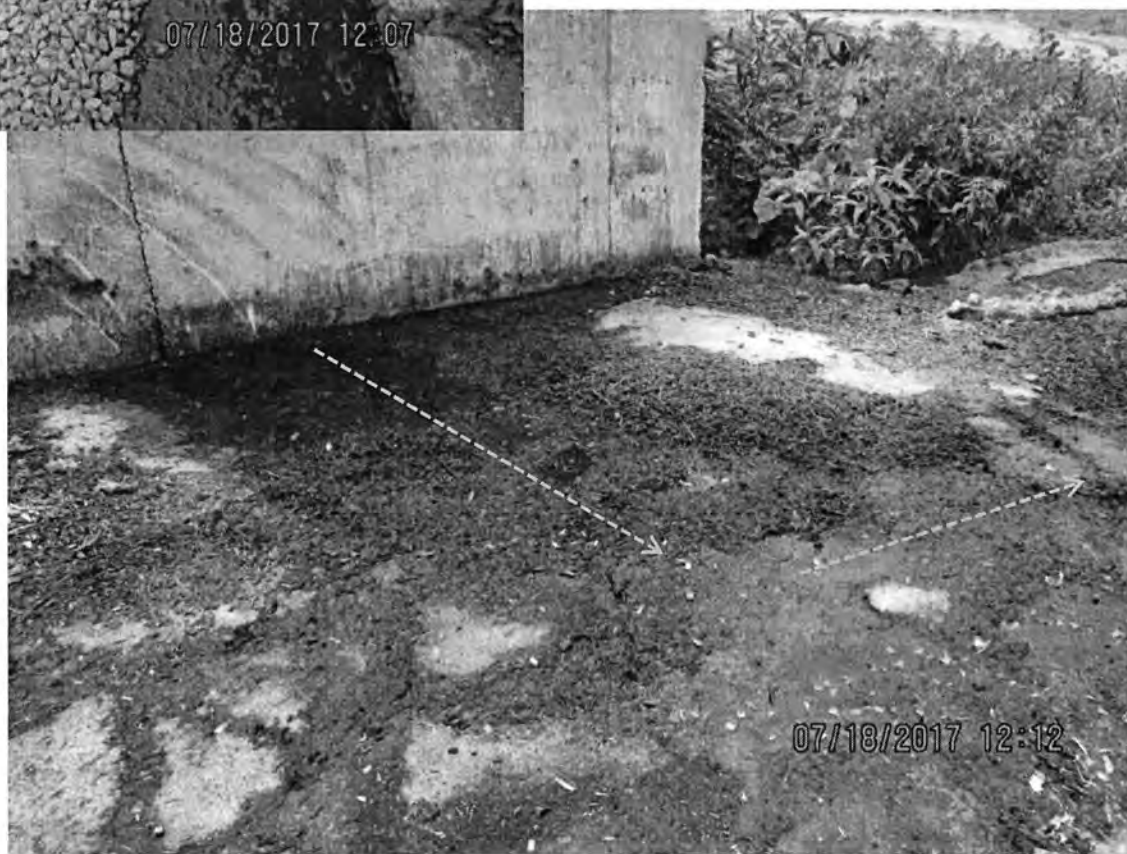
**Photo 78:** View of the north concrete wall of the feed storage area at the heifer site. Leachate was observed discharging from the wall. Orange dashed arrows indicate flow path of leachate discharge. Photo direction is SW and down.

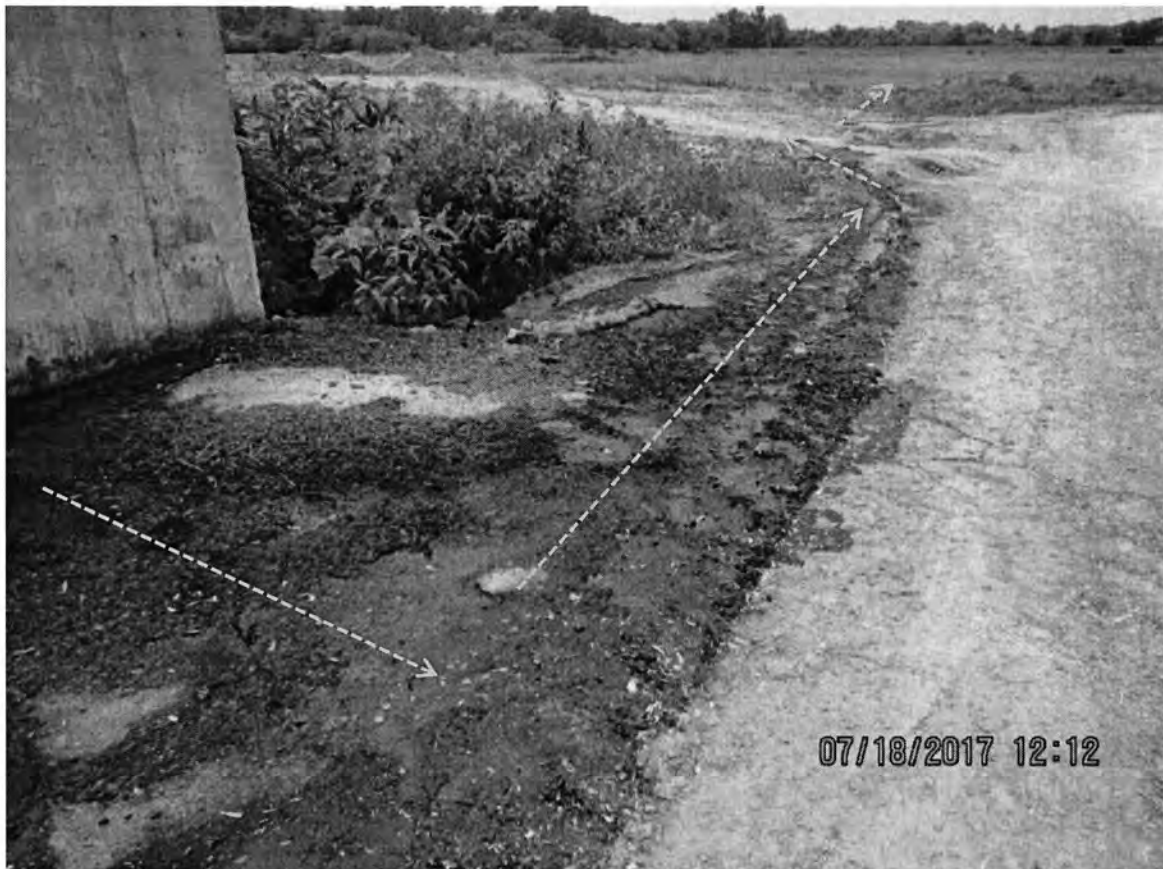
**Photo 79:**  
Alternate view of the north concrete wall of the feed storage area at the heifer site. Leachate was observed discharging from the wall and flowing west. Orange dashed arrows indicate flow path of leachate discharge. Photo direction is west.

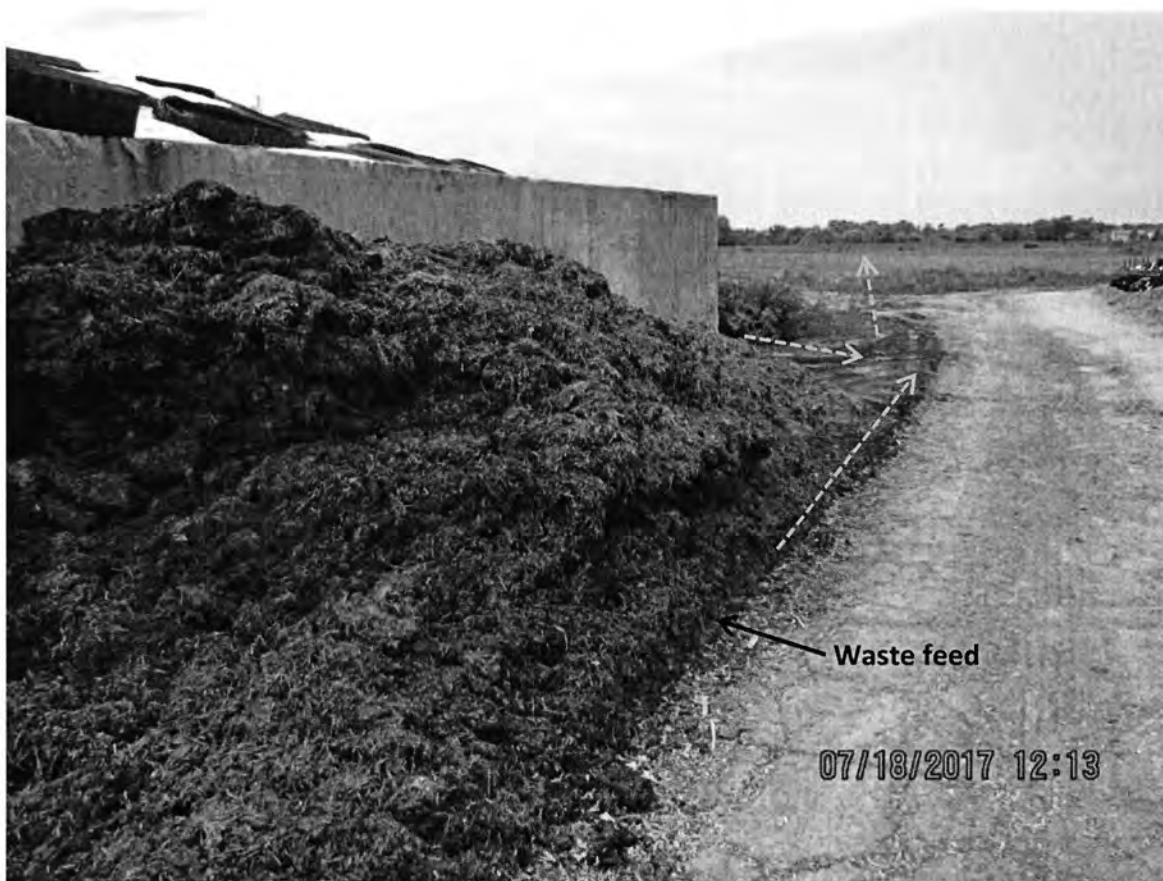
**Photo 80:**  
Alternate view of the north concrete wall of the feed storage area at the heifer site. Leachate was observed discharging from the wall and flowing west. Orange dashed arrows indicate flow path of leachate discharge. Photo direction is west.

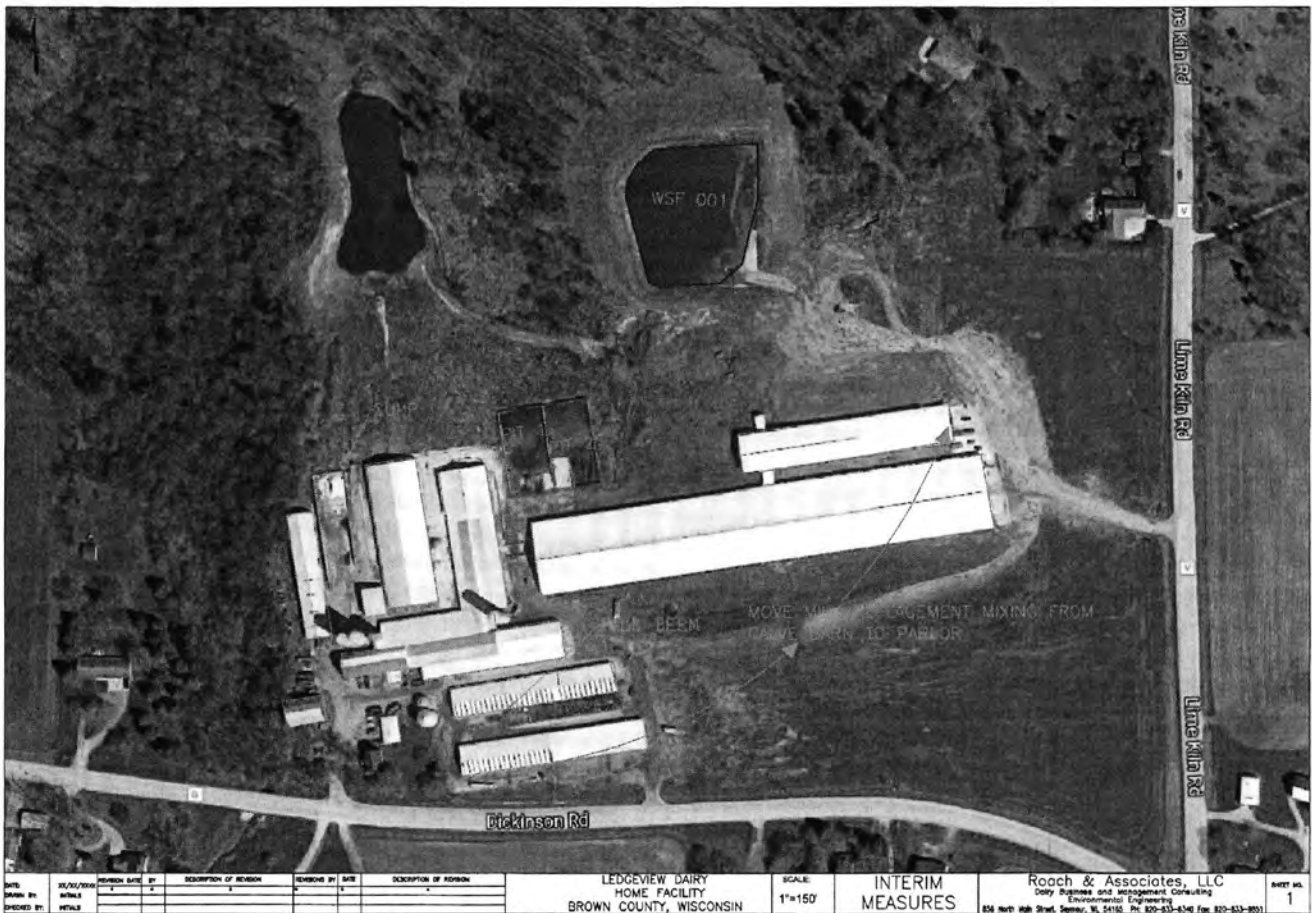
## **Exhibit 2**

DATE: 3/1/2000	REVISION DATE BY	DESCRIPTION OF REVISION	REVISION BY	DATE	DESCRIPTION OF REVISION	LEDGEVIEW DAIRY HOME FACILITY BROWN COUNTY, WISCONSIN	SCALE: 1"=150'	INTERIM MEASURES	Roach & Associates, LLC Dairy Business and Management Consulting Environmental Engineering 828 North Main Street, Oshkosh, WI 54901. PH: 920-433-6348 FAX: 920-433-8933	SHEET NO. 1
DRAWN BY: MTH	1									
CHECKED BY: MTH	2

*The discharge of wastewater that was observed is the result of washing the tank used to deliver milk to the baby calves in the calf barn. Following the visit and as an interim measure until a final solution is found, LD will take wastewater from washing the Milk Tank to the Main Parlor and empty it into the floor drain in the utility room. The wastewater from the floor drain flows to the Waste Storage Facility (001 WSF).*

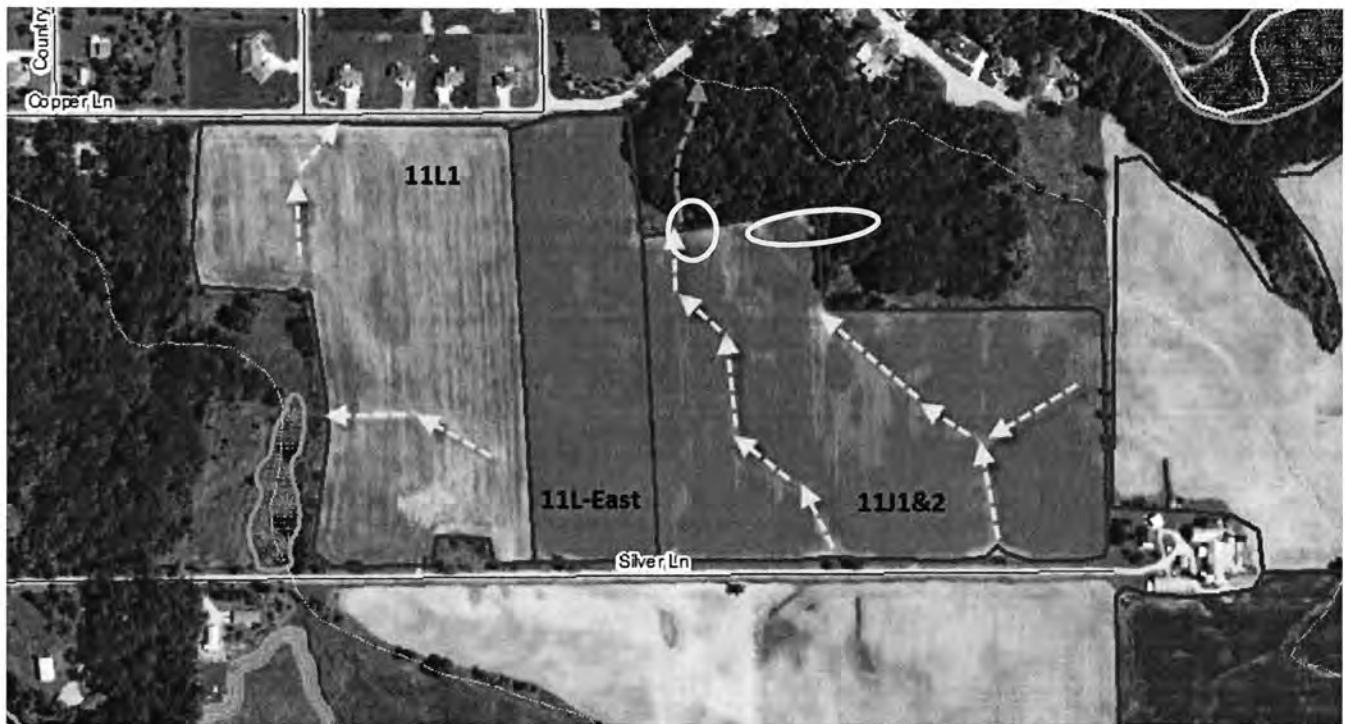
**Figure 1.** Aerial map showing fields that were audited on 01/11/18. Dashed yellow arrows represent concentrated flow channels observed during the audit. Yellow circles indicate locations of ponded storm water/snowmelt. Blue dashed arrow represents a stream observed flowing through the wooded area. Arrows indicate direction of flow.

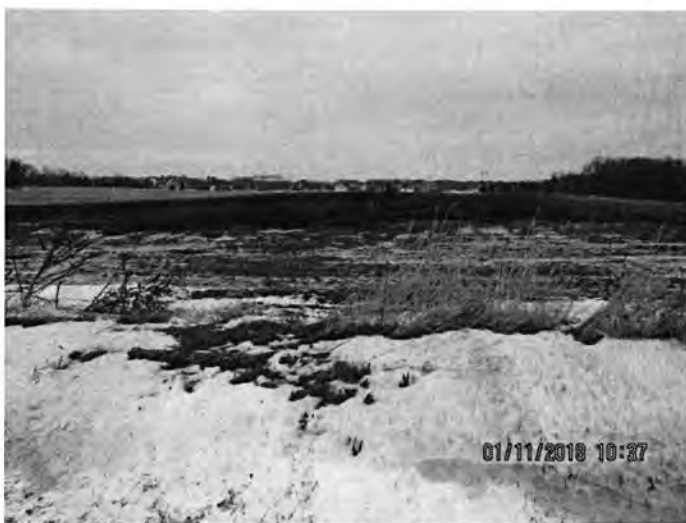
Photo 1: View of 11L-East from Silver Ln showing surface manure. Photo direction is north.
