State of Wisconsin | DEPARTMENT OF NATURAL RESOURCES

Subject: **Notice of Violation - Chapter 283, Wis. Statutes  
Enforcement Conference - March 9, 2009**

### **3. POTENTIAL VIOLATIONS**

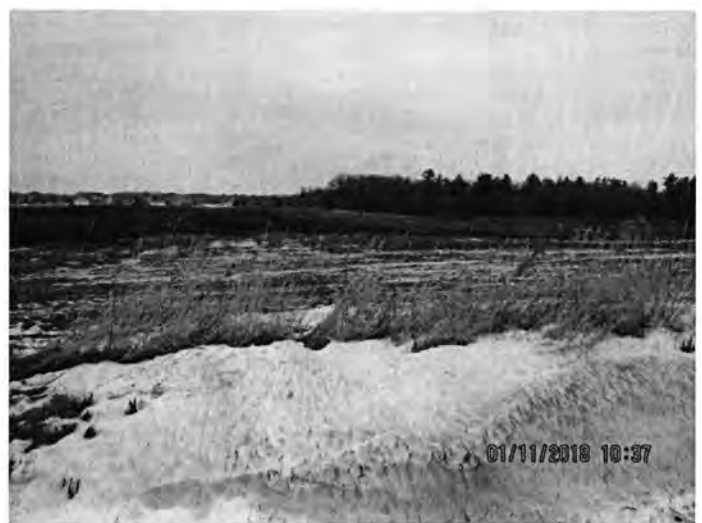
Photo 2: View of the east side of 11L-East from Silver Ln showing surface application of solid manure. Photo direction is north.

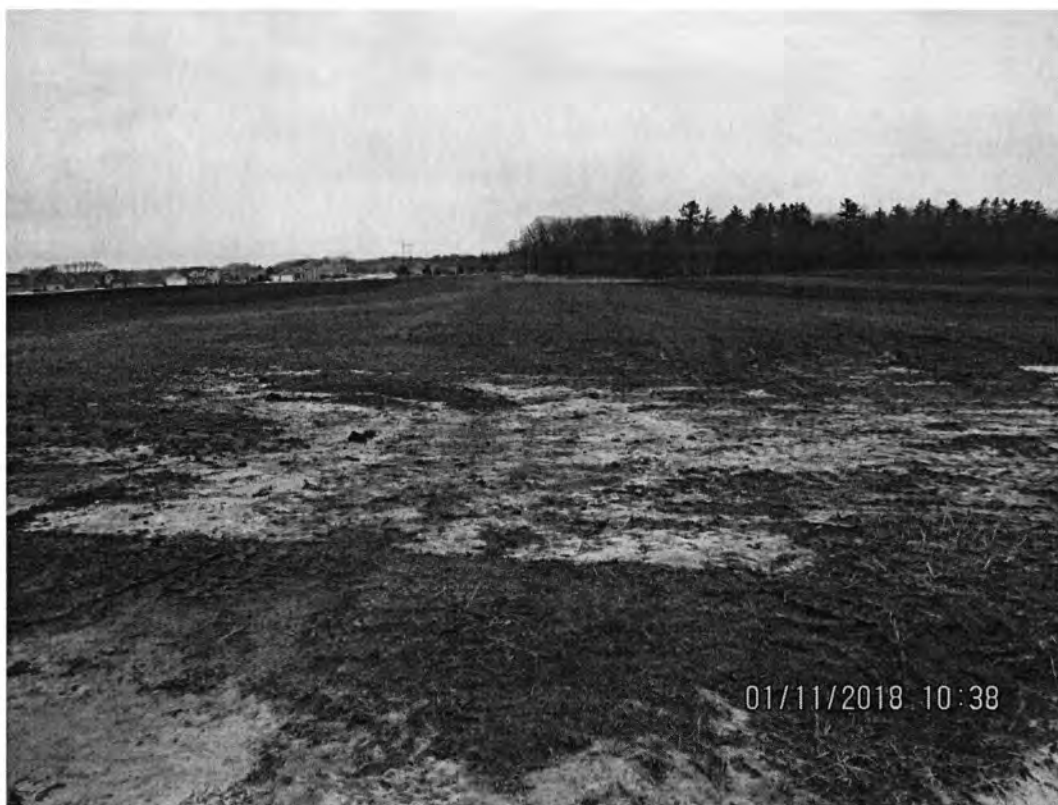
**Photo 3:** View of 11L-East from Silver Ln showing surface application of solid manure. Photo direction is north.

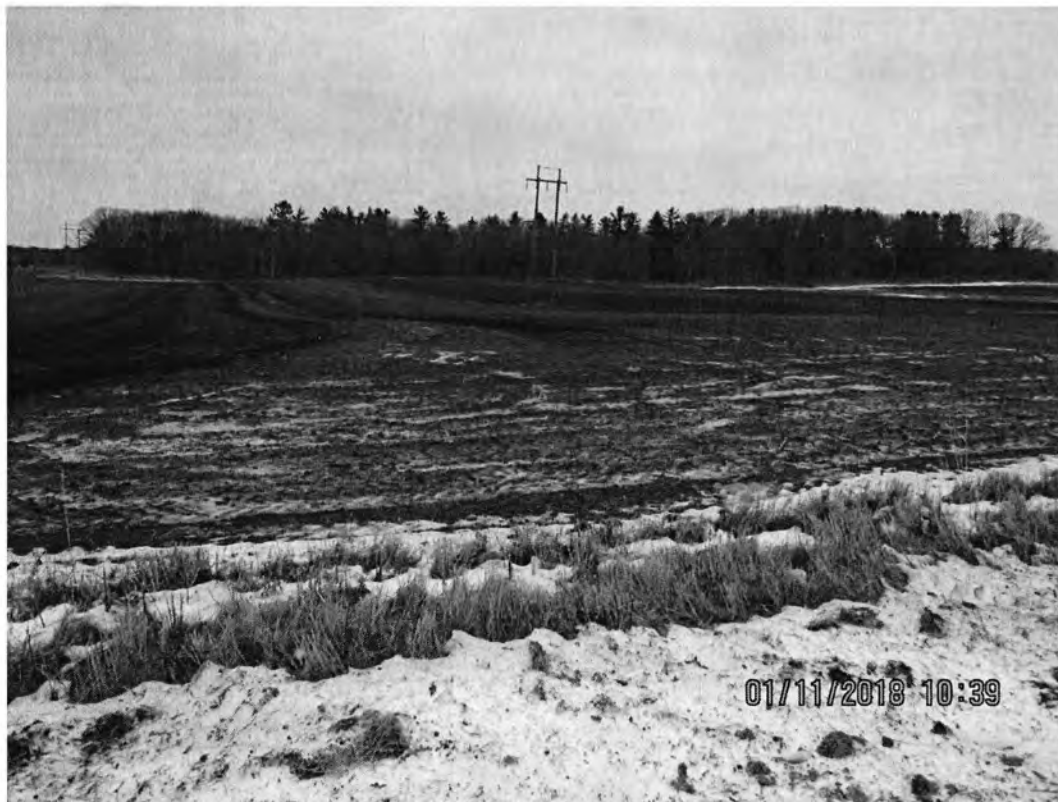
**Photo 4:** View of the west side of 11J1&2 from Silver Ln showing surface application of solid manure. Photo direction is NE.

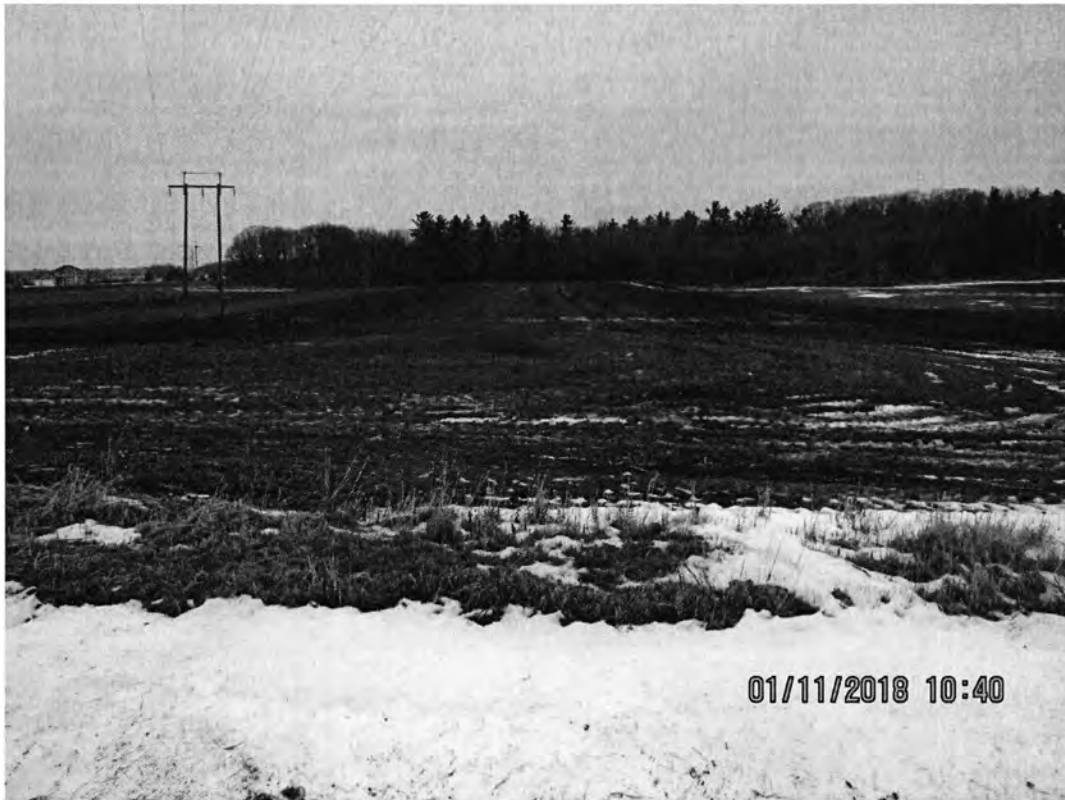
**Photo 5:** View of the middle section of 11J1&2 from Silver Ln showing surface application of solid manure. Photo direction is north.

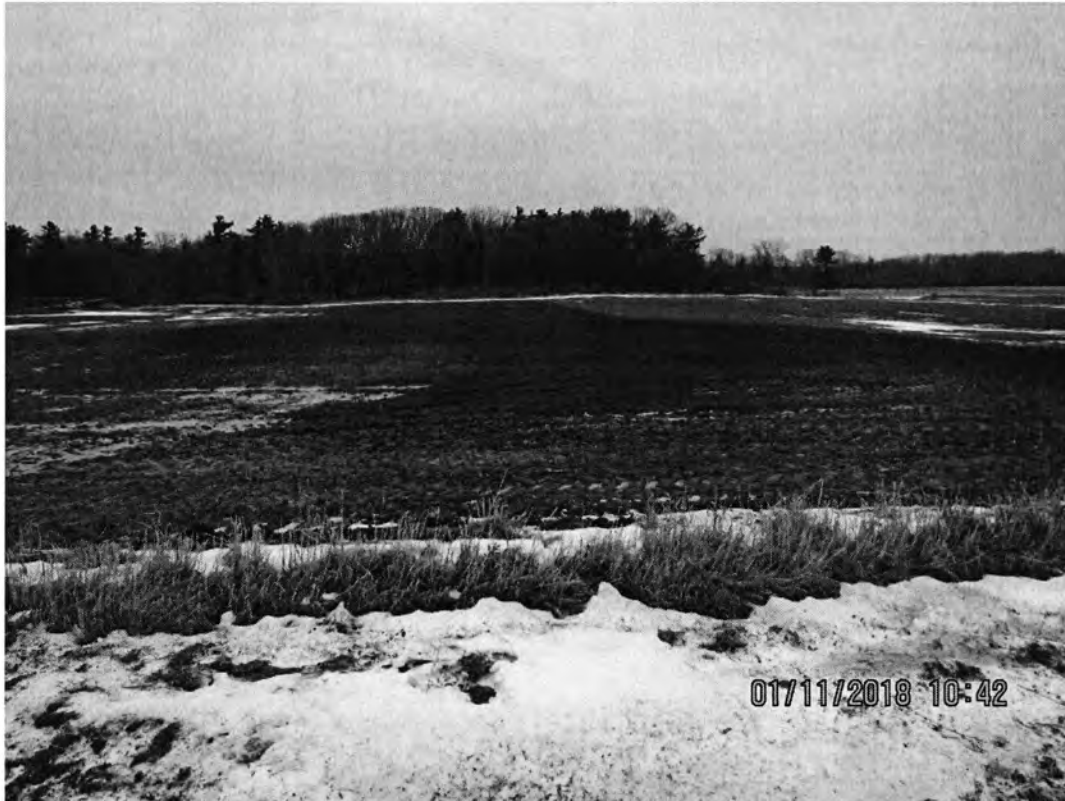
**Photo 6:** View of the east side of 11J1&2 from Silver Ln showing surface application of solid manure. Photo direction is north.

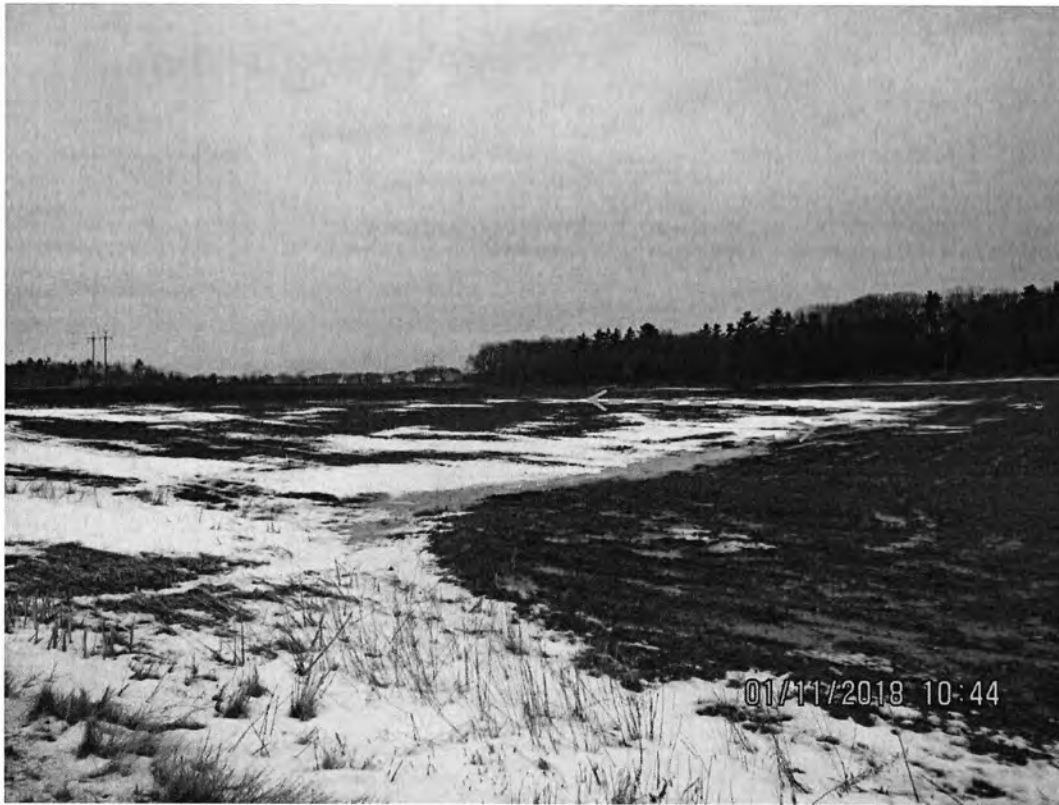
**Photo 7:** View of the south and west sections of 11J1&2 from Silver Ln showing one of the concentrated flow channels /grassed waterways (indicated by the green dashed arrows). Photo direction is NW.

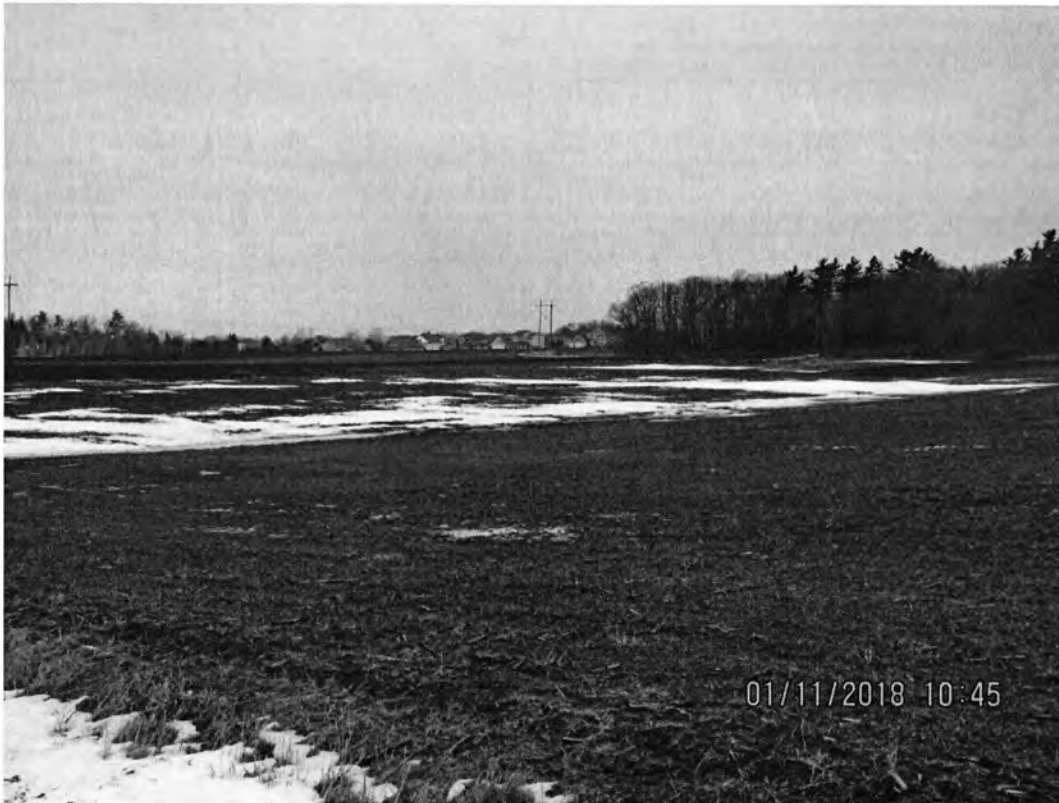
**Photo 8:** Alternate view of the south and west sections of 11J1&2 from Silver Ln showing one of the concentrated flow channels /grassed waterways. Photo direction is NW.

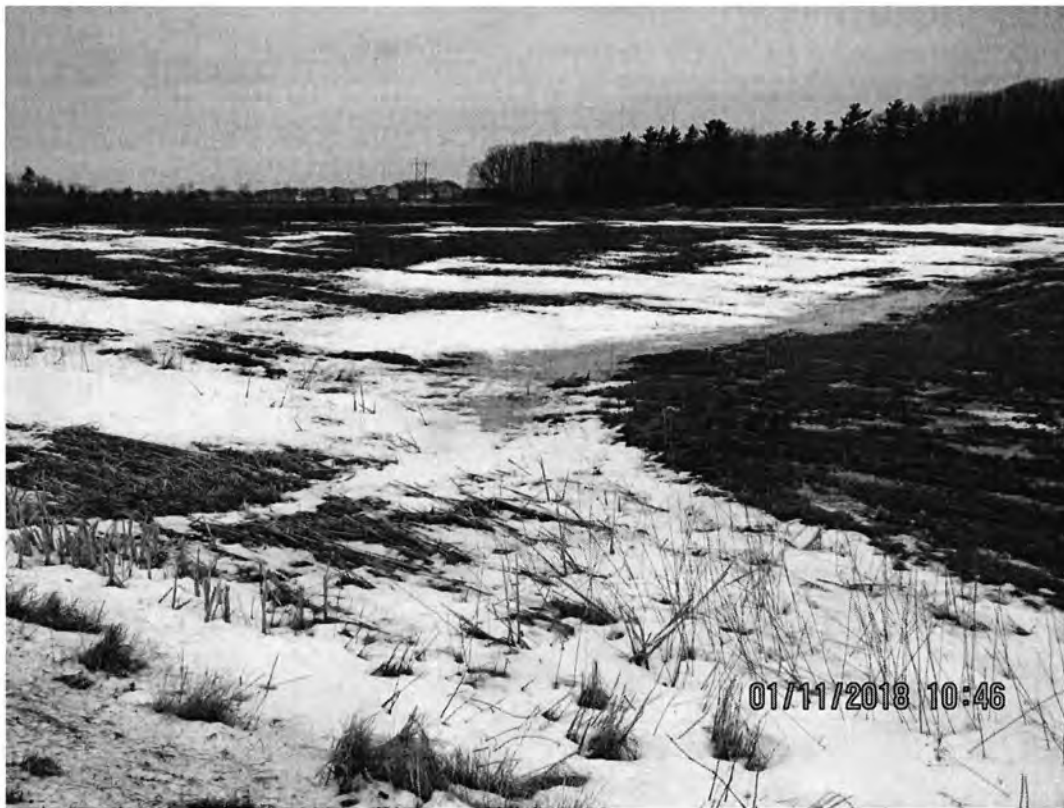
**Photo 9:**  
Alternate view  
of the south  
and west  
sections of  
11J1&2 from  
Silver Ln  
showing one  
of the  
concentrated  
flow channels  
/grassed  
waterways  
(indicated by  
the dashed  
green arrow).  
Photo  
direction is  
NW.

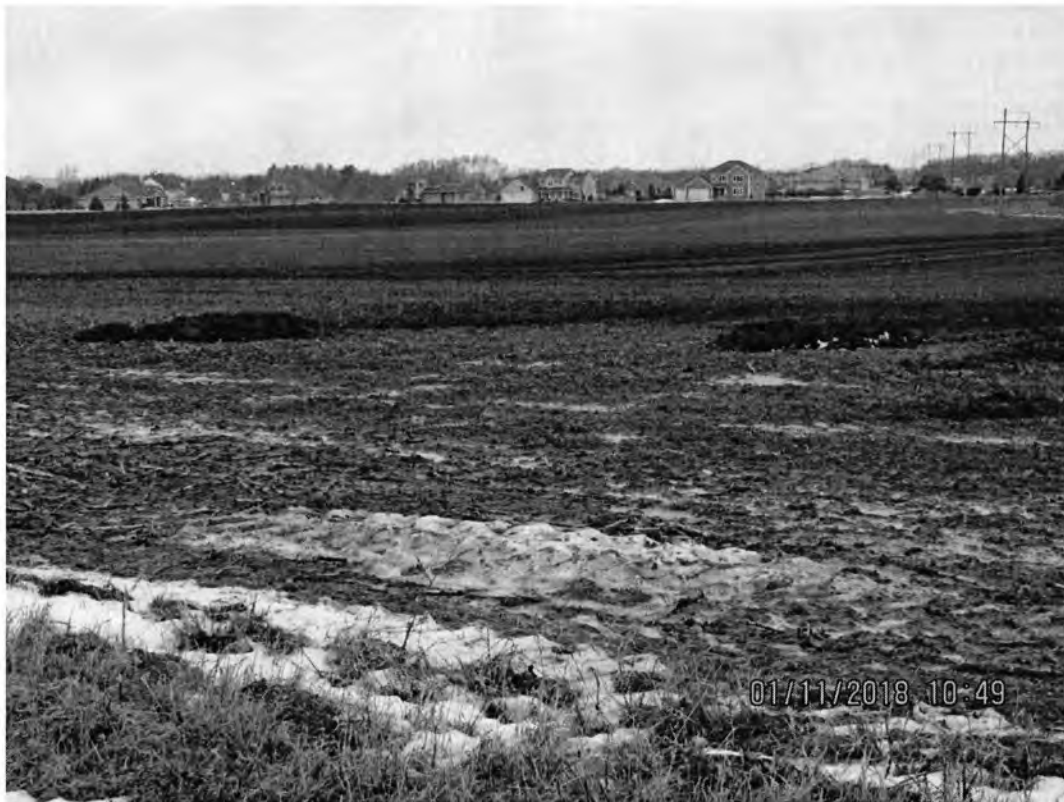
**Photo 10:**  
View of piles  
of solid  
manure in the  
southern  
section of  
11J1&2. Photo  
direction is  
NW.

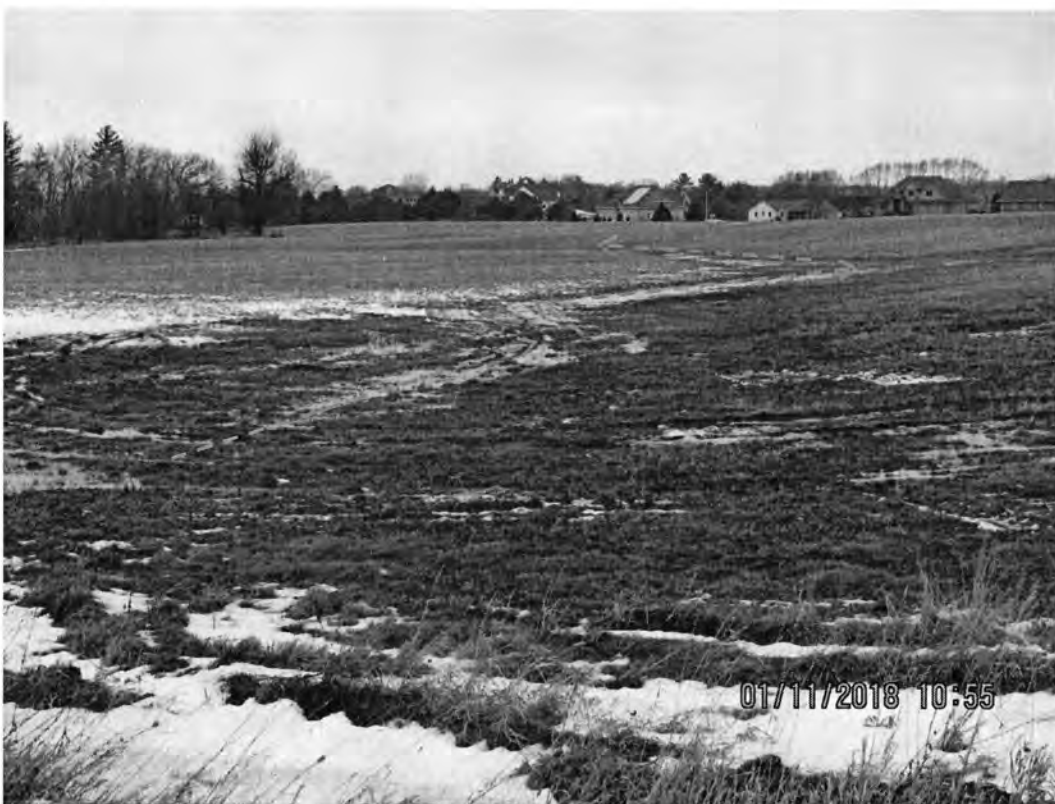
**Photo 11:** View of 11L1 from Silver Ln showing one of the concentrated flow channels /grassed waterways (indicated by the dashed green arrows). Photo direction is NW.

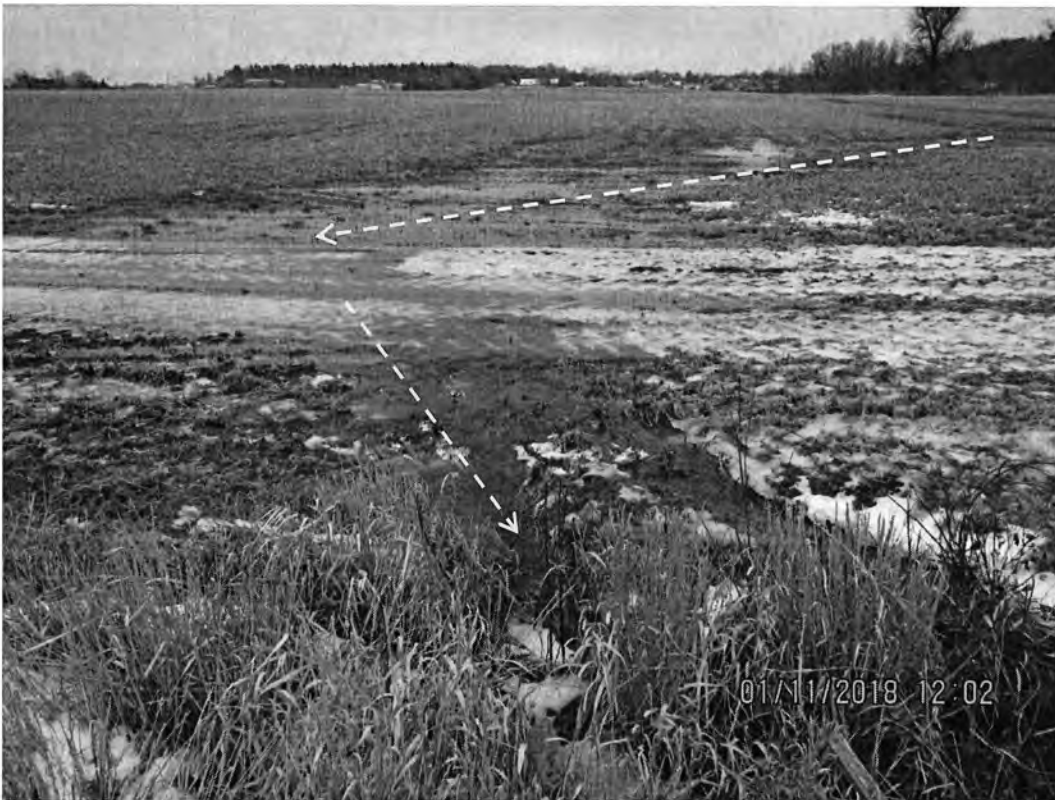
**Photo 12:** View of 11L1 from Copper Ln showing discharge (indicated by the dashed yellow arrows) of snowmelt runoff to the ditch north of the field. Photo direction is south.

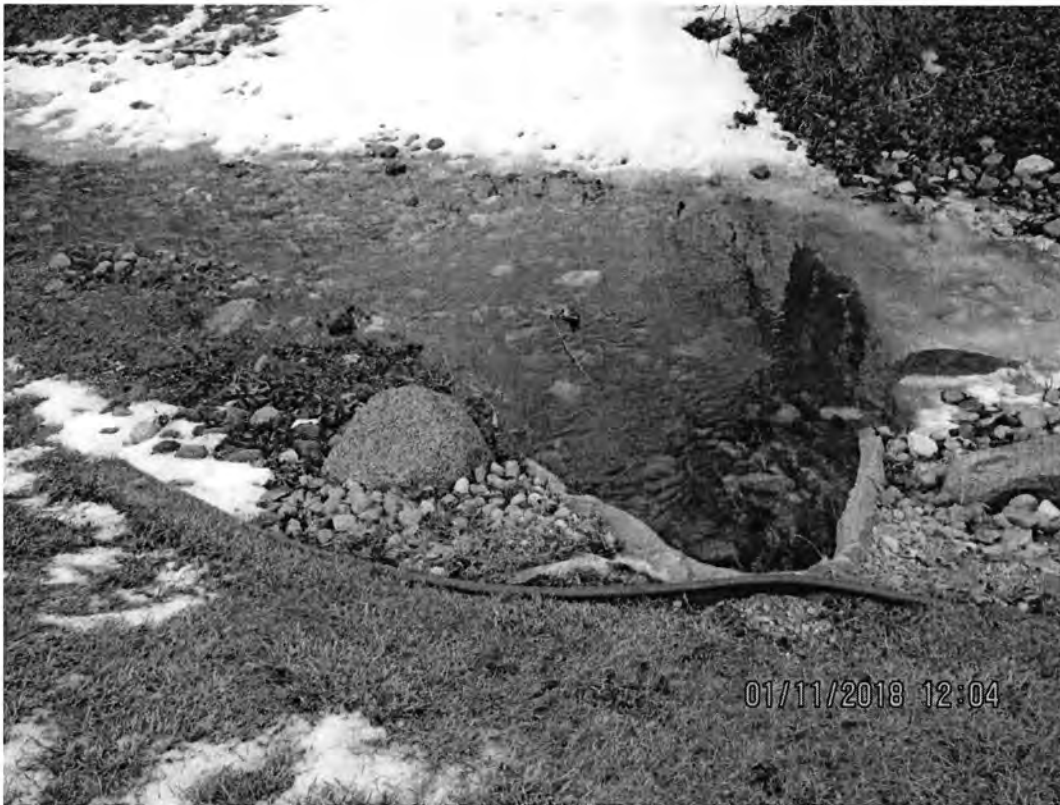
**Photo 13:** View of the culvert north of Copper Ln where snowmelt discharged from field 11L1. Photo direction is down and north.

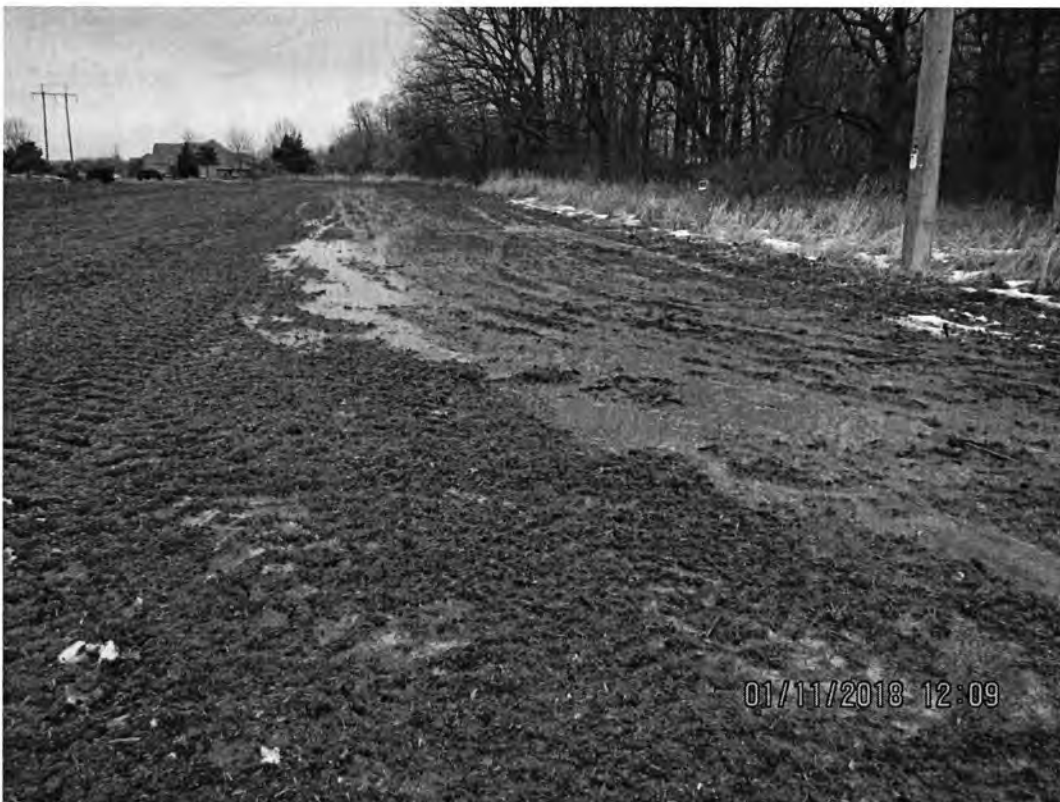
**Photo 14:** View of the NE corner of 11L-East showing ponded storm water from snowmelt. Photo direction is north.

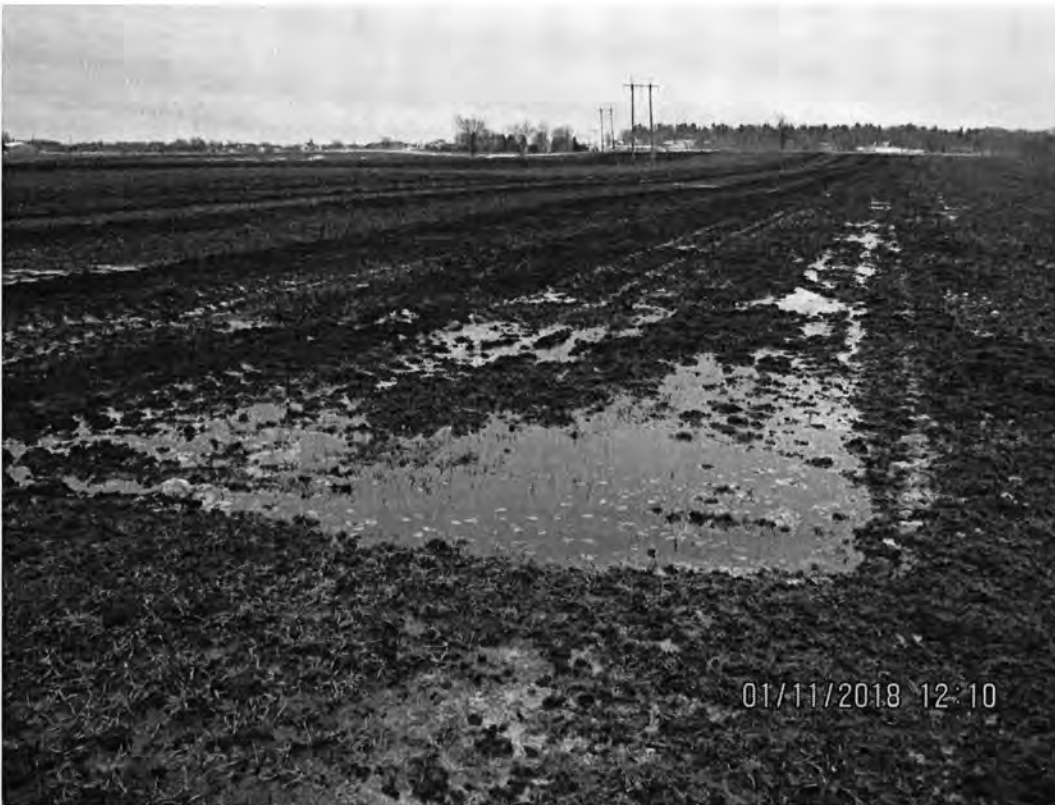
**Photo 15:** View of 11L-East showing ponded storm water from snowmelt surface applied solid manure. Photo direction is south.

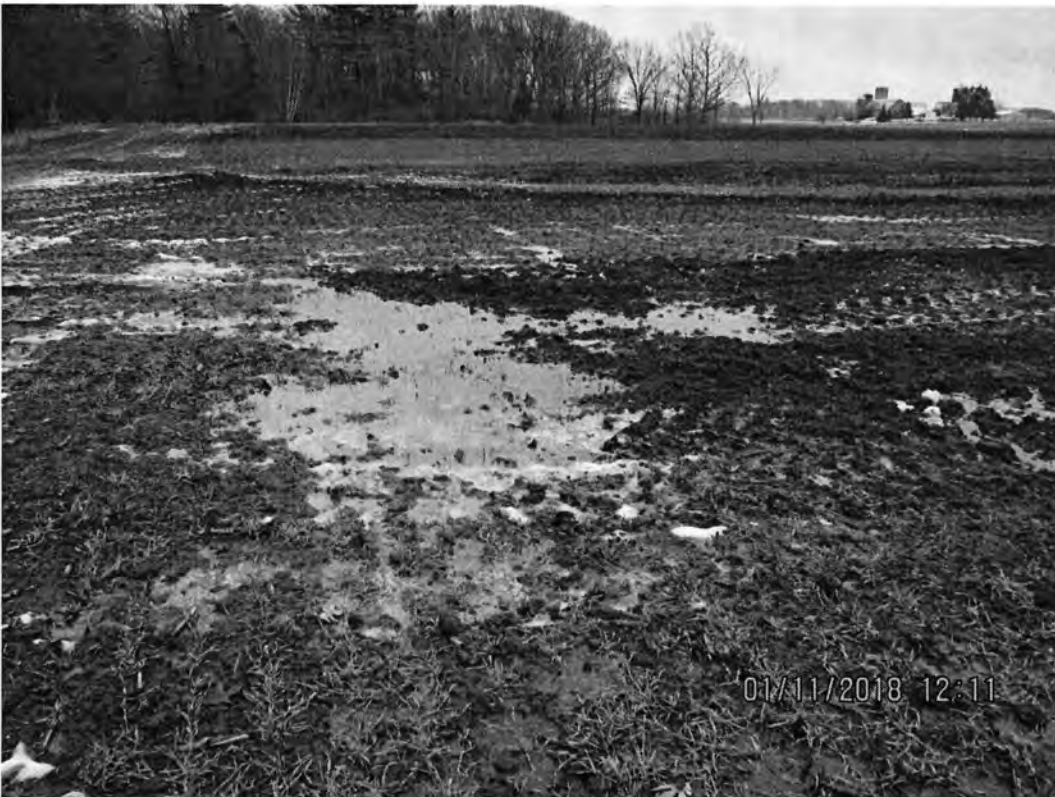
**Photo 16:** View of the northern section of 11J1&2 showing ponded storm water from snowmelt surface applied solid manure. Photo direction is east.

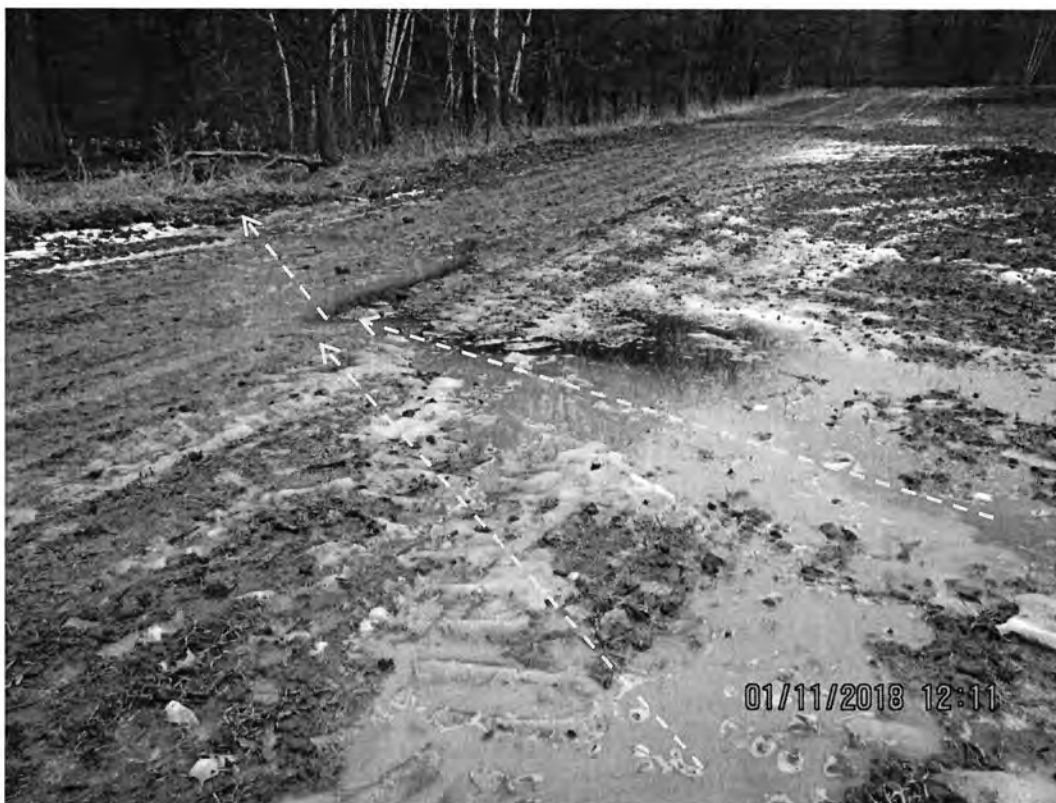
**Photo 17:** View of the northern section of 11J1&2 showing ponded storm water from snowmelt and the runoff flow path (indicated by the dashed yellow arrows). Photo direction is NE.

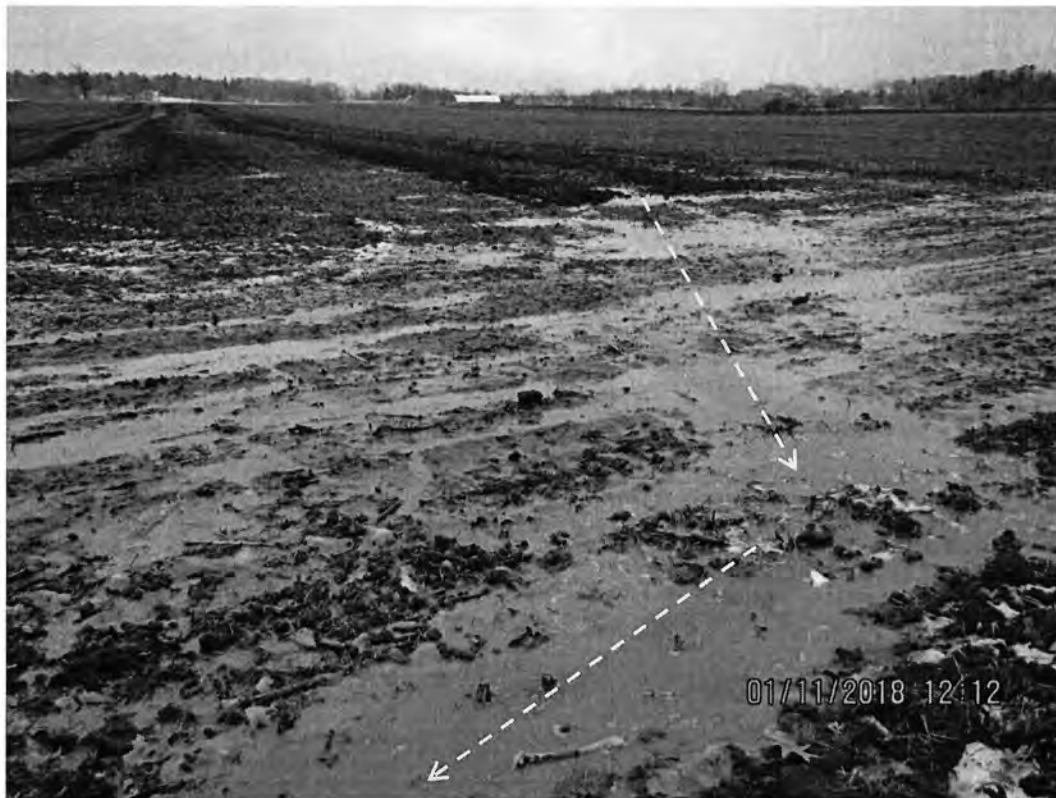
**Photo 18:** View of the northern section of 11J1&2 showing ponded storm water from snowmelt and the runoff flow path (indicated by the dashed yellow arrows). Photo direction is SW.

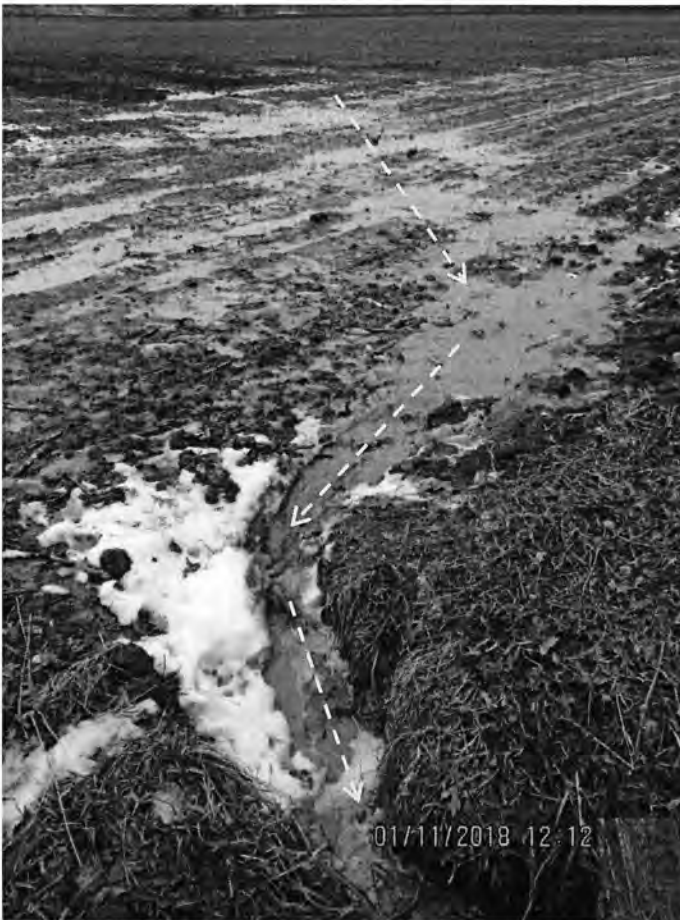
**Photo 19:** View of the discharge location and flow path (indicated by the dashed yellow arrows) of snowmelt storm water from field 11J1&2. Photo direction is SW and down.

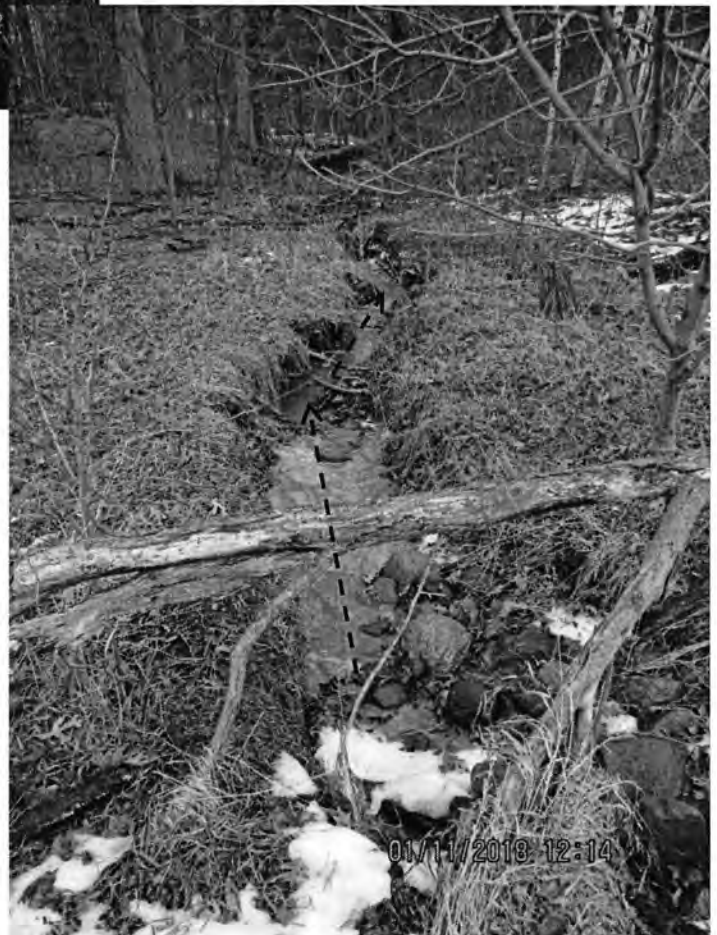
**Photo 20:** View of the waterway in the wooded area north of field 11J1&2 where snowmelt storm water discharged from the field. Blue dashed arrows indicated flow direction. Photo direction is north.

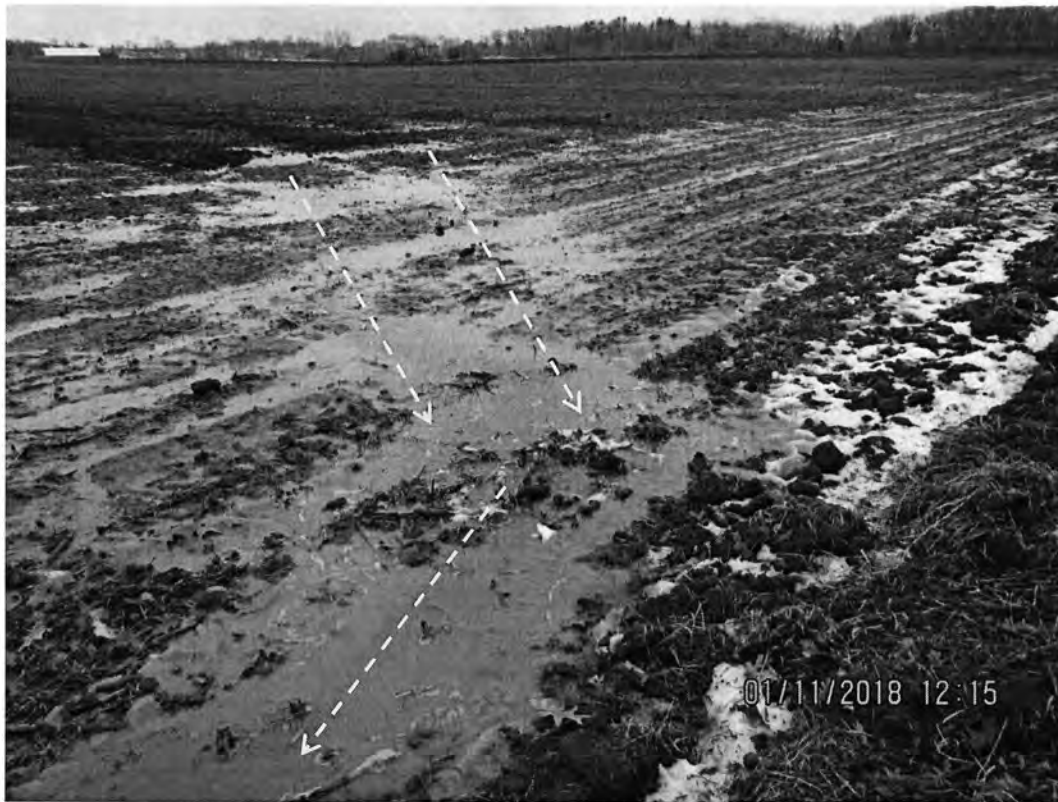
**Photo 21:** Alternate view of the flow path of snowmelt storm water (indicated by the dashed yellow arrows) that discharged from field 11J1&2. Photo direction is SW.

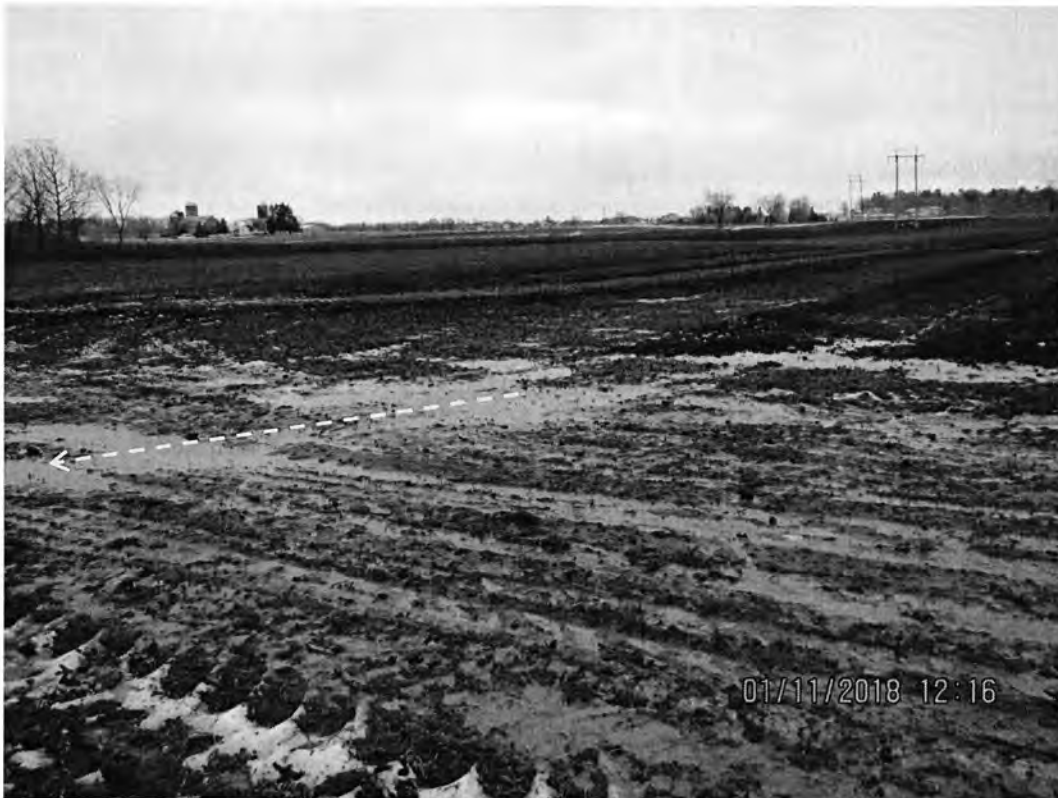
**Photo 22:** View of ponded snowmelt and the middle section of field 11J1&2 where solid manure was spread. Yellow dashed arrow indicates flow path of snowmelt runoff. Photo direction is SE.

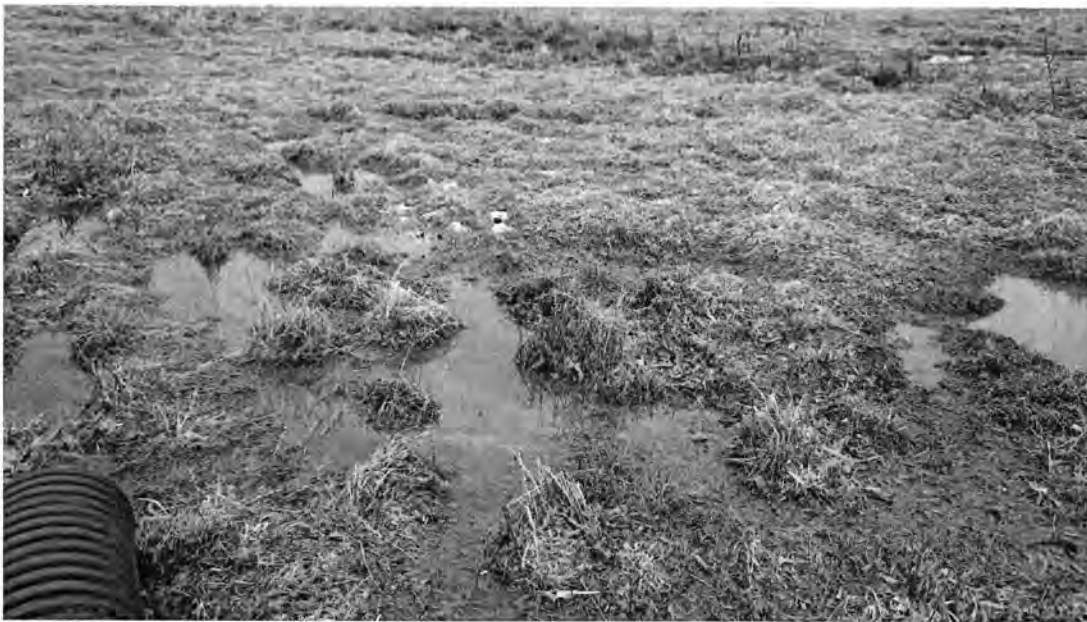
135: RIMG0144

Description: Process wastewater and feed solids were observed throughout the grassed area.

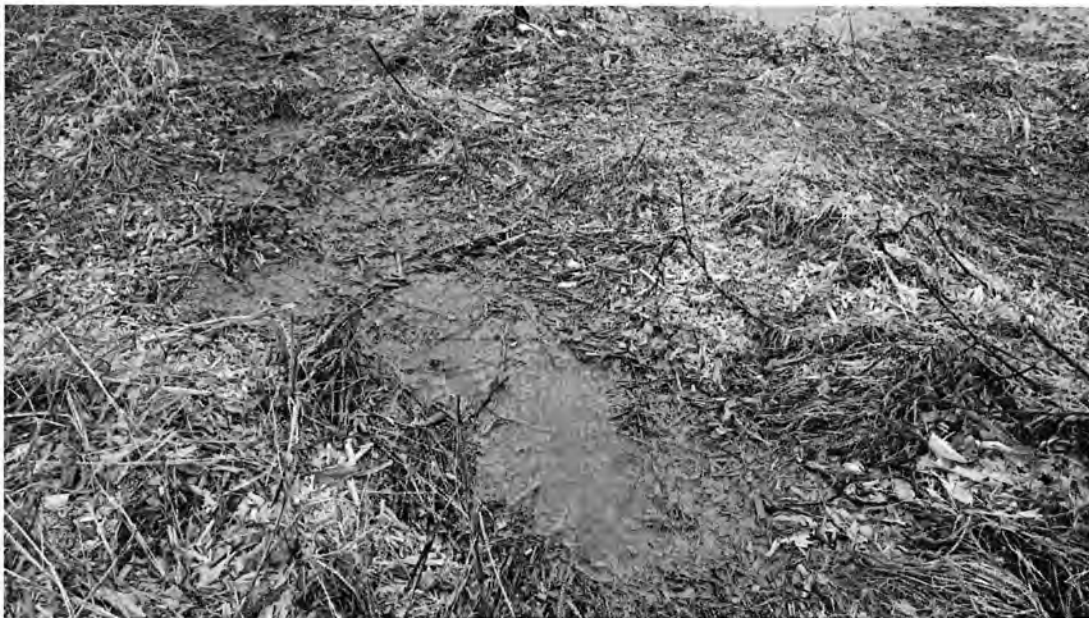
136: RIMG0145

Description: Process wastewater and feed solids were observed throughout the grassed area.

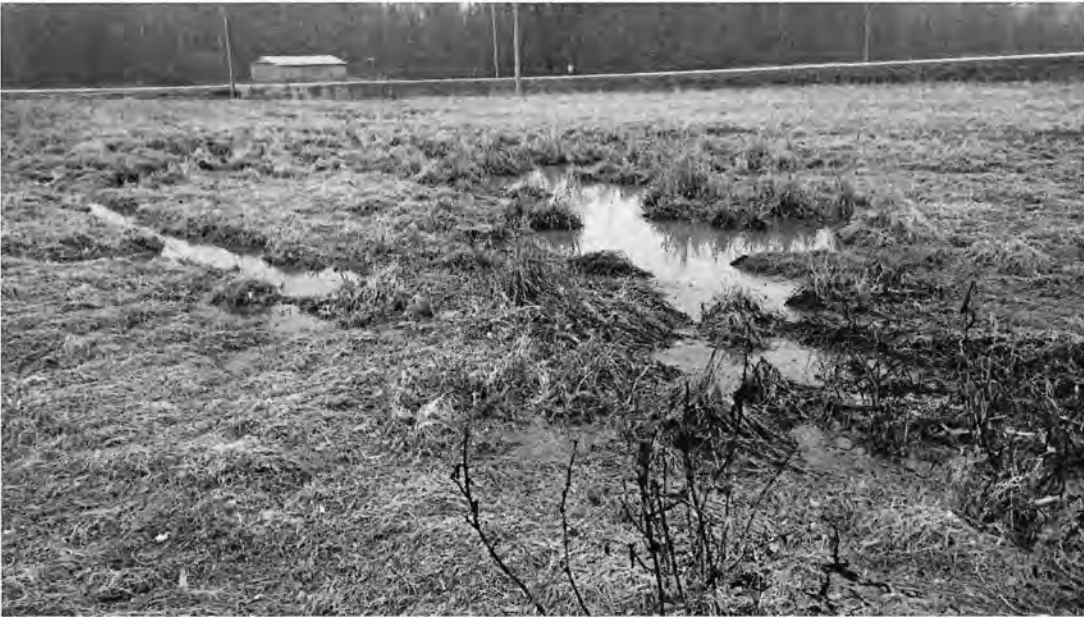
137: RIMG0146

Description: Process wastewater and feed solids were observed throughout the grassed area.

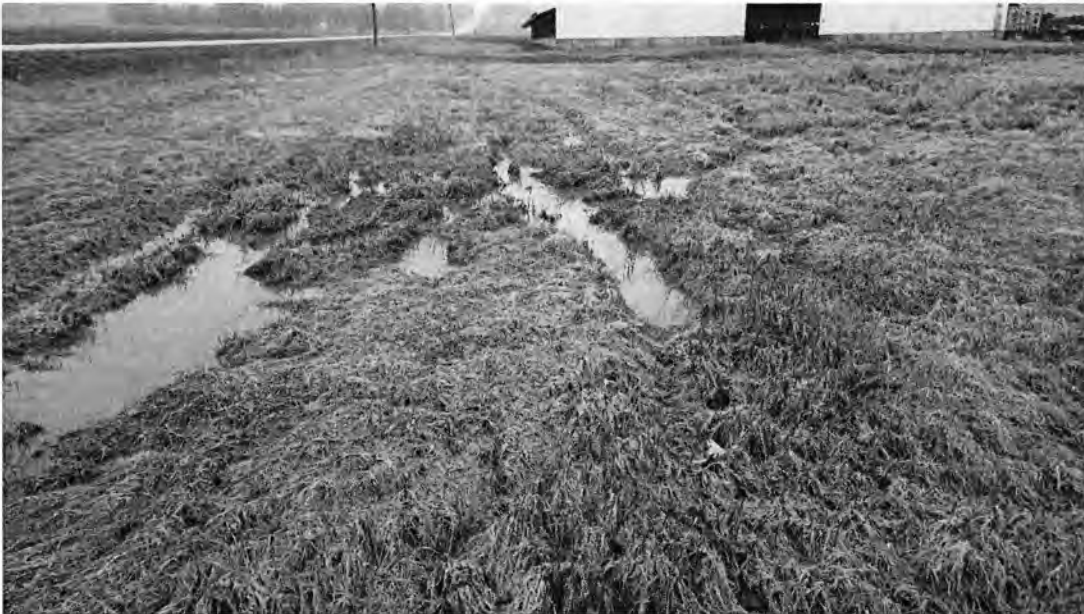
138: RIMG0147

Description: Process wastewater and feed solids were observed throughout the grassed area.

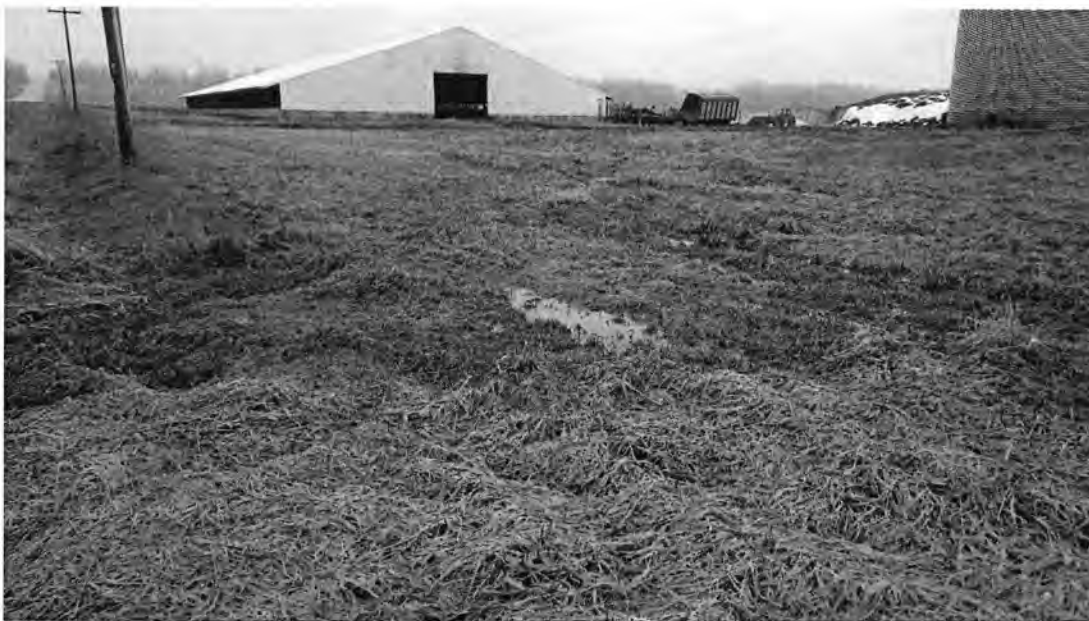
139: RIMG0148

Description: Process wastewater and feed solids were observed throughout the grassed area.

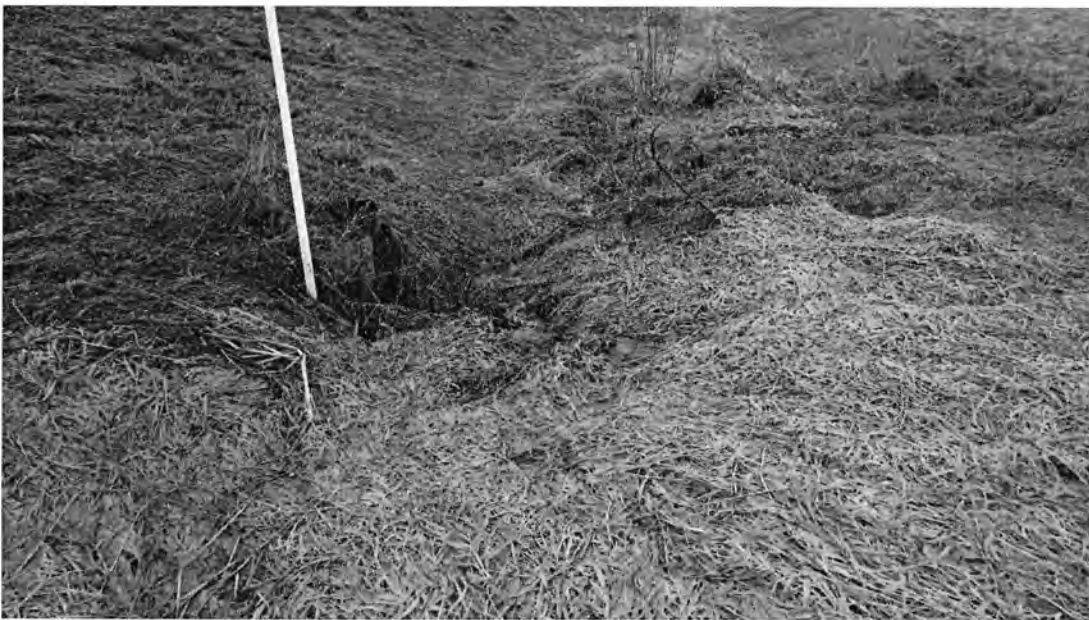
140: RIMG0149

Description: The process wastewater continued through the grassed area and outlet into the ditch. The culvert collected the flow which continued east under County Road V and east along the Silver Lane then north and continued northeast before connecting with an unnamed tributary

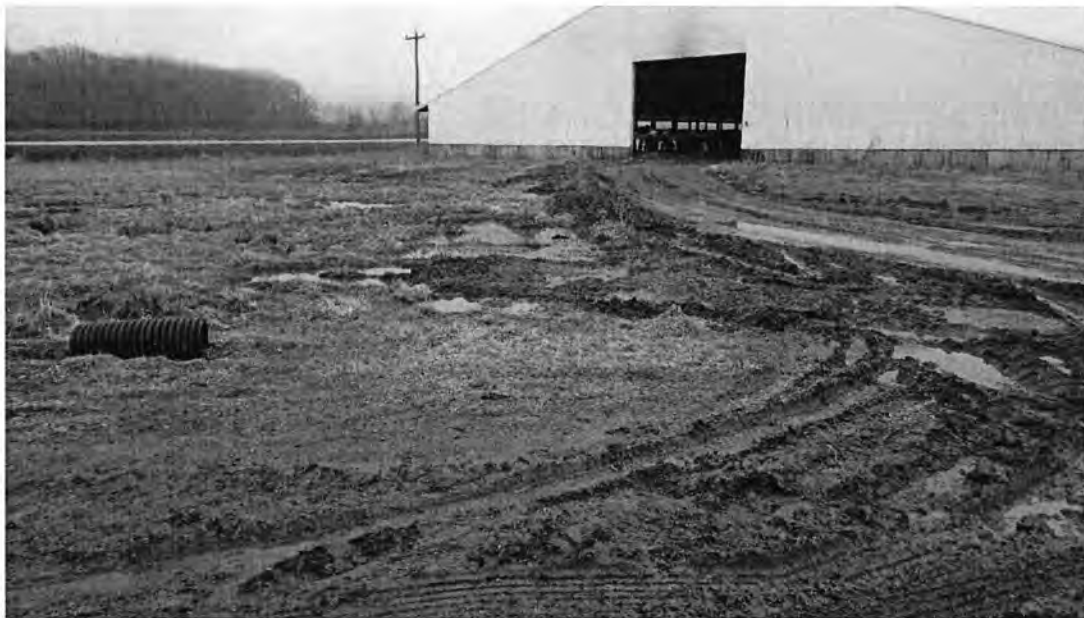
141: RIMG0150

Description: Process wastewater and feed solids were observed throughout the grassed area and the drainage paths leading to the grassed area.
