State of Wisconsin | DEPARTMENT OF NATURAL RESOURCES

Subject: **Notice of Violation - Chapter 283, Wis. Statutes  
Enforcement Conference - March 9, 2009**

### **3. POTENTIAL VIOLATIONS**

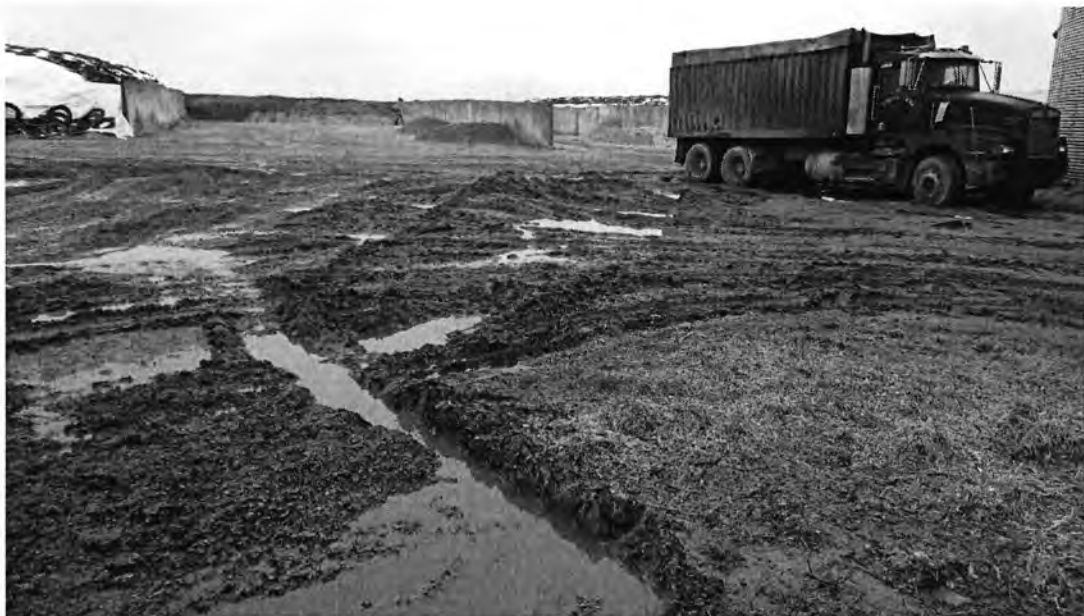
142: RIMG0151

Description: Process wastewater and feed solids were observed throughout the grassed area and the drainage paths leading to the grassed area.

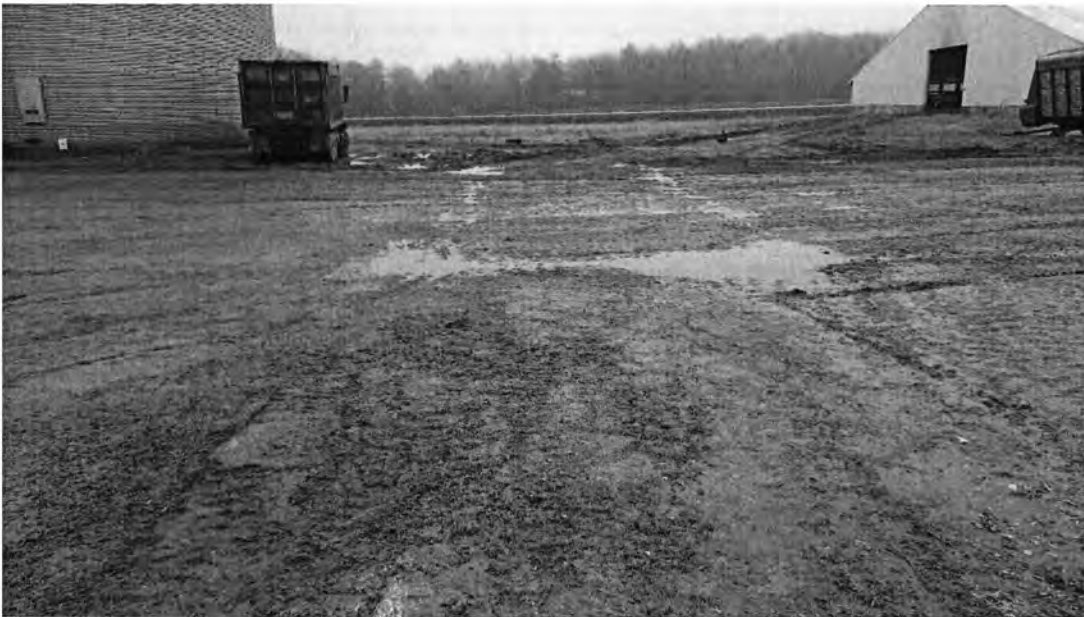
145: RIMG0154

Description: Drainage pathways from the feed bunkers flowed east to the grassed area. Process wastewater and feed solids were observed throughout the drainage pathways and the grassed area.

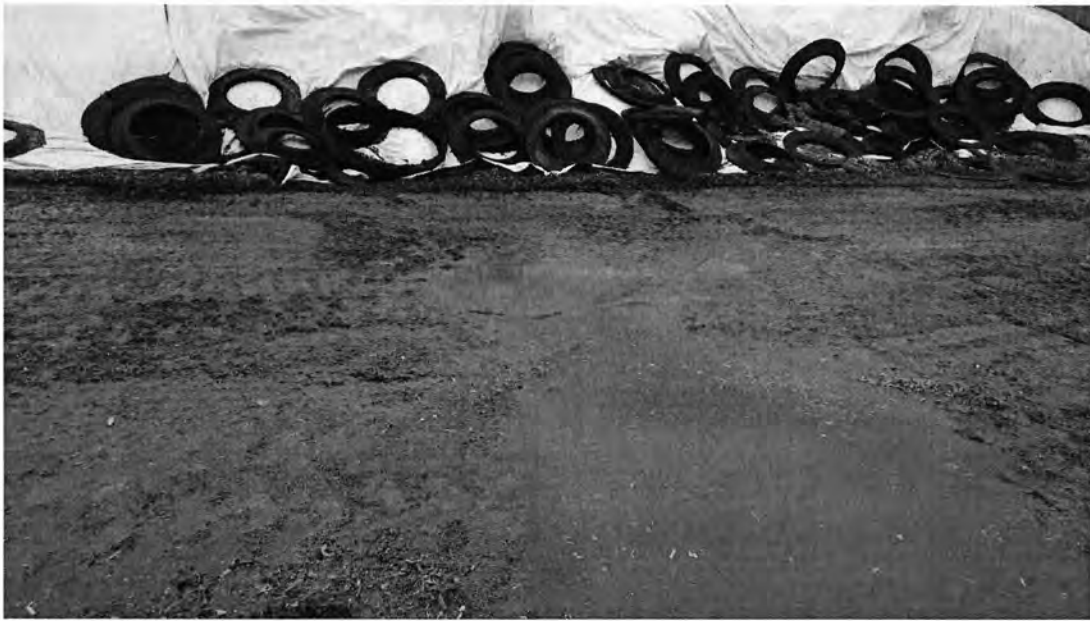
146: RIMG0155

Description: Drainage pathways from the feed bunkers flowed east to the grassed area. Process wastewater and feed solids were observed throughout the drainage pathways.

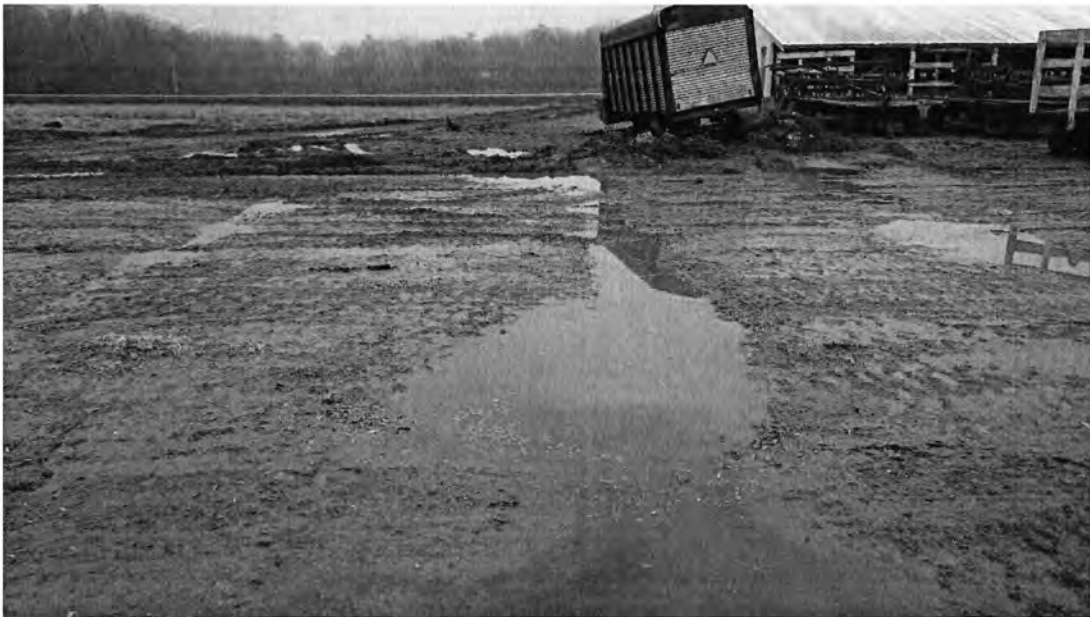
147: RIMG0156

Description: Drainage pathways from the feed bunkers flowed east to the grassed area. Process wastewater and feed solids were observed throughout the drainage pathways.

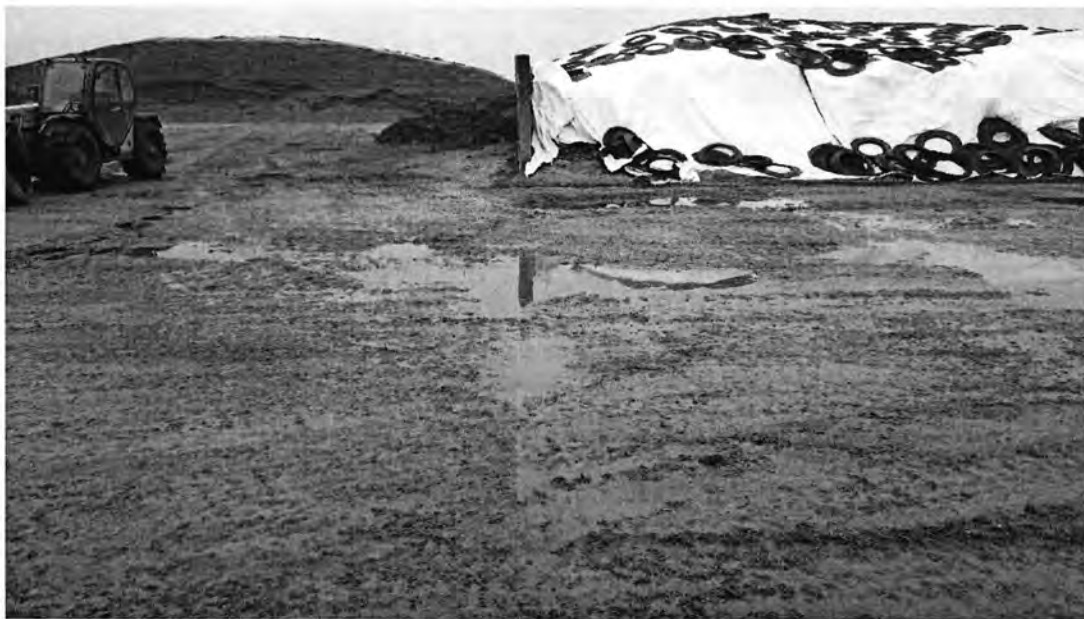
148: RIMG0157

Description: Drainage pathways from the feed bunkers flowed east to the grassed area. Process wastewater and feed solids were observed throughout the drainage pathways.

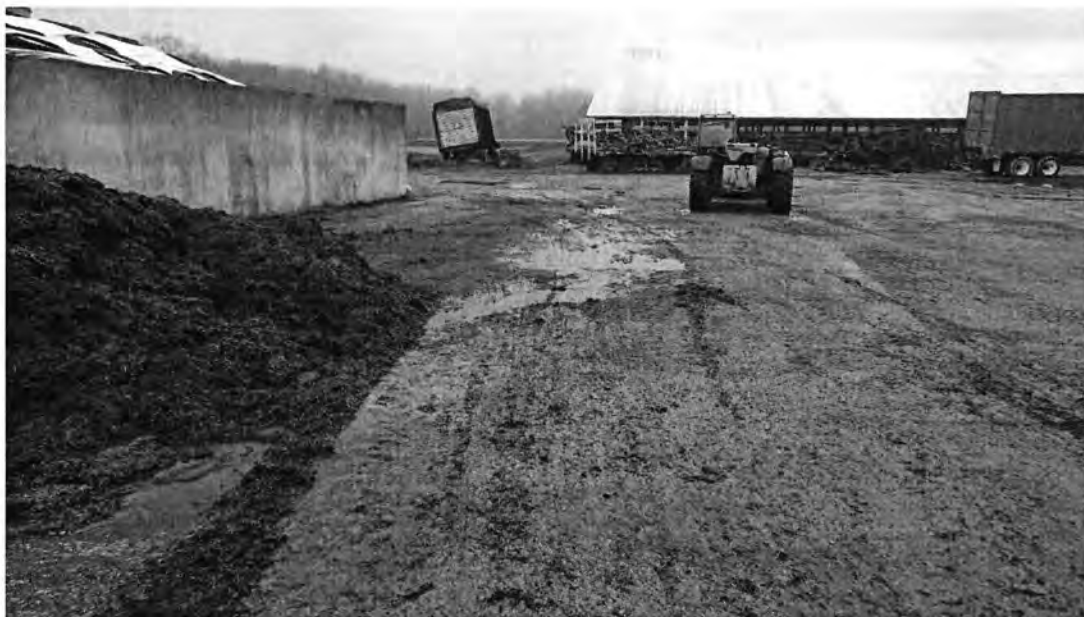
149: RIMG0158

Description: Drainage pathways from the feed bunkers flowed east to the grassed area. Process wastewater and feed solids were observed throughout the drainage pathways.

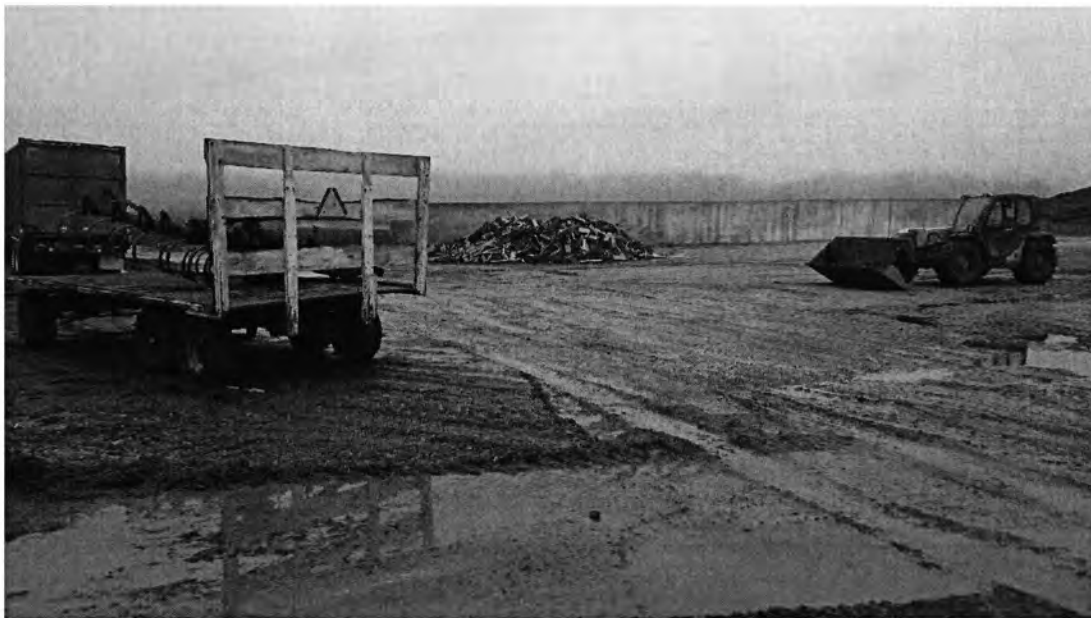
150: RIMG0159

Description: Drainage pathways from the feed bunkers flowed east to the grassed area. Process wastewater and feed solids were observed throughout the drainage pathways.

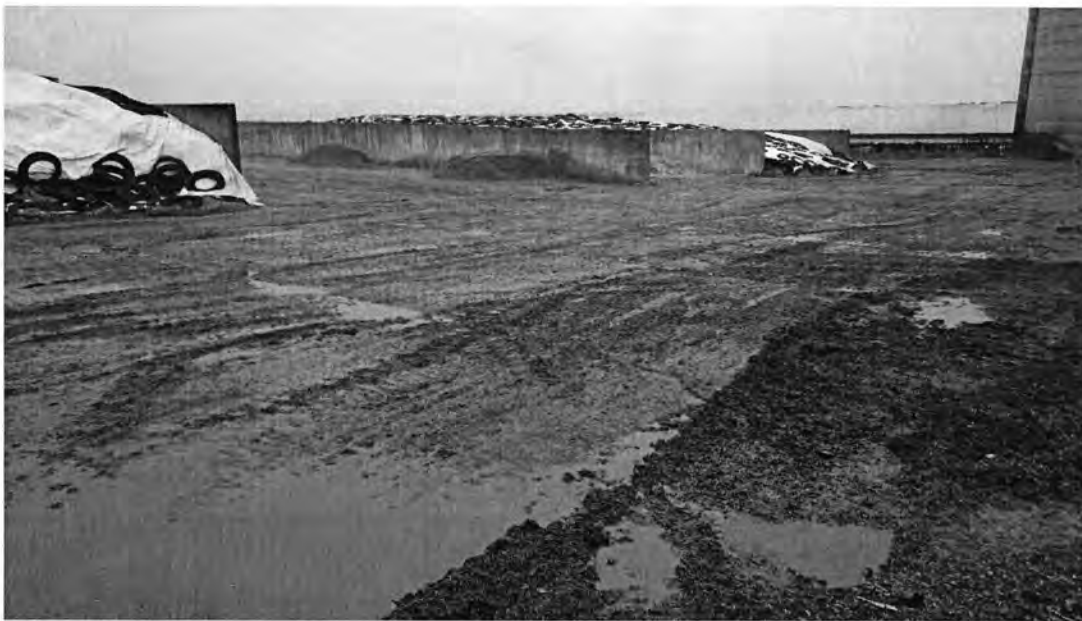
152: RIMG0161

Description: Drainage pathways from the feed bunkers flowed east to the grassed area. Process wastewater and feed solids were observed throughout the drainage pathways.

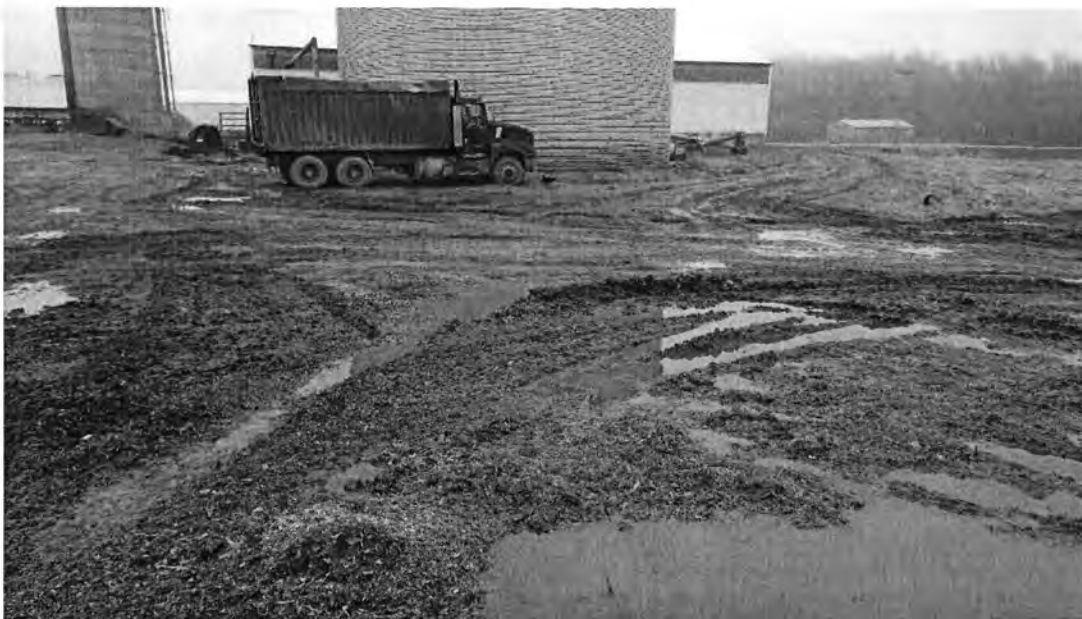
153: RIMG0162

Description: Drainage pathways from the feed bunkers flowed east to the grassed area. Process wastewater and feed solids were observed throughout the drainage pathways.

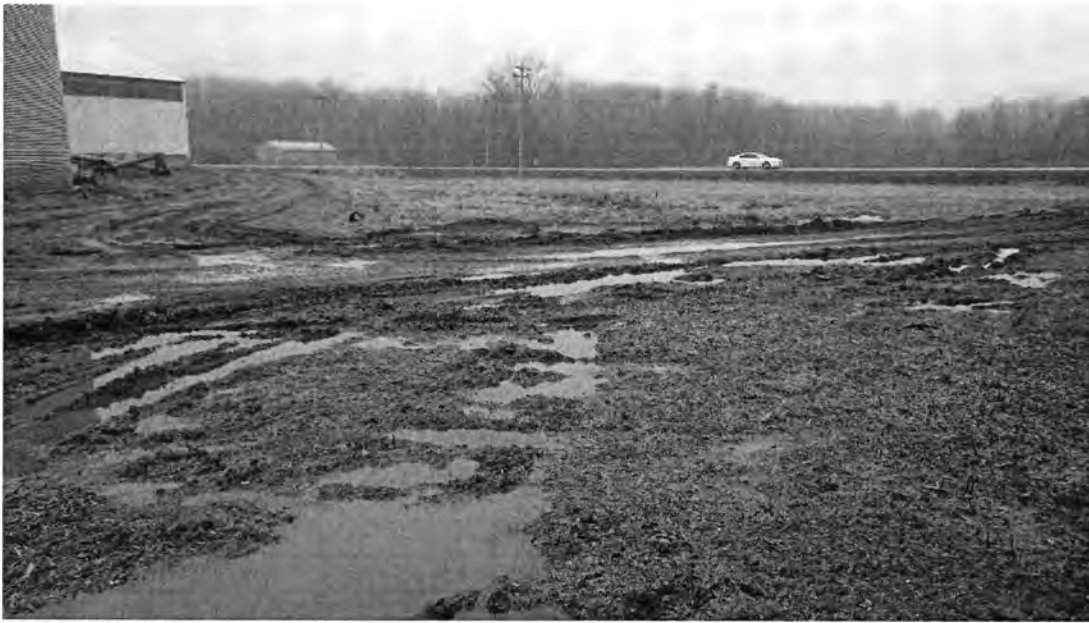
154: RIMG0163

Description: Drainage pathways from the feed bunkers flowed east to the grassed area. Process wastewater and feed solids were observed throughout the drainage pathways.

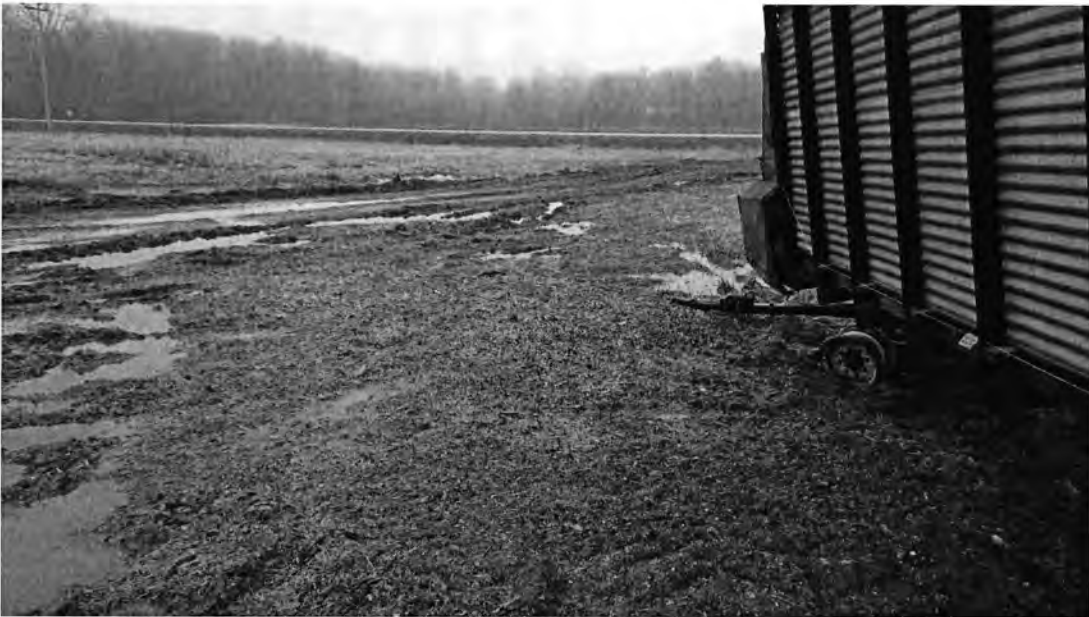
155: RIMG0164

Description: Drainage pathways from the feed bunkers flowed east to the grassed area. Process wastewater and feed solids were observed throughout the drainage pathways.

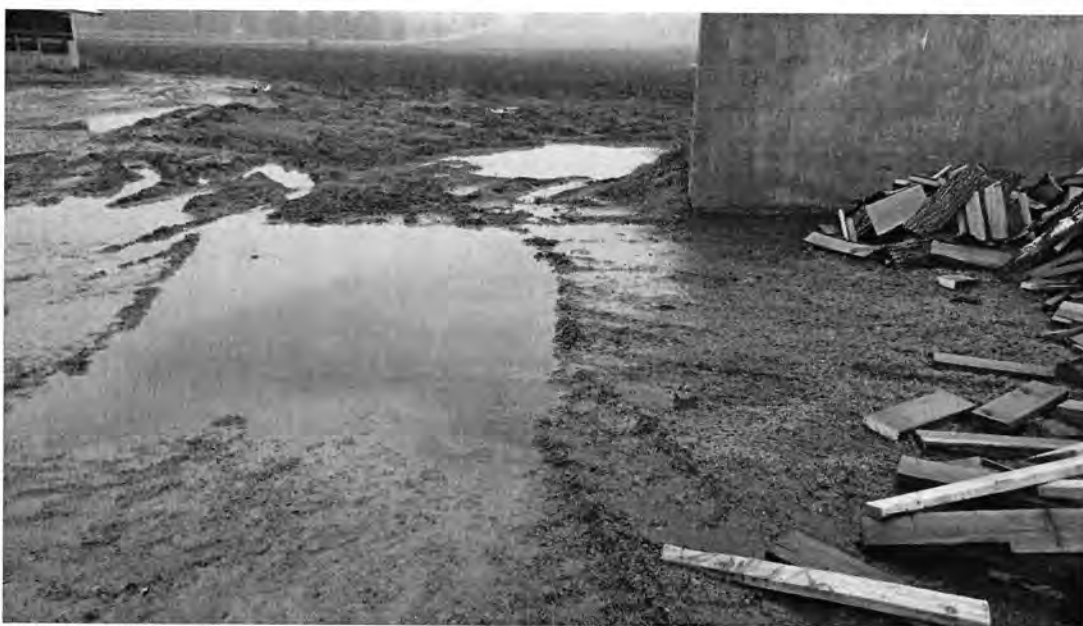
156: RIMG0165

Description: Drainage pathways from the feed bunkers flowed east to the grassed area. Process wastewater and feed solids were observed throughout the drainage pathways.

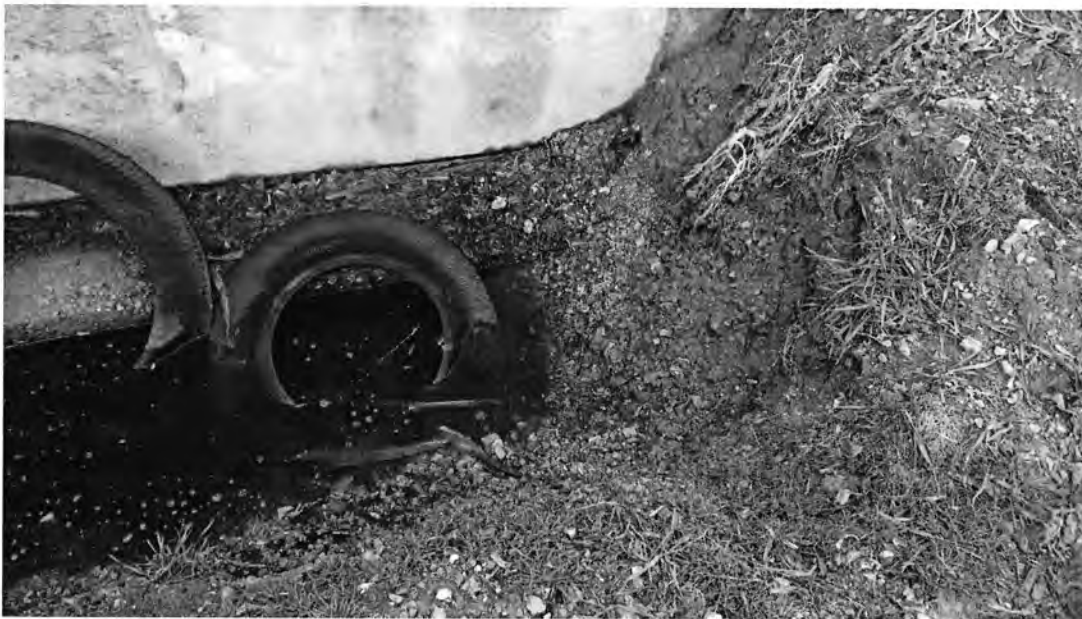
157: RIMG0166

Description: A drainage pathways from the southeast end of the feed bunkers flowed south into a field.

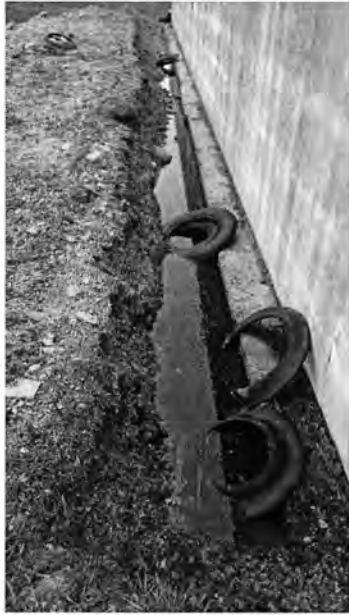
158: RIMG0167

Description: Silage leachate was observed along the south wall of the new bunker. The leachate seeped through the rock/soil and flowed overland to the unnamed tributary.

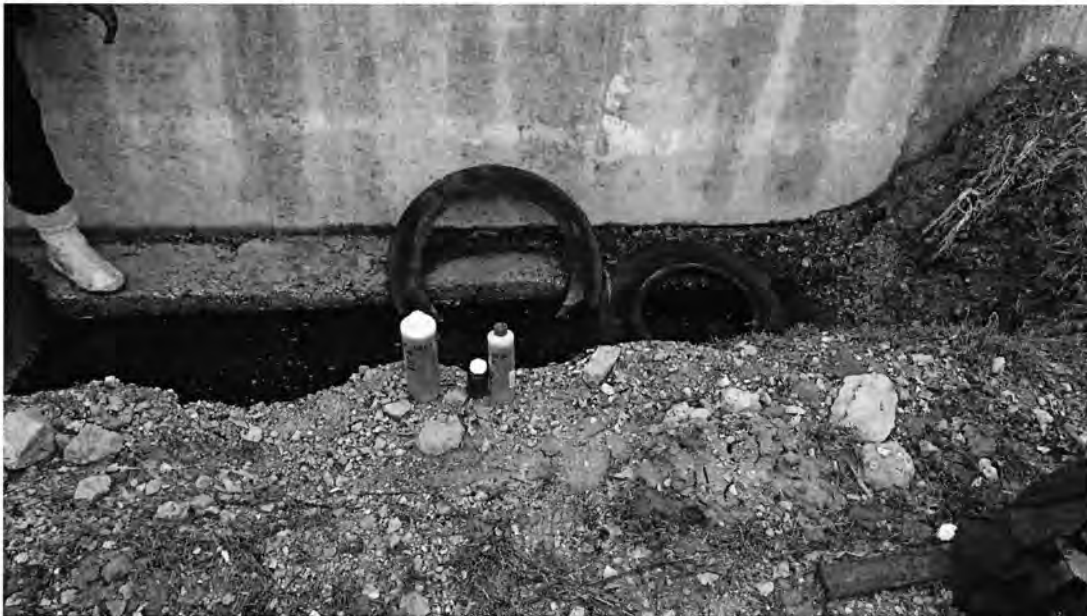
159: RIMG0168

Description: Silage leachate was observed along the south wall of the new bunker. The leachate seeped through the rock/soil and flowed overland to the unnamed tributary.

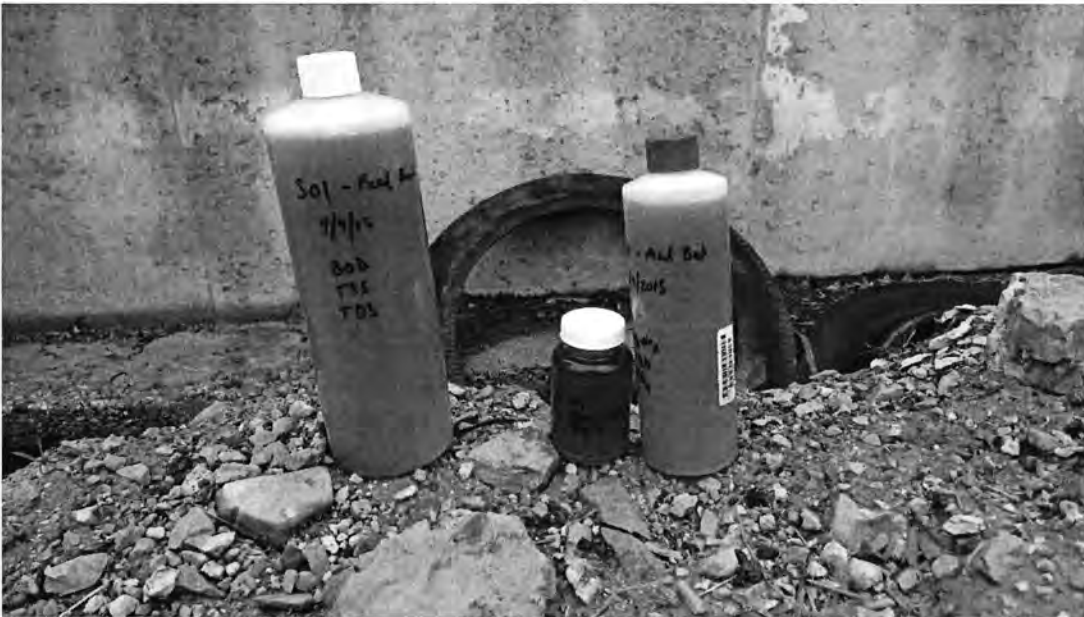
160: RIMG0169

Description: Sample S01 was taken at 11:14 a.m. of process wastewater from the new bunker.

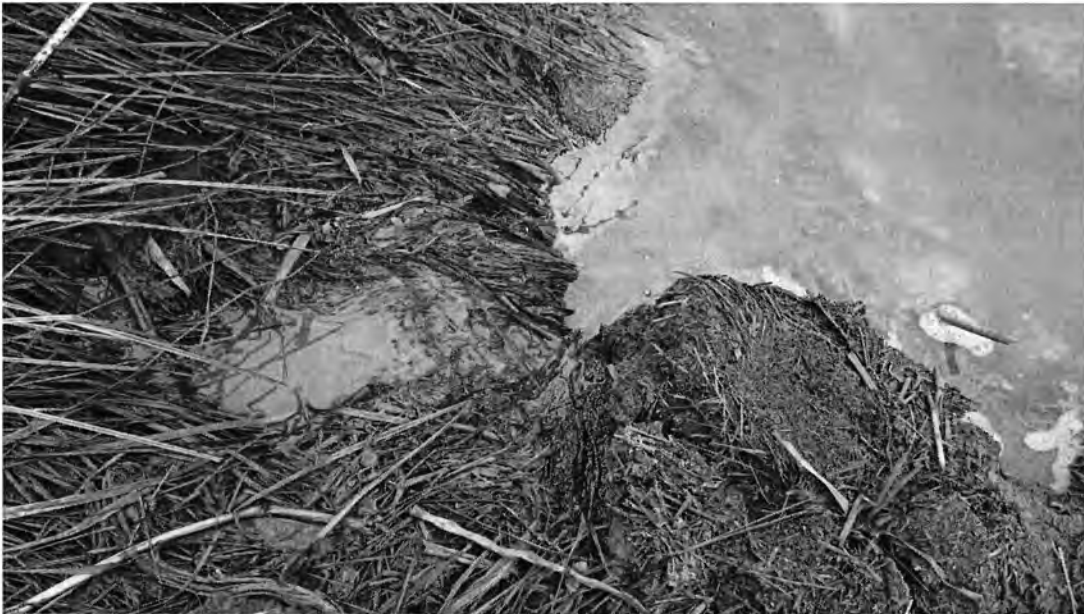
161: RIMG0170

Description: Sample S01 was taken at 11:14 a.m. of process wastewater from the new bunker.

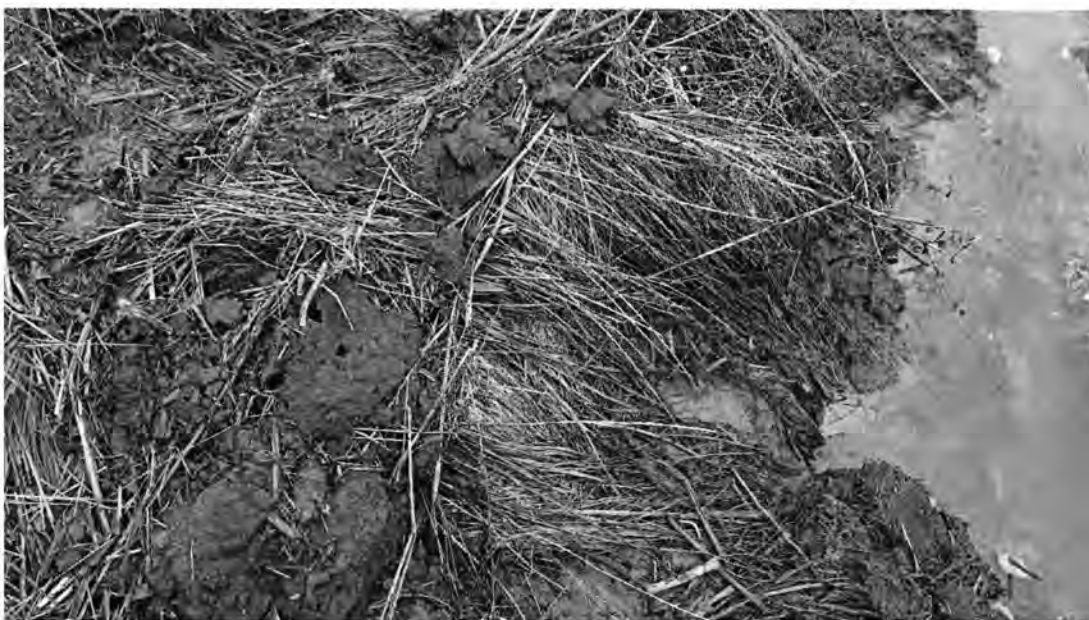
162: RIMG0171

Description: Process wastewater from the new bunker flowed into the unnamed tributary.

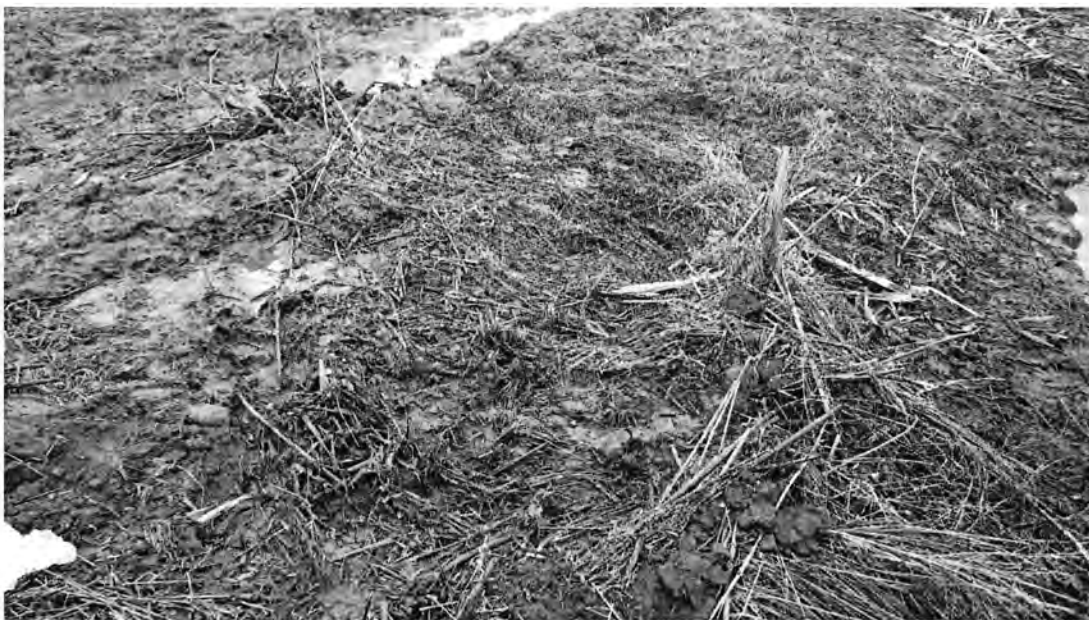
163: RIMG0172

Description: Process wastewater from the new bunker flowed into the unnamed tributary.

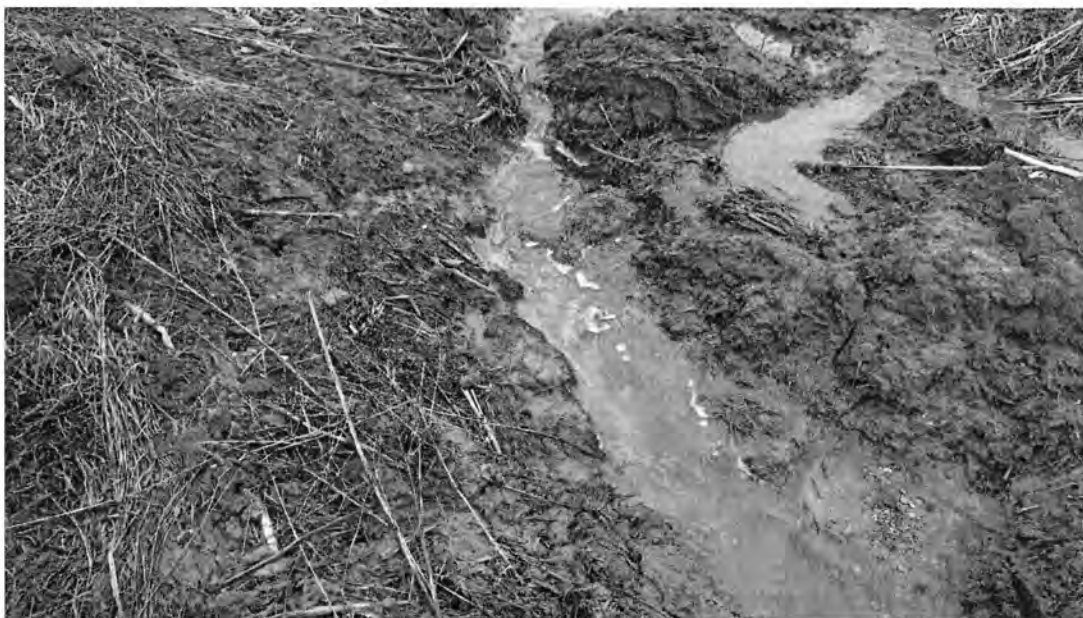
164: RIMG0173

Description: Process wastewater from the new bunker flowed into the unnamed tributary.

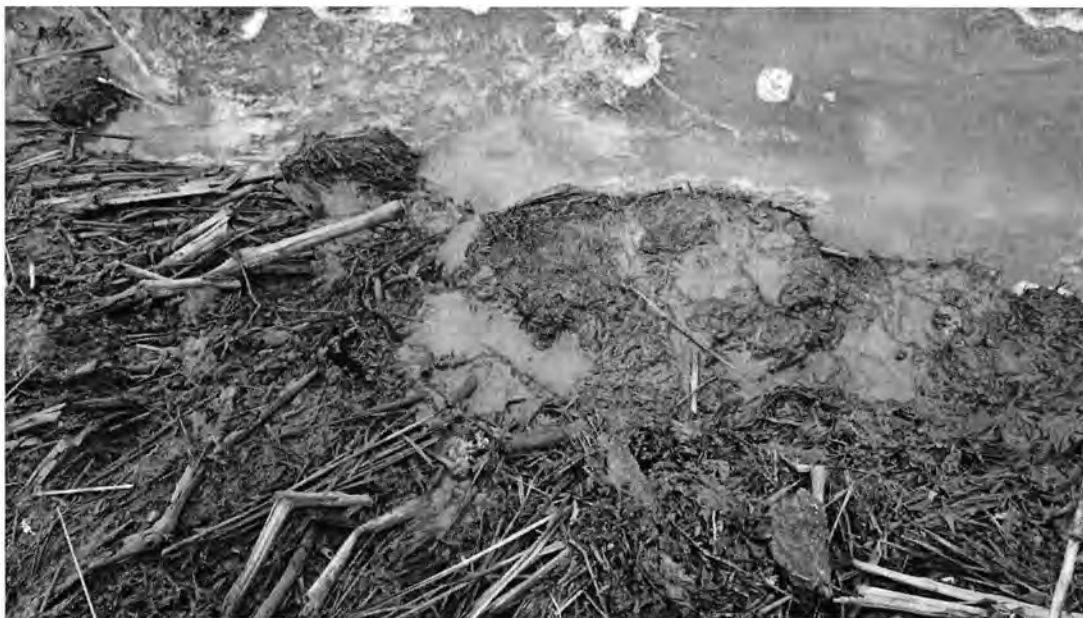
165: RIMG0174

Description: Process wastewater from the new bunker flowed into the unnamed tributary.

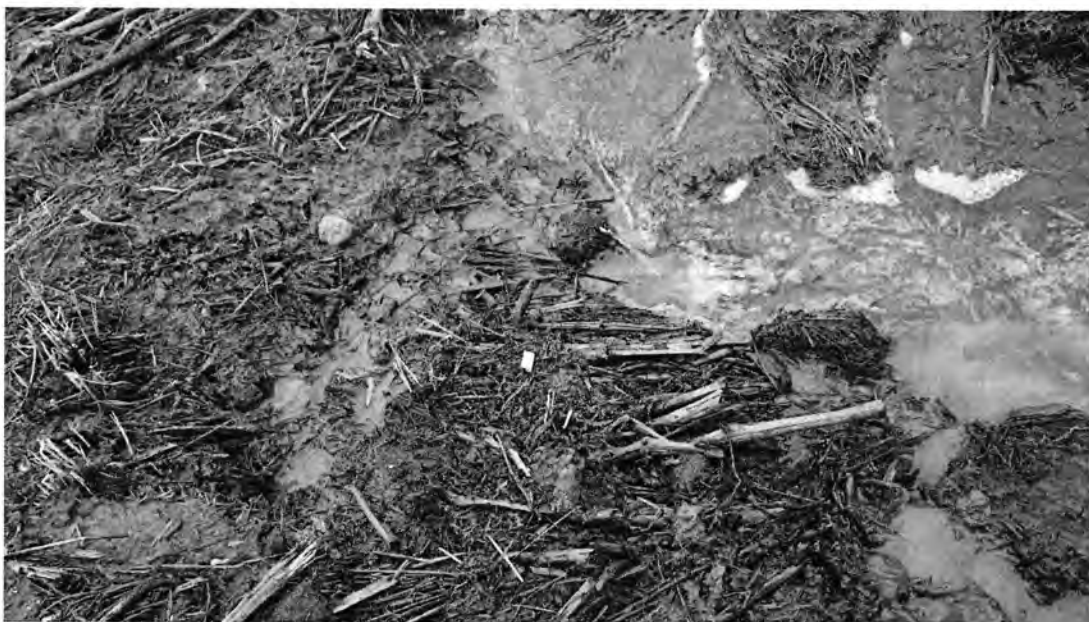
166: RIMG0175

Description: Process wastewater from the new bunker flowed into the unnamed tributary.

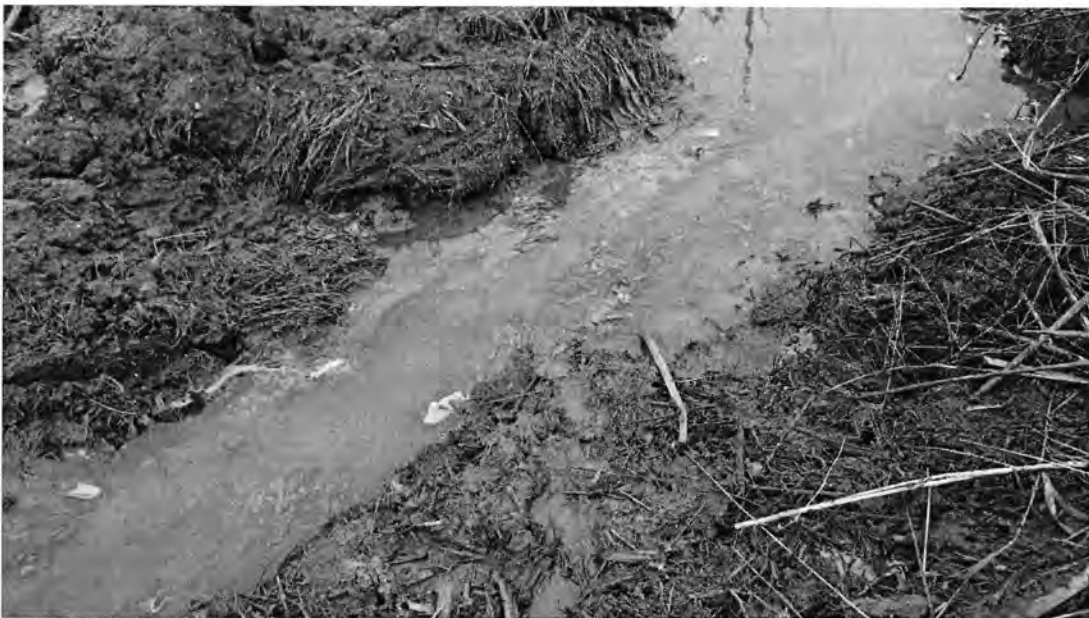
167: RIMG0176

Description: Process wastewater from the new bunker flowed into the unnamed tributary.

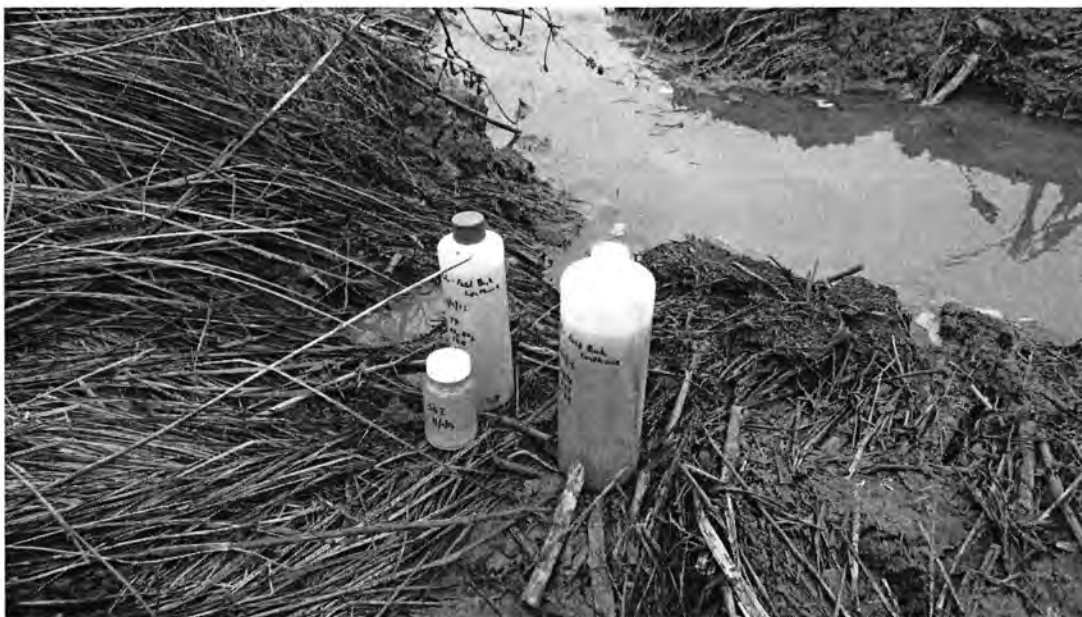
168: RIMG0177

Description: Process wastewater from the new bunker flowed into the unnamed tributary.

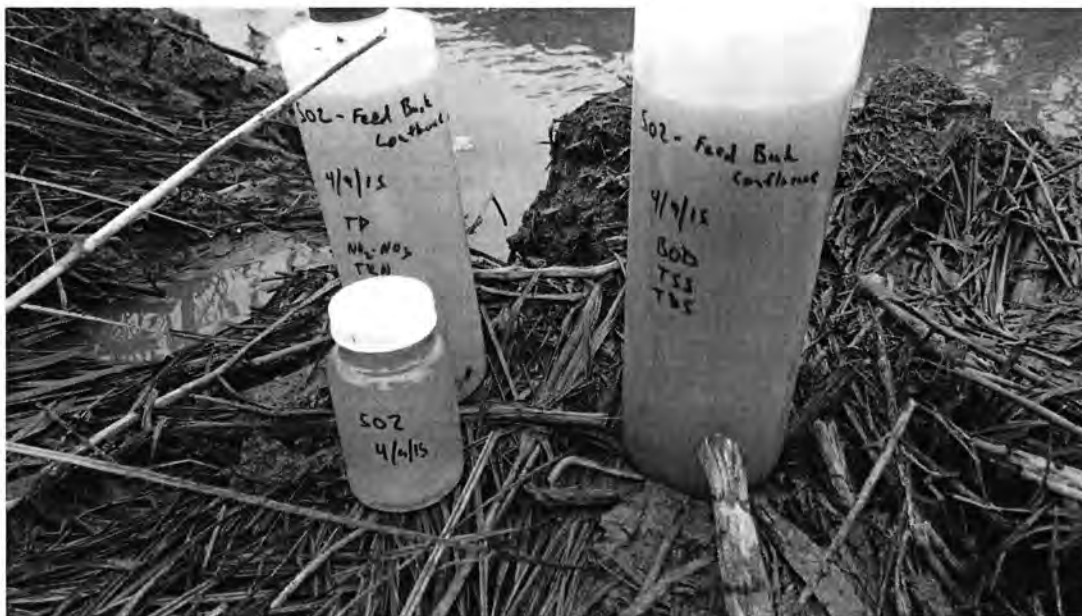
169: RIMG0178

Description: Sample S02 was taken at 11:25 a.m. of process wastewater emanating from the new bunker and flowing into an unnamed tributary.

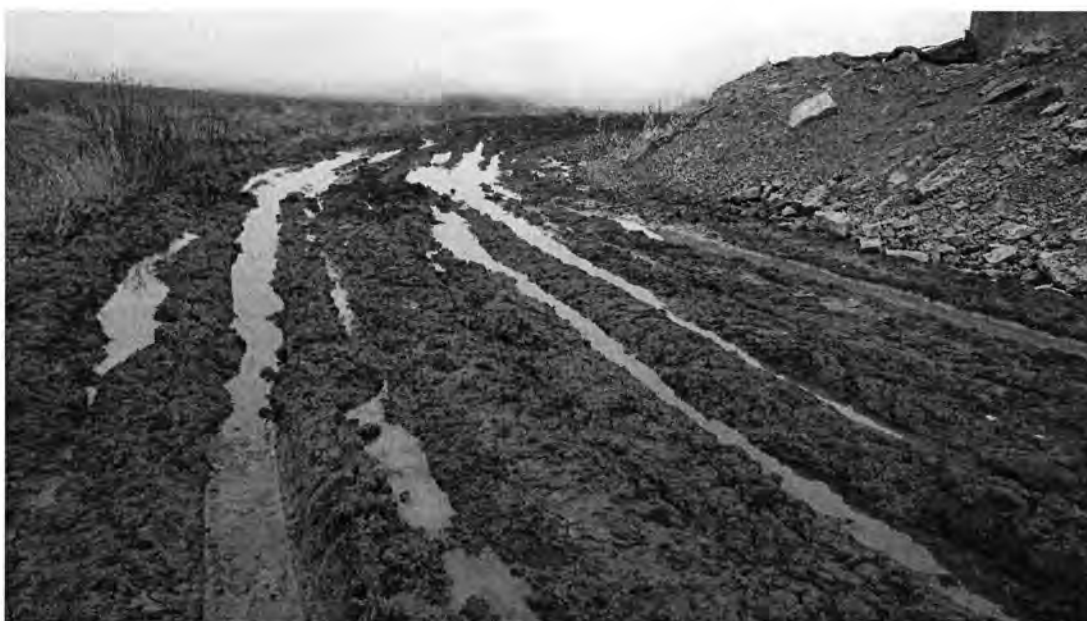
170: RIMG0179

Description: Sample S02 was taken at 11:25 a.m. of process wastewater emanating from the new bunker and flowing into an unnamed tributary.

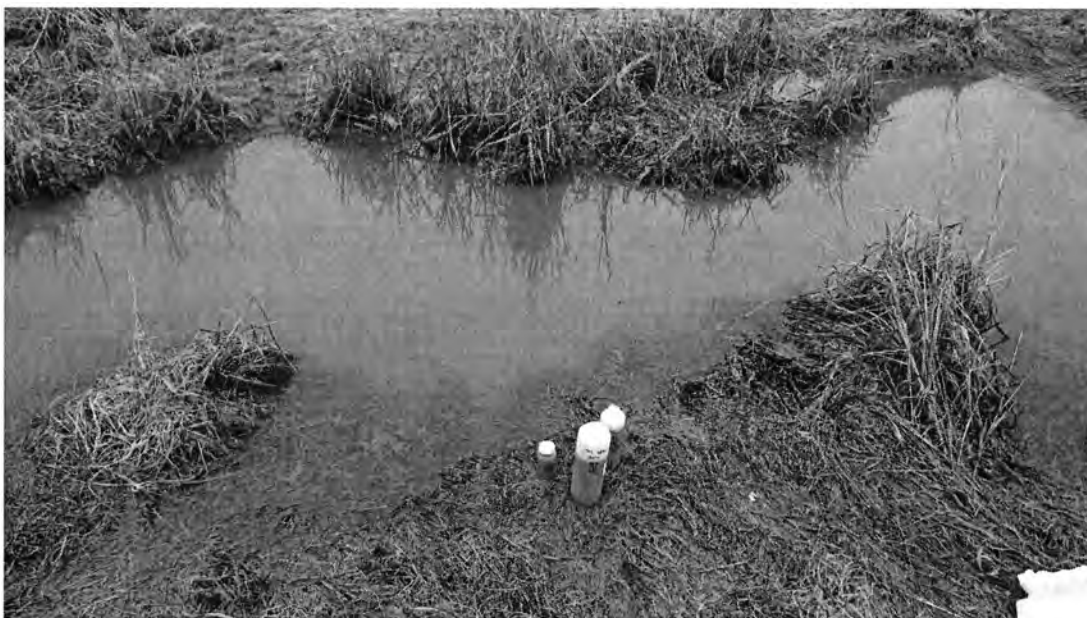
171: RIMG0180

Description: The leachate was draining west through tire ruts and into the unnamed tributary.

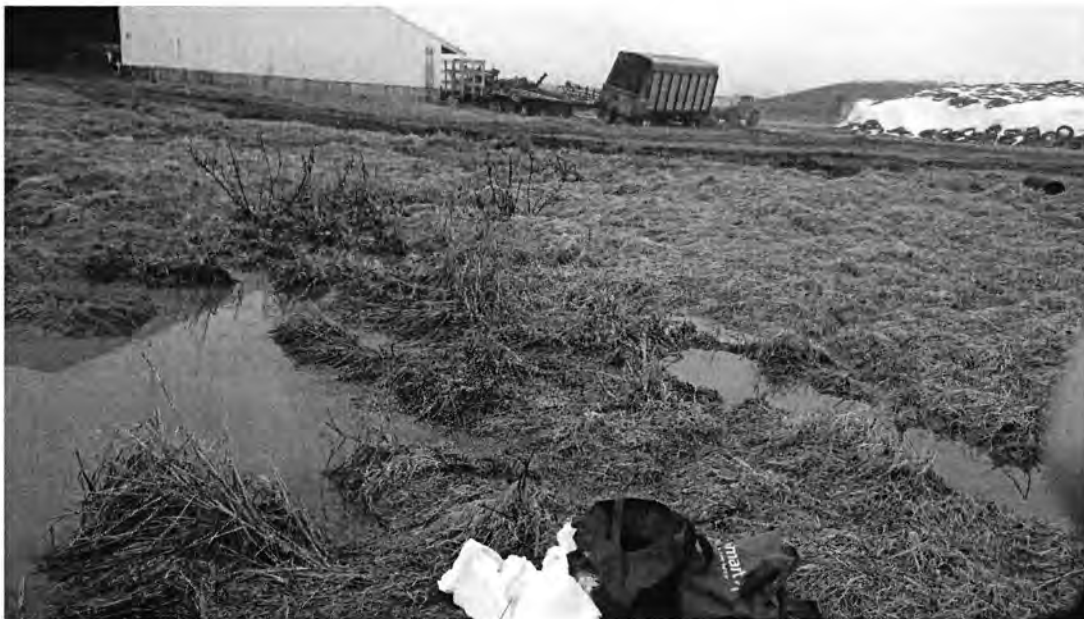
172: RIMG0181

Description: Sample S03 was taken at 11:32 a.m. from process wastewater in the grassed area.

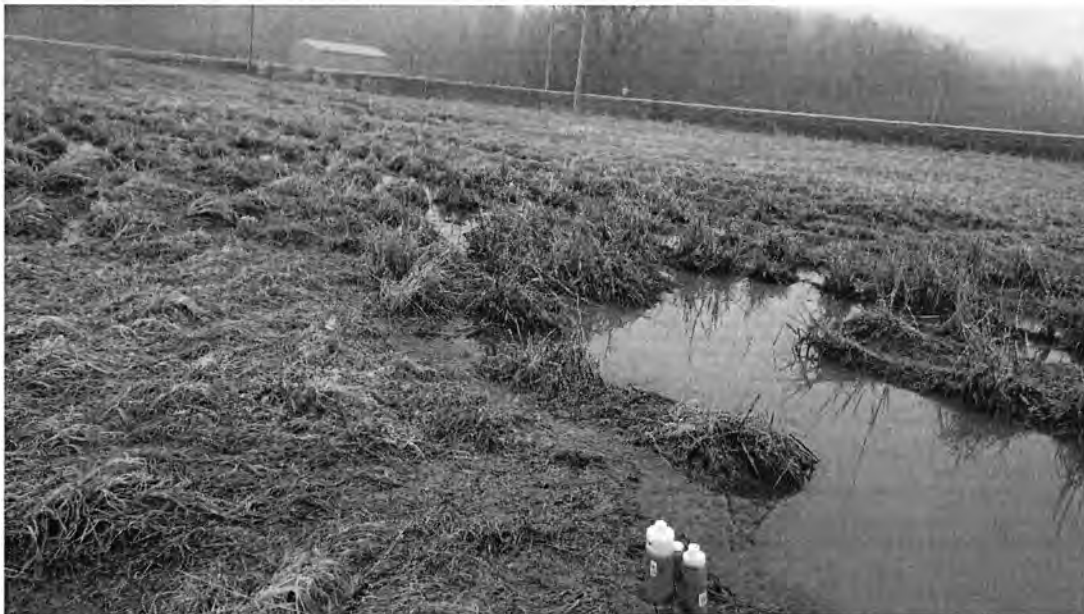
173: RIMG0182

Description: Sample S03 was taken at 11:32 a.m. from process wastewater in the grassed area.

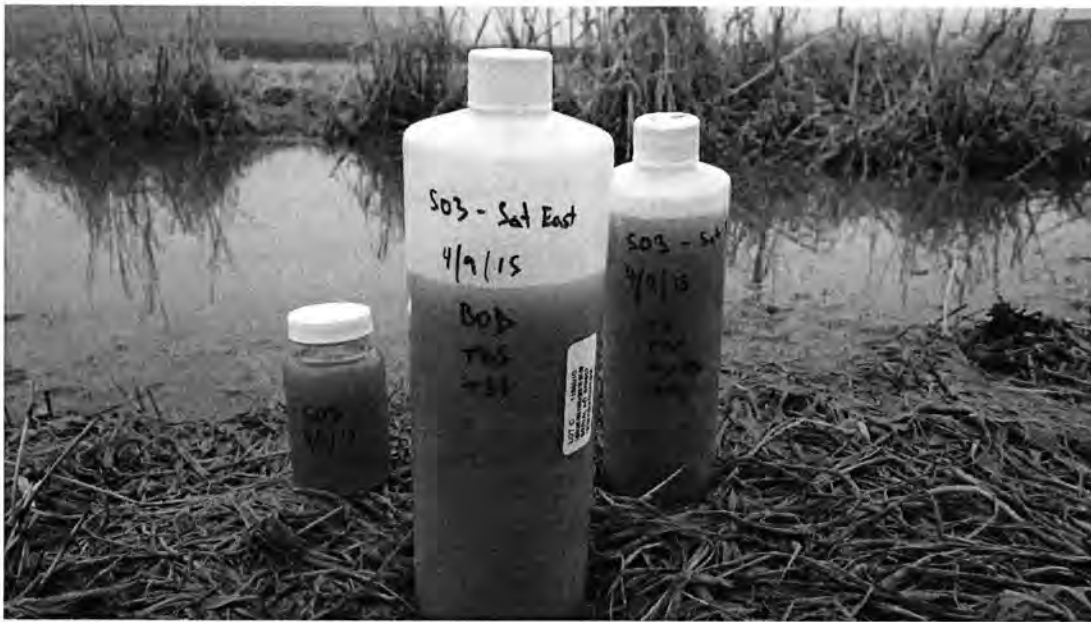
174: RIMG0183

Description: Sample S03 was taken at 11:32 a.m. from process wastewater in the grassed area.

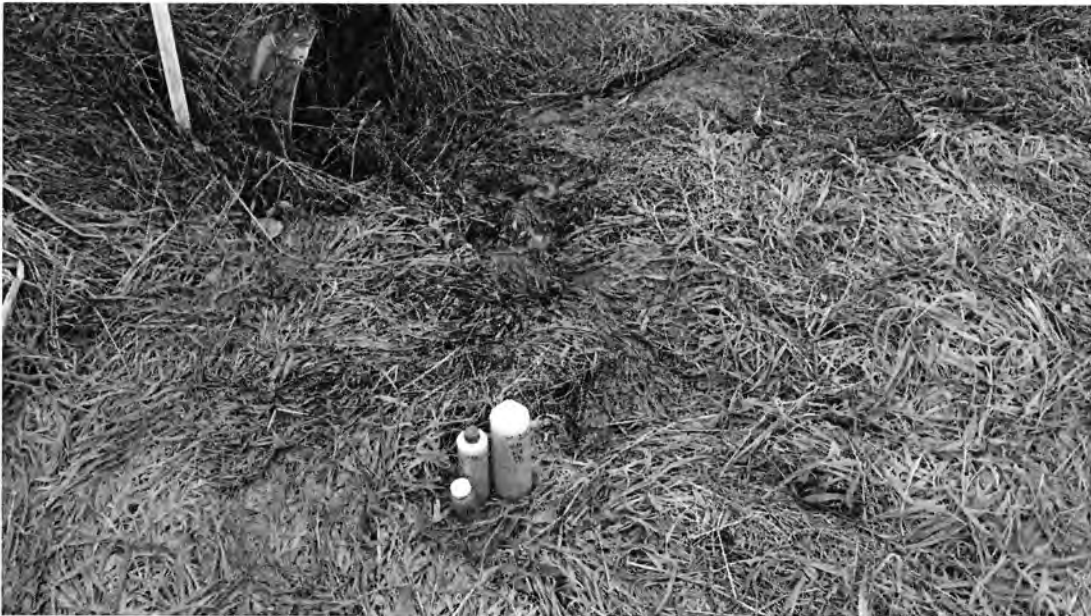
175: RIMG0184

Description: Sample S03 was taken at 11:32 a.m. from process wastewater in the grassed area.

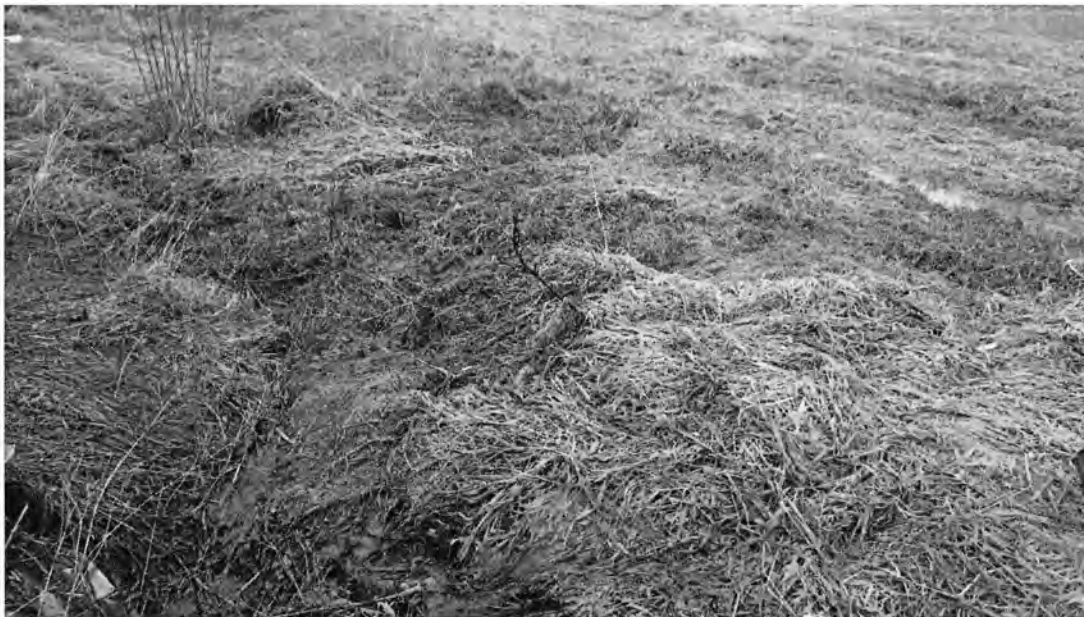
176: RIMG0185

Description: Sample S04 was taken at 11:35 a.m. from process wastewater before entering a culvert under County Road V.

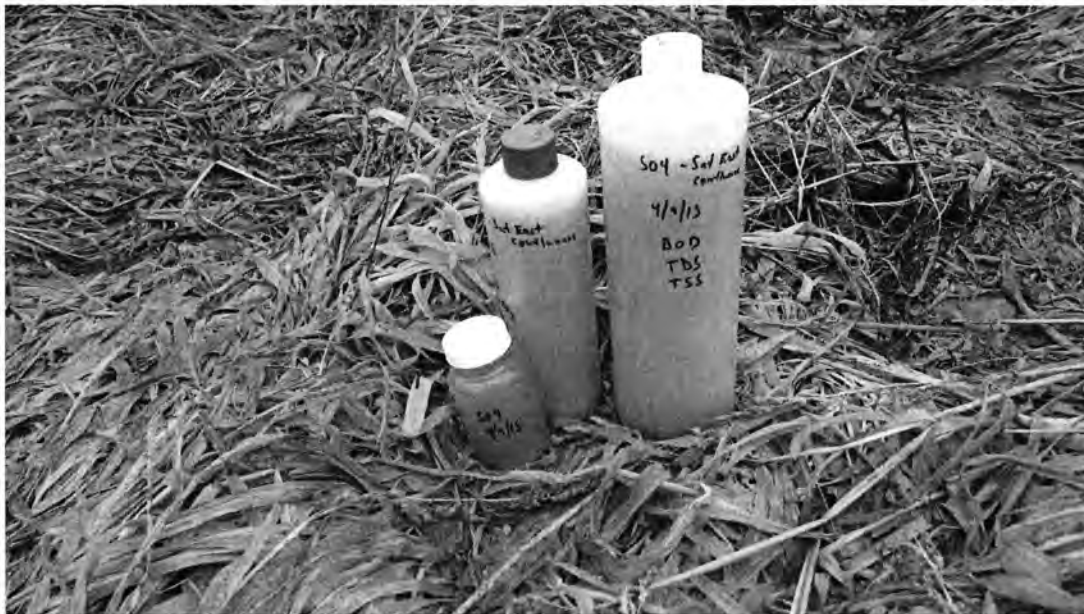
177: RIMG0186

Description: Sample S04 was taken at 11:35 a.m. from process wastewater before entering the culvert under County Road V.
