State of Wisconsin | DEPARTMENT OF NATURAL RESOURCES

Subject: **Notice of Violation - Chapter 283, Wis. Statutes  
Enforcement Conference - March 9, 2009**

### **3. POTENTIAL VIOLATIONS**

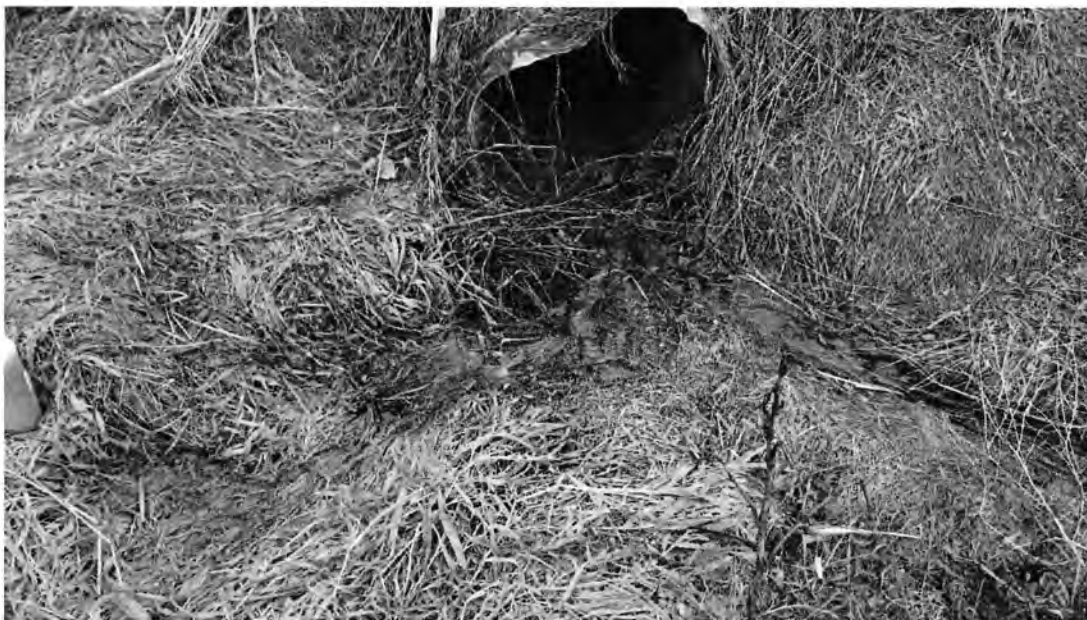
178: RIMG0187

Description: Sample S04 was taken at 11:35 a.m. from process wastewater before entering the culvert under County Road V.

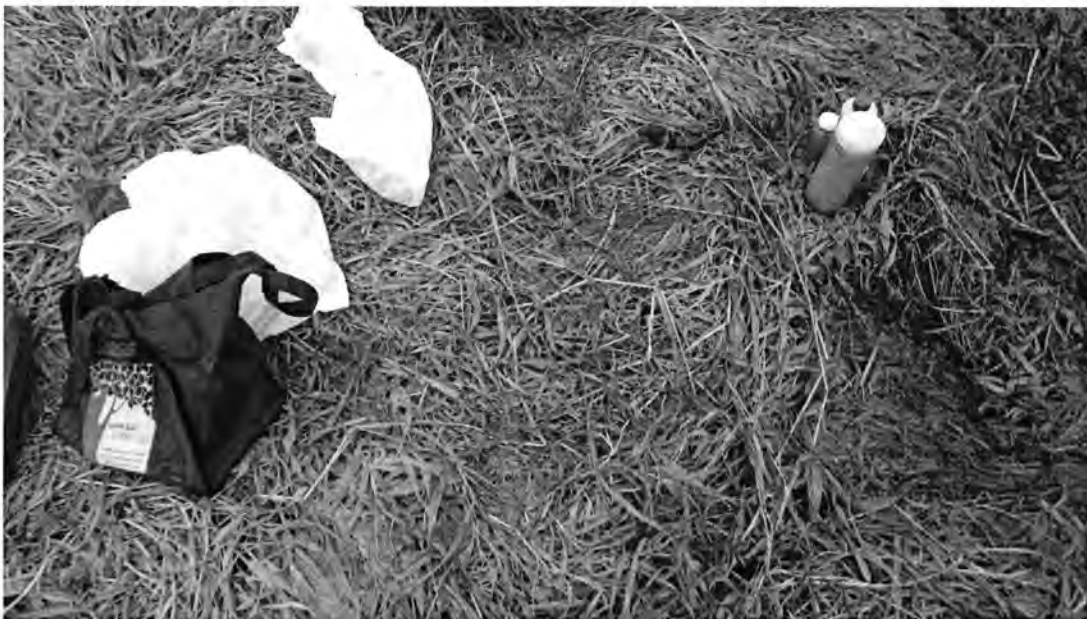
179: RIMG0188

Description: Sample S04 was taken at 11:35 a.m. from process wastewater before entering the culvert under County Road V.

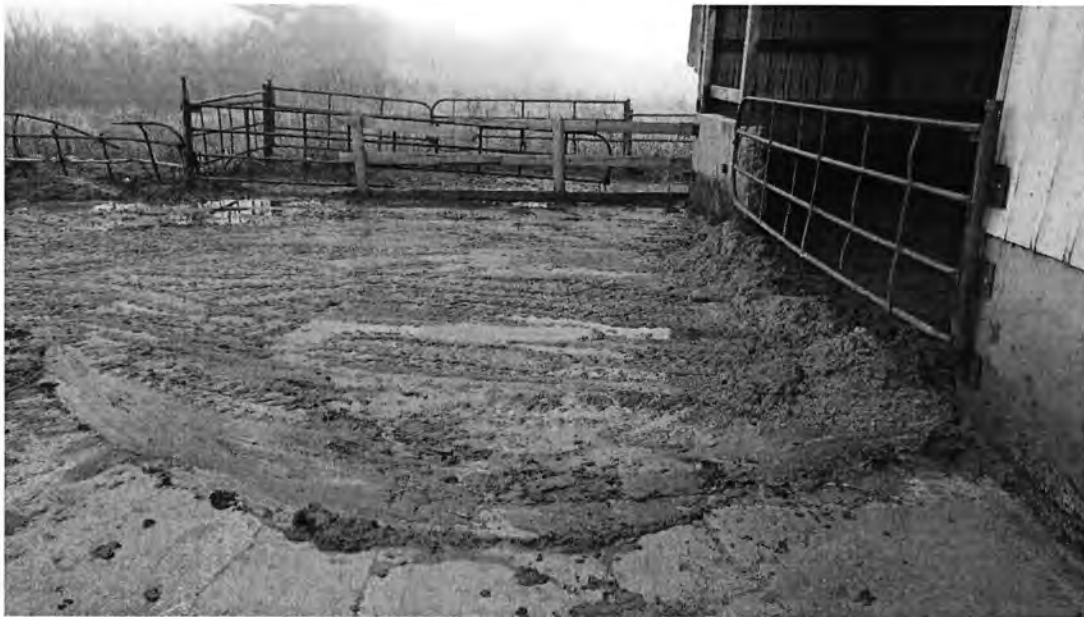
181: RIMG0190

Description: The sand berm in the northwest corner of the Milk Cow Barn had degraded since the start of the walkthrough. Manure and process wastewater were observed on the concrete.

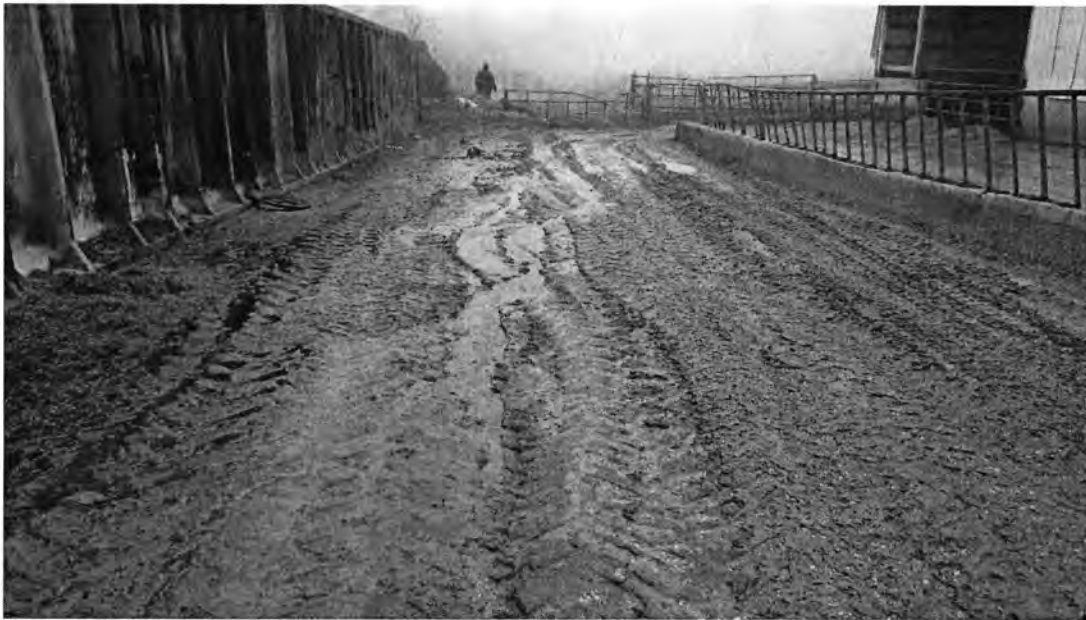
182: RIMG0191

Description: The sand berm in the northwest corner of the Milk Cow Barn had degraded since the start of the walkthrough. Manure and process wastewater were observed on the concrete.

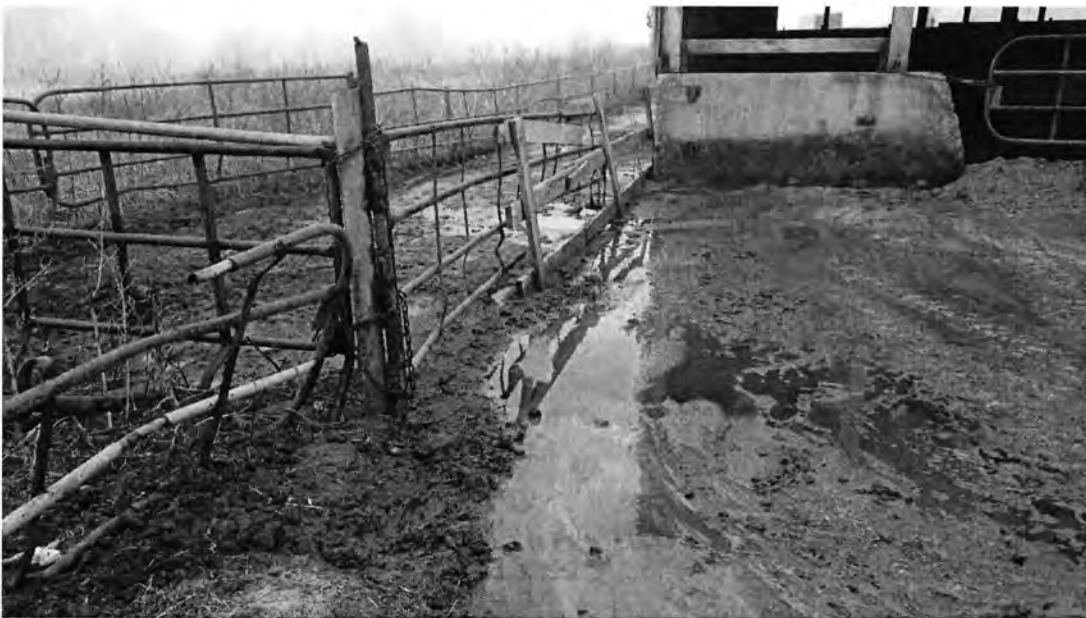
183: RIMG0192

Description: The access way between the feed bunker and the Milk Cow Barn contained the tracking of manure and process wastewater. Additionally, feed and leachate from the feed bunker were observed on the access way. Process wastewater drained north to the field north of the Milk Cow Barn.

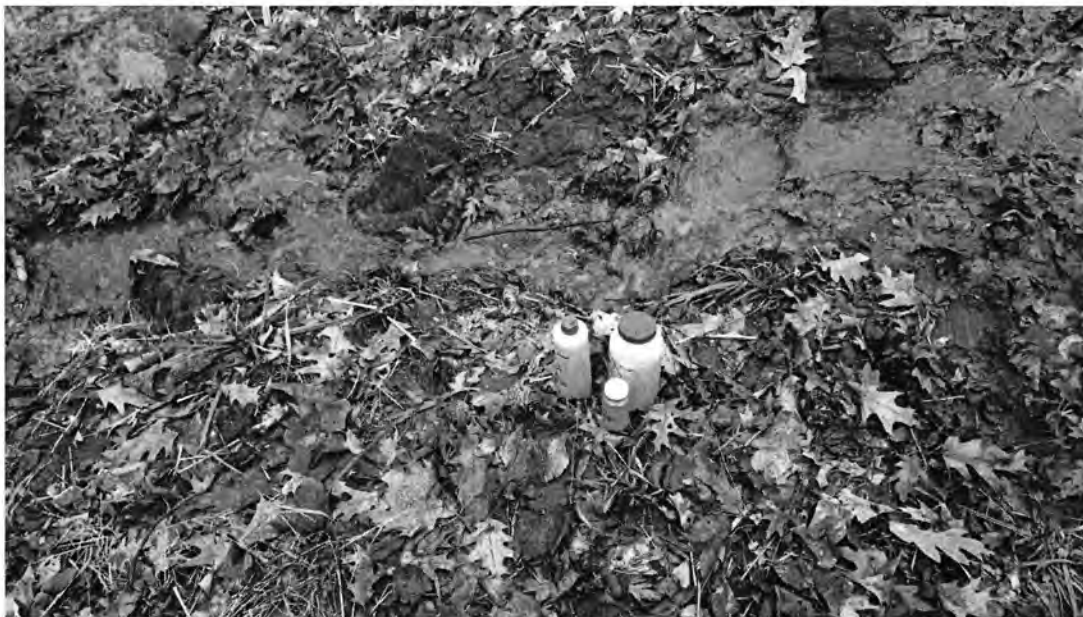
184: RIMG0193

Description: Process wastewater drained north to the field north of the Milk Cow Barn.

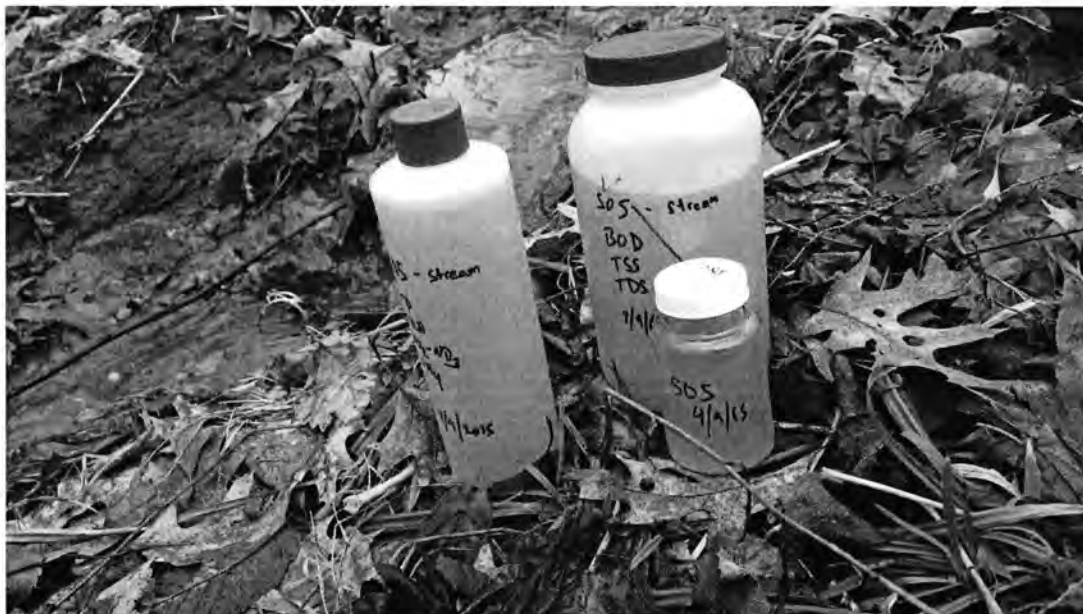
185: RIMG0194

Description: Sample S05 was taken at 12:45 p.m. from the process wastewater in the drainage pathway at the unnamed tributary on the east side of the Home site.

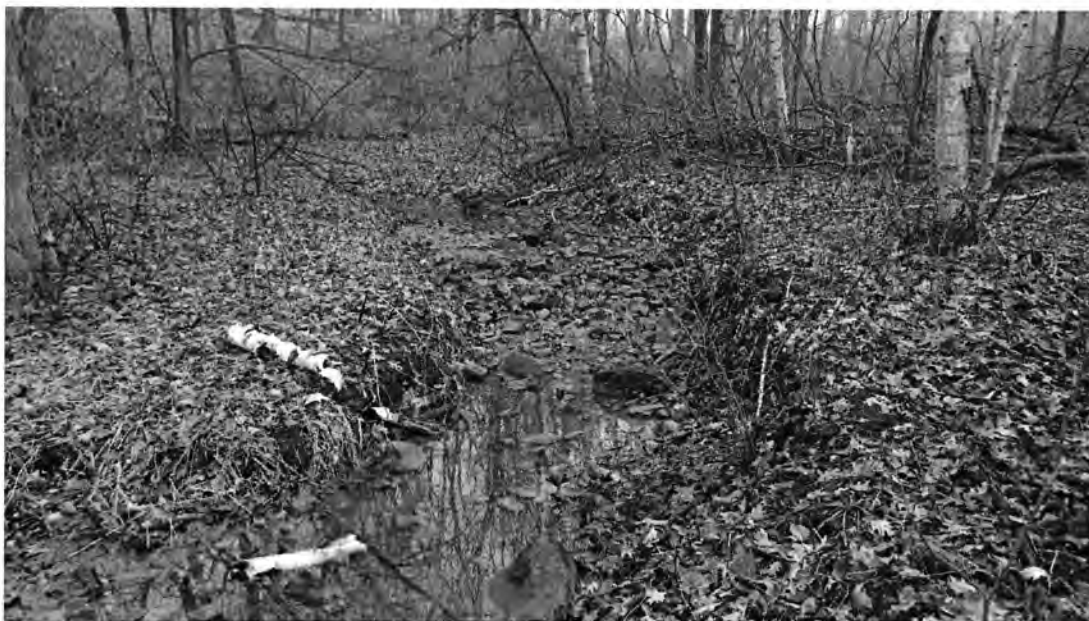
186: RIMG0195

Description: Sample S05 was taken at 12:45 p.m. from the process wastewater in the drainage pathway at the unnamed tributary on the east side of the Home site.

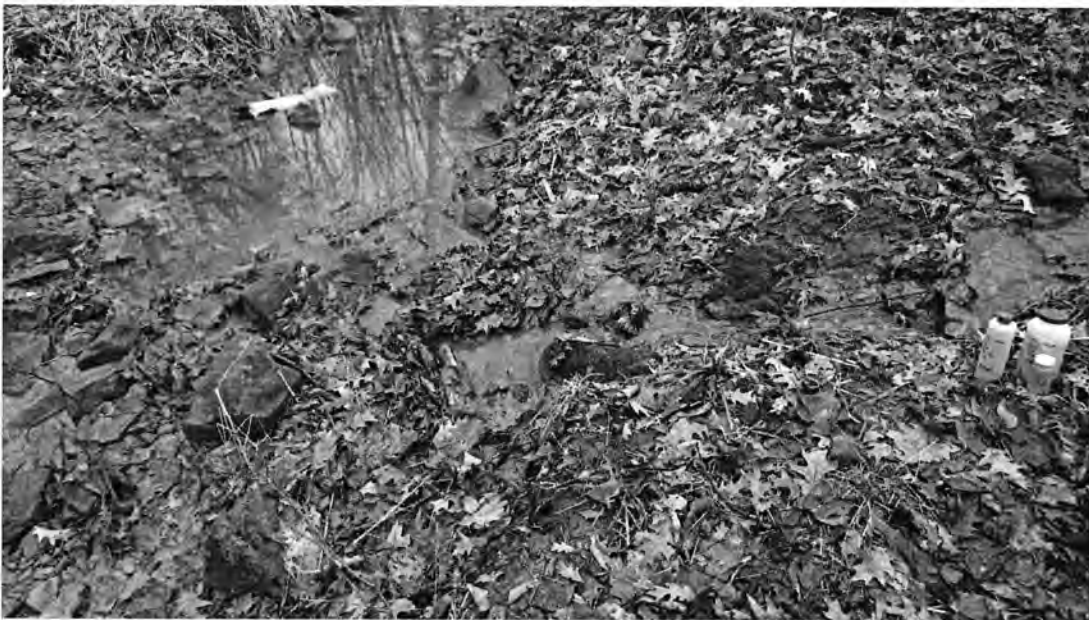
187: RIMG0196

Description: The unnamed tributary on the east side of the Home site contained a bed and bank.

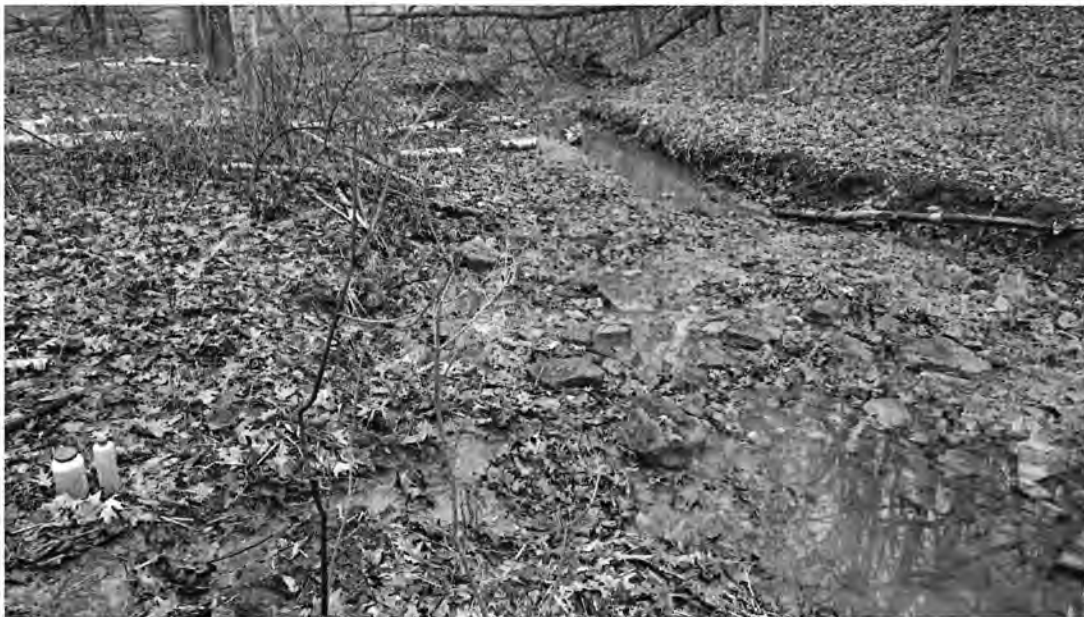
188: RIMG0197

Description: Sample S05 was taken at 12:45 p.m. from the process wastewater in the drainage pathway at the unnamed tributary on the east side of the Home site.

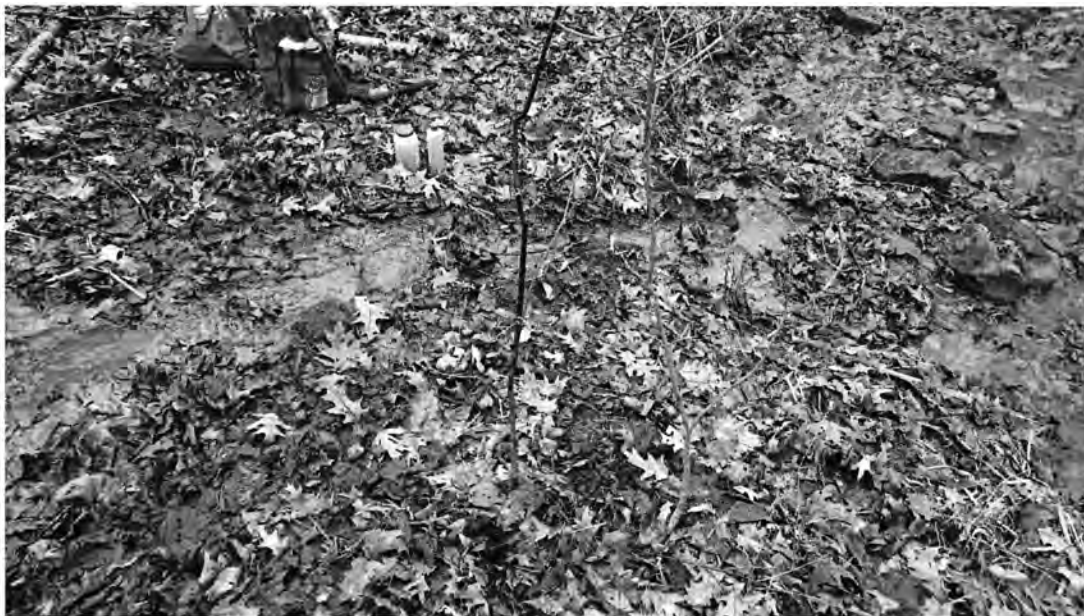
189: RIMG0198

Description: The unnamed tributary on the east side of the Home site contained a bed and bank.

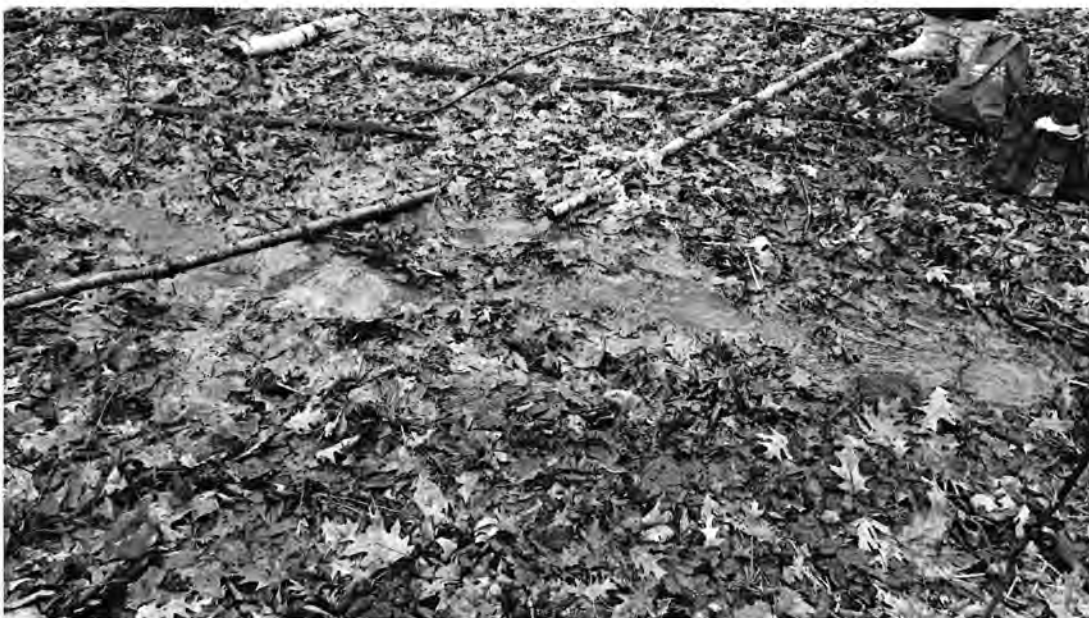
190: RIMG0199

Description: Sample S05 was taken at 12:45 p.m. from the process wastewater in the drainage pathway at the unnamed tributary on the east side of the Home site.

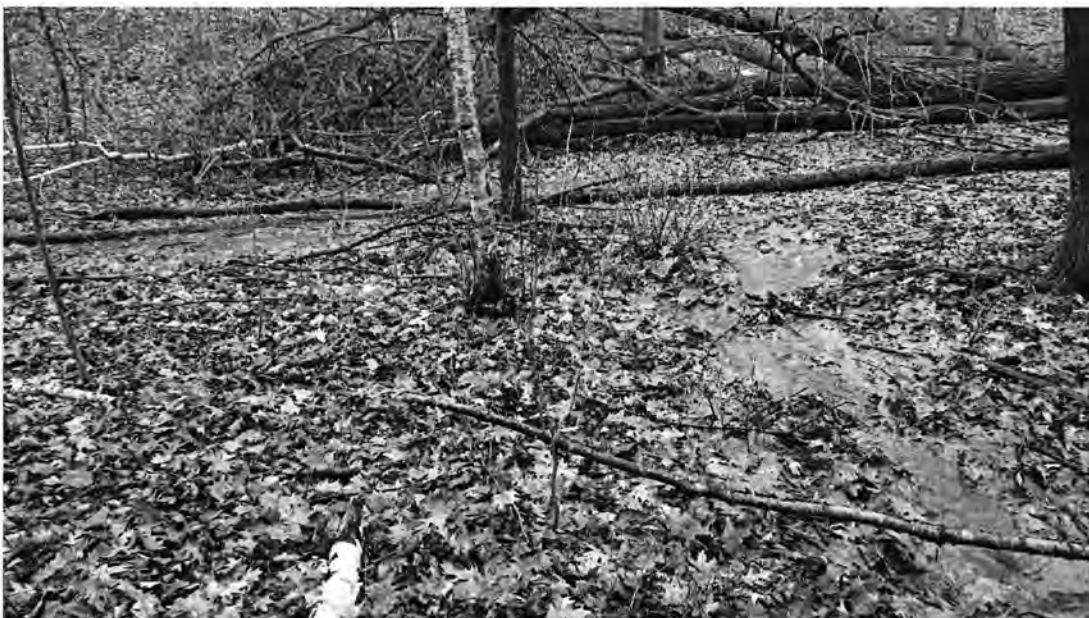
191: RIMG0200

Description: Sample S05 was taken at 12:45 p.m. from the process wastewater in the drainage pathway at the unnamed tributary on the east side of the Home site.

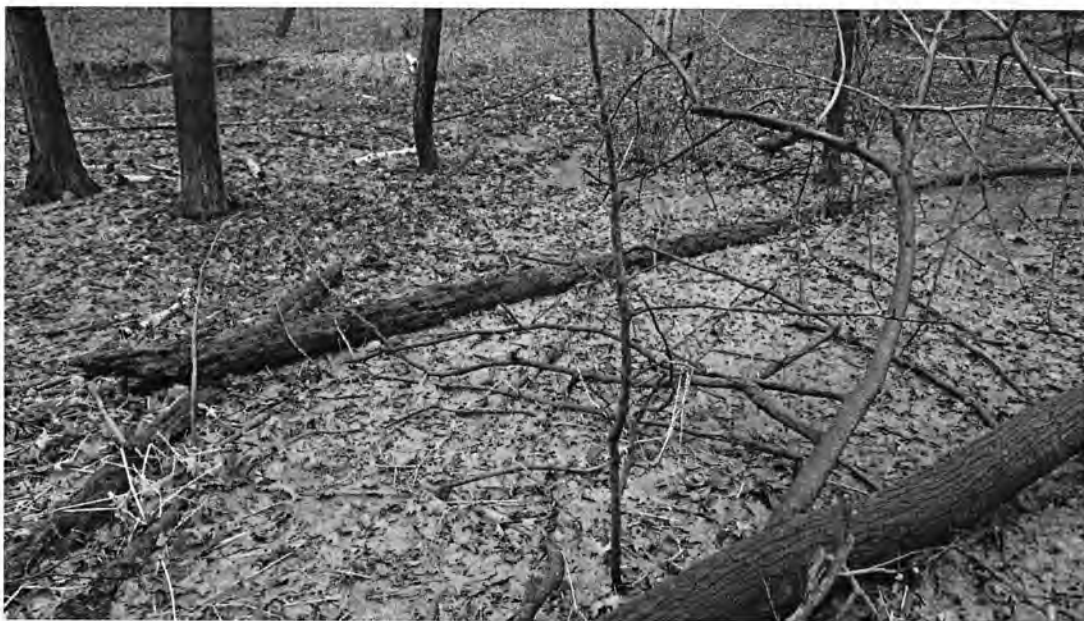
192: RIMG0201

Description: The drainage pathway flowed to the unnamed tributary.

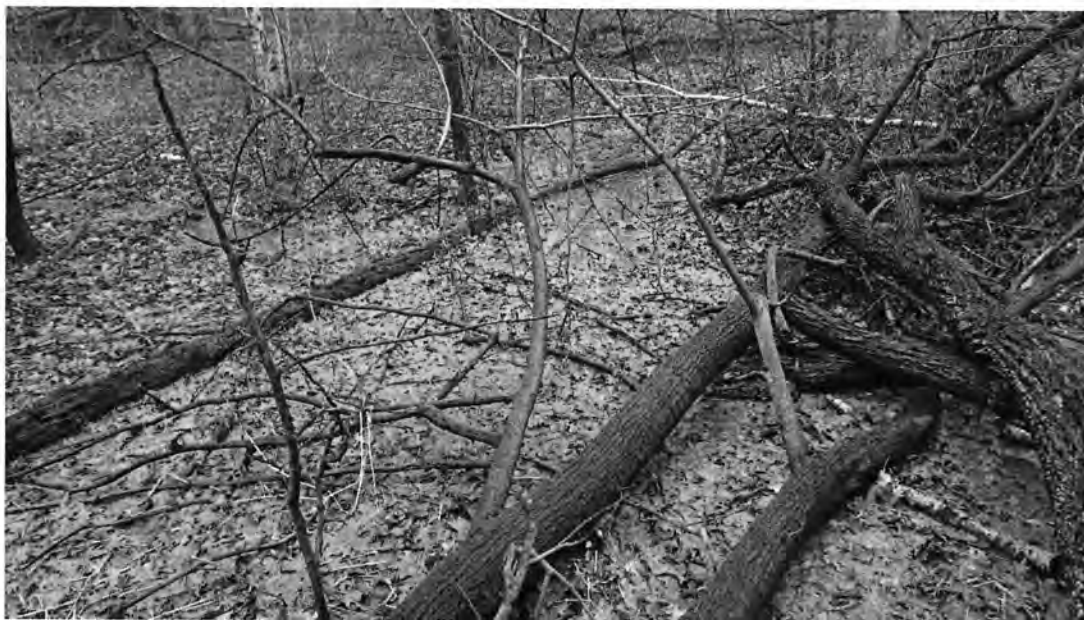
193: RIMG0202

Description: Red/orange sediment covered the forest floor. The sediment had been deposited from the borrow area.

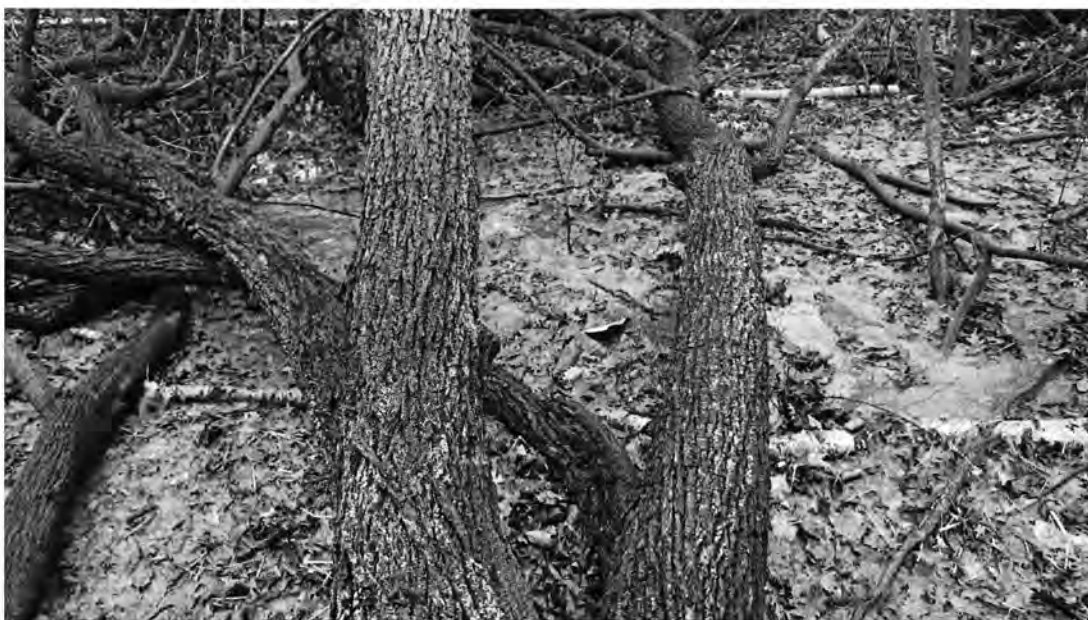
194: RIMG0203

Description: Red/orange sediment covered the forest floor. The sediment had been deposited from the borrow area.

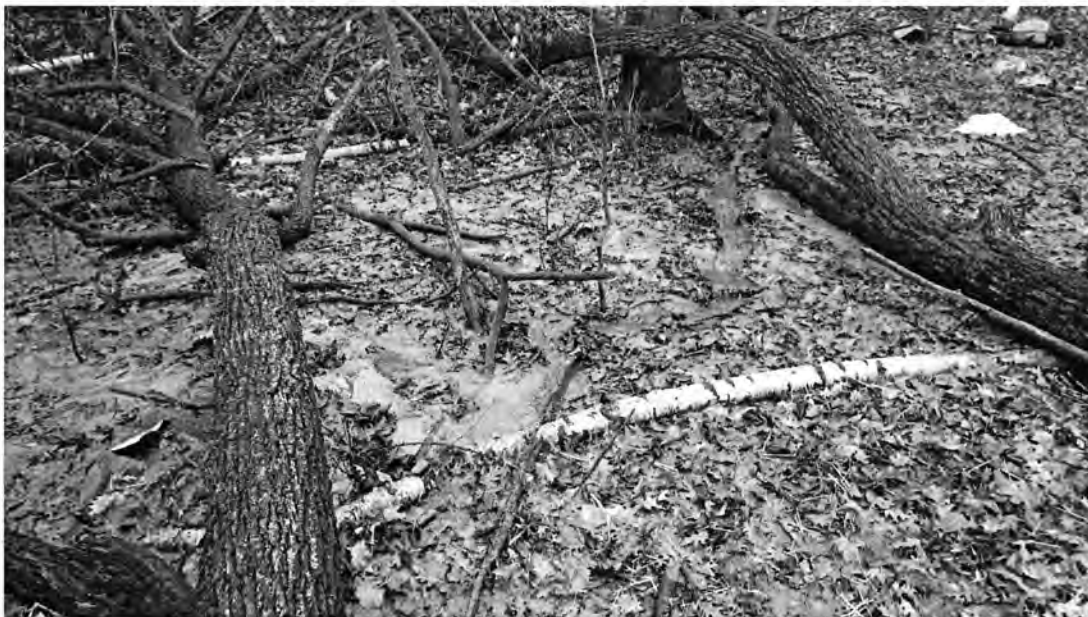
195: RIMG0204

Description: Red/orange sediment covered the forest floor. The sediment had been deposited from the borrow area.

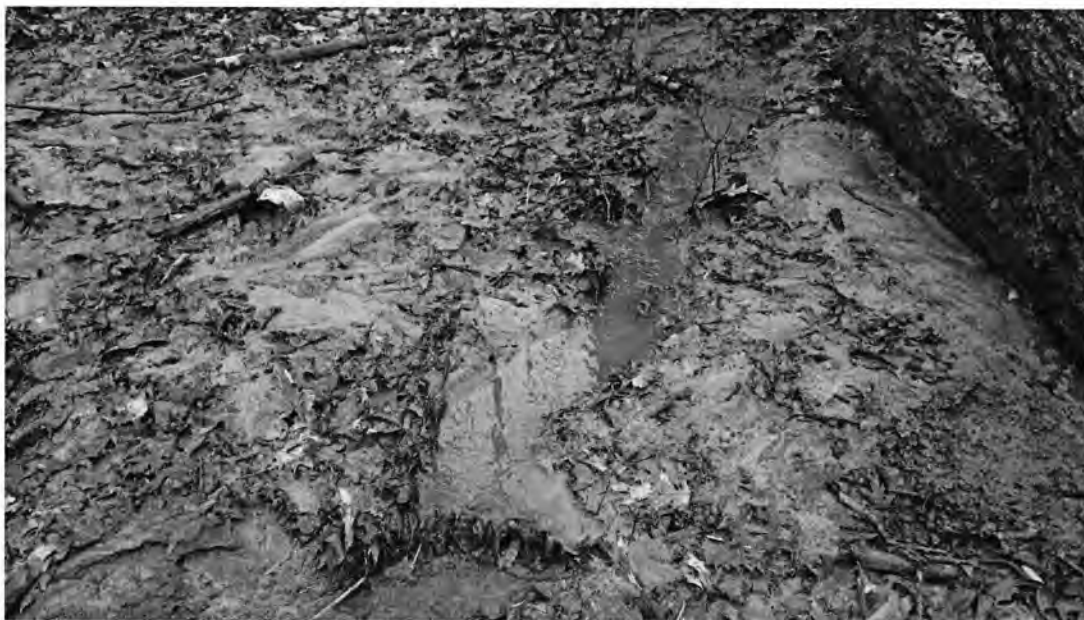
196: RIMG0205

Description: Red/orange sediment covered the forest floor. The sediment had been deposited from the borrow area.

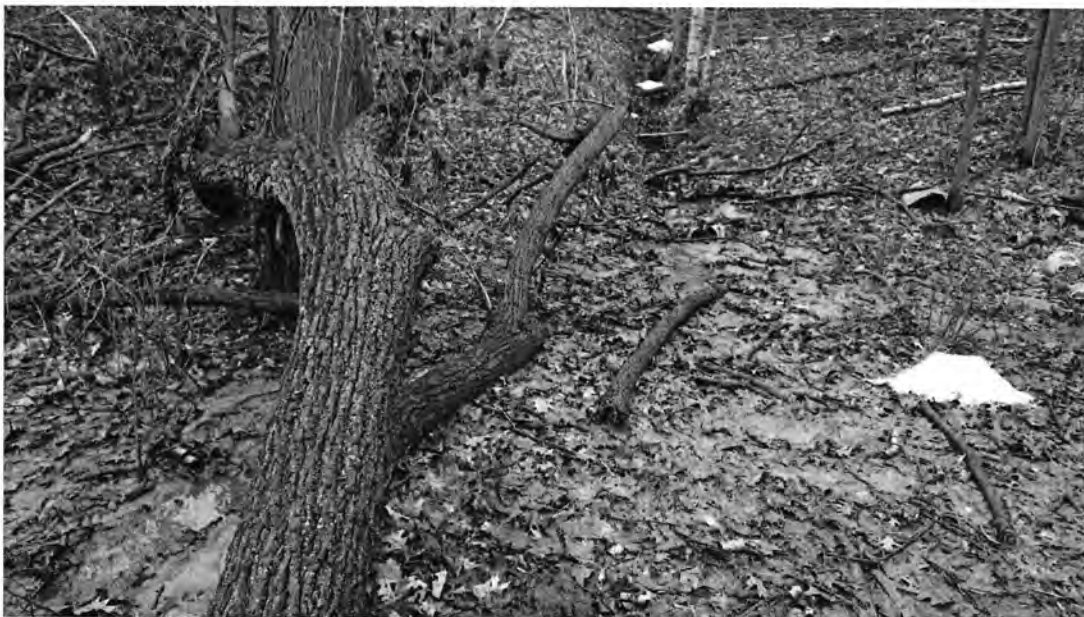
197: RIMG0206

Description: Red/orange sediment covered the forest floor. The sediment had been deposited from the borrow area. The drainage pathway flowed to the unnamed tributary.

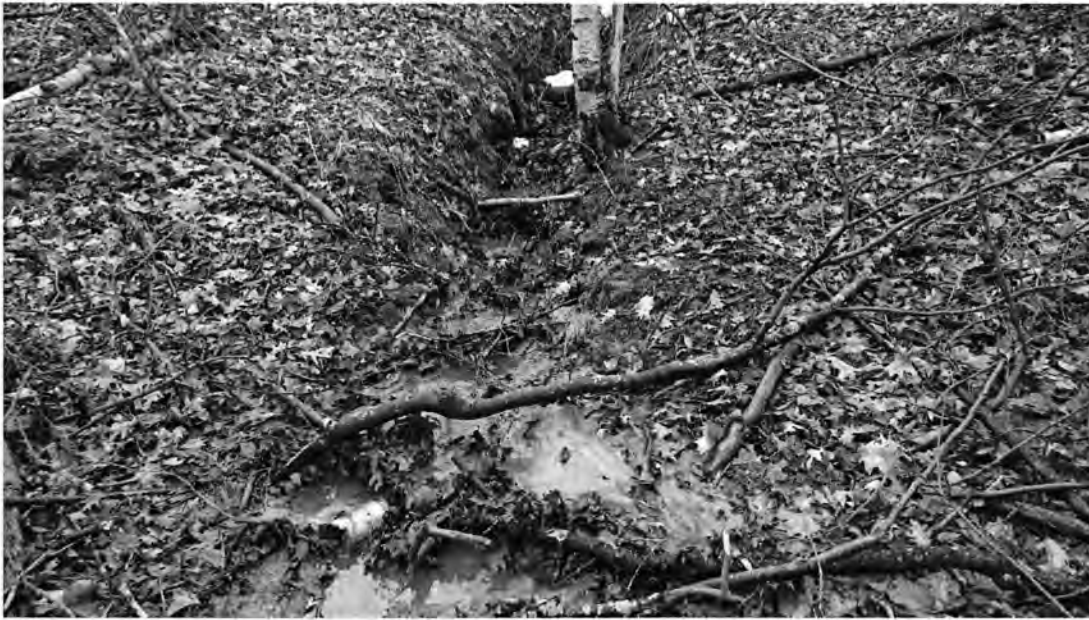
198: RIMG0207

Description: Red/orange sediment covered the forest floor. The sediment had been deposited from the borrow area. The drainage pathway flowed to the unnamed tributary.

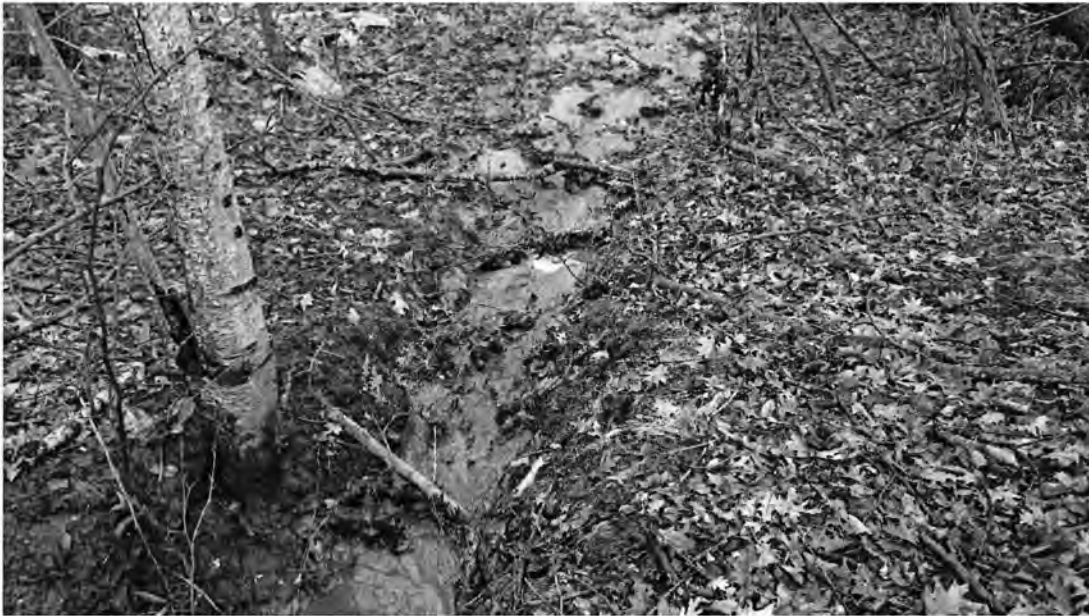
199: RIMG0208

Description: The drainage pathway flowed to the unnamed tributary.

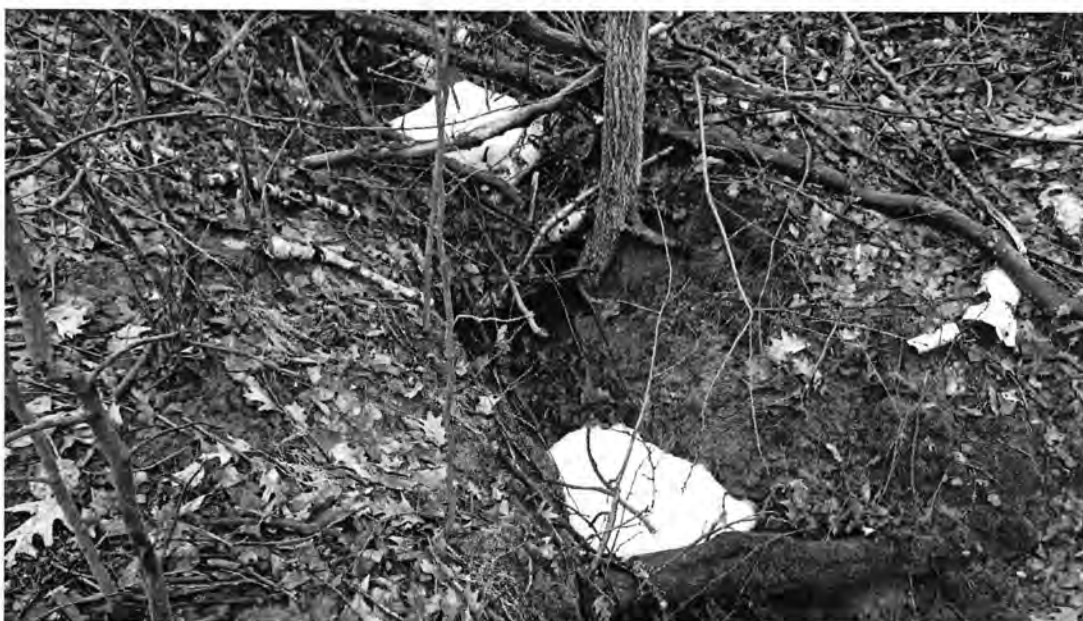
200: RIMG0209

Description: The drainage pathway flowed to the unnamed tributary.

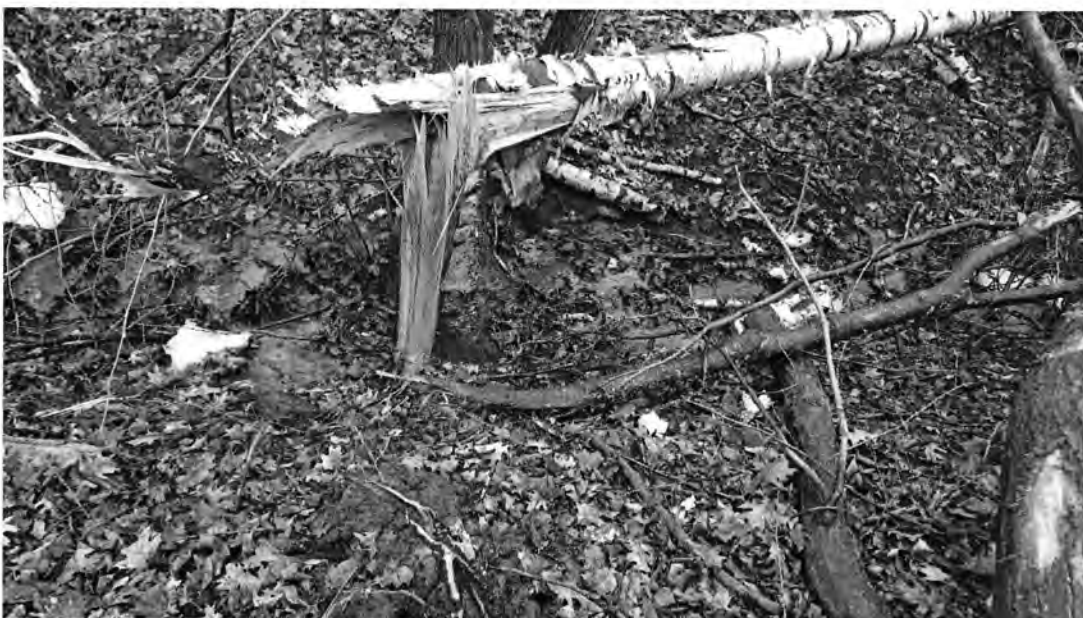
201: RIMG0210

Description: The drainage pathway flowed to the unnamed tributary. Foam was observed in the drainage pathway.

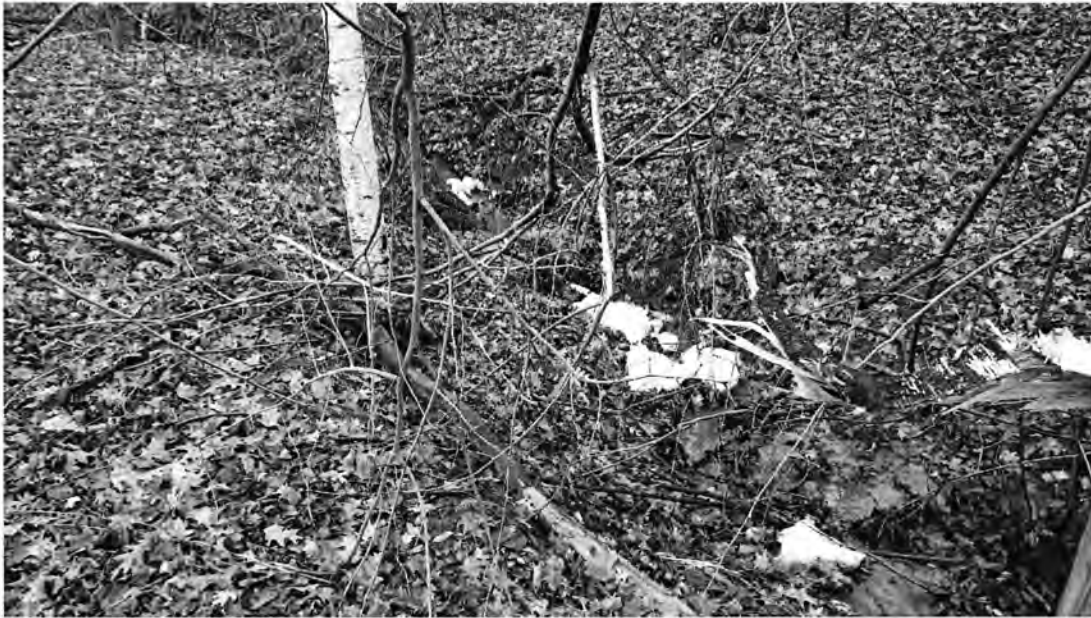
202: RIMG0211

Description: The drainage pathway flowed to the unnamed tributary. Foam was observed in the drainage pathway.

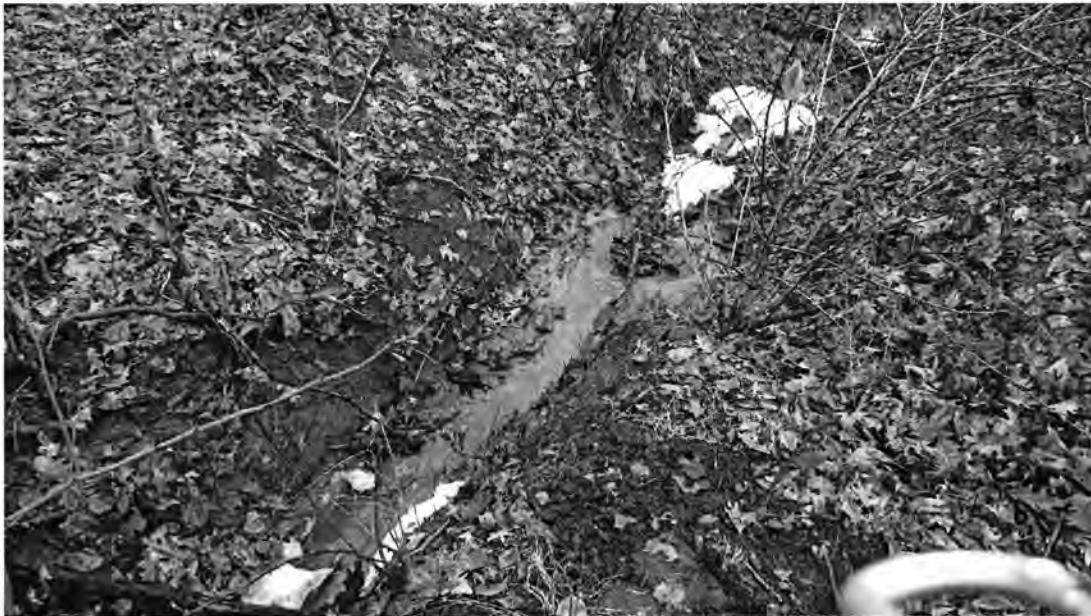
203: RIMG0212

Description: The drainage pathway flowed to the unnamed tributary. Foam was observed in the drainage pathway.

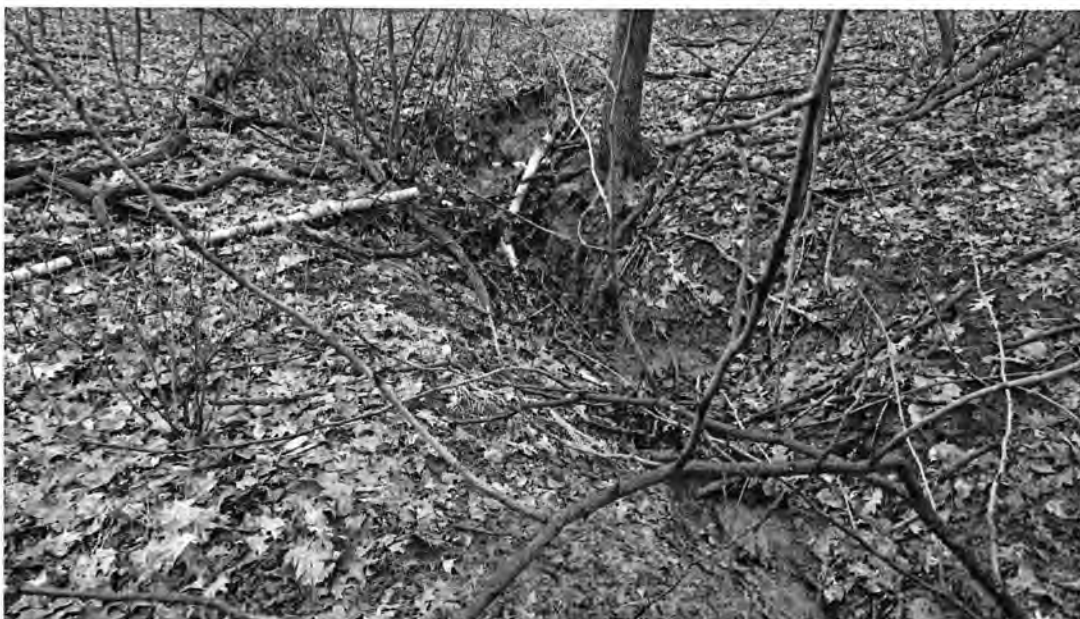
204: RIMG0213

Description: The drainage pathway flowed to the unnamed tributary. Foam was observed in the drainage pathway.

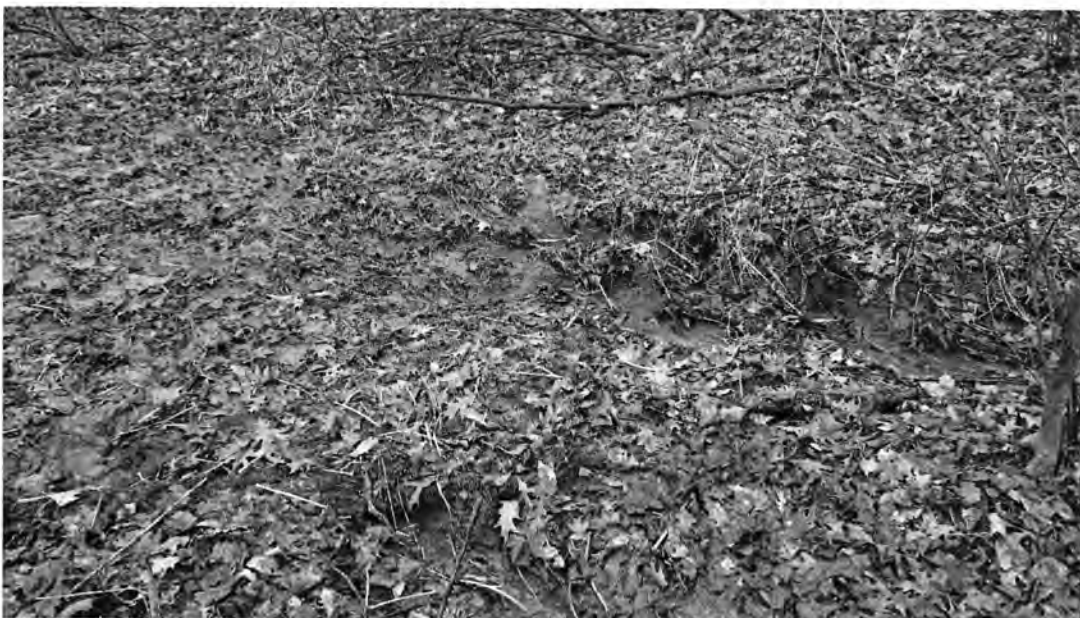
205: RIMG0214

Description: The drainage pathway flowed to the unnamed tributary. Foam was observed in the drainage pathway.

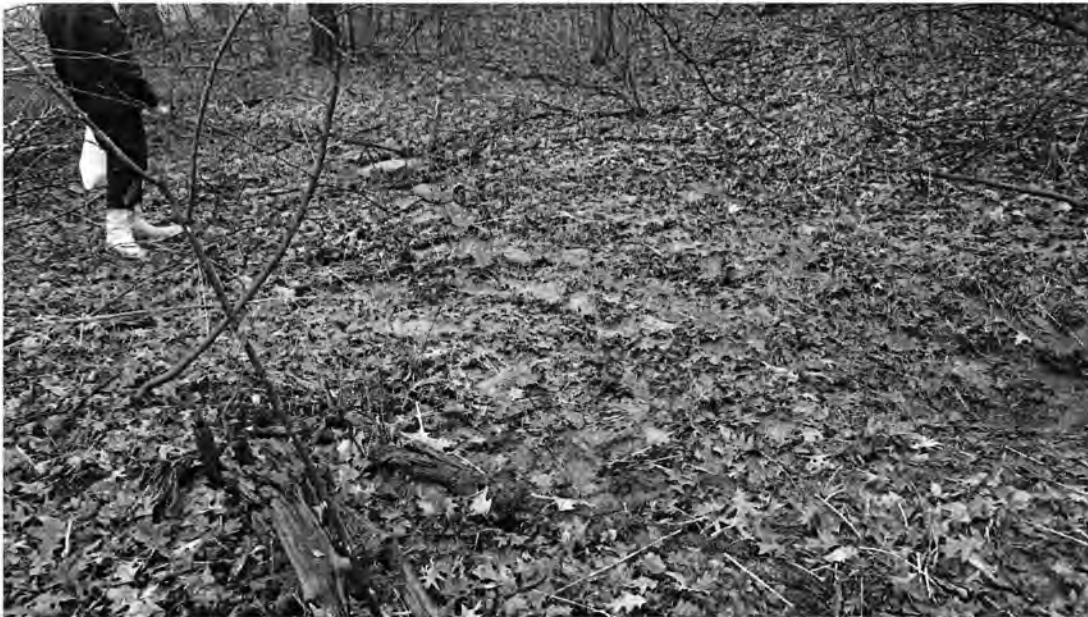
206: RIMG0215

Description: The drainage pathway flowed to the unnamed tributary.

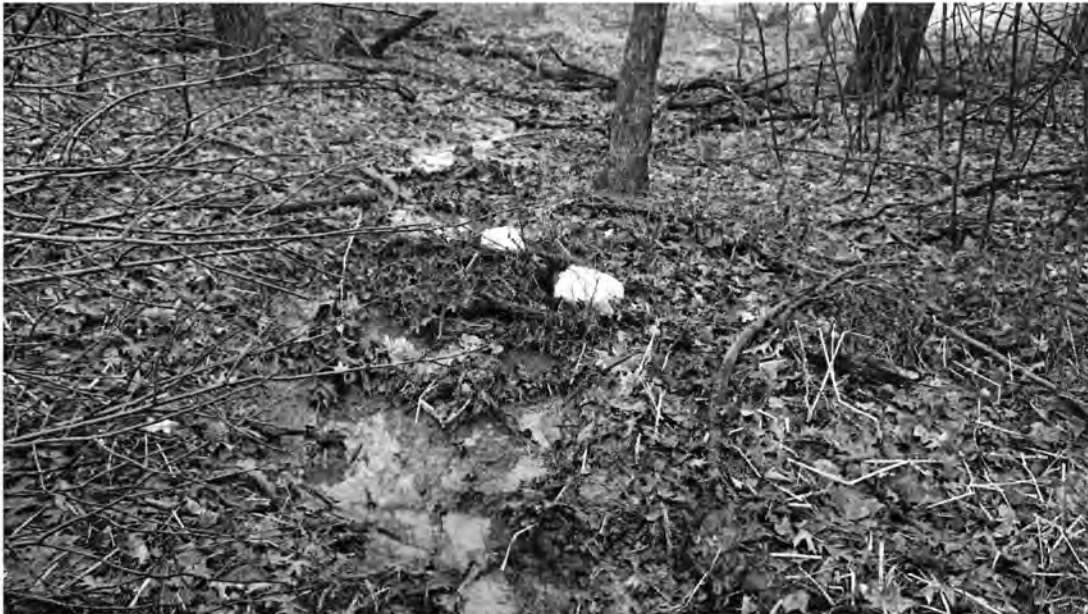
207: RIMG0216

Description: The drainage pathway flowed to the unnamed tributary.

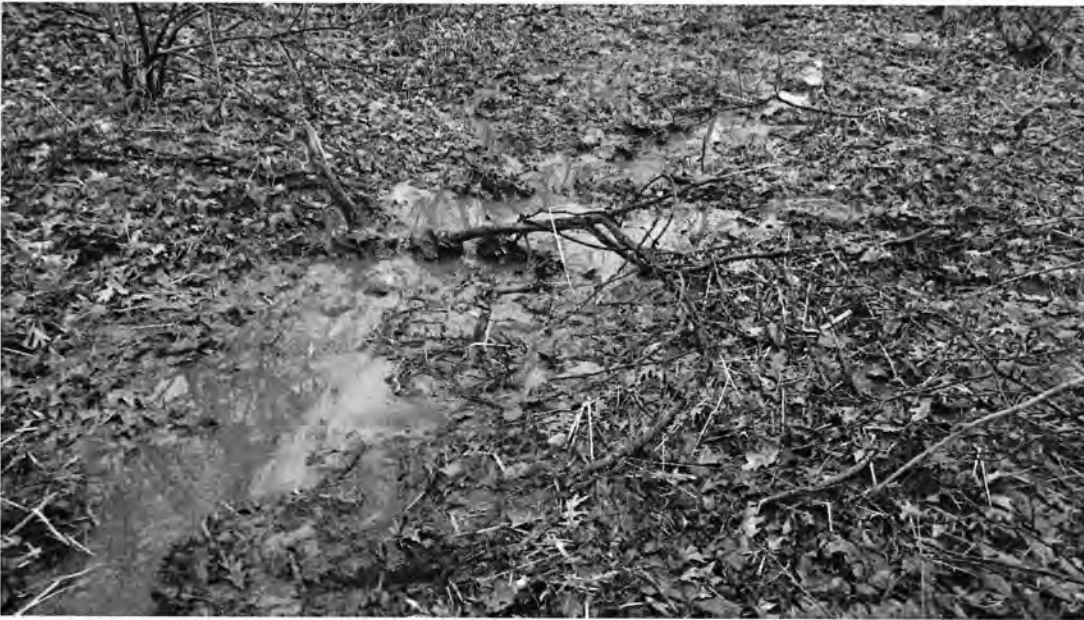
208: RIMG0217

Description: The drainage pathway flowed to the unnamed tributary.

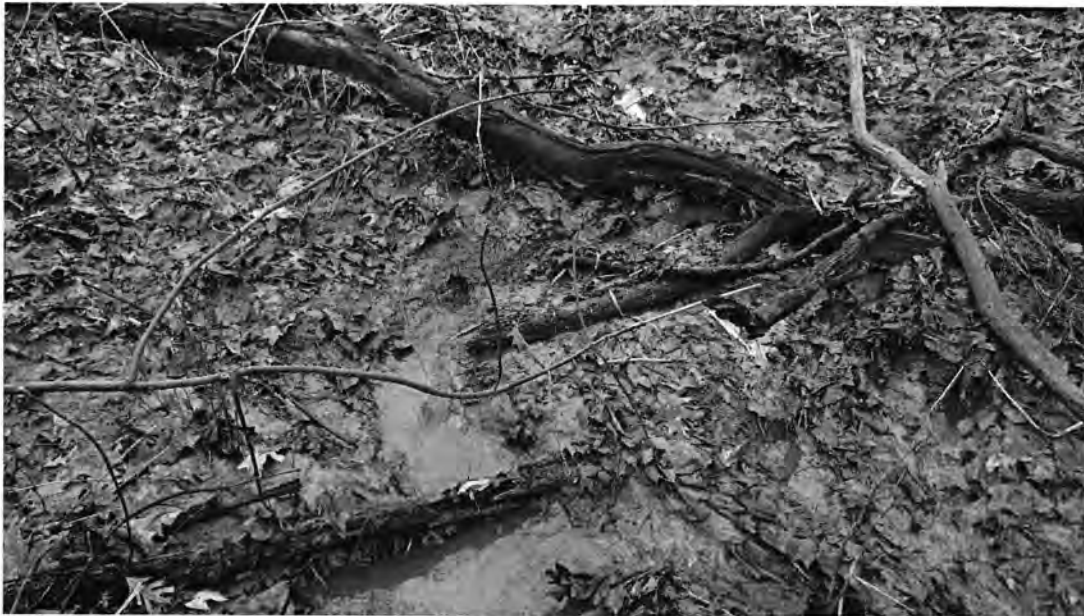
209: RIMG0218

Description: The drainage pathway flowed to the unnamed tributary.

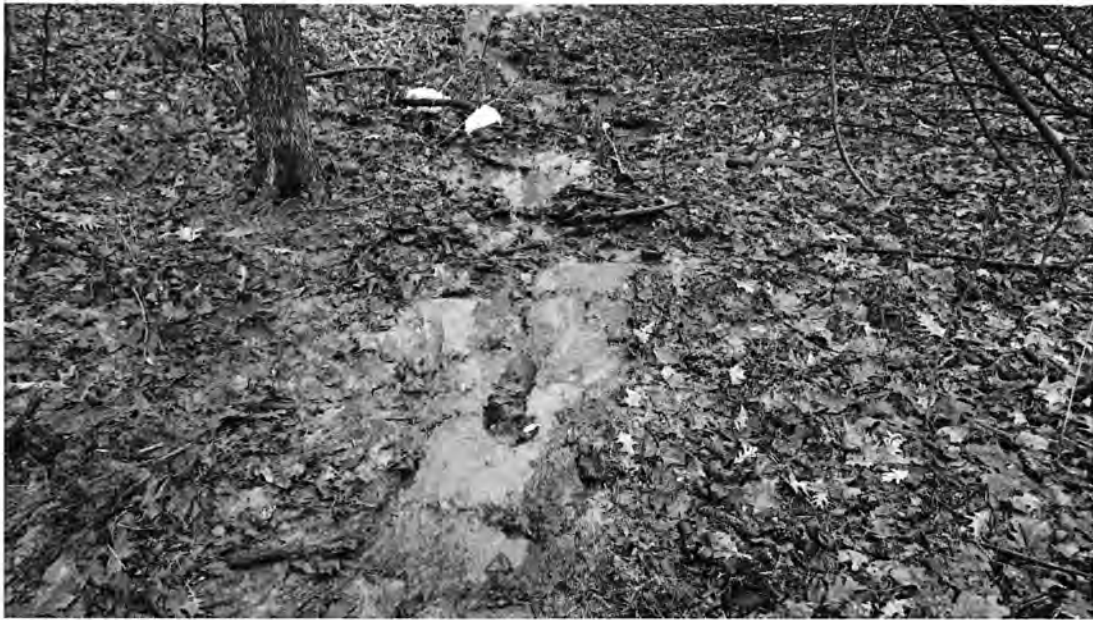
210: RIMG0219

Description: The drainage pathway flowed to the unnamed tributary.
