State of Wisconsin | DEPARTMENT OF NATURAL RESOURCES

Subject: **Notice of Violation - Chapter 283, Wis. Statutes  
Enforcement Conference - March 9, 2009**

### **3. POTENTIAL VIOLATIONS**

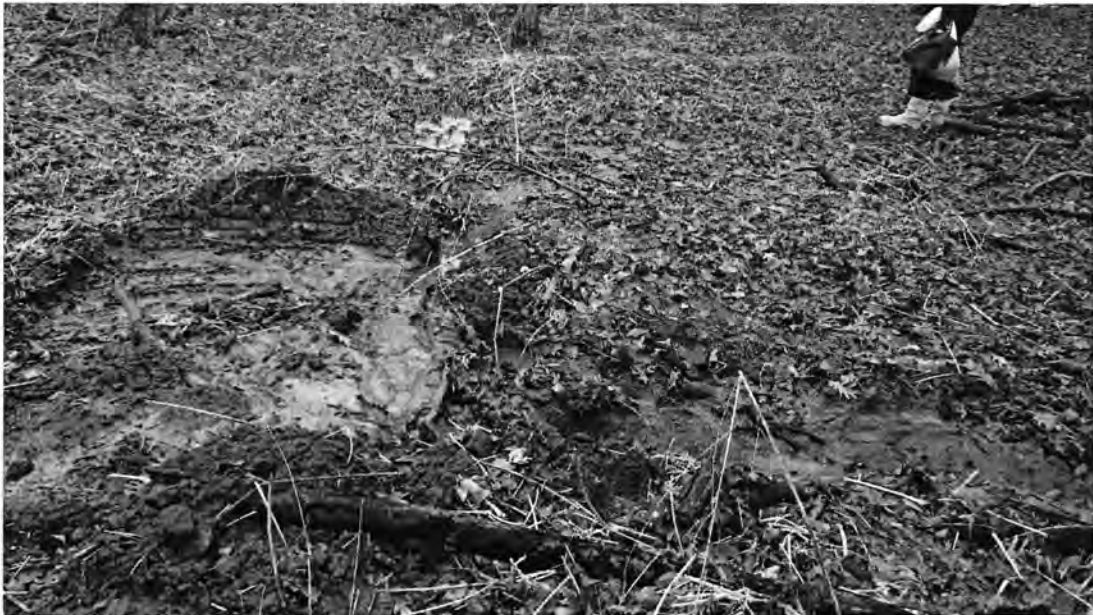
211: RIMG0220

Description: The drainage pathway flowed to the unnamed tributary.

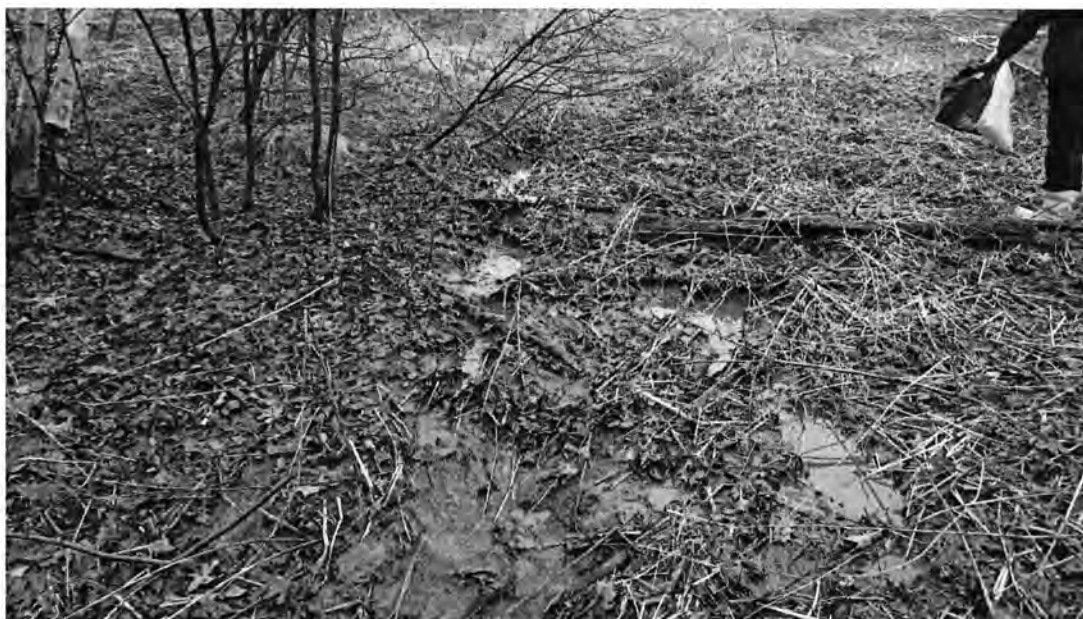
212: RIMG0221

Description: The drainage pathway flowed to the unnamed tributary.

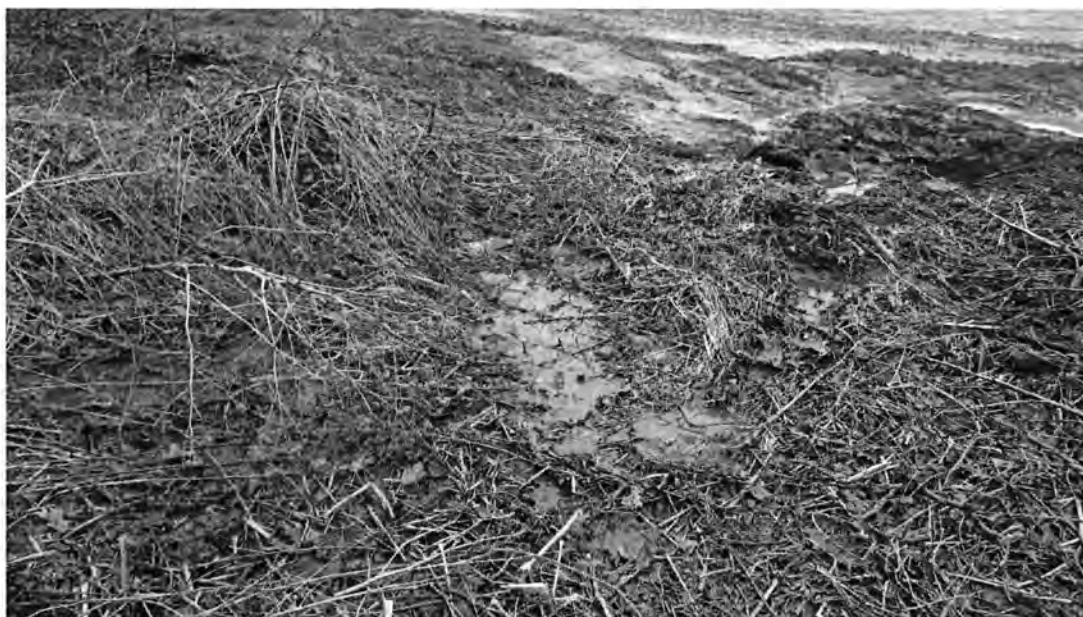
213: RIMG0222

Description: The drainage pathway flowed to the unnamed tributary.

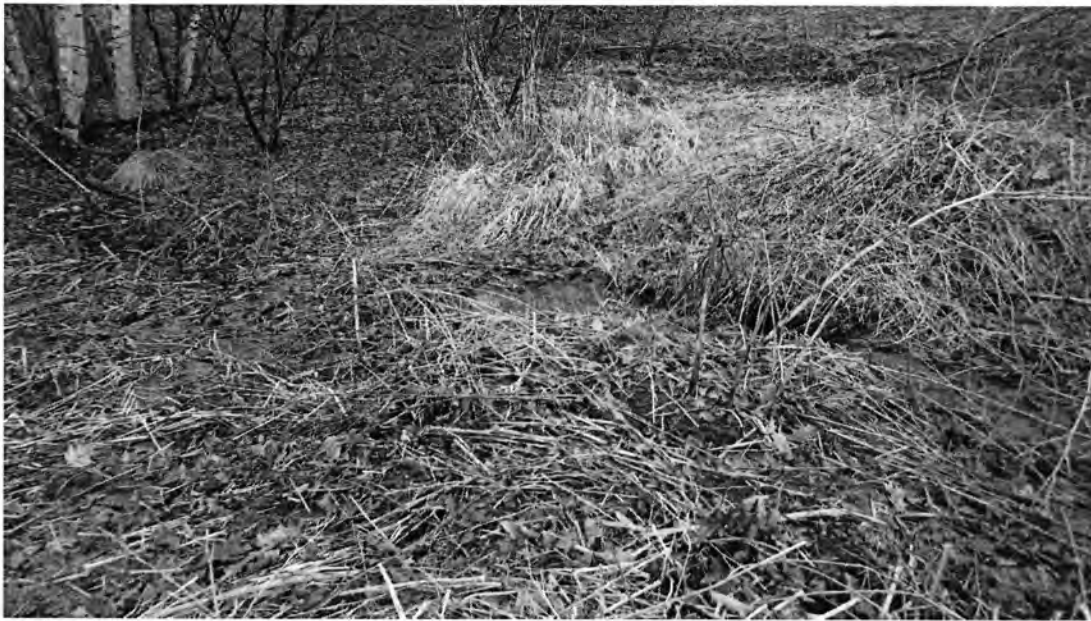
214: RIMG0223

Description: The drainage pathway flowed to the unnamed tributary.

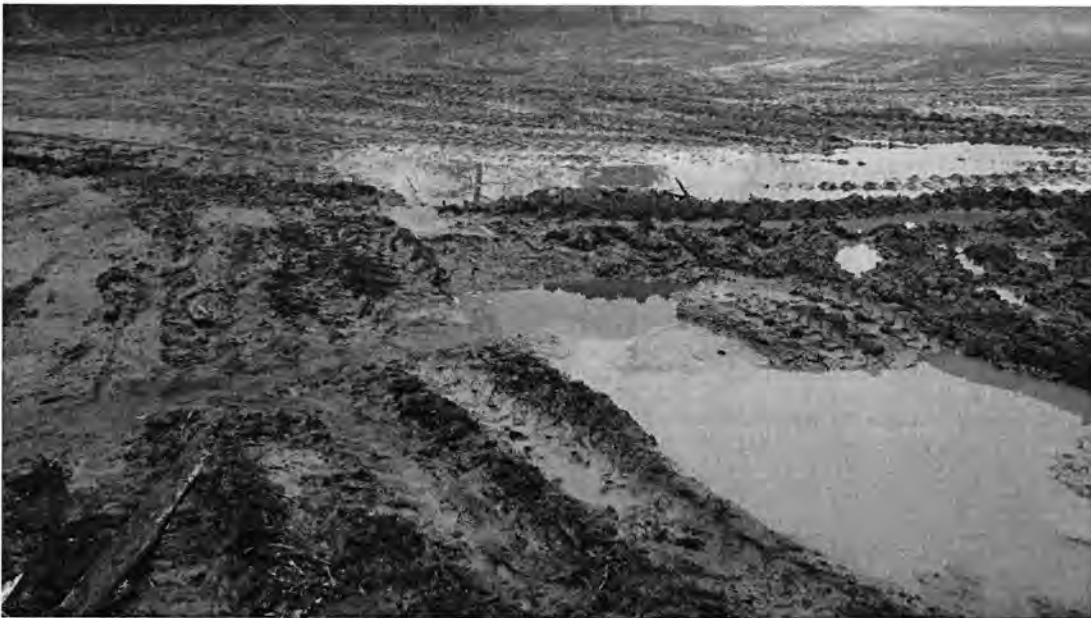
215: RIMG0224

Description: The drainage pathway flowed to the unnamed tributary.

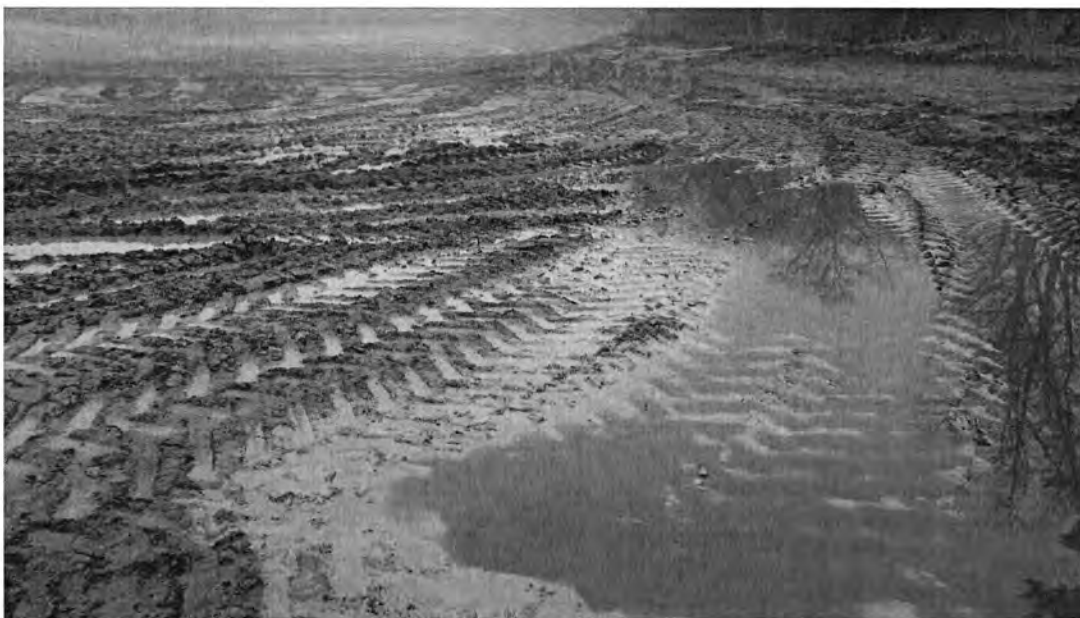
216: RIMG0225

Description: The drainage pathway flowed to the unnamed tributary.

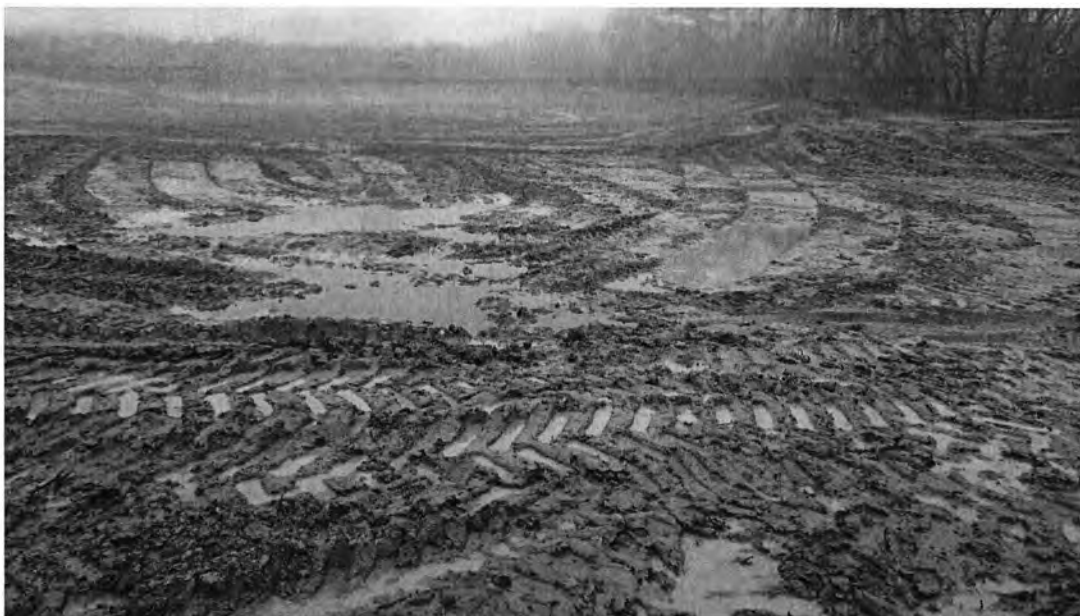
217: RIMG0226

Description: The drainage pathway flowed to the unnamed tributary.

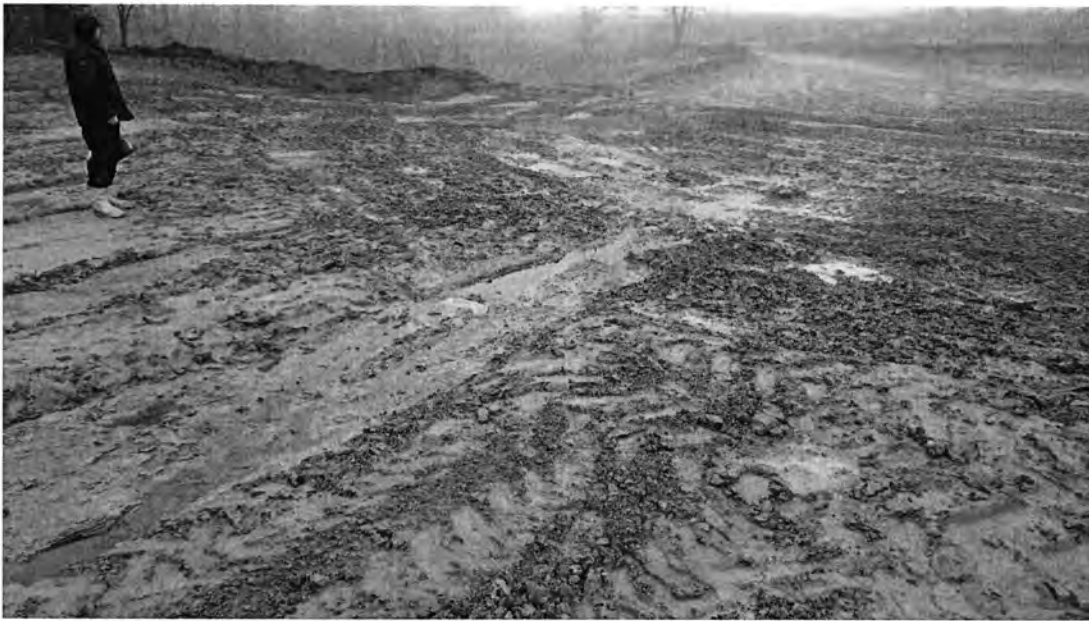
218: RIMG0227

Description: The drainage pathway flowed to the unnamed tributary.

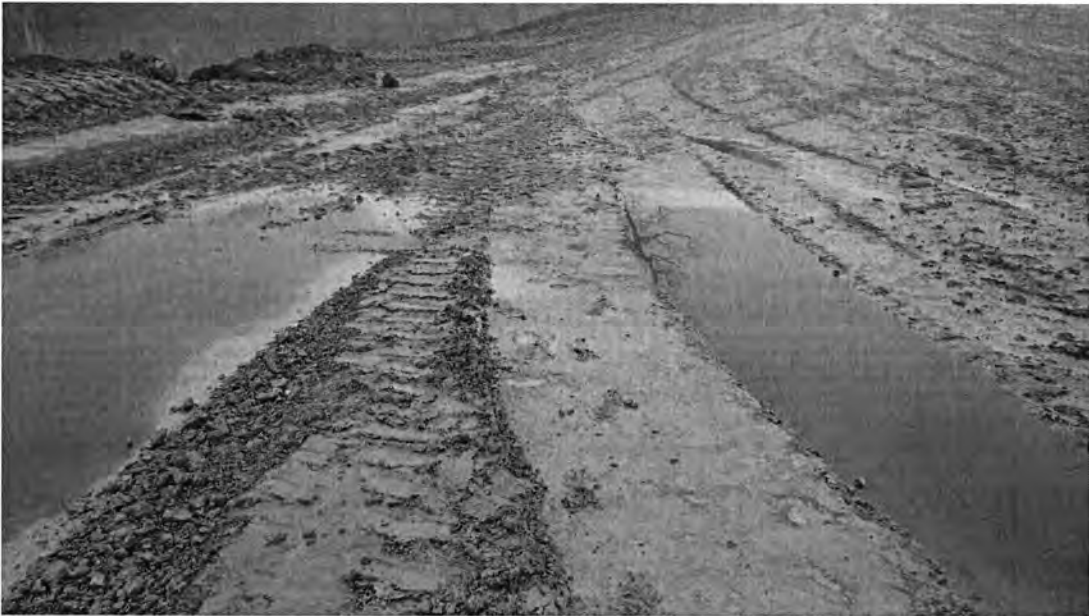
219: RIMG0228

Description: The drainage pathway flowed to the unnamed tributary.

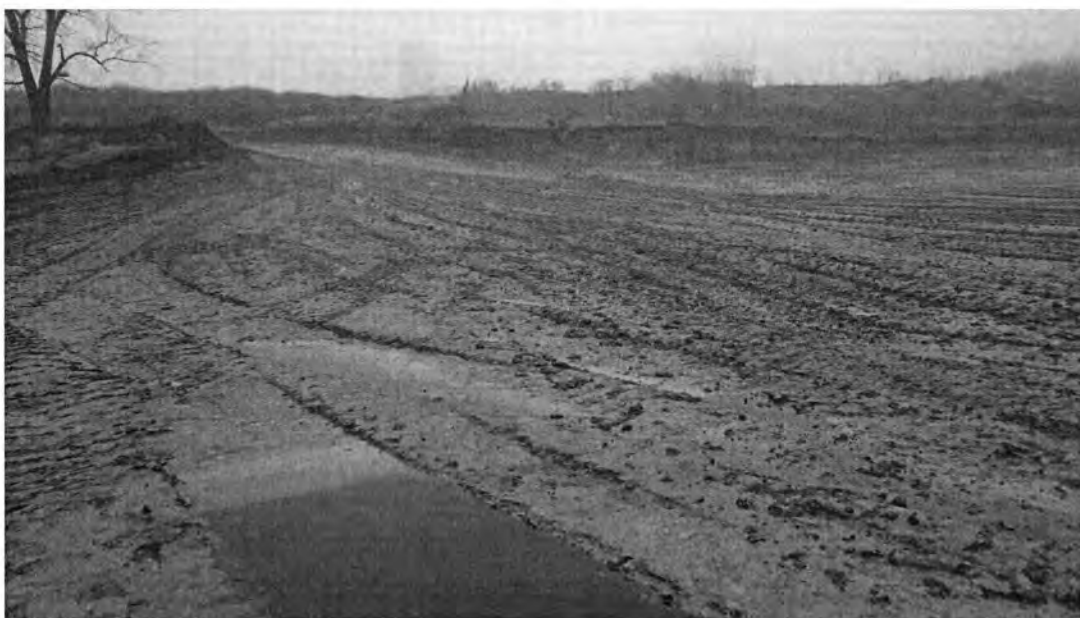
220: RIMG0229

Description: The drainage pathway flowed to the unnamed tributary.

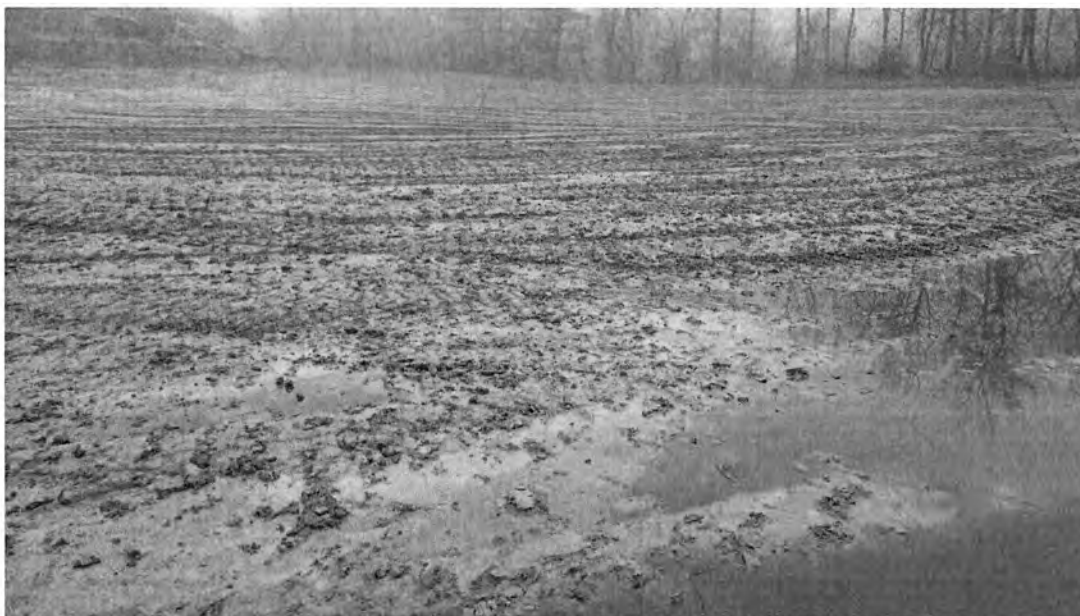
221: RIMG0230

Description: The drainage pathway flowed to the unnamed tributary.

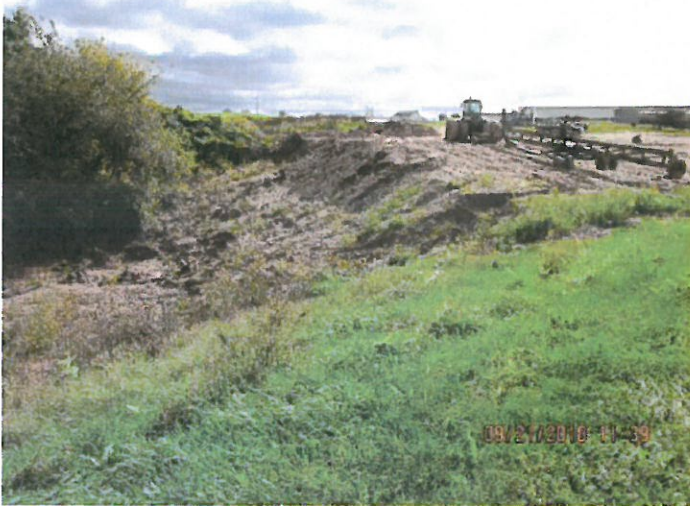
- Soil stockpiles
    - Schmitt Marquez observed disturbed areas east of the waste storage facility that were not stabilized with vegetation. Severe rill erosion in the disturbed areas has caused discharges of soil-laden storm water to the wooded area immediately north and downslope of the site.

**Photo 1:** View of a disturbed area without storm water erosion controls vegetative stabilization east of the waste storage facility. Photo direction is east.

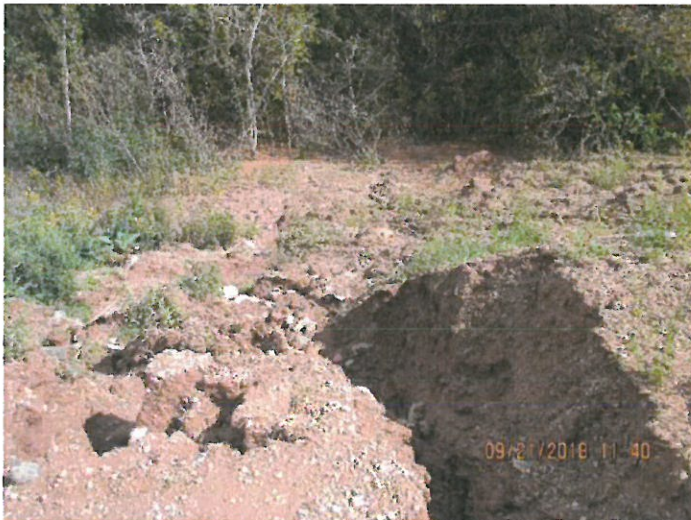
**Photo 2:** View of the north side of the disturbed area looking down into a wooded area where ponded turbid water is visible. Severe rill erosion is visible in the foreground. Photo direction is north and down.

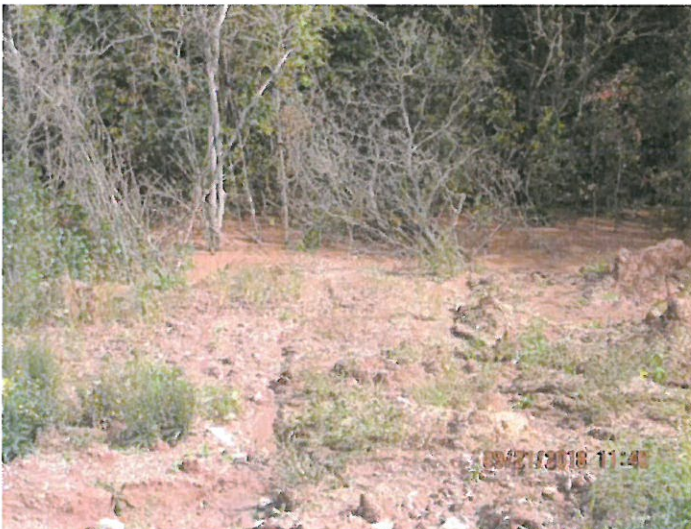
**Photo 3:** Close up view of the ponded turbid water in the wooded area north of the disturbed area. Photo direction is north and down.

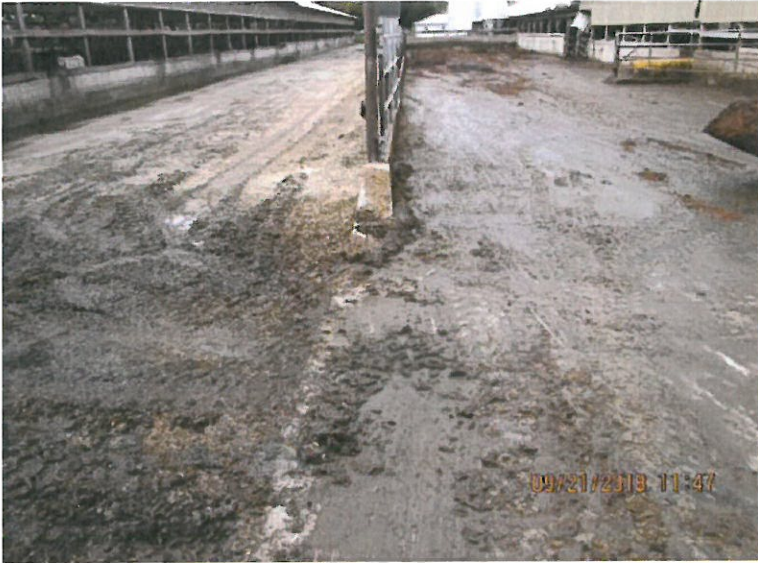
- Heifer lot area
    - Schmitt Marquez observed concrete walls built in the northeast corner of the heifer lot (north wall and east wall). At the time of the inspection, solid manure from the heifer barn was piled in the interior of the wall and it appeared that solids were also pushed mechanically into the corner from the southeast corner of the lot. Manure and process wastewater were not observed discharging from the northeast corner of the wall. Uncontained solid manure was observed piled along the exteriors of both the east and north walls.

**Photo 4:** View of the south wall and southeast corner of the concrete heifer lot. Photo direction is west.

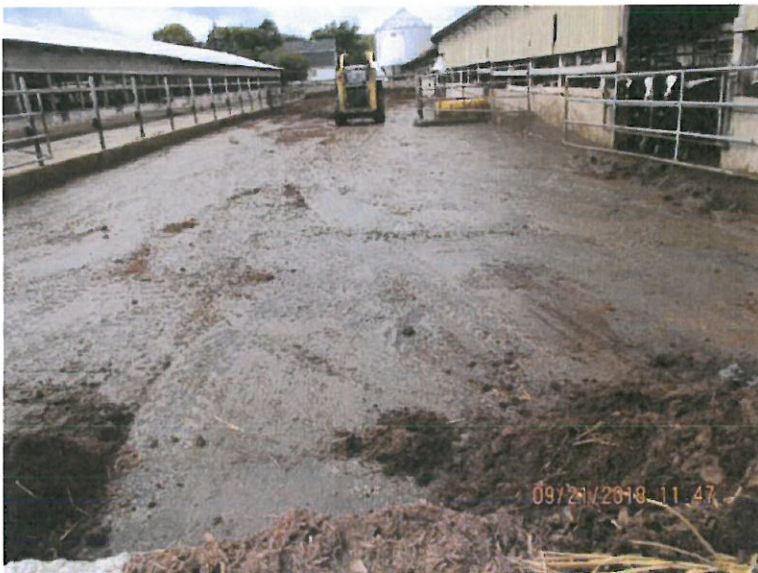
**Photo 5:** View of the concrete heifer lot from the east end. Photo direction is west.

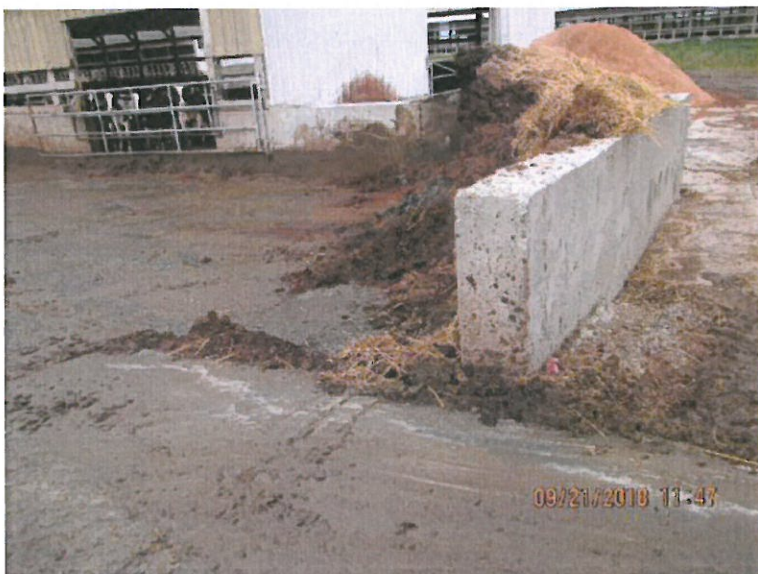
**Photo 6:** View of the east end of the concrete heifer lot where the northeast corner was enclosed with concrete walls as part of interim runoff control requirements. Photo direction is north/NW.

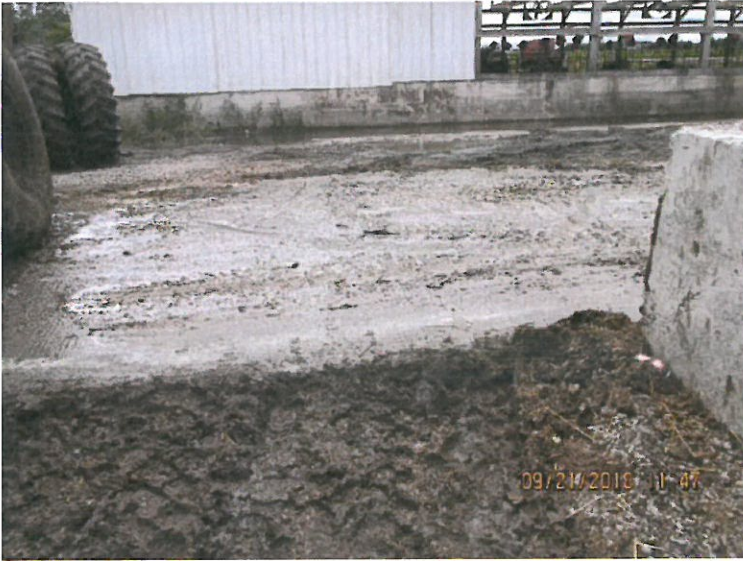
**Photo 7:** View of the east end of the concrete heifer lot. The east wall is partially visible. Photo direction is south.

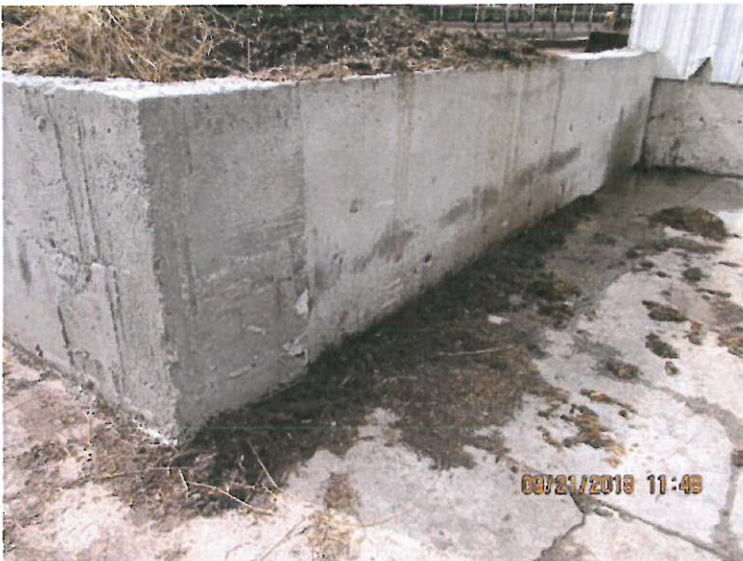
**Photo 8:** View of the exterior of the north wall at the east end of the concrete heifer lot. Photo direction is SW.

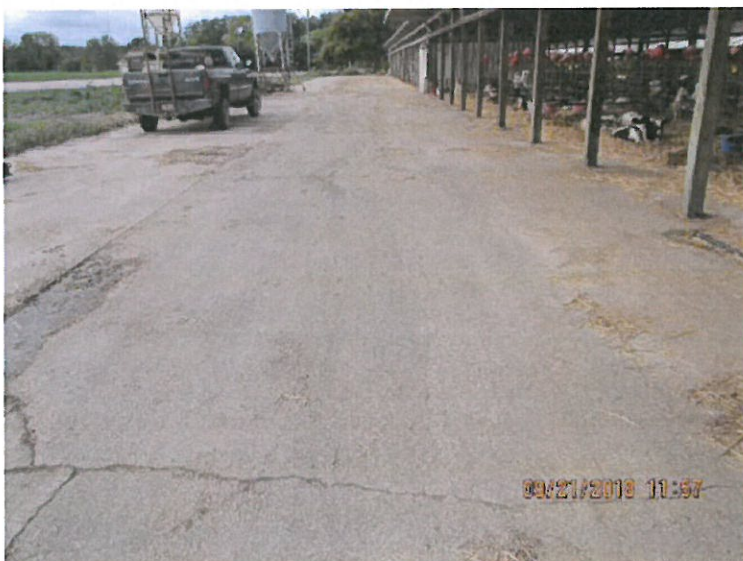
**Photo 9:** View of the concrete lane south/in front of the calf barn. Photo direction is west.

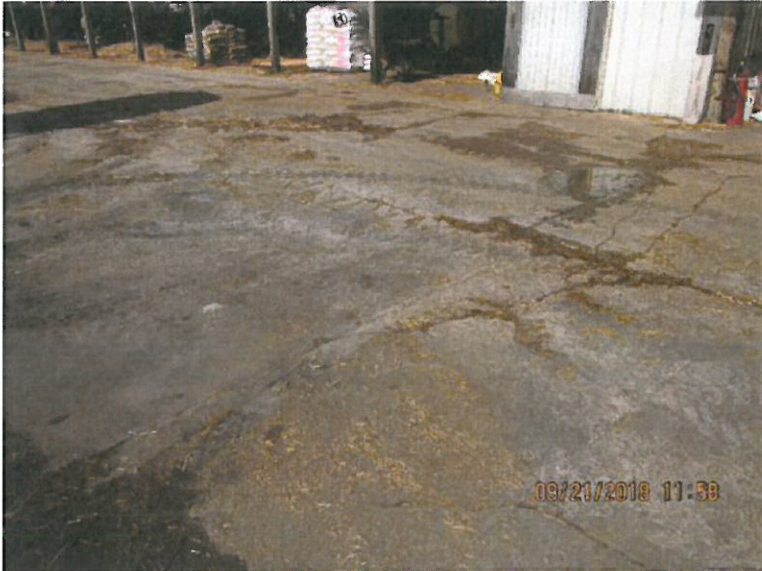
**Photo 10:** View of the concrete lane south of the calf barn where discharges of process wastewater were previously observed. Photo direction is down and NW.

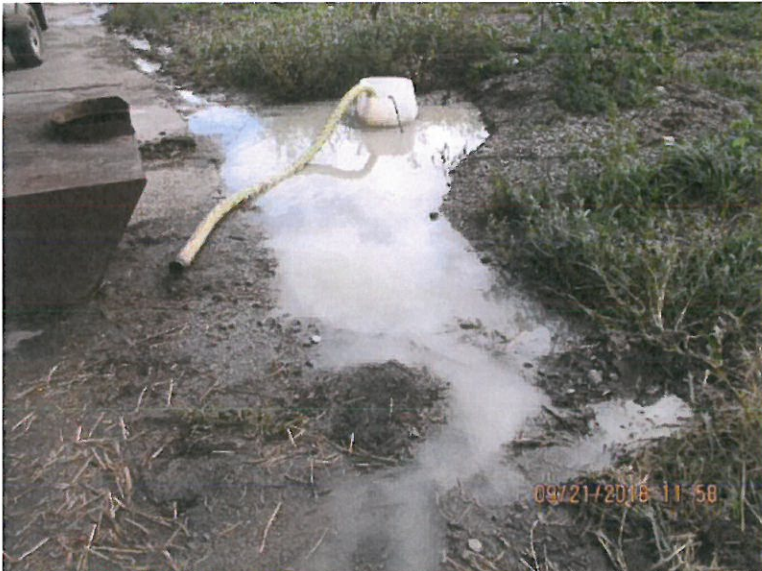
- Schmitt Marquez observed ponded process wastewater from washing the calf feeding buckets in the vegetated area directly south of the concrete drive lane south of and adjacent to the calf barn.

**Photo 11:** View of the vegetated area south of the concrete lane south of the calf barn. Process wastewater is visible ponded near a partially submerged plastic drum. Photo direction is down and SE.

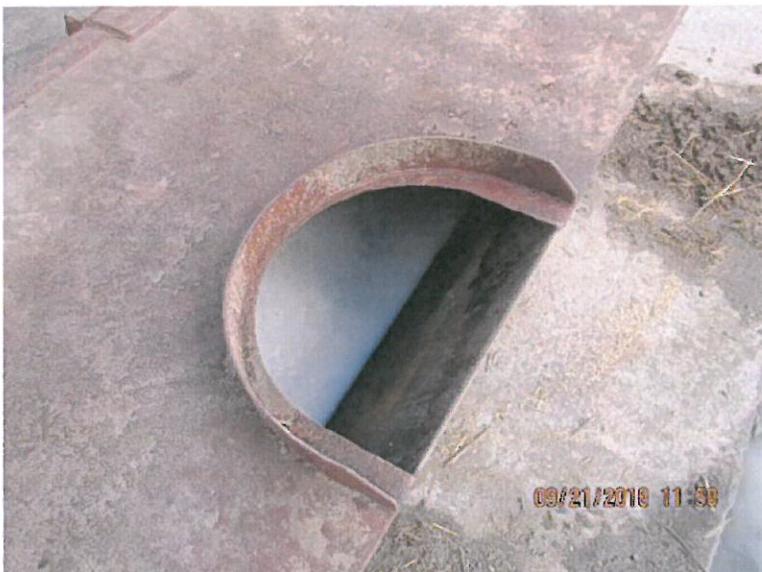
**Photo 12:** View of the inside of a metal tank adjacent to the area of ponded process wastewater south of the calf barn. Process wastewater is visible inside the tank. Photo direction is down.

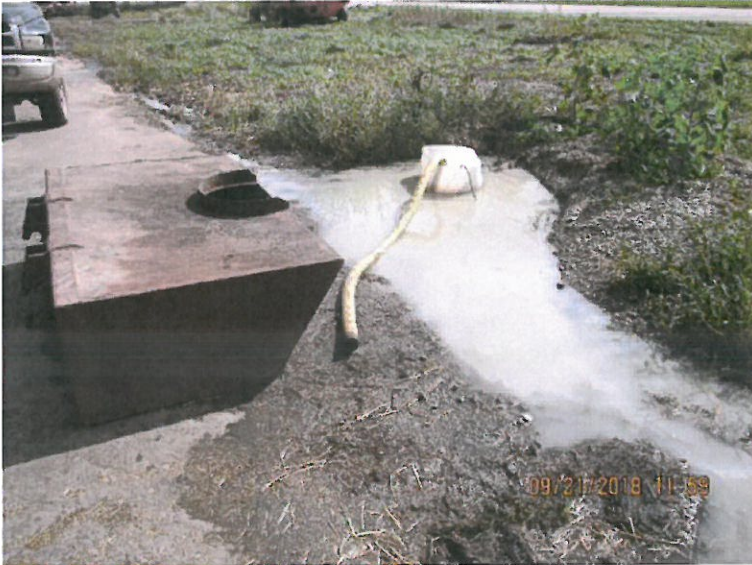
**Photo 13:** Alternate view of area of ponded process wastewater south of the calf barn. Photo direction is down and SE.

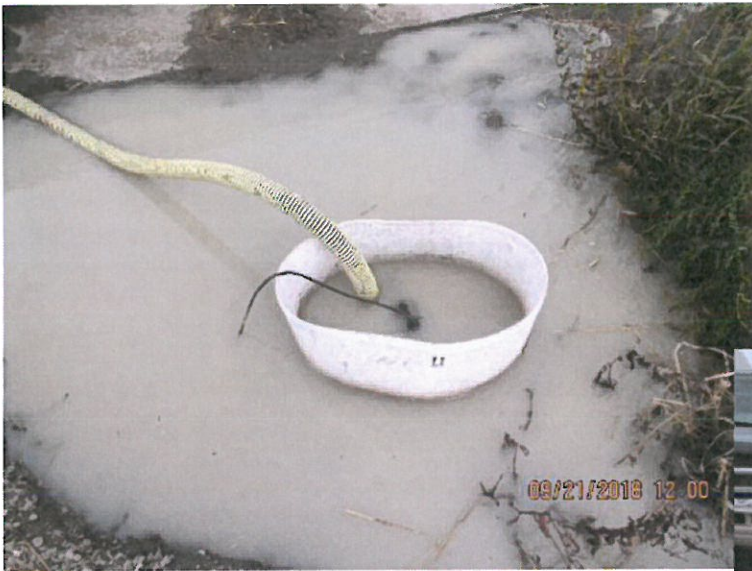
**Photo 14 (left):** Close up view of process wastewater ponded around the partially submerged plastic drum. Photo direction is down.

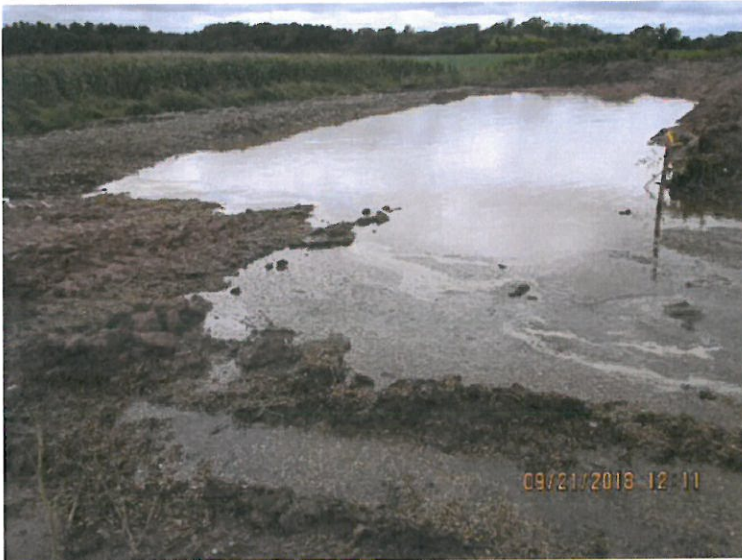
**Photo 16:** View of the leachate/process wastewater collection basin south of the FSA constructed to meet interim runoff control requirements. Photo direction is SW.

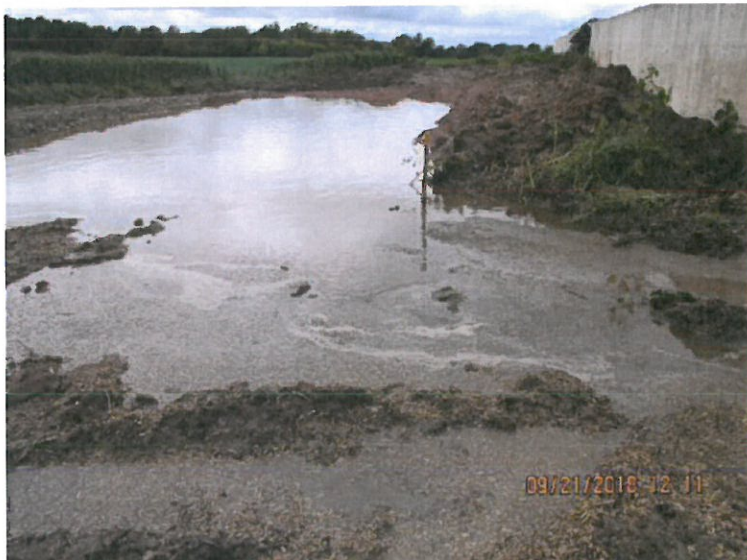
**Photo 17:** View of the leachate/process wastewater collection basin south of the FSA showing the south bunker wall. Photo direction is west.

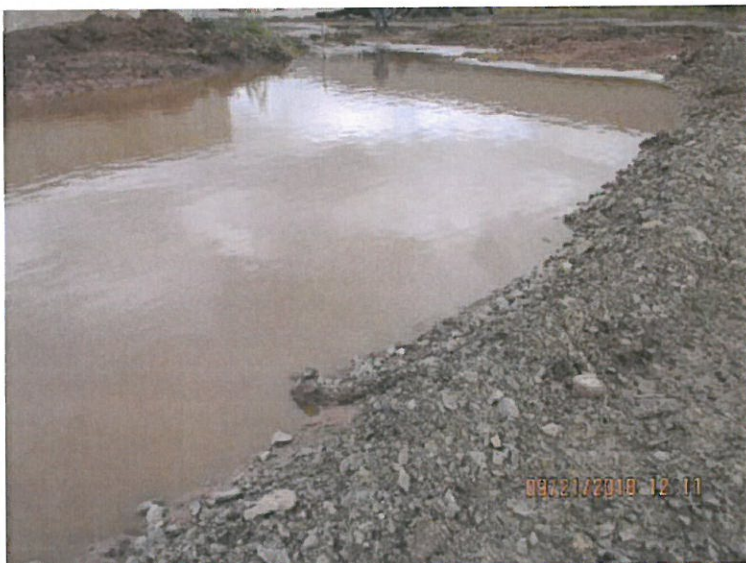
**Photo 18:** Close up view of the southern berm wall of the leachate/process wastewater collection basin south of the FSA. Photo direction is NE.

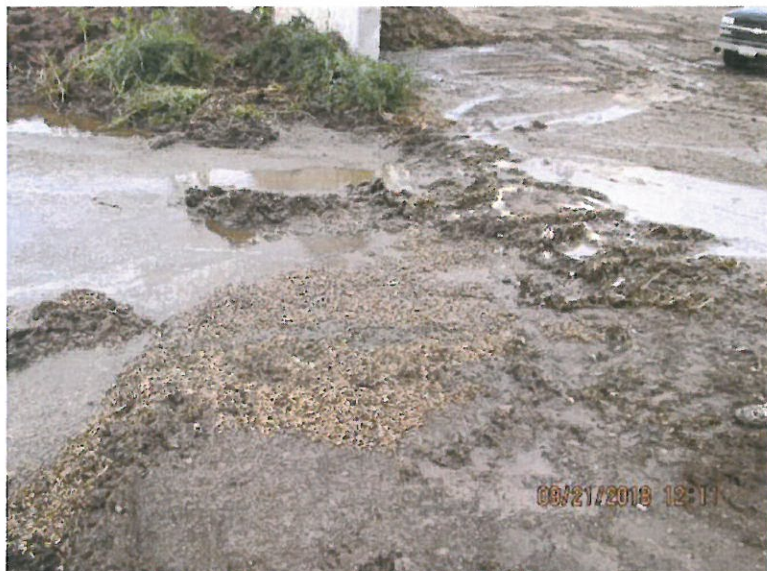
**Photo 19:** View of the SE corner of the FSA where the flow of leachate/process wastewater flow is directed. The leachate/process wastewater collection basin is partially visible. Photo direction is down and NW.

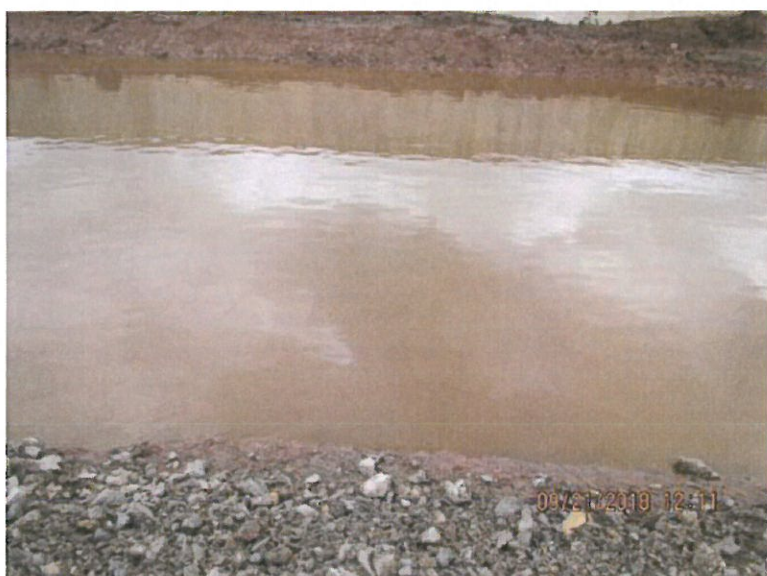
**Photo 20:** Close up view of the water in the leachate/process wastewater collection basin south of the FSA. Photo direction is down and north.

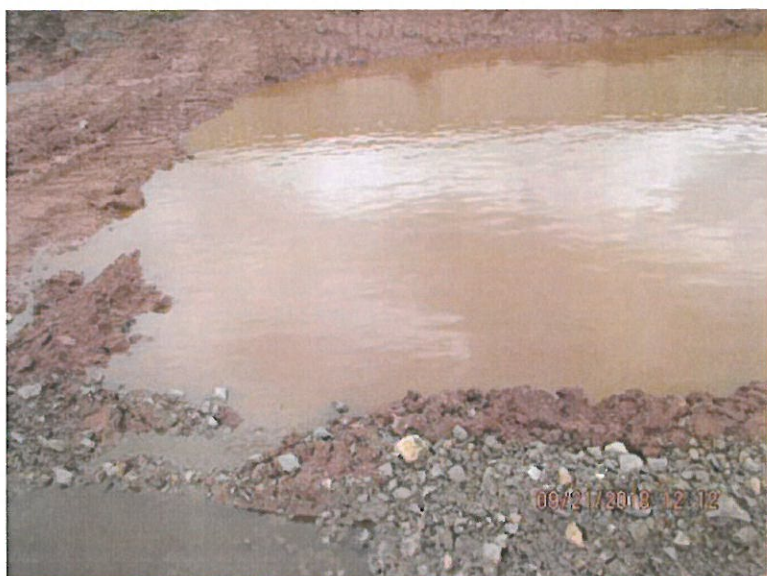
**Photo 21:** Close up view of the western section of the leachate/process wastewater collection basin south of the FSA. Photo direction is down and north.

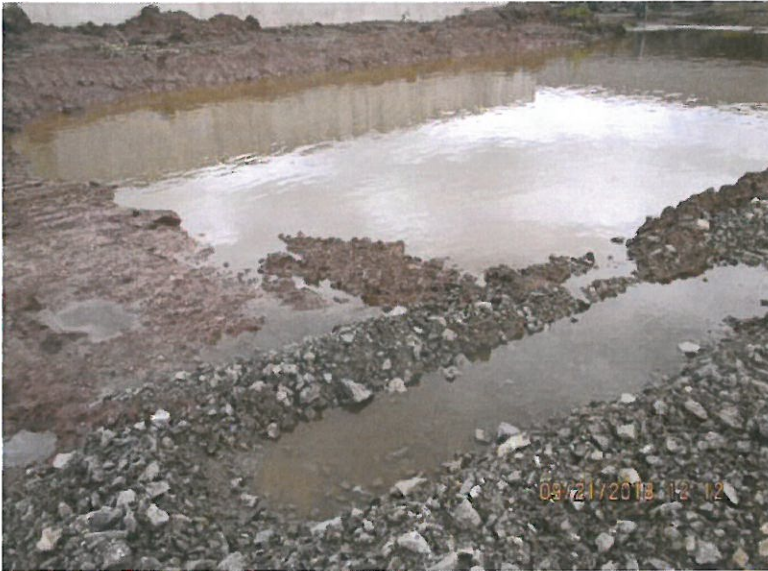
**Photo 22:** View of the leachate/process wastewater collection basin south of the FSA from the SW corner. Photo direction is down and NE.

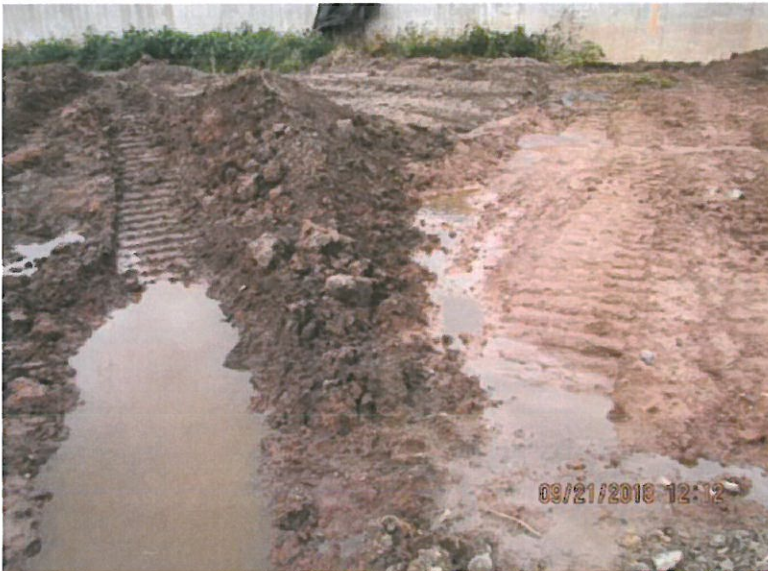
**Photo 23:** Close up view of the construction of the N/NW wall of the leachate/process wastewater collection basin south of the FSA. Photo direction is NW.

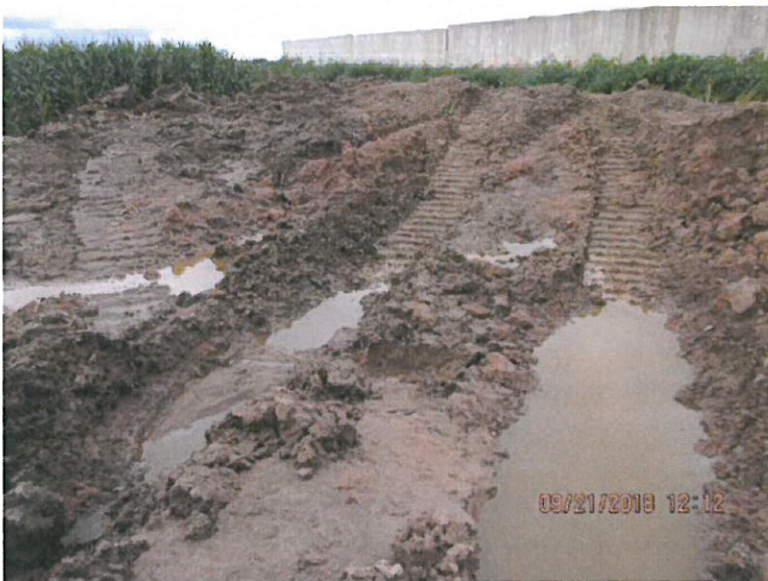
**Photo 24:** Alternate view of the construction of the N/NW wall of the leachate/process wastewater collection basin south of the FSA. Photo direction is NW.

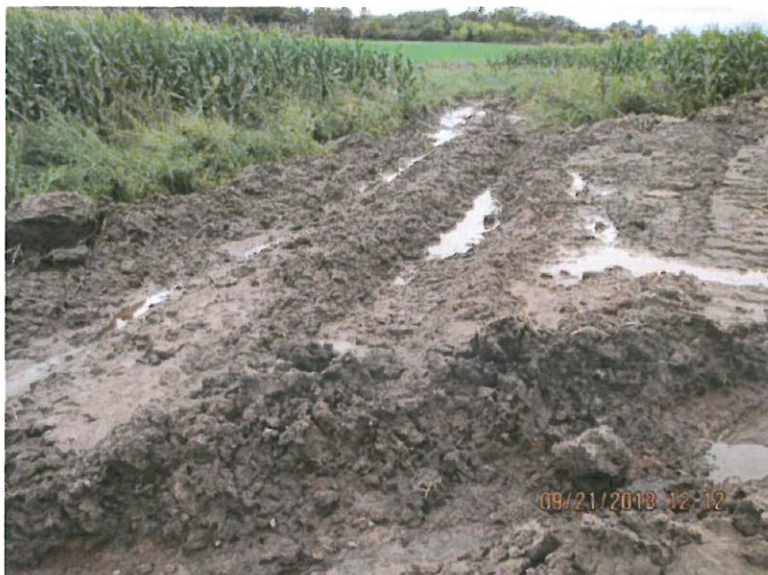
**Photo 25:** View of the construction of the S/SW wall of the leachate/process wastewater collection basin south of the FSA. Photo direction is SW.

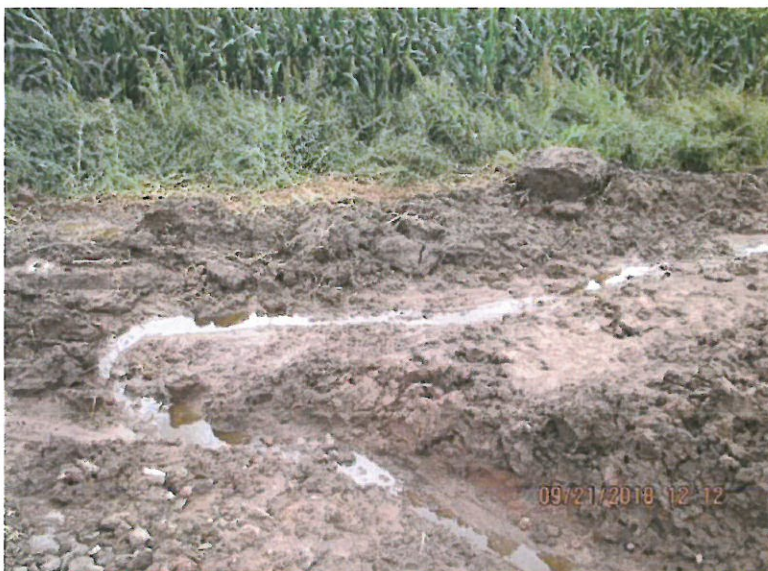
**Photo 26:** View of process wastewater in a drainage path near the southern berm wall of the leachate/process wastewater collection basin south of the FSA. Photo direction is south and down.

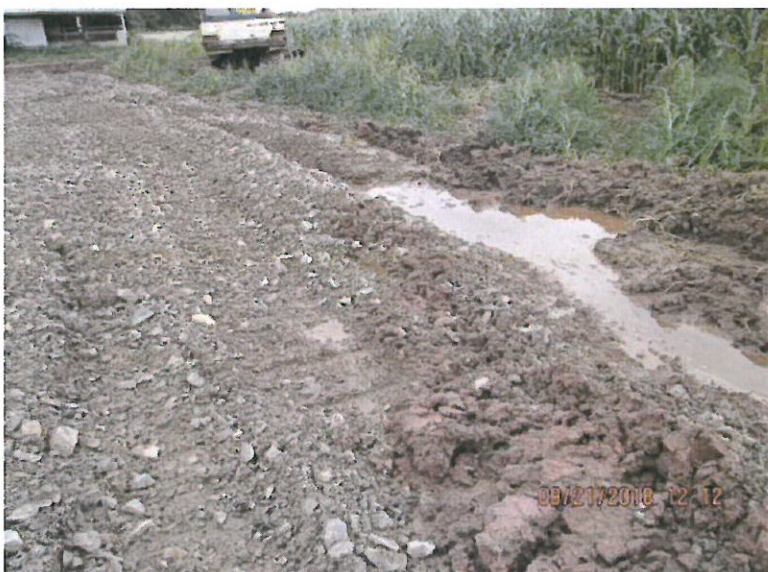
**Photo 27:** View of the S/SE wall section of the leachate/process wastewater collection basin south of the FSA. Photo direction is SE and down.

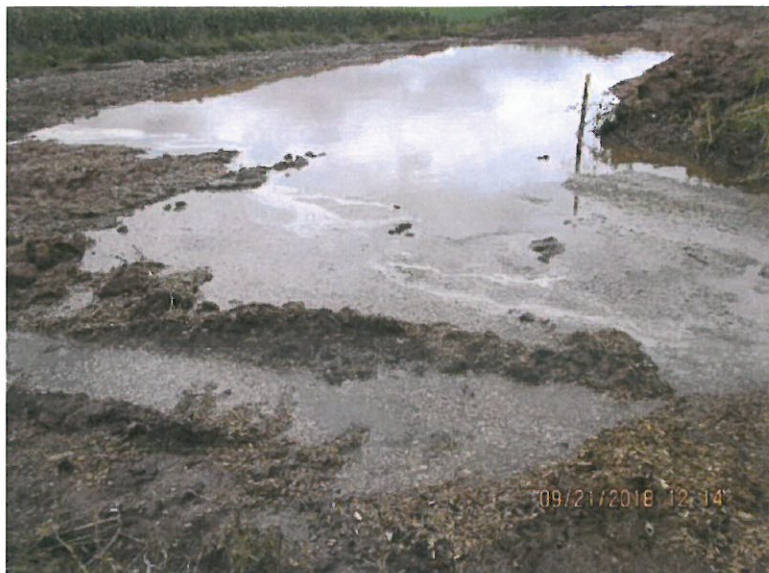
**Photo 28:** View of the leachate/process wastewater collection basin south of the FSA from the NE corner. Blown feed is visible near the inlet to the basin. Photo direction is SW and down.

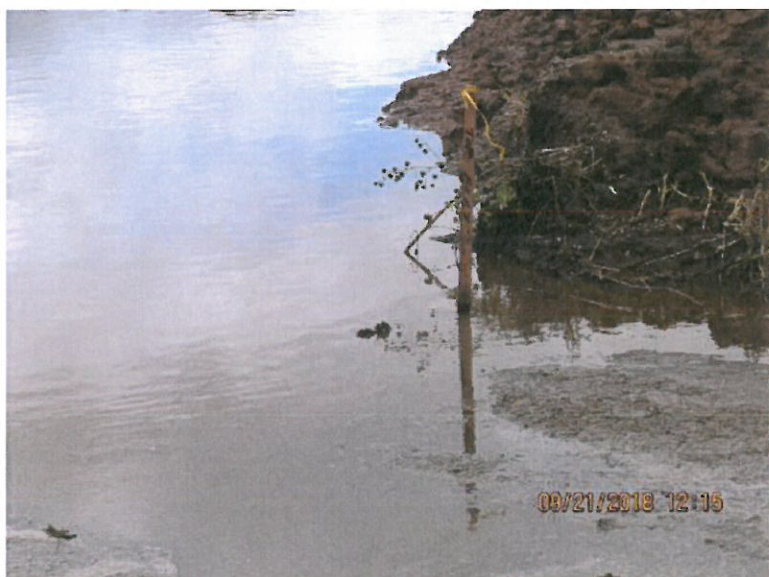
**Photo 29:** Close up view of a wooden stake in the leachate/process wastewater collection basin that appeared to be a level /volume indicator. Photo direction is SW and down.

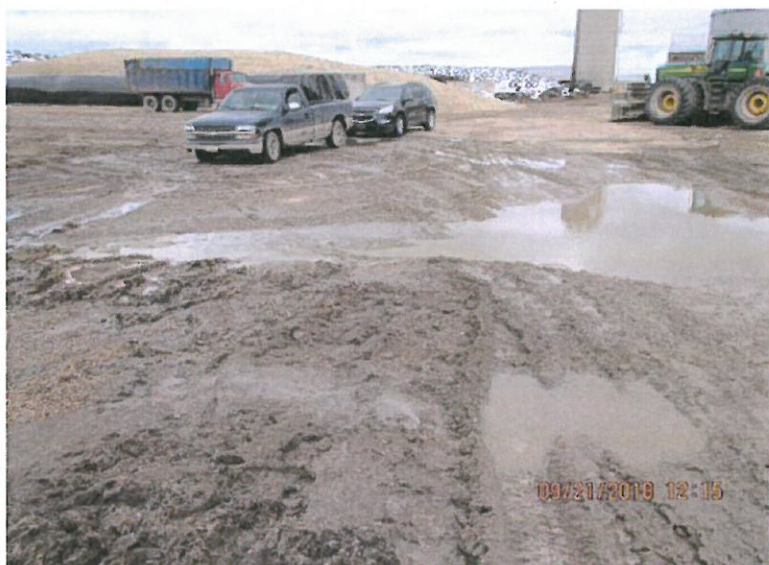
**Photo 30:** View of the feed pad (left) and the yard area (right), which drains to the collection basin south of the FSA. Photo direction is NW.

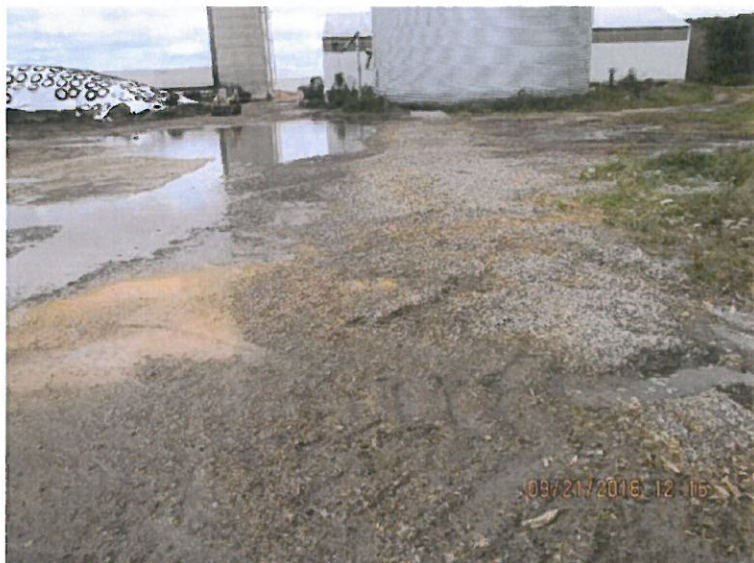
**Photo 31:** View of the gravel berm placed on the east side of the site between the steer barn and a grain bin to prevent discharges to the ditch at Lime Kiln Rd. Photo direction is north.

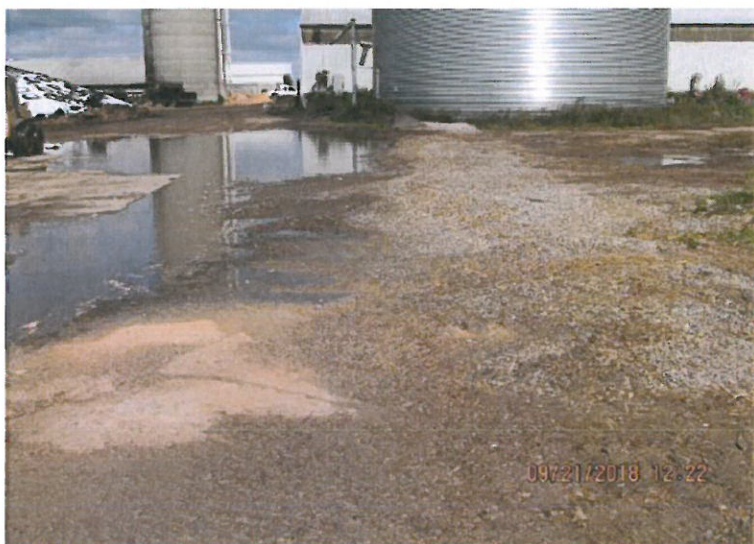
**Photo 32:** Alternate view of the gravel berm placed on the east side of the site between the steer barn and a grain bin to prevent discharges to the ditch at Lime Kiln Rd. Photo direction is north.

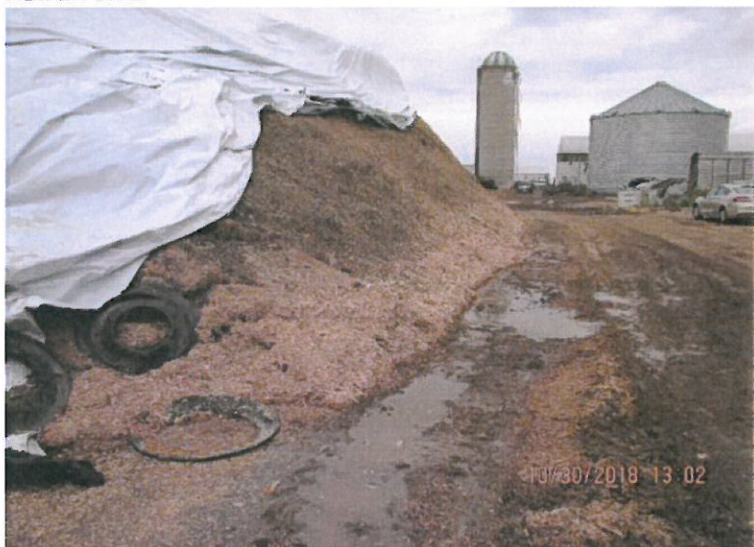
**Photo 33:** View of the feed pile in the FSA showing ponded leachate/process wastewater. Photo direction is north.
