State of Wisconsin | DEPARTMENT OF NATURAL RESOURCES

Subject: **Notice of Violation - Chapter 283, Wis. Statutes  
Enforcement Conference - March 9, 2009**

### **3. POTENTIAL VIOLATIONS**

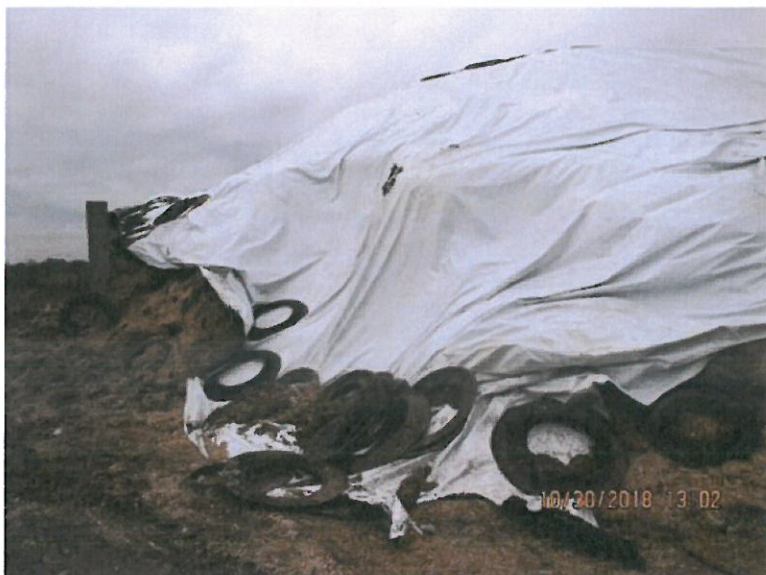
**Photo 34:** Alternate view of the feed pile in the FSA, which is only partially covered with plastic. Photo direction is west.

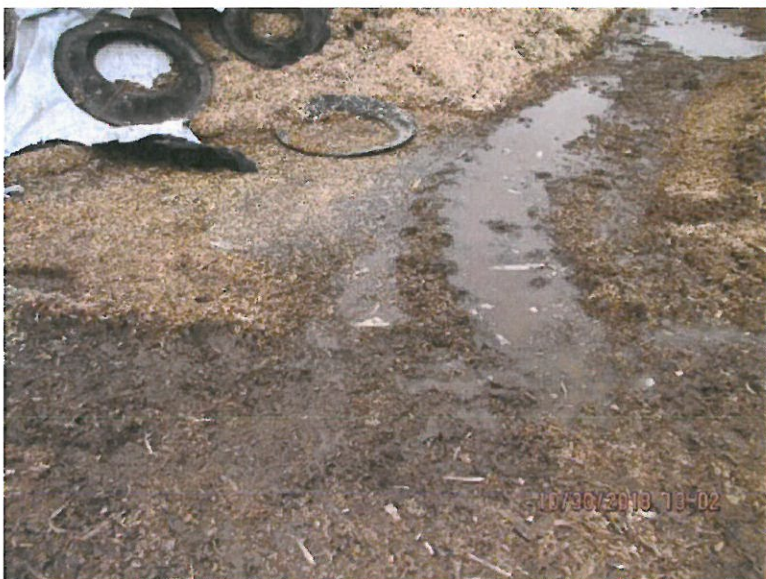
**Photo 35:** Close up view of the ponded leachate/process wastewater near the feed pile in the FSA. Photo direction is down and NW.

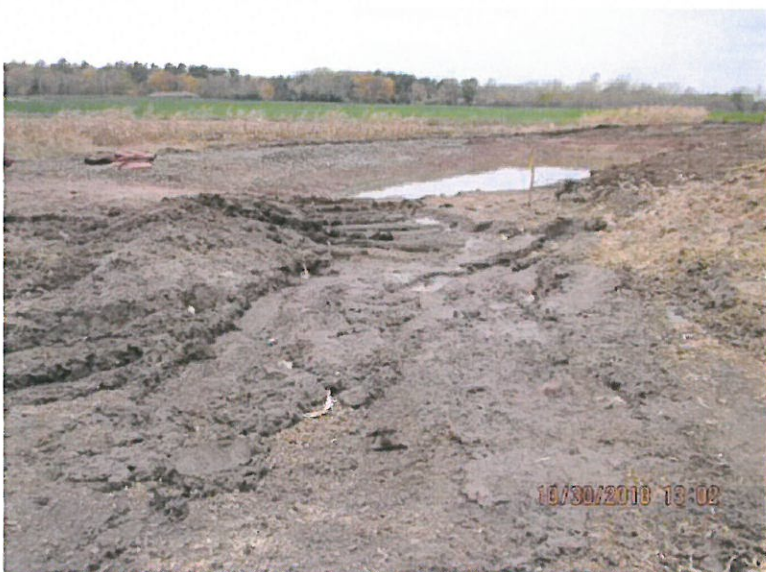
**Photo 36:** View of the leachate/process wastewater collection basin south of the FSA. Photo direction is SW.

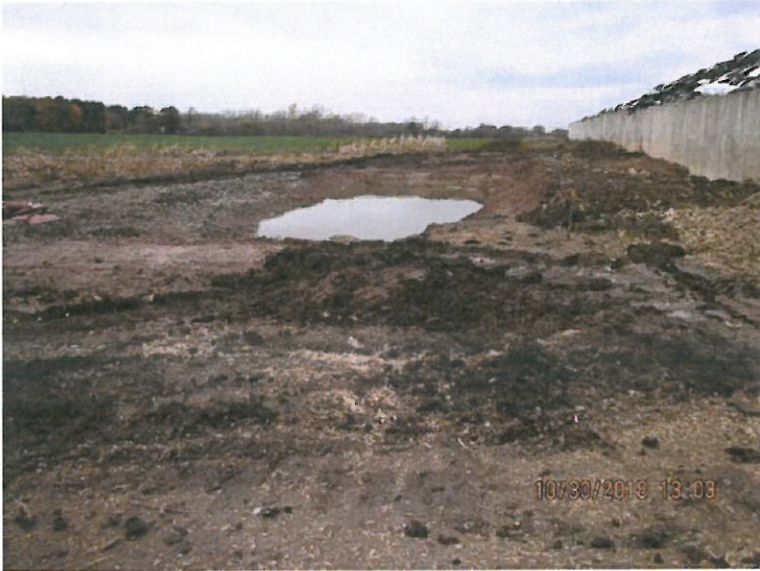
**Photo 37:** Alternate view of the leachate/process wastewater collection basin south of the FSA. Photo direction is west.

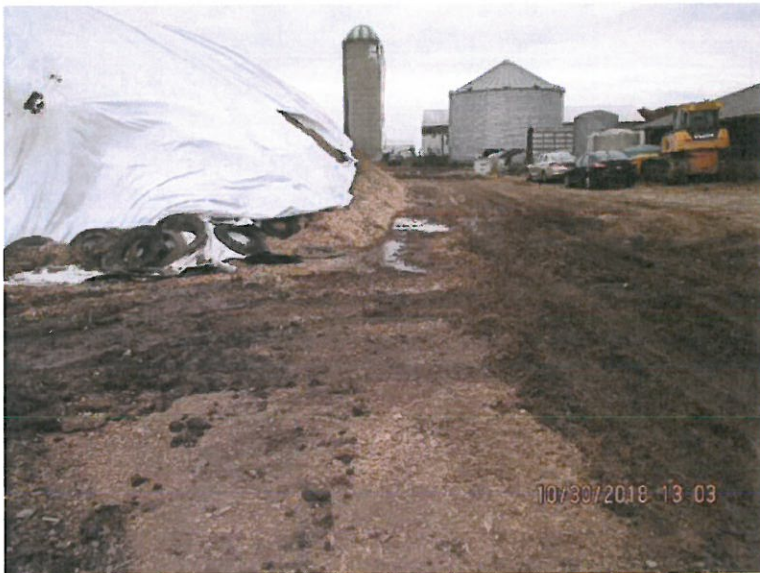
**Photo 38:** View of the feed pile in the FSA from near the inlet to the leachate/process wastewater collection basin south of the FSA. Photo direction is north.

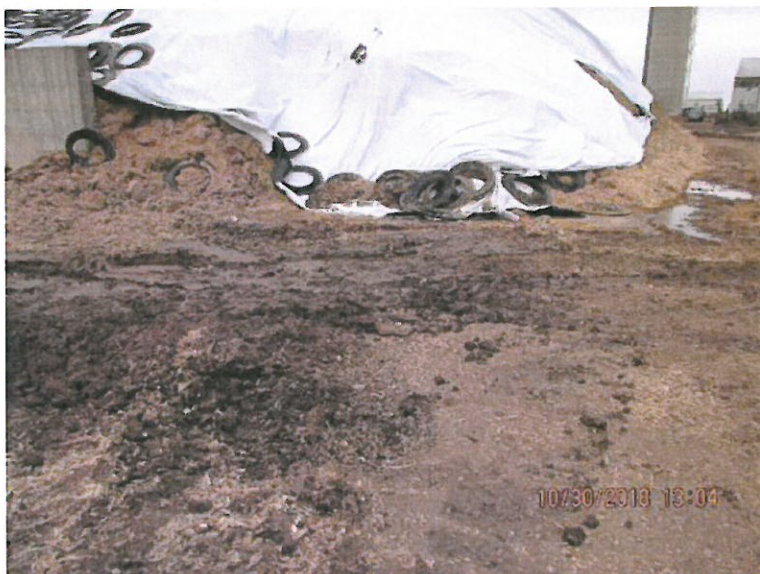
**Photo 39:** View of the SE corner of the FSA showing feed solids outside the feed pad and near the inlet to the leachate/process wastewater collection basin south of the FSA. Photo direction is north.

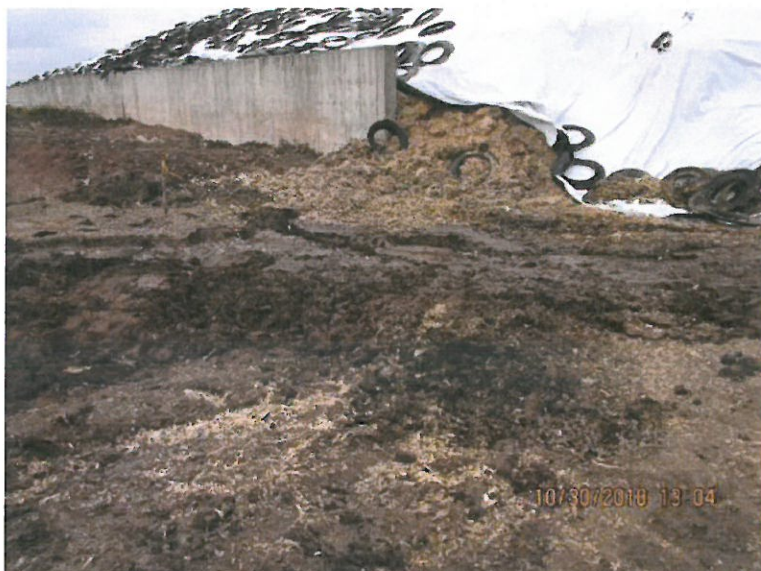
**Photo 40:** Alternate view of the SE corner and south wall of the FSA, showing feed solids outside the feed pad and near the inlet to the leachate/process wastewater collection basin south of the FSA. Photo direction is NW.

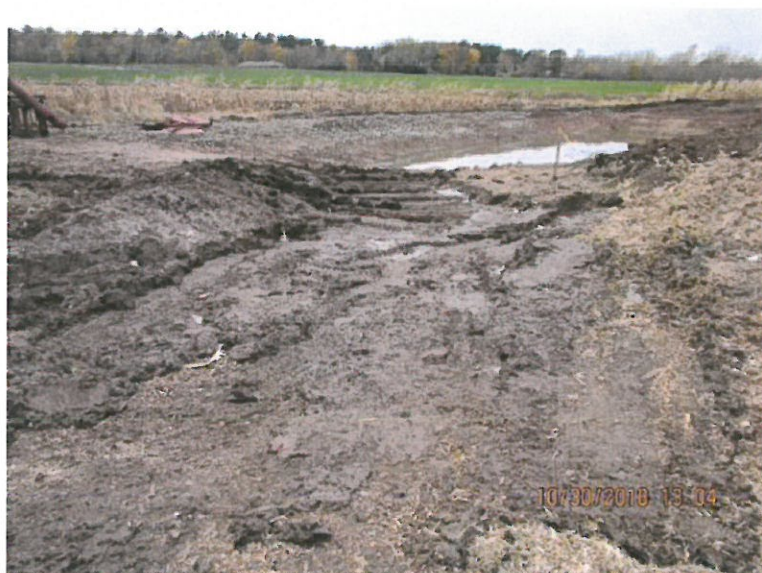
**Photo 41:** View of the leachate/process wastewater collection basin south of the FSA, showing the regraded inlet area. Photo direction is SW.

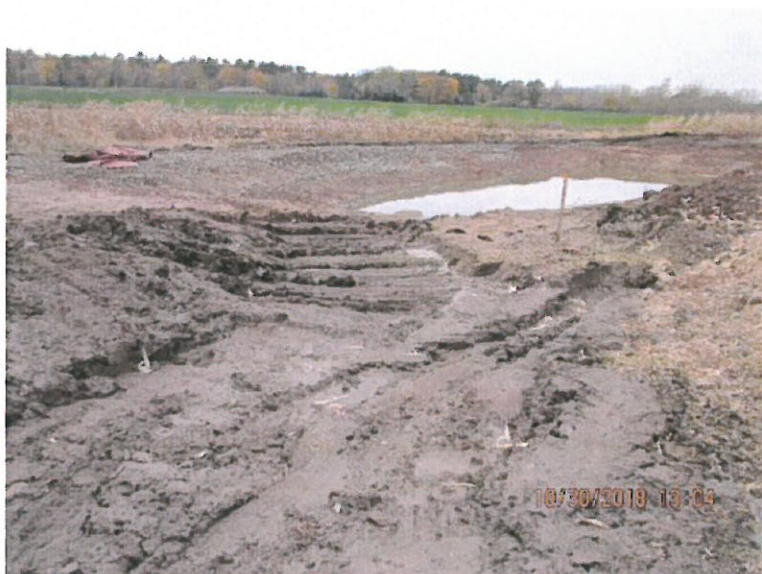
**Photo 42:** Closer view of the leachate/process wastewater collection basin south of the FSA, showing the regraded inlet area. Photo direction is SW.

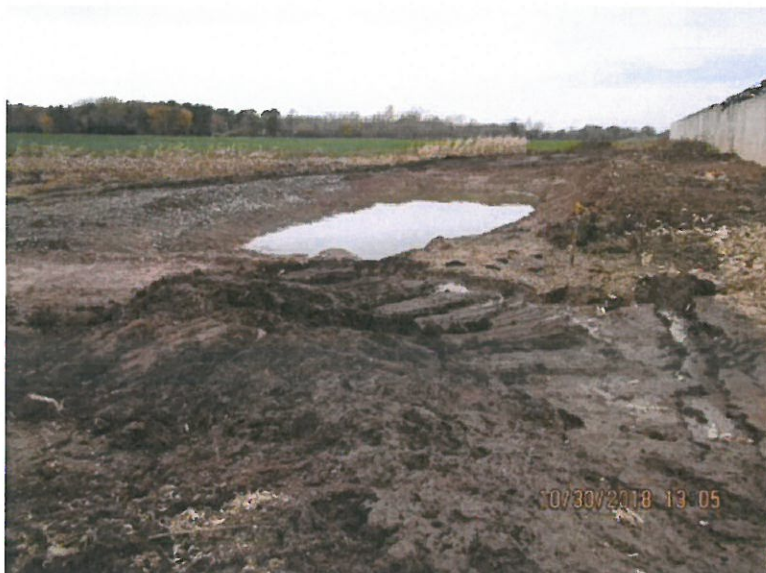
**Photo 43:** Closer view of the leachate/process wastewater collection basin south of the FSA, showing the regraded inlet area. Photo direction is SW.

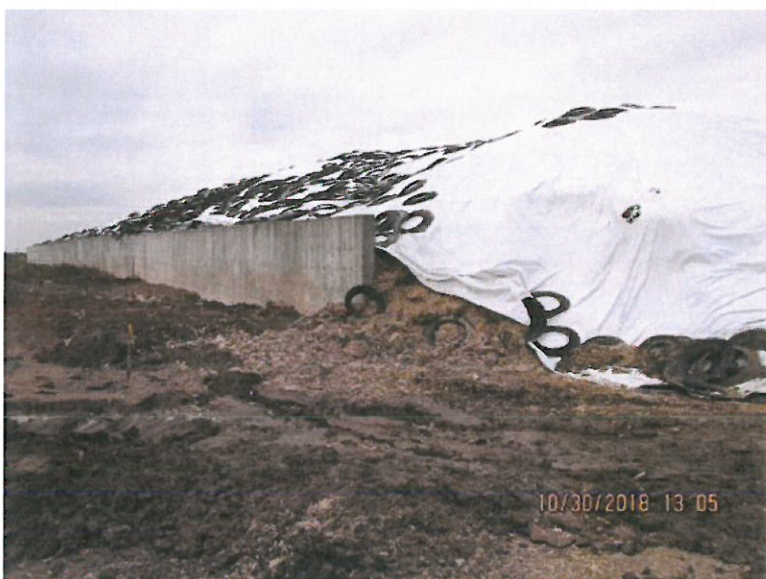
**Photo 44:** Alternate view of the SE corner and south wall of the FSA, showing feed solids outside the feed pad and near the inlet to the leachate/process wastewater collection basin south of the FSA. Photo direction is NW.

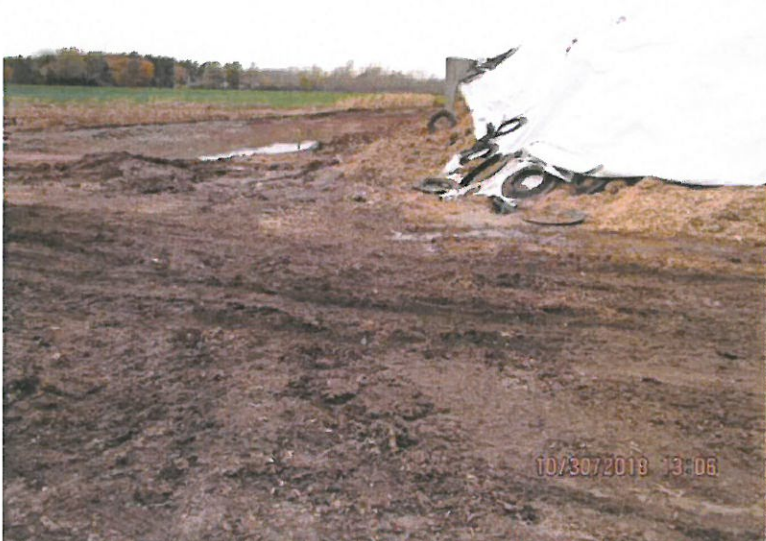
**Photo 45:** Alternate view of the SE corner and south wall of the FSA, showing feed solids outside the feed pad and near the inlet to the leachate/process wastewater collection basin south of the FSA. Photo direction is SW.

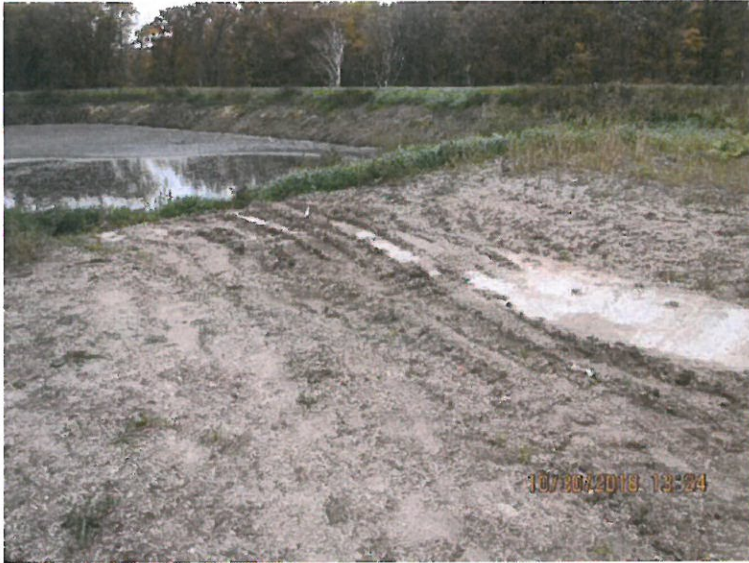
**Photo 46:** View of the concrete overflow weir constructed in the waste storage facility to meet secondary containment requirements. Photo direction is W/NW.

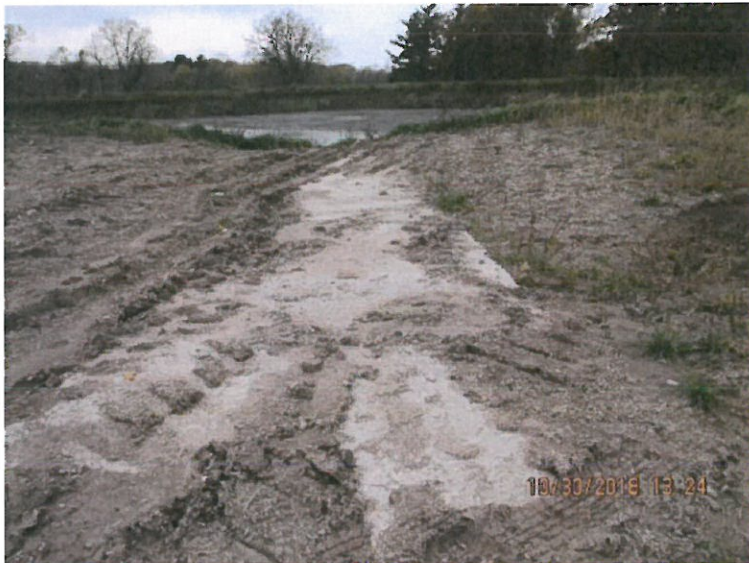
**Photo 47:** Alternate view of the concrete overflow weir constructed in the waste storage facility to meet secondary containment requirements. Photo direction is west.

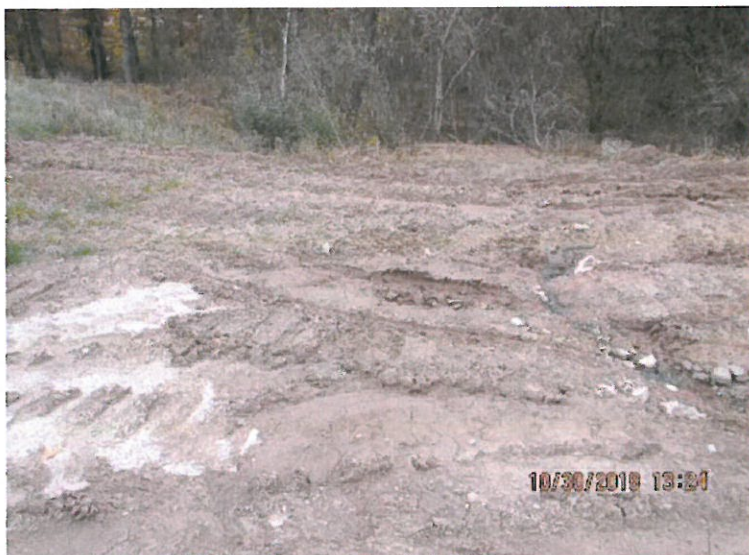
**Photo 48:** Alternate view of the concrete overflow weir constructed in the waste storage facility to meet secondary containment requirements, showing the direction and location of the overflow. Photo direction is down and NE.

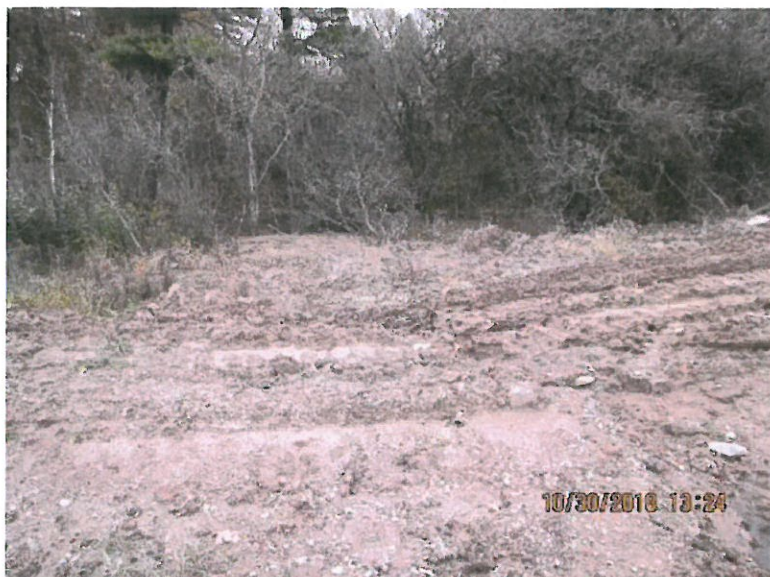
**Photo 49:** View of a wooded area downslope and NE of the waste storage facility where manure will be directed if the storage facility overflows. Photo direction is down and N/NE.

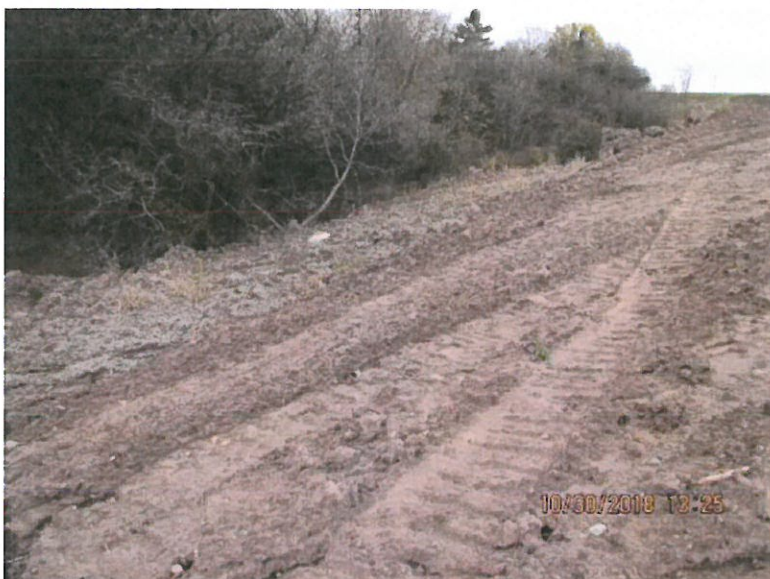
**Photo 50:** View of a disturbed area east of the waste storage facility that does not contain storm water erosion controls or vegetative stabilization. Photo direction is down and east.

- 5. Storm water erosion controls (main farm site)
  - a. A disturbed area was observed east of the waste storage facility during both site inspections. Storm water controls and stabilization of this area were not in place, and sediment-laden water was observed ponded in the wooded area north and downslope of the disturbed area.

- 1. **Actions should be taken to comply with the requirements of the applicable sections of ch. NR 151, Wis. Adm. Code, listed above.**
  - b. A ponded area of liquid manure was observed during the 10/30/2018 site inspection that was discharging through rill erosion channels in the disturbed area to the wooded area northeast of the waste storage facility, where sediment-laden water was ponded.

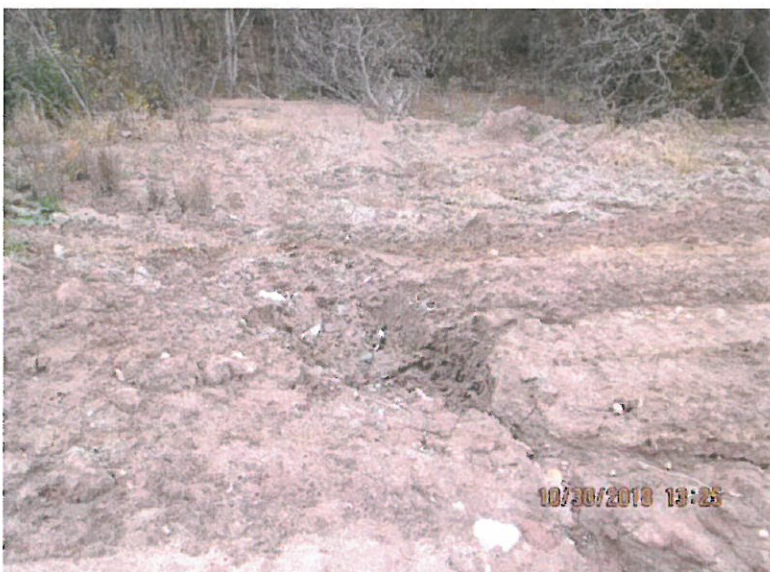
**Photo 51:** View of rill erosion in a disturbed area east of the waste storage facility that does not contain storm water erosion controls or vegetative stabilization. Turbid water is visible ponded in the wooded area in the background. Photo direction is down and down and N/NE.

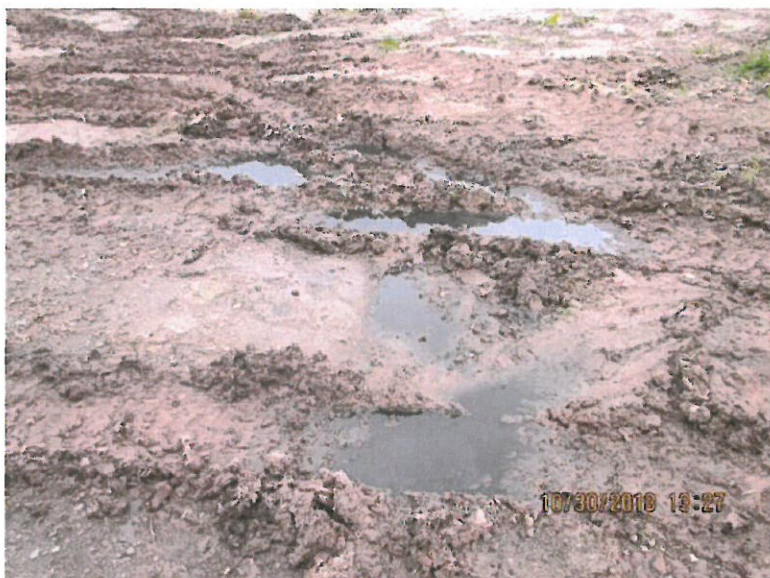
**Photo 52:** View of ponded liquid manure in a disturbed area east of the waste storage facility. Photo direction is down.

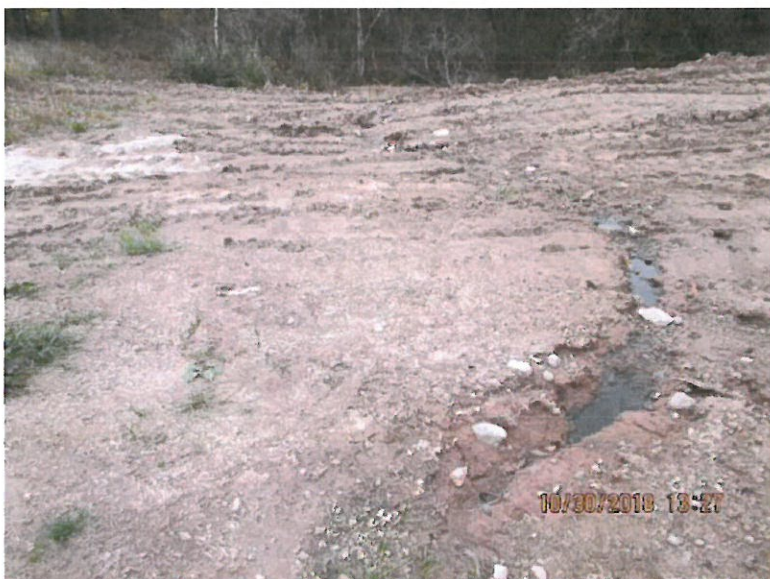
**Photo 53:** View of a discharge path of liquid manure from an area of ponded manure in a disturbed area east of the waste storage facility. Photo direction is down and north.

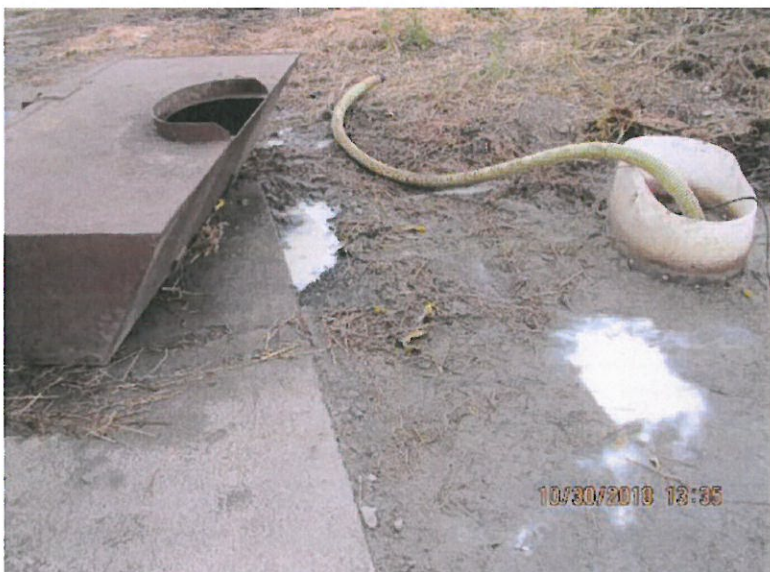
**Photo 54:** View of ponded process wastewater south of the calf barn, near a partially submerged plastic drum and metal tank. Photo direction is down and east.

1. Calf barn (main farm site)
  - a. Process wastewater discharges to the environment were observed during both site visits.
  - b. **Changes in management/handling of process wastewater generated by the calf barn and/or installation of a collection system are required to prevent discharges of process wastewater.**

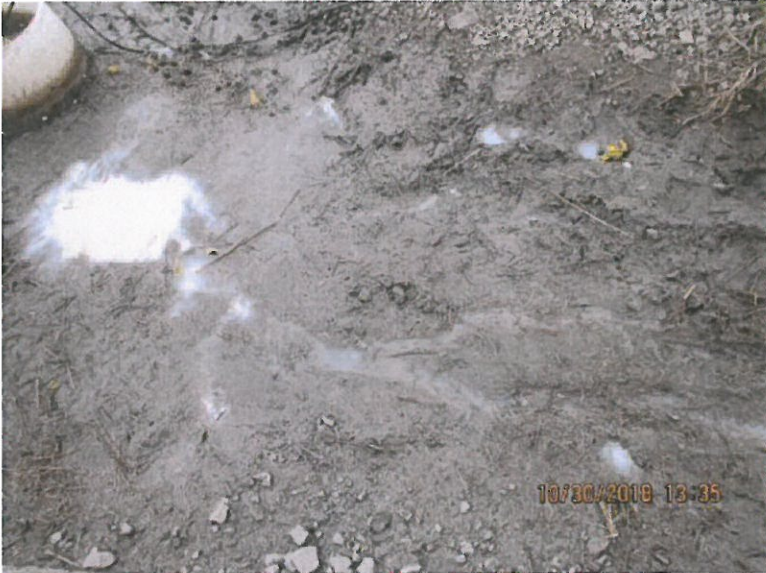
**Photo 55:** View of ponded process wastewater south of the calf barn, near a partially submerged plastic drum and metal tank. Photo direction is down.

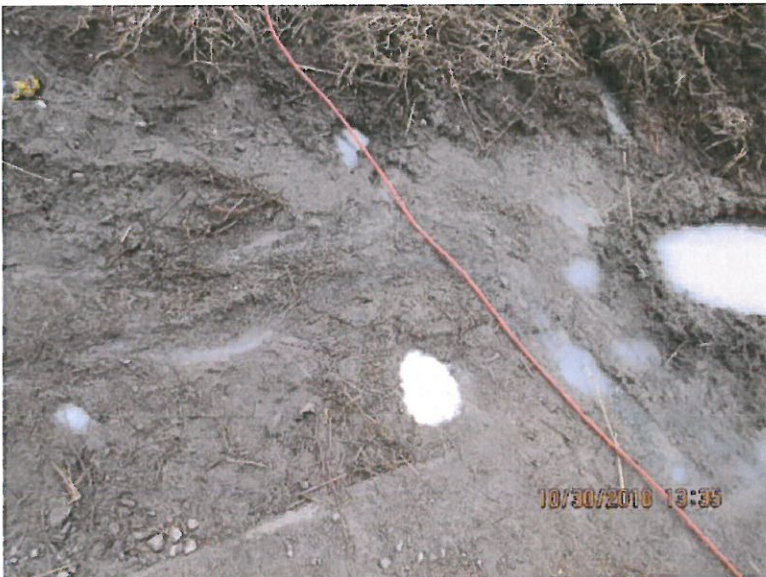
**Photo 56:** View of ponded process wastewater, south of the calf barn and west of the plastic drum and metal tank. Photo direction is down.

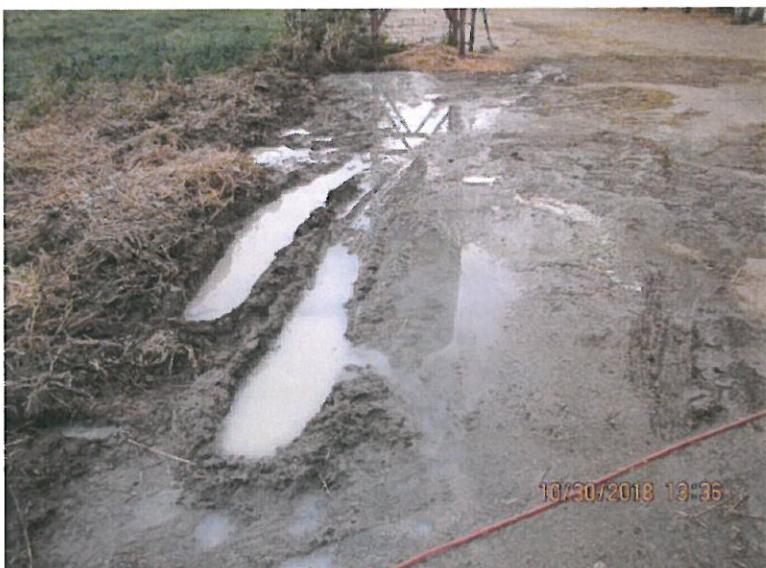
**Photo 57:** View of ponded process wastewater, south of the calf barn and farther west of the plastic drum and metal tank. Photo direction is down and west.

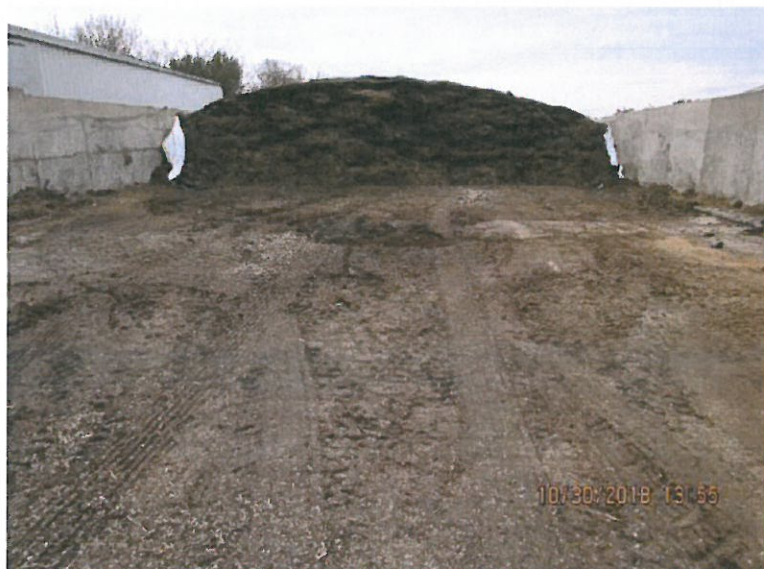
**Photo 58:** View of the FSA with plastic covering the top and sides of the feed pile. Photo direction is north.

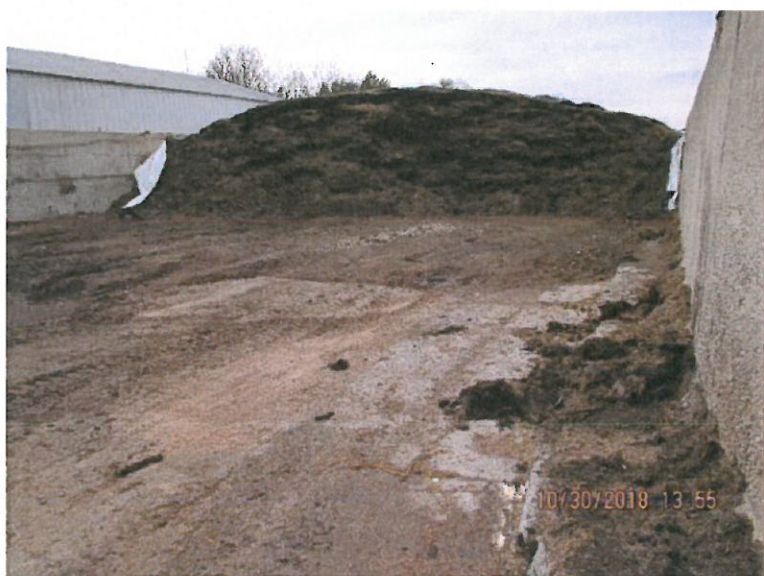
**Photo 59:** Alternate view of the FSA with plastic covering the top and sides of the feed pile. Photo direction is north/NW.

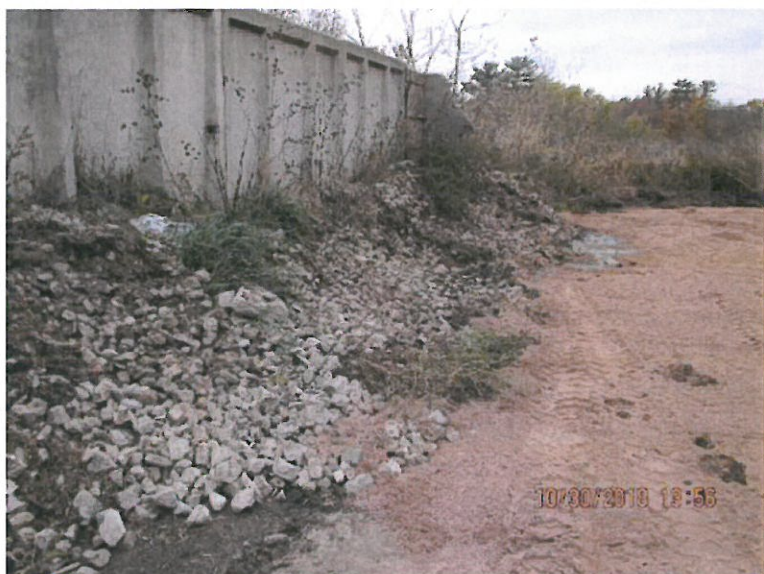
**Photo 60:** View of the exterior of the east wall of the FSA with plastic showing rocks and other vegetation piled against the concrete wall. Photo direction is NW.

- b. Clay soil was previously placed along the exterior of the bunker walls to contain leachate and process wastewater from the feed storage area. The material present along the exterior of the bunker walls during the inspection should be removed and replaced with clay soils. This method requires frequent monitoring to ensure that leachate and process wastewater are not seeping through the clay berm.

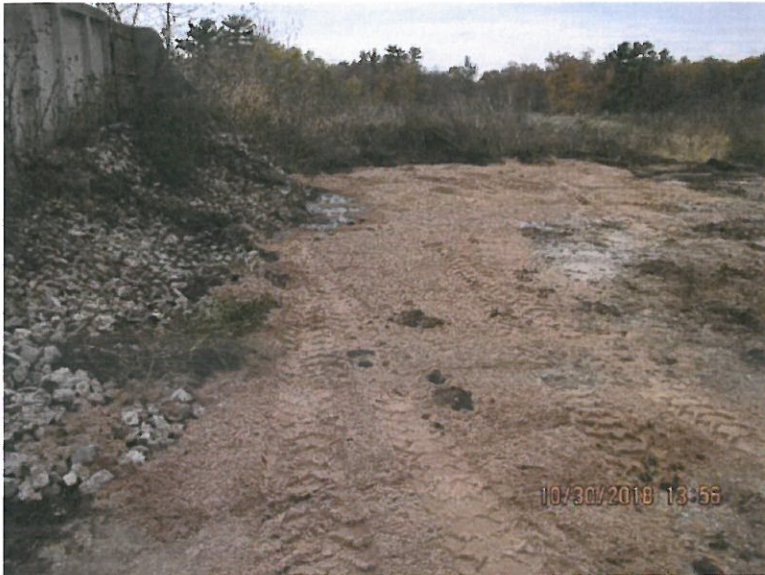
**Photo 61:** View of the area outside the east wall of the FSA, showing rocks and vegetation piled against the wall and sand spread on the ground. Photo direction is north.

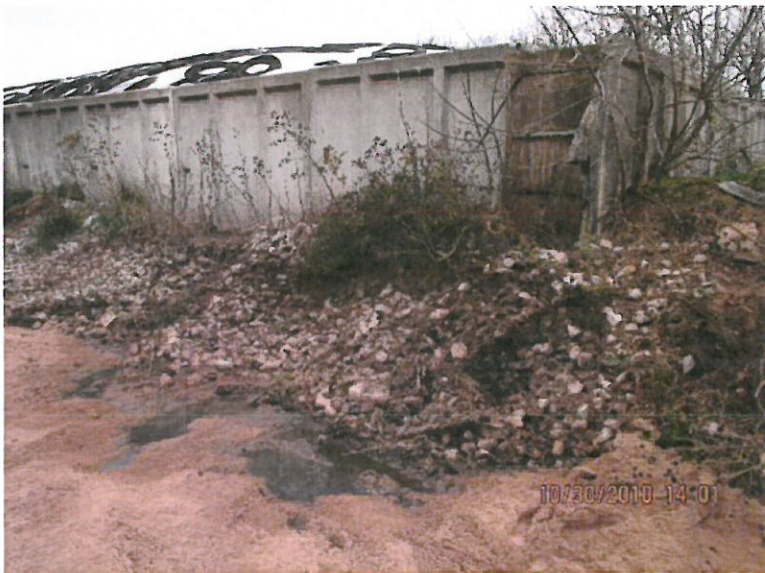
**Photo 62:** View of the NE corner of the FSA where leachate has been observed discharging during previous site inspections. Leachate is visible ponded on the ground outside the dirt/stone/sand pile outside the wall. Photo direction is west.

2. Feed storage area (main farm site)
  - a. Leachate was visible discharging from the northeast corner of the bunker wall to the vegetated area north of the feed storage area. Leachate was observed ponded in areas of burnt out/dead vegetation in the vegetated area north of the feed storage area. Materials placed along the exterior of the east bunker wall appeared to require maintenance to continue to function as a method to contain leachate generated by feed. Waste/blown feed appeared to be mixed in with the material placed along the exterior of the bunker walls.

- ii. **The condition of the clay should be monitored at least weekly to ensure that it is functioning properly and leachate and/or process wastewater are not discharging.**

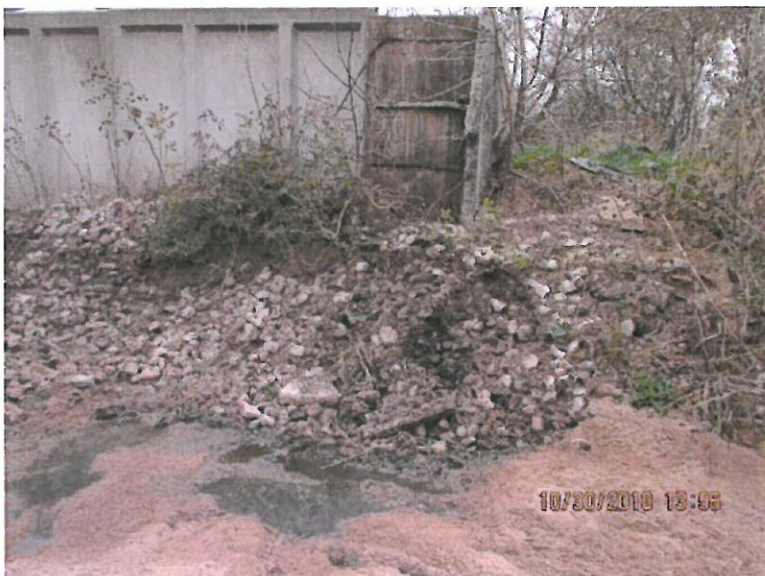
**Photo 63:** Close up view of the NE corner of the FSA where leachate has been observed discharging during previous site inspections. Leachate is visible ponded on the ground outside the dirt/stone/sand pile outside the wall. Photo direction is west.

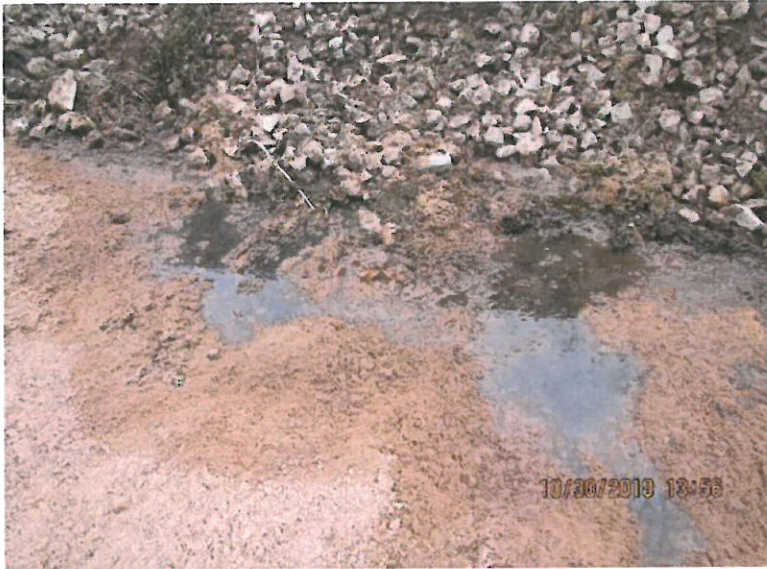
**Photo 64:** Close up view of the ponded leachate outside the wall of the NE corner of the FSA. Photo direction is down and west.

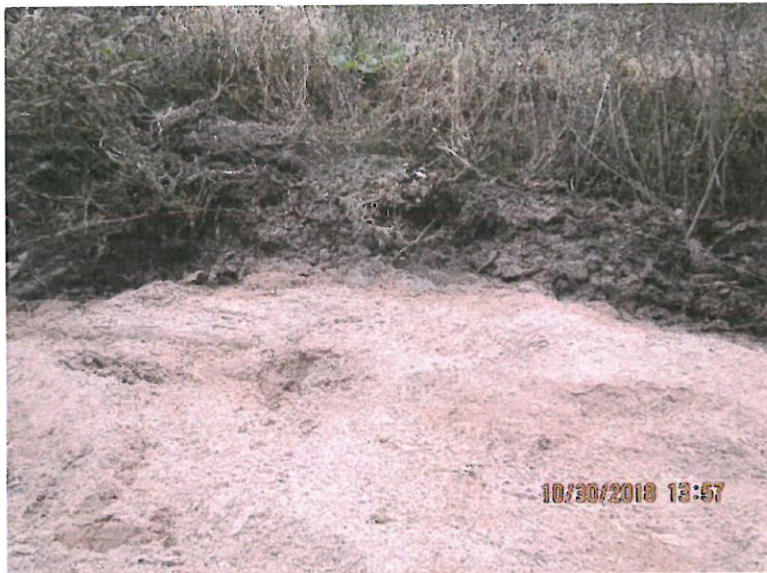
**Photo 65:** Close up view of leachate and feed solids near the NE corner of the FSA. Sand covering the ground is visible in the foreground. Photo direction is north and down.

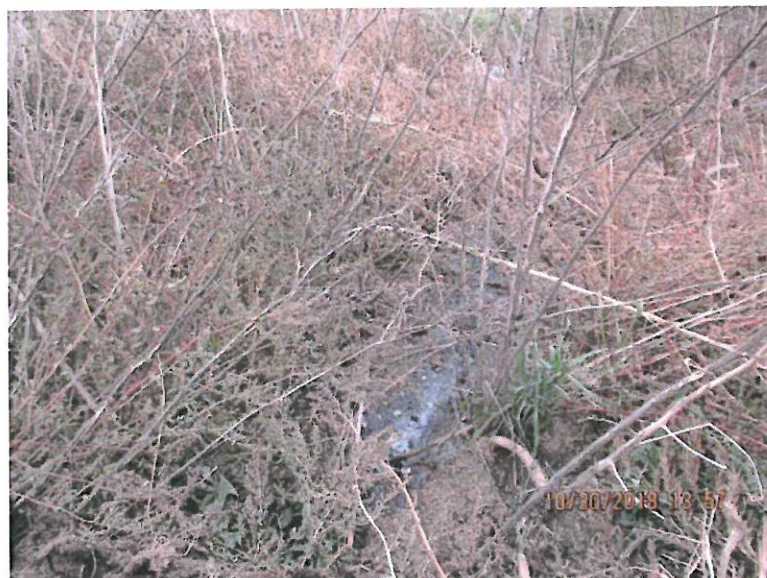
**Photo 66:** View of a ponded area of leachate and dead vegetation in the field/vegetated area N/NE of the FSA. Photo direction is north and down.

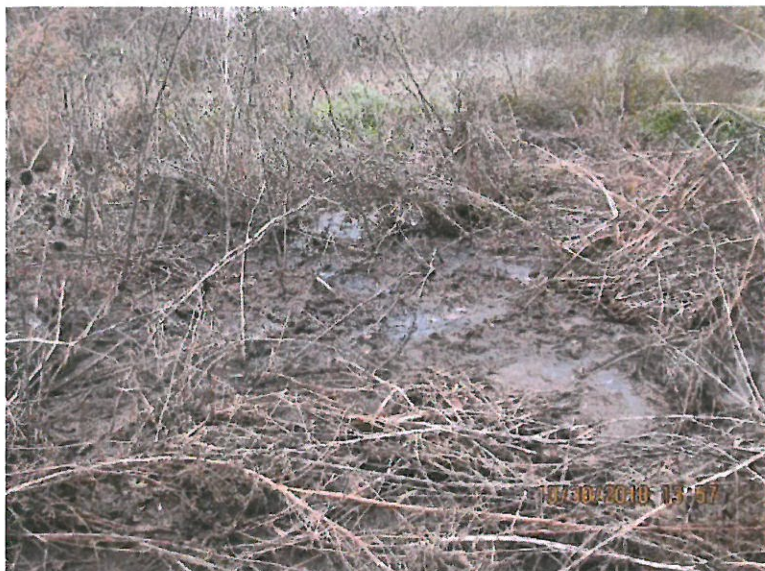
**Photo 67:** View of the leachate discharge pathway northward into the vegetated area N/NE of the FSA. Ponded leachate and dead vegetation are visible. Photo direction is N/NW.

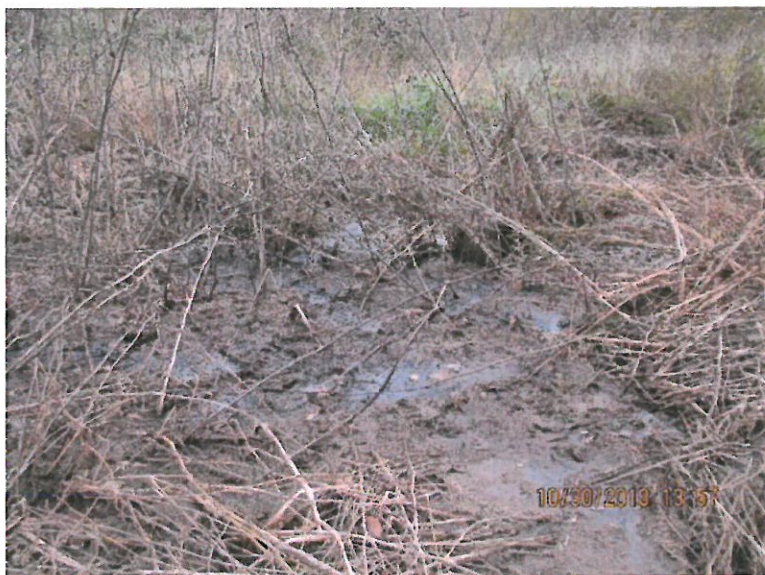
**Photo 68:** View of the leachate discharge pathway northward into the vegetated area N/NE of the FSA. Ponded leachate and dead vegetation are visible. Photo direction is N/NW.

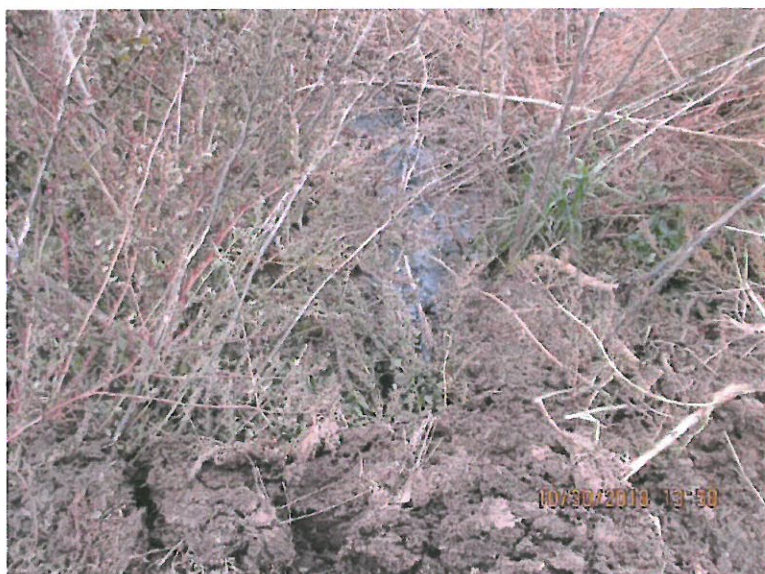
**Photo 69:** View of the leachate discharge pathway northward into the vegetated area N/NE of the FSA. Ponded leachate, dead vegetation, and feed solids are visible. Photo direction is down and N/NW.

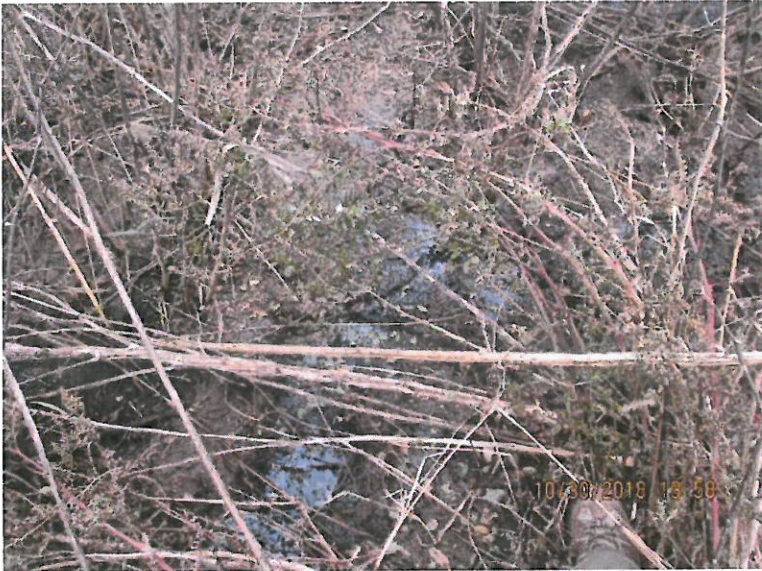
**Photo 70:** View of the leachate discharge pathway northward into the vegetated area N/NE of the FSA. Ponded leachate and dead vegetation are visible. Photo direction is down.

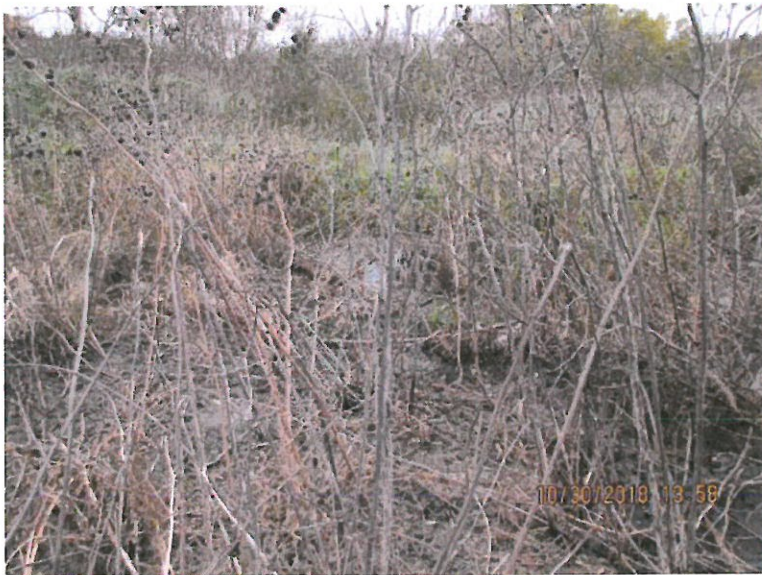
**Photo 71:** View of the leachate discharge pathway northward into the vegetated area N/NE of the FSA. Ponded leachate and dead vegetation are visible. Photo direction is N/NW.

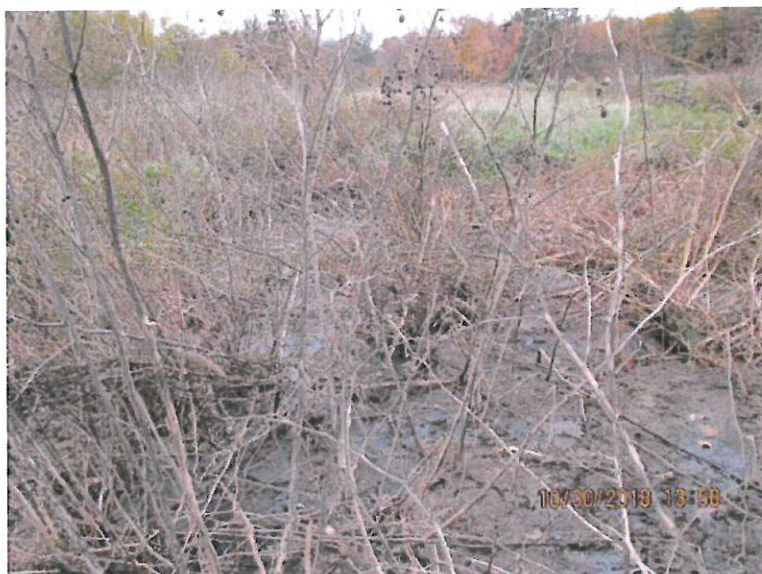
**Photo 72:** View of the leachate discharge pathway northward into the vegetated area N/NE of the FSA. Ponded leachate and dead vegetation are visible. Photo direction is N/NW.

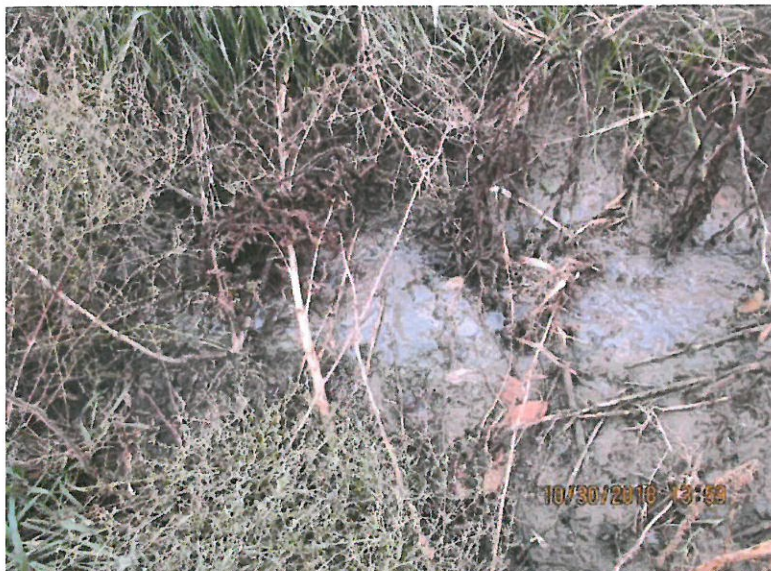
**Photo 73:** Close up view of the leachate discharge ponded in the vegetated area N/NE of the FSA. Dead vegetation is also visible. Photo direction down.

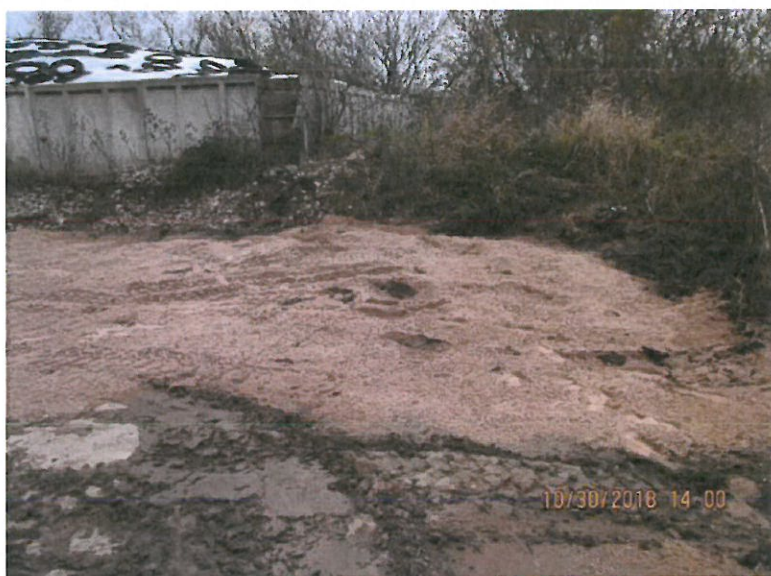
**Photo 74:** Alternate view of the NE corner of the FSA showing the piled stones, sand, and feed solids. Photo direction is west.

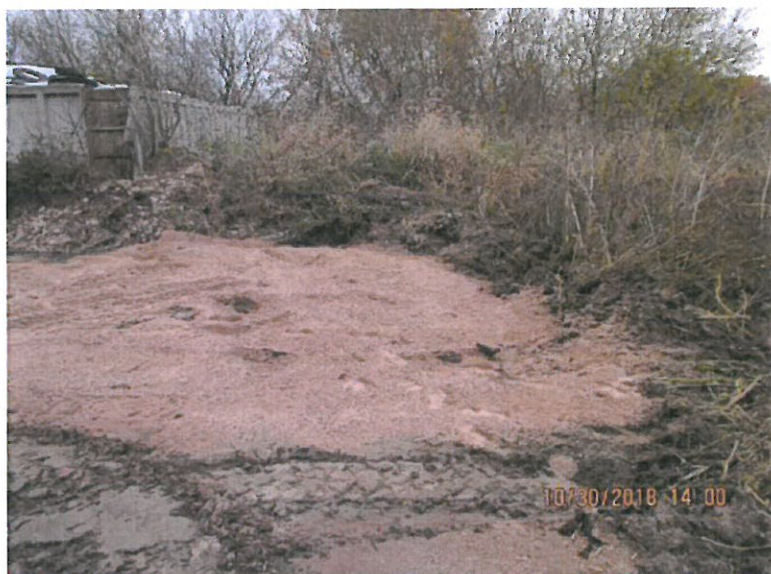
**Photo 75:** View of the sand and feed solids pushed into the vegetated area N/NE of the FSA. Photo direction is west.

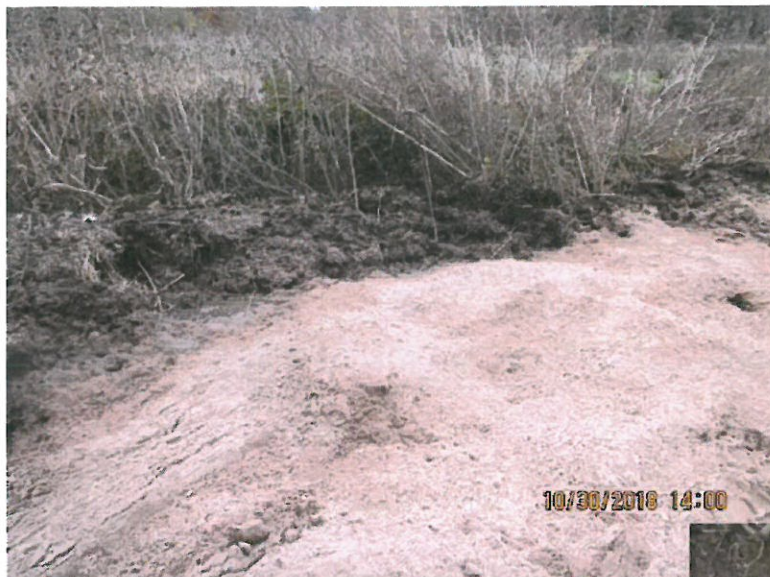
**Photo 76:** Close up view of the sand and feed solids pushed into the vegetated area N/NE of the FSA. Photo direction is north.

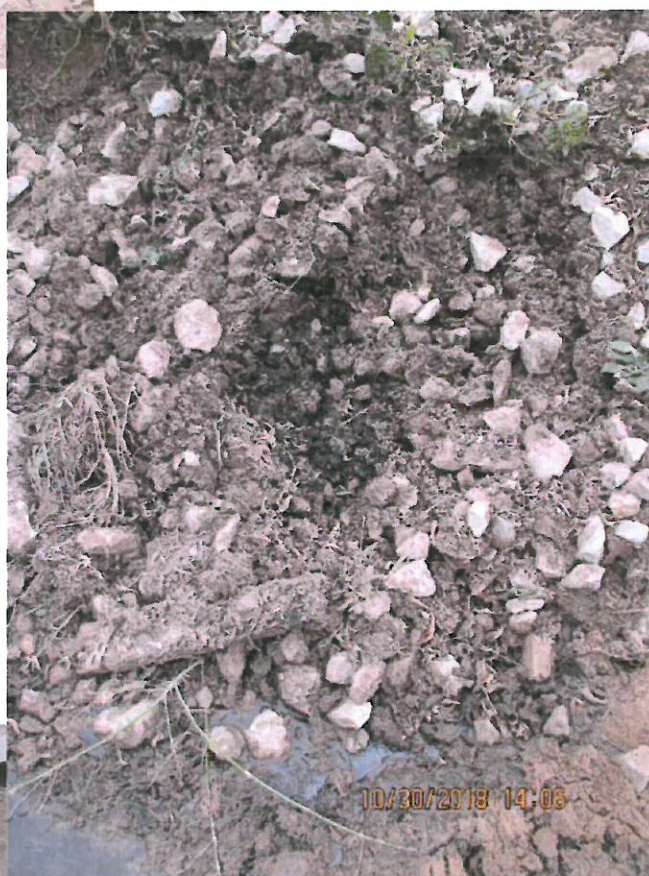
**Photo 77 (right):** Close up view of the stone, feed solids, and soil mixture piled against the exterior of the east wall of the FSA. Leachate seepage is visible. Photo direction is west and down.

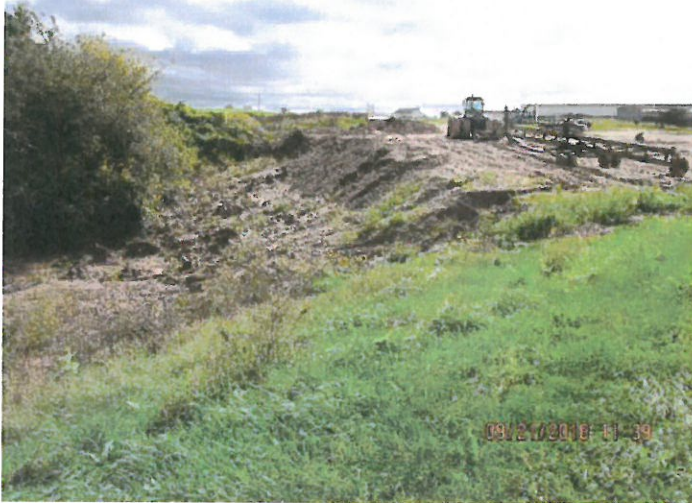
**Photo 1:** View of a disturbed area without storm water erosion controls vegetative stabilization east of the waste storage facility. Photo direction is east.

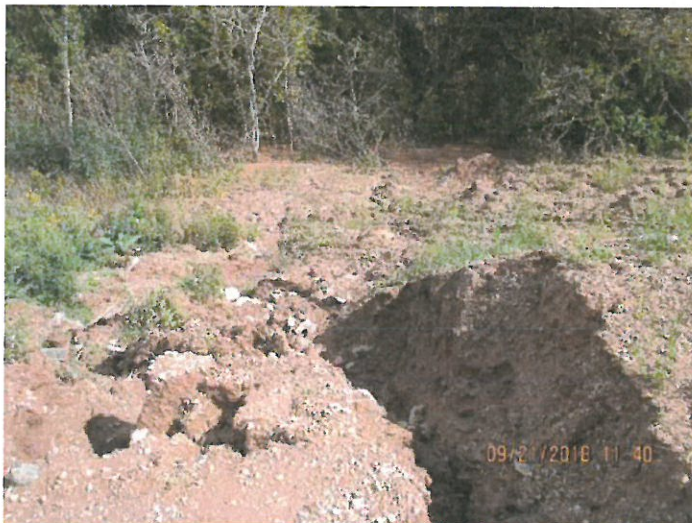
- The disturbed area east of the waste storage facility appeared to be in the same condition; no attempt at erosion controls or vegetative stabilization was observed. Rill erosion areas noted during the previous site visit appeared more severely eroded.

**Photo 2:** View of the north side of the disturbed area looking down into a wooded area where ponded turbid water is visible. Severe rill erosion is visible in the foreground. Photo direction is north and down.
