State of Wisconsin | DEPARTMENT OF NATURAL RESOURCES

Subject: **Notice of Violation - Chapter 283, Wis. Statutes  
Enforcement Conference - March 9, 2009**

### **3. POTENTIAL VIOLATIONS**

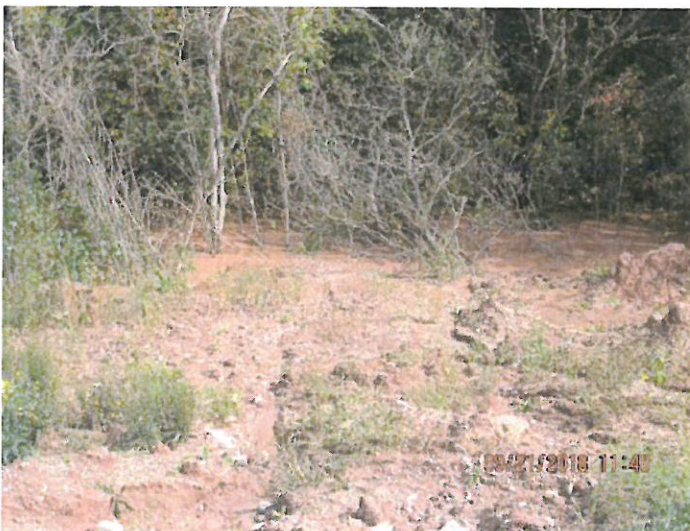
**Photo 3:** Close up view of the ponded turbid water in the wooded area north of the disturbed area. Photo direction is north and down.

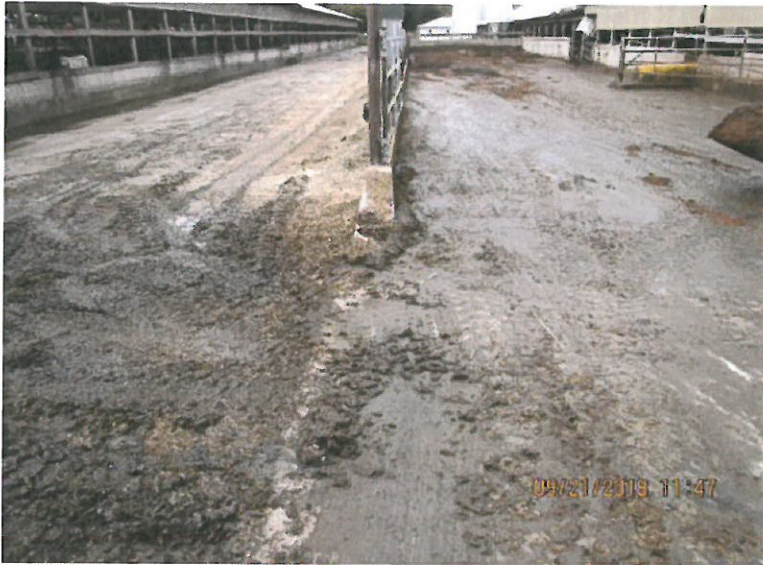
**Photo 4:** View of the south wall and southeast corner of the concrete heifer lot. Photo direction is west.

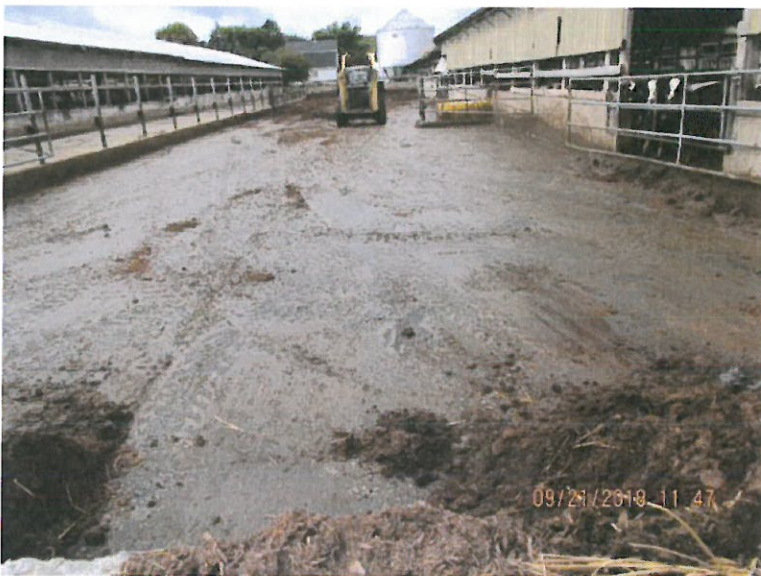
**Photo 5:** View of the concrete heifer lot from the east end. Photo direction is west.

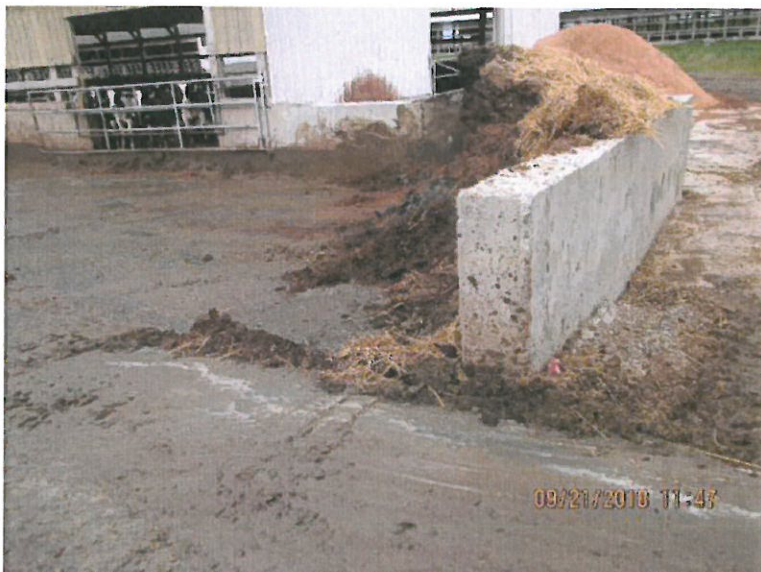
**Photo 6:** View of the east end of the concrete heifer lot where the northeast corner was enclosed with concrete walls as part of interim runoff control requirements. Photo direction is north/NW.

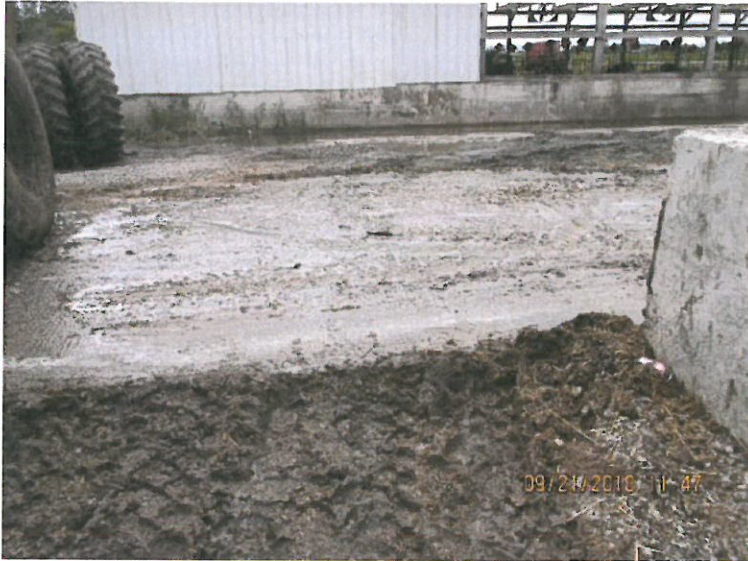
**Photo 7:** View of the east end of the concrete heifer lot. The east wall is partially visible. Photo direction is south.

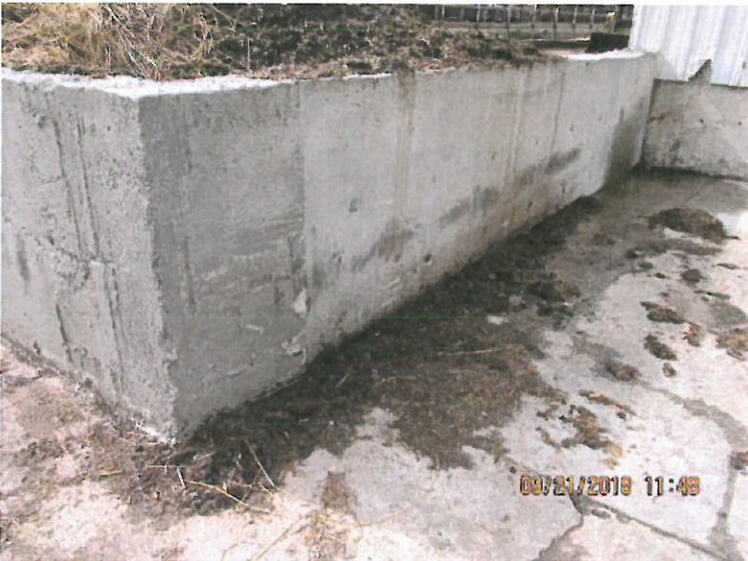
**Photo 8:** View of the exterior of the north wall at the east end of the concrete heifer lot. Photo direction is SW.

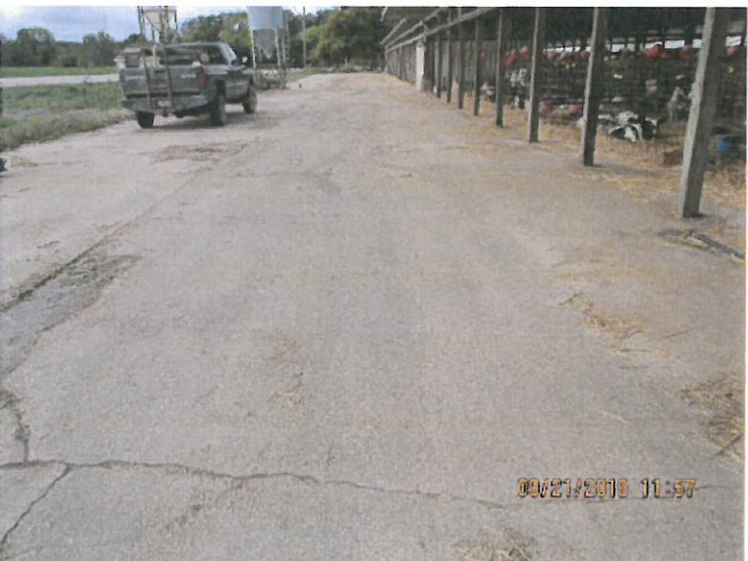
**Photo 9:** View of the concrete lane south/in front of the calf barn. Photo direction is west.

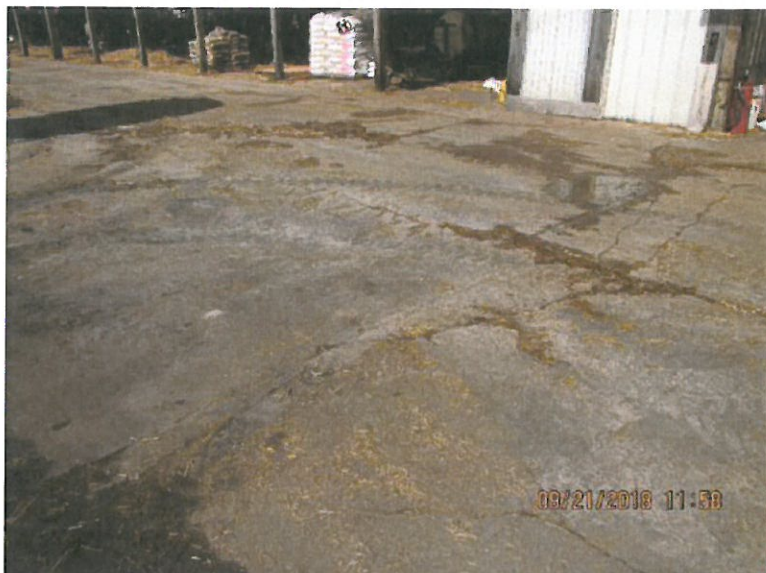
**Photo 10:** View of the concrete lane south of the calf barn where discharges of process wastewater were previously observed. Photo direction is down and NW.

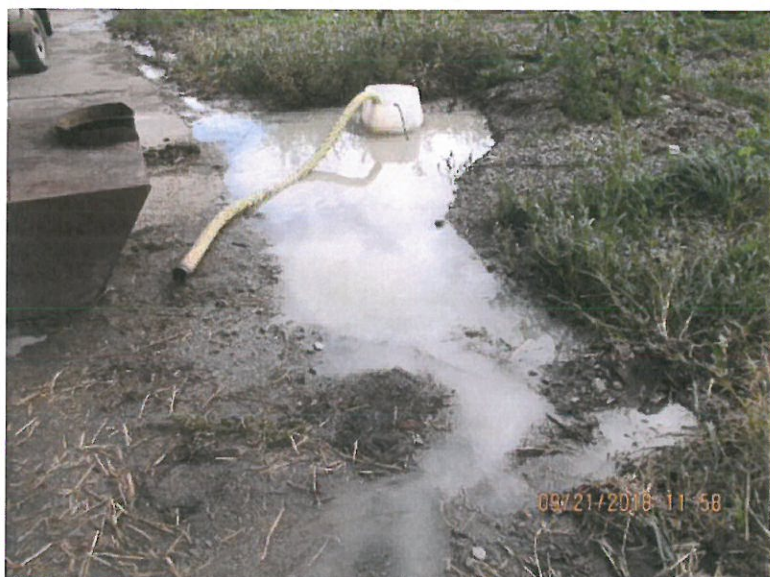
**Photo 11:** View of the vegetated area south of the concrete lane south of the calf barn. Process wastewater is visible ponded near a partially submerged plastic drum. Photo direction is down and SE.

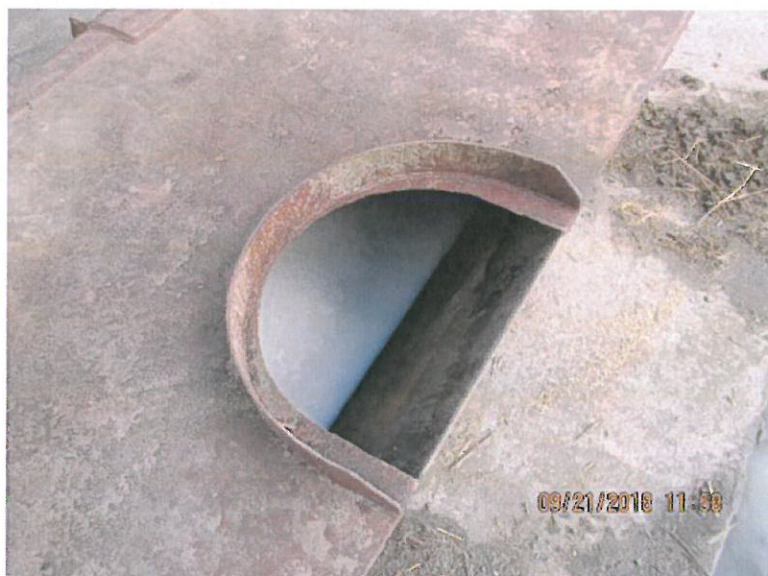
**Photo 12:** View of the inside of a metal tank adjacent to the area of ponded process wastewater south of the calf barn. Process wastewater is visible inside the tank. Photo direction is down.

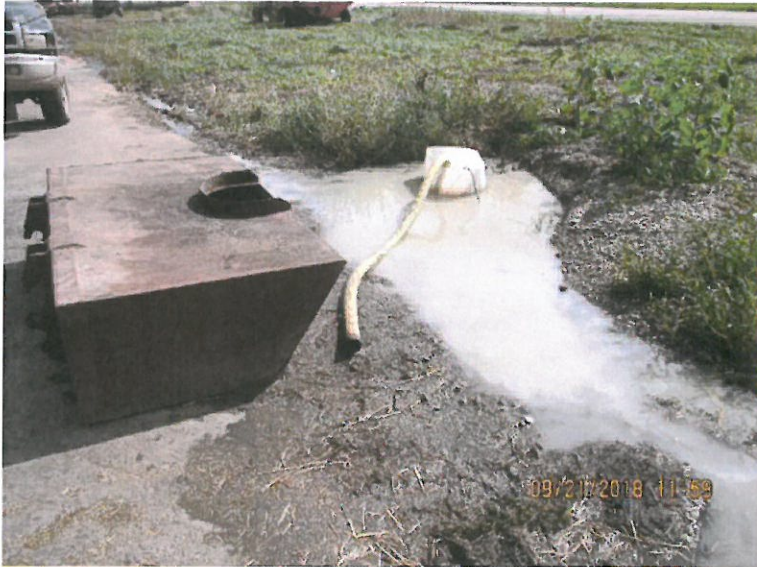
**Photo 13:** Alternate view of area of ponded process wastewater south of the calf barn. Photo direction is down and SE.

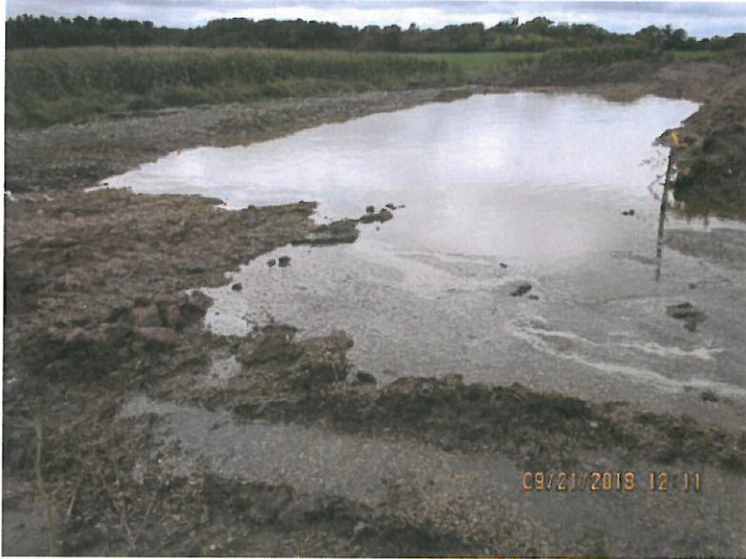
**Photo 16:** View of the leachate/process wastewater collection basin south of the FSA constructed to meet interim runoff control requirements. Photo direction is SW.

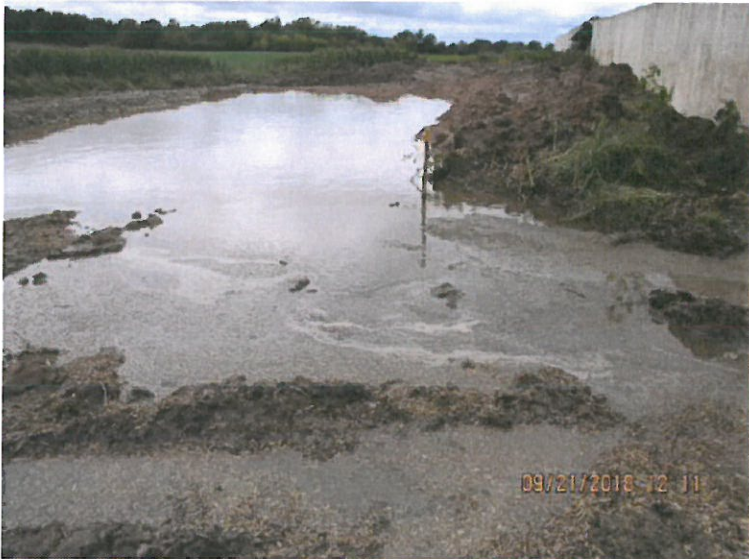
**Photo 17:** View of the leachate/process wastewater collection basin south of the FSA showing the south bunker wall. Photo direction is west.

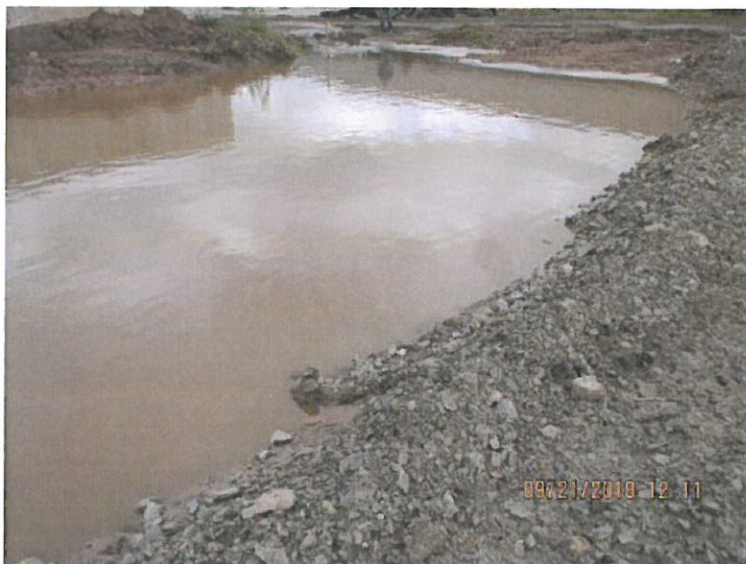
**Photo 18:** Close up view of the southern berm wall of the leachate/process wastewater collection basin south of the FSA. Photo direction is NE.

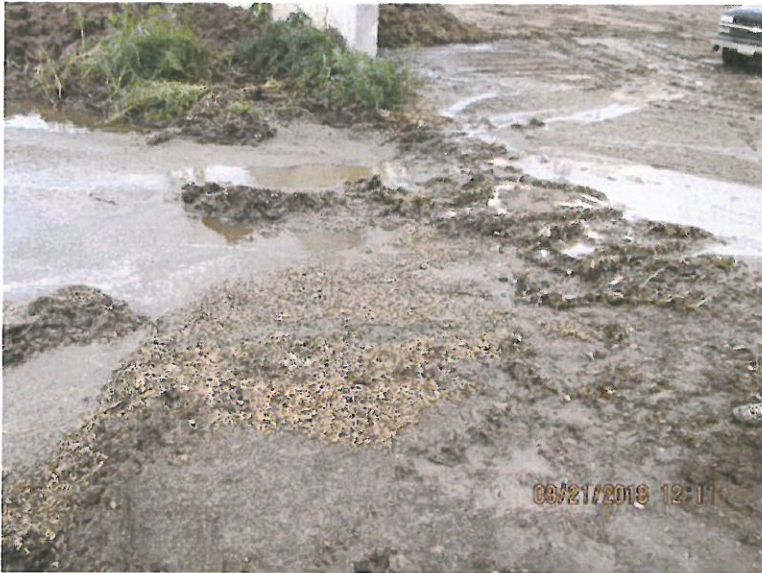
**Photo 19:** View of the SE corner of the FSA where the flow of leachate/process wastewater flow is directed. The leachate/process wastewater collection basin is partially visible. Photo direction is down and NW.

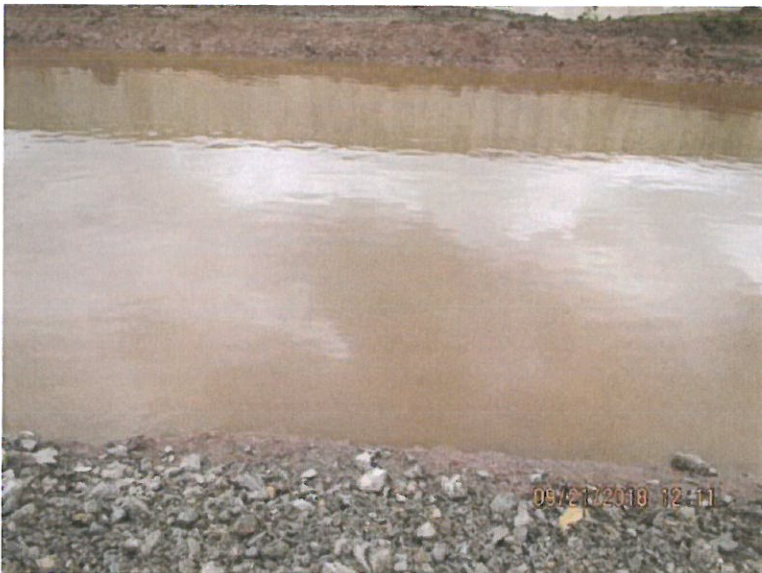
**Photo 20:** Close up view of the water in the leachate/process wastewater collection basin south of the FSA. Photo direction is down and north.

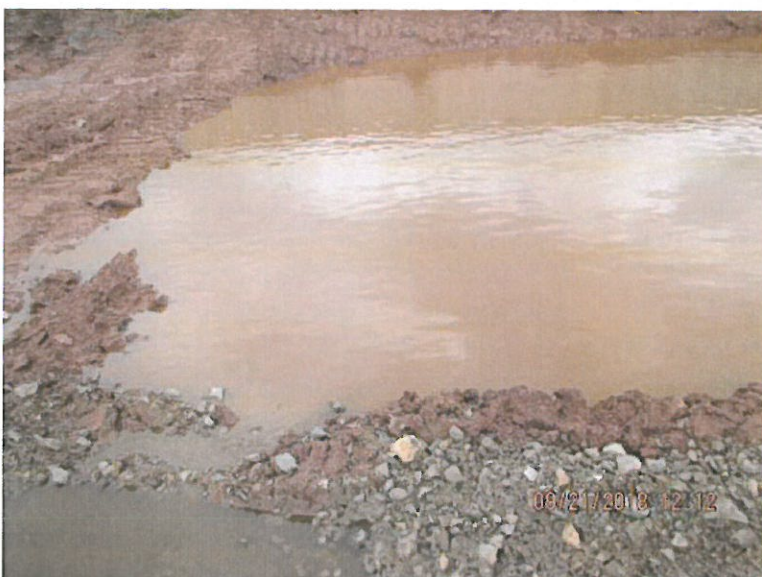
**Photo 21:** Close up view of the western section of the leachate/process wastewater collection basin south of the FSA. Photo direction is down and north.

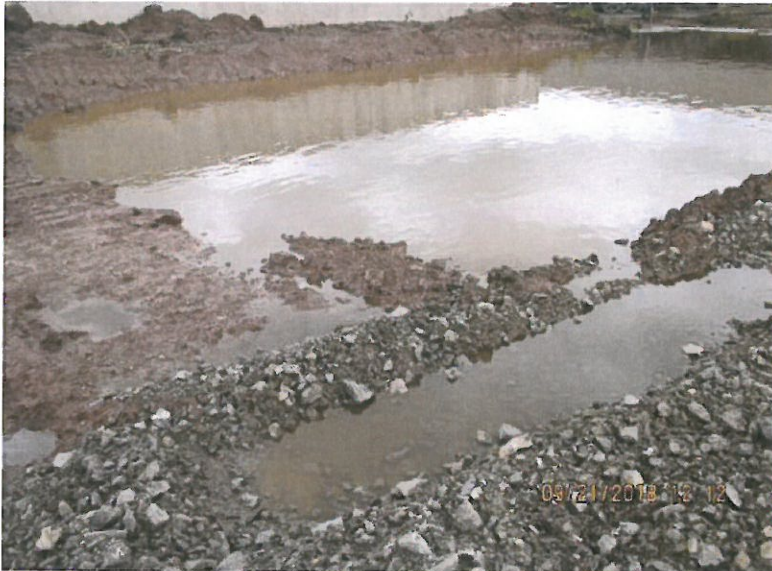
**Photo 22:** View of the leachate/process wastewater collection basin south of the FSA from the SW corner. Photo direction is down and NE.

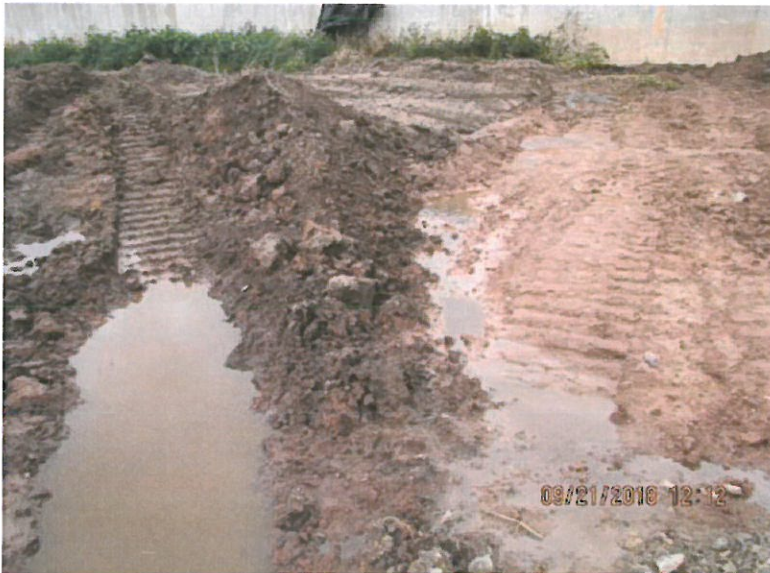
**Photo 23:** Close up view of the construction of the N/NW wall of the leachate/process wastewater collection basin south of the FSA. Photo direction is NW.

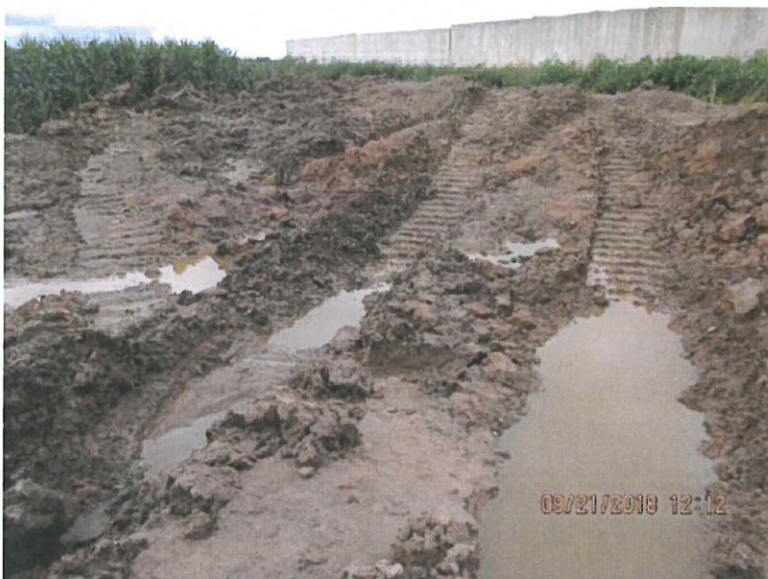
**Photo 24:** Alternate view of the construction of the N/NW wall of the leachate/process wastewater collection basin south of the FSA. Photo direction is NW.

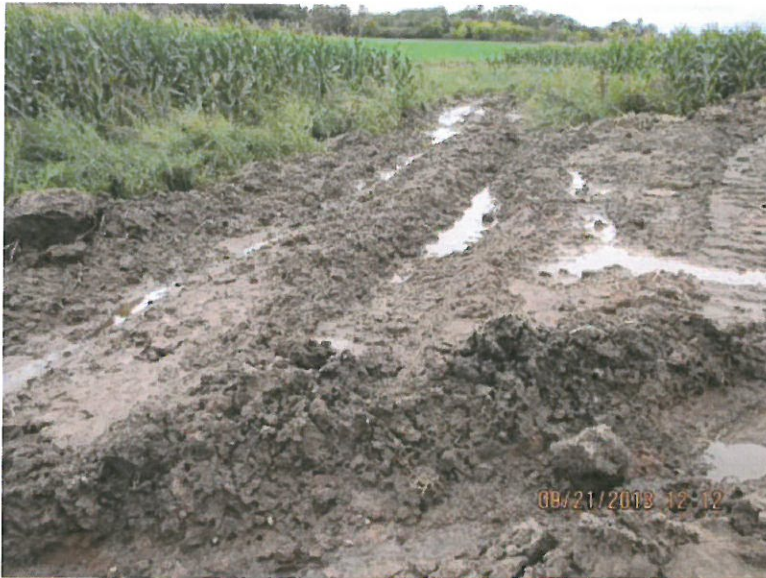
**Photo 25:** View of the construction of the S/SW wall of the leachate/process wastewater collection basin south of the FSA. Photo direction is SW.

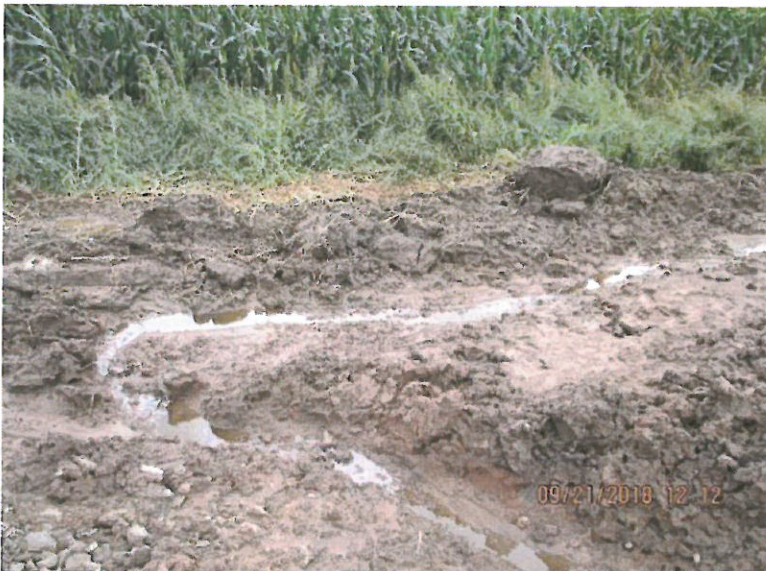
**Photo 26:** View of process wastewater in a drainage path near the southern berm wall of the leachate/process wastewater collection basin south of the FSA. Photo direction is south and down.

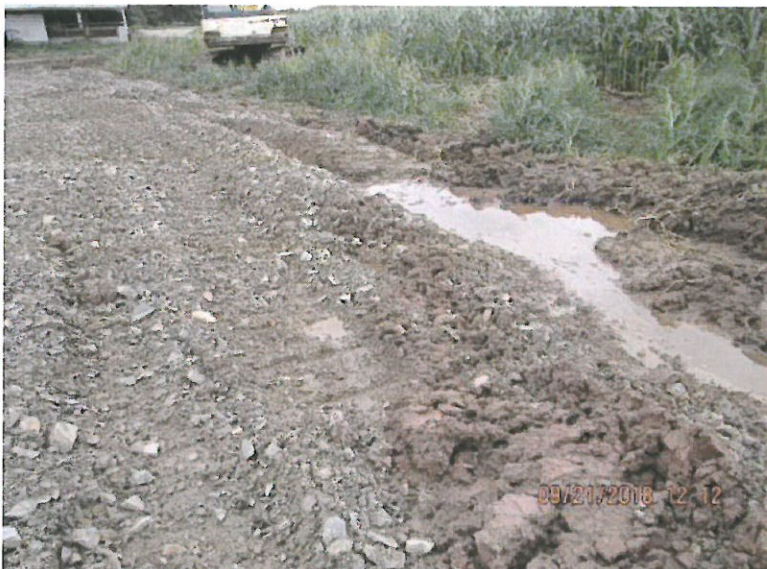
**Photo 27:** View of the S/SE wall section of the leachate/process wastewater collection basin south of the FSA. Photo direction is SE and down.

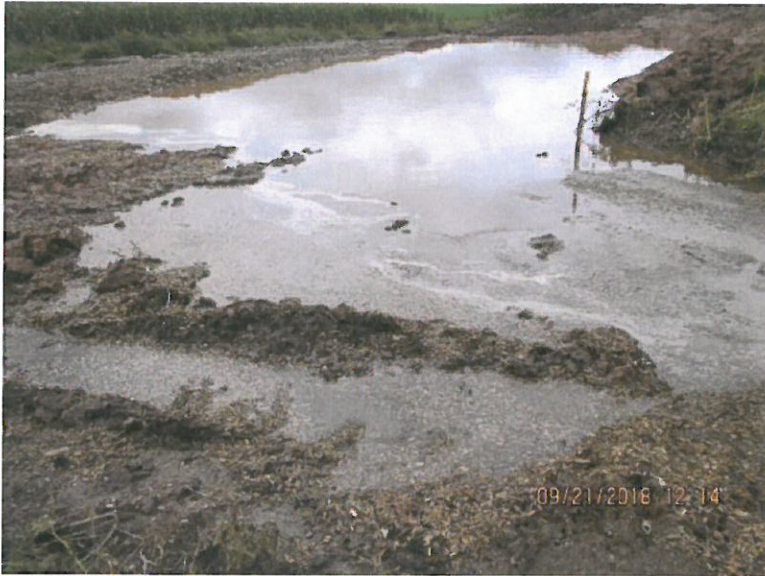
**Photo 28:** View of the leachate/process wastewater collection basin south of the FSA from the NE corner. Blown feed is visible near the inlet to the basin. Photo direction is SW and down.

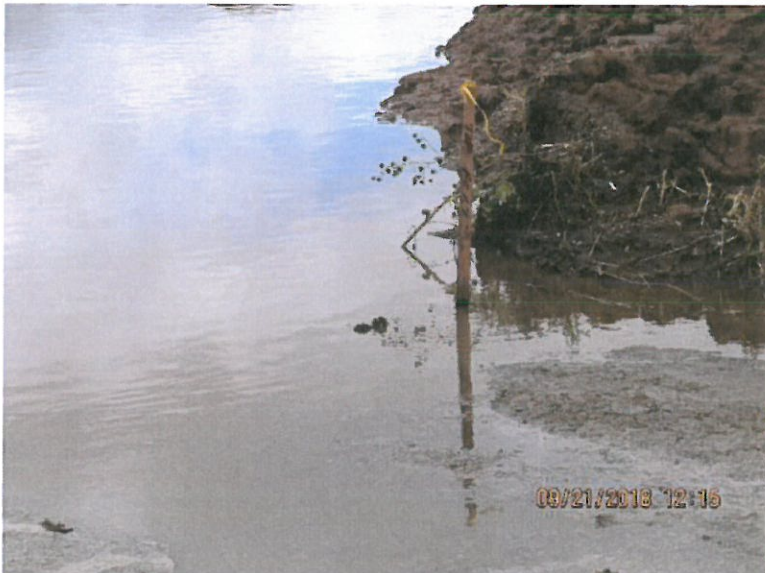
**Photo 29:** Close up view of a wooden stake in the leachate/process wastewater collection basin that appeared to be a level /volume indicator. Photo direction is SW and down.

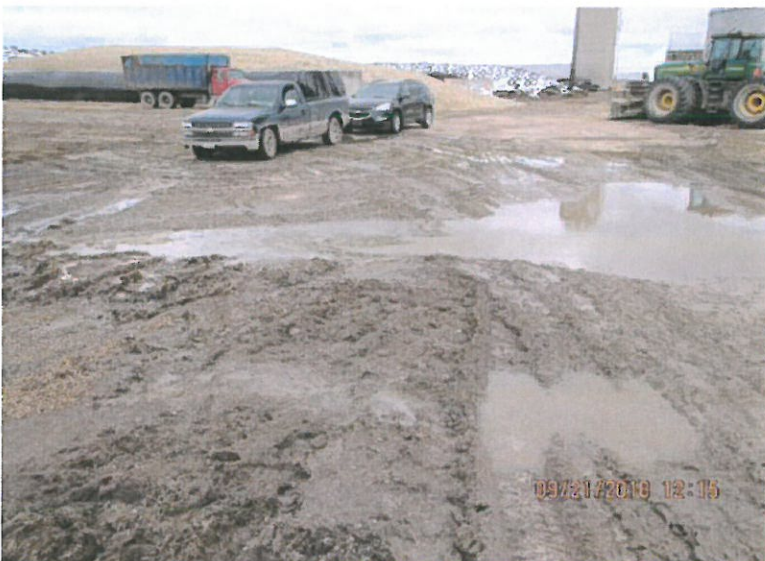
**Photo 30:** View of the feed pad (left) and the yard area (right), which drains to the collection basin south of the FSA. Photo direction is NW.

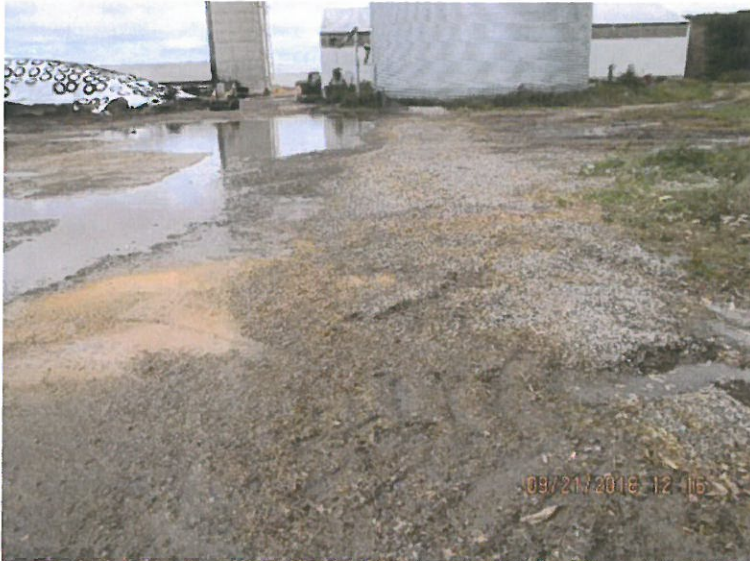
**Photo 31:** View of the gravel berm placed on the east side of the site between the steer barn and a grain bin to prevent discharges to the ditch at Lime Kiln Rd. Photo direction is north.

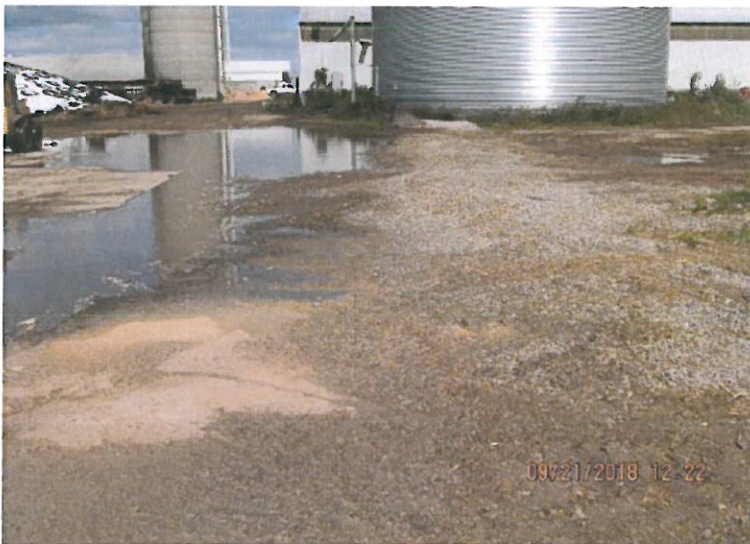
**Photo 32:** Alternate view of the gravel berm placed on the east side of the site between the steer barn and a grain bin to prevent discharges to the ditch at Lime Kiln Rd. Photo direction is north.

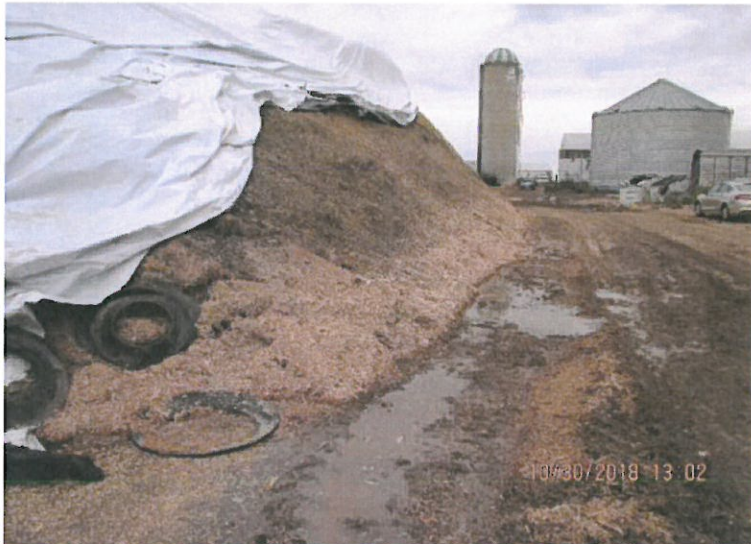
**Photo 33:** View of the feed pile in the FSA showing ponded leachate/process wastewater. Photo direction is north.

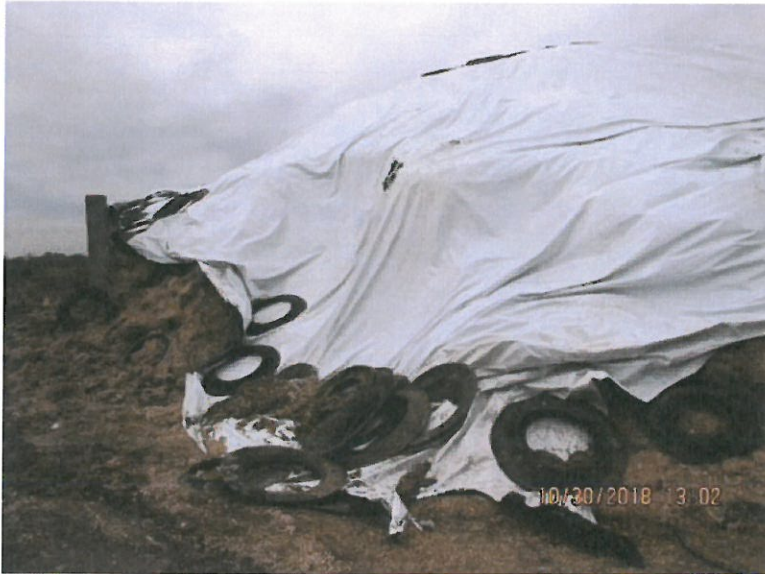
**Photo 34:** Alternate view of the feed pile in the FSA, which is only partially covered with plastic. Photo direction is west.

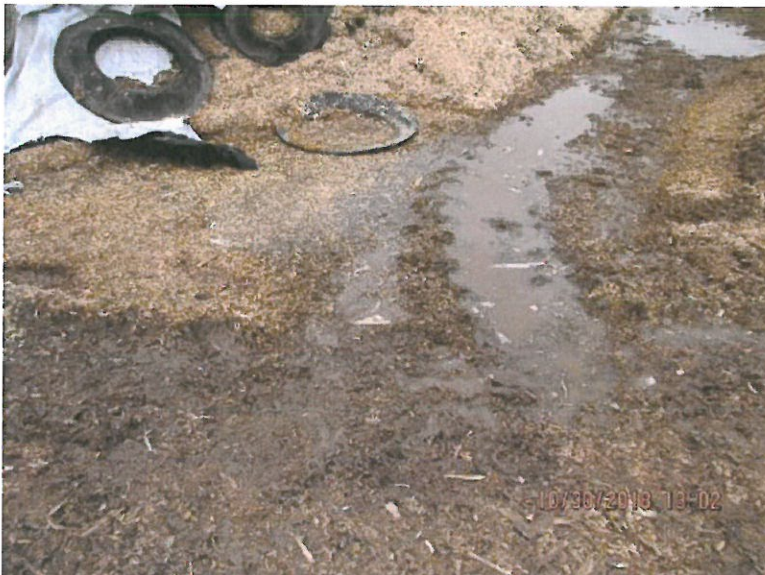
**Photo 35:** Close up view of the ponded leachate/process wastewater near the feed pile in the FSA. Photo direction is down and NW.

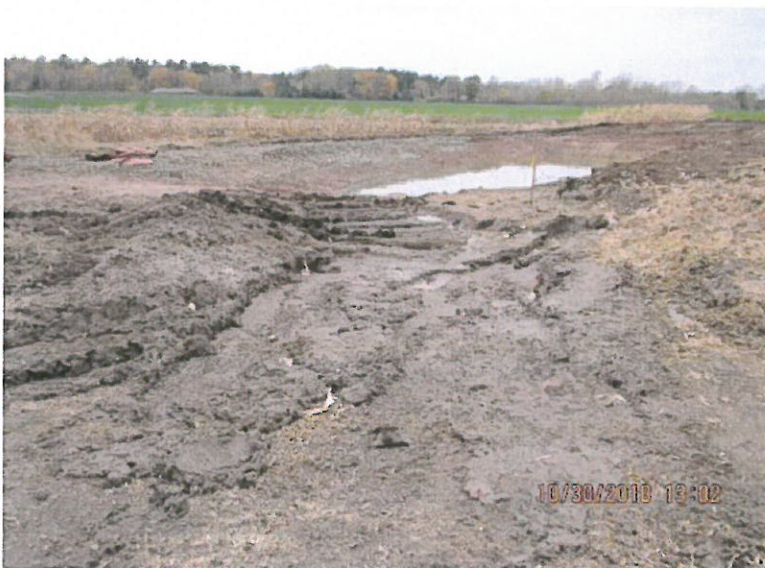
**Photo 36:** View of the leachate/process wastewater collection basin south of the FSA. Photo direction is SW.

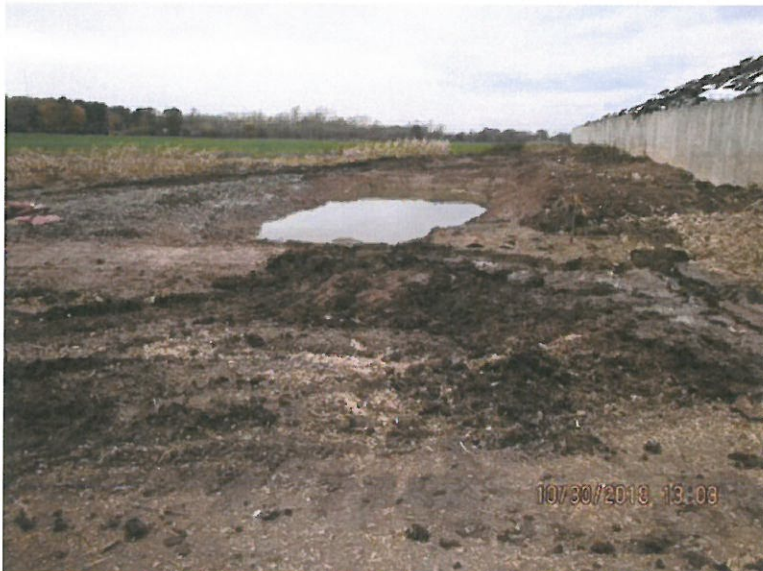
**Photo 37:** Alternate view of the leachate/process wastewater collection basin south of the FSA. Photo direction is west.

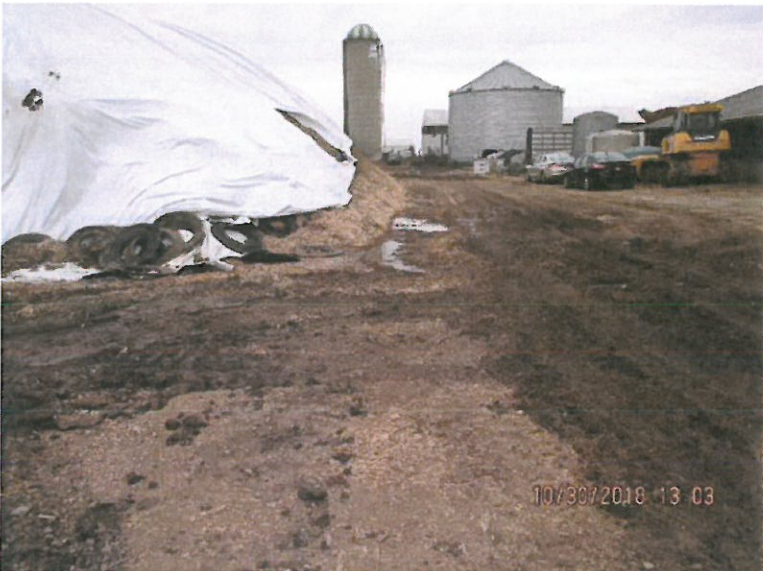
**Photo 38:** View of the feed pile in the FSA from near the inlet to the leachate/process wastewater collection basin south of the FSA. Photo direction is north.

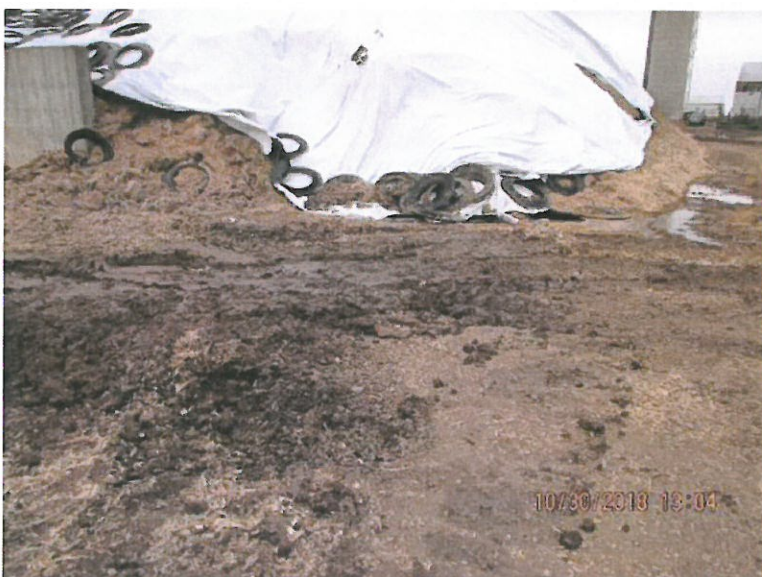
**Photo 39:** View of the SE corner of the FSA showing feed solids outside the feed pad and near the inlet to the leachate/process wastewater collection basin south of the FSA. Photo direction is north.

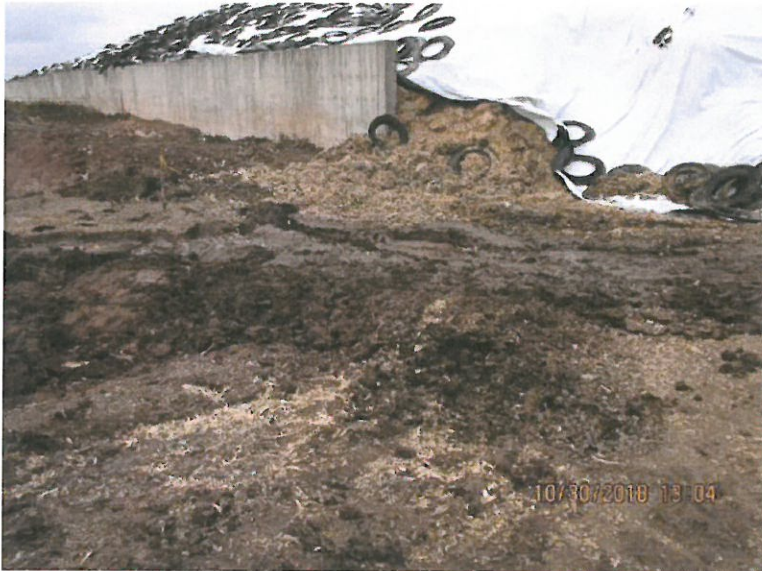
**Photo 40:** Alternate view of the SE corner and south wall of the FSA, showing feed solids outside the feed pad and near the inlet to the leachate/process wastewater collection basin south of the FSA. Photo direction is NW.

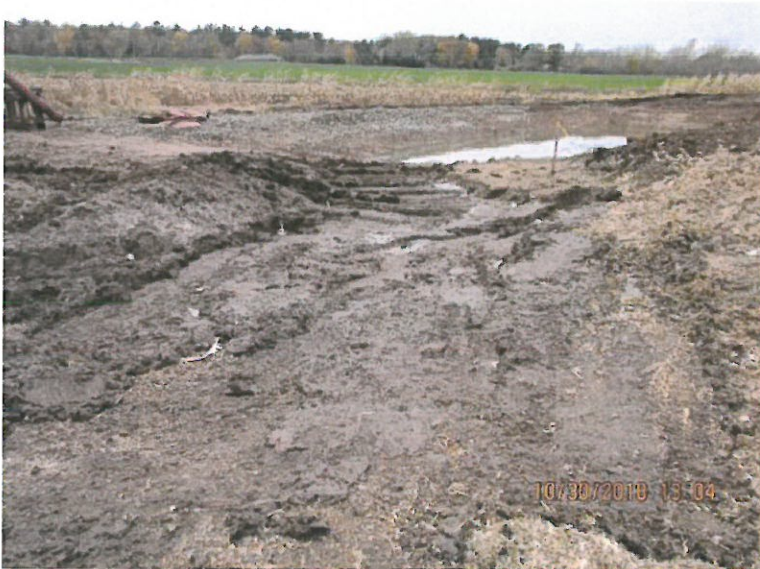
**Photo 41:** View of the leachate/process wastewater collection basin south of the FSA, showing the regraded inlet area. Photo direction is SW.

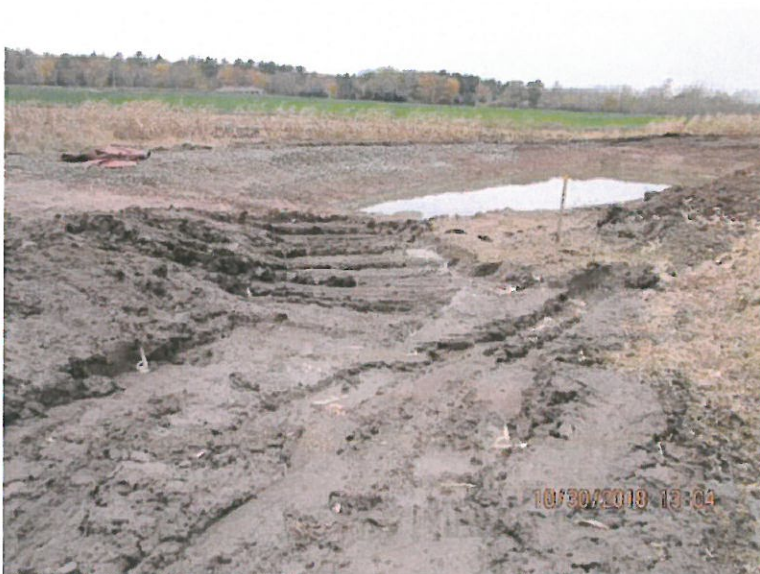
**Photo 42:** Closer view of the leachate/process wastewater collection basin south of the FSA, showing the regraded inlet area. Photo direction is SW.

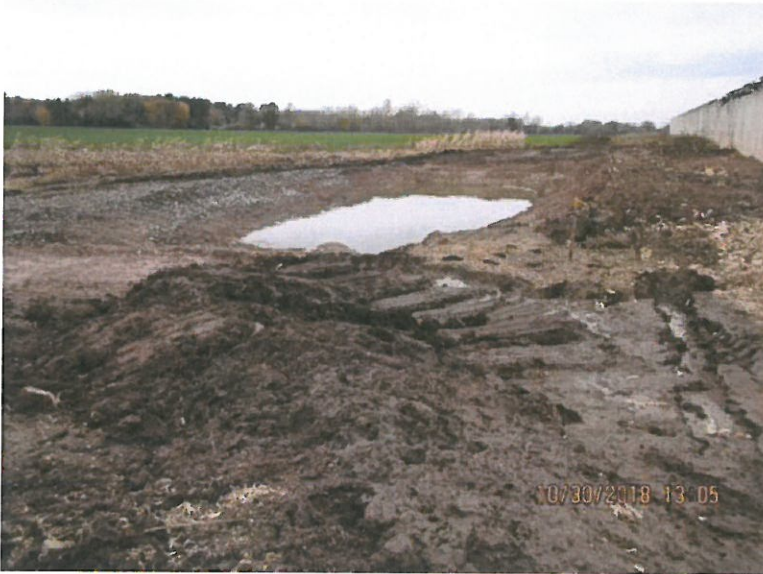
**Photo 43:** Closer view of the leachate/process wastewater collection basin south of the FSA, showing the regraded inlet area. Photo direction is SW.

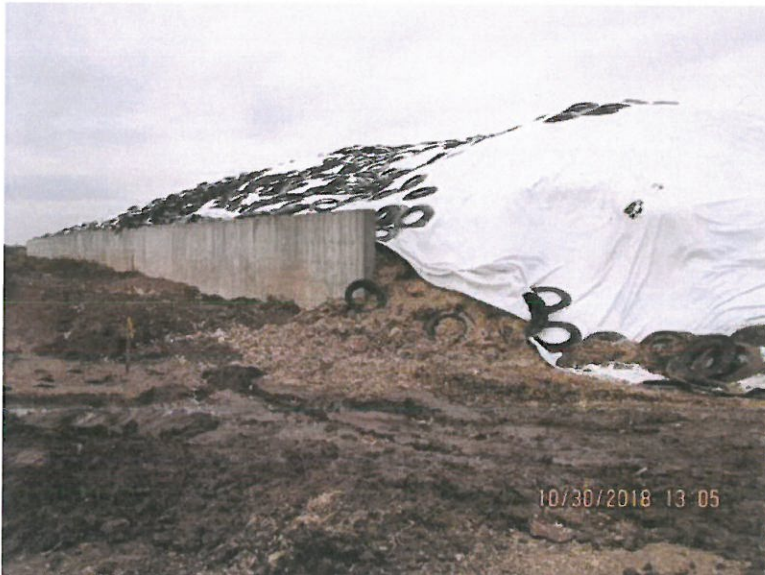
**Photo 44:** Alternate view of the SE corner and south wall of the FSA, showing feed solids outside the feed pad and near the inlet to the leachate/process wastewater collection basin south of the FSA. Photo direction is NW.

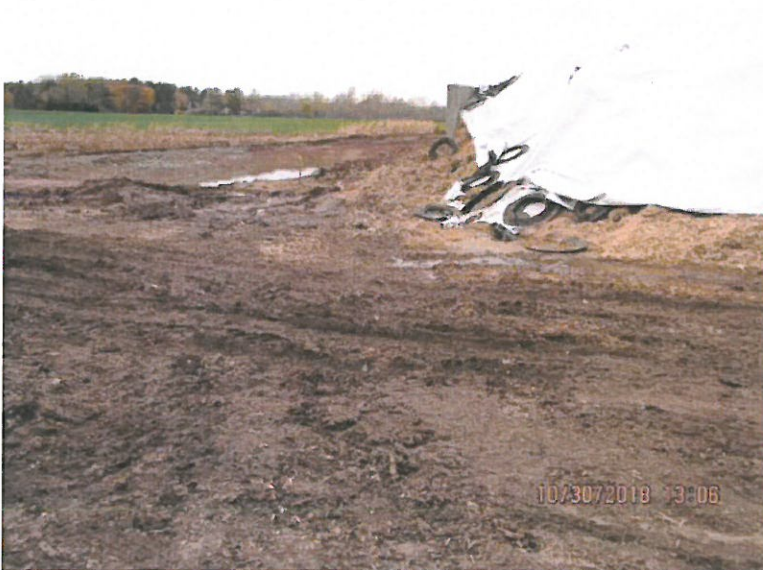
**Photo 45:** Alternate view of the SE corner and south wall of the FSA, showing feed solids outside the feed pad and near the inlet to the leachate/process wastewater collection basin south of the FSA. Photo direction is SW.

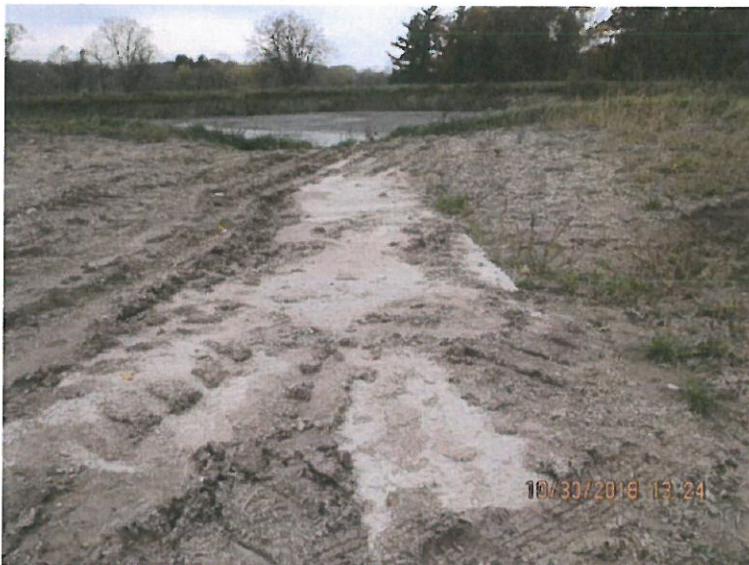
**Photo 47:** Alternate view of the concrete overflow weir constructed in the waste storage facility to meet secondary containment requirements. Photo direction is west.

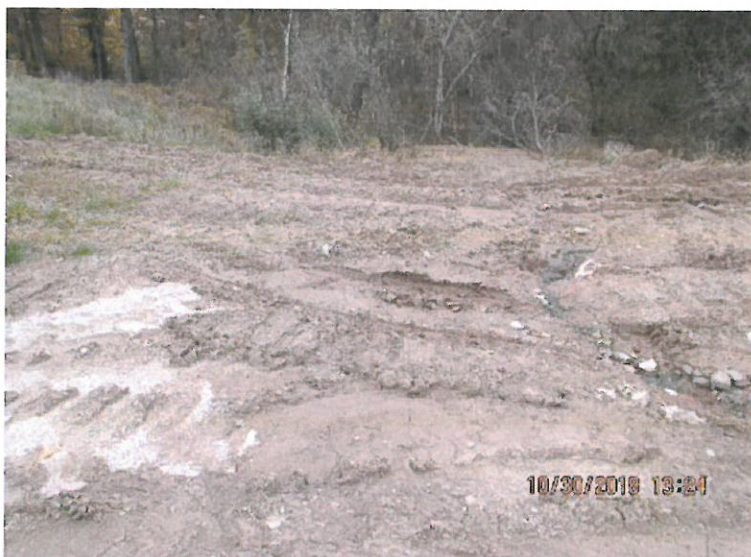
**Photo 48:** Alternate view of the concrete overflow weir constructed in the waste storage facility to meet secondary containment requirements, showing the direction and location of the overflow. Photo direction is down and NE.

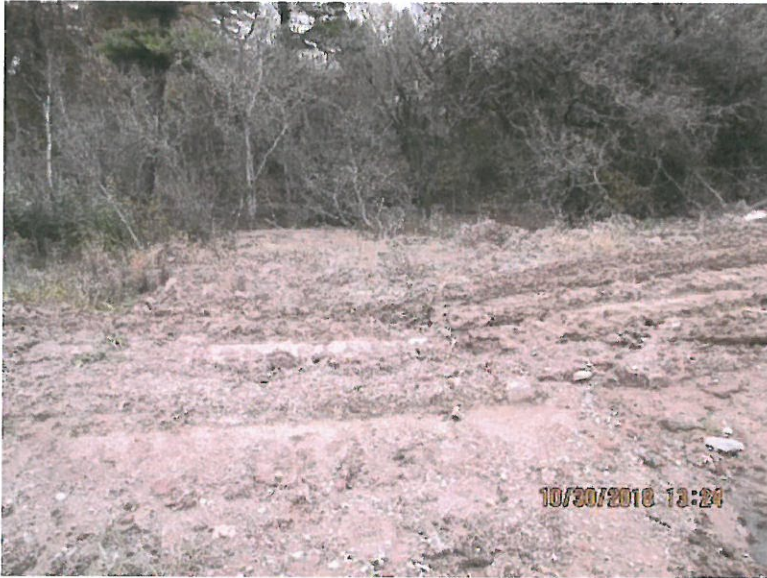
**Photo 49:** View of a wooded area downslope and NE of the waste storage facility where manure will be directed if the storage facility overflows. Photo direction is down and N/NE.

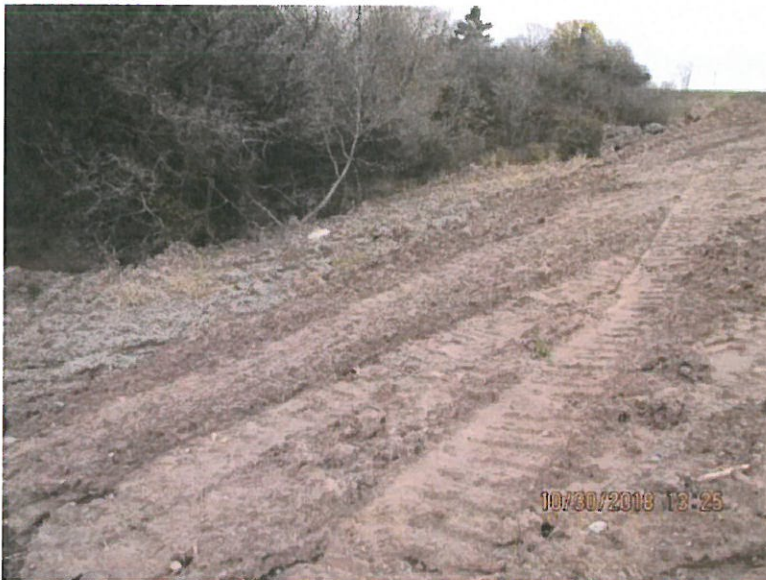
**Photo 50:** View of a disturbed area east of the waste storage facility that does not contain storm water erosion controls or vegetative stabilization. Photo direction is down and east.

- 5. Storm water erosion controls (main farm site)
  - a. A disturbed area was observed east of the waste storage facility during both site inspections. Storm water controls and stabilization of this area were not in place, and sediment-laden water was observed ponded in the wooded area north and downslope of the disturbed area.

- 1. **Actions should be taken to comply with the requirements of the applicable sections of ch. NR 151, Wis. Adm. Code, listed above.**
  - b. A ponded area of liquid manure was observed during the 10/30/2018 site inspection that was discharging through rill erosion channels in the disturbed area to the wooded area northeast of the waste storage facility, where sediment-laden water was ponded.

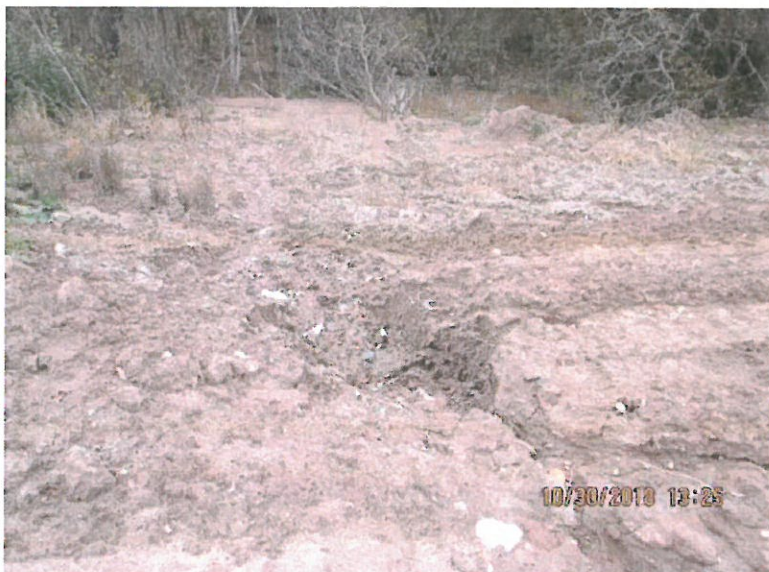
**Photo 51:** View of rill erosion in a disturbed area east of the waste storage facility that does not contain storm water erosion controls or vegetative stabilization. Turbid water is visible ponded in the wooded area in the background. Photo direction is down and down and N/NE.

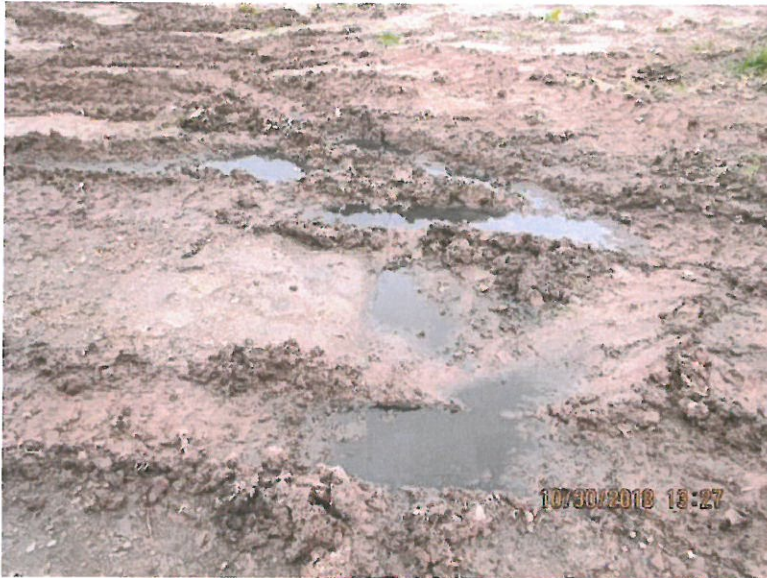
**Photo 52:** View of ponded liquid manure in a disturbed area east of the waste storage facility. Photo direction is down.

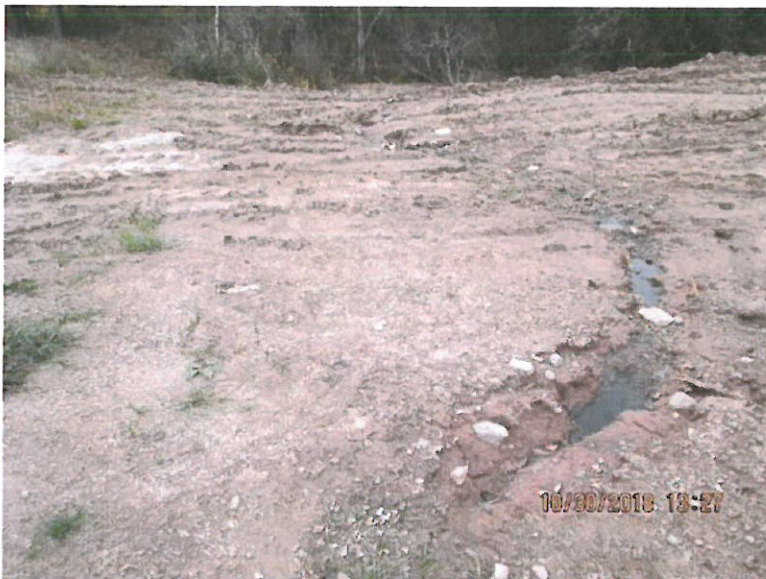
**Photo 53:** View of a discharge path of liquid manure from an area of ponded manure in a disturbed area east of the waste storage facility. Photo direction is down and north.
