State of Wisconsin | DEPARTMENT OF NATURAL RESOURCES

Subject: **Notice of Violation - Chapter 283, Wis. Statutes  
Enforcement Conference - March 9, 2009**

### **3. POTENTIAL VIOLATIONS**

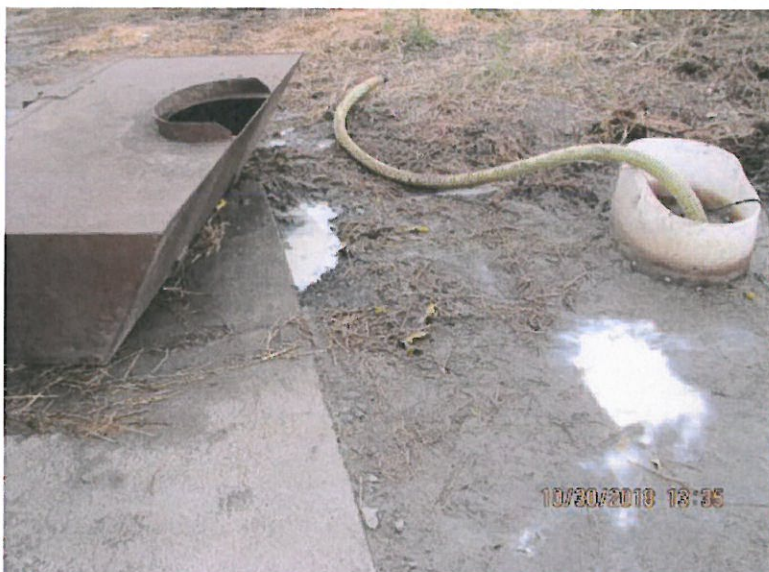
**Photo 54:** View of ponded process wastewater south of the calf barn, near a partially submerged plastic drum and metal tank. Photo direction is down and east.

1. Calf barn (main farm site)
  - a. Process wastewater discharges to the environment were observed during both site visits.
  - b. **Changes in management/handling of process wastewater generated by the calf barn and/or installation of a collection system are required to prevent discharges of process wastewater.**

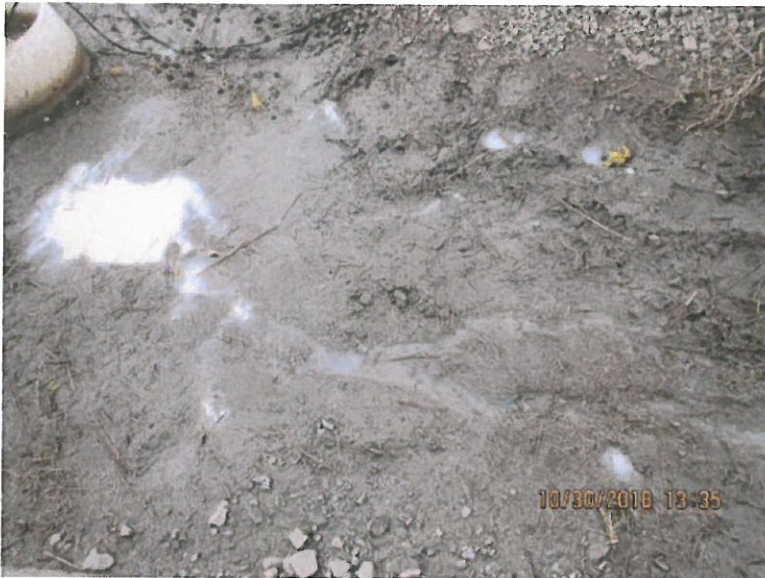
**Photo 55:** View of ponded process wastewater south of the calf barn, near a partially submerged plastic drum and metal tank. Photo direction is down.

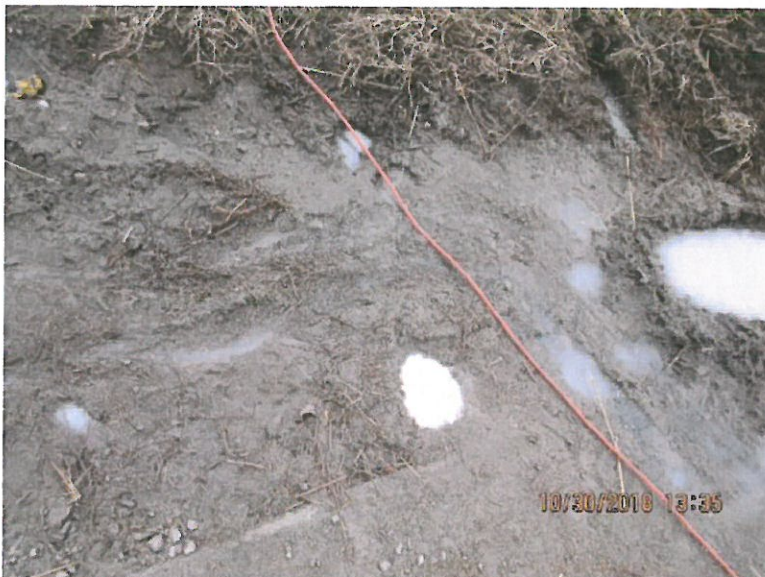
**Photo 56:** View of ponded process wastewater, south of the calf barn and west of the plastic drum and metal tank. Photo direction is down.

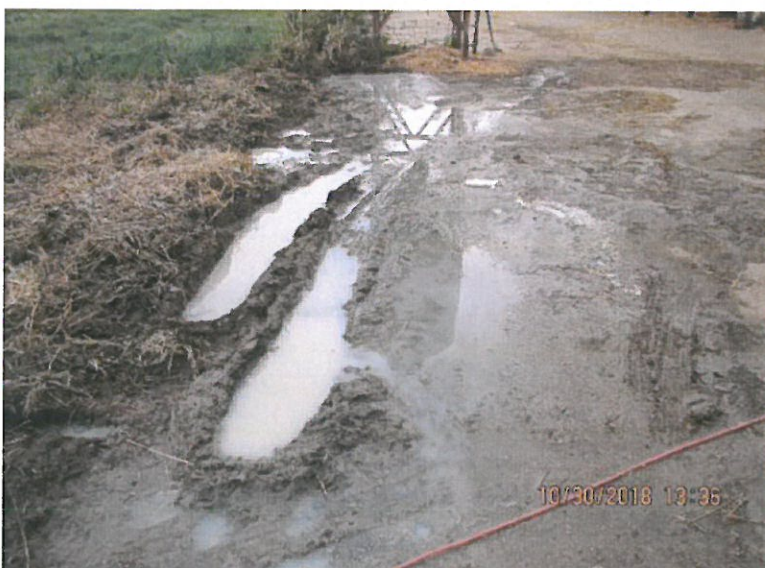
**Photo 57:** View of ponded process wastewater, south of the calf barn and farther west of the plastic drum and metal tank. Photo direction is down and west.

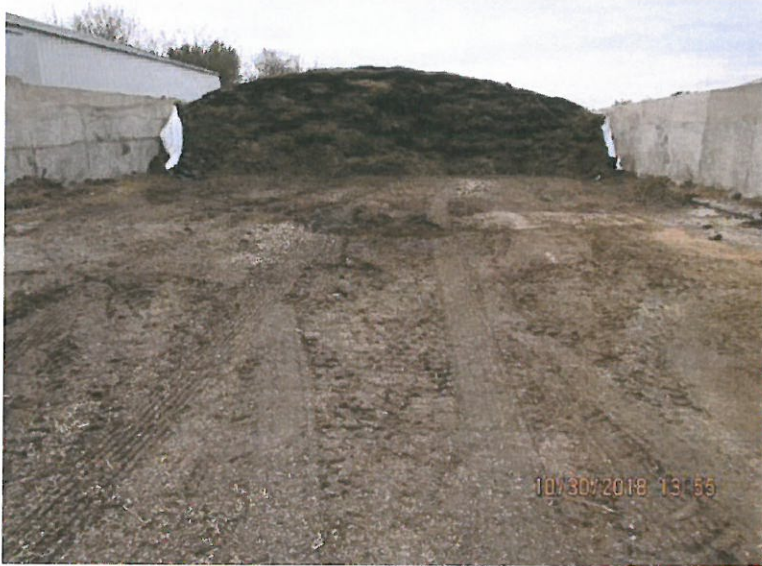
**Photo 58:** View of the FSA with plastic covering the top and sides of the feed pile. Photo direction is north.

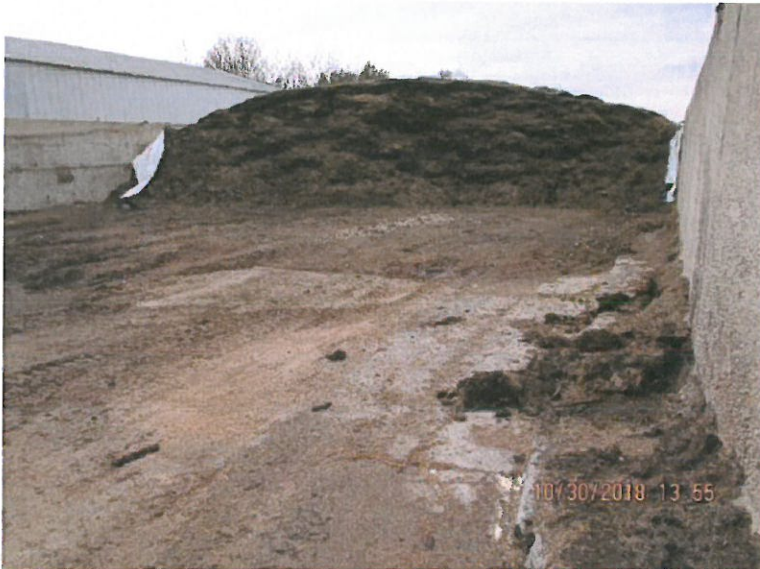
**Photo 59:** Alternate view of the FSA with plastic covering the top and sides of the feed pile. Photo direction is north/NW.

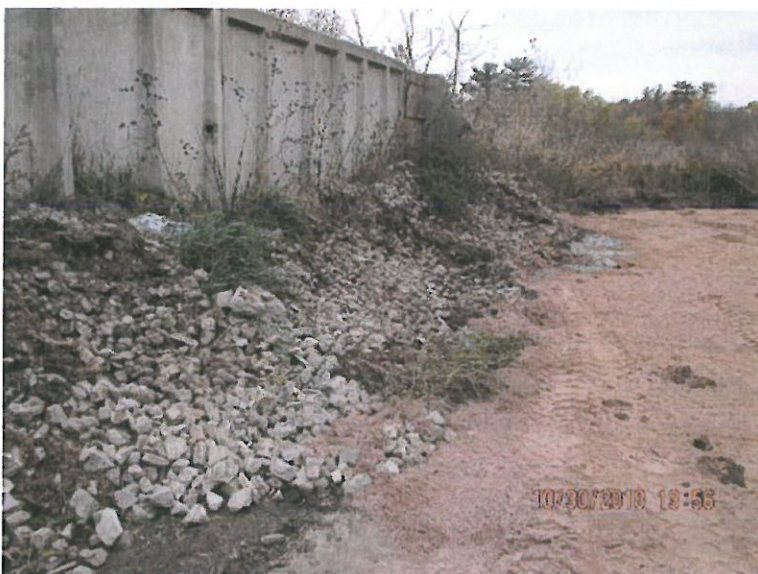
**Photo 60:** View of the exterior of the east wall of the FSA with plastic showing rocks and other vegetation piled against the concrete wall. Photo direction is NW.

- b. Clay soil was previously placed along the exterior of the bunker walls to contain leachate and process wastewater from the feed storage area. The material present along the exterior of the bunker walls during the inspection should be removed and replaced with clay soils. This method requires frequent monitoring to ensure that leachate and process wastewater are not seeping through the clay berm.

- i. The Department received photographic documentation on 11/02/2018 that the material along the exterior of the east wall of the bunker was removed and replaced with clay soils.

- ii. **The condition of the clay should be monitored at least weekly to ensure that it is functioning properly and leachate and/or process wastewater are not discharging.**

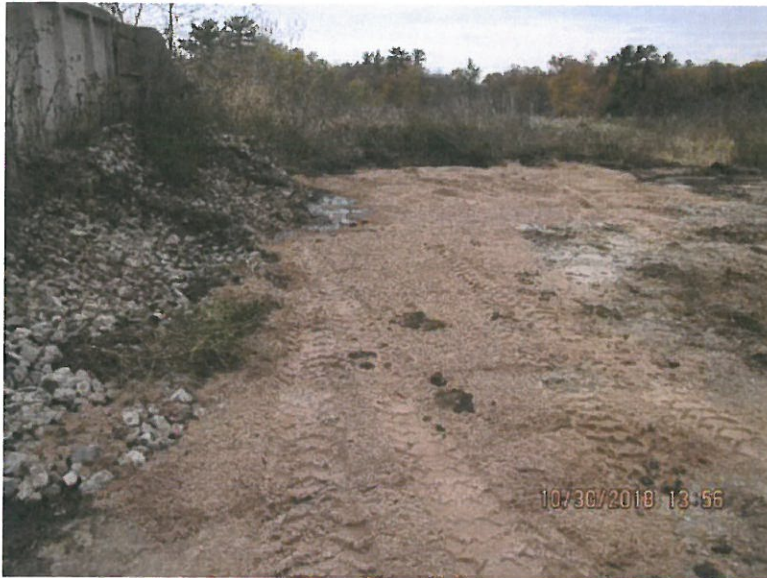
**Photo 61:** View of the area outside the east wall of the FSA, showing rocks and vegetation piled against the wall and sand spread on the ground. Photo direction is north.

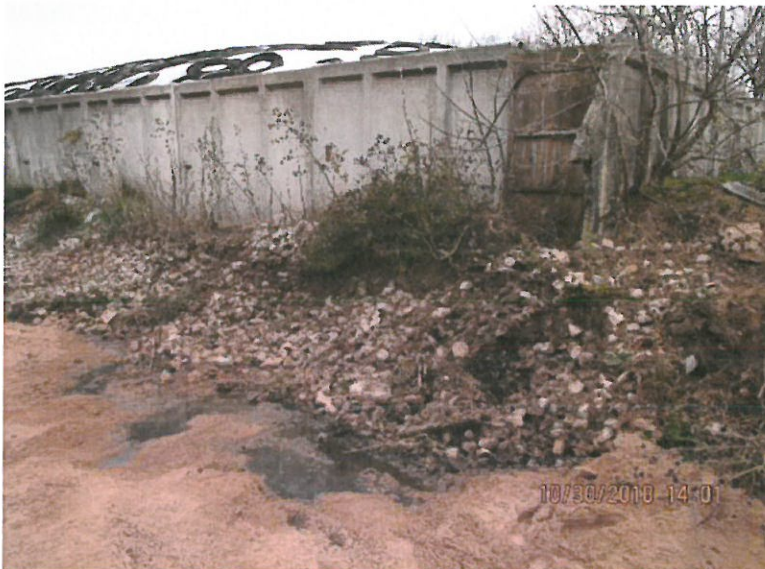
**Photo 62:** View of the NE corner of the FSA where leachate has been observed discharging during previous site inspections. Leachate is visible ponded on the ground outside the dirt/stone/sand pile outside the wall. Photo direction is west.

2. Feed storage area (main farm site)
  - a. Leachate was visible discharging from the northeast corner of the bunker wall to the vegetated area north of the feed storage area. Leachate was observed ponded in areas of burnt out/dead vegetation in the vegetated area north of the feed storage area. Materials placed along the exterior of the east bunker wall appeared to require maintenance to continue to function as a method to contain leachate generated by feed. Waste/blown feed appeared to be mixed in with the material placed along the exterior of the bunker walls.

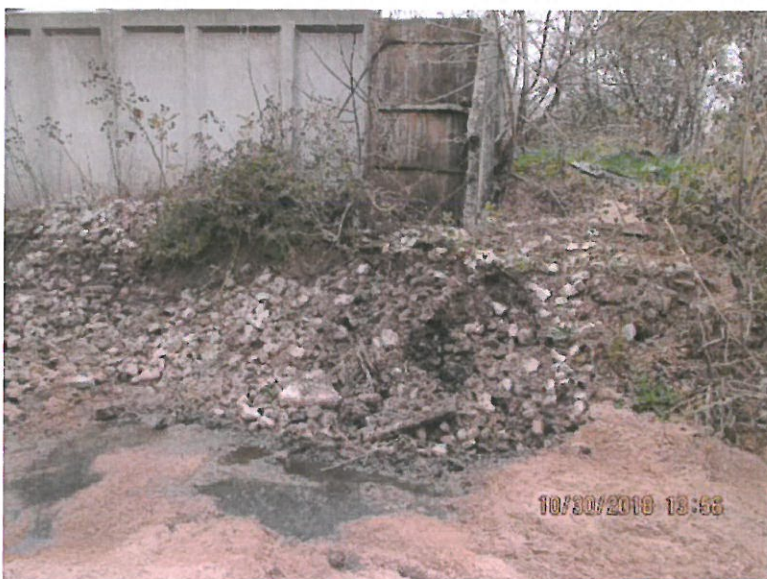
**Photo 63:** Close up view of the NE corner of the FSA where leachate has been observed discharging during previous site inspections. Leachate is visible ponded on the ground outside the dirt/stone/sand pile outside the wall. Photo direction is west.

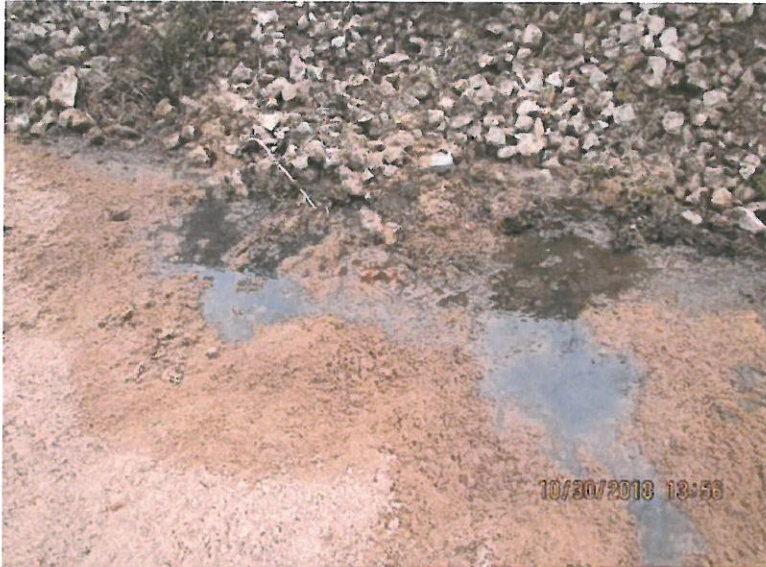
**Photo 64:** Close up view of the ponded leachate outside the wall of the NE corner of the FSA. Photo direction is down and west.

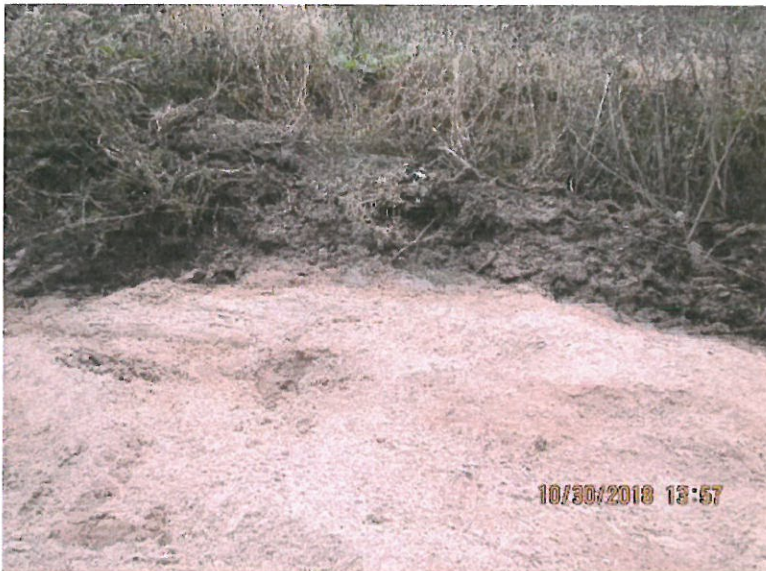
**Photo 65:** Close up view of leachate and feed solids near the NE corner of the FSA. Sand covering the ground is visible in the foreground. Photo direction is north and down.

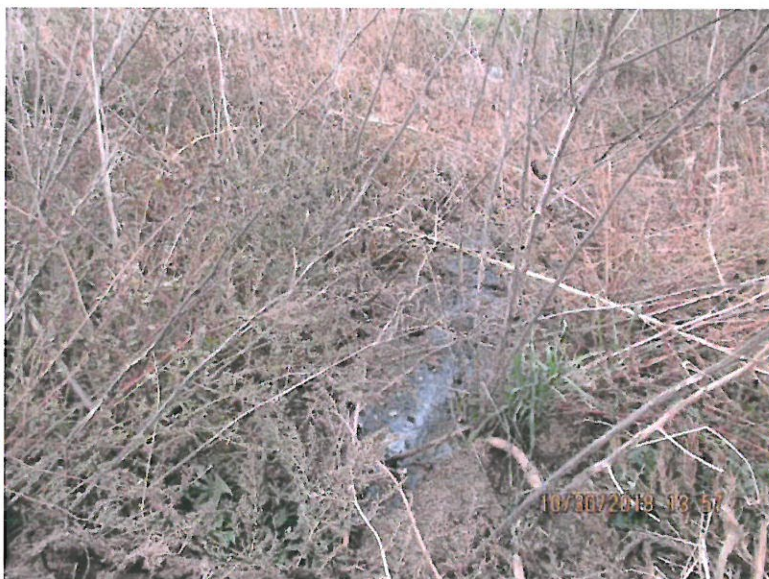
**Photo 66:** View of a ponded area of leachate and dead vegetation in the field/vegetated area N/NE of the FSA. Photo direction is north and down.

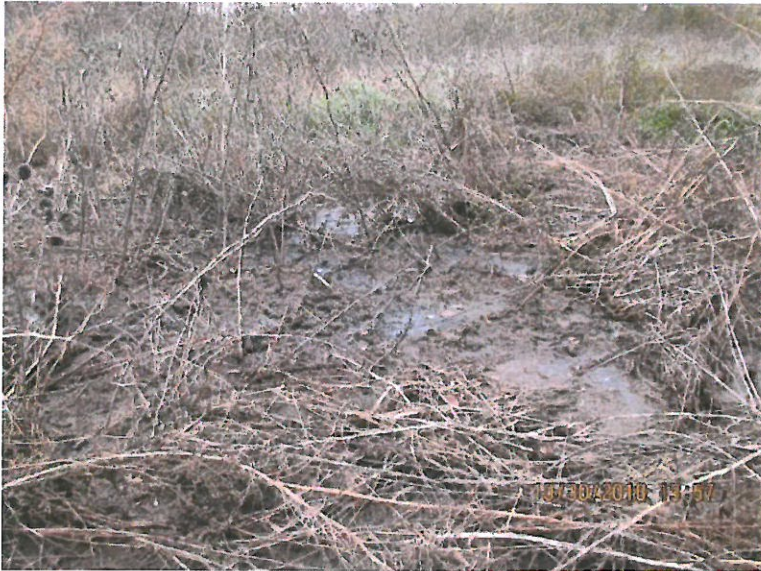
**Photo 67:** View of the leachate discharge pathway northward into the vegetated area N/NE of the FSA. Ponded leachate and dead vegetation are visible. Photo direction is N/NW.

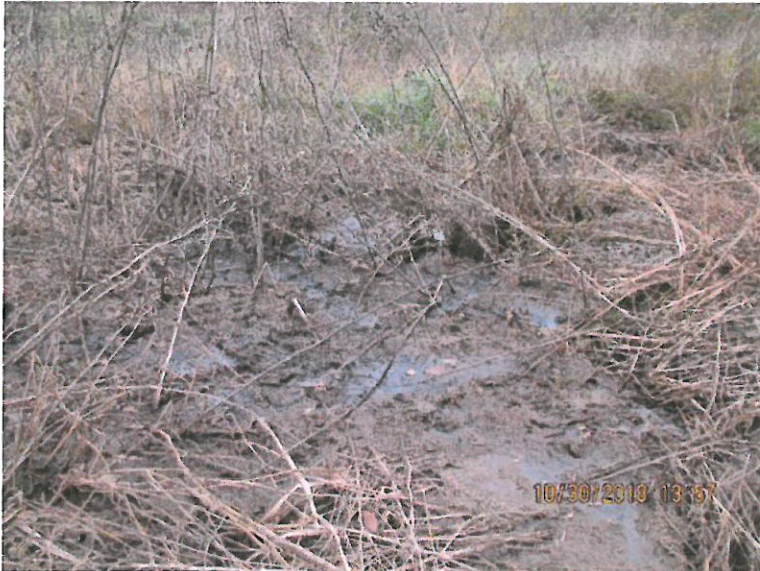
**Photo 68:** View of the leachate discharge pathway northward into the vegetated area N/NE of the FSA. Ponded leachate and dead vegetation are visible. Photo direction is N/NW.

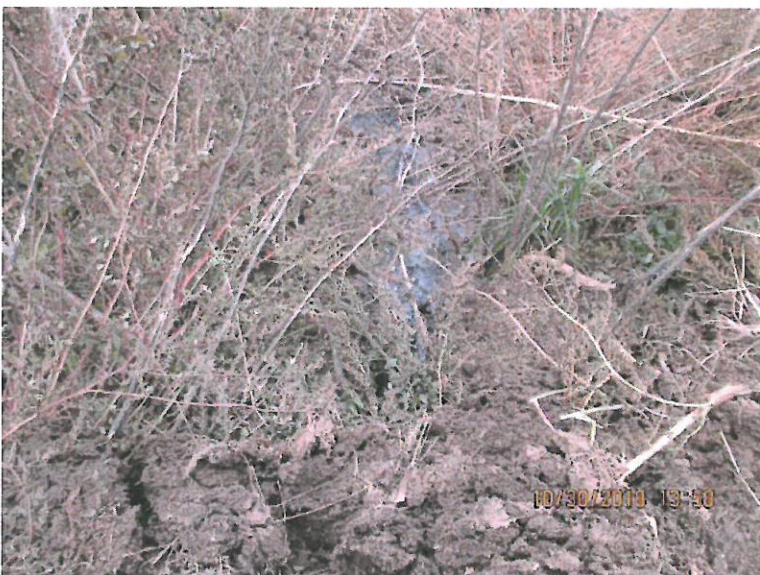
**Photo 69:** View of the leachate discharge pathway northward into the vegetated area N/NE of the FSA. Ponded leachate, dead vegetation, and feed solids are visible. Photo direction is down and N/NW.

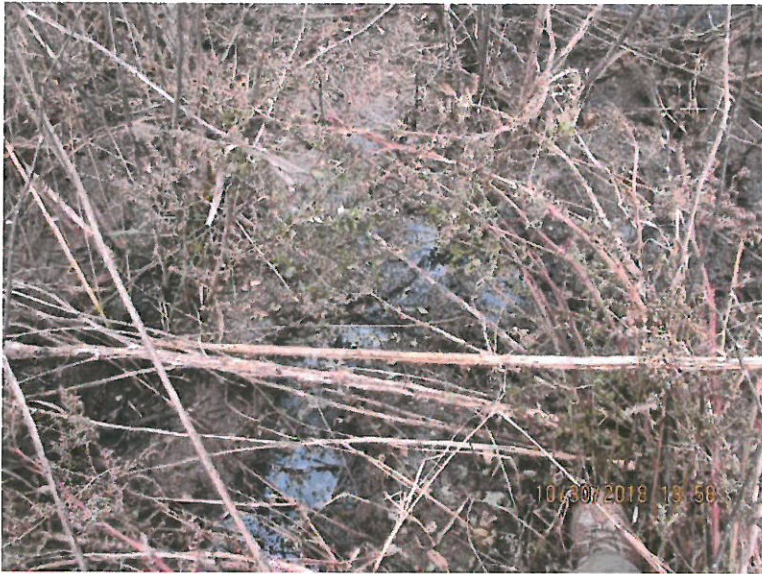
**Photo 70:** View of the leachate discharge pathway northward into the vegetated area N/NE of the FSA. Ponded leachate and dead vegetation are visible. Photo direction is down.

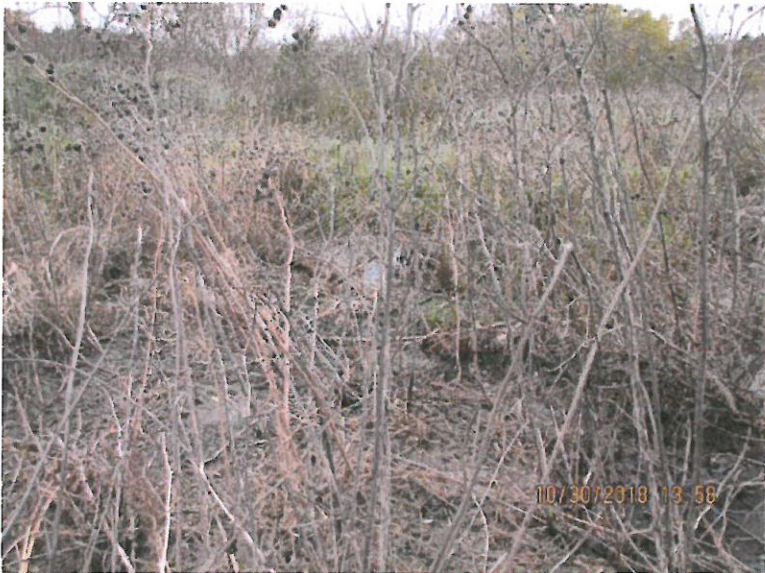
**Photo 71:** View of the leachate discharge pathway northward into the vegetated area N/NE of the FSA. Ponded leachate and dead vegetation are visible. Photo direction is N/NW.

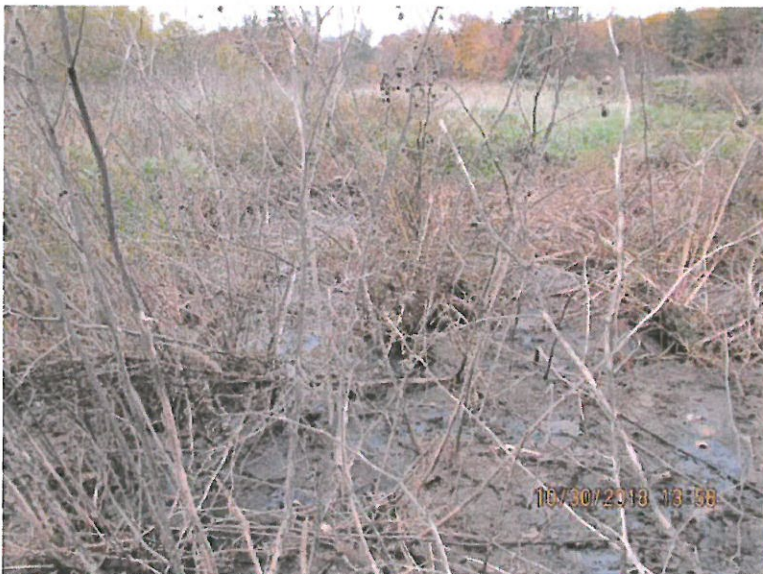
**Photo 72:** View of the leachate discharge pathway northward into the vegetated area N/NE of the FSA. Ponded leachate and dead vegetation are visible. Photo direction is N/NW.

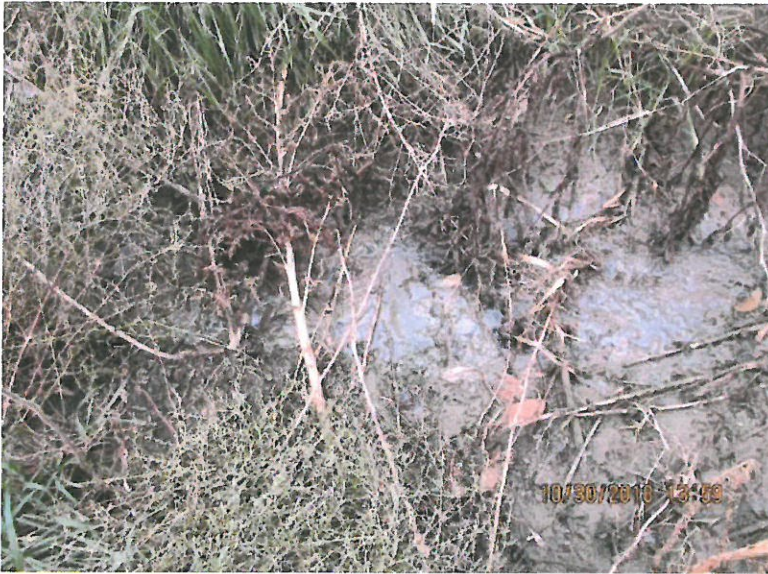
**Photo 73:** Close up view of the leachate discharge ponded in the vegetated area N/NE of the FSA. Dead vegetation is also visible. Photo direction down.

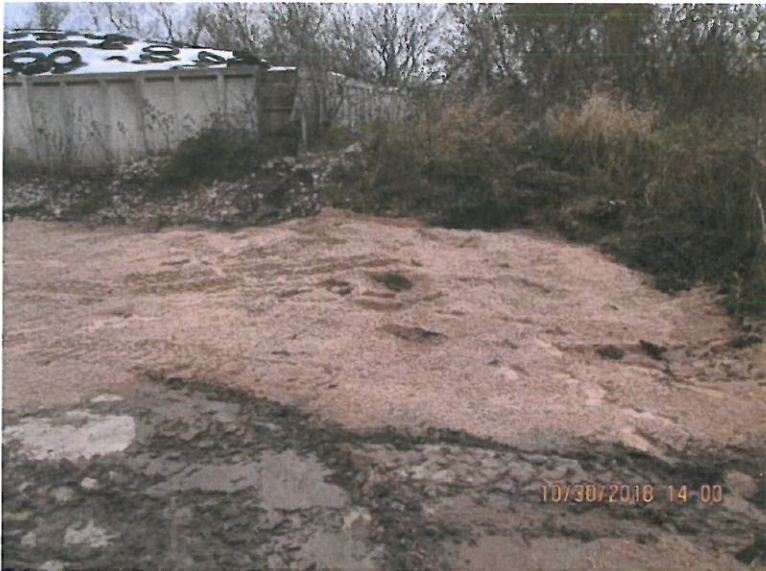
**Photo 74:** Alternate view of the NE corner of the FSA showing the piled stones, sand, and feed solids. Photo direction is west.

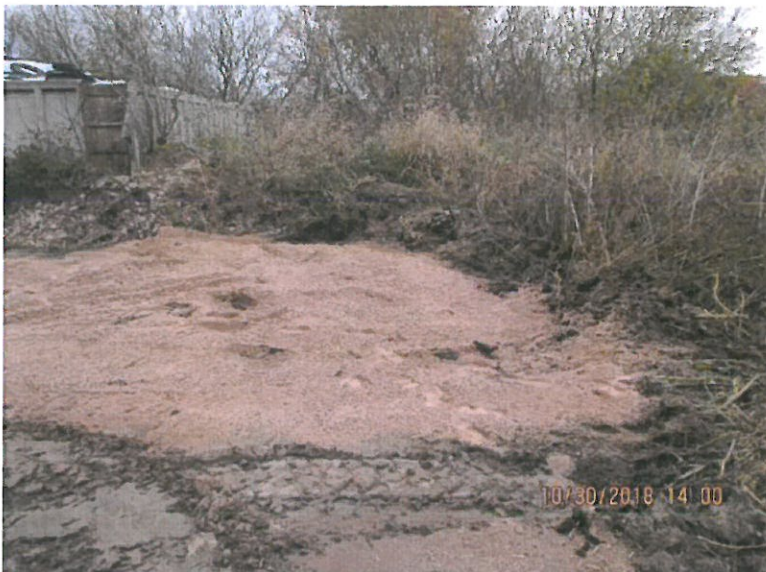
**Photo 75:** View of the sand and feed solids pushed into the vegetated area N/NE of the FSA. Photo direction is west.

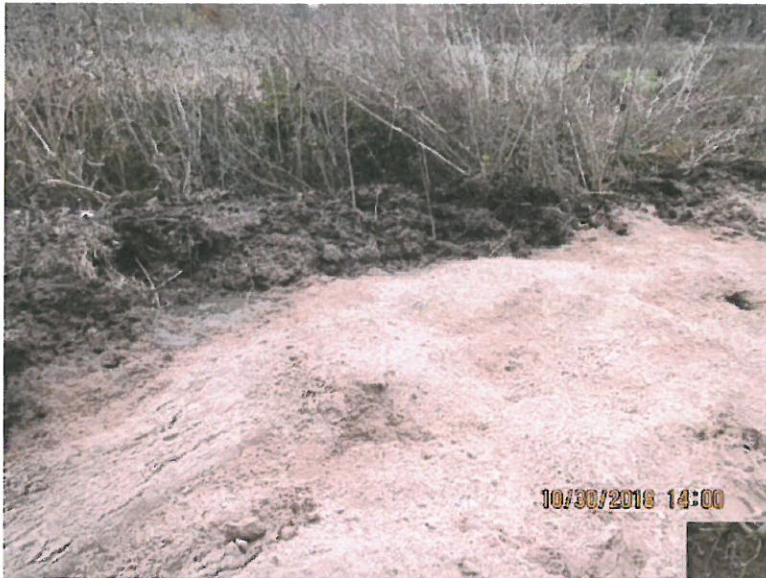
**Photo 76:** Close up view of the sand and feed solids pushed into the vegetated area N/NE of the FSA. Photo direction is north.

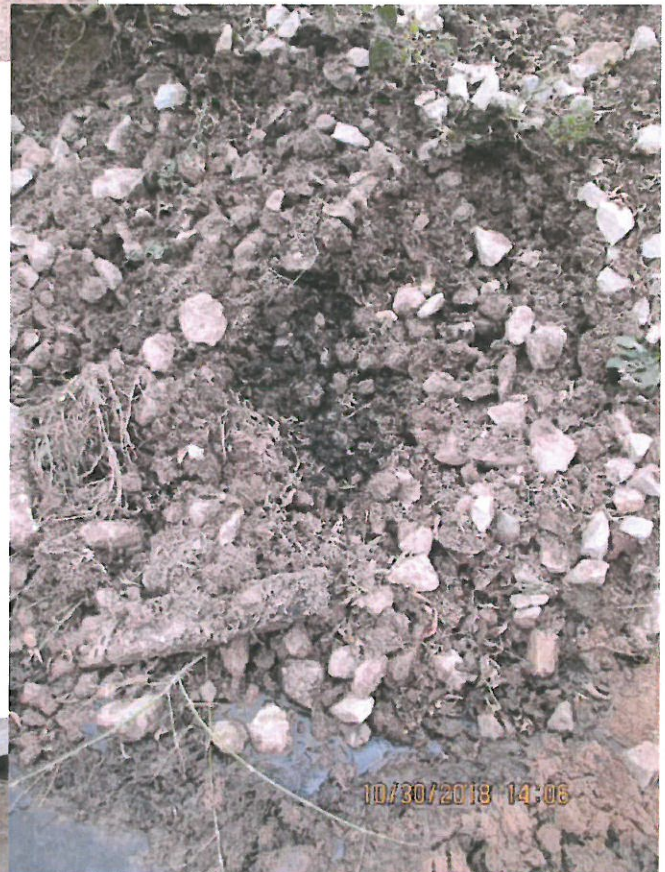
**Photo 77 (right):** Close up view of the stone, feed solids, and soil mixture piled against the exterior of the east wall of the FSA. Leachate seepage is visible. Photo direction is west and down.

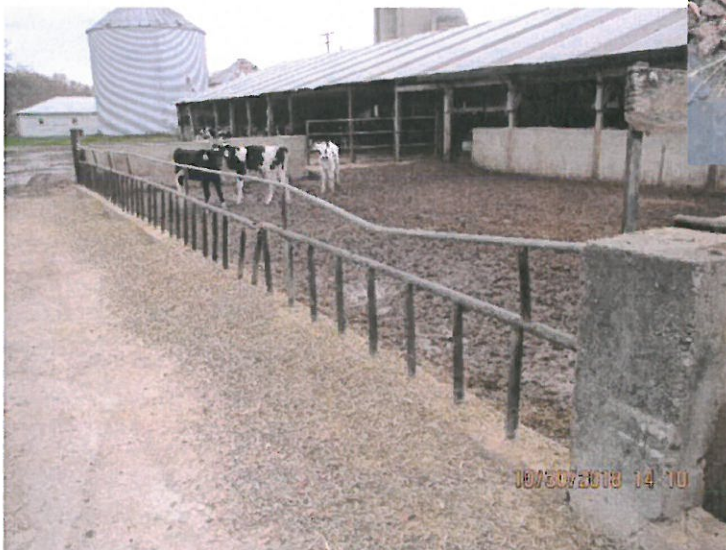
**Photo 78 (left):** View of the west end of the concrete heifer lot. Photo direction is W/NW.

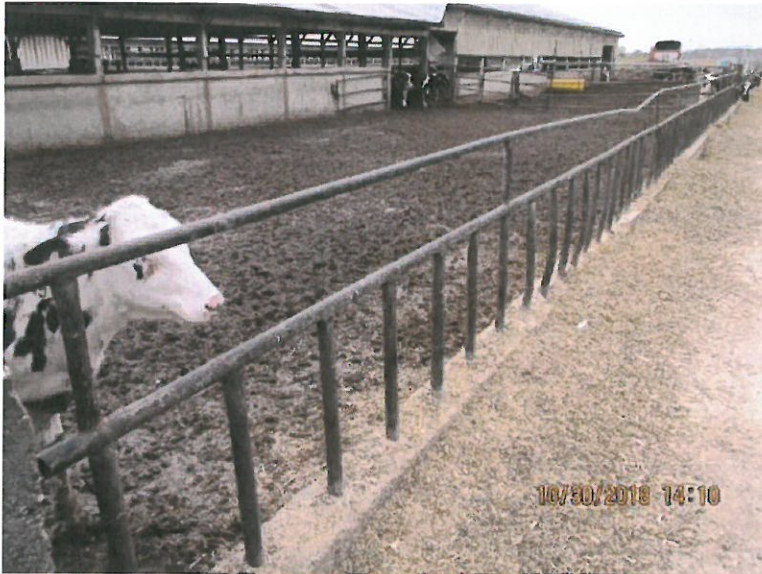
**Photo 79:** View of the middle section of the concrete heifer lot. Photo direction is east.

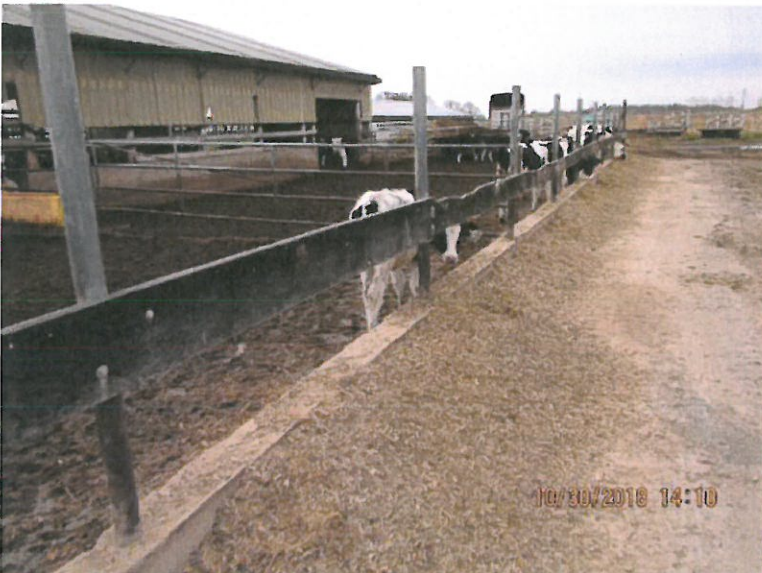
**Photo 80:** View of the east end of the concrete heifer lot. Photo direction is east.

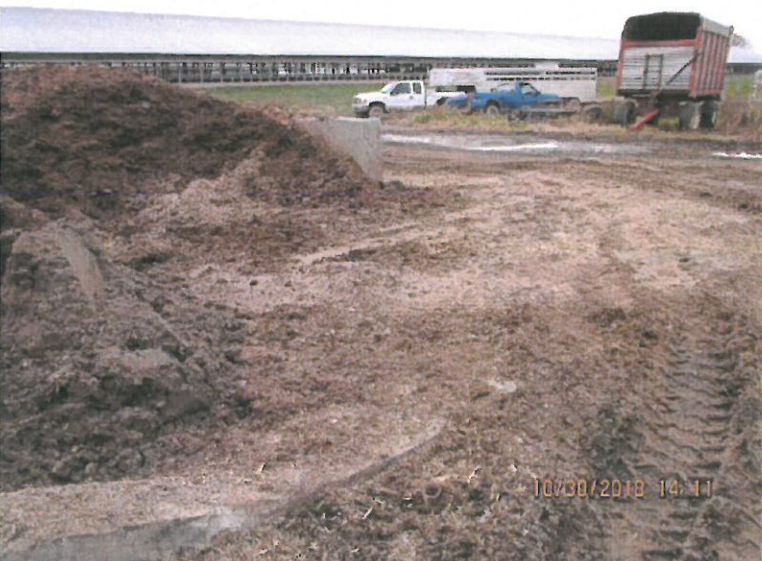
**Photo 81:** View of the concrete pad and partially walled east end/NE corner of heifer lot. Photo direction is NE.

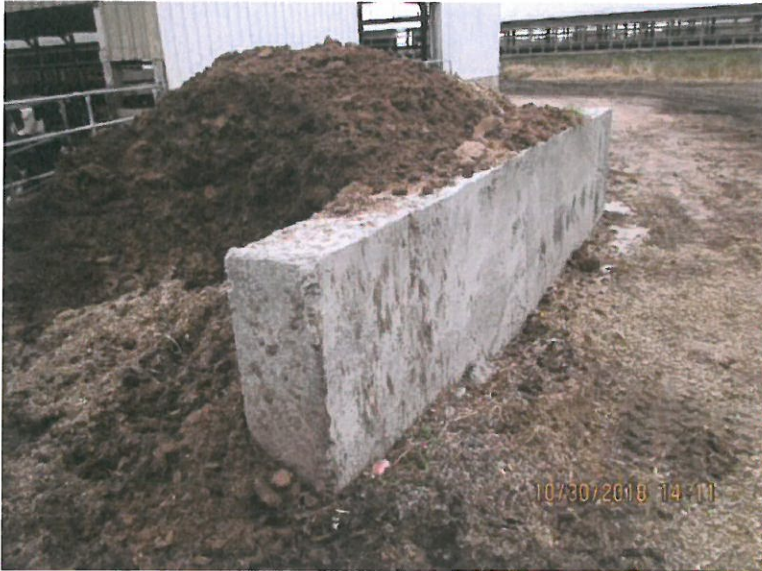
**Photo 82:** View of the NE corner of the concrete heifer lot. Photo direction is NW.

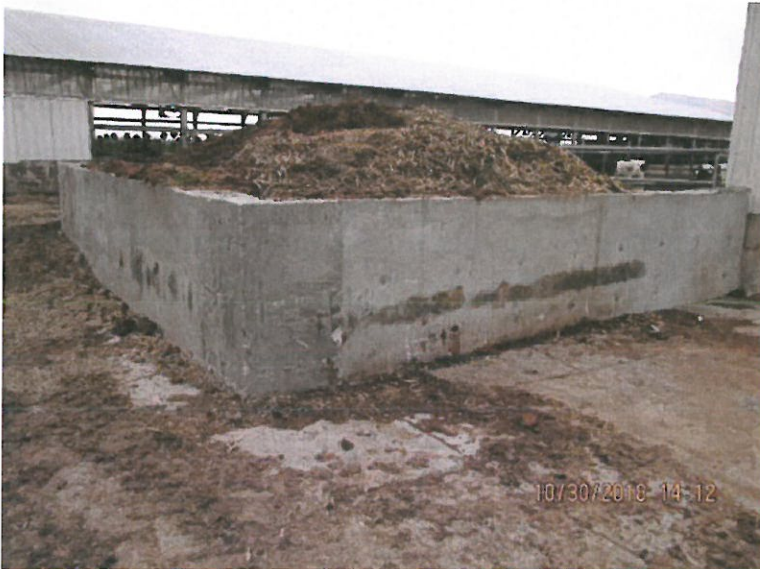
**Photo 83:** Alternate view of the NE corner of the concrete heifer lot, showing the exterior of the walls. Photo direction is SW.

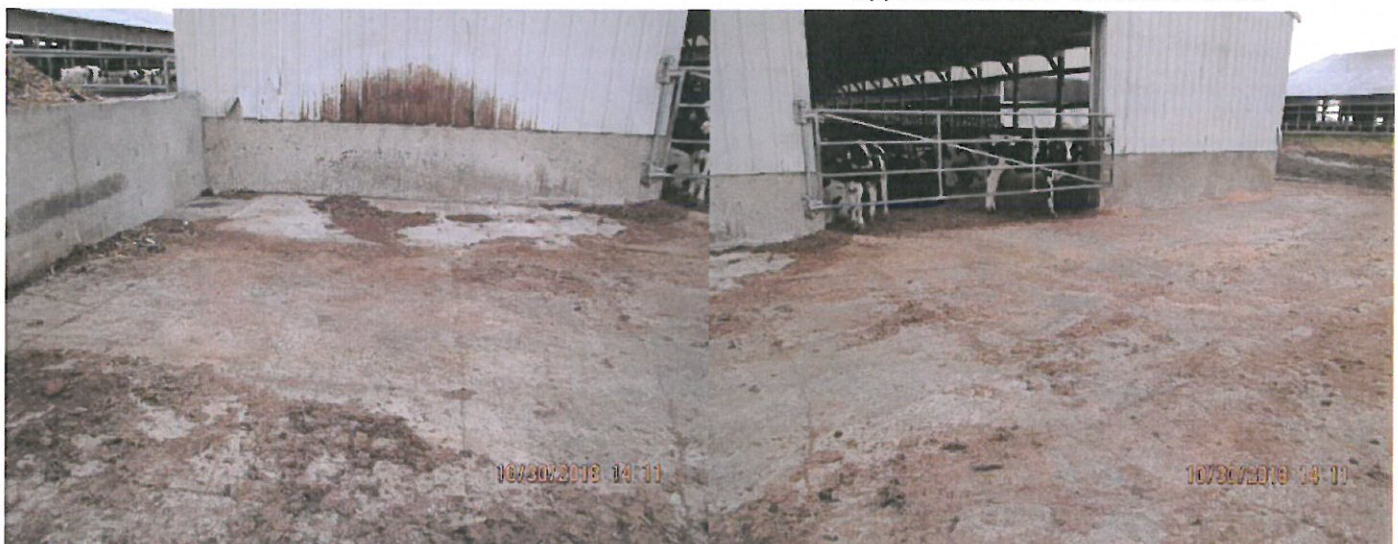
**Photos 84 & 85 (below):** View of the areas east of the heifer barn previously used to stack solid manure from the heifer barn prior to land application. Photo direction is west.
