2017 Wisconsin Land and Water Conservation Annual Report

Department of Agriculture, Trade and Consumer Protection

Department of Natural Resources

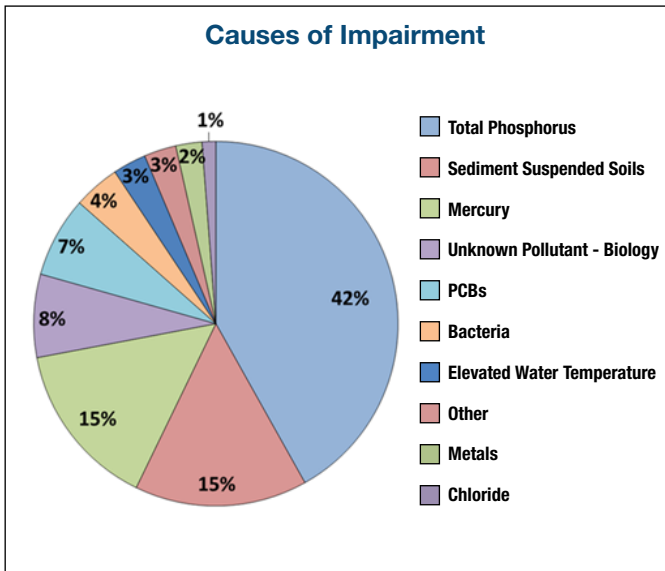
Causes of impairment (or pollutants) for waters included on Wisconsin's 2016 CWA Section 303(d) list of impaired waters.

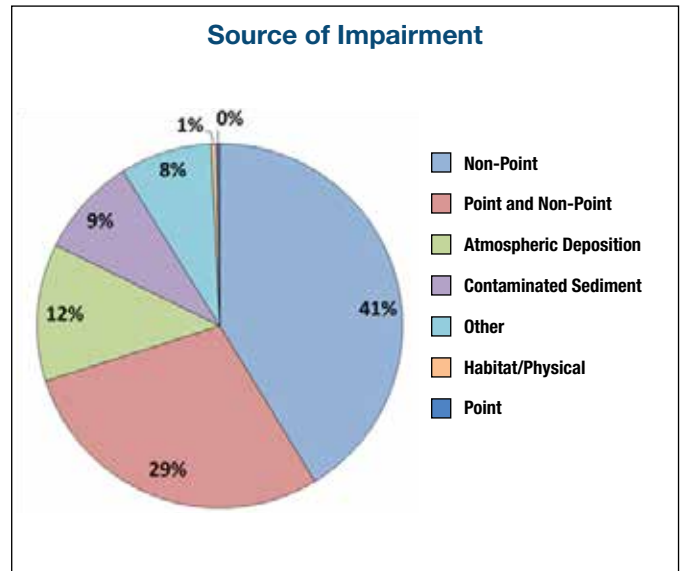
Impairment source categories for impaired waters listings included on the 2016 impaired waters list.

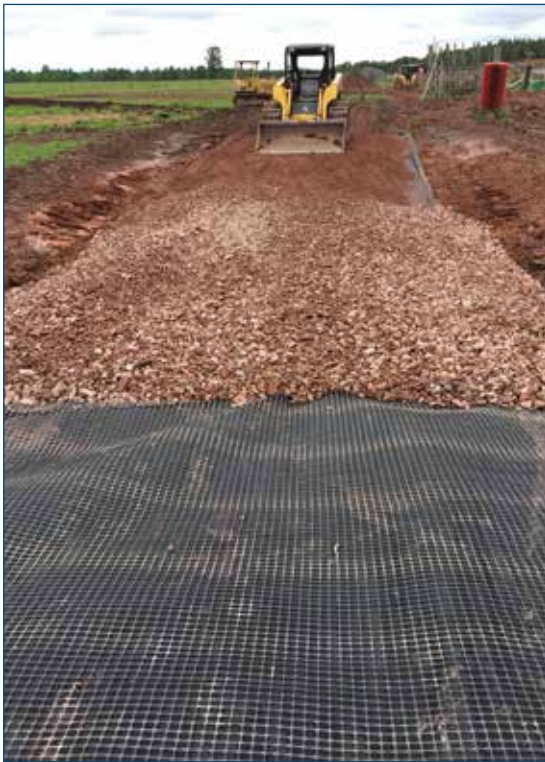
Gravel crossing, Ashland County. Photo: Tom Fratt

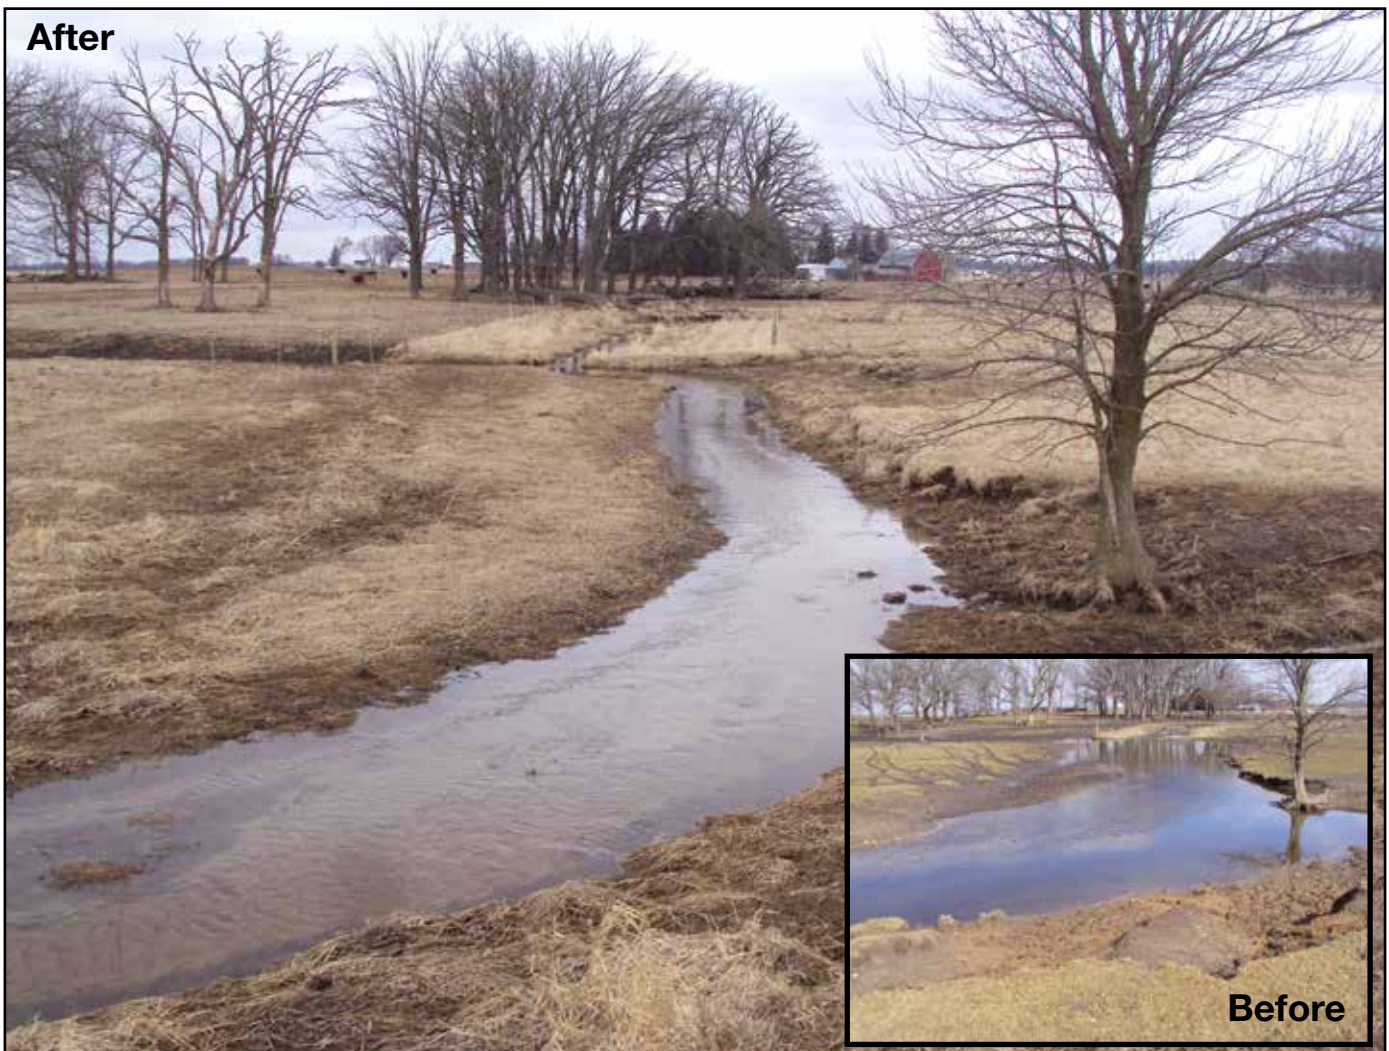
Stabilized and seeded streambanks return Crawfish Creek to its channel

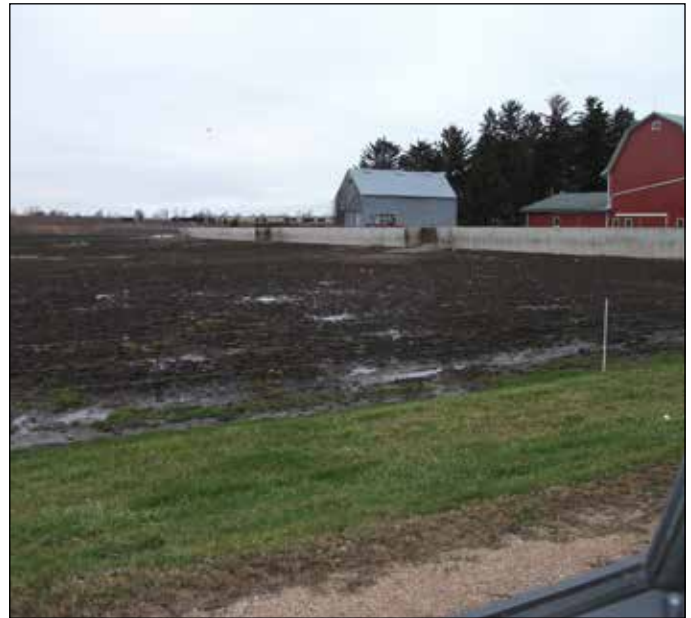
Before: The undeveloped area around the feed bunker kept growing at the Hahn’s farm every year

Hahn himself covered the rest of the costs. As the before and after photos show, the results are dramatic.

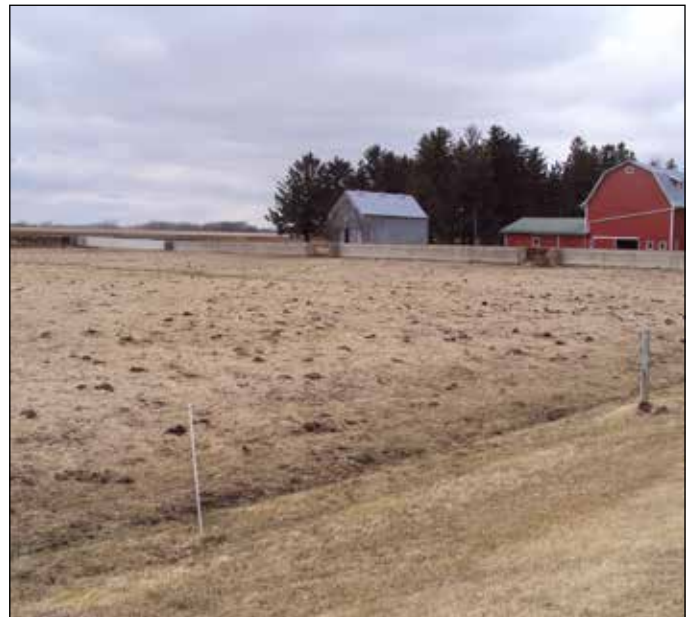
After: Traffic lanes between feed bunkers and pastures and reseeding controlled runoff and gave calves better access to clean water

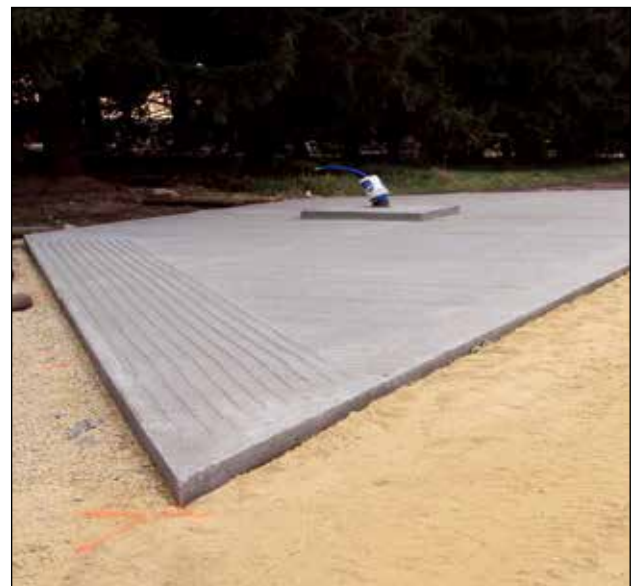
Feed lane with newly installed watering station

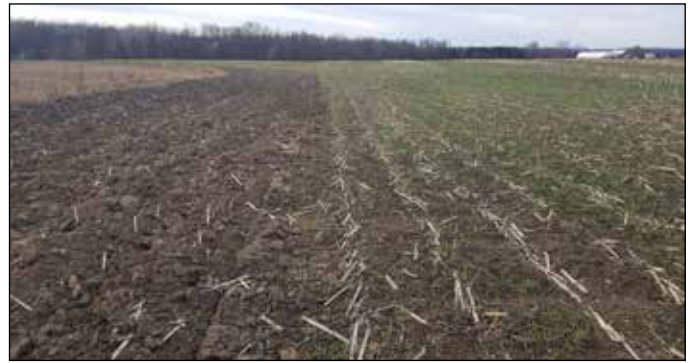
A split between deep tillage and seeded cover crop one month after planting on Hodorff’s farm, useful for tillage checks to see if there is a difference in the crop throughout the season, or just a savings on fewer passes through the field

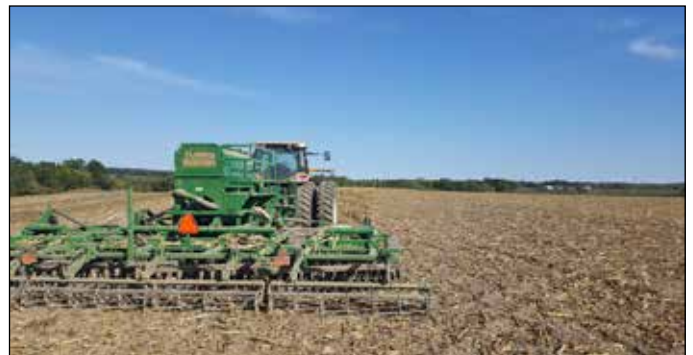
Hodorff’s Turbo Max vertical tillage unit with Turbo Seeder for applying cover crops in one pass after silage harvest

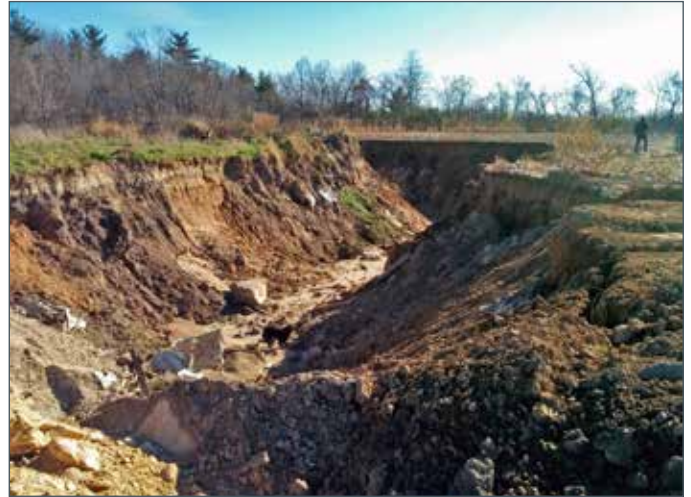
Eroded Channel: 22-foot deep gully cutting through the Swoboda's crop field

In mid-July 2016, huge rain storms hit west central Wisconsin, causing significant flooding and related damages throughout the region. A single storm dumped eight inches of rain on the Swoboda's farm, something Bryon had never experienced before. The unprecedented volume of water pummeled the edges of his field and adjacent drainage ways. When the storm subsided, a gully the length of a football field was left running like a massive gash up the field.

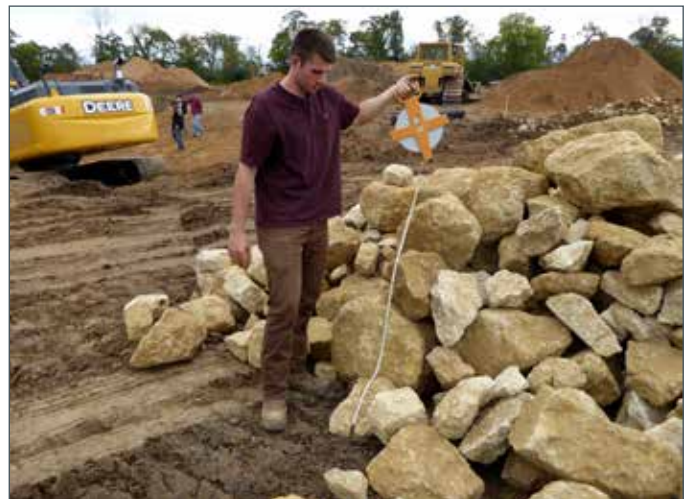
Jared Looney, Chippewa County Engineering Intern, measures gradation of limestone riprap

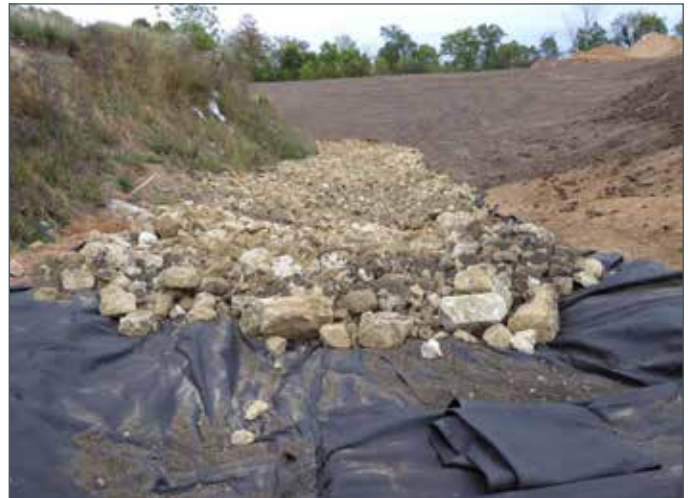
Bottom of the channel, during placement of geotextile fabric and riprap

A berm and grass buffer were built between the crop field and the waterway to catch runoff from the field and divert it to the head of the channel. Three rock-check dams, one at the mouth and two at the base, were installed to manage the volume of water that was being diverted into the channel. Additionally, a smaller gully was partially filled and capped with topsoil to prevent damage on the far side of the berm.

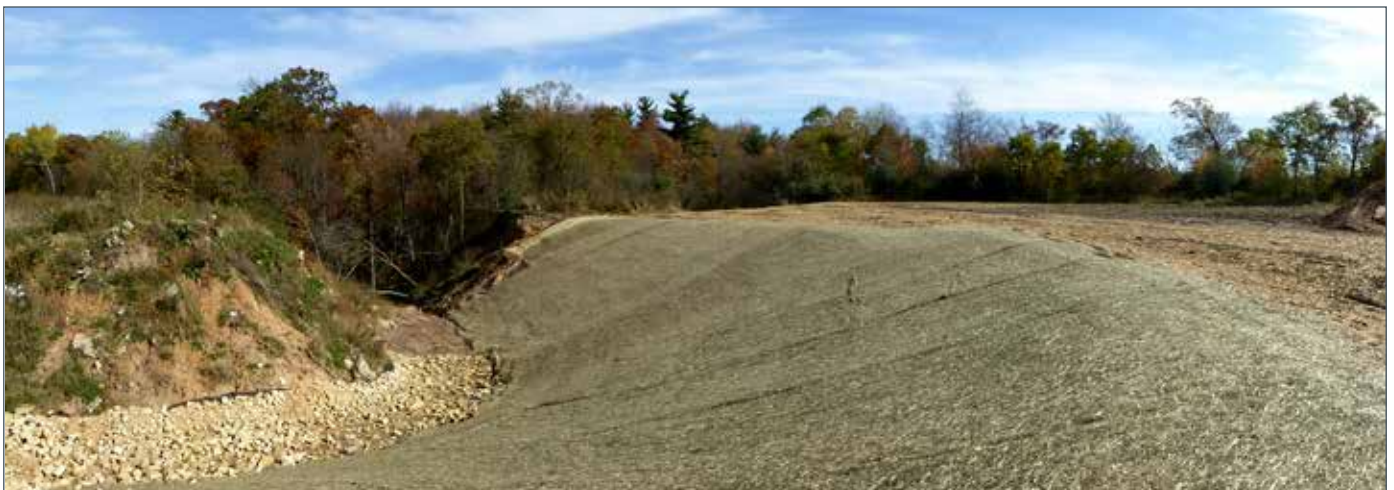
Finished project: Rock-lined channel and seeded slopes protected with erosion control mats

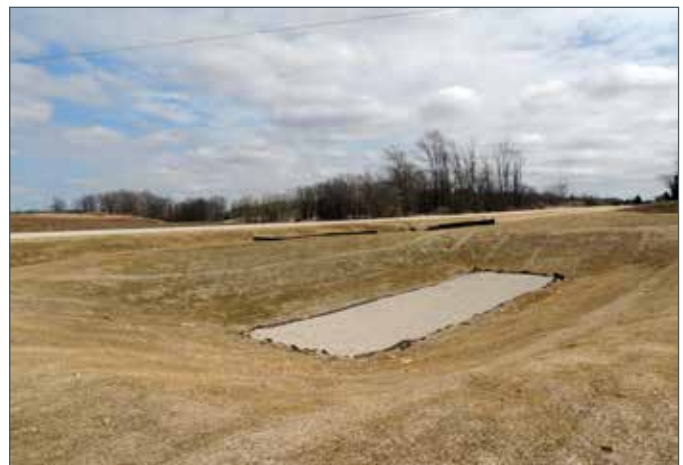
Completed iron filtration bed on the north edge of Jen's property (looking north towards the lake)

Preliminary water testing indicated an 88 percent reduction in dissolved phosphorus. “We’ve seen some fluctuation since then,” Emily said, “as we’ve slowed down through the winter season. Our department will be collecting grab samples and keeping record of weather conditions, so when we have more data, we can look for better

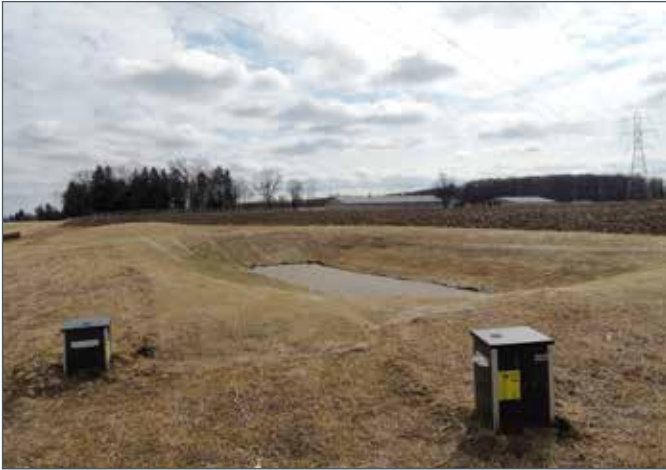
Dissolved phosphorous monitoring stations/water volume control boxes (R- intake; L- outflow)

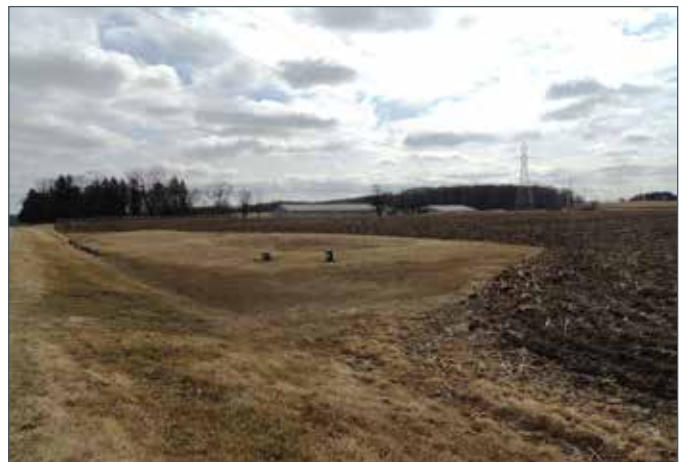
Full size of the filter; half acre in size

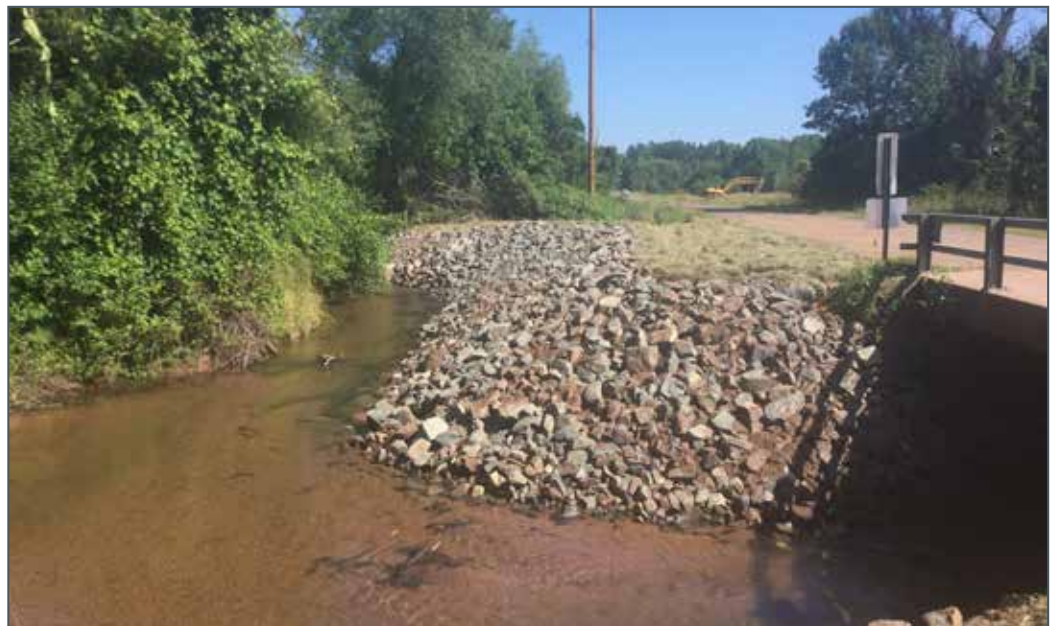
The completed streambank riprap installed on Whittlesey Creek reduces sedimentation and protects the stream crossing

Streambank erosion occurring several hundred feet upstream became a threat to this small refuge in 2016 when a big storm accelerated the problem. Overnight, the rain washed a large amount of sediment away, causing the bank to slump, and brought the streambank up to a town road bridge's concrete wall and within five feet of a power pole. With the power pole and bridge in jeopardy, and the resulting sedimentation of the creek from the failing bank, something needed to be done.

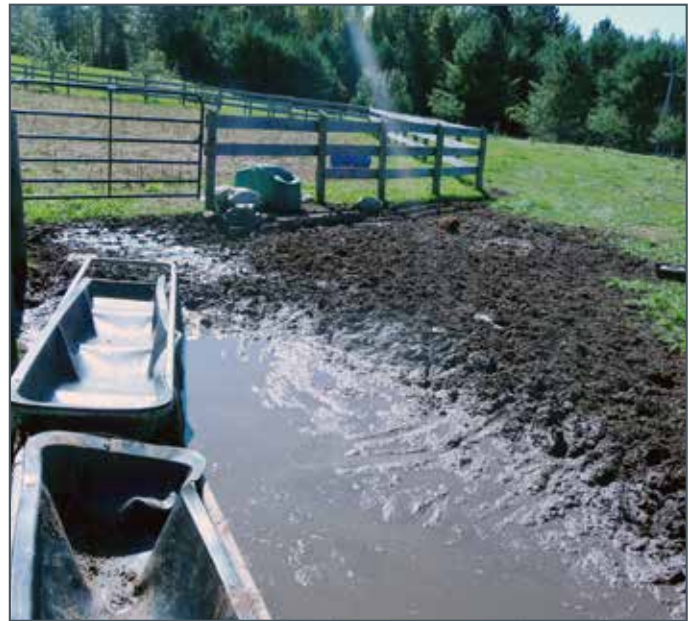
Muddy conditions around the water fixture were made worse by heavy rains, and erosion to a nearby stream was evident

At the site, cattle accessed both a watering trough and a protective shed. Muddy conditions from the traffic were exacerbated by the spring melt and recent heavy rains. Erosion to a nearby stream was clearly an issue. “The soils were compacted, disturbed, and did not drain even after a minor rain event,” says Karl. “The cattle got really muddy.” He explains that the horses and cattle were congregating to get out of the wind, further compacting the soil. To make matters worse, water was flowing downhill into the shed and creating several feet of muck, which was especially problematic because it took a long time to dry out.

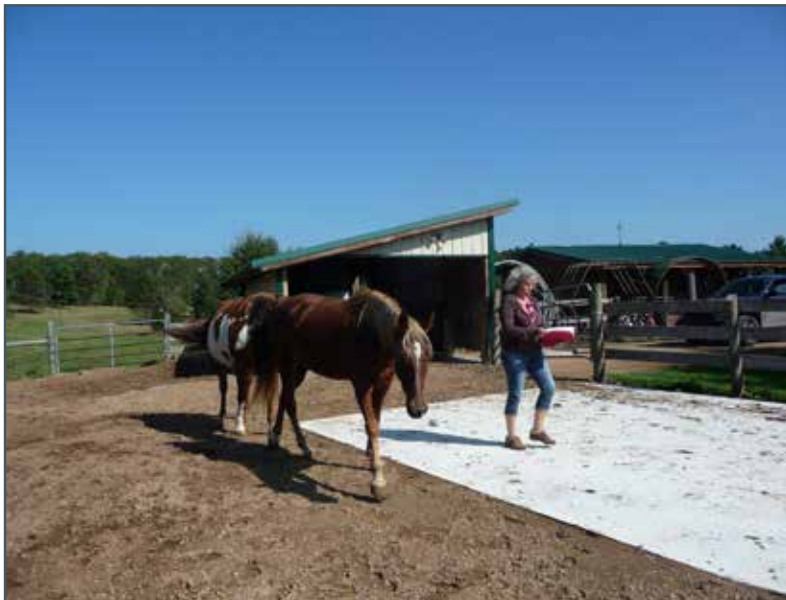
The newly installed concrete slab helps prevent soil compaction and soil erosion

county had previously worked with them on a watering fixture and fencing. Using county cost-sharing, and working with a local concrete supplier familiar with requirements for concrete mix and sealant, they installed a 90-foot access road that consisted of two concrete slabs and a gravel apron to allow the runoff water to infiltrate and limit soil erosion to the stream. One patch of cement went next to the watering fixture and the other next to the shed. A couple layers of gravel were added at the gate where the cattle congregate. Not only was the gravel cheaper, but it also allowed for the heavy machinery to drive through. The final result allows the livestock to access water and shelter without compacting the soil and without contributing erosion to a nearby stream.

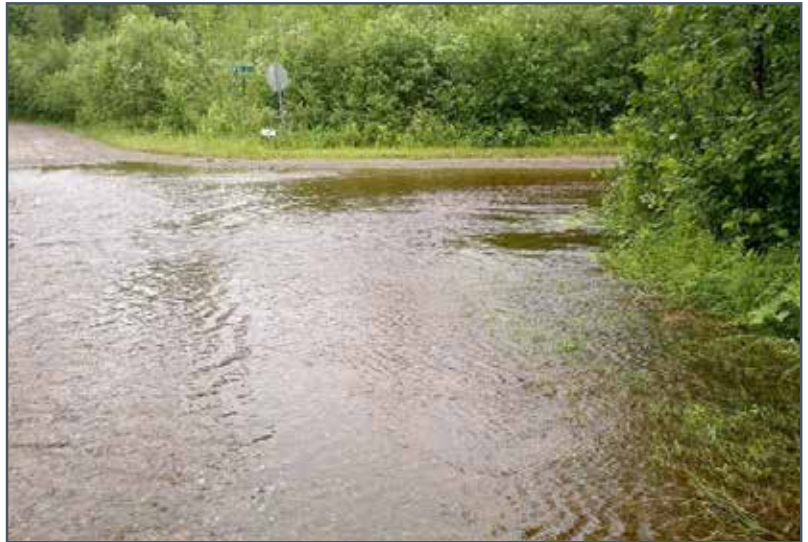
Significant 2017 rains and an undersized culvert led to flooding

In 2017 two undersized culverts on Woods Creek were identified for replacement. Woods Creek is the highest quality trout stream in Florence County, according to Wisconsin DNR surveys. Due to the heavy rains in 2017, another culvert on an unnamed stream was affected. Although not initially planned for, the people and equipment were already in place to make the project cost effective.

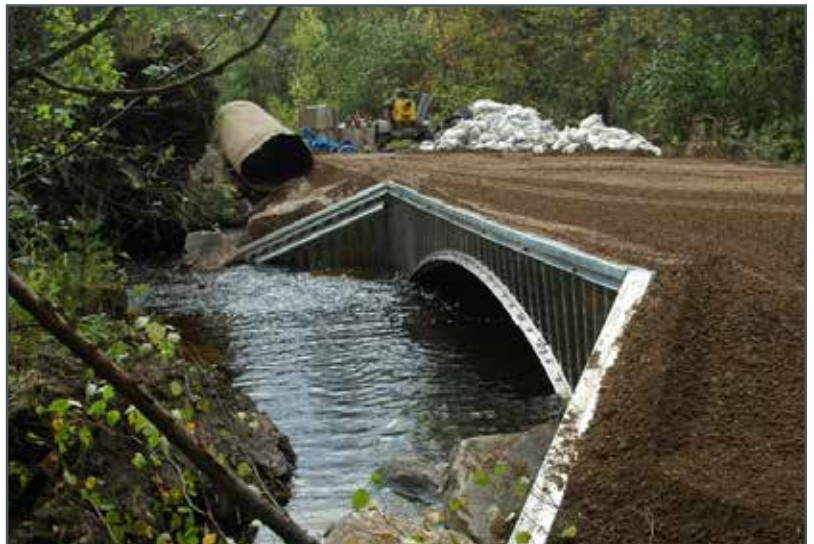
The new culvert has a higher capacity. The old undersized culvert can be seen in the background

These are just the latest of about 30 that have been installed on the creek over the years. “The new structures are very large,” says Stacey. “They are outside of our typical bag of tricks.” No maintenance is needed and no washouts have occurred around the culverts replaced in the past 17 years.

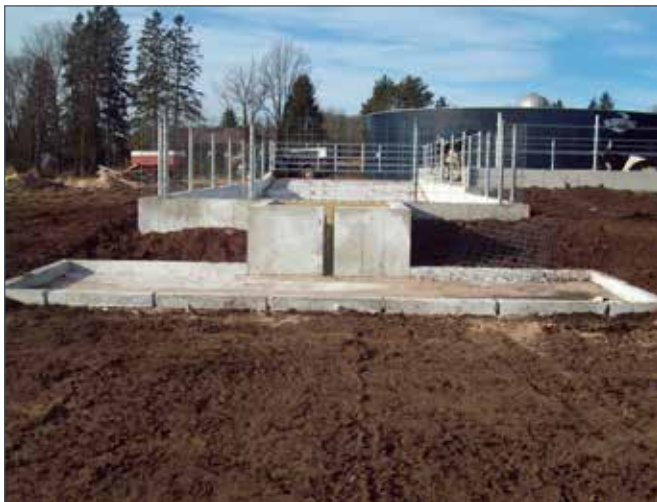
Feedlot spreader box. Photo: Tom Fratt, Ashland County Land and Water Conservation Department
